INL/RPT-22-68773 Revision 0

Post-irradiation Examination Status for the BSU-269 Project

August 2022

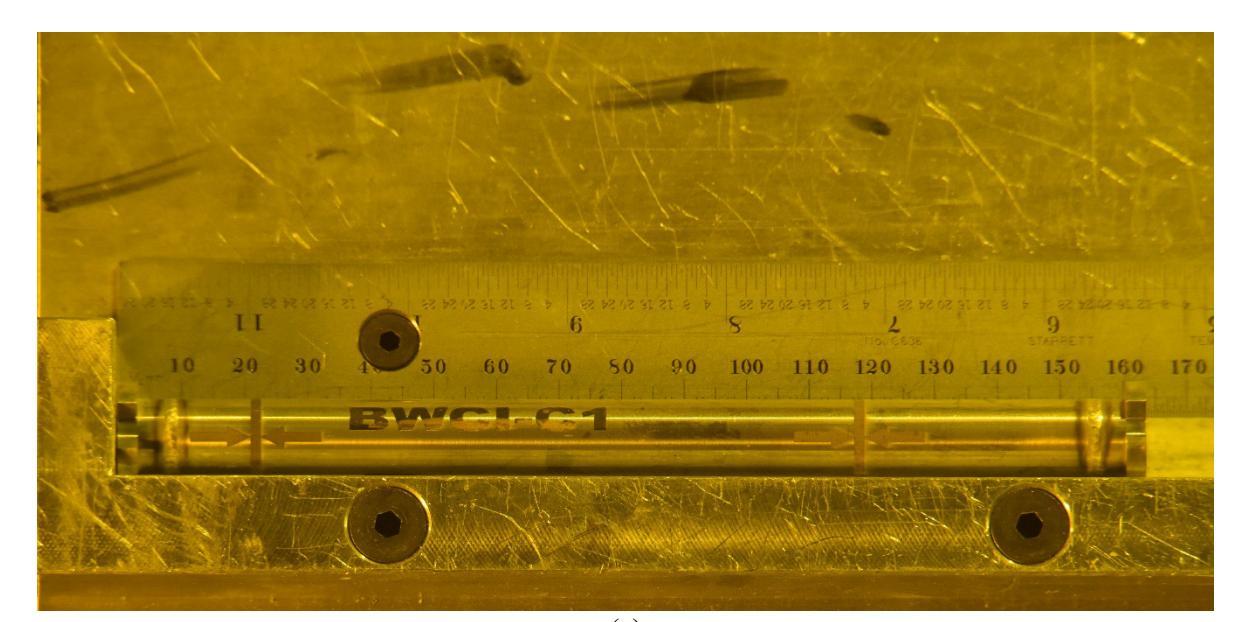
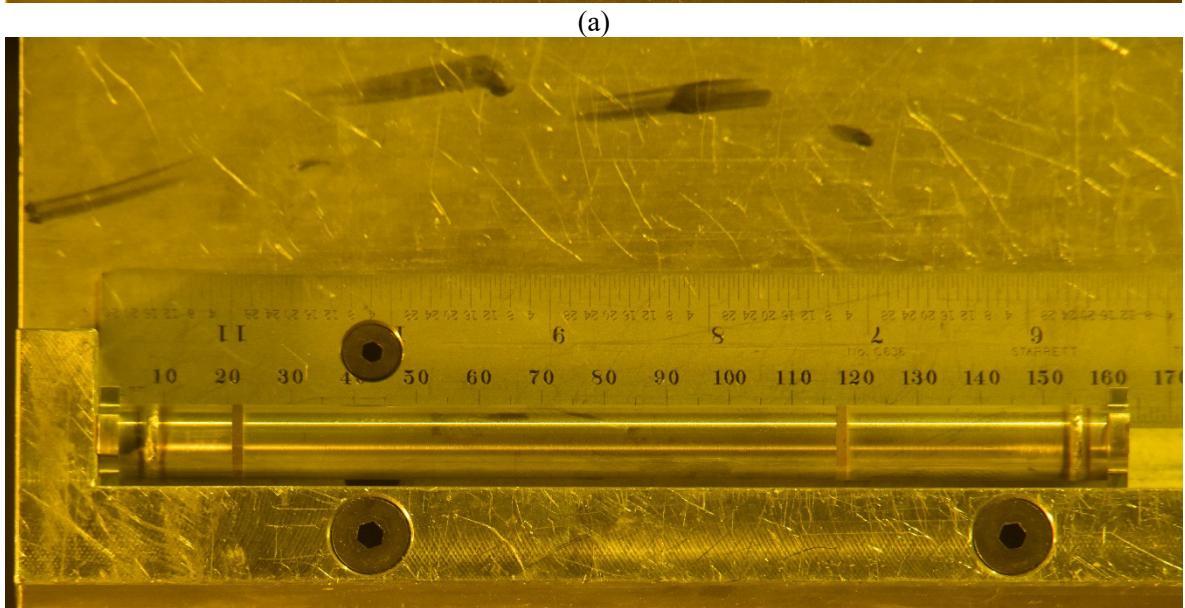
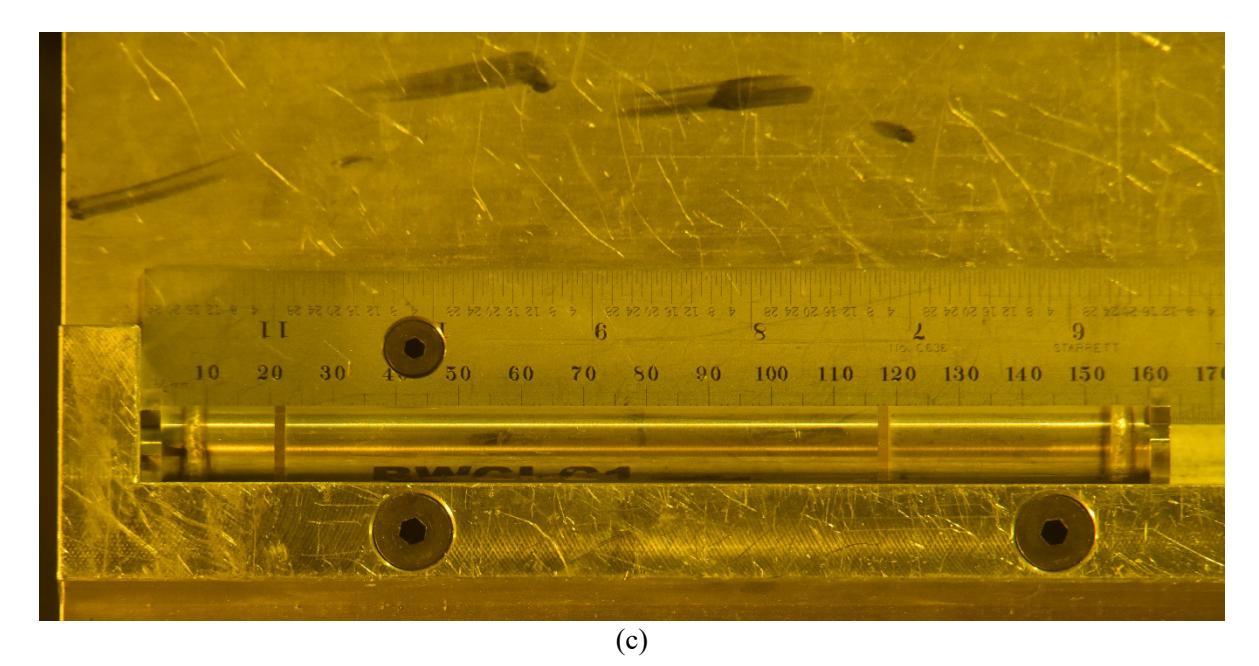
Visual examination of the capsule was performed upon receipt after unloading it from the GE-100 cask. The capsule was placed on the visual examination stand and rotated to inspect the entire circumference. Figure 1a through Figure 1c shows no visible bulging or damage to the capsule which indicates no major issues. Figure 2 shows the radiography of the capsule from which the five Mo cups can be seen. From the radiograph, the cups appear intact and likely in good condition. After the capsule was disassembled the rodlet was inspected and no damage was observed (Figure 3).

Figure 1. (a)-(c) Visual examinations of capsule BWCI-C1 at different azimuthal angles.

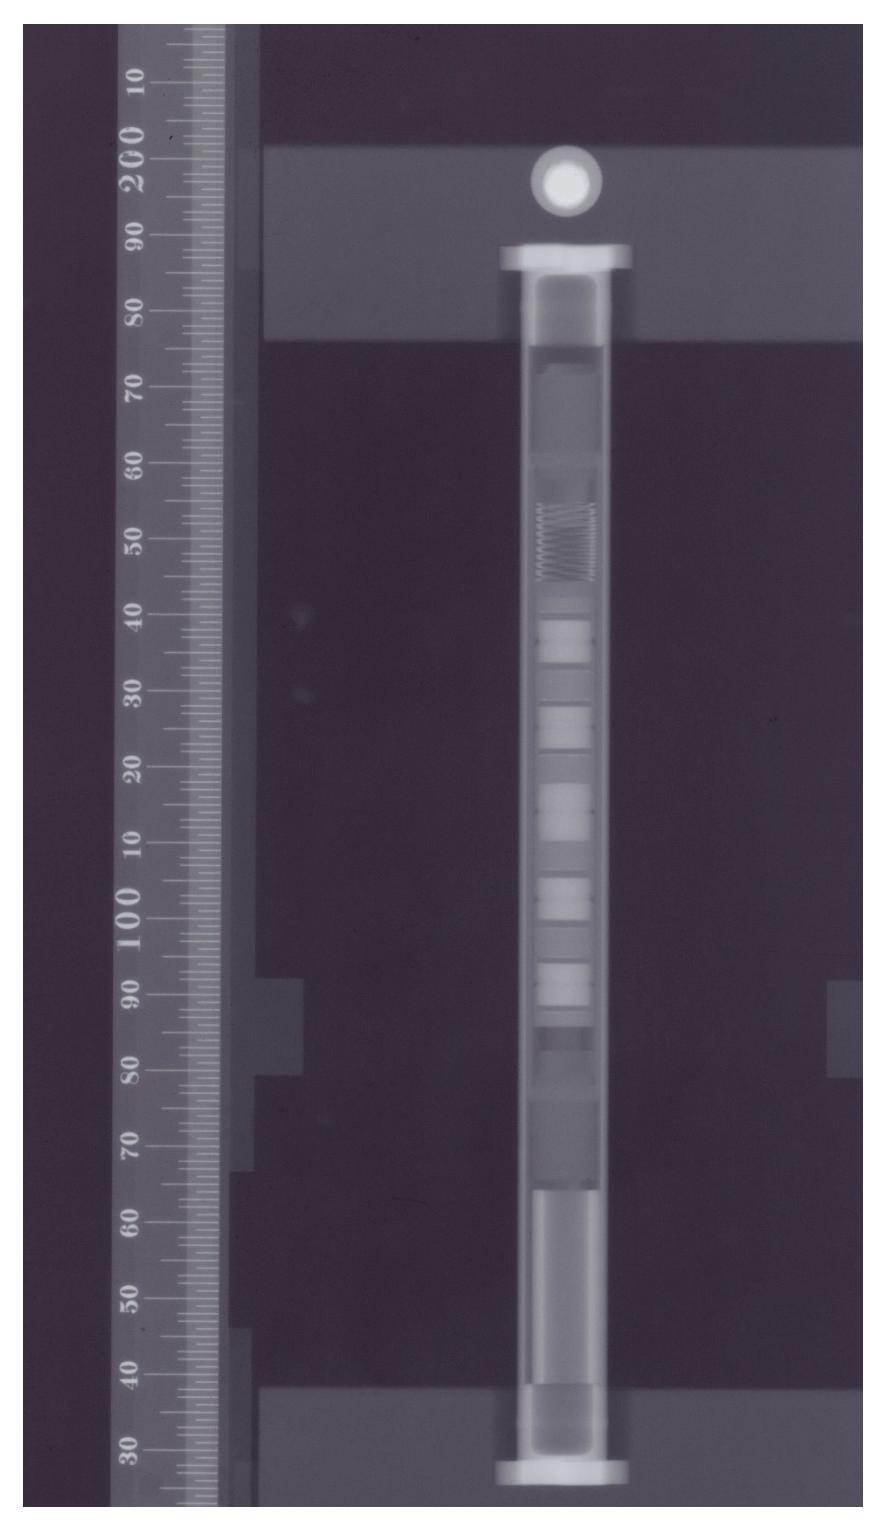
Figure 2. Neutron radiography of the capsule.

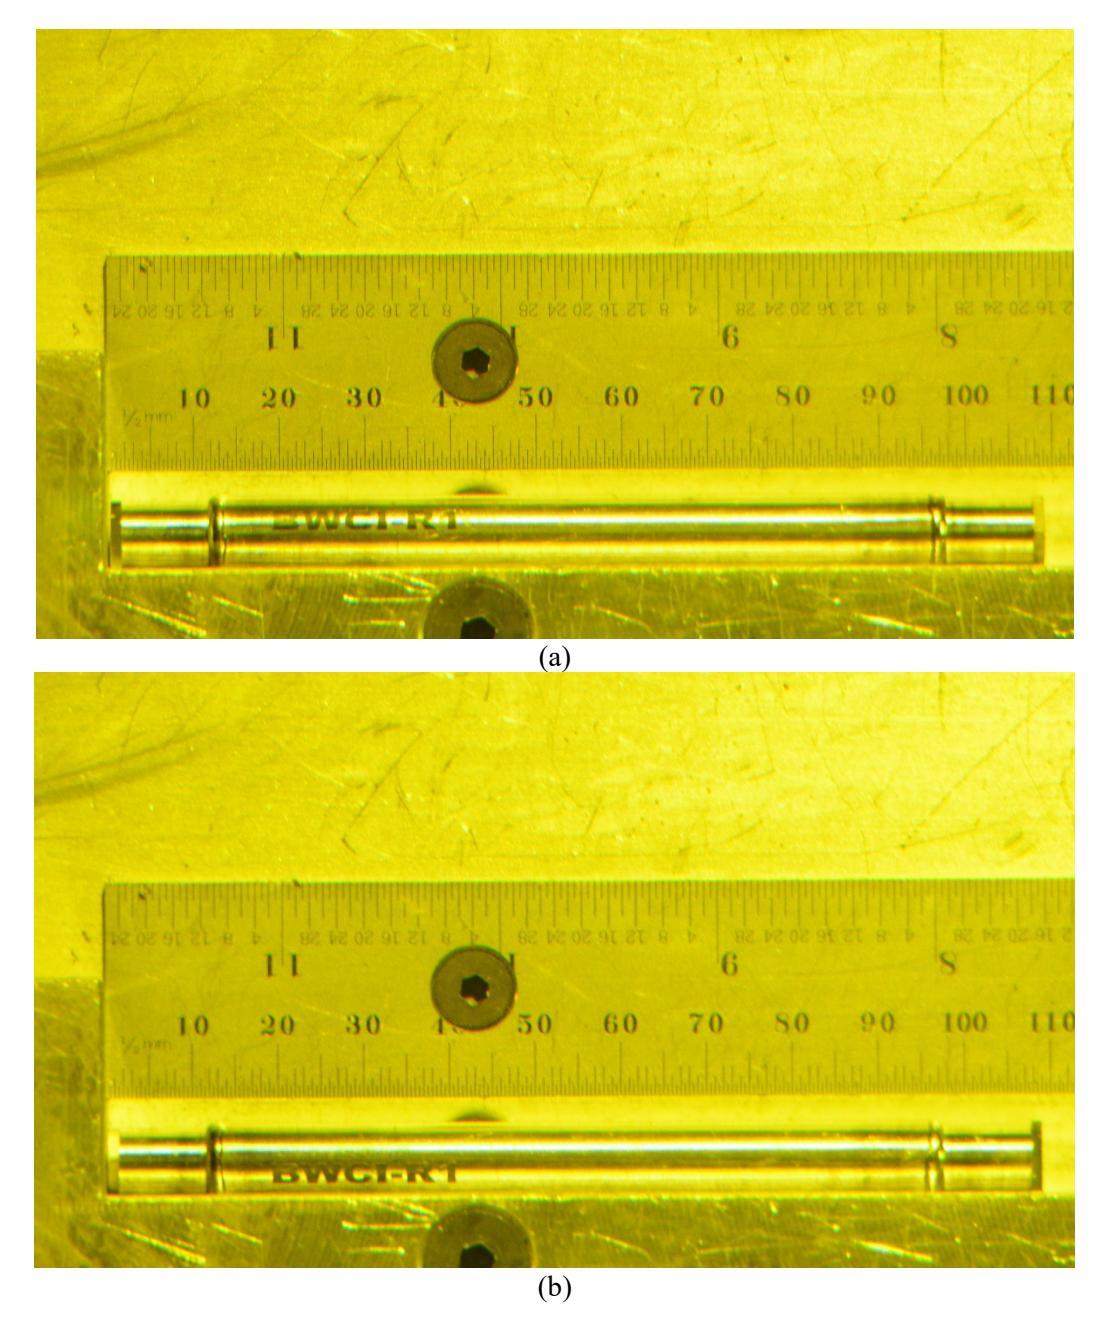
Figure 3. (a)-(b) Visual examinations of the BWCI-R1 rodlet.

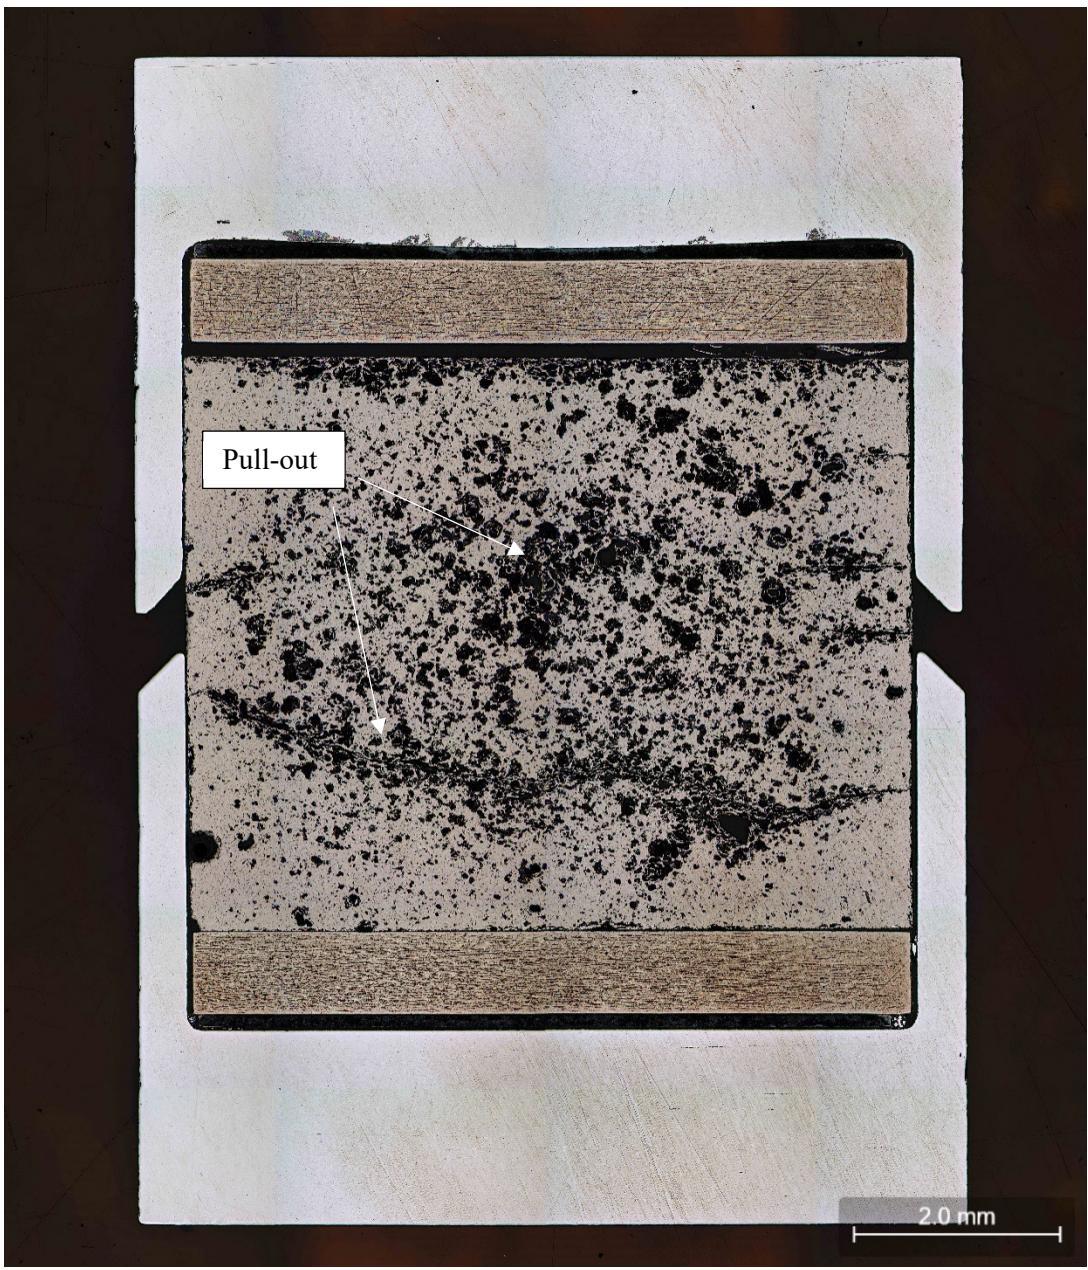
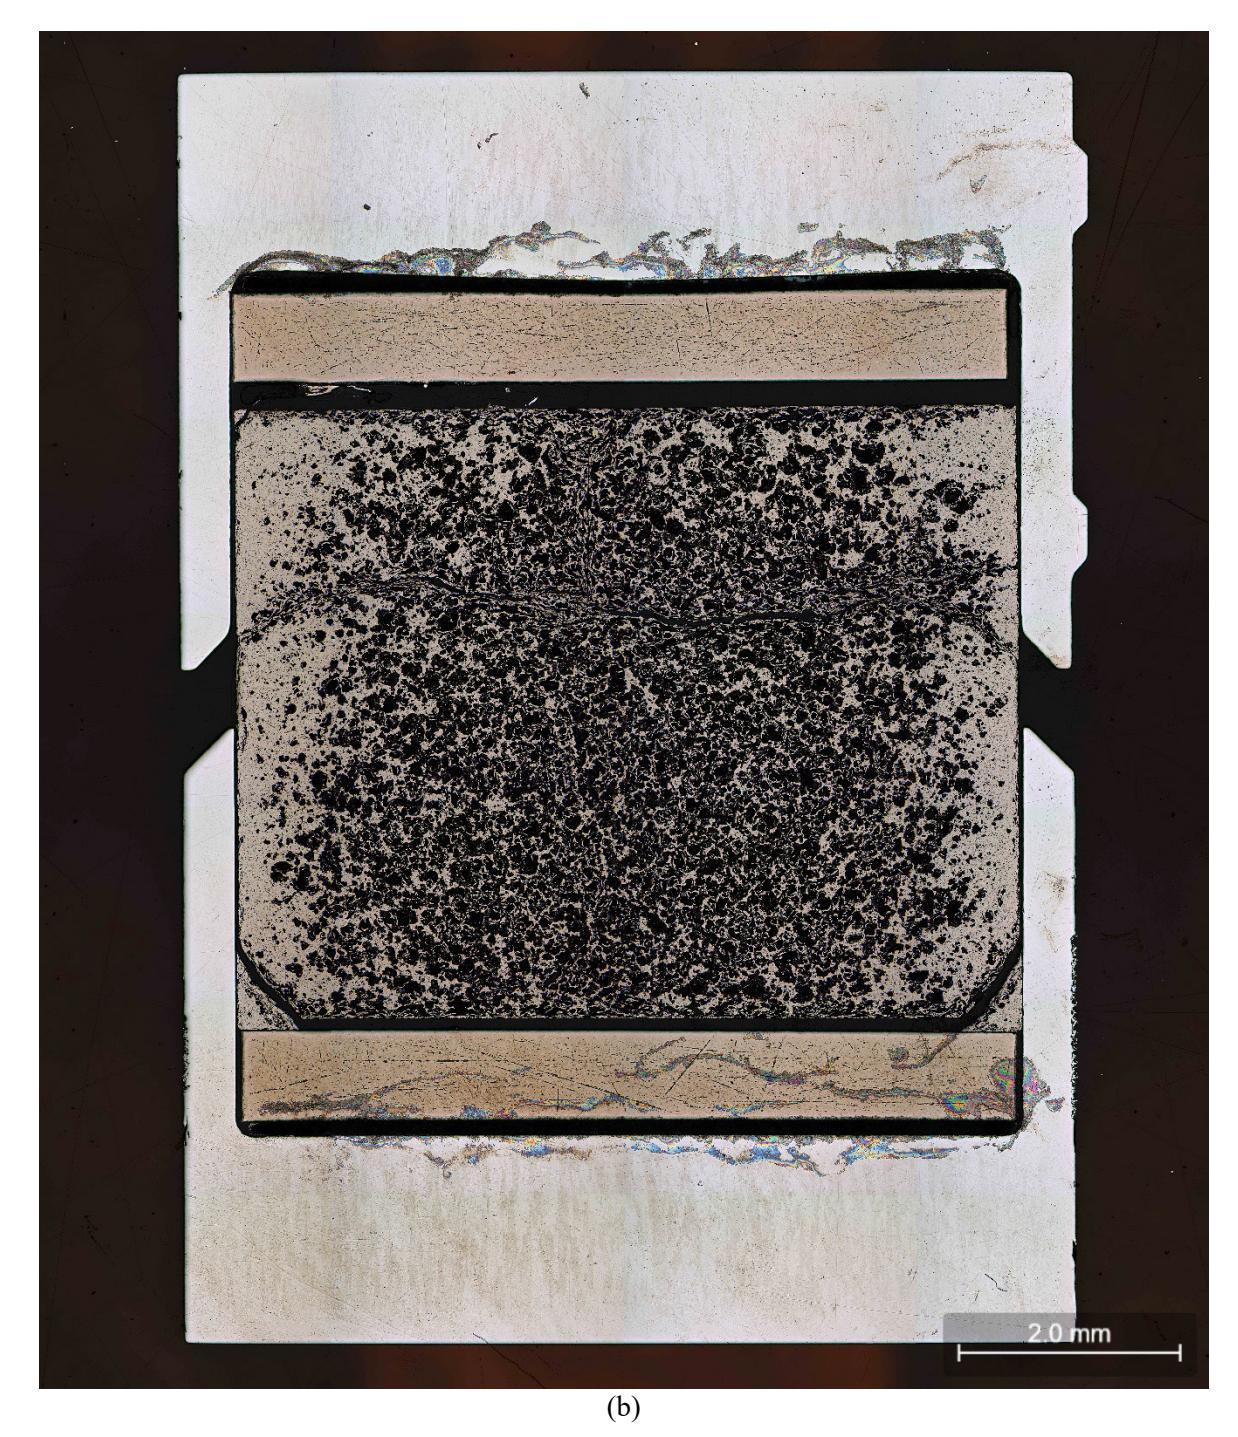
After disassembly, each H-cup was mounted and ground through mid-plane to show the U3Si2 and cladding interfaces. Low-magnification overviews of the mounts are shown in Figure 4 through Figure 6. The mounts show ethanol residuals and the U3Si2 phase shows extensive pull-out (for example, see the white arrows in Figure 4). More refined sample preparation will be performed at the Irradiated Materials and Characterization Laboratory at a later stage. This preliminary investigation was performed to provide a first insight on the extent, if any, of the FCCI in each capsule. In all mounts, already at low magnification, a gap between the fuel and the cladding discs was visible, showing that there was no permanent chemical bonding between the two materials.

Figure 4. (a)-(b) Low-magnification overview of the two U3Si2/Zry-4 specimens.

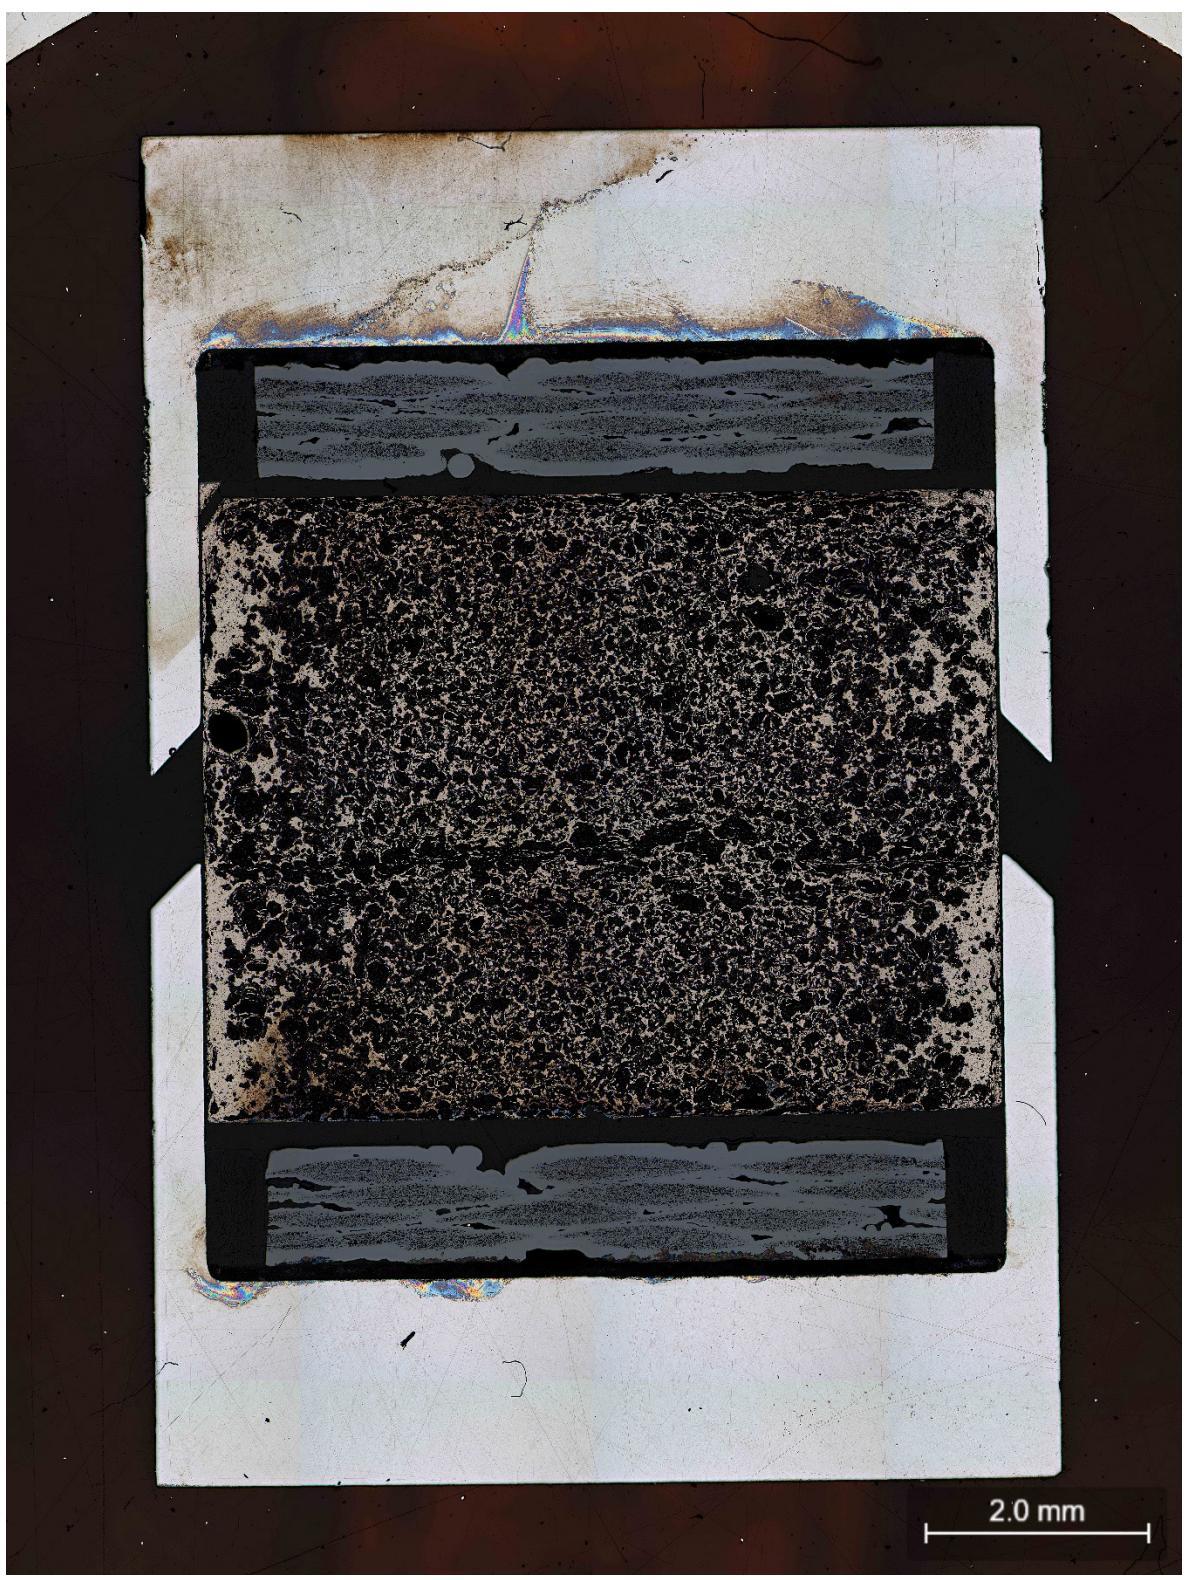
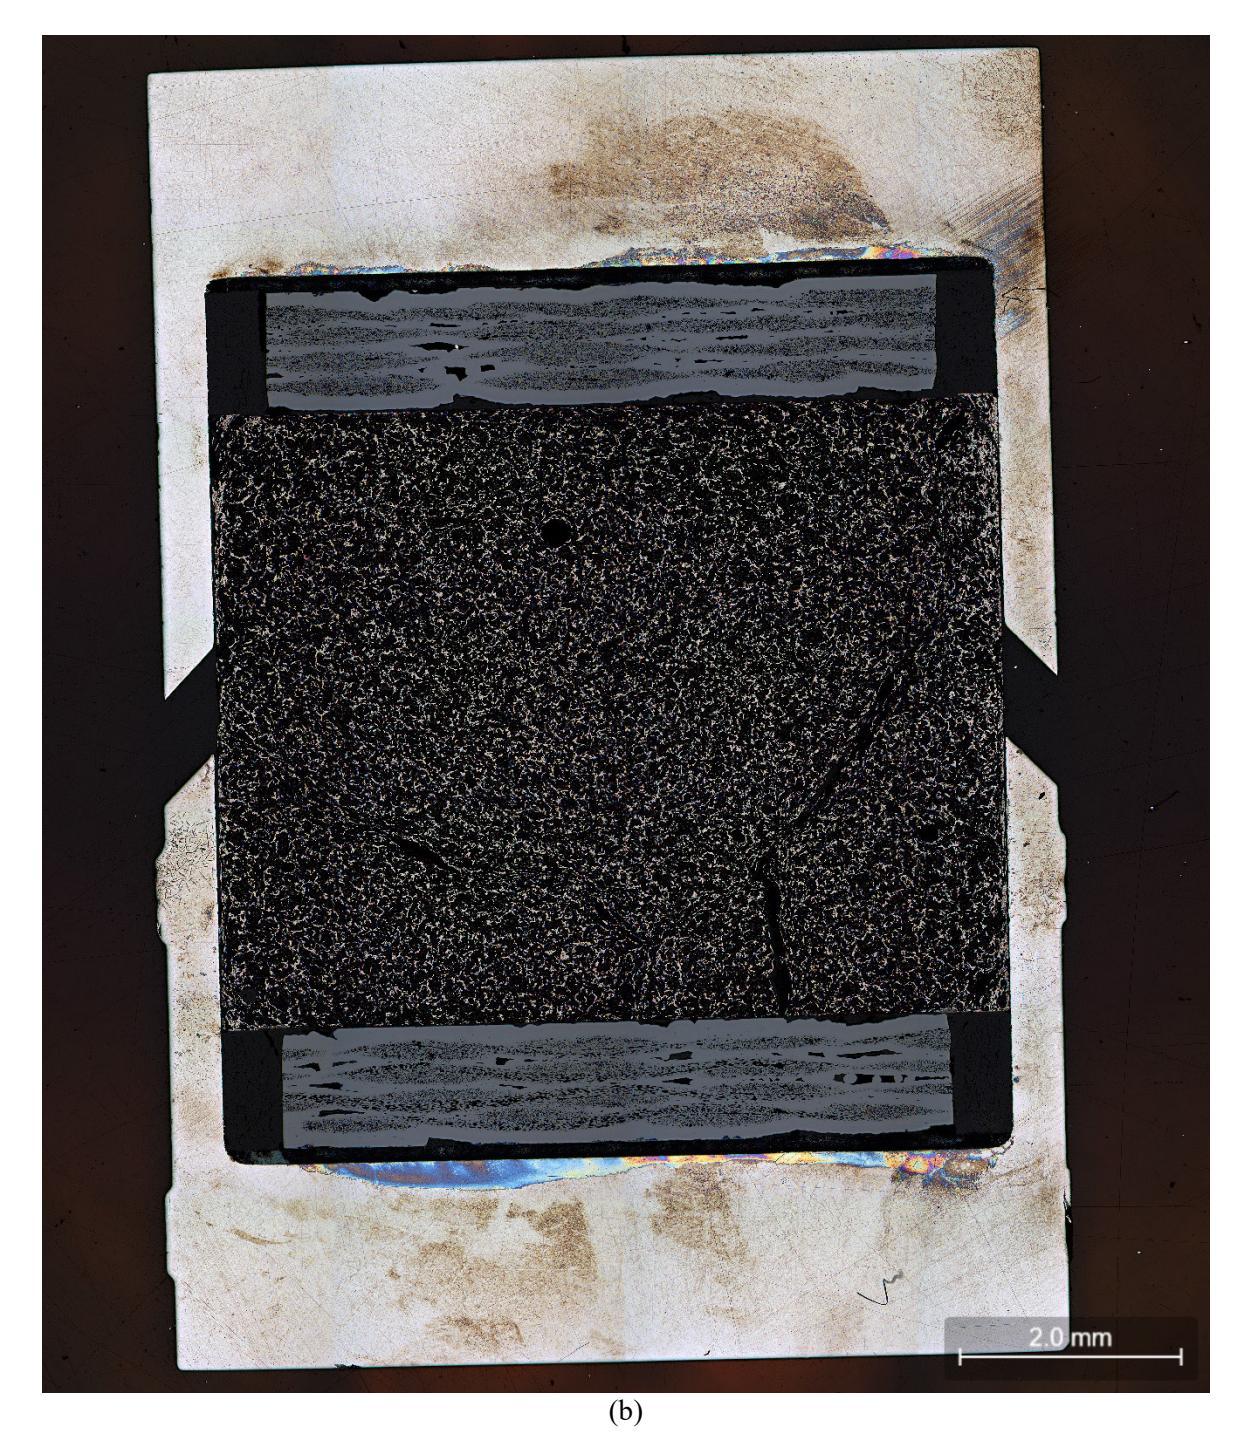
The irregular surface of the SiC discs in the two H-cups shown in Figure 5 could point to a loss of integrity of the area that might have pulled out during sample preparation. A large gap remains in most of the interfaces, but signs of potential interaction could be observed towards the edges of the SiC discs in contact with the U3Si2, as highlighted by Figure 8. It cannot be excluded that these are localized areas of oxidation of the U3Si2 fuel, since it is known that these first-generation samples contained oxygen impurities that caused grey precipitates in the U3Si2 matrix, which looked exactly like the ones observed here [1,7]. Figure 9 shows an example of potential localized interaction with the FeCrAl discs. In the U3Si2 several UO2 precipitates can also be observed making it unclear if FCCI is beginning to develop or the layer is a result of pre-irradiation oxidation. SEM and EDS will be needed to determine the composition of these layers.

Figure 5. (a)-(b) Low-magnification overview of the two U3Si2/SiC specimens.

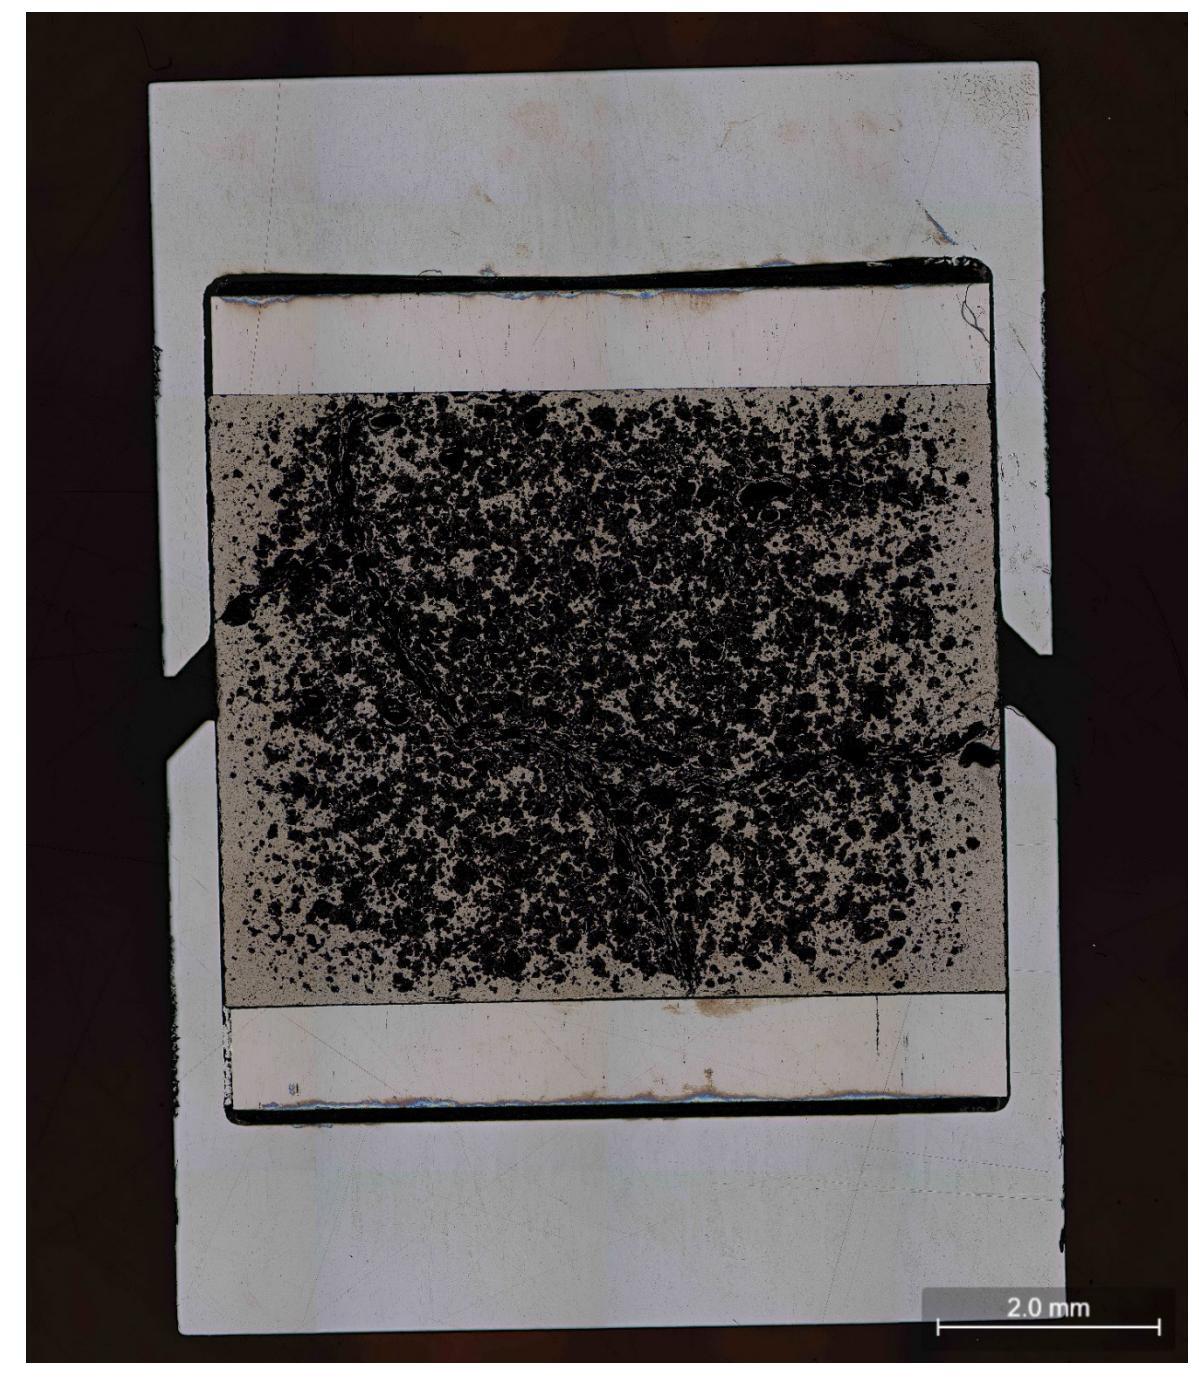
Figure 6. Low-magnification overview of the U3Si2/FeCrAl specimen.

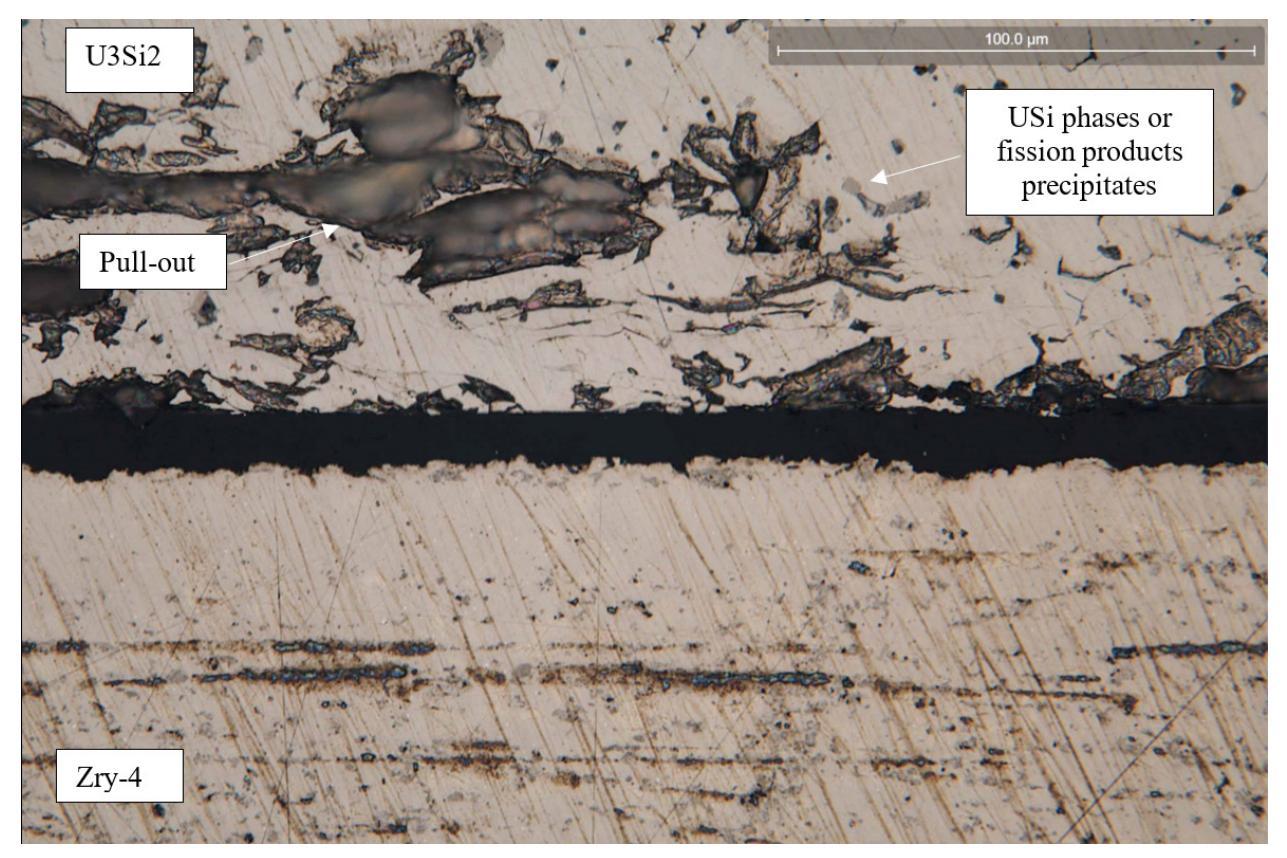
Higher magnification images were acquired to provide more details of the interfaces. A representative micrograph of the U3Si2/Zry-4 interface is shown in Figure 7. The gaps extended along all the interfaces, both top and bottom, in both capsules. No FCCI above the resolution limit of the optical microscope (generally $\sim 1 \mu m$) is visible, but only scanning electron microscopy (SEM) and energy dispersive x-ray spectroscopy (EDS) will confirm this preliminary observation.

Figure 7. Representative high magnification image of the U3Si2/Zry-4 interface.

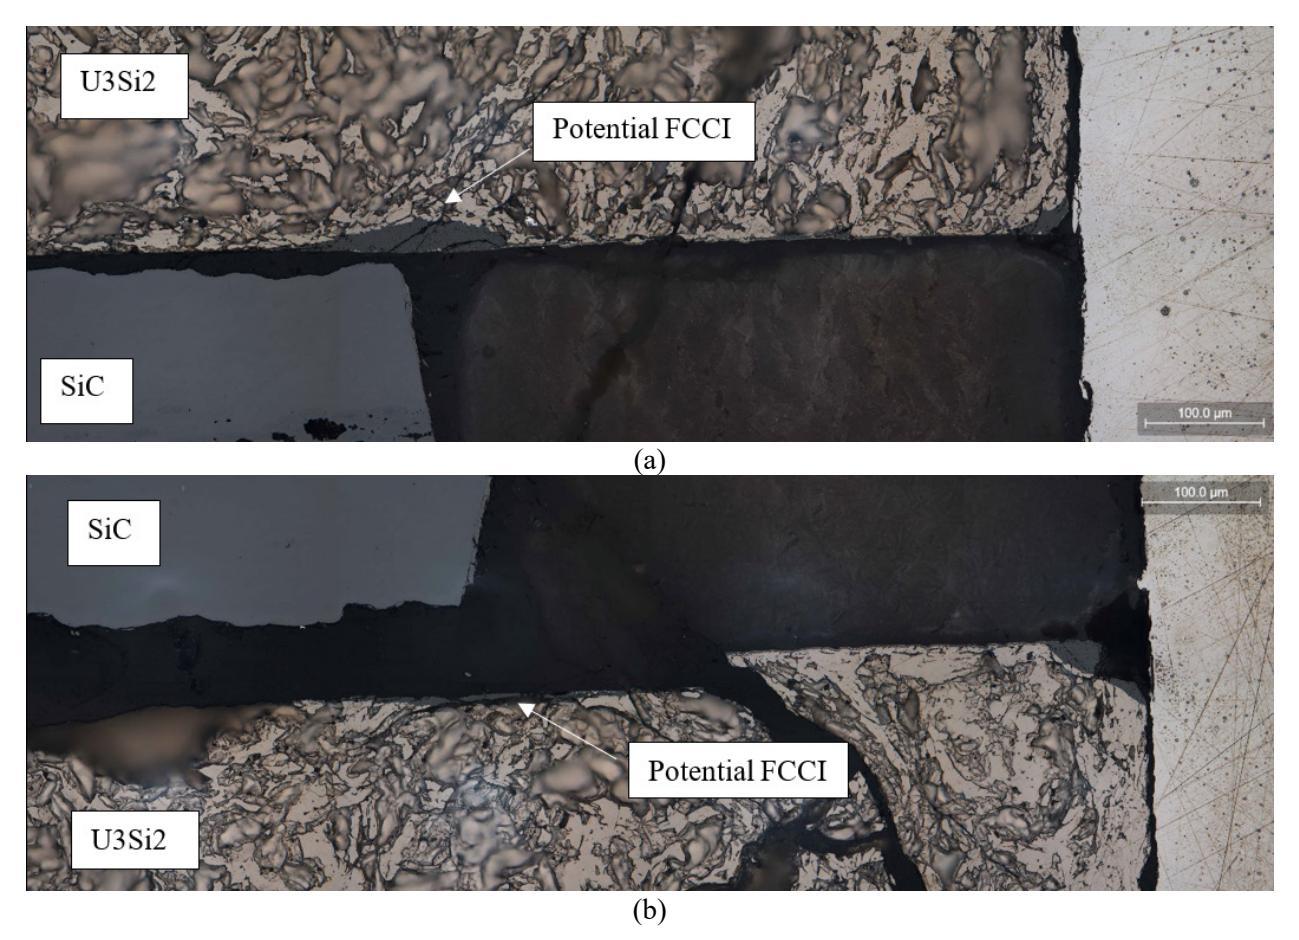
Figure 8. Examples of (a) bottom and (b) top FCCI in one of the U3Si2/SiC specimens.

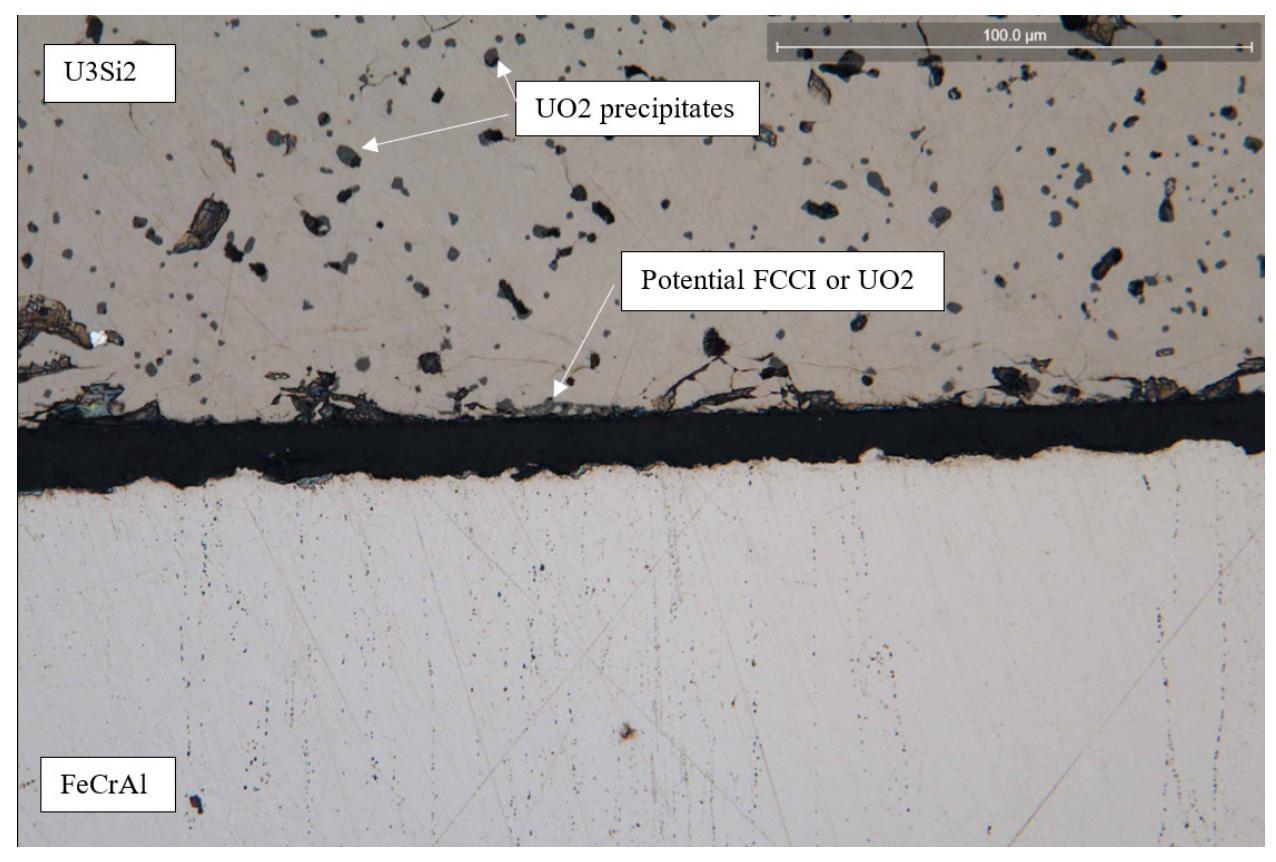
Figure 9. Example of a location on the U3Si2/FeCrAl interface where potential FCCI was observed.
