Electrochemical Corrosion Testing of Neutron Absorber Materials

May 2007

INL/EXT-06-11772, Rev. 1

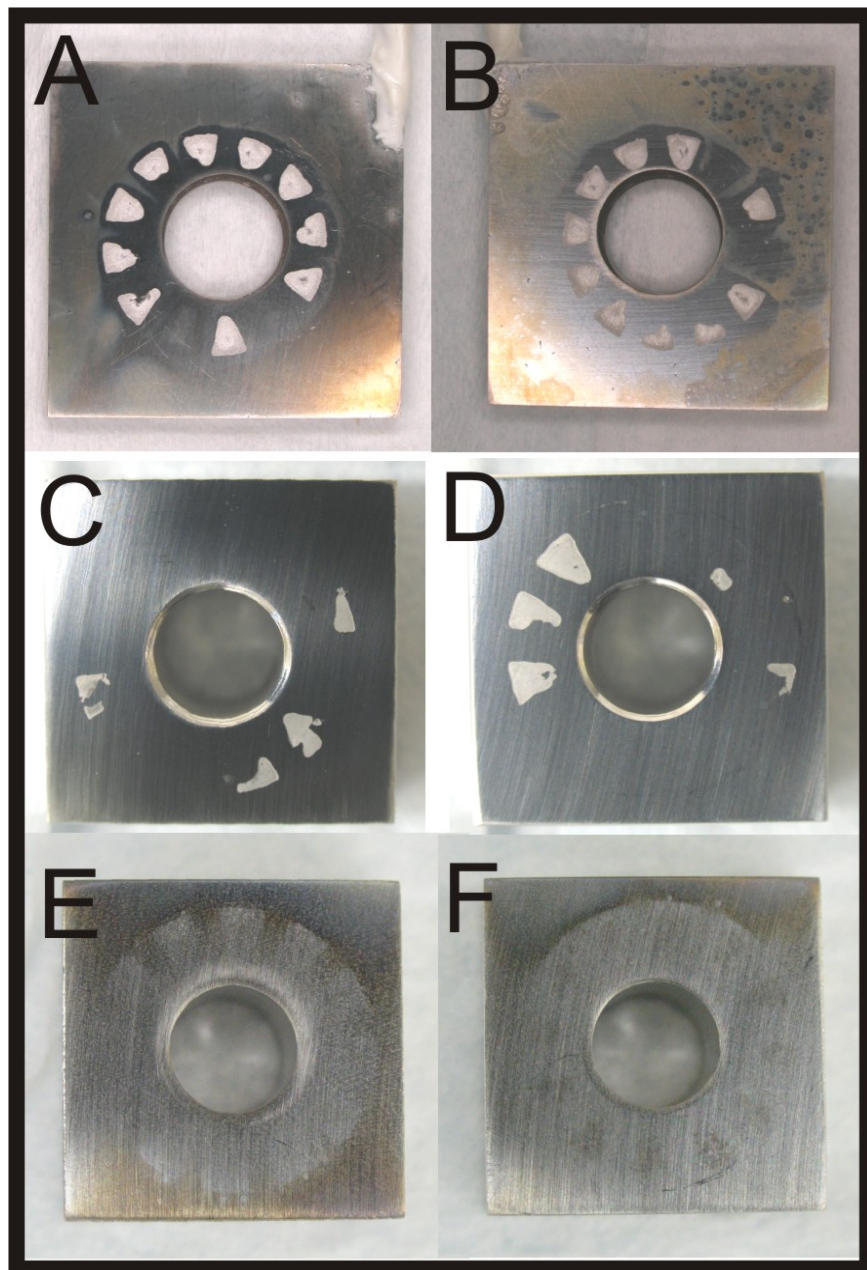
Photographs of the specimens after the PD testing are shown in Figure 5. The specimens show attack occurring primarily at the base metal/MCA teeth interface. The A978 specimen showed much greater crevice attack with 20 of the 24 teeth showing crevice attack. The 304B4 showed attack in 9 of the 24 teeth, with the total damage area/damaged area under the MCA teeth being lower. The Ni-Cr-Mo-Gd alloy did not show any extensive etching or pitting under the crevice teeth. There are stains outside the crevice regions. These stains were likely caused by corrosion products leeching from within the crevice areas (lower pH) and precipitating into high-pH regions.

Figure 5. Macro photographs of A978 (A and B), 304B4 (C and D), and Ni-Cr-Mo-Gd (E and F) after PD testing.

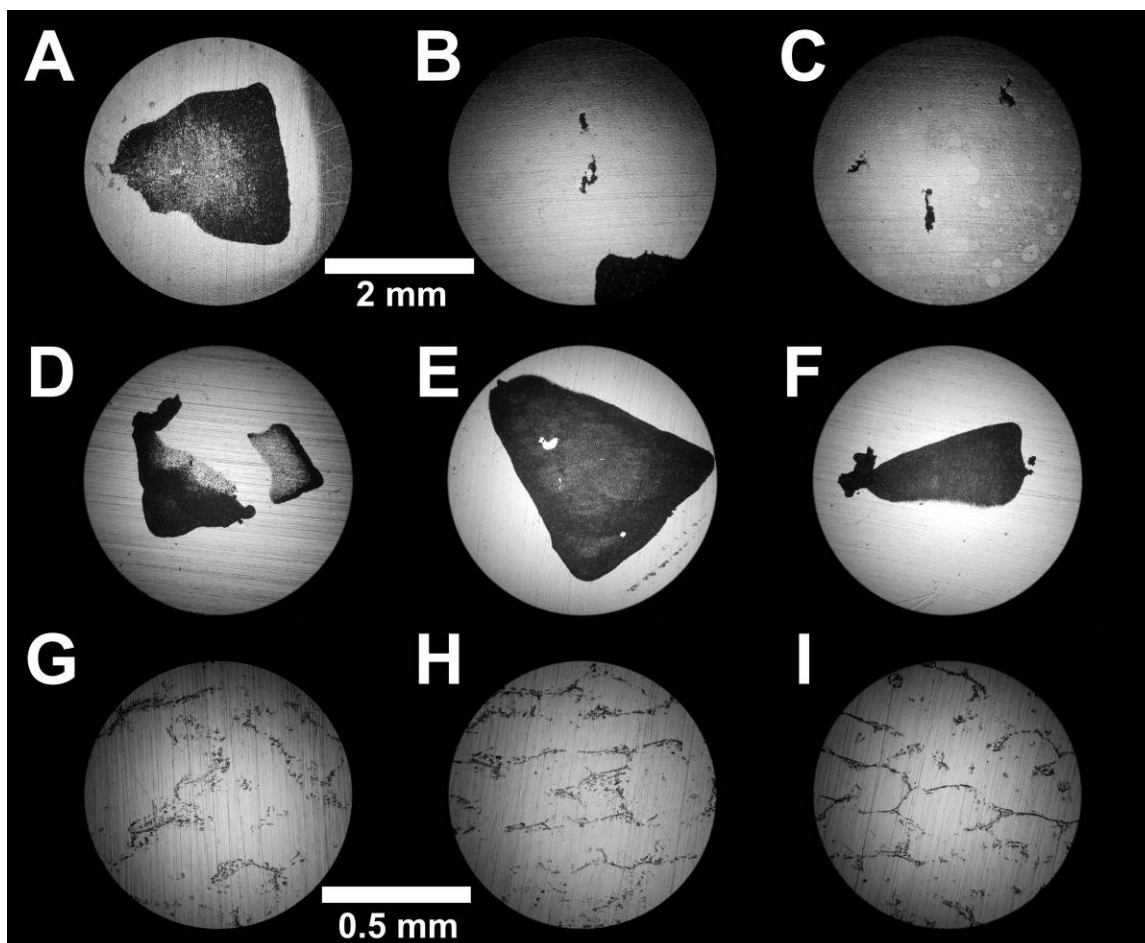
LOM images of the specimens are shown in Figure 6. It is apparent that significant crevice corrosion occurred under the MCA teeth of the borated stainless steel specimens. The damage was more pronounced on the A978 specimen. There was also pitting outside the crevice area (see Figure 6, B and C) on the A978 specimen, while none was observed on the 304B4 specimen. The Ni-Cr-Mo-Gd alloy shows the removal of the gadolinide particles through dissolution. This observation agrees with the large anodic current observed in the forward sweep.

Figure 6. LOM images taken at 50× magnification factor for A978 (A–C) and 304B4 (D–F) and at 200× magnification factor of Ni-Cr-Mo-Gd (G–I) after PD testing.

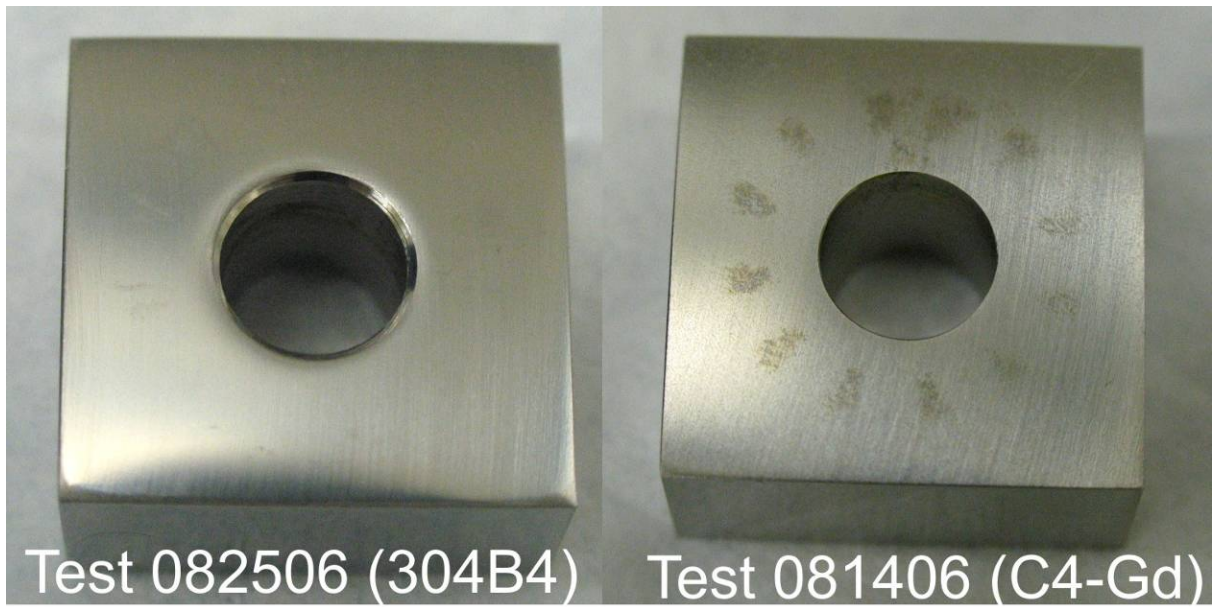
Representative LOM images of the damage from each of these alloys are shown in Figure 18. In several cases, small pits or light etching was observed under a crevice former for 304B4 specimens (see Figure 18). The most damage was observed for Tests 080806-1 and 080806-2, which were incomplete and are not shown. For the Ni-Cr-Mo-Gd tests, the removal of the gadolinide phase was partial for completed tests (Tests 081406, 081706, 082406). No evidence of primary phase corrosion was found for the Ni-Cr-Mo-Gd alloys. Figure 19 shows that there was a partial removal of the gadolinide secondary phase for Test 081406.

Figure 18. Photographs of PS test specimens after testing.

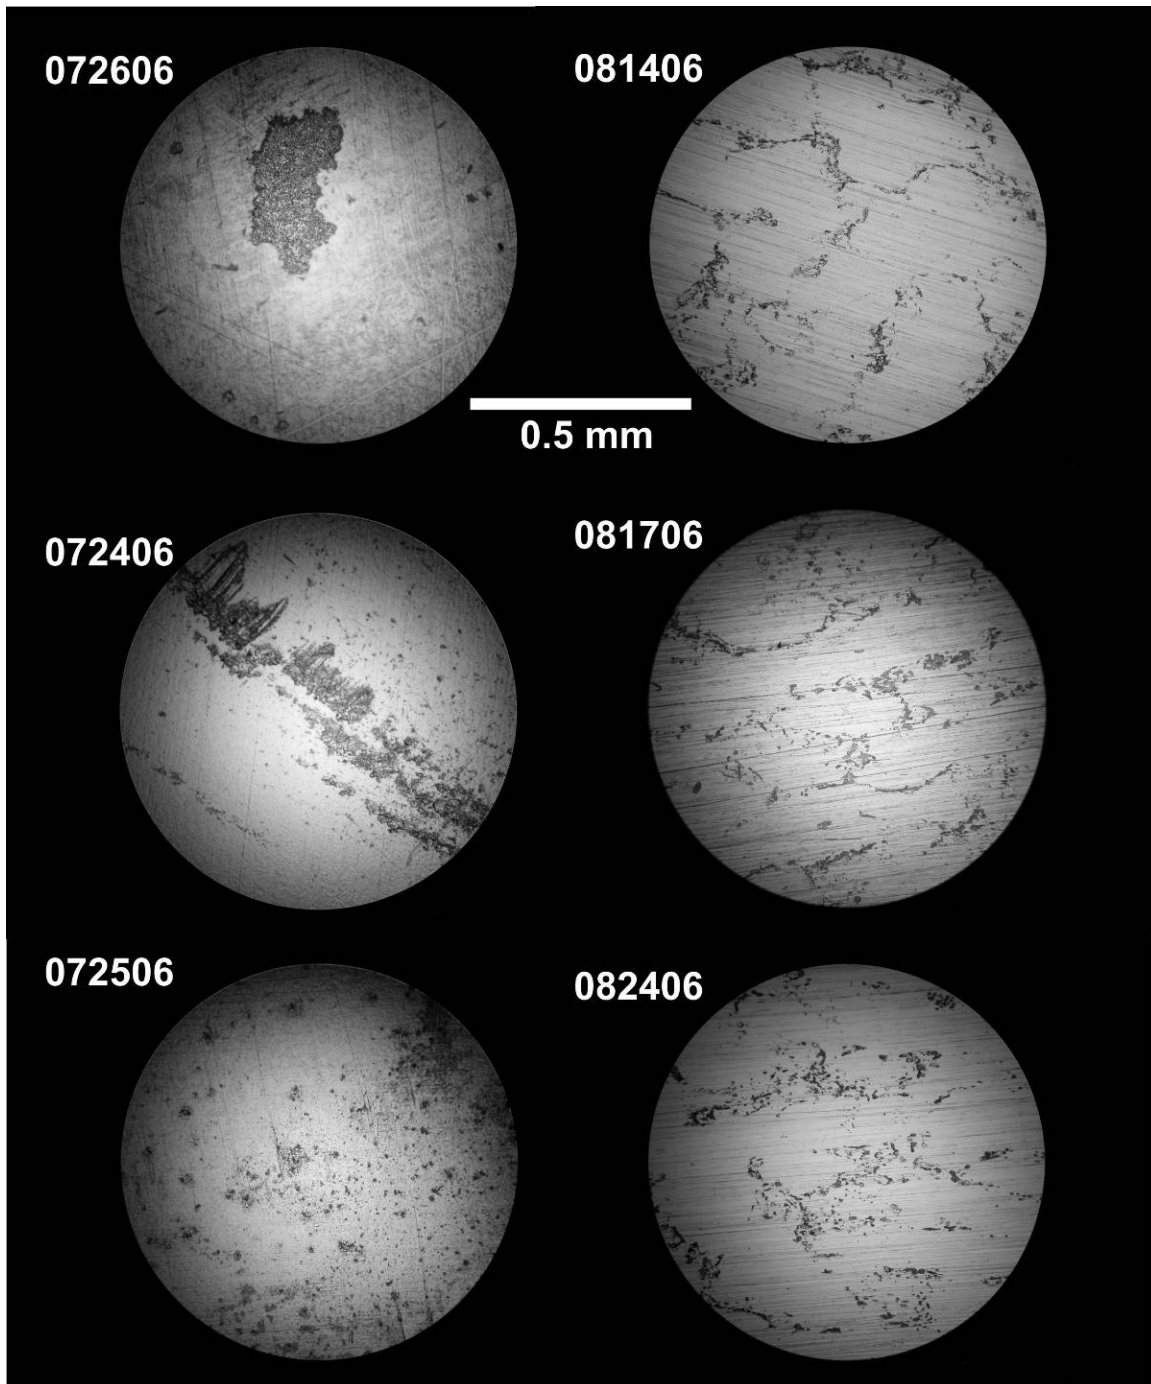
Figure 19. LOM images of selected specimens showing damage to the surface. Tests 072606, 072406, and 072506 are 304B4 specimens, and Tests 081406, 081706, and 082406 are Ni-Cr-Mo-Gd specimens. All images were taken at a magnification factor of 200 \times .

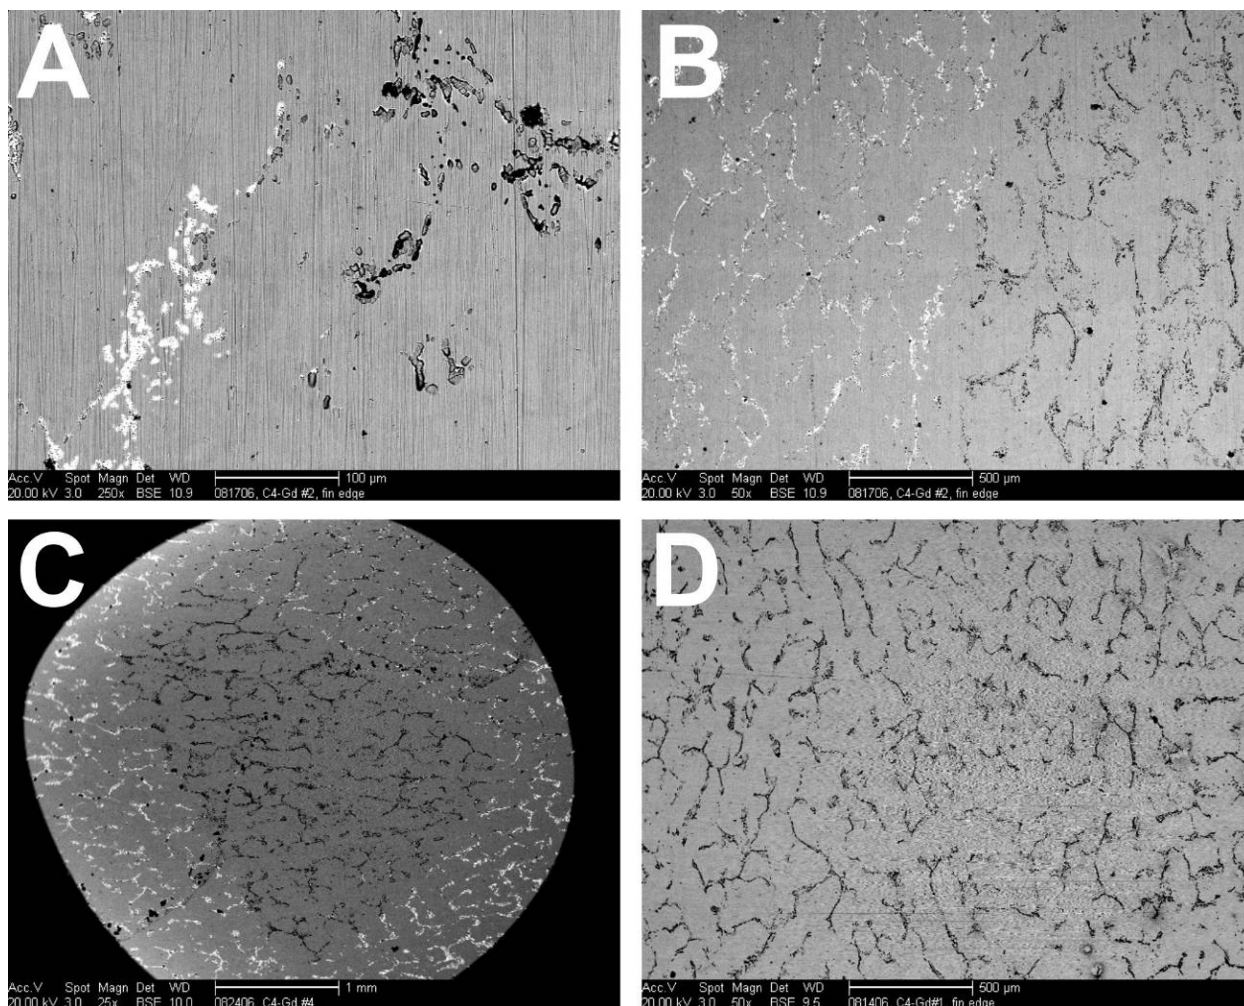
scale. Figure 21 shows the Ni-Cr-Mo-Gd alloy after corrosion testing. The bright areas are due to the gadolinide phase particles, which appear to be partially removed. Figure 21C shows the area of an entire MCA tooth where the gadolinide under the tooth is removed while the surrounding material is still intact. Figure 21A and B shows the edge of the crevice former where the inner gadolinides are removed, while gadolinides outside the crevice appear intact.

Figure 21. SEM images of Ni-Cr-Mo-Gd alloy corrosion specimens following testing. The images were obtained in BSE mode.

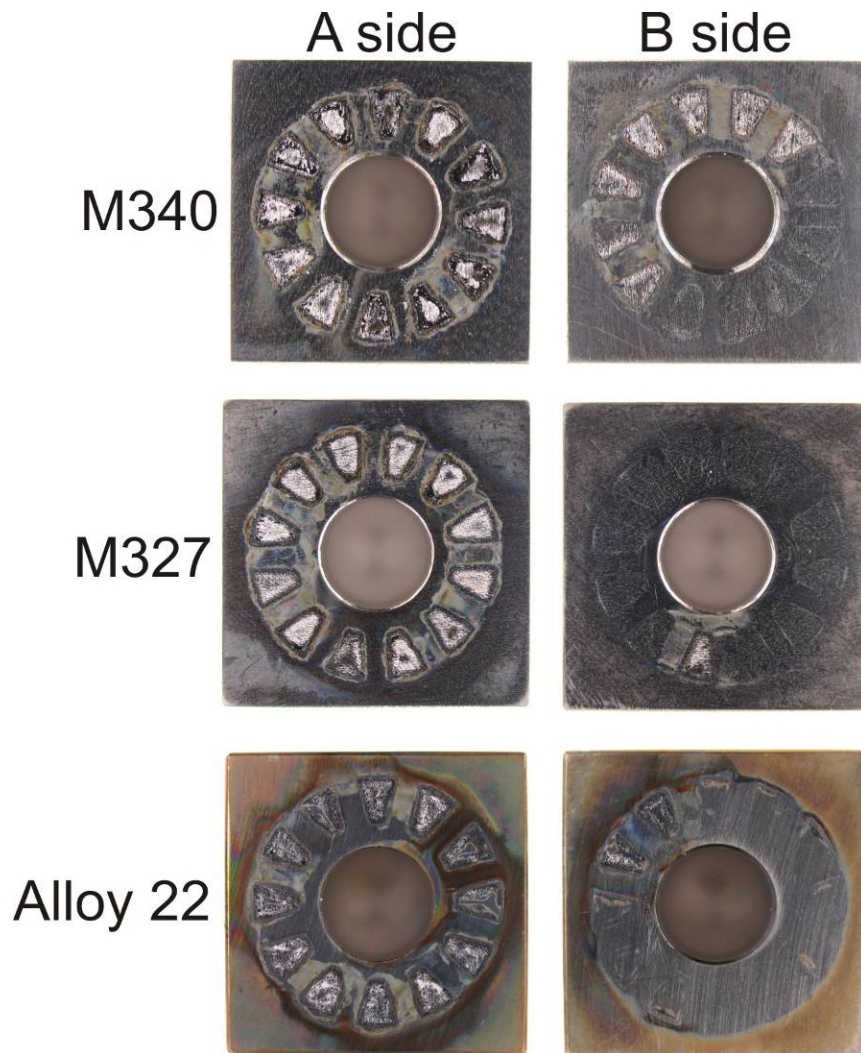
of crevice corrosion from one side to the other. This is likely due to the N_2 purge affecting the chemical transport, with the side most affected having less crevice attack. There are some differences in the attack of the Ni-Cr-Mo-Gd alloys versus Alloy 22. The Alloy 22 attack was more at the edges of the crevice tooth, while the Ni-Cr-Mo-Gd is more uniform across the crevice tooth. There is more pronounced staining of the Alloy 22 specimen.

Figure 23. Macro photographs of the three alloys after descaling. The most damaged side is in the “A” column, and the less damaged side is in the “B” column.

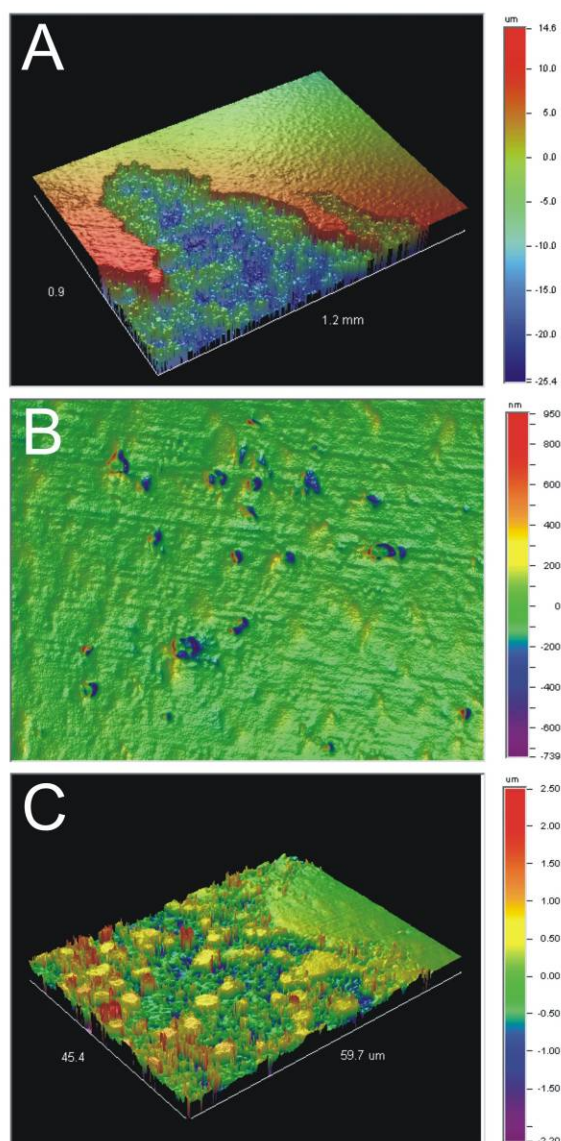
Figure 24 shows optical profilometer data acquired on Neutrosorb Plus 304 stainless steels after corrosion testing. Figure 24A shows the extensive crevice corrosion damage to 304B6 at the Teflon compression gasket during exposure to solution B3 at 60°C at E_{corr} . Figures 24B and C show damage from a PS test for 304B4 under the Teflon MCA. Figure 24B shows what appears to be removal of material around secondary-phase particles in what could be the initiation of localized corrosion. Figure 24C shows the edge of a crevice corrosion pit where islands of material, on the same level as the polished surface, remain. These islands are likely secondary-phase particles (borides) that had not been released from the surface as the stainless steel austenite matrix was etched around them.

Figure 24. Optical profilometer data of specimens after corrosion experiments. (A) is 304B6 after E_{corr} measurement for 4 weeks in solution B3, and (B) and (C) are the 304B4 specimen damage from under the Teflon crevice former after the PS test at 0.1 V in solution B3.

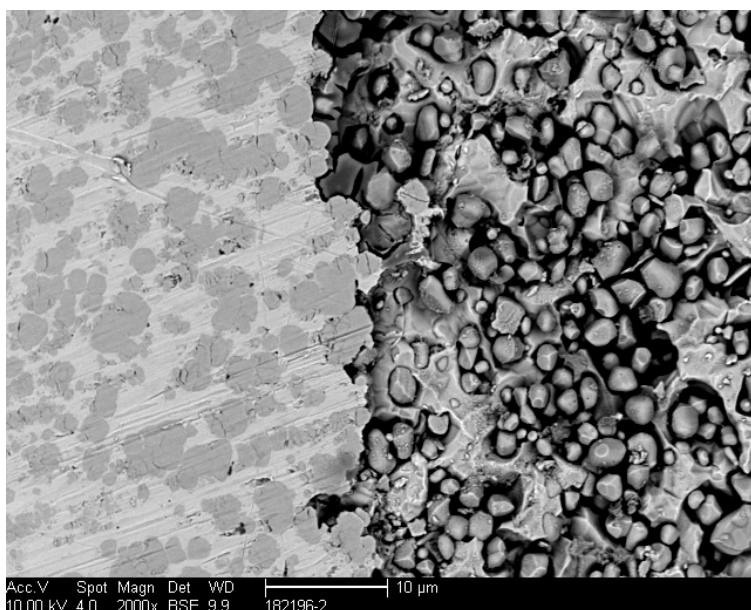
Figure 25. BSE image of localized corrosion near gasket in 304B6.

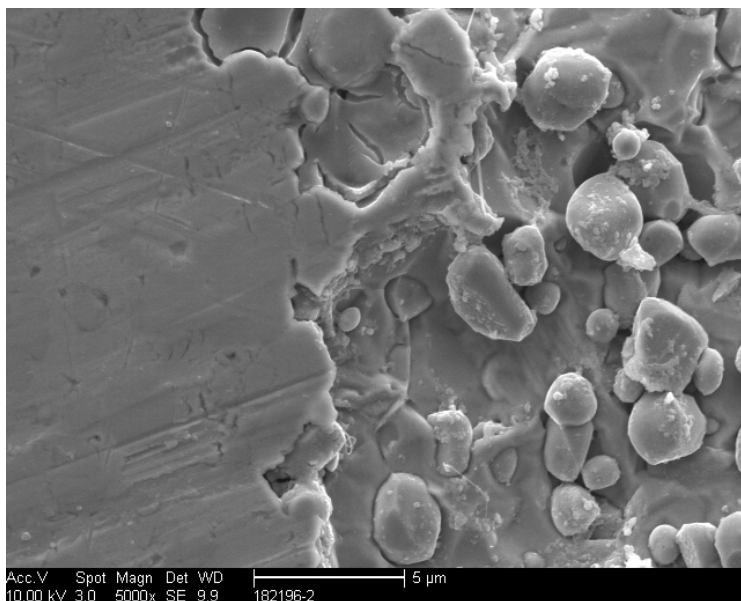
Figure 26. Secondary electron (SE) image of localized corrosion near gasket in 304B6.

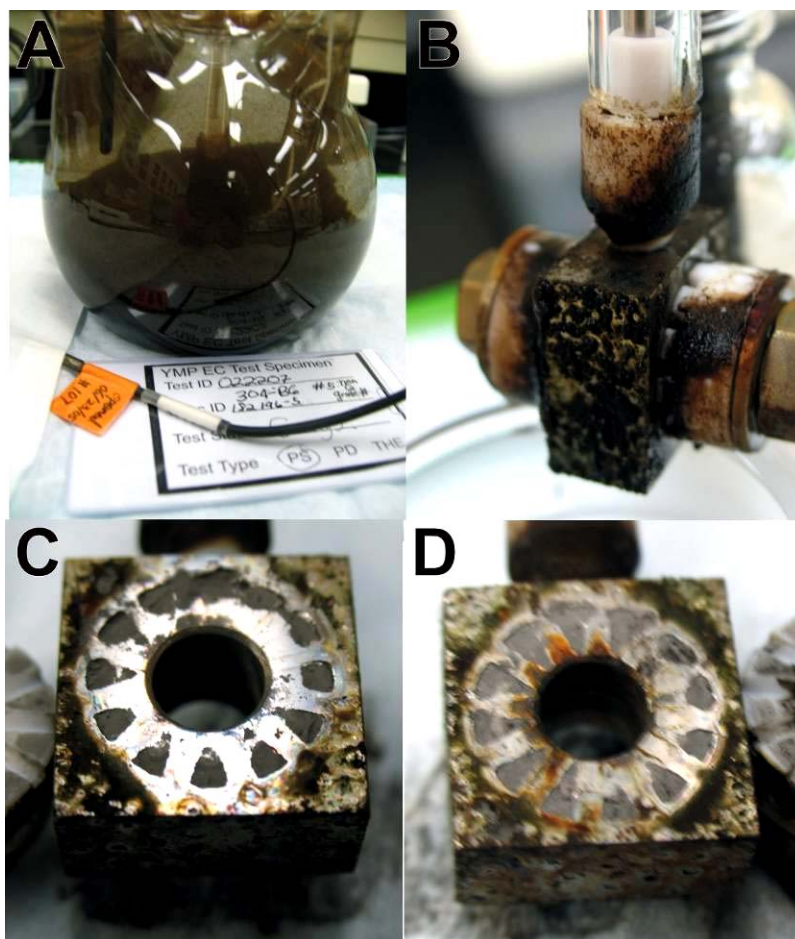
To increase the amount of corrosion product for XRD analysis, an accelerated corrosion test was performed using a 304B6 crevice-corrosion specimen polarized above the expected E_{corr} value (0.4 V versus SCE) at 90°C for 24 hours in solution B3. The 304B6 alloy was chosen as it shows a reduced resistance to localized corrosion compared to alloys 304B4 and 304B5 as reported in Section 3.2.6. This resulted in an excessive amount of crevice corrosion product that clouded the solution significantly (see Figure 27) and resulted in catastrophic attack to all surfaces of the specimen. The precipitate and corrosion product on the specimen was black and mostly lacked additional color. A total charge of 5616 C (355.4 C/cm²) was passed during the test, with a maximum current of 5.29 A/cm² and a minimum of 2.25 A/cm². Thus, localized corrosion was initiated instantly and remained active throughout the test. The specimen lost 1.83141 g during the test. Precipitate was collected during descaling, with sonication in 10% HNO₃. After descaling cleanup, the specimen continued to produce small grey particles upon shaking. The particles from descaling were analyzed by XRD and matched with FeCr₂B. A similar match was made with settled precipitate collected at the bottom of the flask, which also indicated significant amounts of amorphous material.

Figure 27. Photographs of corrosion damage from 304B6 specimen in accelerated test: (A) corrosion flask, (B) specimen immediately after removal, and (C) and (D) two sides of specimen.

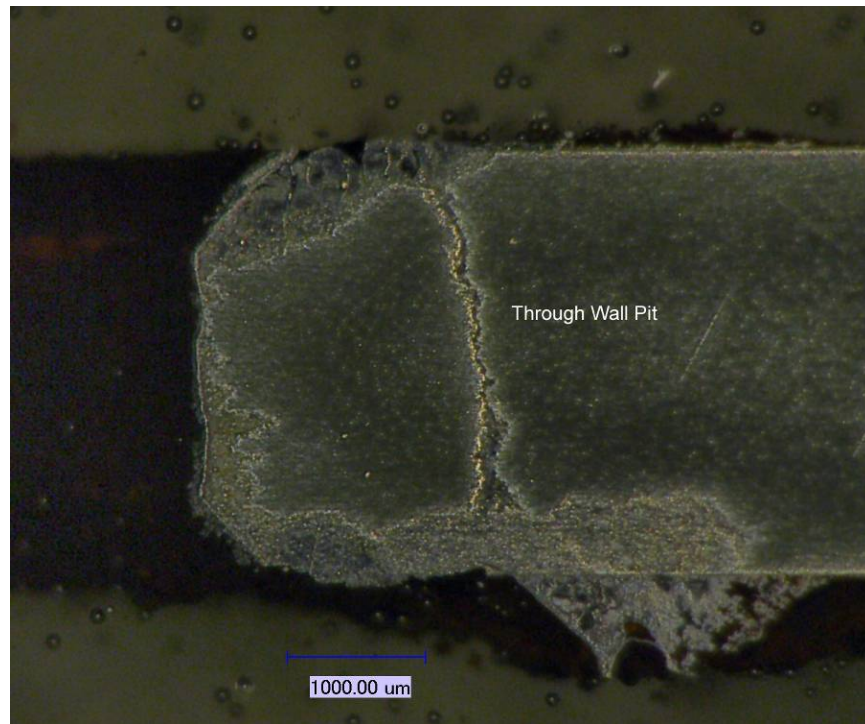
LOM images of the specimen after vacuum mounting are shown in Figures 31 and 32. The sample is totally penetrated under the Teflon attachment washer, with corrosion products evident on the surface and under the original surface.

Figure 31. Specimen SSE 30, mounted specimen, showing through-wall penetration and corrosion product.

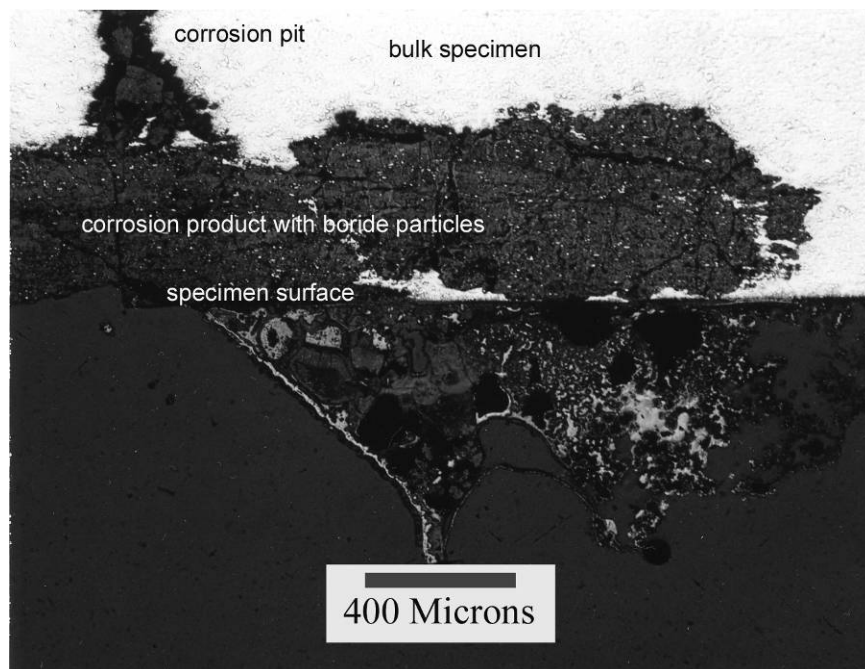
Figure 32. Specimen SSE 30 corrosion products.

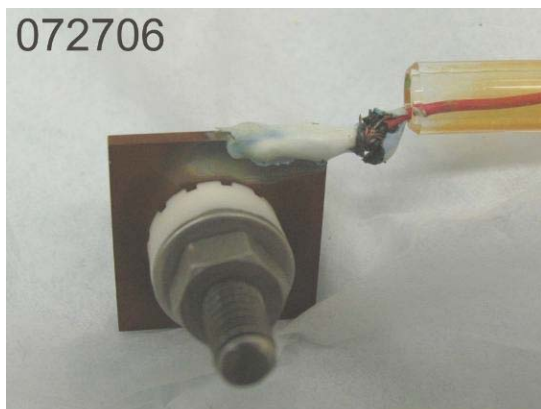
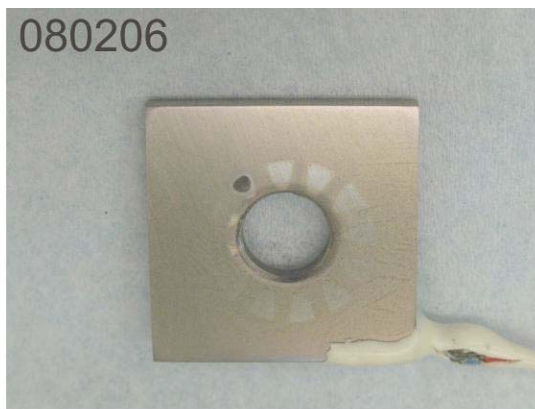
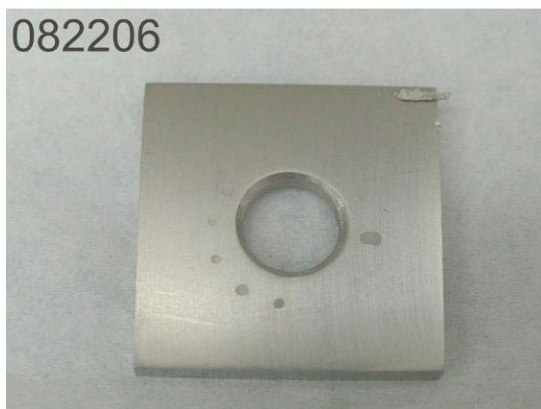
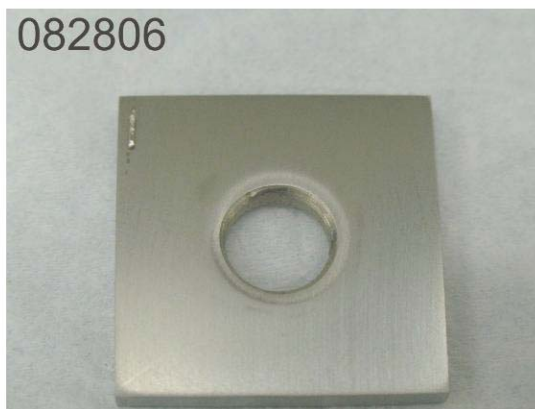
Figure A4 shows macro photographs of the specimen surfaces after testing. While the electrochemical data was not very useful, the damage to the surface observed during the test is likely to be what would occur on a test using the properly configured crevice specimen. The exception might be Test 072706. The contact was so corroded that the specimen was not in electrical contact for much of the test. A thick brown film coated the surface of the Test 072706 specimen, and the solution was clouded with precipitate. The film appeared to be from the corrosion of the solder and wire of the contacting lead. Significant crevice corrosion was observed only on Tests 080206 and 082206. LOM of damage to these specimens under the crevice formers is shown in Figure A5. There was no significant damage to Test 072706 and 082806 specimens.

Figure A4. Macro photographs of A978 specimens after testing. Note that part of the platinum wire from the Tests 082206 and 082806 remains in the corner of these specimens.

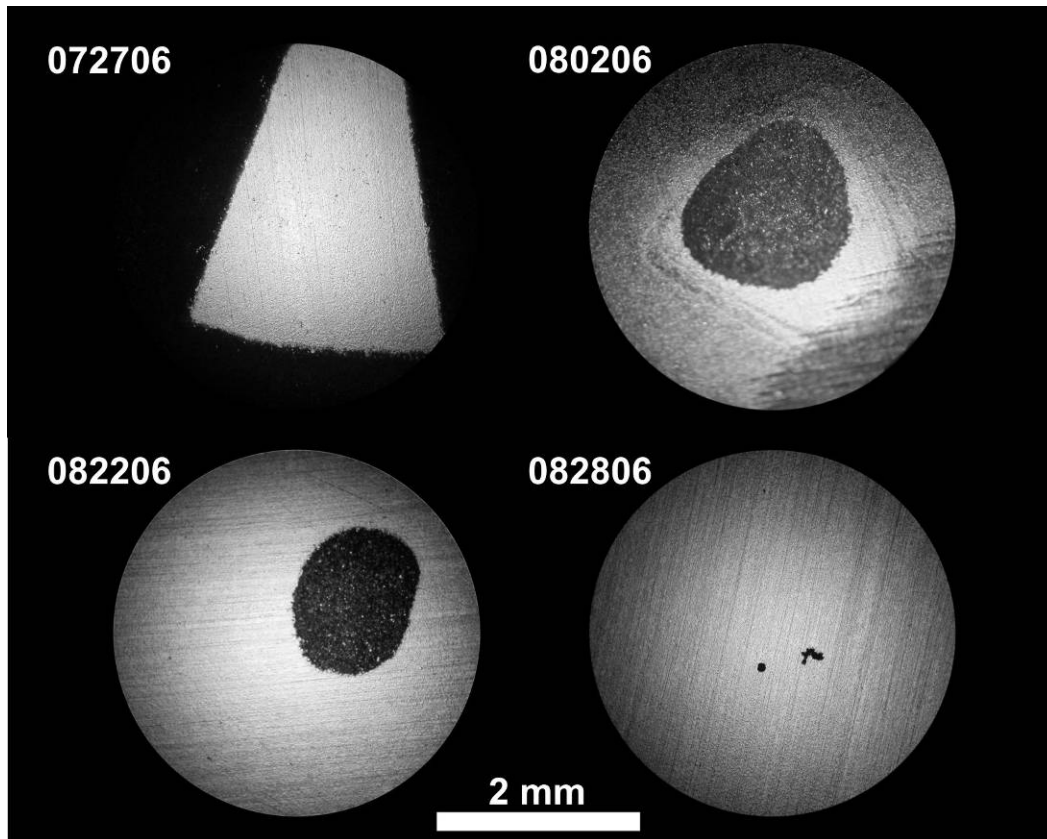
Figure A5. LOM images of A978 specimens after testing.
