FY2017 1st Quarter INL/EXT-17-40995

IDAHO NATIONAL LABORATORY

QUARTERLY OCCURRENCE

DEEPER LEARNING THROUGH EVENT ANALYSIS

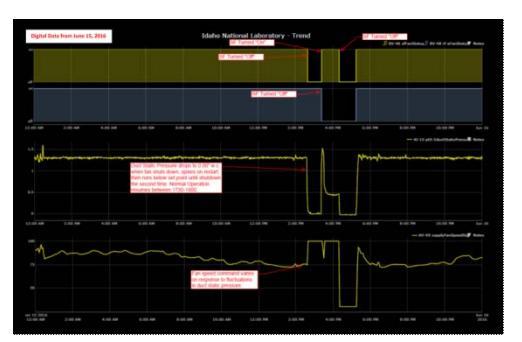
This was a follow-up lessons learned on a hand injury that occurred in June 2016 when a mechanic who was performing preventive maintenance on an air handler at the Energy Innovation Laboratory on the INL Idaho Falls Campus received an injury to his right ring finger. The mechanic had isolated the fan electrically through a simple Lockout/Tagout (LO/TO) of the variable frequency drive (VFD) and observed the fan slow to a stop. After removing the belt guard, he reached back and placed his hand on the belt system to brace himself as he stood up. He did not notice that the fan had unexpectedly started to rotate. His hand was pulled between the belt and the pulley resulting in trauma to his right hand and a broken bone in the ring finger.

• Loss of situational awareness. The mechanic lost situational awareness and did not notice that the fan had started to move when he reached behind his back and

placed his hand on the fan belt. He did not expect the fan to move because he had locked out the electrical

source of energy for mechanical movement and confirmed the fan had stopped before he removed the guard. In addition, he had never experienced the fan movement during this maintenance activity in the past. He did not recognize the risk of potential fan movement from other sources. Blocking fans during maintenance is not a common practice due to the need to move the fan belts or pulleys during some maintenance activities.

- Identify all the hazards of an activity and appropriately implement controls for those hazards.
- Understand your system interactions and incorporate that information into work planning.

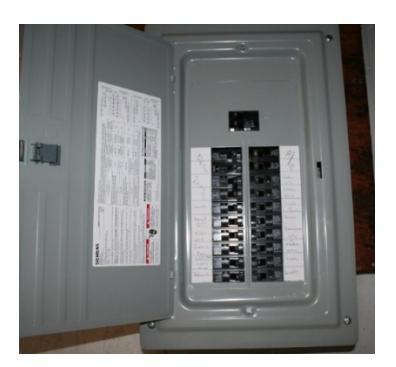
Electrical power was found within a breaker panel during an electrical outage at ATR. After the zero energy checks were

performed, power was discovered by an electrician using a proximity tester prior to removing a panel cover. The panel had been missed and was not included on the LO/TO record sheet; however, it was part of the work

scope listed in the work order being executed. After discovering power, all work was stopped and appropriate personnel were notified.

- Five individuals failed to notice that the panel was part of the work scope resulting in an inadequate LO/TO.
- A high amount of trust was put in the knowledge of the Job Supervisor (JS) during the preparation of the LO/TO.

- Drawings and information for facilities needs to be checked and verified for accurate and up-to-date information prior to conducting work. Also, access to old drawings or drawings that have sensitive information can be hard to access at times. Ensuring all available drawings are used is essential to identifying all potential hazardous points.

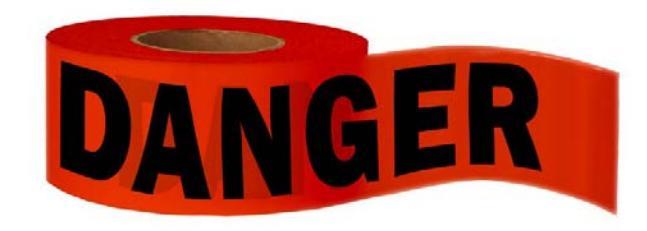
NE-ID--BEA-CFA-2016-0005 (Significance Category 3) After performing work in a substation walk-in electrical cabinet, subcontractors failed to either replace the personnel door to prevent others from entering unintentionally, or to post and barricade the area alerting others to the potential hazardous electrical energy.

The walk-in cabinet is located inside the Naval Reactor Facility (NRF) substation on the INL site. The subcontractors were performing work inside the cabinet in support of an INL project. The door to the cabinet opens at a 90 degree angle and was difficult to work around. To mitigate this problem, the subcontract workers asked the INL lineman if they could remove the door to gain better access to the cabinet. The lineman agreed and the door was removed. Two days later, an NRF safety and health representative requested a barricade be positioned and the area posted when the door was removed. These barriers were established as requested. The following day, while performing cleanup in the area, one of the workers moved the barricade to the inside of the door. He inadvertently forgot to return the barricade to the outside of the doorway when the subcontractors completed work that day.

NRF personnel discovered the open cabinet during a walkthrough of the facility the following morning. NRF personnel notified INL Power Management who took action to barricade the area with Danger tape.

The decision to remove the door constituted a change in the work direction; however, the hazard mitigation for this change was not adequately evaluated, understood, or briefed. When changes to work scope occur, employees must take the time to evaluate the change so that work can be performed safely and that personnel understand their new responsibilities.

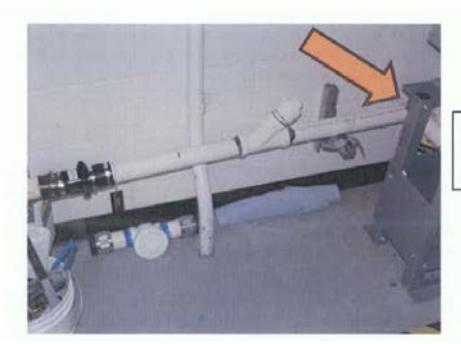
The pipe on the confinement side has a loop seal (P-trap) and a vacuum breaker which should maintain confinement integrity. It is unlikely that a breach exists; however, the break creates a configuration that is not tested by the confinement surveillance (e.g., building leak rate test).

An investigation found that the construction subcontractors who installed the drain line failed to realize they had not glued one of the pipe joints. Both the subcontractor and an INL Quality Assurance representative verified the work had been completed prior to it being turned over to ATR Operations, but failed to catch the unglued joint.

This unglued joint was almost hidden from view behind the unistrut leg.

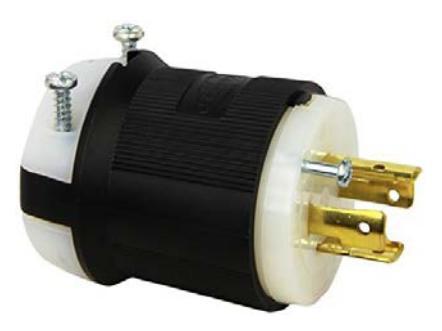
NE-ID--BEA-AL-2016-0001 (Significance Category 3) The Analytical Laboratory (AL) NFM was notified that an electrical subcontractor in the MFC AL had been measuring along a wall preparation for cutting and attaching a length of conduit. As the subcontractor was retracting the metal measuring tape, the tape buckled and collapsed. As it collapsed, it twisted and fell into the space between a 20

amp, 3 phase, NEMA L18-20 twist lock electrical plug and the receptacle in which it was plugged. The subcontractor observed an arc and heard a noise indicating an
