**THE EBR-I MELTDOWN - PHYSICAL AND
METALLURGICAL CHANGES IN THE CORE**

THE EBR-I MELTDOWN -
PHYSICAL AND METALLURGICAL CHANGES IN THE CORE

Final Report - Metallurgy Program 7.2.18

November 1957

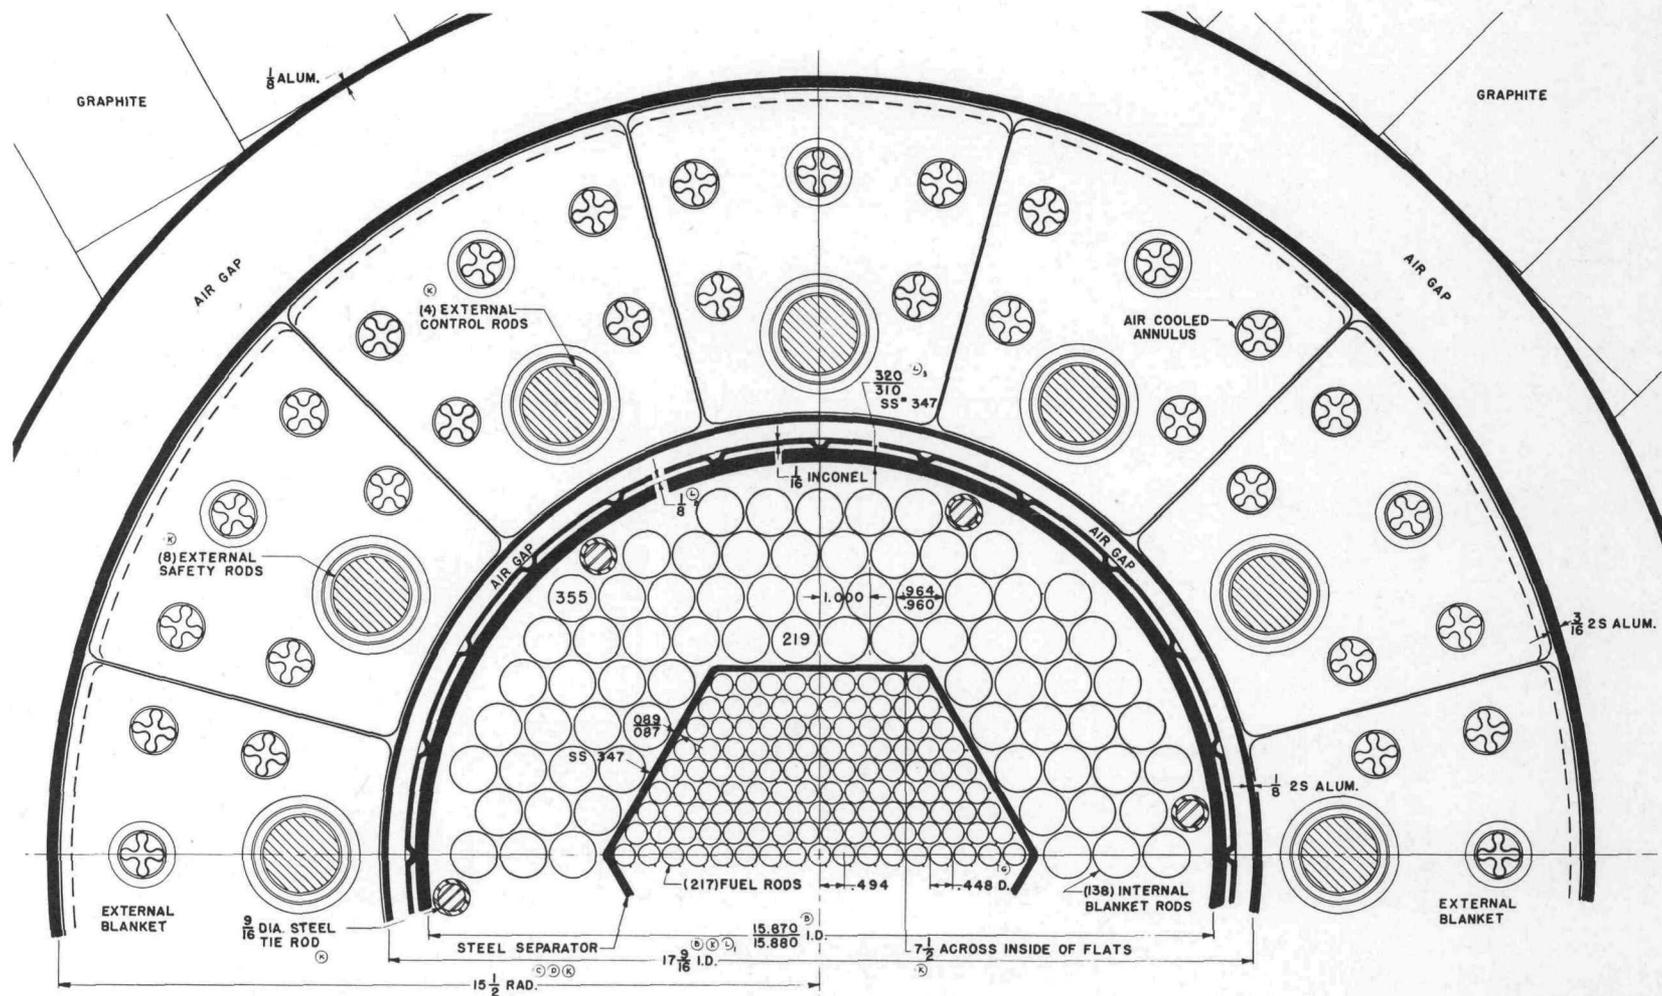
Figure 1. Horizontal cross section of EBR-I at the reactor midplane.
 (Dimensions are given in inches.)

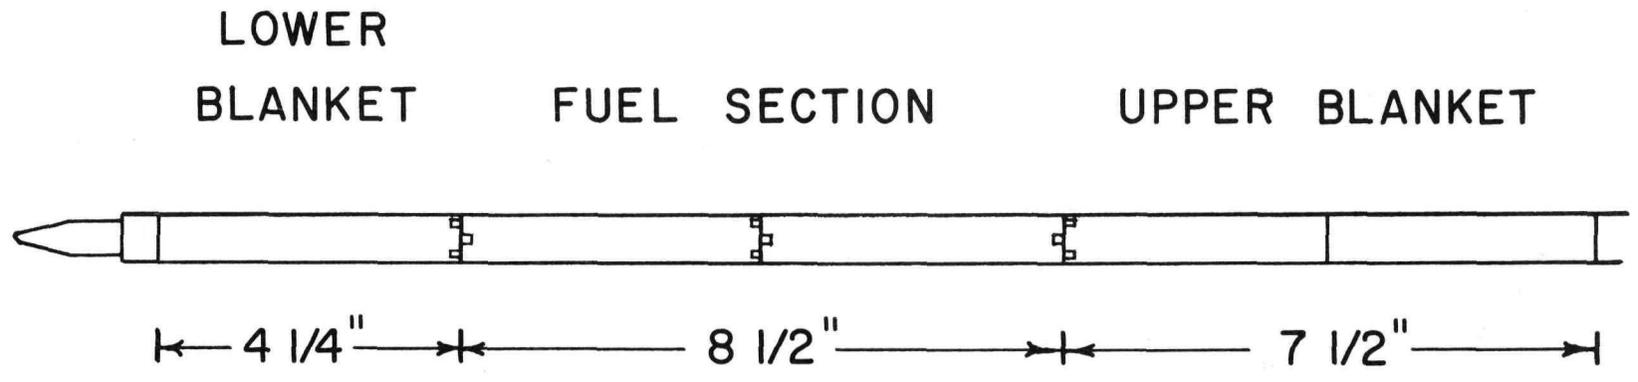
Figure 2. Simplified drawing of a typical fuel element from the EBR-I second loading. The diameter of the assembled fuel element is 0.45 in.

Figure 2 shows a drawing of a typical fuel element used in the second loading. The fuel section was made up of two $4\frac{1}{4}$ in. long bare slugs, 93.21% enriched, which were separated by a 0.005-in. thick stainless steel spacer. The lower blanket slug, also $4\frac{1}{4}$ in. long, was made of unenriched uranium and was encased in a drawn-on stainless steel jacket. The upper blanket section, also of unenriched uranium, consisted of two $3\frac{3}{4}$ -in. long slugs encased in a single drawn-on stainless steel jacket. The fuel slugs were separated from the jacketed blanket slugs by 0.005-in. thick stainless steel spacers. The diameter of the jacketed blanket slugs and the bare fuel slugs was 0.384 in. Surrounding these slugs was a 0.012-in. thick NaK annulus and a stainless steel outer jacket with a 0.021-in. wall. As mentioned previously, both the fuel and blanket slugs were made of centrifugally cast uranium - 2 w/o zirconium alloy. As can be seen from Figure 2, numerous possible contacts are present for uranium and stainless steel to interdiffuse. When the EBR-I was in its initial design stages, in 1947 and 1948, a study was made of the diffusion problems in this reactor.⁽⁶⁾ It was found that uranium and stainless steel were among the two elements which diffused into each other most rapidly, and Figure 3 shows a typical diffusion zone between uranium and stainless steel which developed after six days at 700°C. Diffusion zones also formed at temperatures as low as 500°C, although at a slower rate.

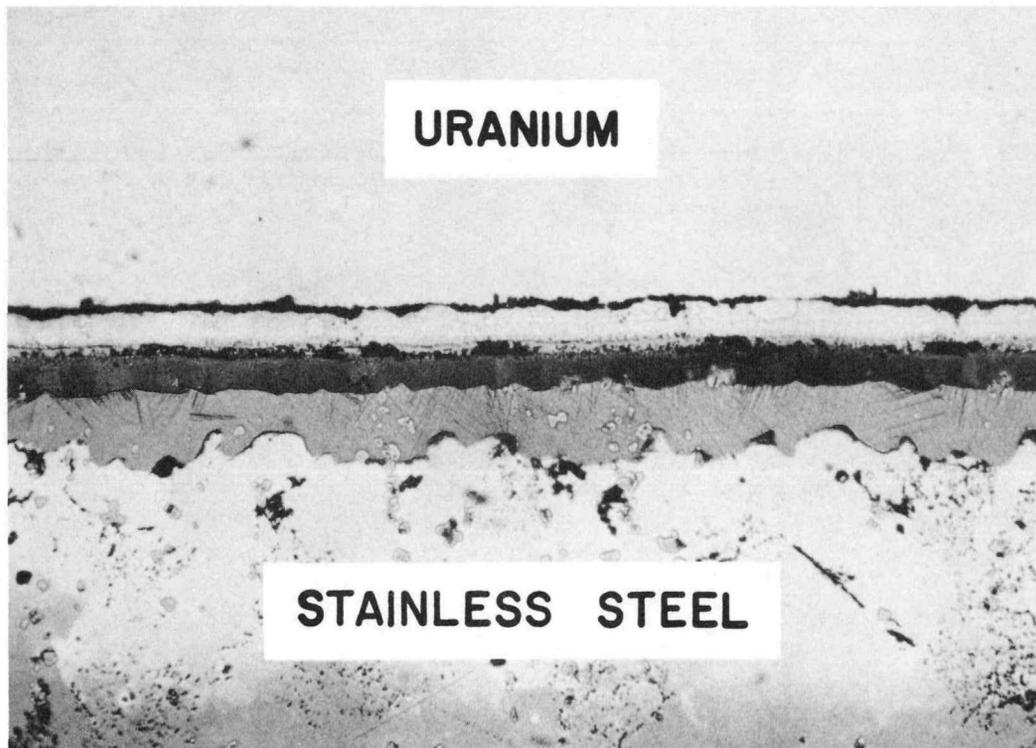
Figure 3. Intermetallic compound layers formed as a result of interdiffusion between uranium and Type 347 stainless steel after six days at 700°C. Total thickness of the layers is 0.0018 in.

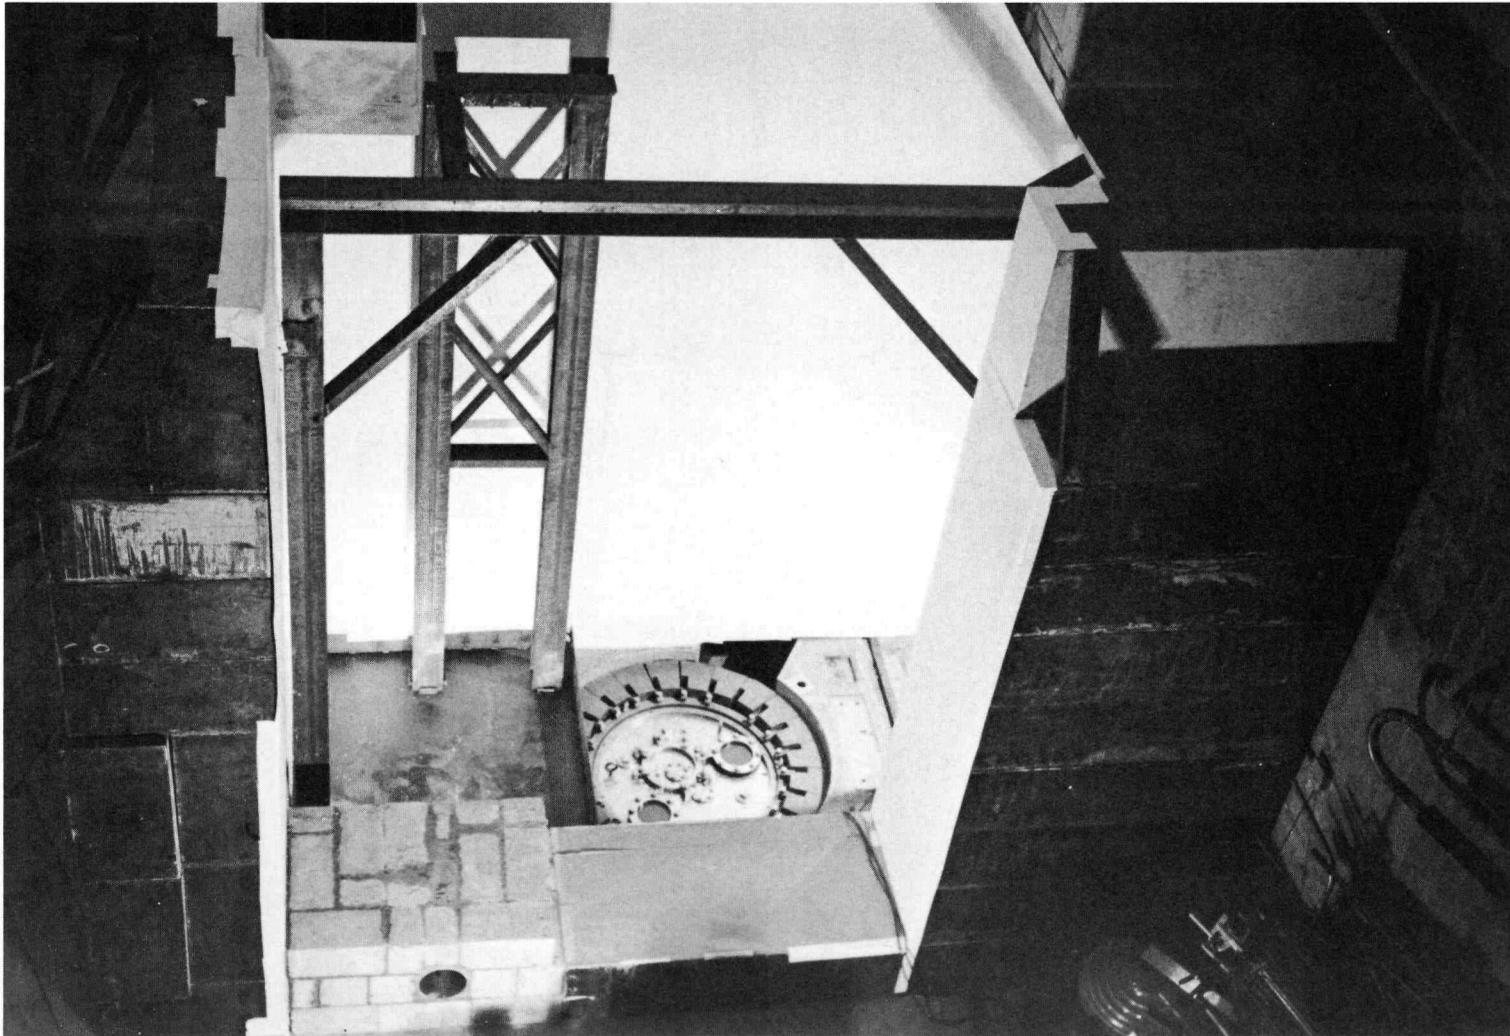
Figure 4. Construction of temporary cave above EBR-I before closure of front face. The top of the reactor is shown at the center of the cave floor. After lifting the core assembly from the reactor tank, it was suspended from the bracket shown at the upper left.

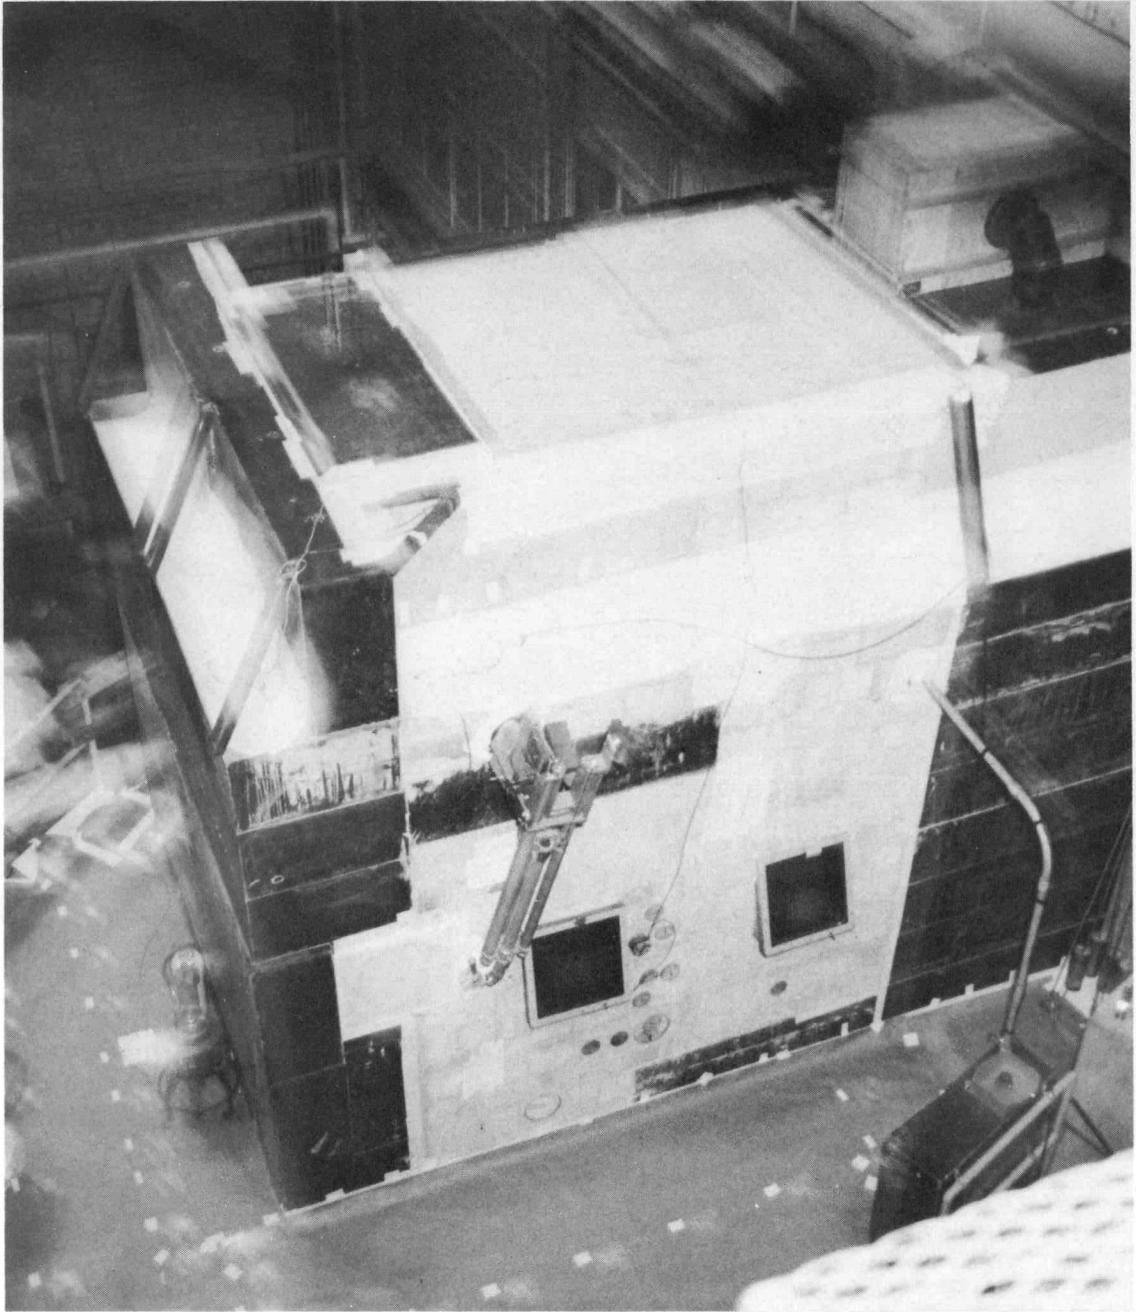
Figure 5. Completed temporary cave built over EBR-I for removal of core assembly.

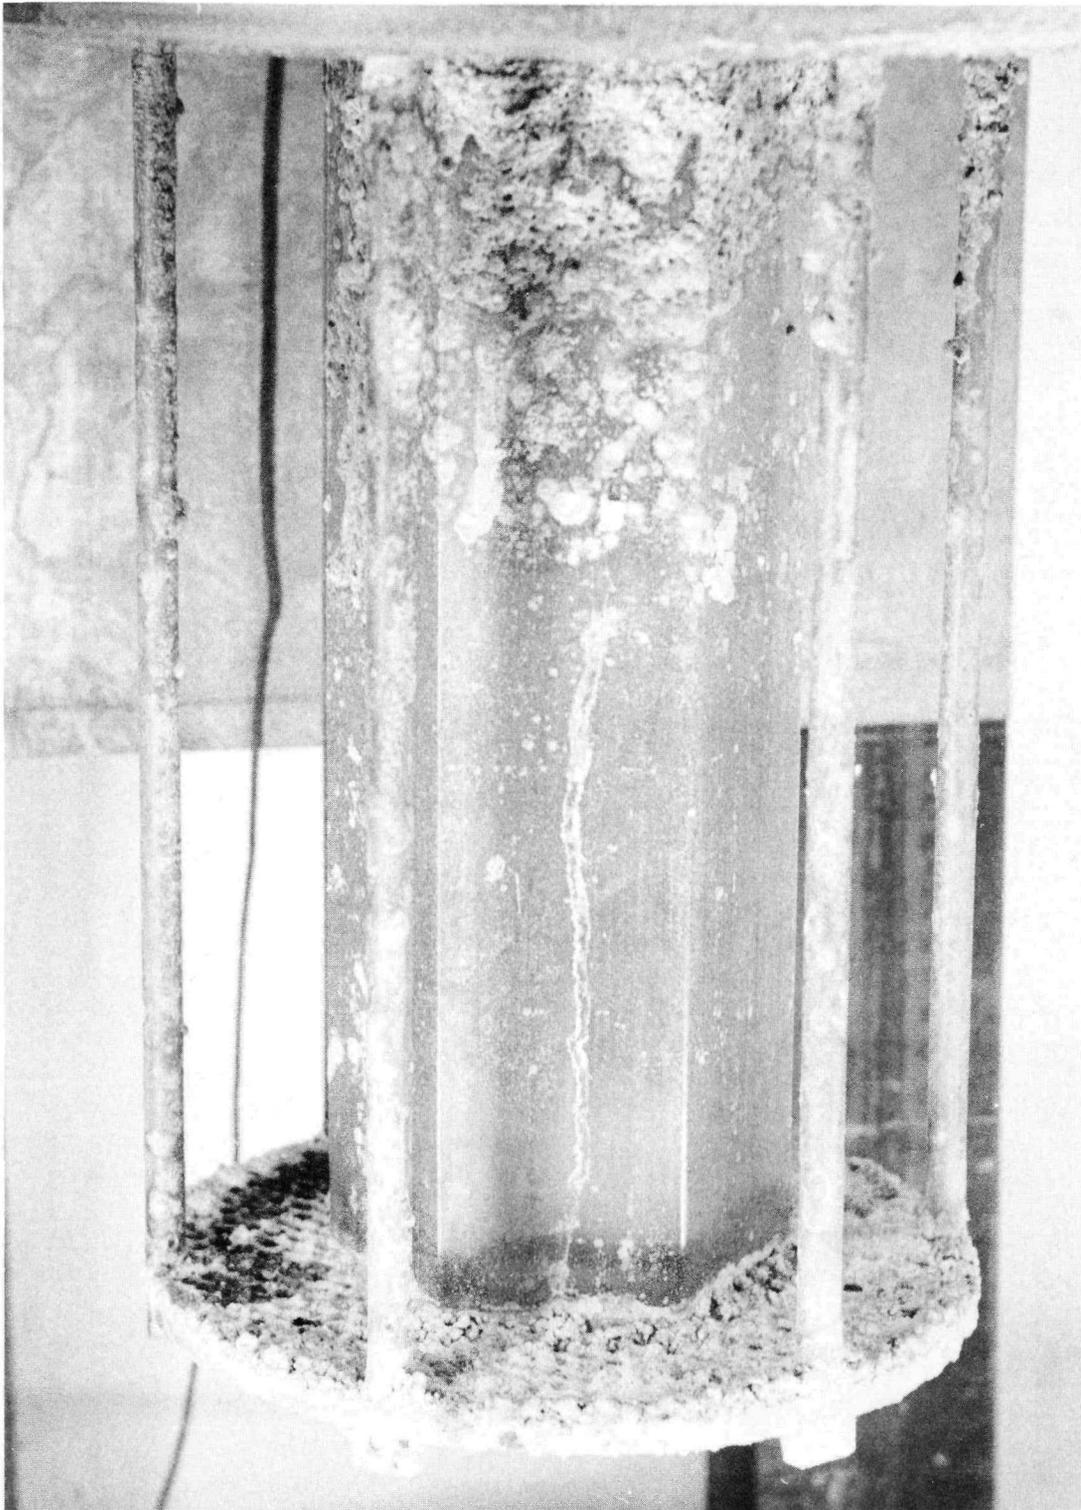
Figure 6. Core assembly after removal of blanket rods. The fuel section is enclosed in the hexagonal separator.

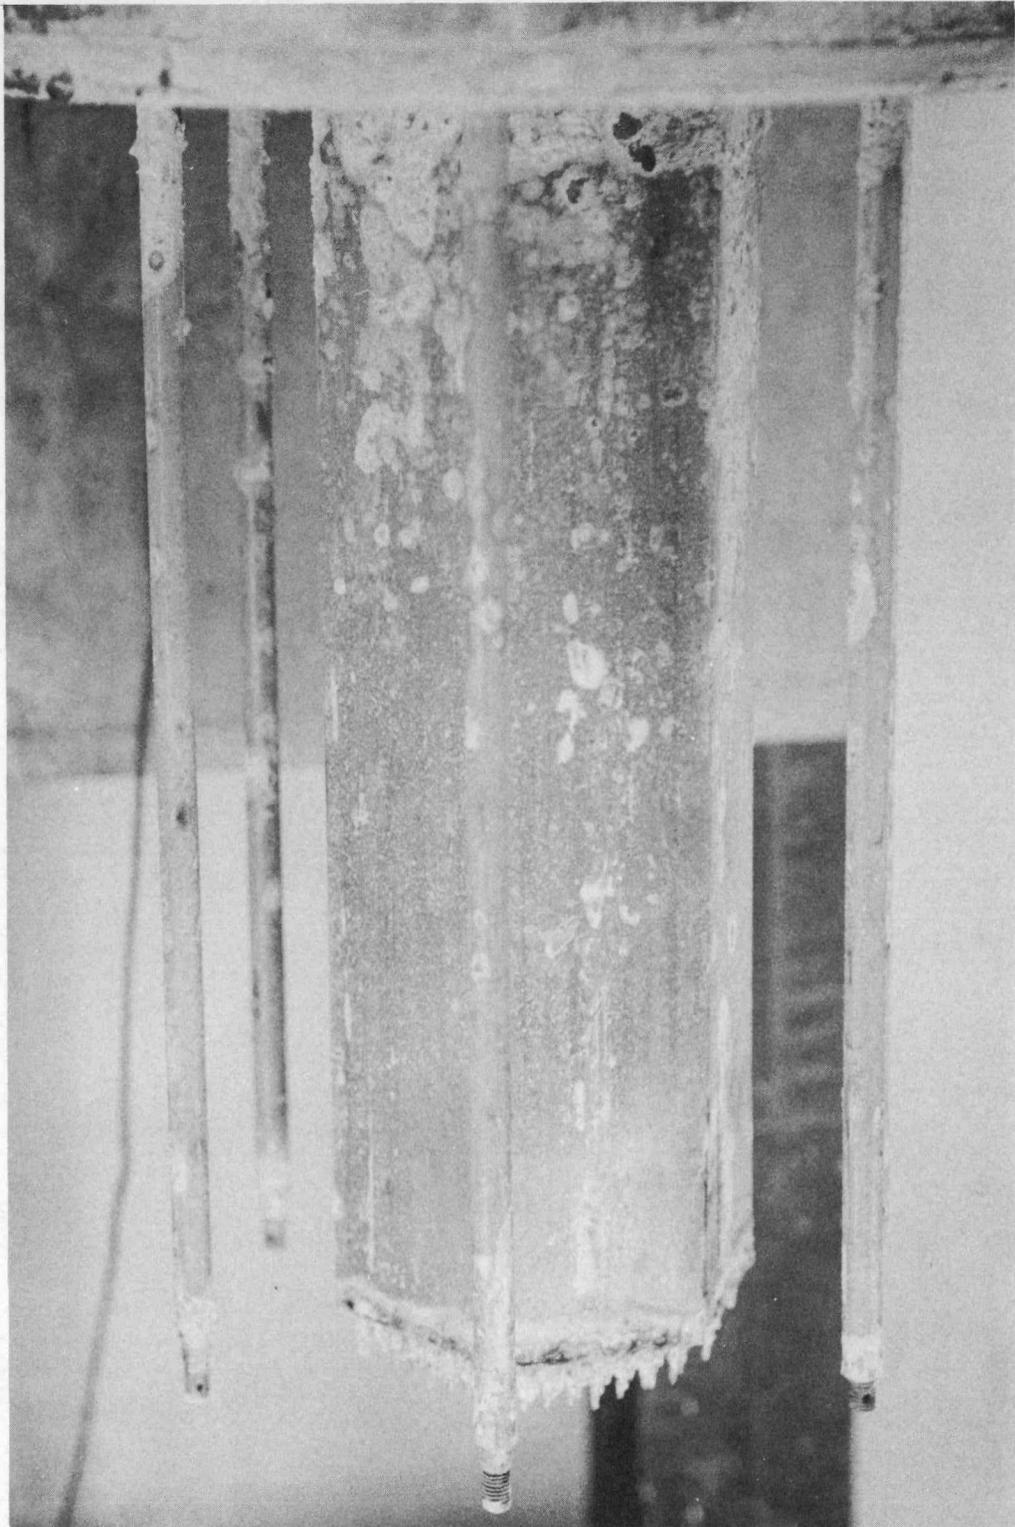
Figure 7. Core assembly after removal of bottom plate. The tips of the fuel rods in the hexagonal separator are visible.

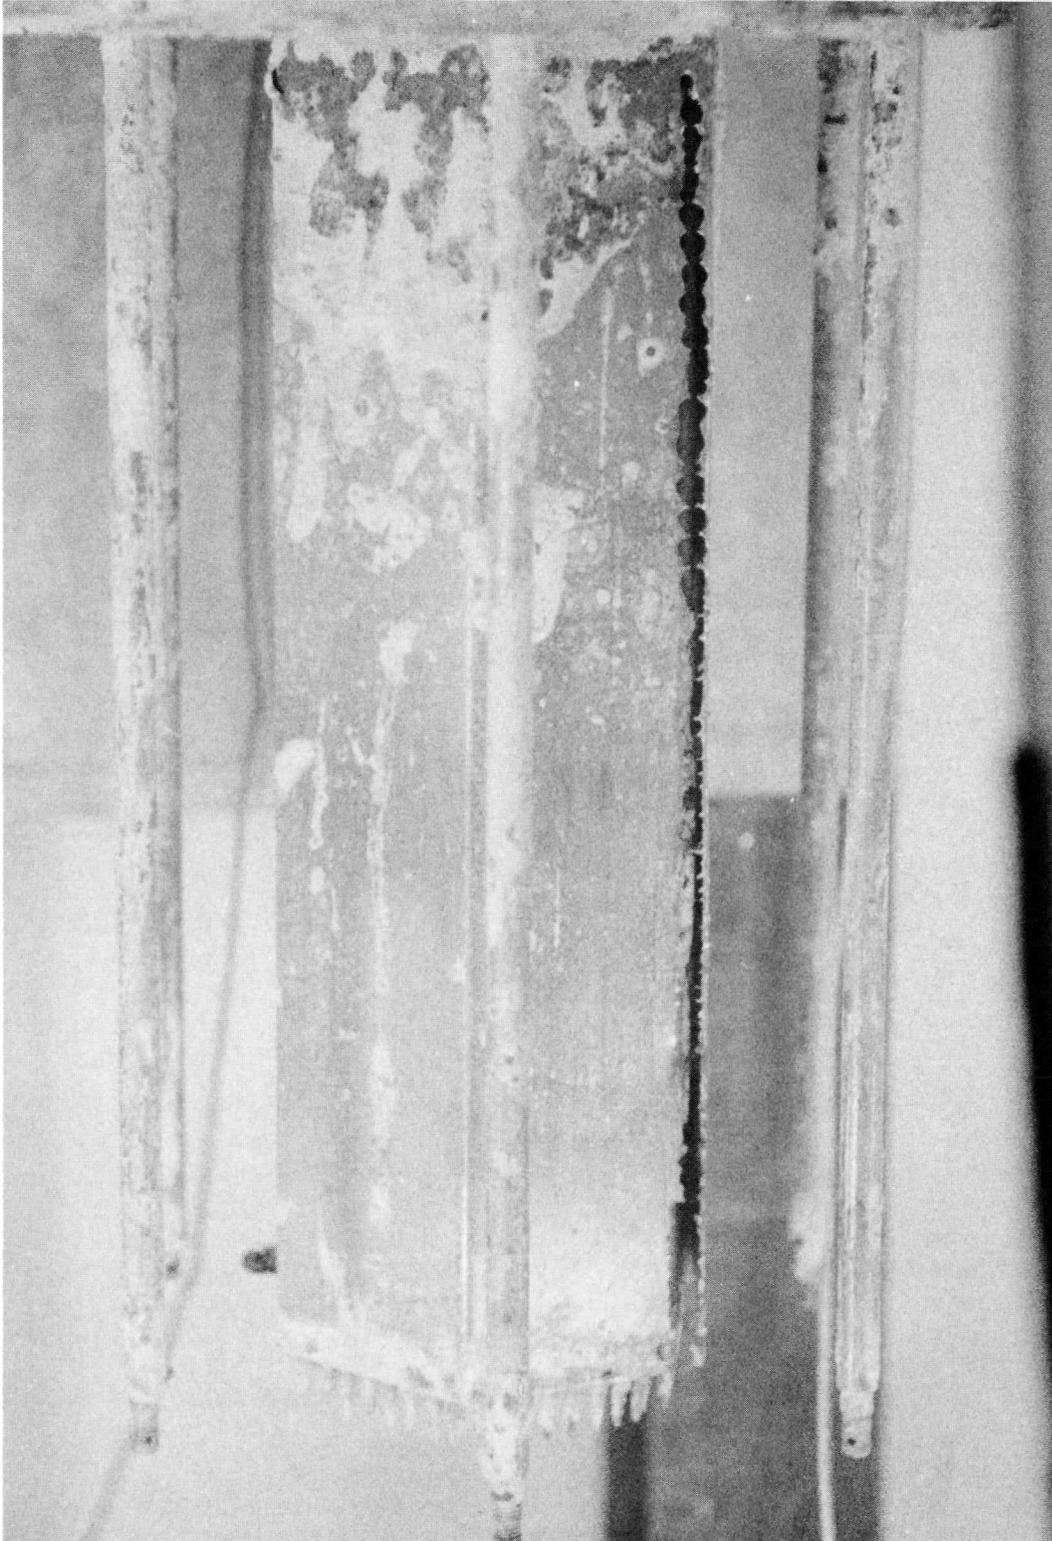
Figure 8. Holes drilled in hexagonal separator to facilitate removal from core assembly.

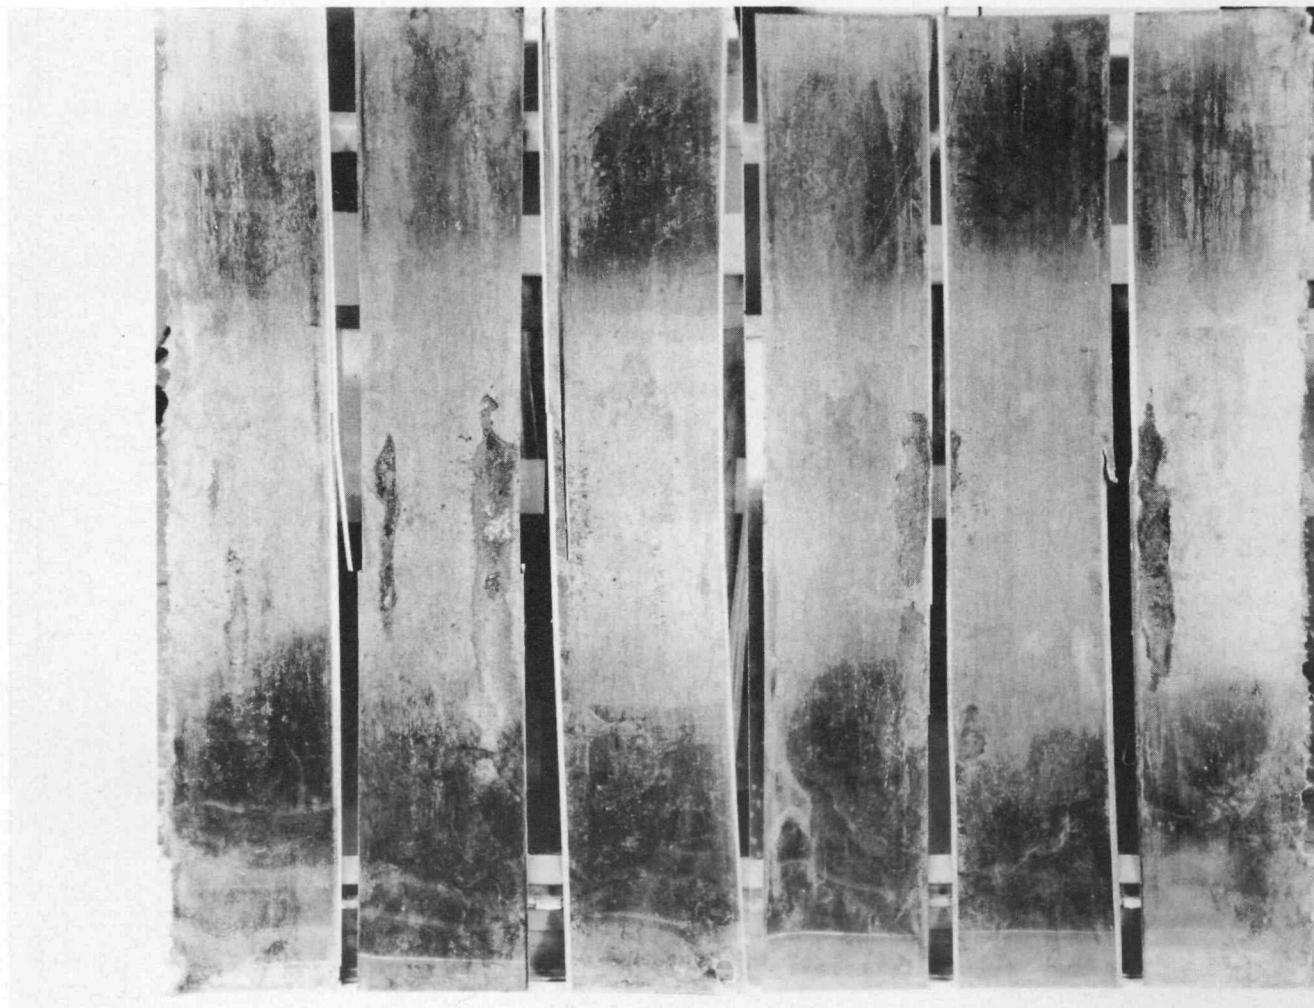
Figure 9. Interior surfaces of hexagonal separator, showing superficial alloying of molten phase with separator, particularly on sides 2, 4, and 6.

Subsequently, at the Lemont site of the Laboratory, the hexagonal separator was split down each corner to provide specimen material for determination of the effects of irradiation on the mechanical properties of the stainless steel. Figure 9 shows a photograph of the six interior faces of the separator, and it can be noted that the material formed during the temperature excursion had alloyed superficially with the separator in certain areas, particularly on sides 2, 4, and 6.

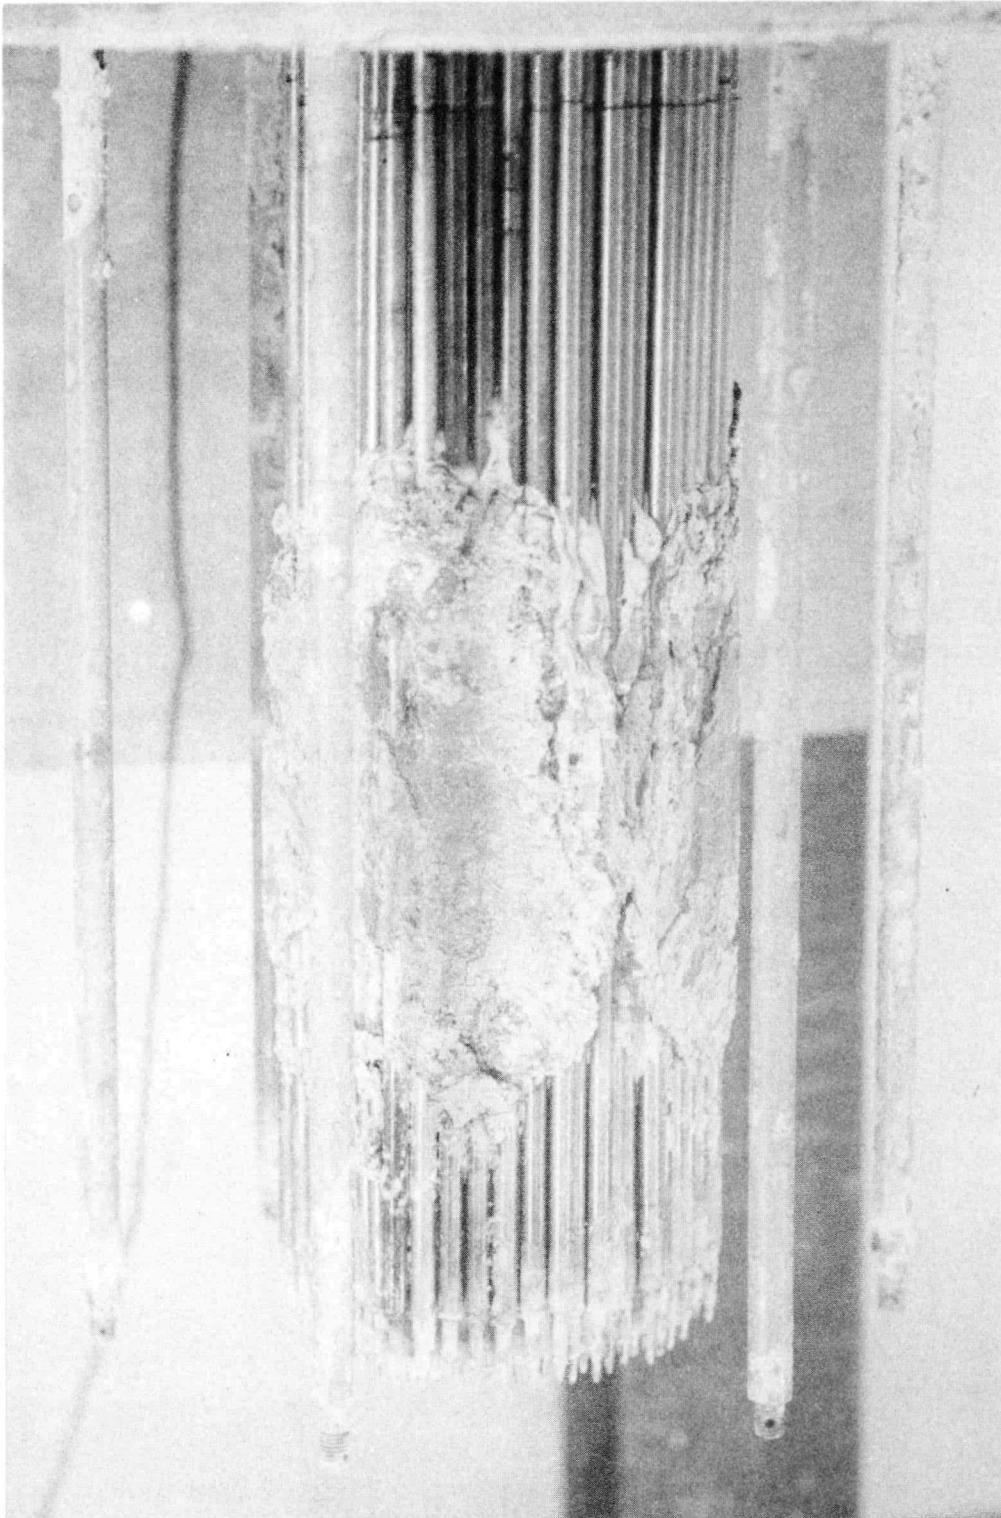
The appearance of the damaged core after removal of the hexagonal separator is shown in Figure 10. The molten core alloy was found to have extruded into the coolant channels and to have finally solidified into a mass surrounding the fuel section and molded into shape by the separator can. The solidified material was heavily covered with oxides of NaK.

Figure 10. Damaged EBR-I core after removal of hexagonal separator.

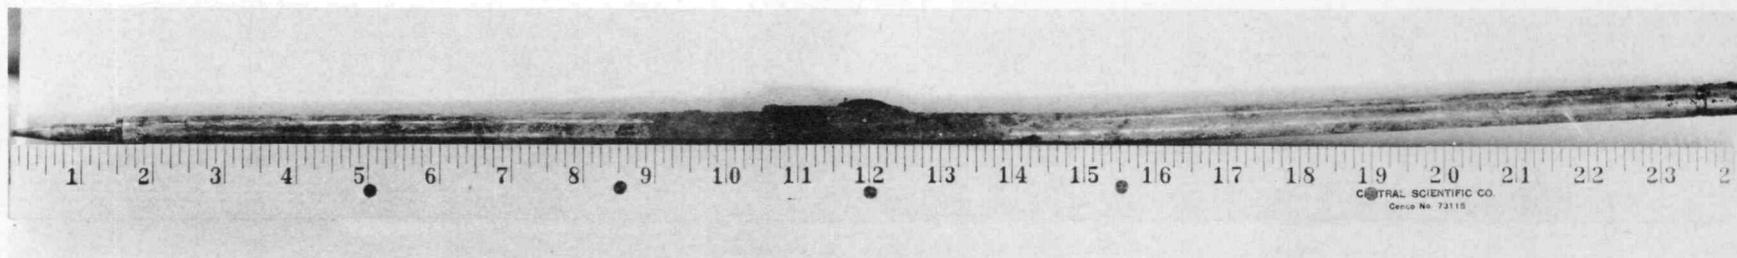
Typical fuel rods from this group are shown in Figures 11 and 12. Although the outer jackets were damaged on most of the fuel elements in the outer row, as shown in Figure 11, it was evident that any jacket melting resulted from external causes, rather than from the fuel slugs which they contained. This is clearly shown in Figure 13, in which can be seen an undamaged stainless steel spacer between fuel slugs contained in an outer jacket which had been subjected to melting damage. Had these particular slugs overheated, the spacer, being at the center of the fuel section, would have formed a eutectic before any jacket damage occurred.

Figure 11. Typical fuel element from the first (outer) row of the damaged EBR-I core.

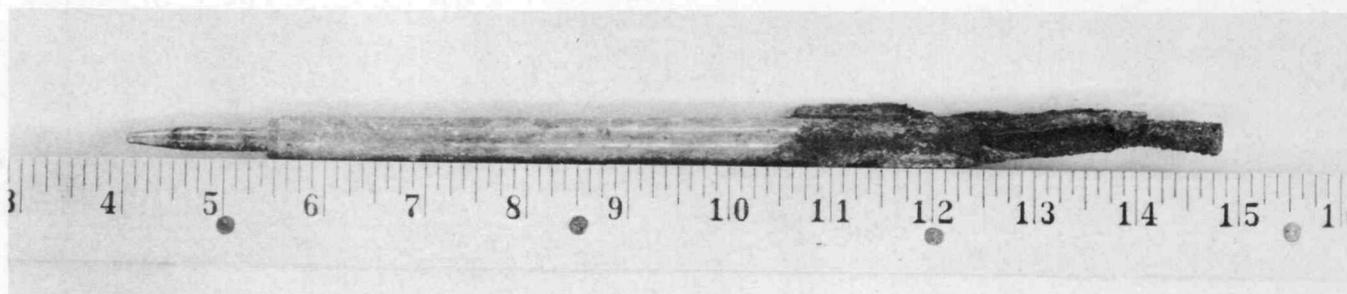
Figure 12. Typical fuel element from the second row of the damaged EBR-I core.

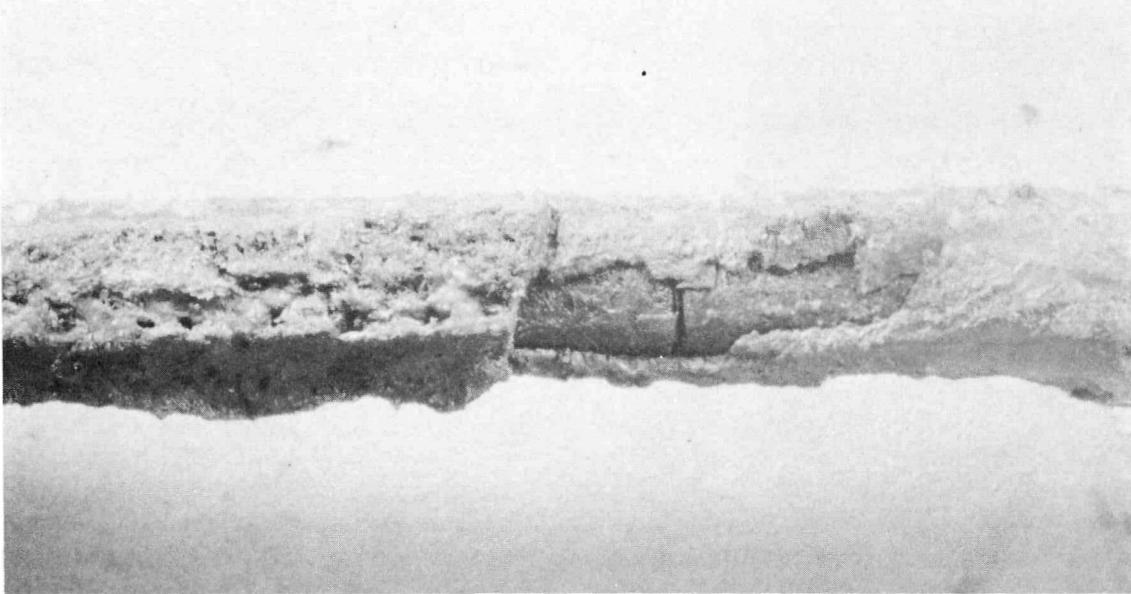
Figure 13. Fuel element from outer row of damaged EBR-I core assembly, showing that although the outer jacket has been severely damaged by melting, the stainless steel spacer between adjacent fuel slugs is undamaged.

Additional evidence that the fuel in the outer row of elements did not participate in the molten phase is shown in Figure 14. Here, the damaged jacket shown in Figure 13 has been peeled back to expose one of the fuel slugs, and it can be noted that the surface of the slug and the interior surface of the stainless steel jacket have not been affected by the meltdown. For the outer row of fuel elements, therefore, it appears that the fuel temperature did not exceed about 850° to 950°C, which have been reported⁽¹⁰⁾ to be the lowest temperatures at which uranium and stainless steel form a liquid phase for short heating periods.

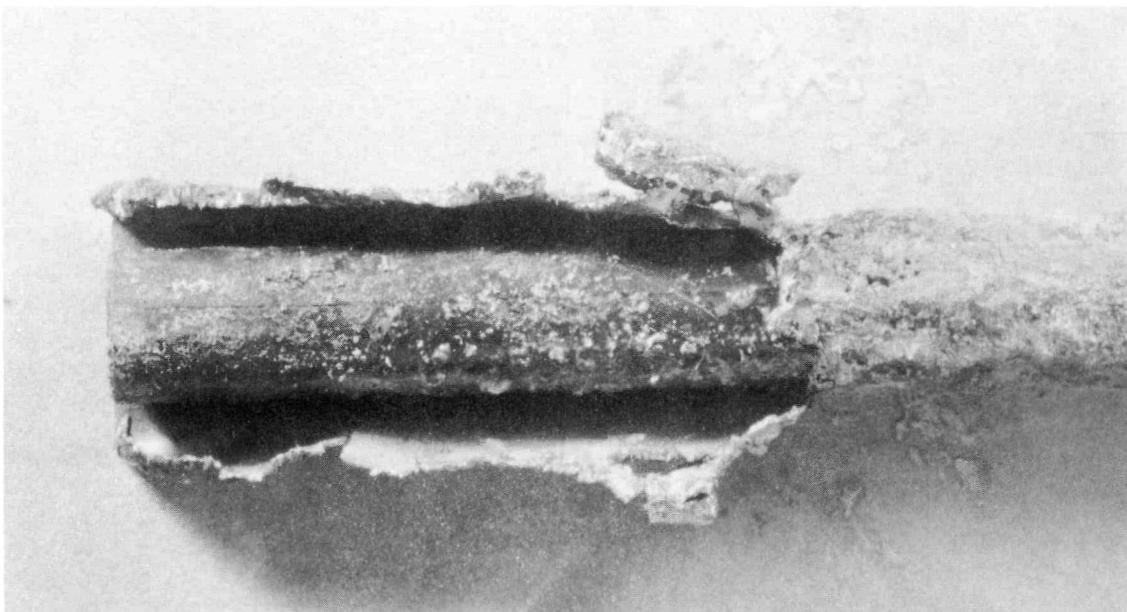
Figure 14. The stainless steel jacket shown above in Figure 13 has been peeled back, and it can be noted that the surface of the fuel slug and the interior surface of the jacket were unaffected by the meltdown.

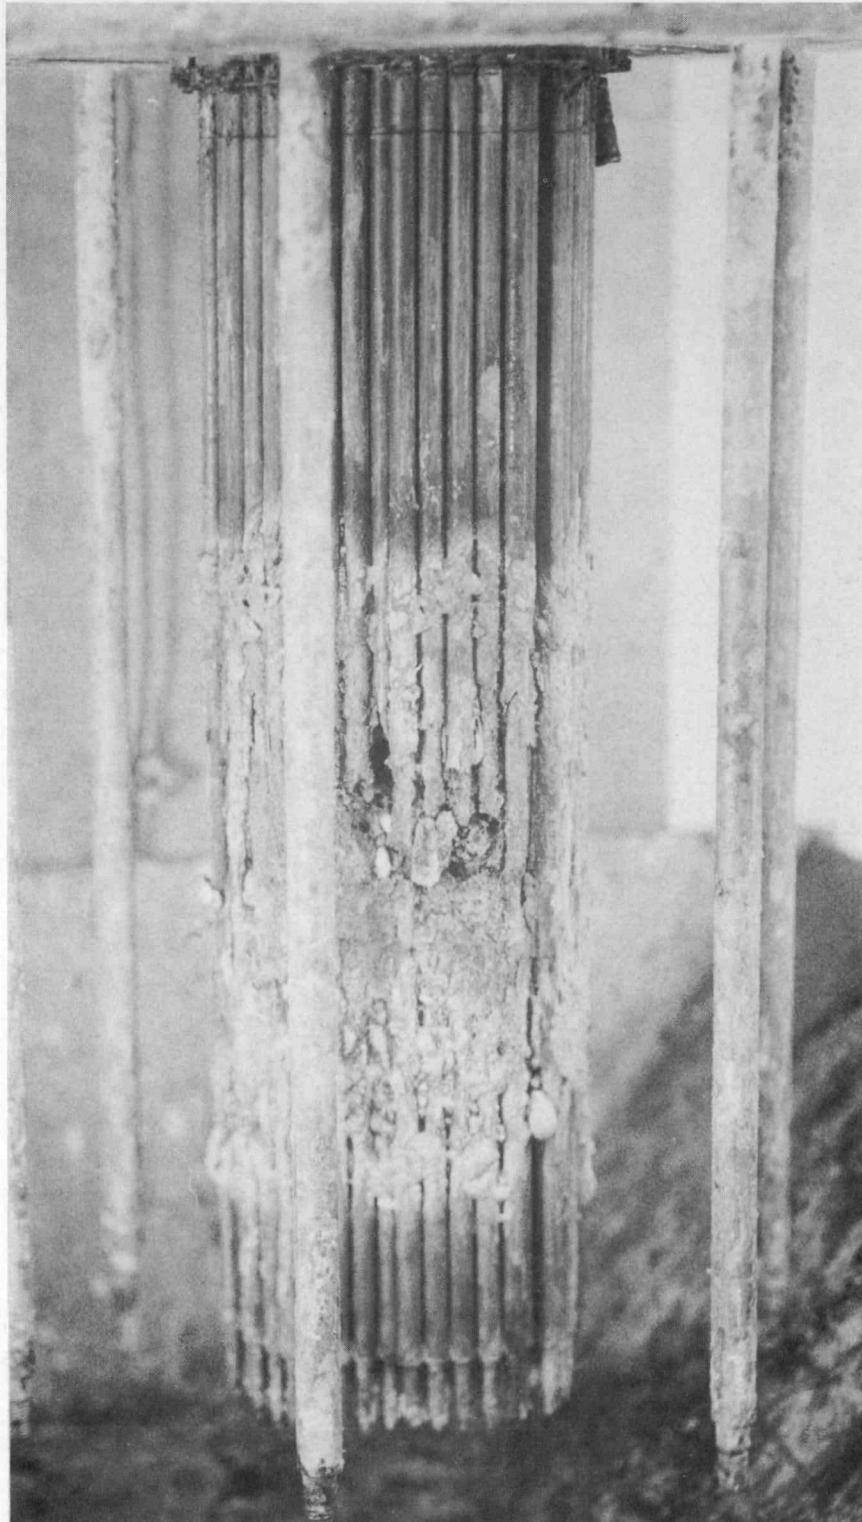
The appearance of the core assembly after removal of the outer fuel elements is shown in Figure 15. It is evident that severe melting damage had occurred in the fuel section, which had slumped somewhat so that the lower half was tightly packed with solidified material. The upper half, on the other hand, contained numerous cavities. Evidently many of the jackets, after forming a molten phase with the fuel slugs they contained, sloughed off and left the partially dissolved fuel still more or less in place. It was subsequently learned during final disassembly that the partially dissolved fuel still in position was confined generally to the second row of fuel elements, i.e., the row next to the outermost row. Moving inwardly from the second row, damage was more extensive.

Figure 15. Damaged EBR-I core after removal of outer fuel elements.

After the core assembly had been reduced to the 153 fuel elements shown in Figure 15, it was apparent that the facilities at the reactor site were not adequate for further operations to be conducted in a safe manner. The pyrophoric nature of the damaged core presented a serious fire hazard, a condition which was further aggravated by the presence of large amounts of entrained NaK. After several small NaK fires were observed in debris resulting from removal of the outer fuel elements, it was decided to stop further disassembly operations at the Idaho site and to ship the core assembly to the Lemont site of the Laboratory, where more complete hot laboratory facilities existed and where disassembly could be completed in an inert atmosphere. Accordingly, as shown in Figure 16, a stainless steel thimble was pulled up and supported around the assembly, leaving the upper part of the rods visible. Argon gas was allowed to fill the thimble to prevent fire. Saber saws were again used to cut through the entire assembly below the bottom plate, and all remaining fuel elements were sawed through, permitting the assembly to drop into the thimble as shown in Figure 17.

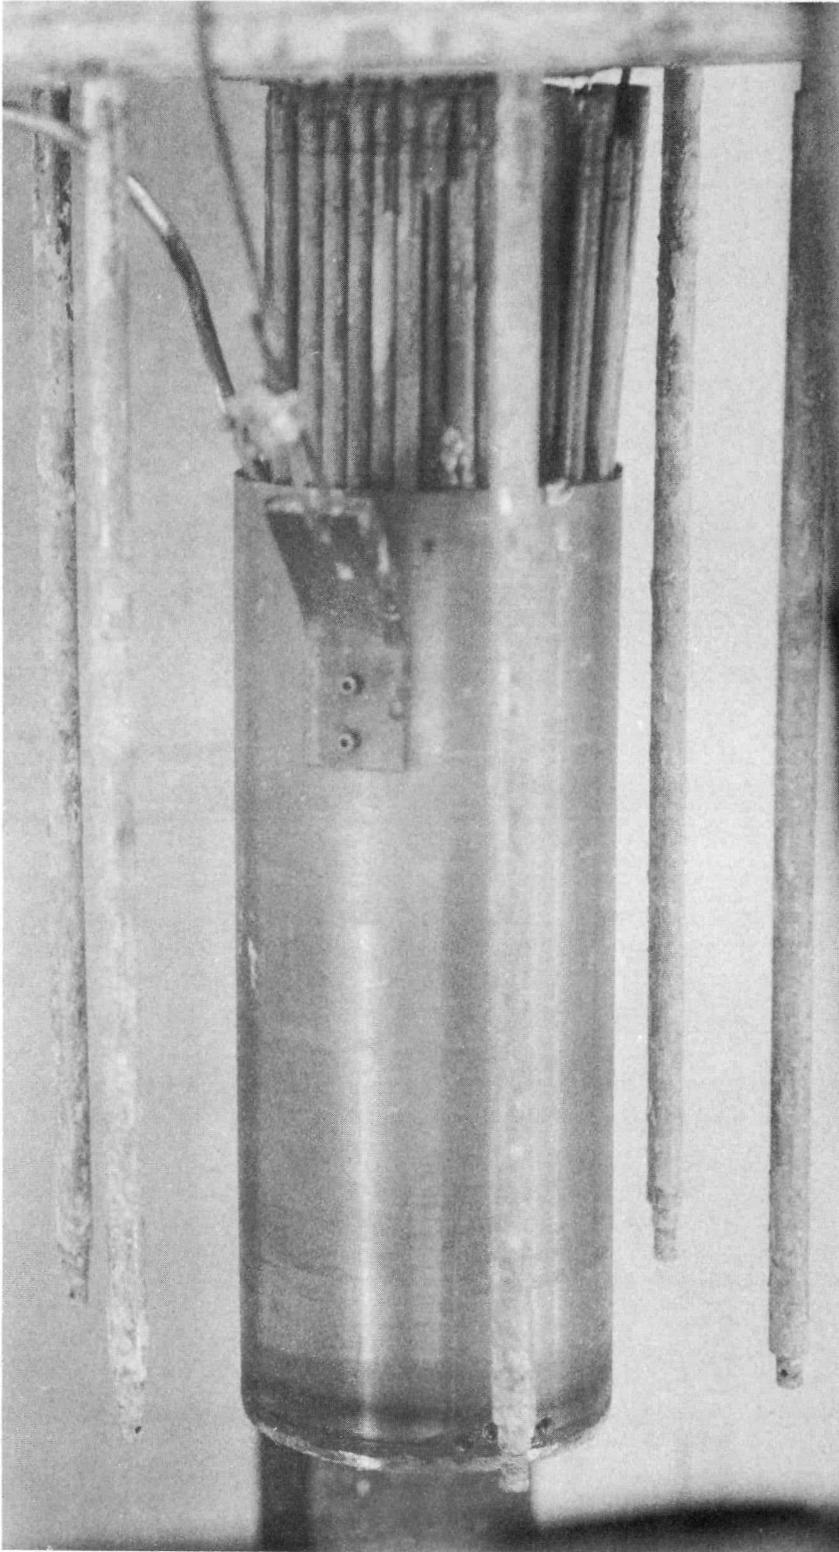
Figure 16. Thimble used to contain damaged core. Argon gas is being led into the thimble by the tube on the left.

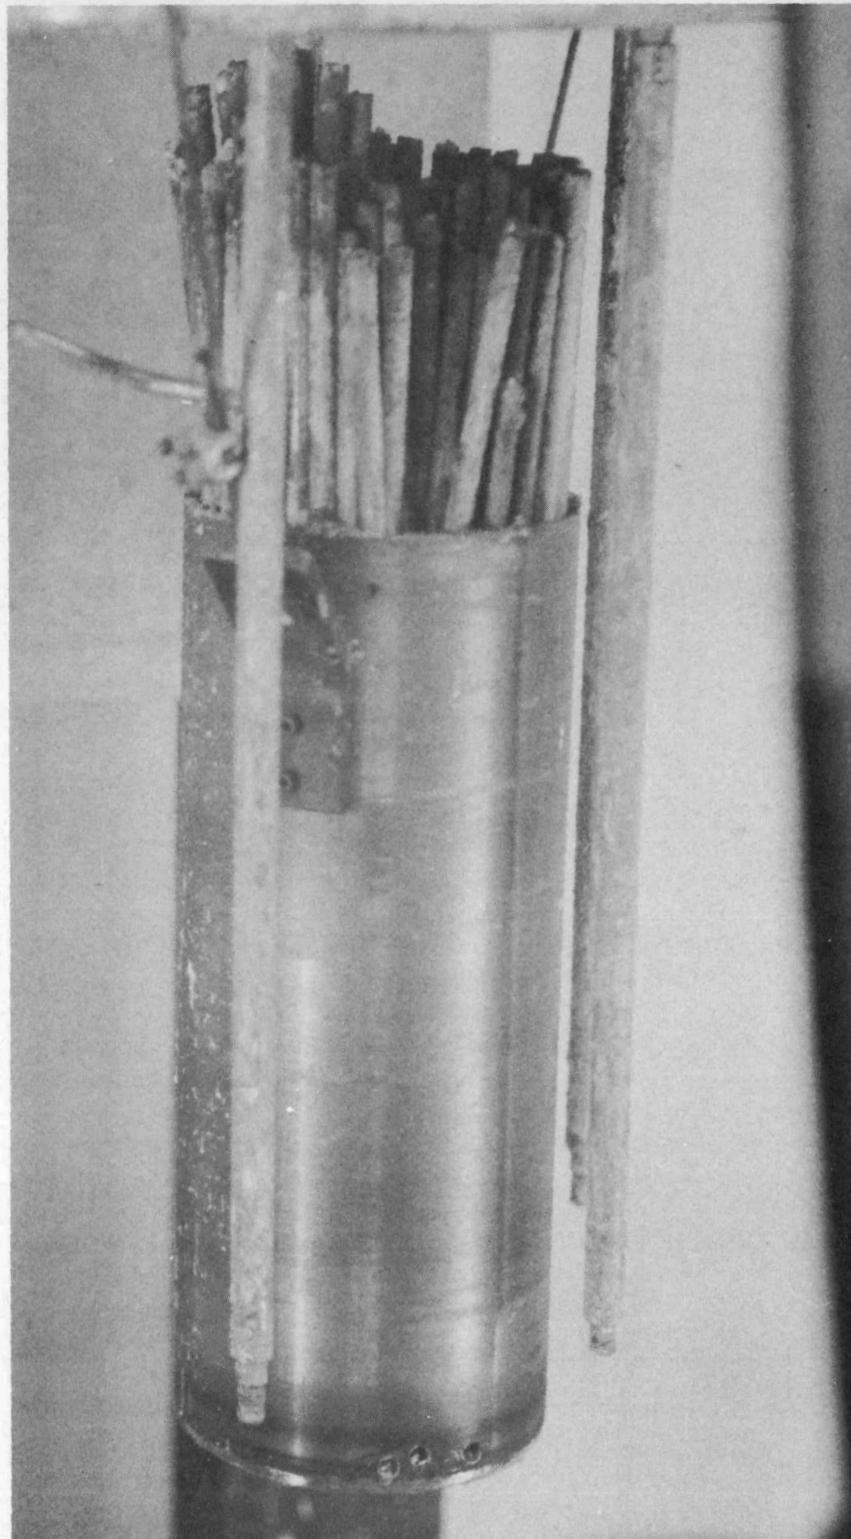
Figure 17. Appearance of core assembly after all remaining fuel rods had been sawed through.
