**THE EBR-I MELTDOWN - PHYSICAL AND
METALLURGICAL CHANGES IN THE CORE**

THE EBR-I MELTDOWN -
PHYSICAL AND METALLURGICAL CHANGES IN THE CORE

Final Report - Metallurgy Program 7.2.18

November 1957

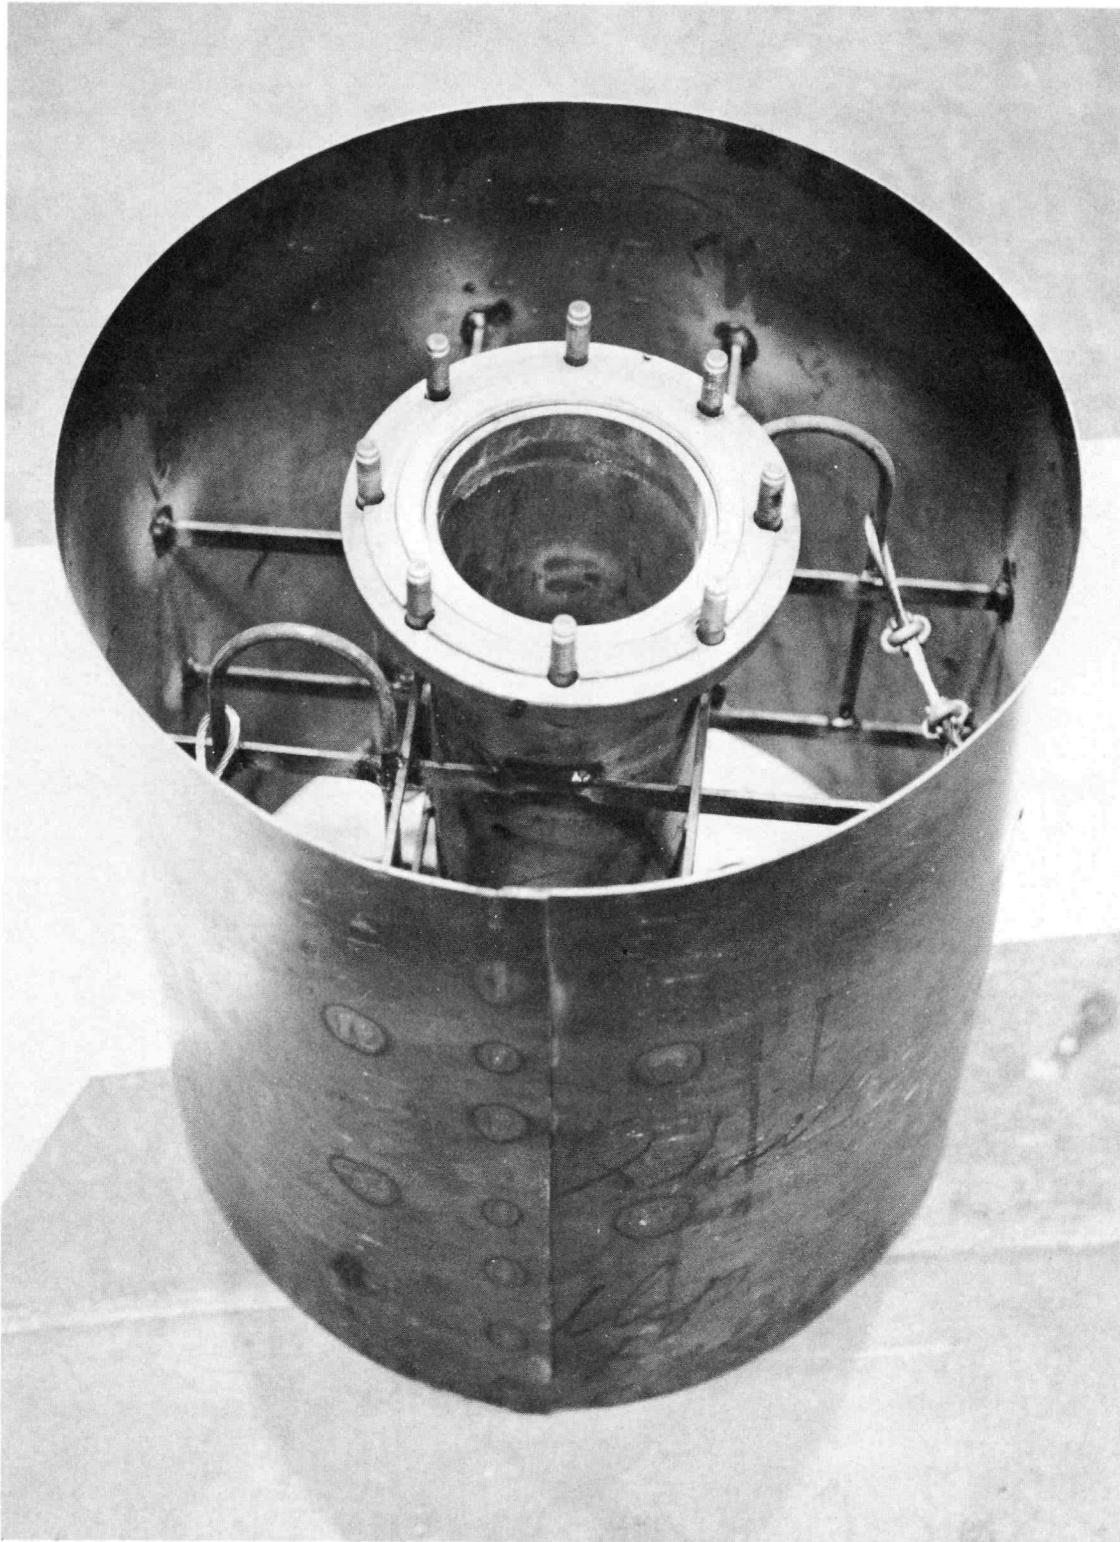
Figure 18. Gas-tight container and cage assembly used for shipment of the damaged EBR-I core assembly.

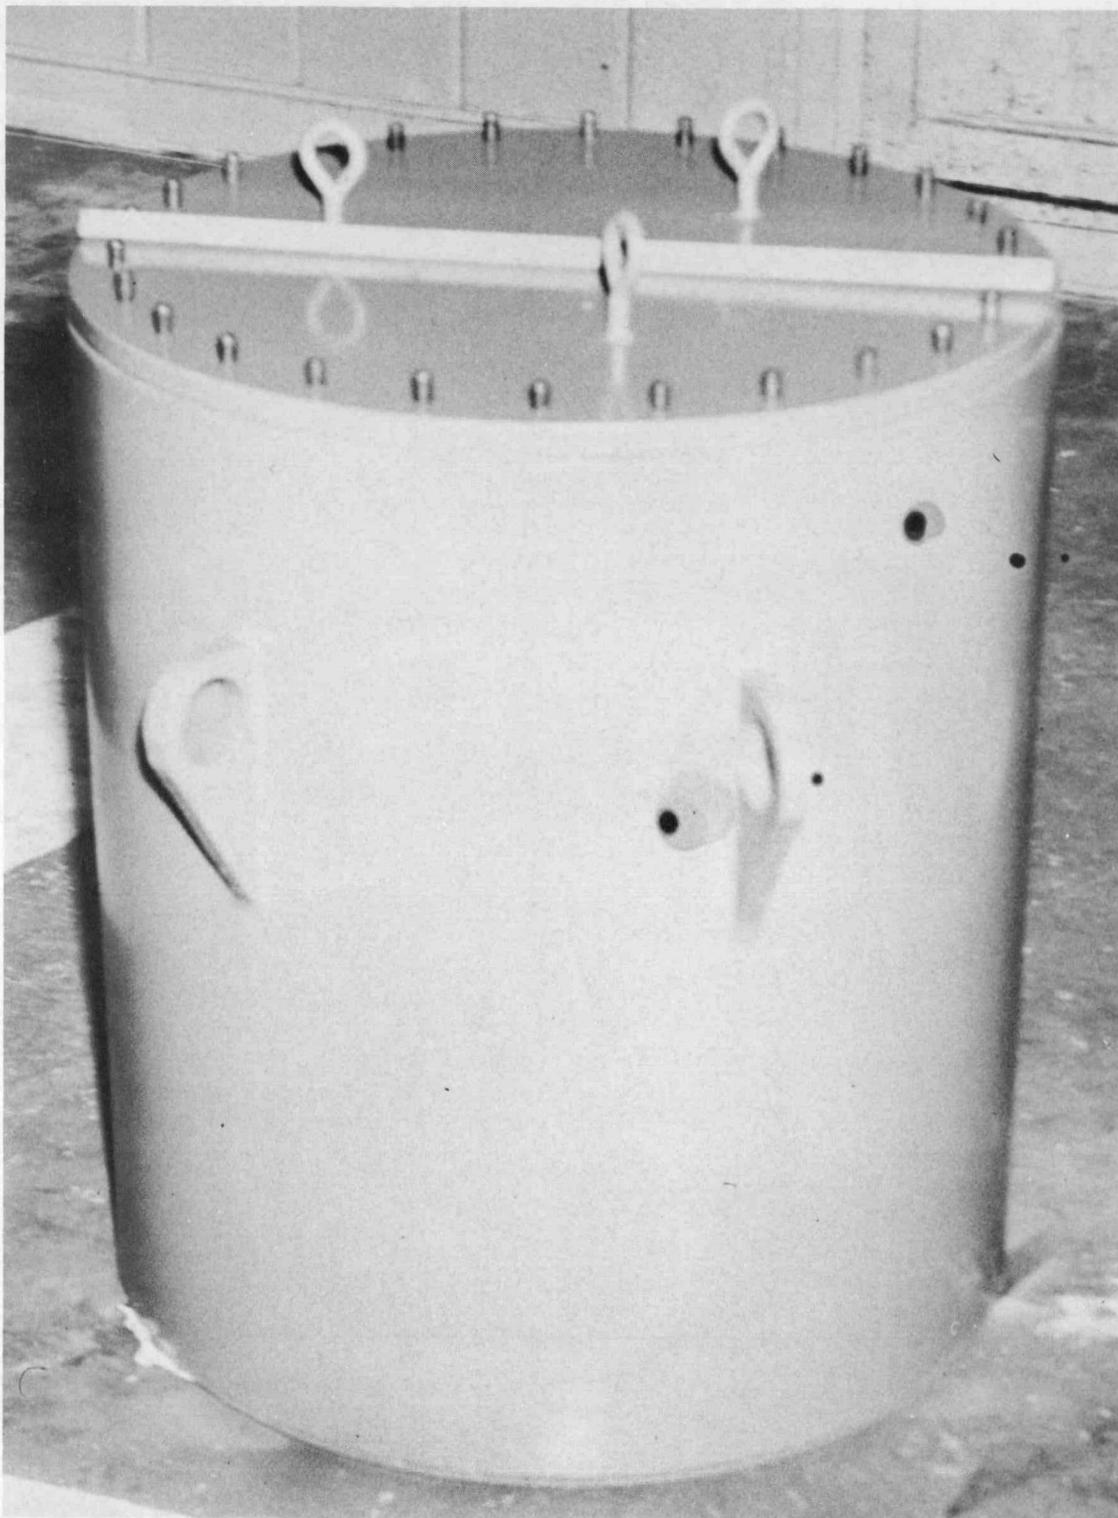
Figure 19. Lead cask used to ship the damaged EBR-I core assembly. The cask is 43 inches high, 40 inches in diameter, and weighs 10,800 lb.

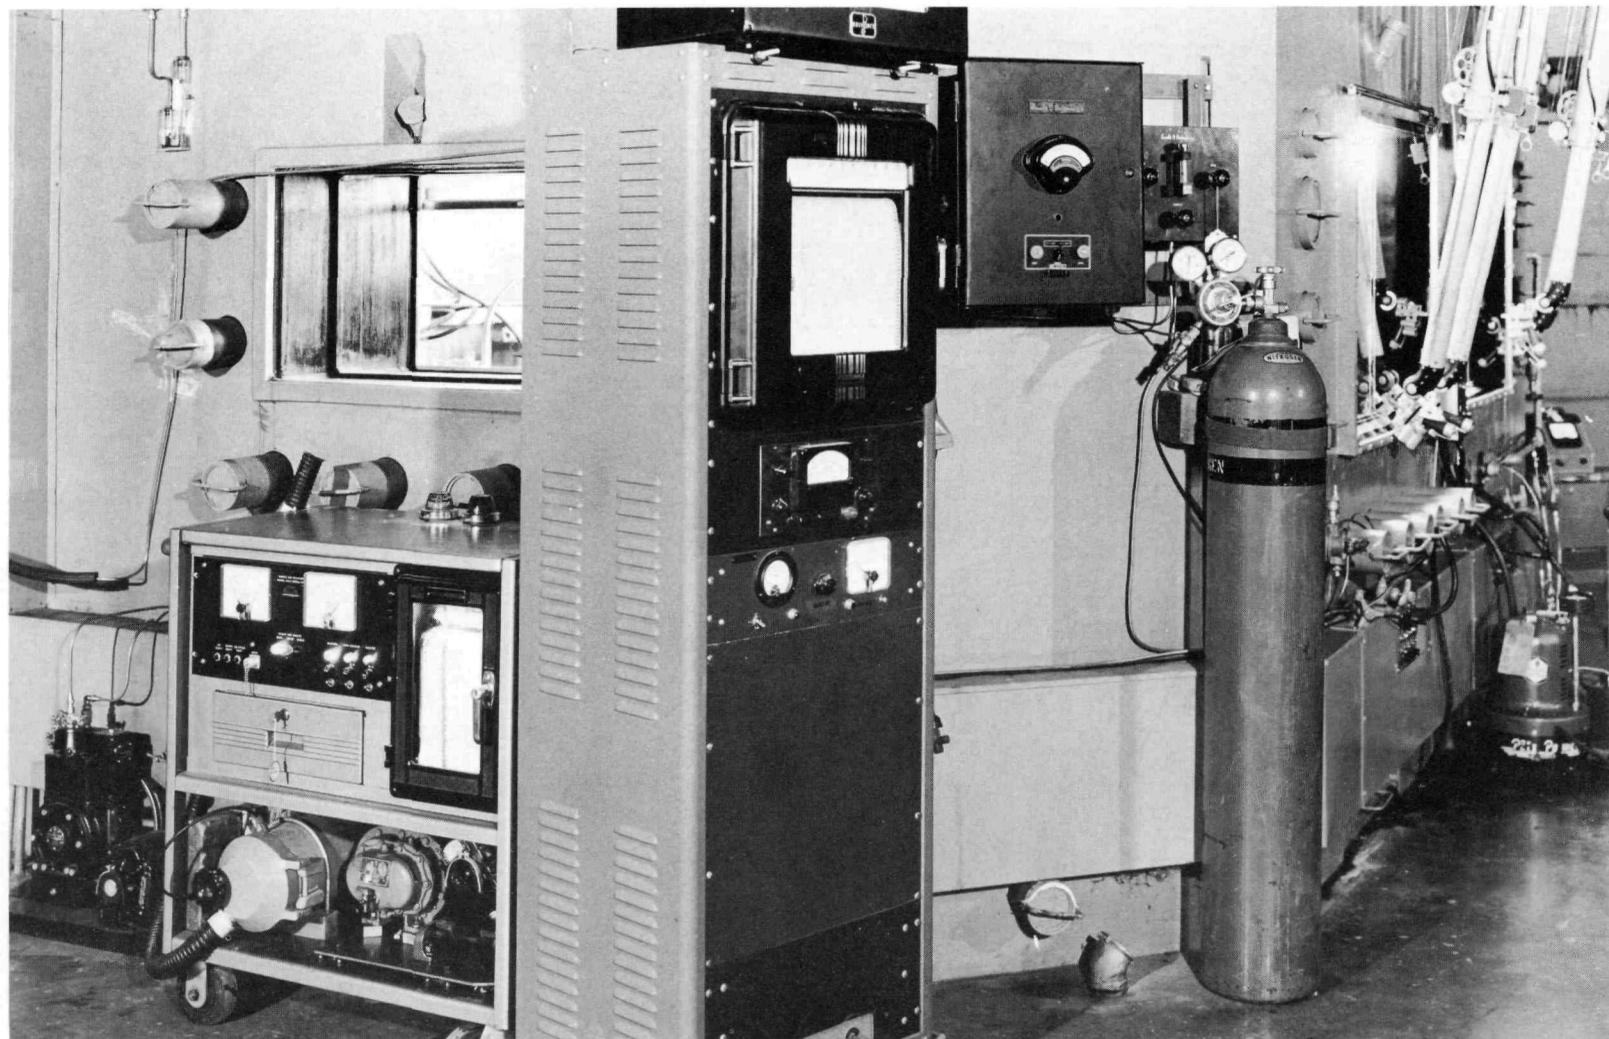
Figure 20. View of some of the instrumentation outside the cave used for final disassembly of the EBR-I core. The equipment at the left recorded air-borne particulate activity in the cave atmosphere. The equipment at the center recorded oxygen level in the cave atmosphere. Other instruments, not visible, measured nitrogen flow rate, temperature, humidity, and gamma and neutron levels in the cave.

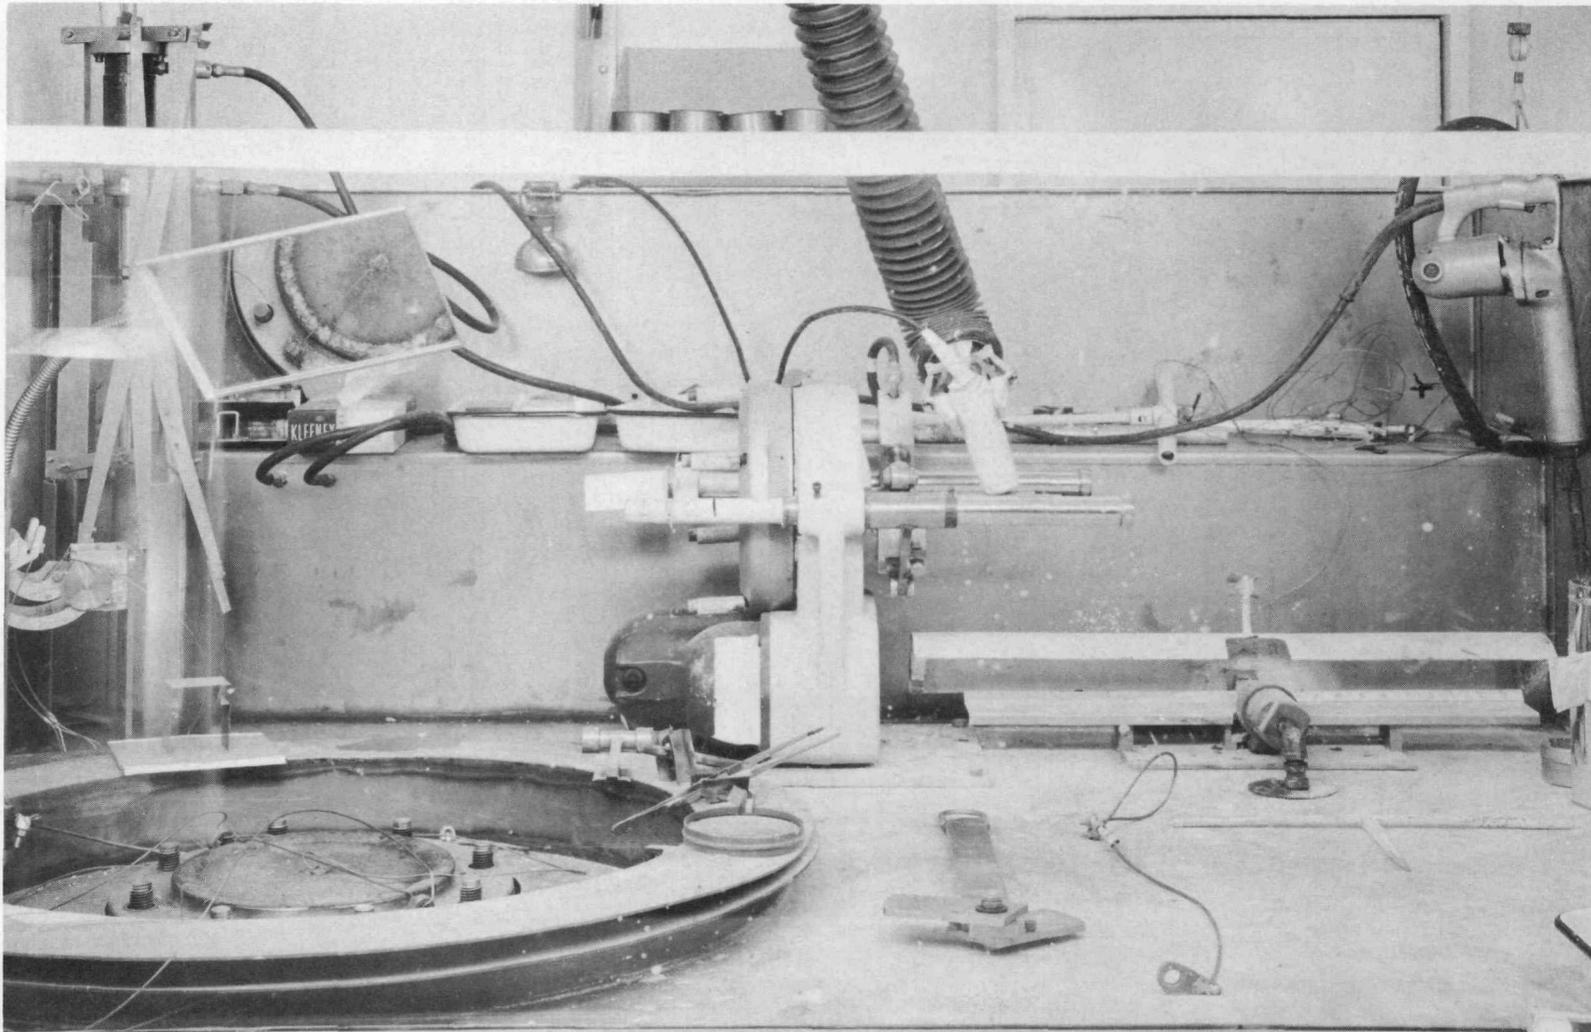
Figure 21. Area in left part of cave used for disassembly of EBR-I core. The top of the cage assembly used for shipment, shown in Figure 18, is at the lower left. The device in the center background is a pipe cutter, and the object in the right background is a hydraulic chisel. An electric impact chisel is suspended at the extreme right. All powered equipment was remotely operated.

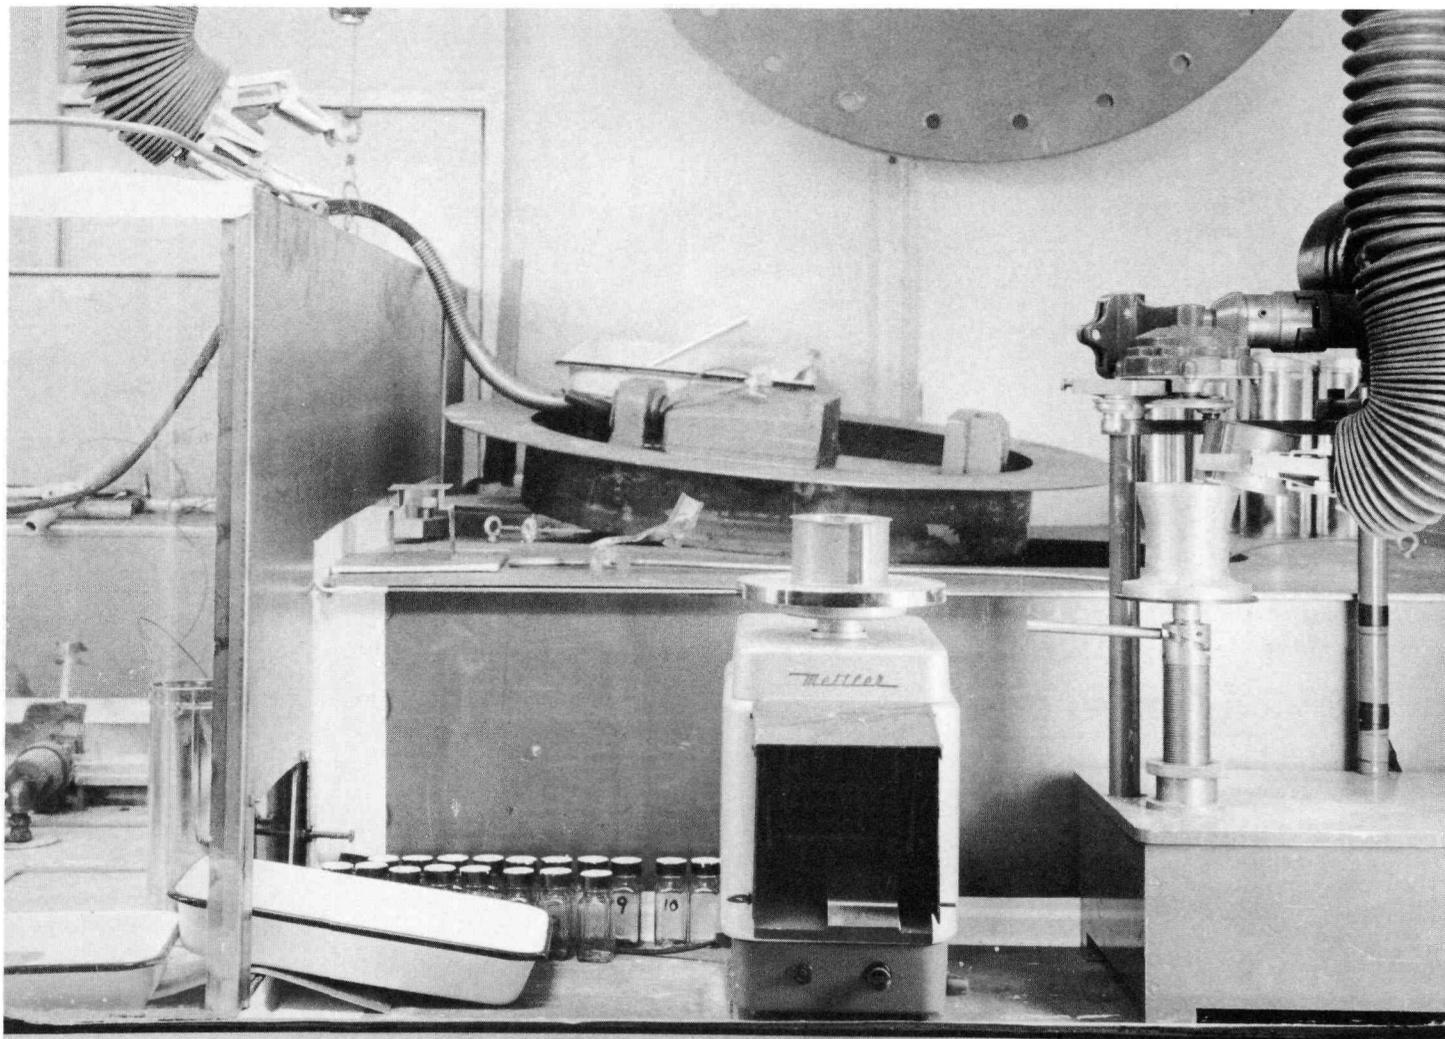
Figure 22. Area in right part of cave used for weighing and sealing cans of separated enriched material. The numbered bottles in the foreground were used for chemical samples. A partition at the left divided this area of the cave from the disassembly operations in the left area.

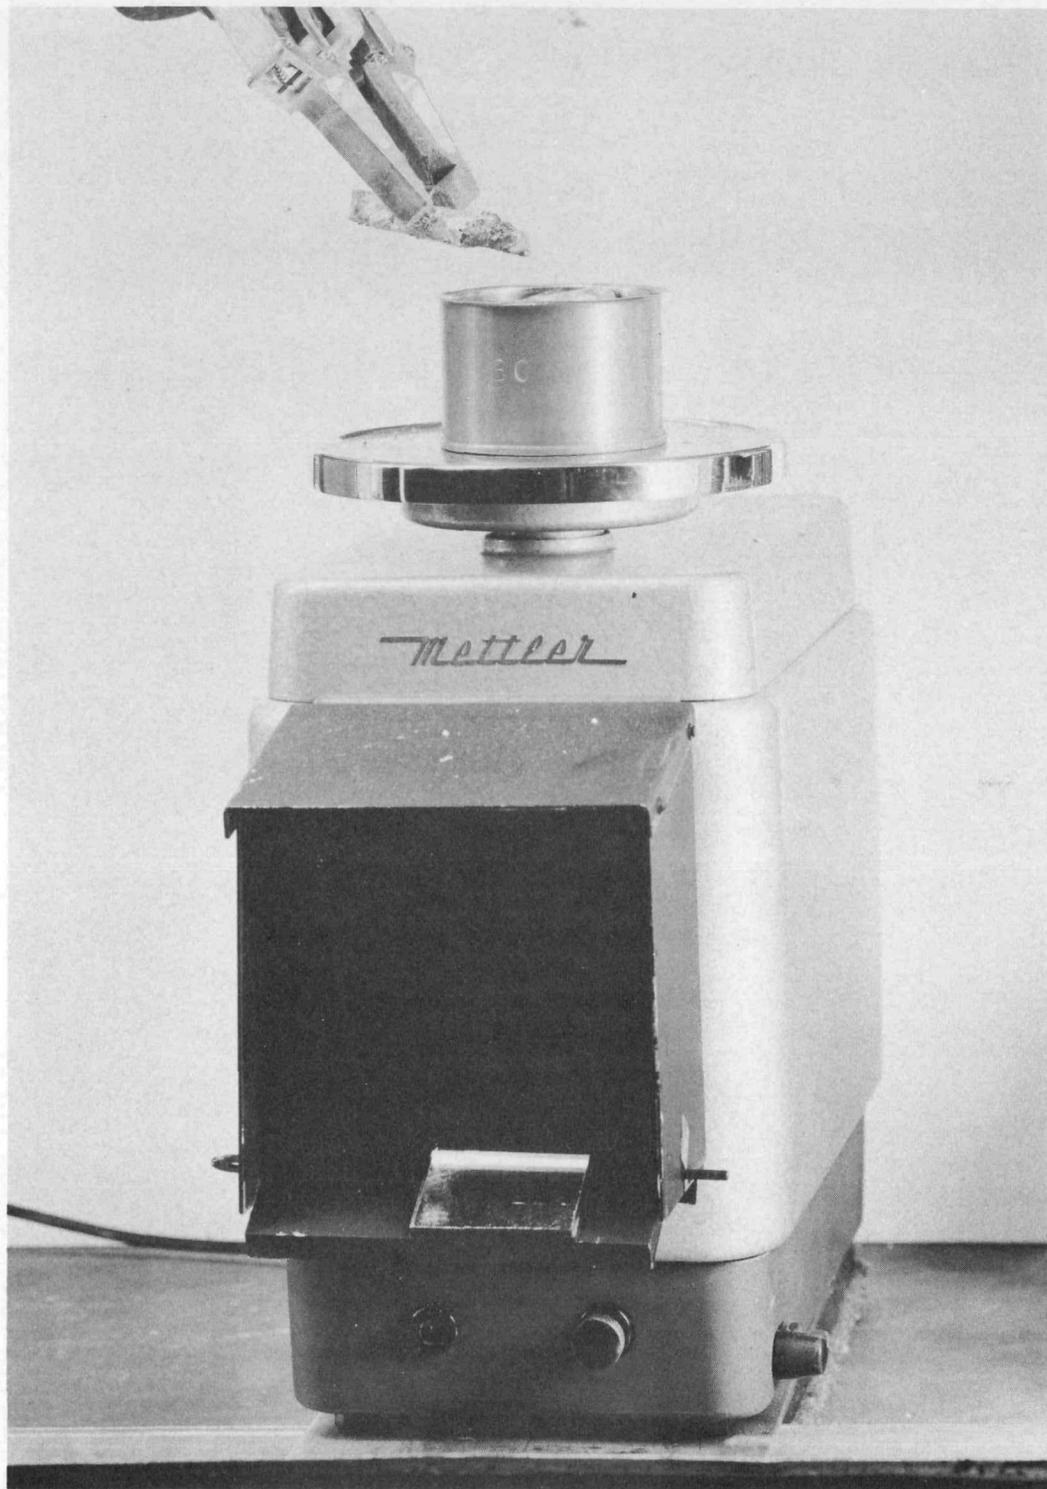
Figure 23. Typical piece of fuel being loaded into a storage can. After each filled can was weighed it was moved to the can sealer shown in Figure 24.

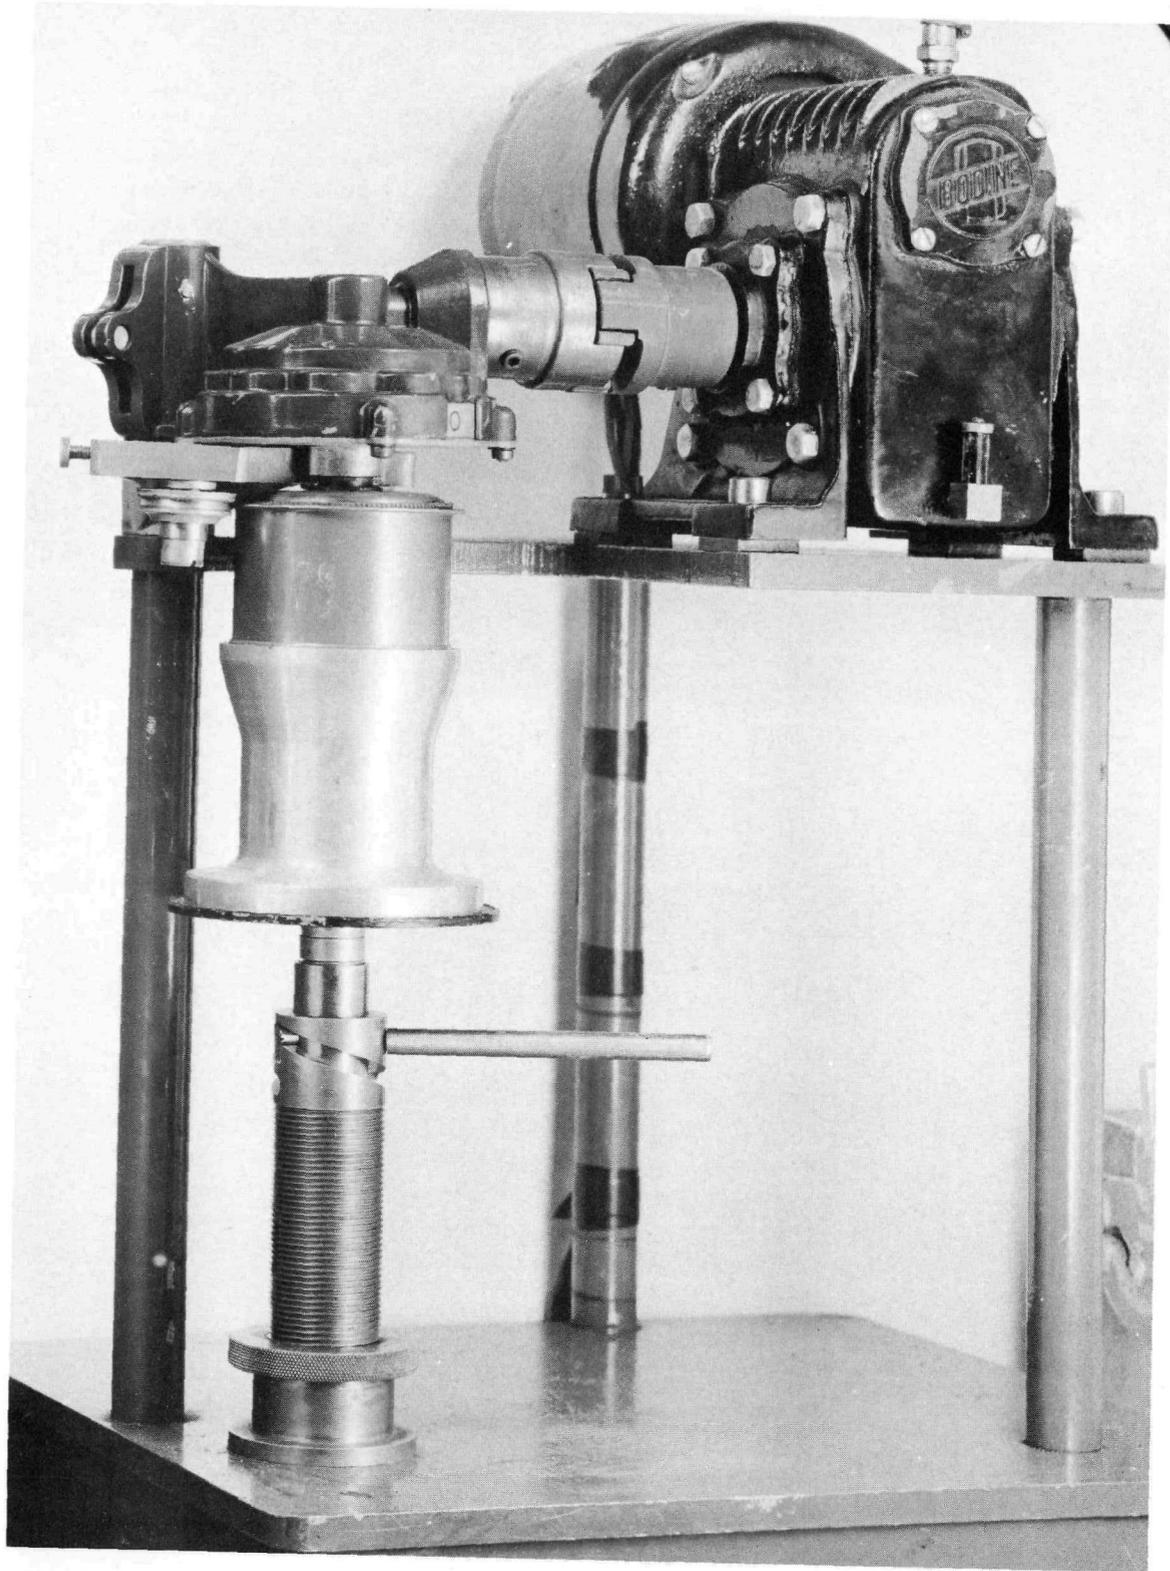
Figure 24. Remotely operated equipment shown sealing a can of enriched fuel.

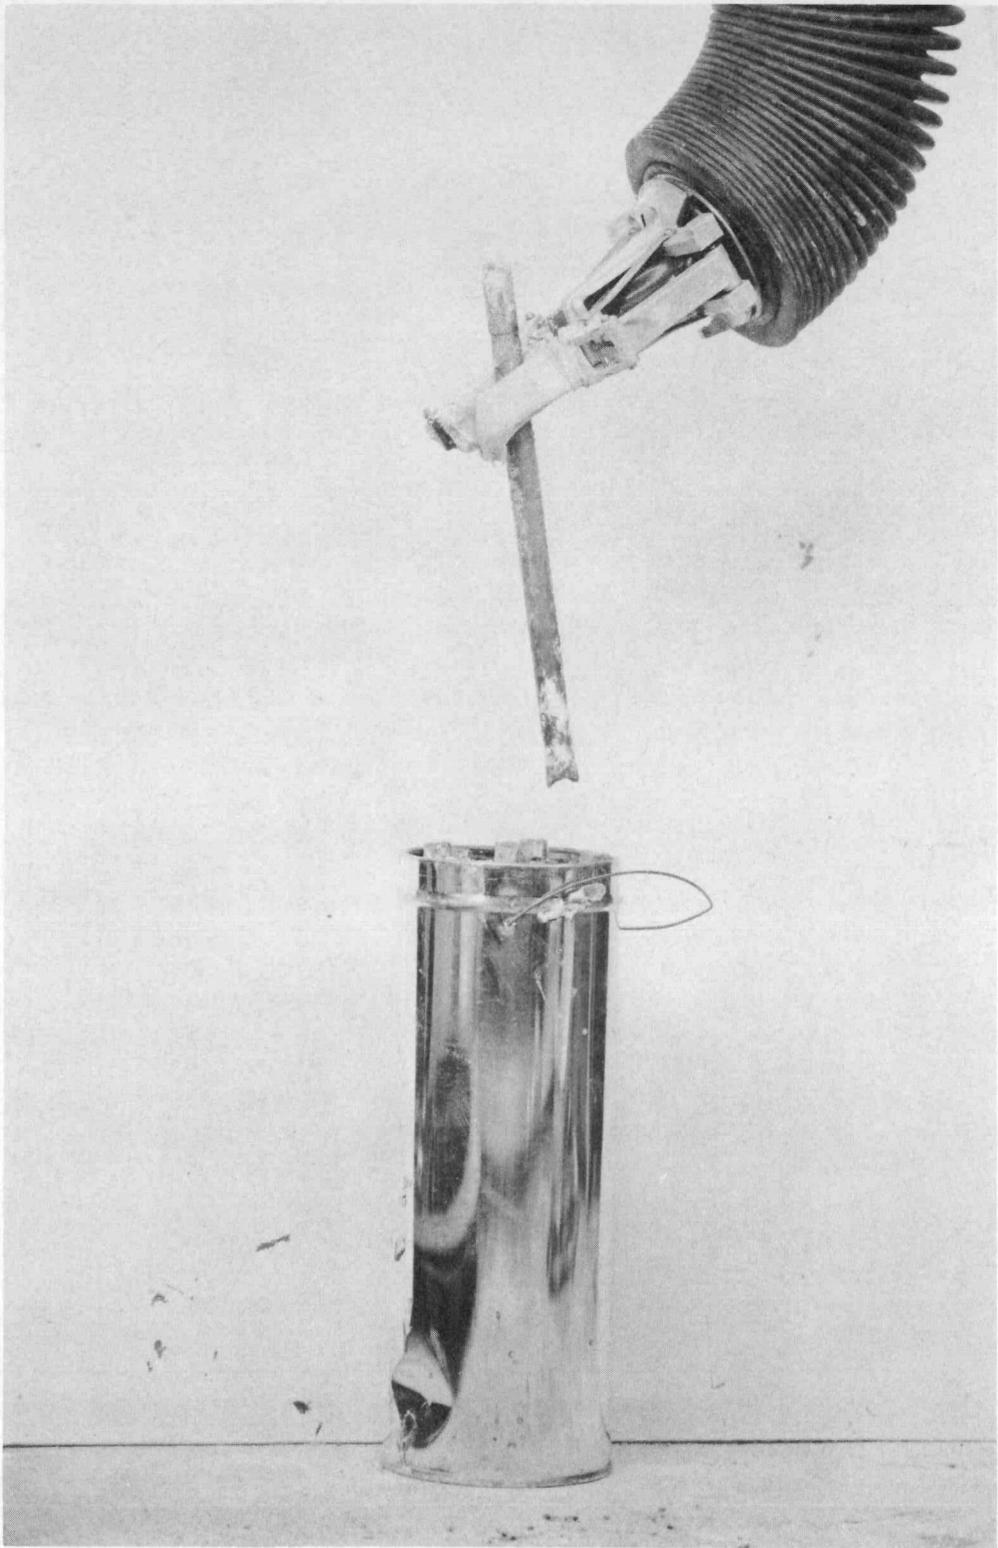
Figure 25. Procedure used for loading unenriched blanket material.

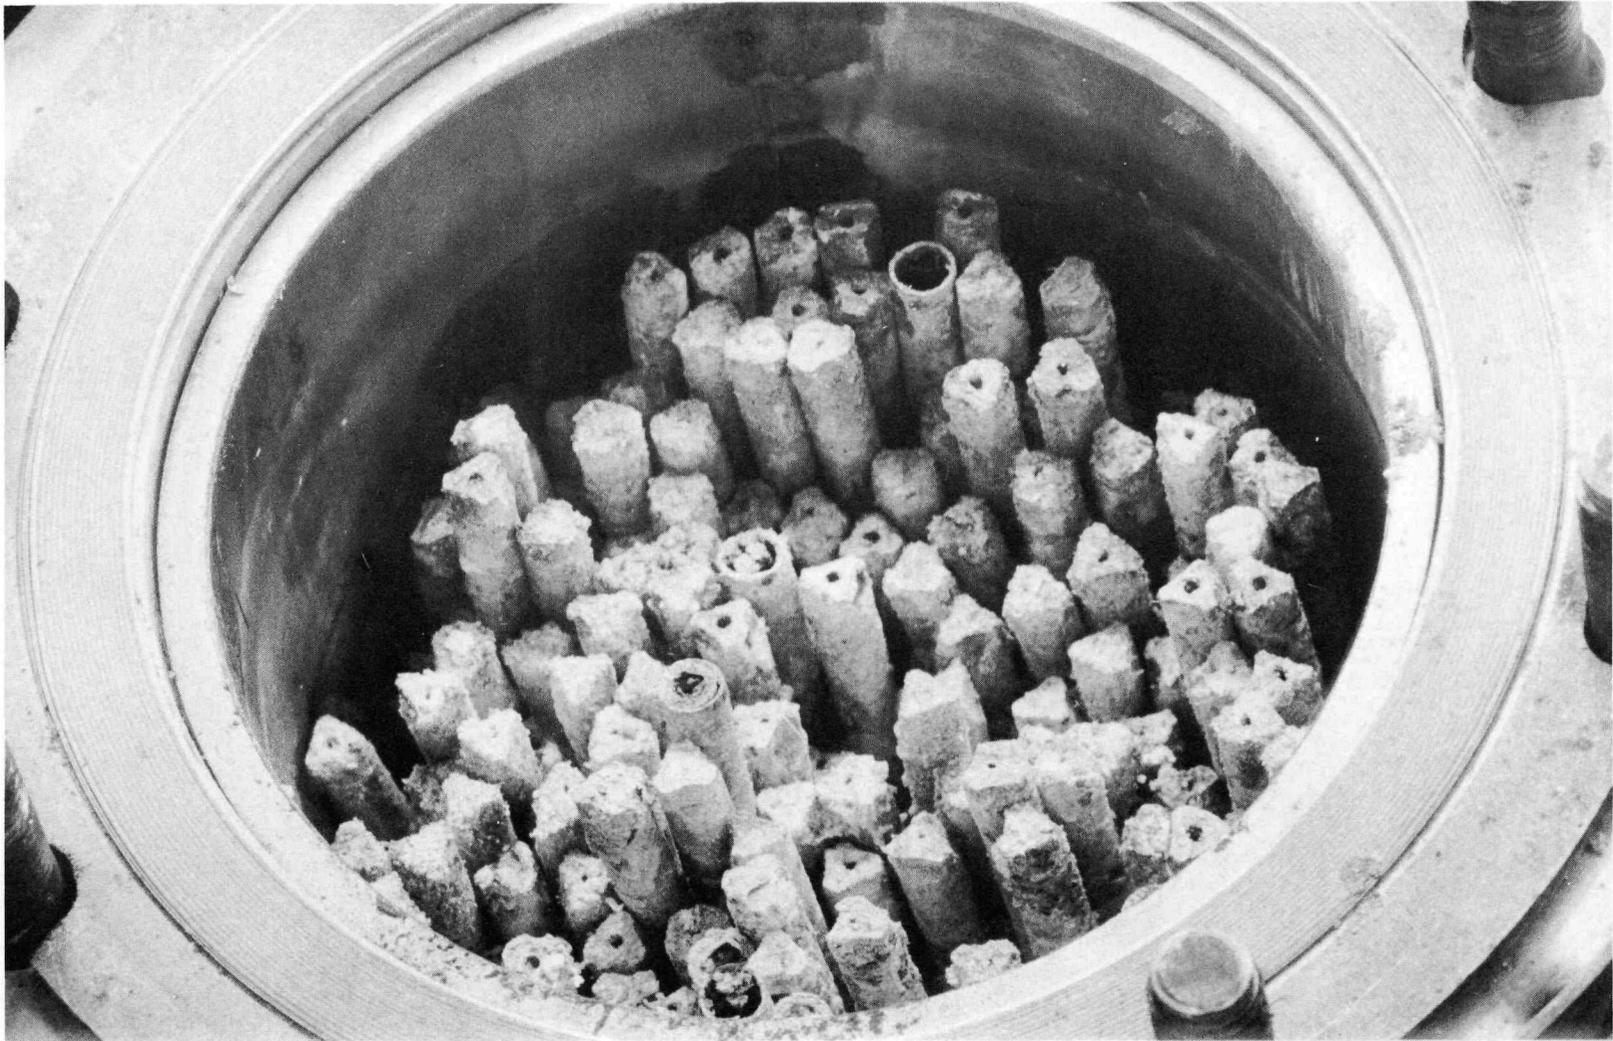
Figure 26. Appearance of the top of the damaged EBR-I core before final disassembly operations were started.

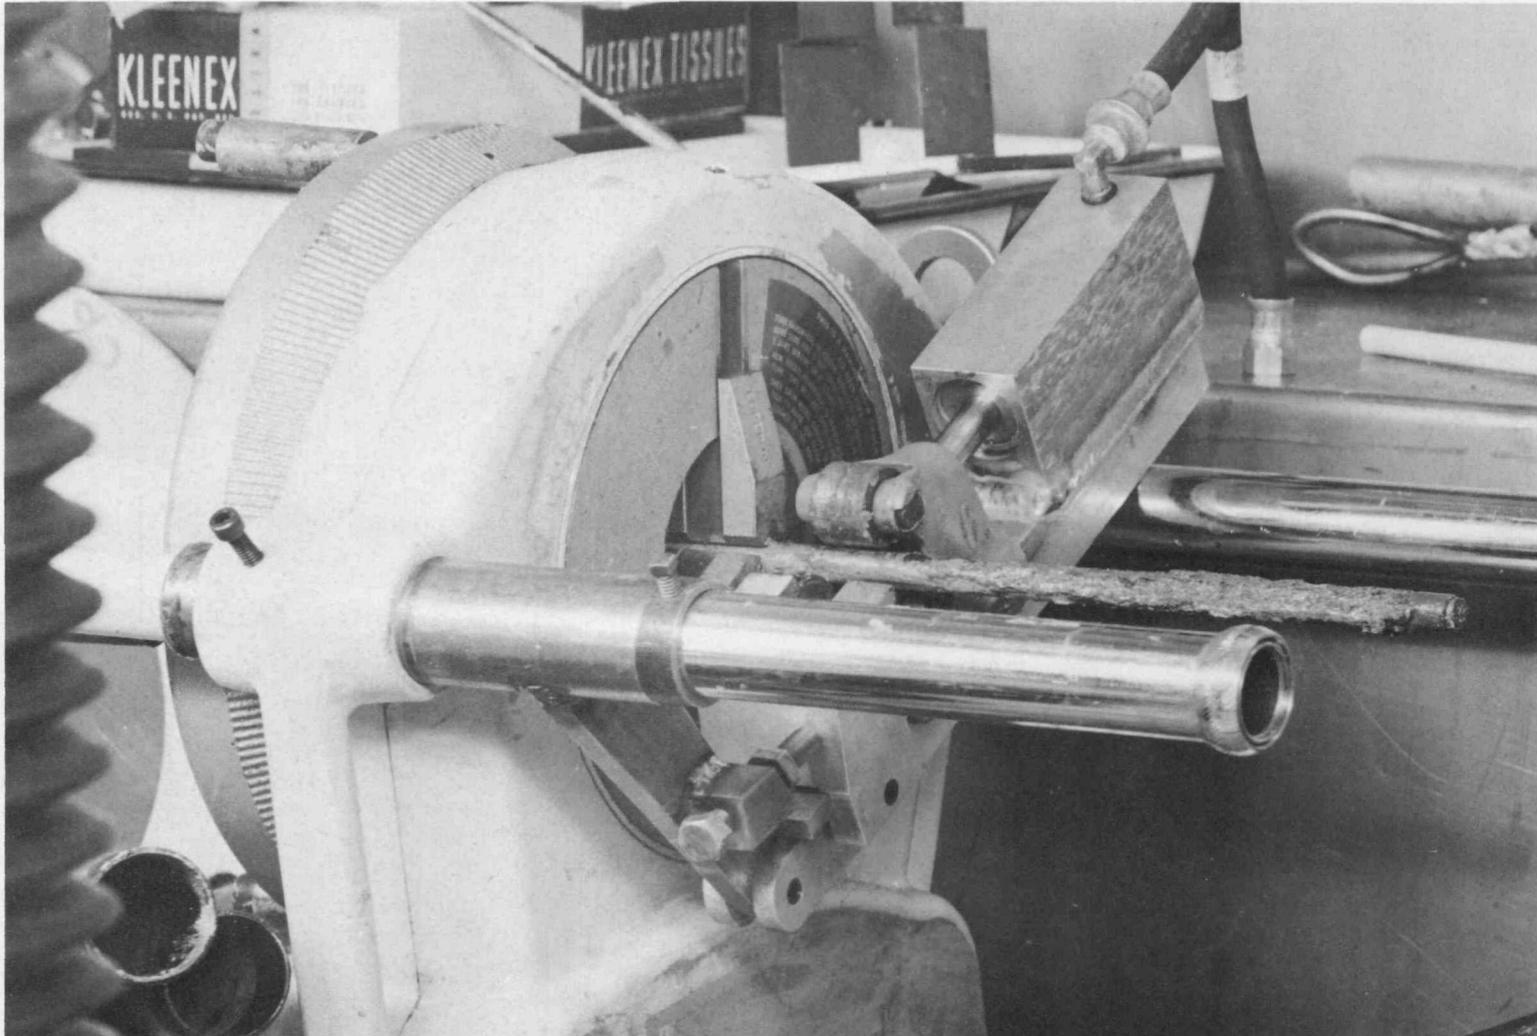
Figure 27. Remotely operated pipe cutter being used to cut outer jacket on a fuel element near the junction of fuel and blanket. The blanket section at the right end of the element has already been removed with the pipe cutter, and the tip of a fuel slug is visible.

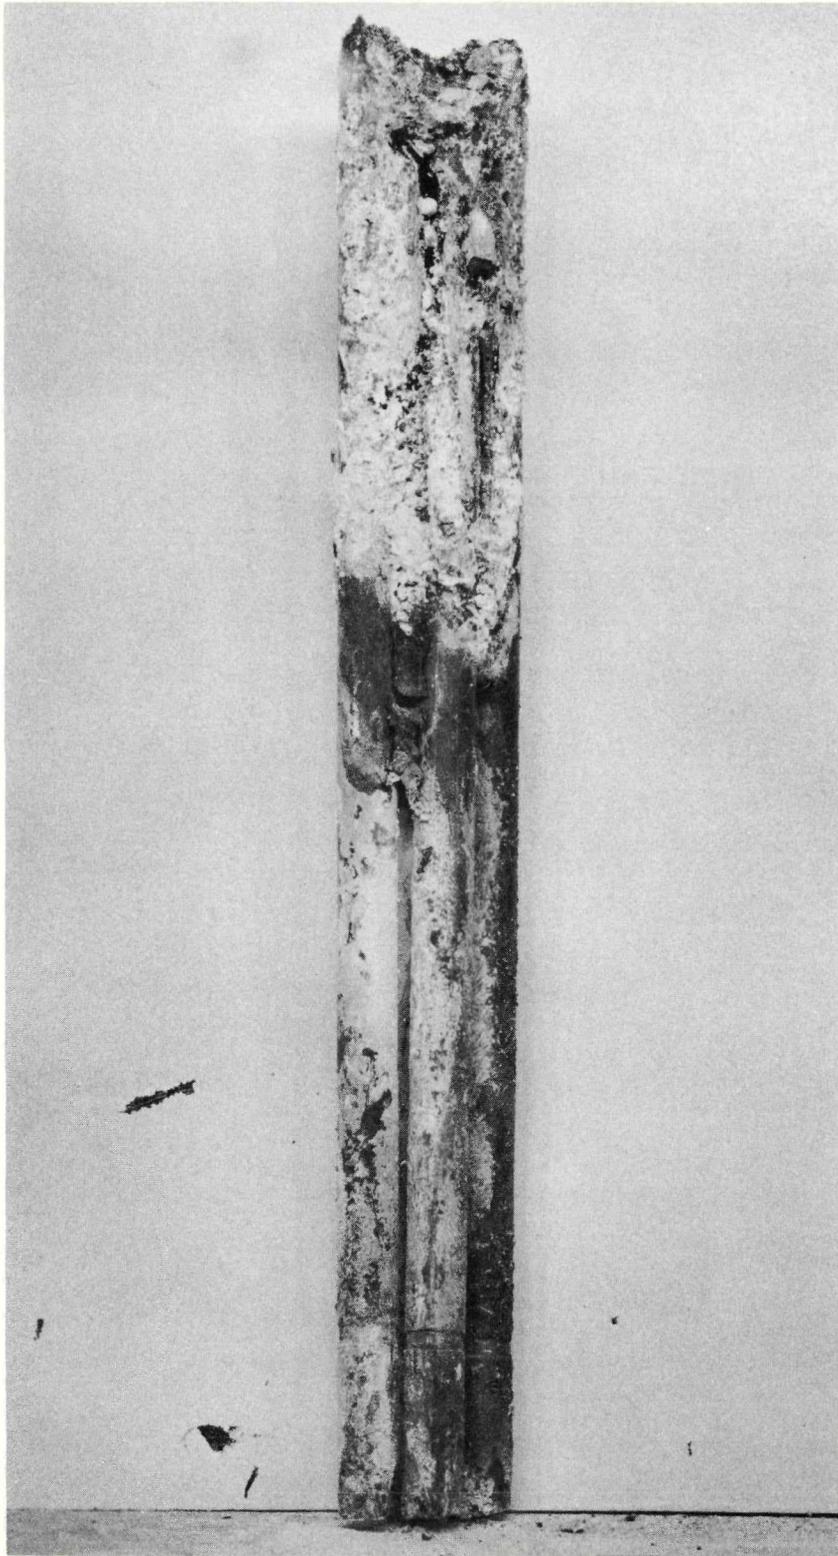
Figure 28. Clump of upper blanket rods from near the center of the core assembly. The blanket section begins about one-half in. above the lower end, and it can be noted that the molten fuel alloy has moved upward between the rods for approximately 5 in.

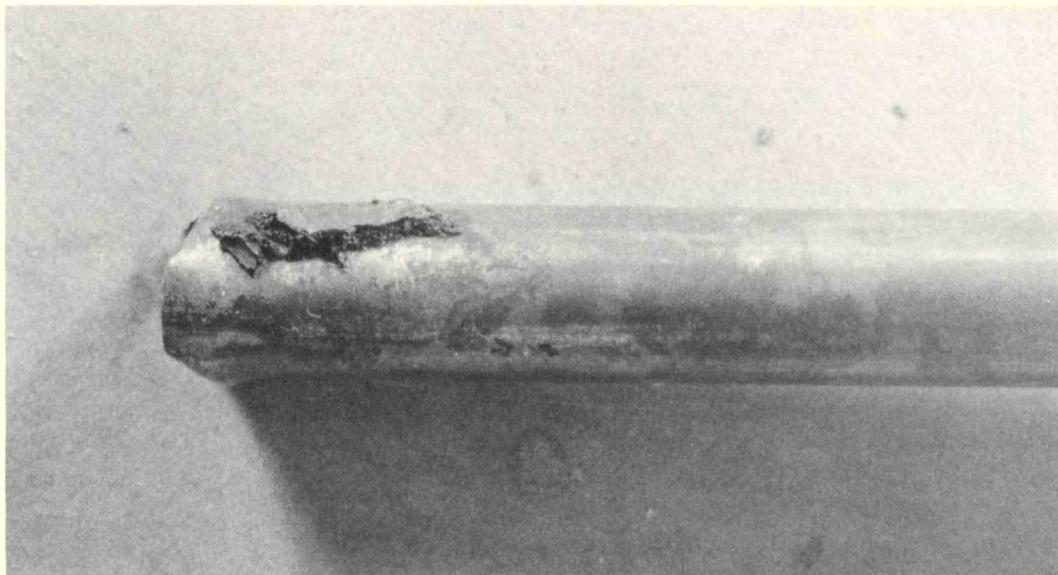
Figure 29. Stainless steel outer jacket from the upper blanket. The left end originally was attached to the fuel section. Most of the adhering fuel alloy has been removed, and it can be noted that the jacket does not appear to have been damaged by melting.

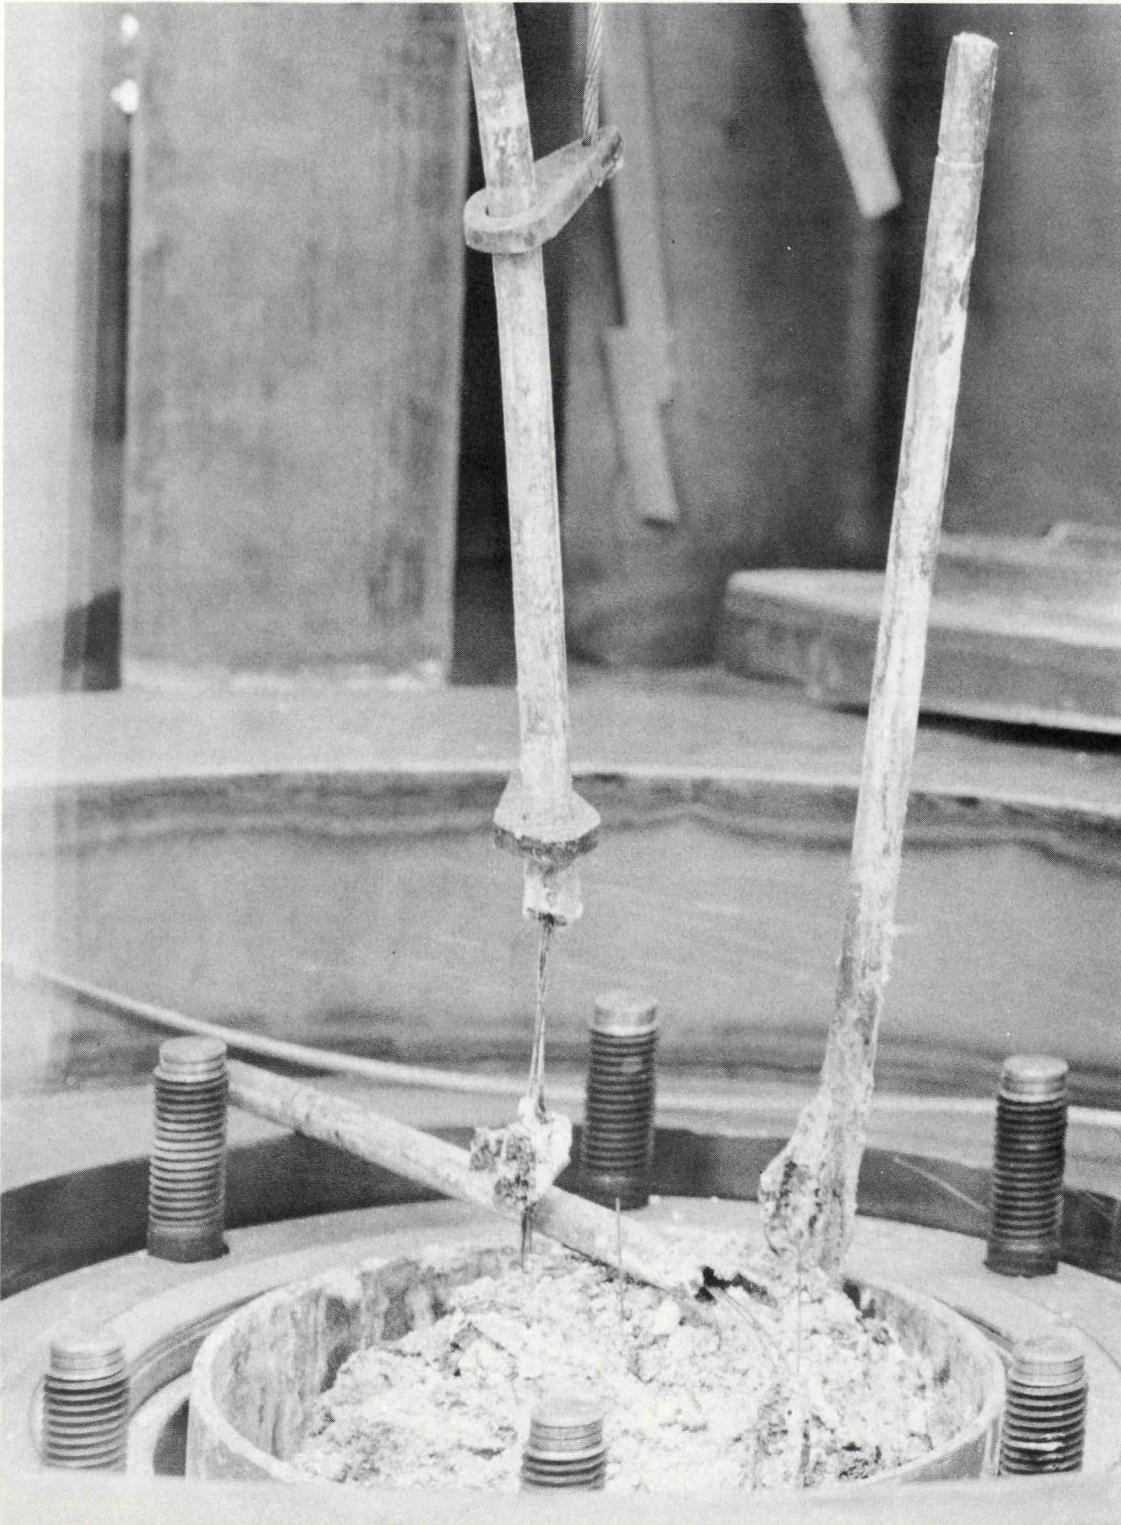
Figure 30. Use of thermocouple wires embedded in the fuel section to lift the fuel and lower blanket assembly from the thimble used for shipping.

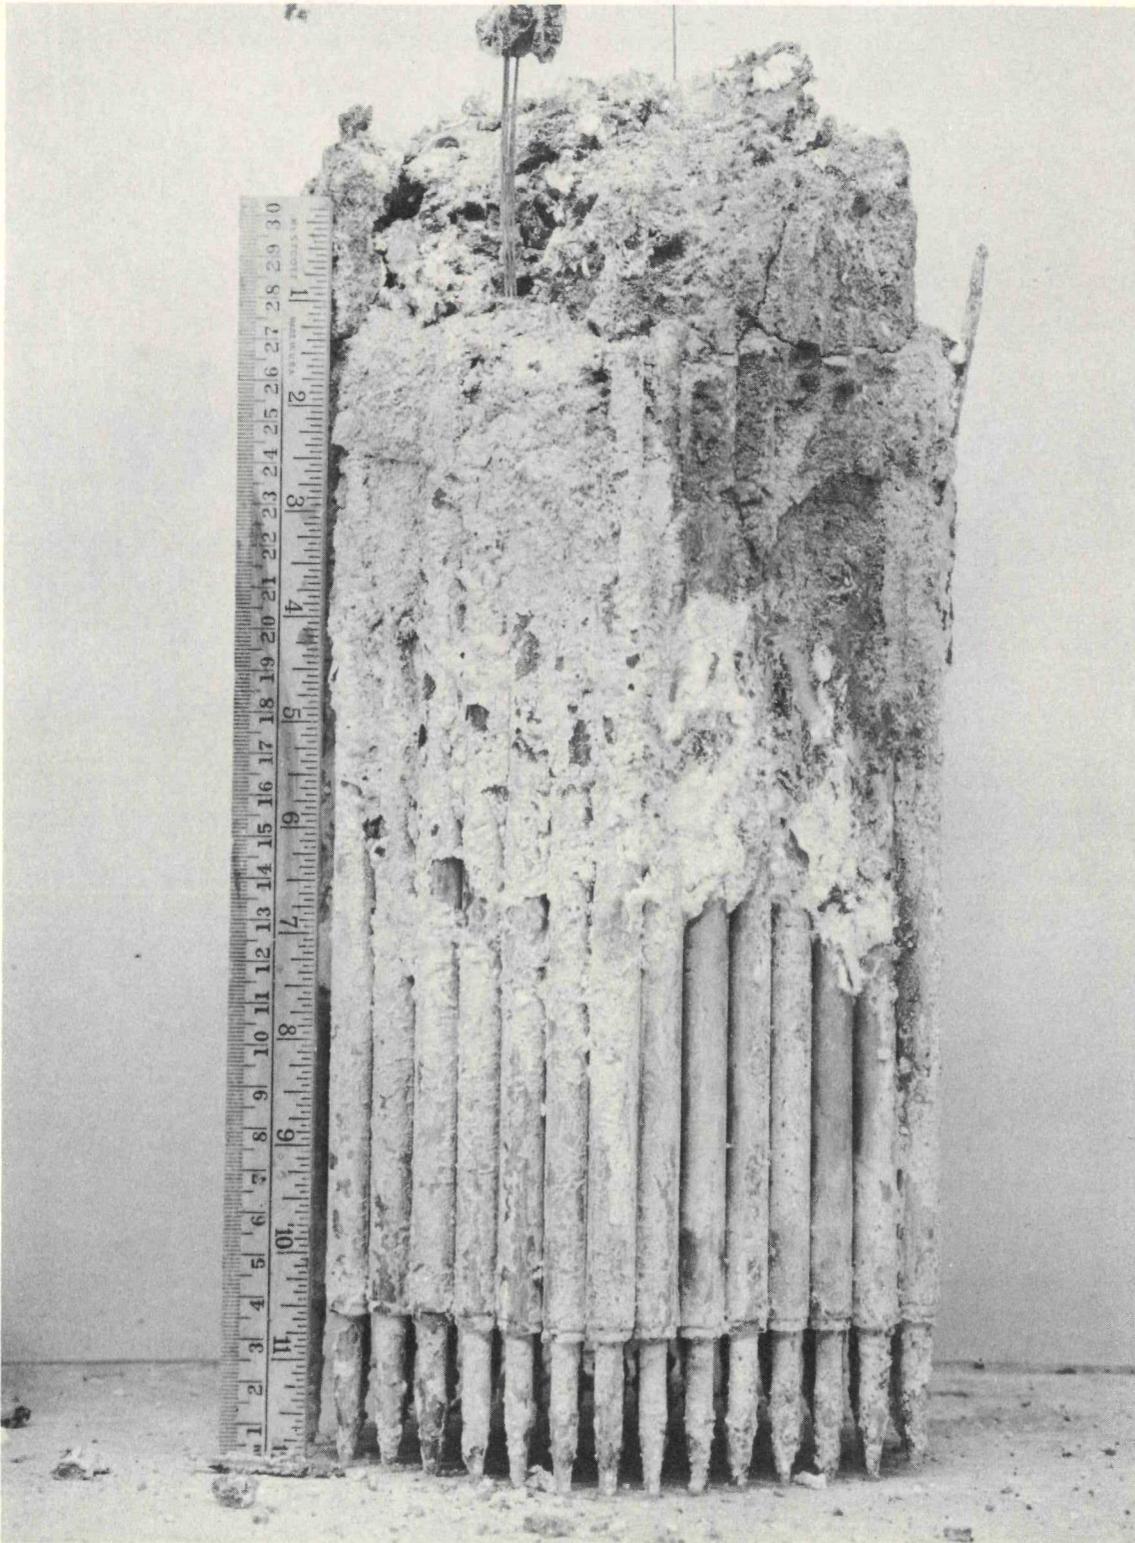
Figure 31. Appearance of the damaged EBR-I core after removal of the upper blanket section.
