**THE EBR-I MELTDOWN - PHYSICAL AND
METALLURGICAL CHANGES IN THE CORE**

THE EBR-I MELTDOWN -
PHYSICAL AND METALLURGICAL CHANGES IN THE CORE

Final Report - Metallurgy Program 7.2.18

November 1957

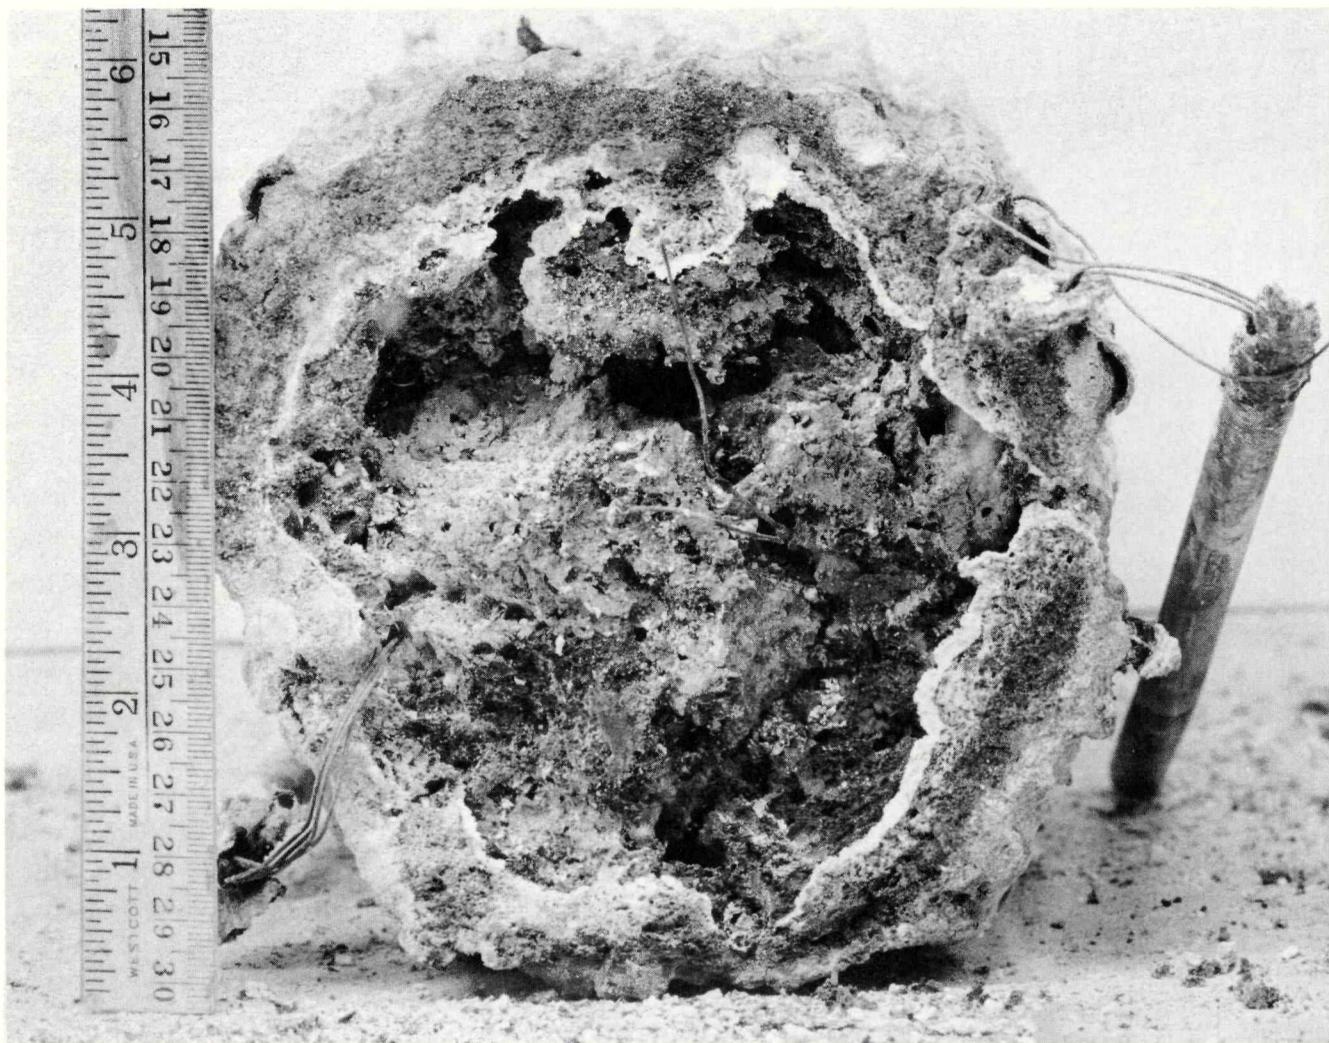
Figure 32. Cross section of damaged EBR-I core at the midplane of the fuel section. Two distinct sponge-like zones are present. Thermocouple wires in the fused mass are undamaged.

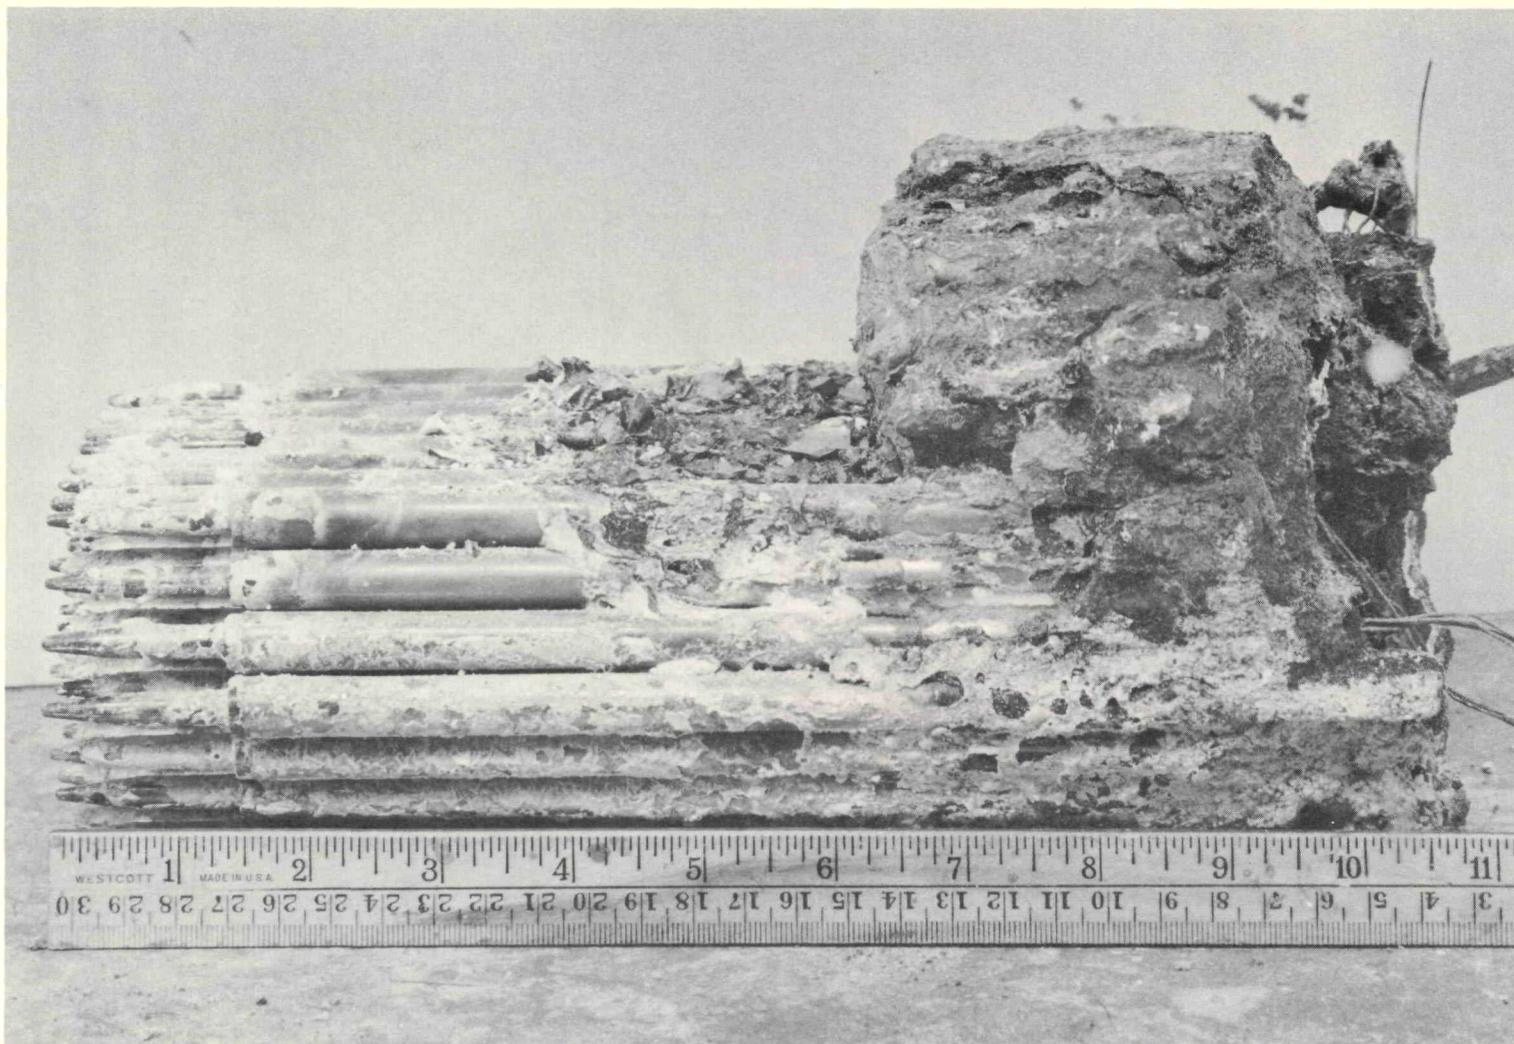
Figure 33. Side view of core assembly after partial removal of lower blanket section.

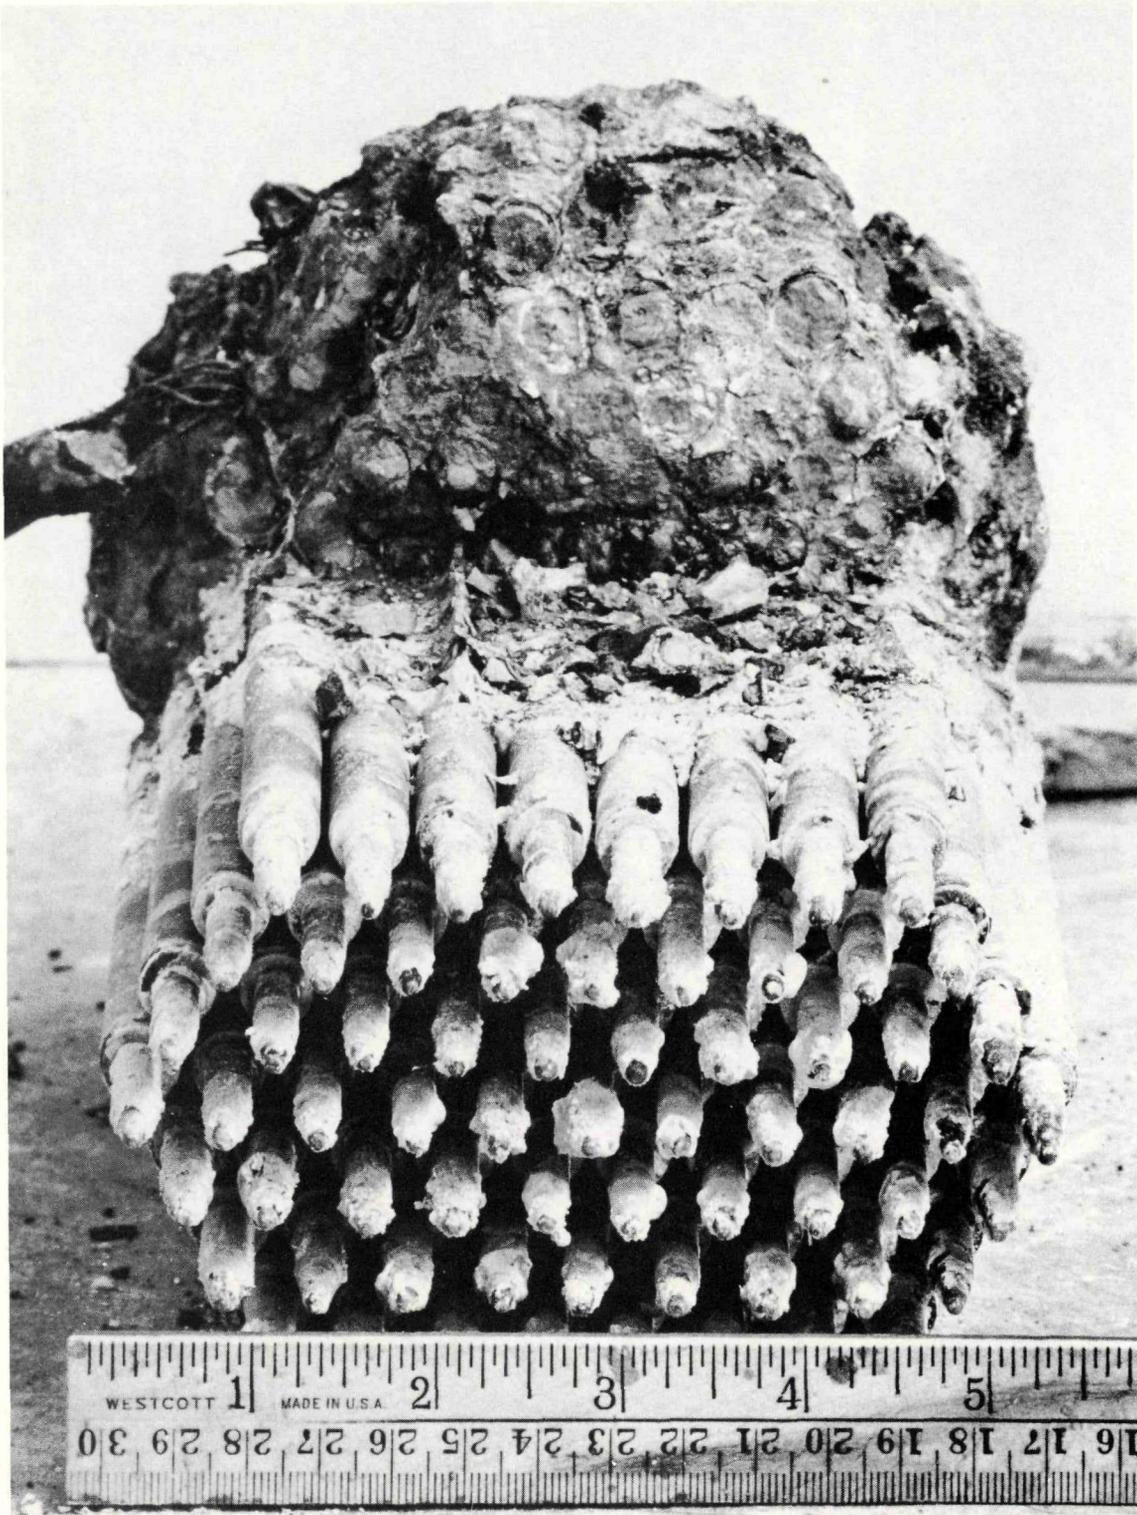
Figure 34. Bottom of fuel section, after partial removal of lower blanket rods.

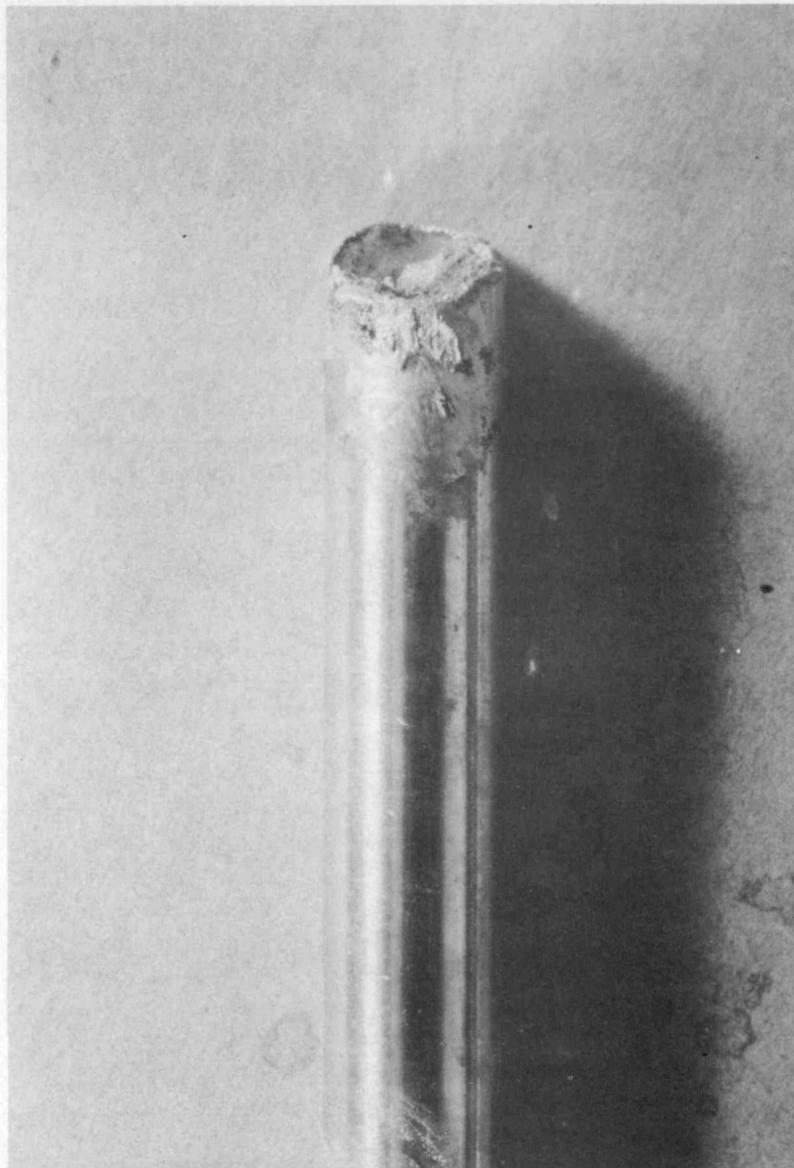
Figure 35. Stainless steel outer jacket from the lower blanket. The upper end was originally attached to the fuel section. Most of the adhering fuel alloy has been removed, and it can be noted that the jacket does not appear to have been damaged by melting.

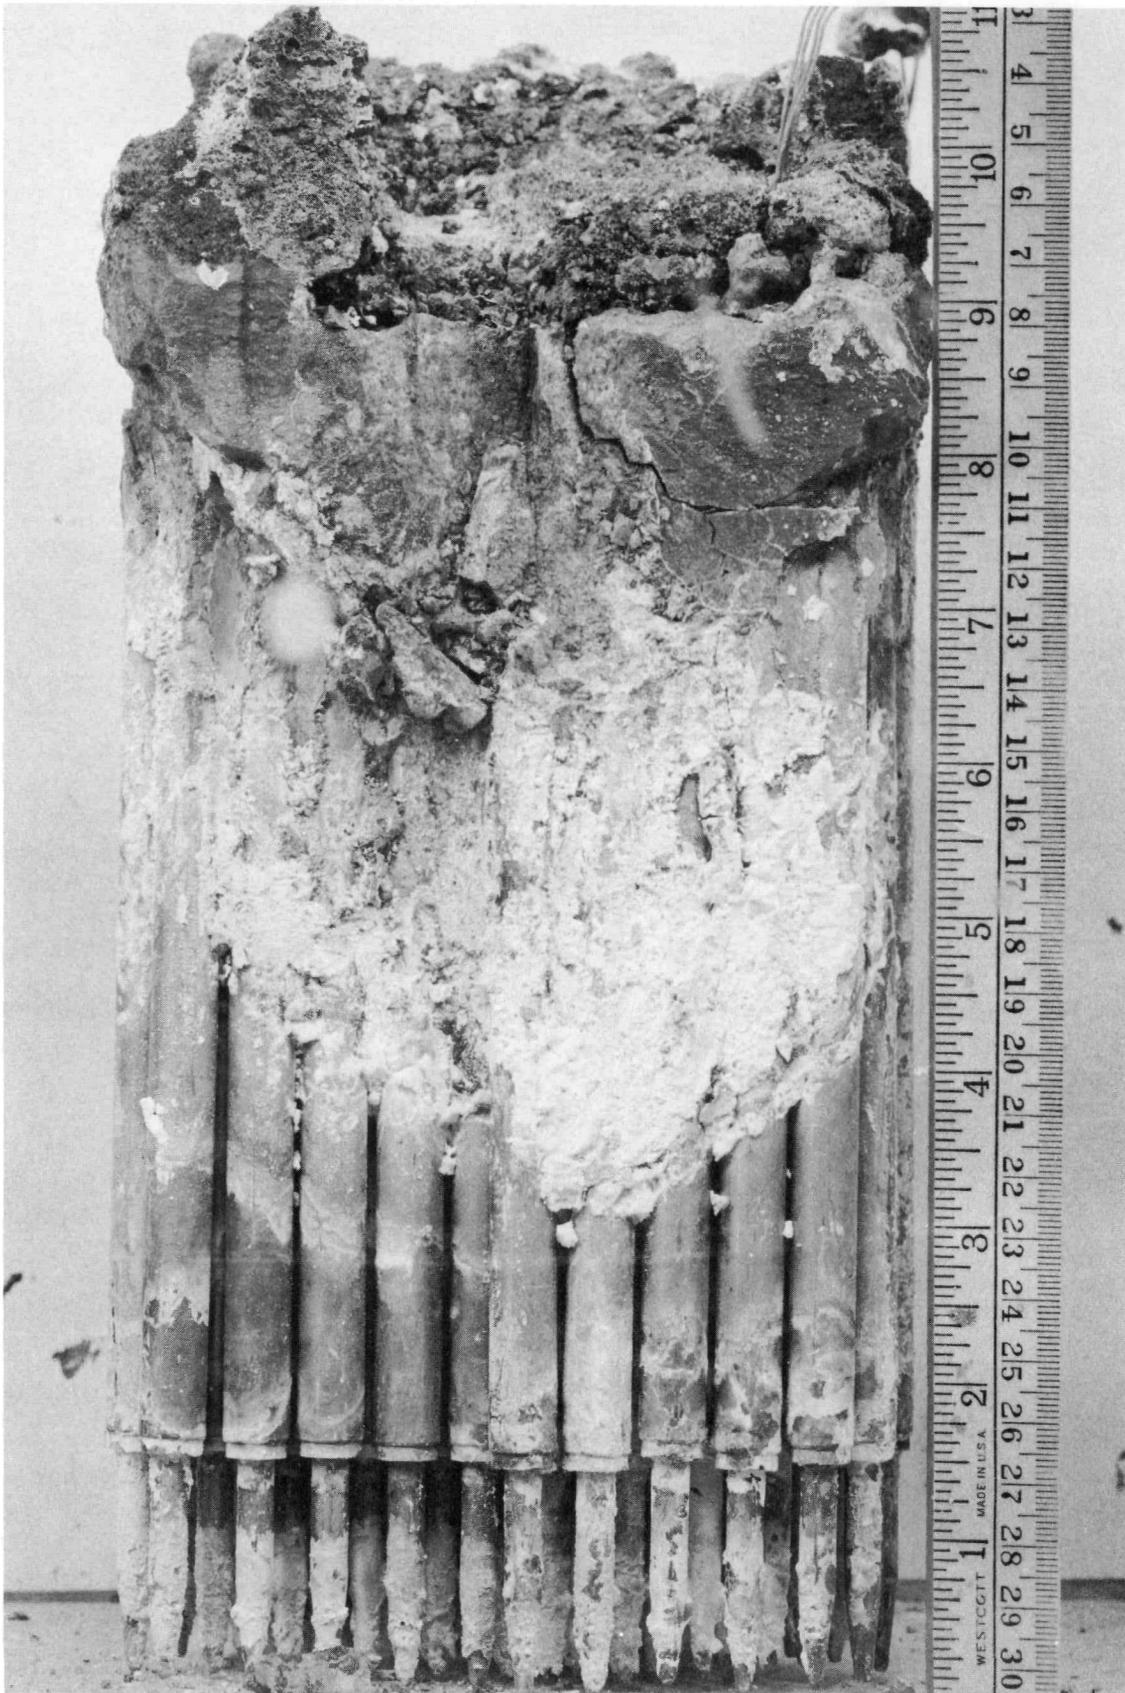
Figure 36. Vertical cross section of the lower half of the core. The junction between fuel and lower blanket is at the 6-1/4 in. level.

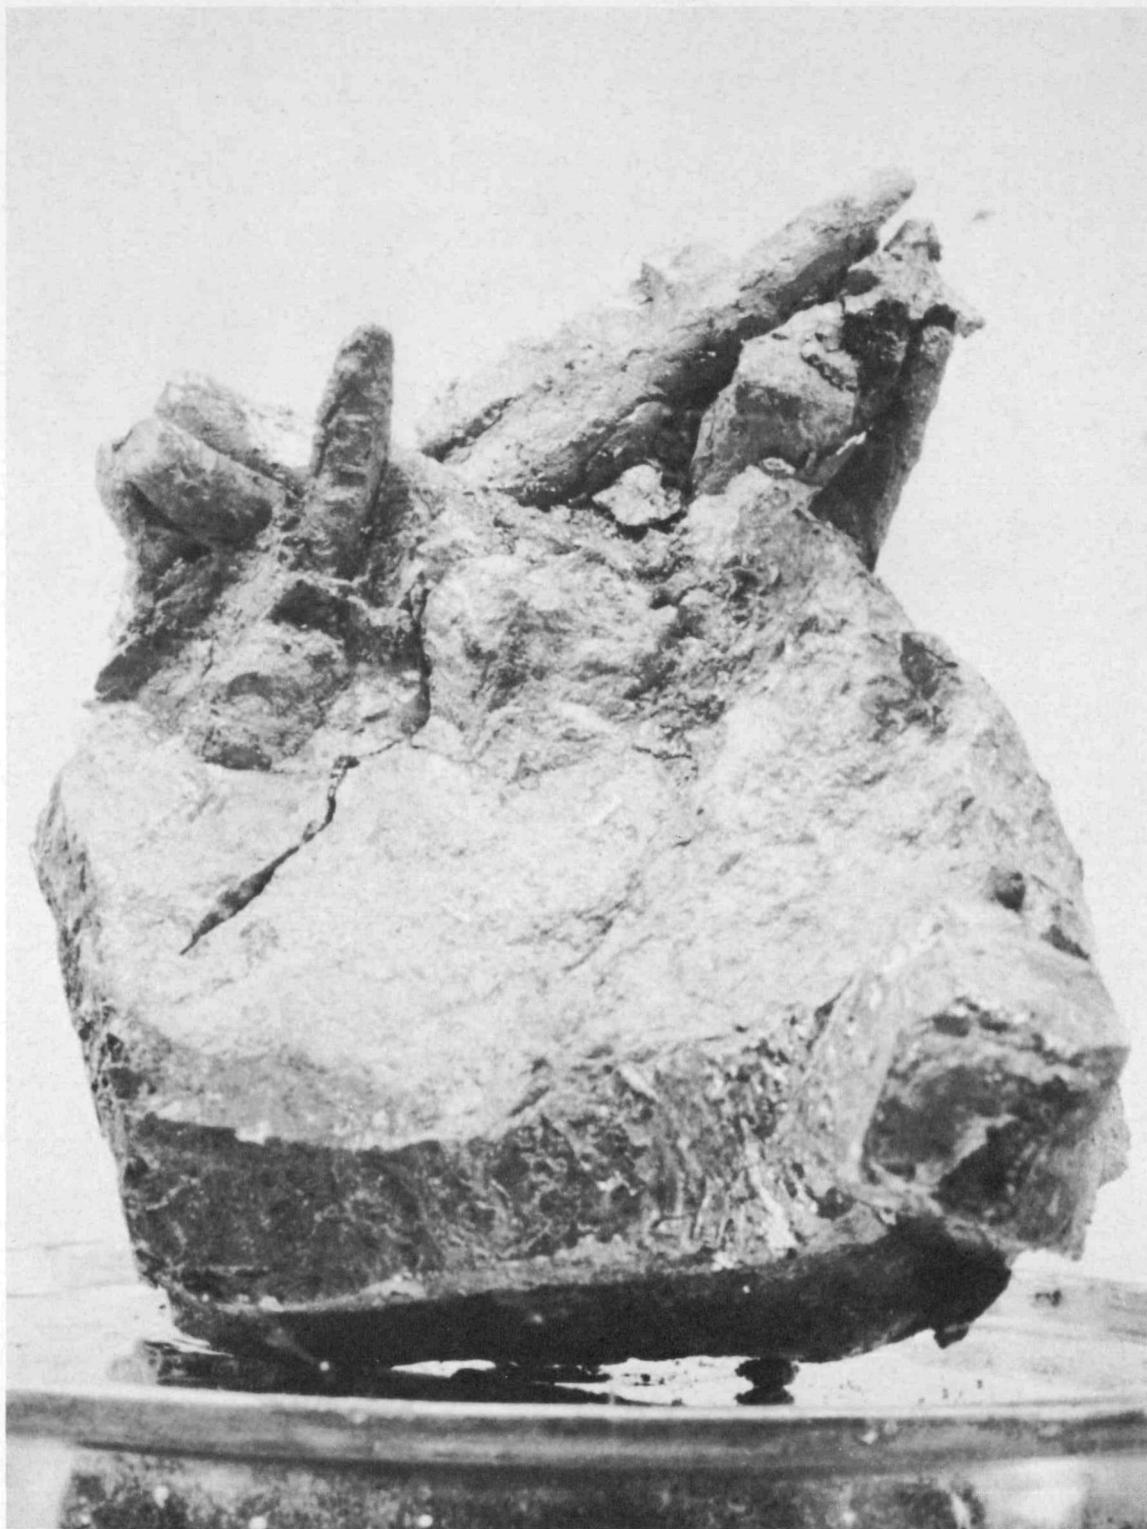
Figure 37. Partially dissolved fuel slugs embedded in dense material from near bottom of fuel section.

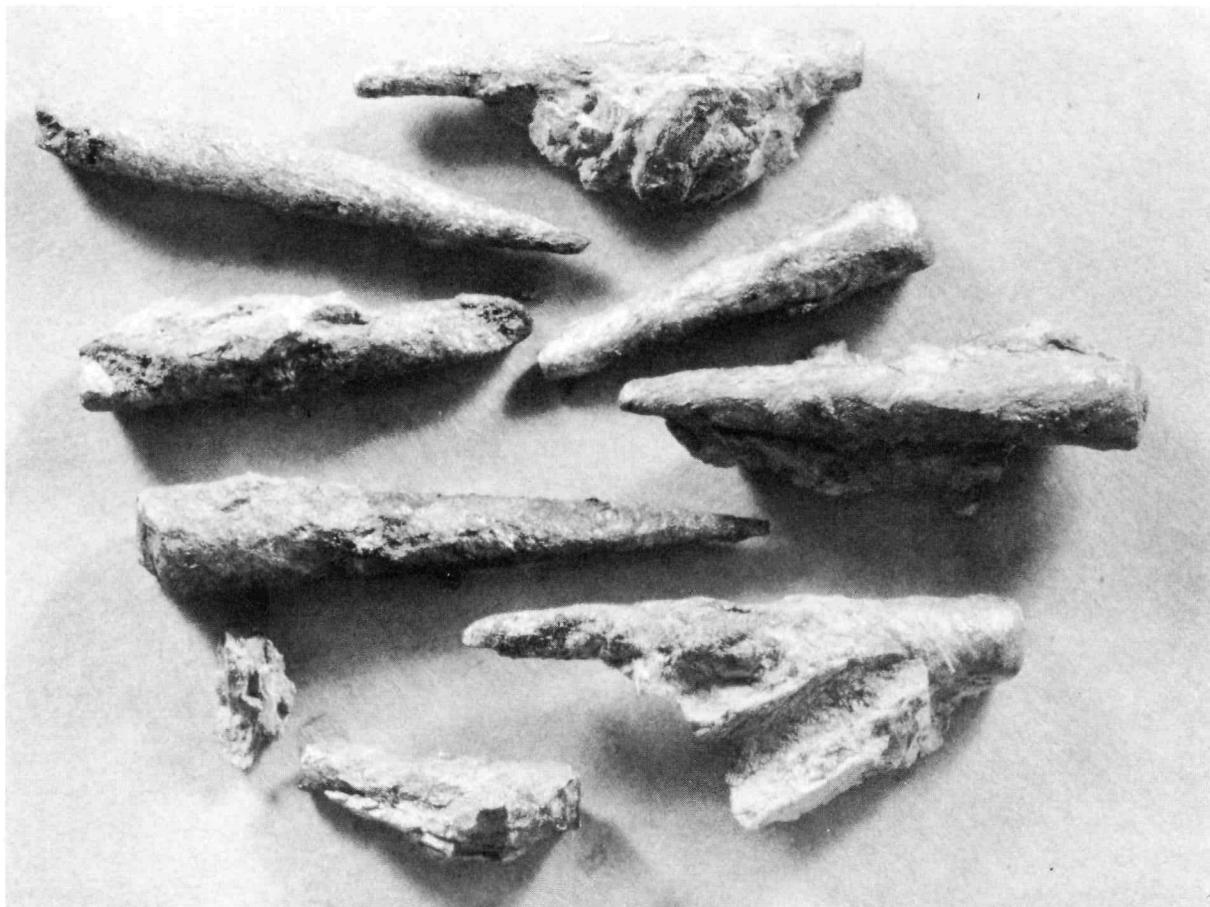
Figure 38. Partially dissolved fuel slugs separated from adjoining material.

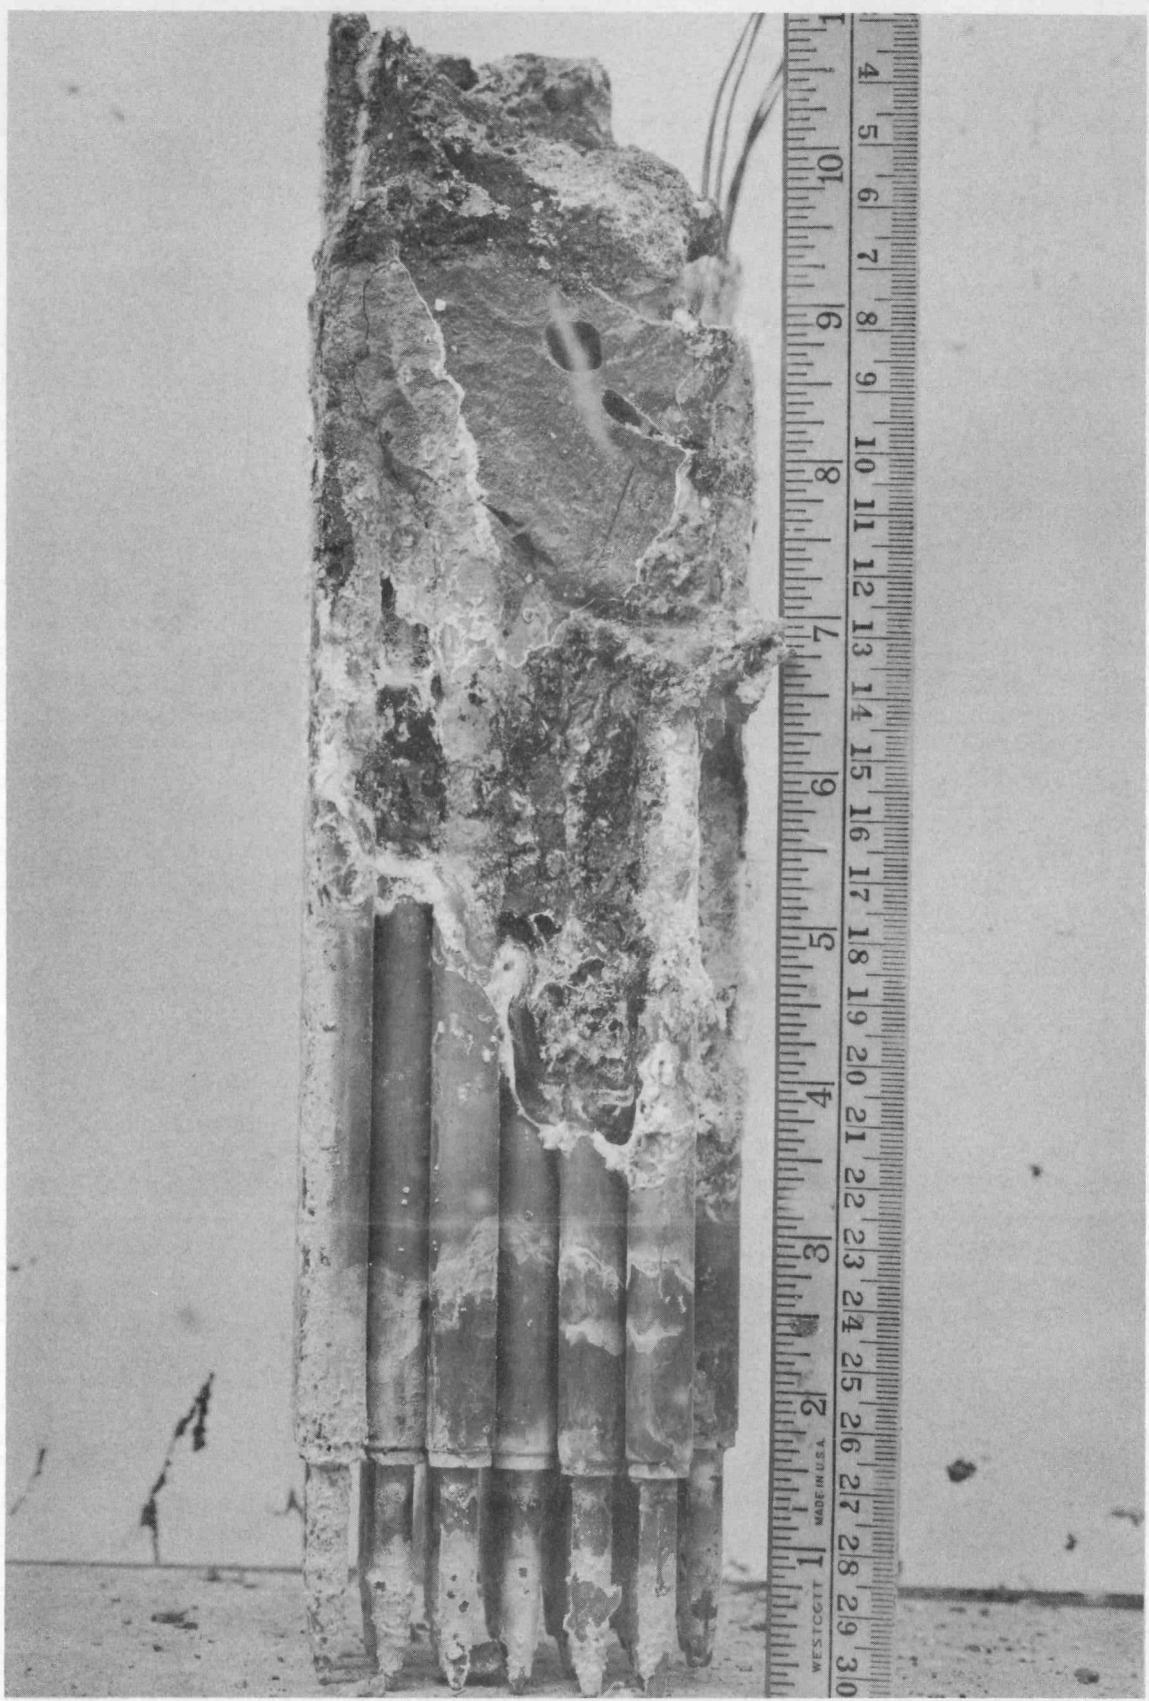
Figure 39. Illustration of voids which were found in the dense zone in the lower fuel section.

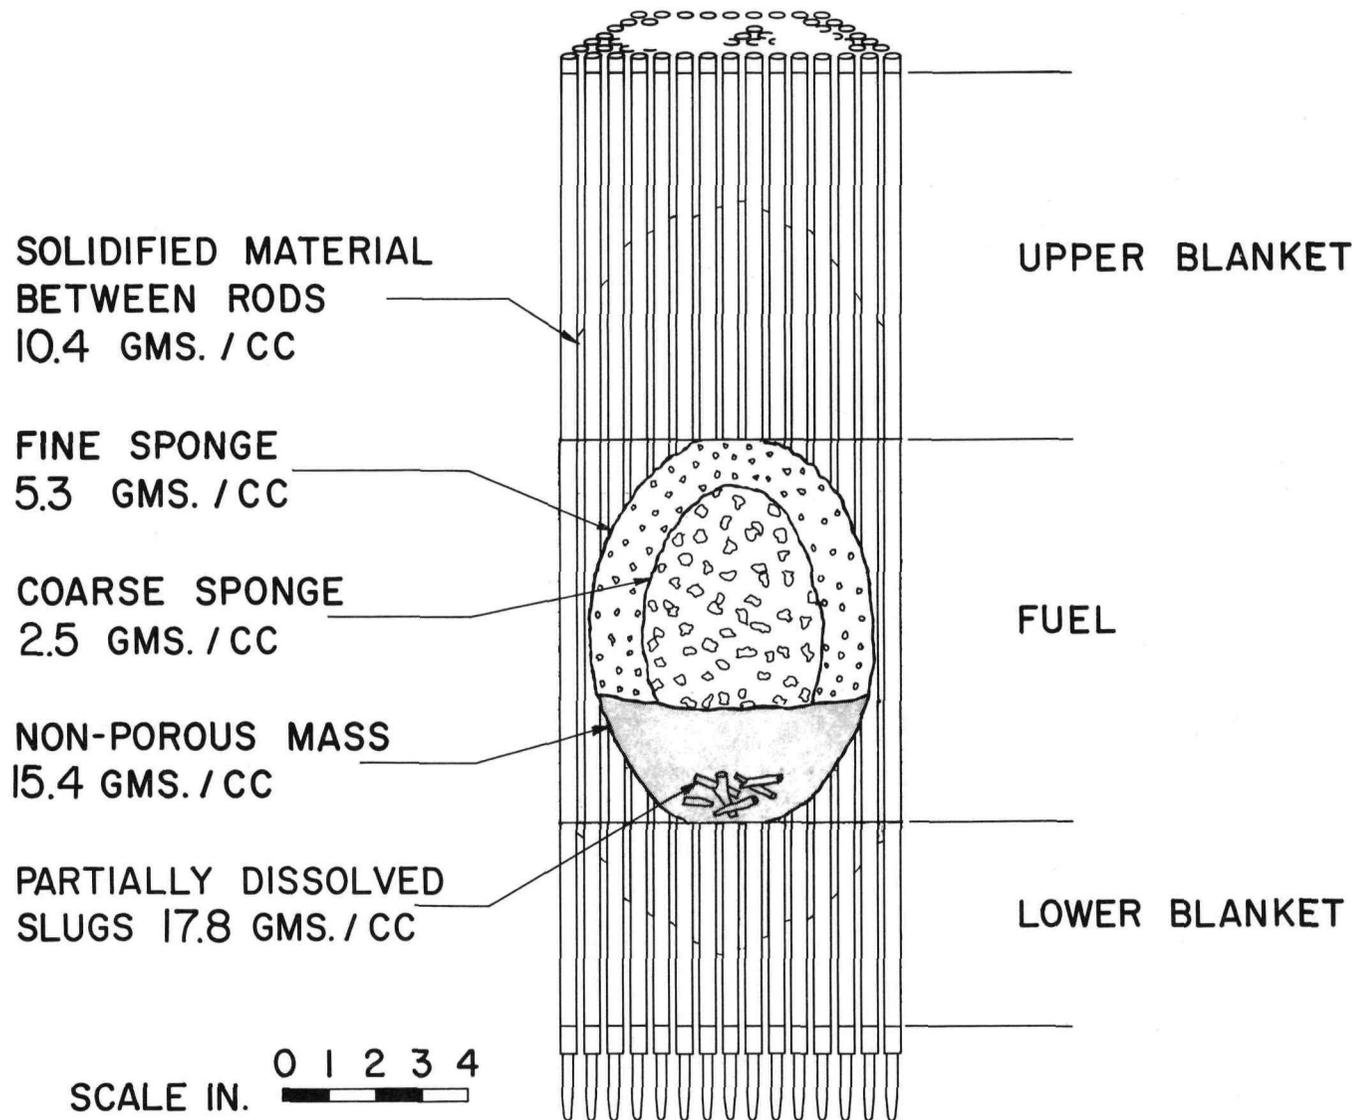
Figure 40. Artist's reconstruction of a vertical cross section through the damaged EBR-I core. The most reliable values for the densities of the various areas are shown at the left.

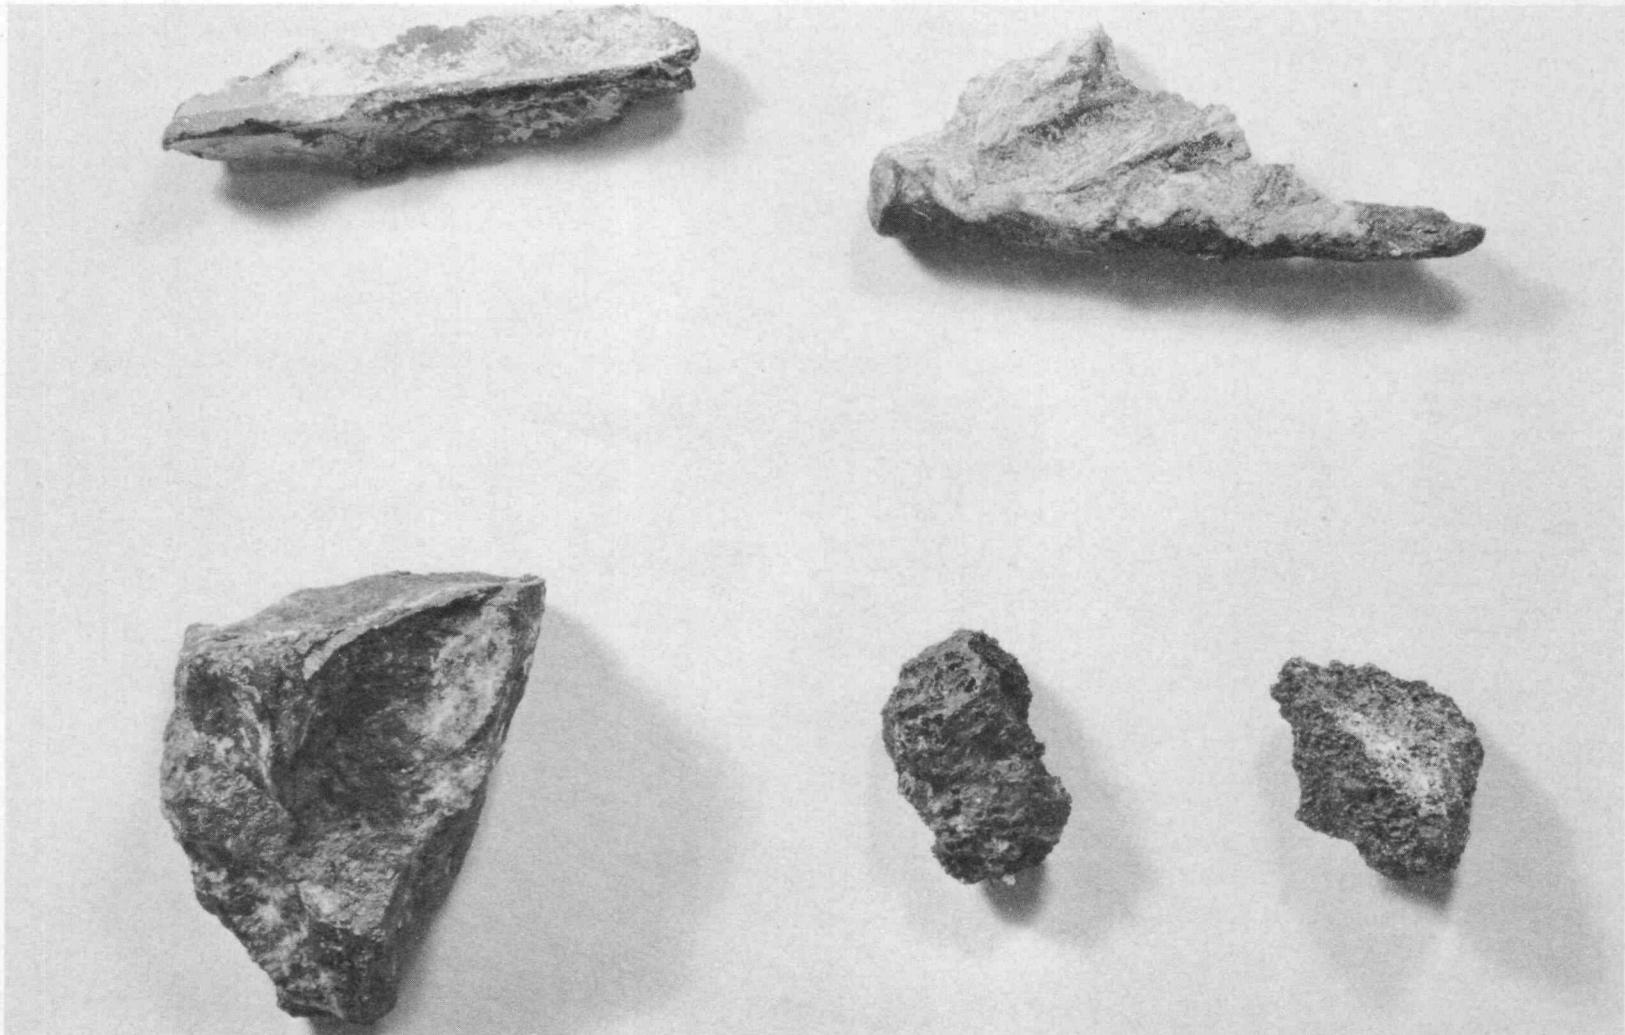
Figure 41. Appearance of samples removed for metallographic examination. Reading left to right, sample numbers are: top, 31 and 32; bottom, 33, 29, and 30. Locations from which the samples were taken are given in Table I.

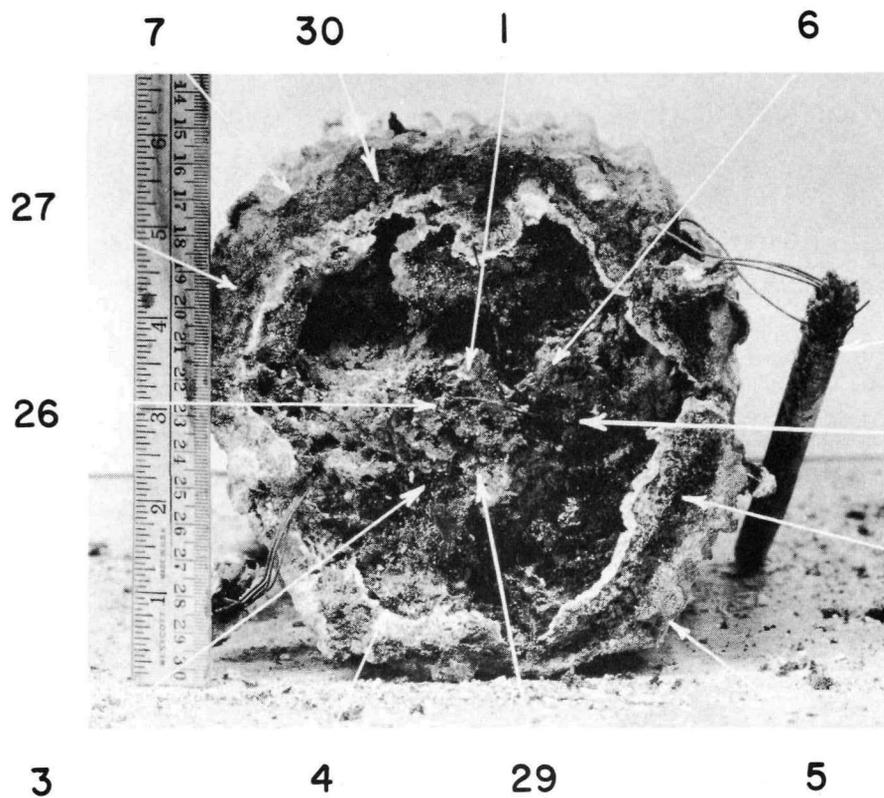
Figure 42. Approximate location of samples taken from a horizontal cross section of the core for chemical analyses and metallographic studies.

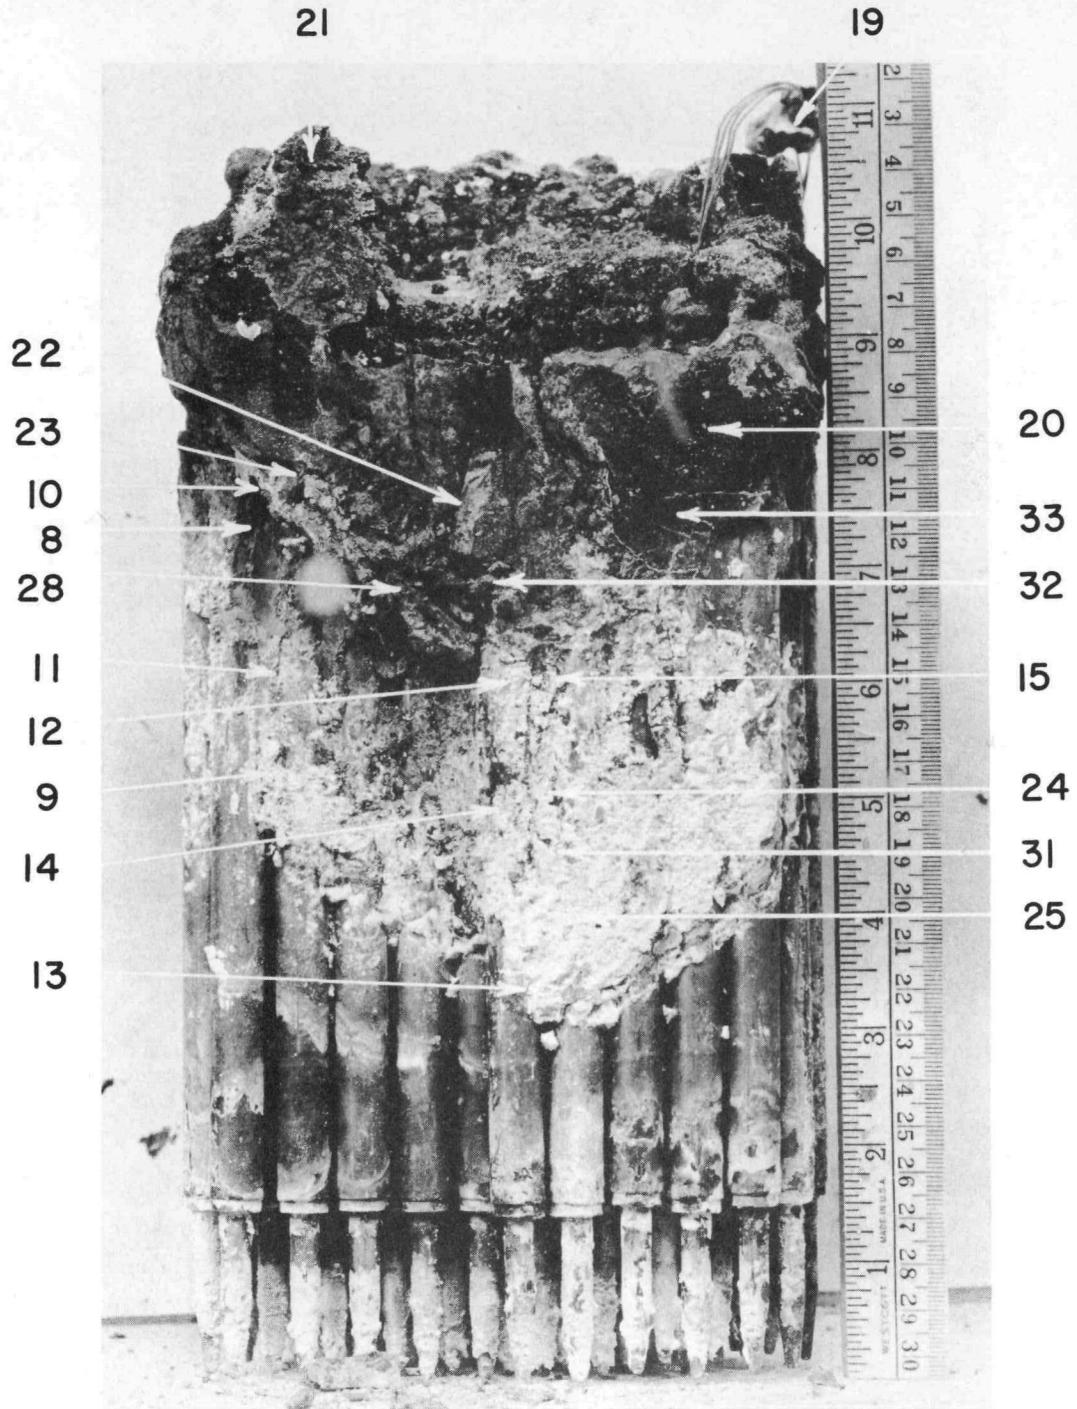
Figure 43. Approximate location of samples taken from a vertical cross section of the core for chemical analyses and metallographic studies.

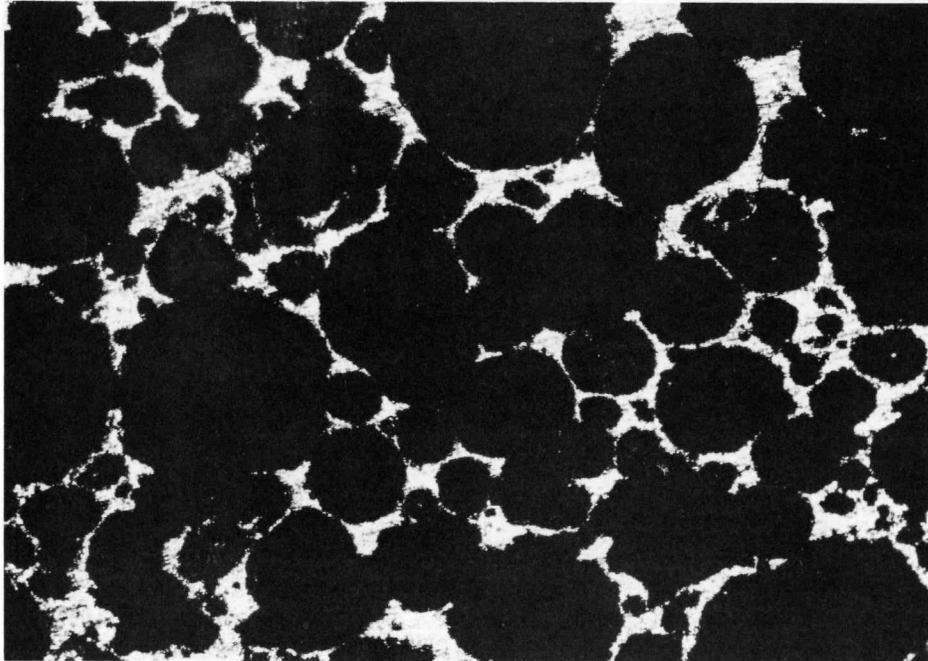
Figure 44. Typical porosity in sample No. 29, from coarse sponge zone.

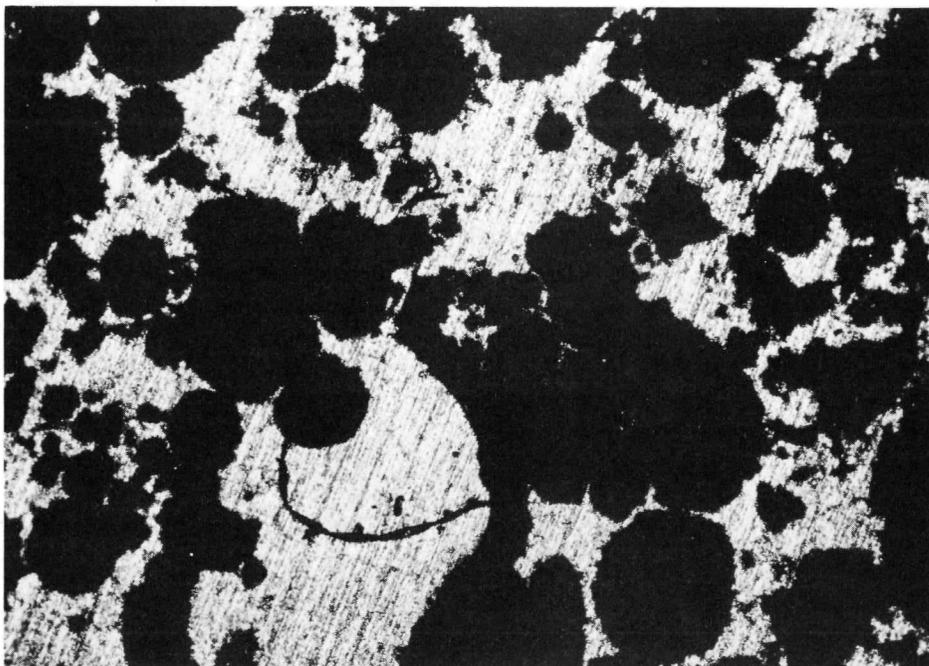
Figure 45. Typical porosity in sample No. 30, from fine sponge zone.

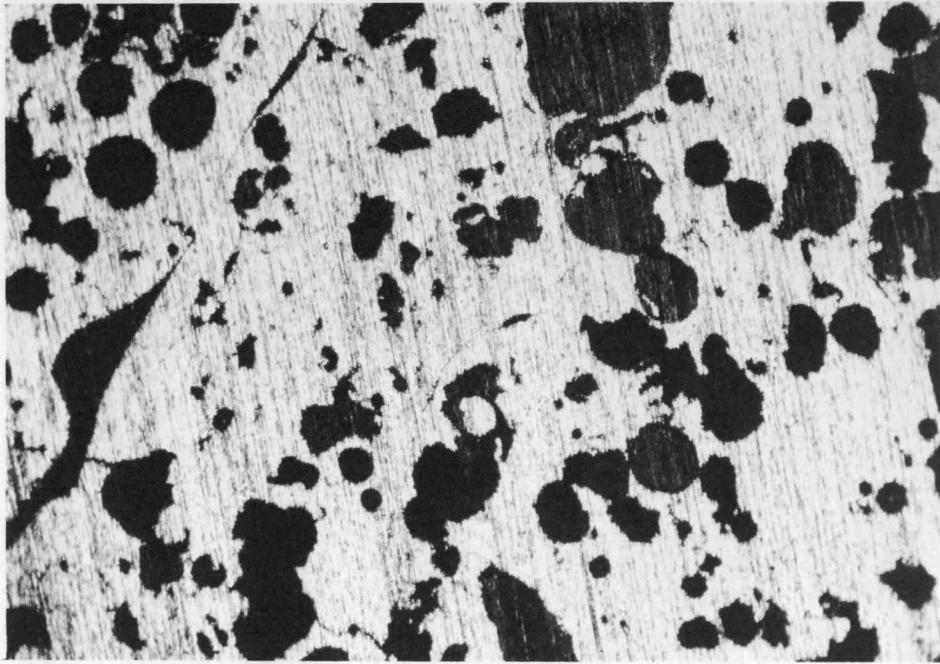
Figure 46. Typical porosity in sample No. 31, from material between blanket rods.

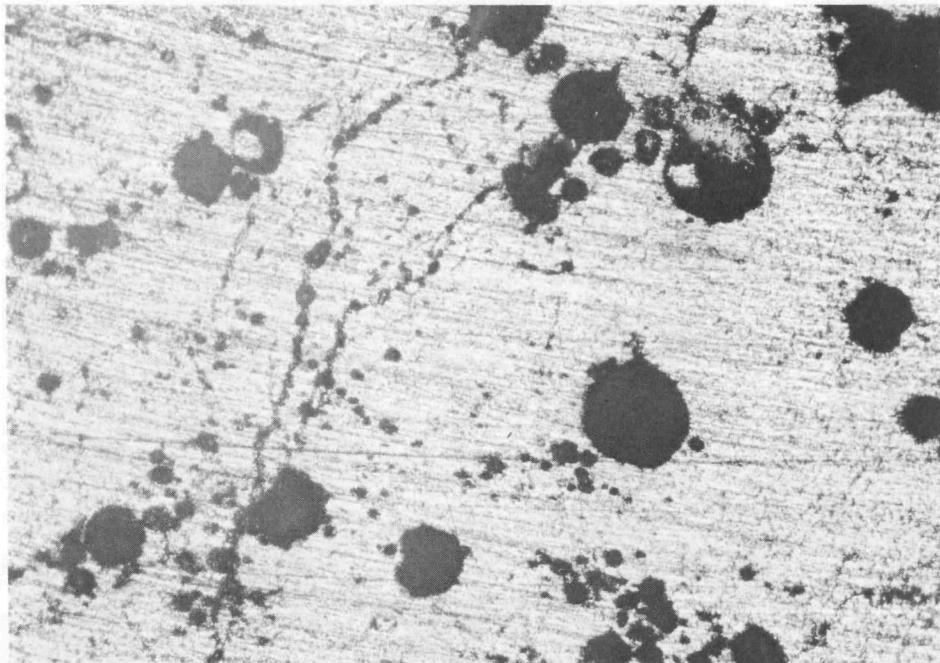
Figure 47. Porosity in material adhering to partially dissolved fuel slug, in sample No. 32.

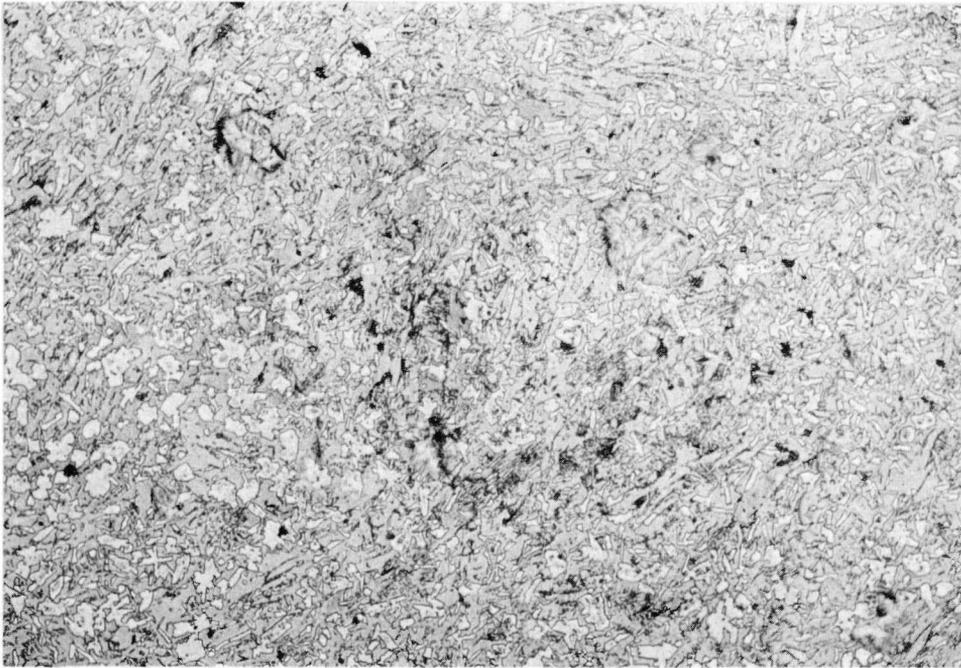
Figure 48. Typical porosity in sample No. 33, from high-density zone.

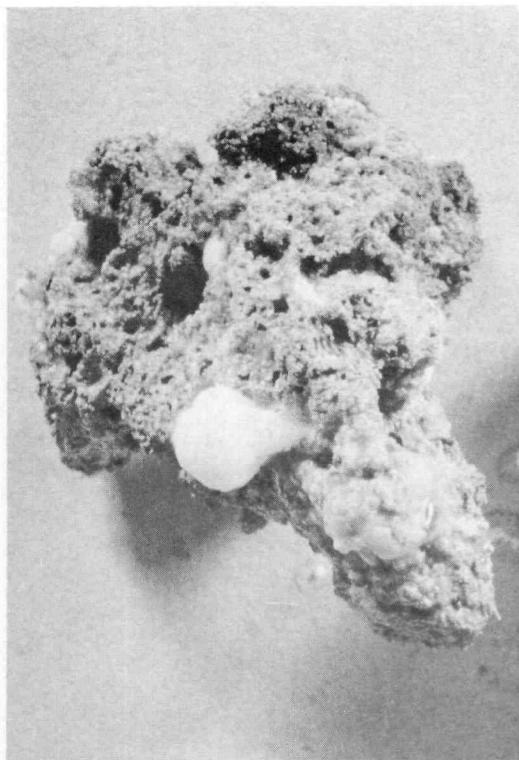
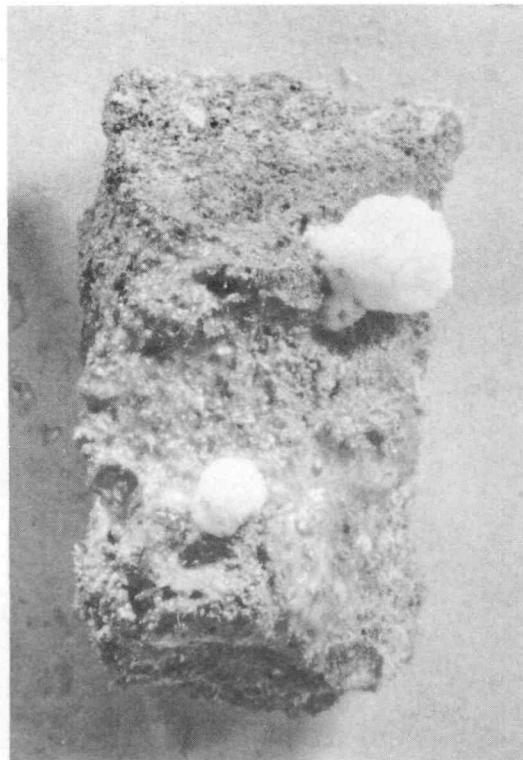
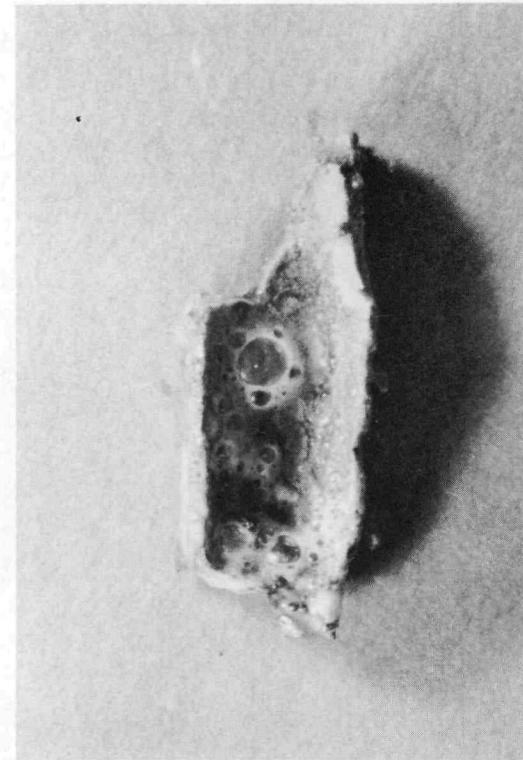
Figure 49. Exudation of NaK oxide and resulting deliquescence in porous samples removed from damaged core. From left to right, the samples are from the coarse sponge zone, the fine sponge zone, and material solidified between lower blanket rods.
