**THE EBR-I MELTDOWN - PHYSICAL AND
METALLURGICAL CHANGES IN THE CORE**

THE EBR-I MELTDOWN -
PHYSICAL AND METALLURGICAL CHANGES IN THE CORE

Final Report - Metallurgy Program 7.2.18

November 1957

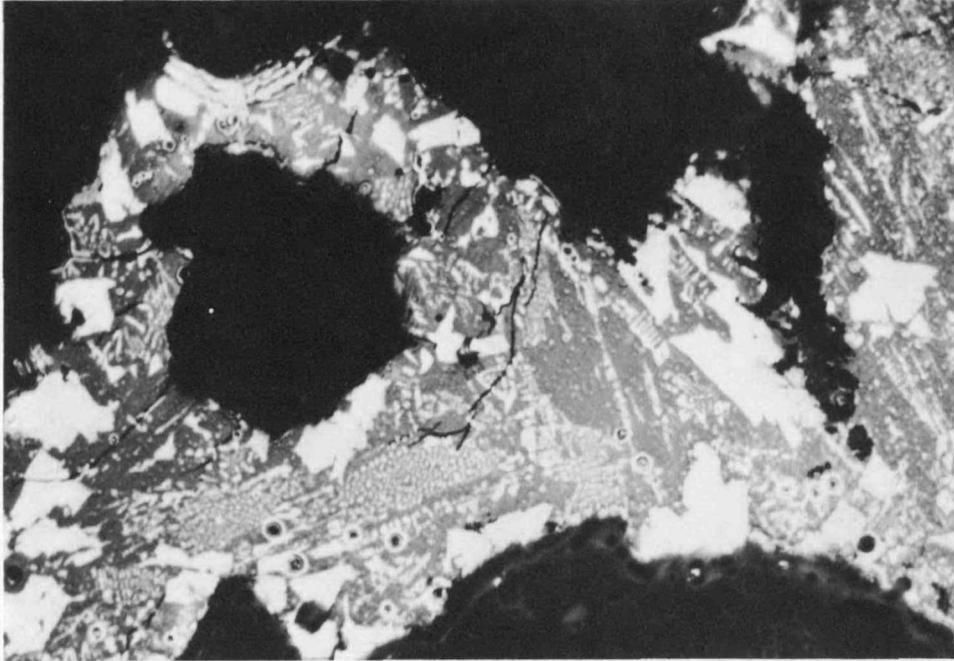
Figure 50. Microstructure in sample No. 29, from coarse sponge zone. The light phase is believed to be analogous to UFe_2 and the dark phase analogous to U_6Fe .

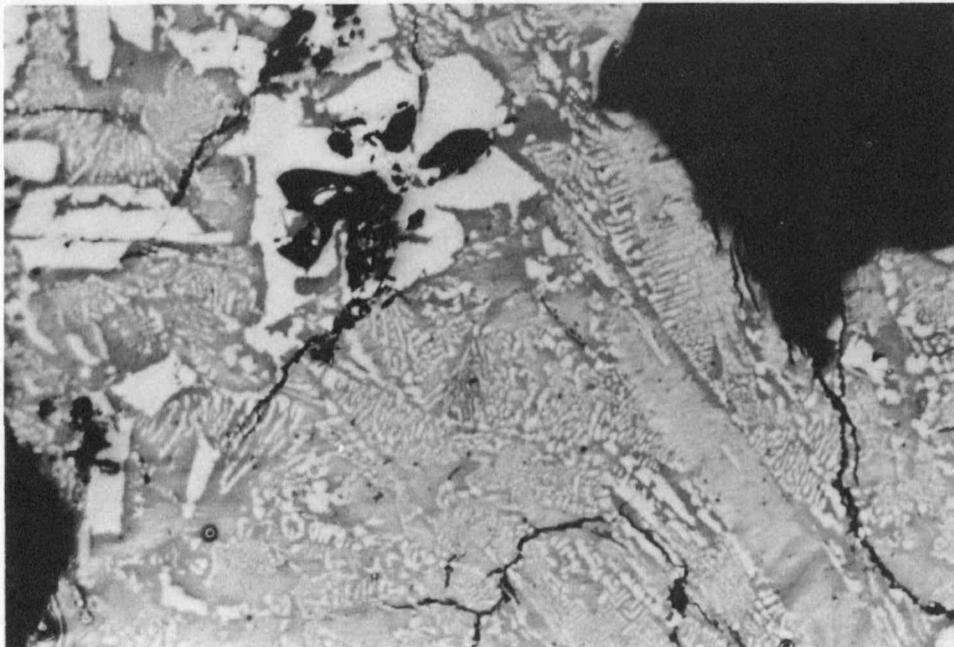
Figure 51. Microstructure in sample No. 30, from fine sponge zone. The light phase is believed to be analogous to UFe_2 and the dark phase analogous to U_6Fe .

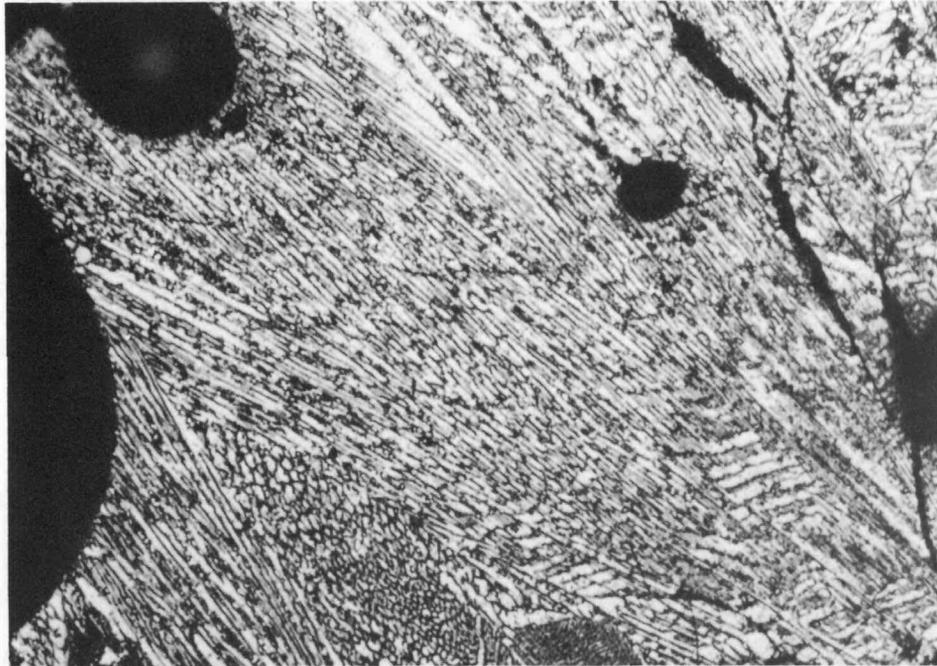
Figure 52. Microstructure in sample No. 31, from material between blanket rods. The light phase is believed to be analogous to UFe_2 and the dark phase analogous to U_6Fe .

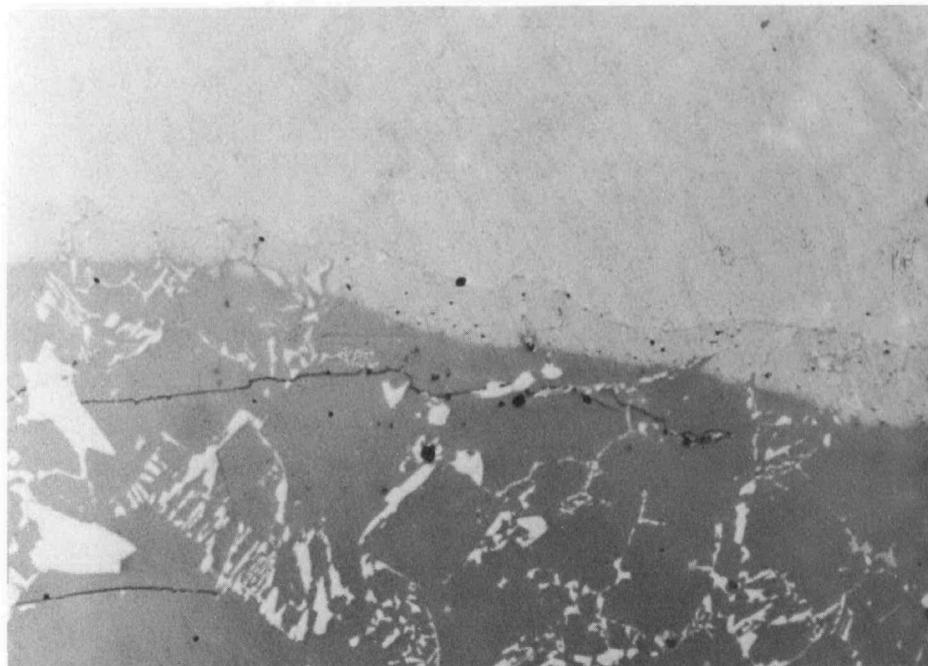
Figure 53. Microstructure of sample No. 32, showing junction between embedded fuel slug and adjoining material. The undissolved fuel slug is shown in the upper half of the photograph. The light phase is believed to be analogous to UFe_2 and the dark phase analogous to U_6Fe .

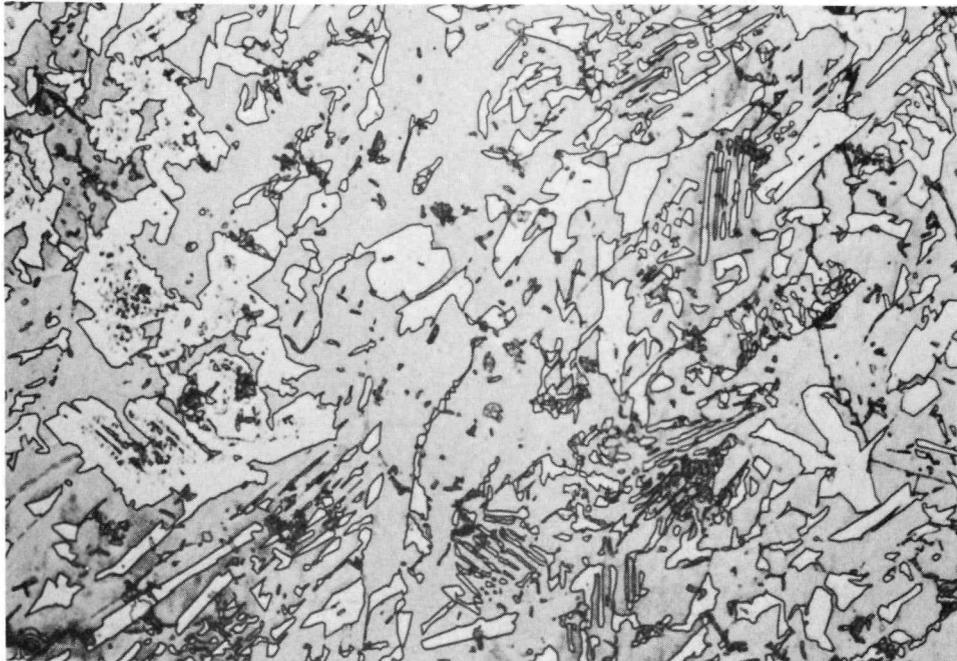
Figure 54. Microstructure in sample No. 33, from high-density zone. The light phase is believed to be analogous to UFe_2 and the dark phase analogous to U_6Fe .

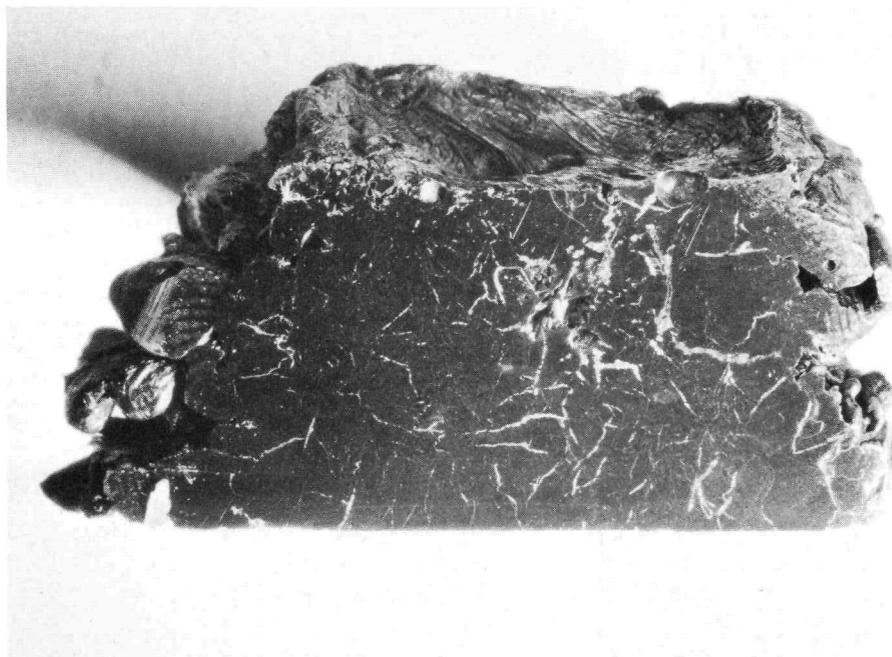
Figure 55. Cross section of first casting made by pouring uranium-stainless steel alloy into NaK. A small amount of NaK was trapped in the casting, evidenced by the traces of NaK oxide.

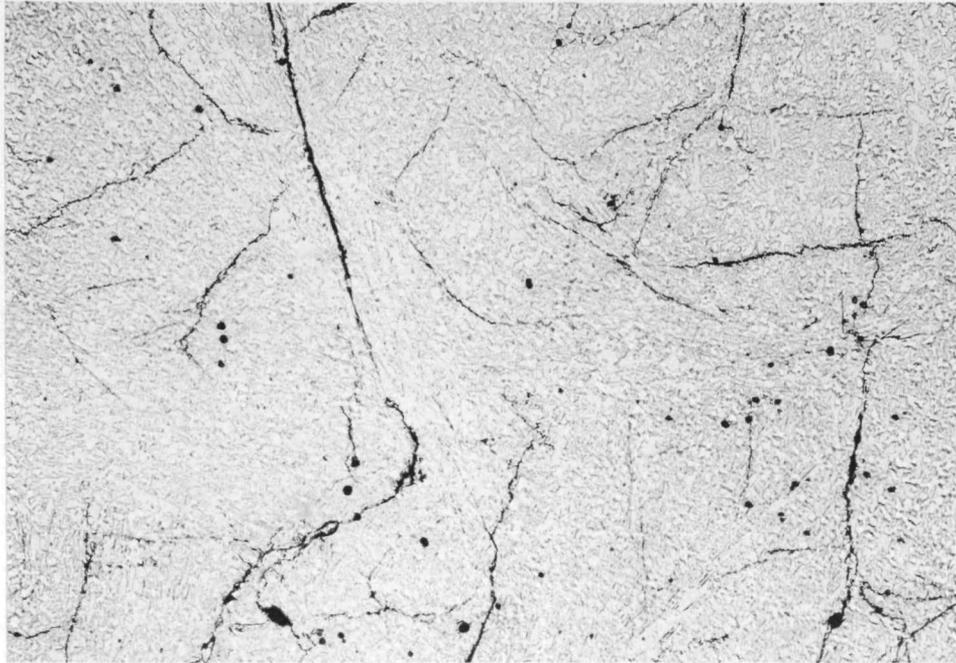
Figure 56. Porosity in casting shown in Figure 55.

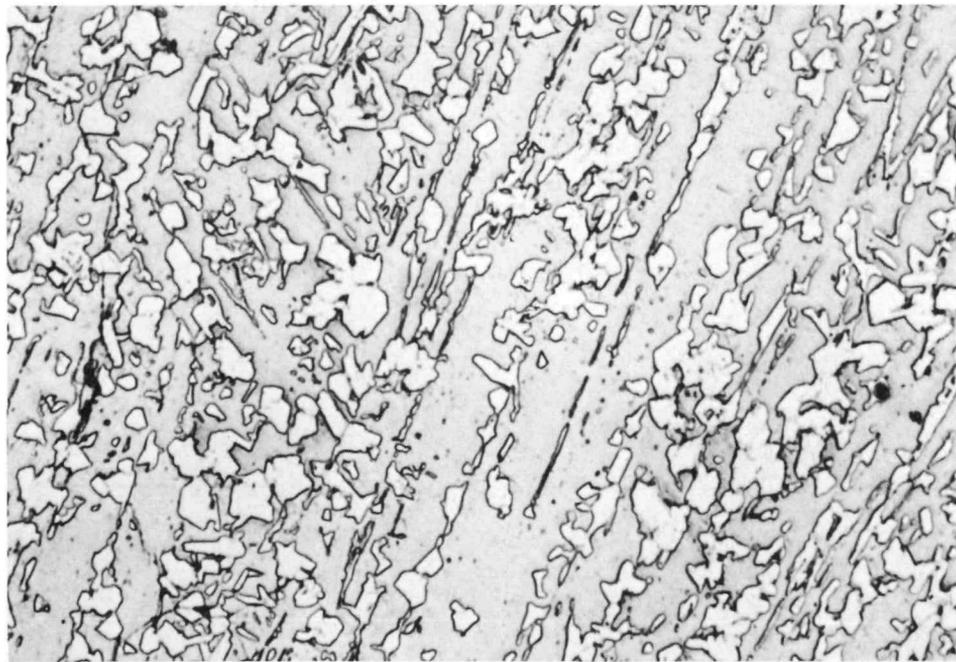
Figure 57. Microstructure of casting shown in Figure 55. The light phase is believed to be analogous to UFe_2 and the dark phase analogous to U_6Fe .

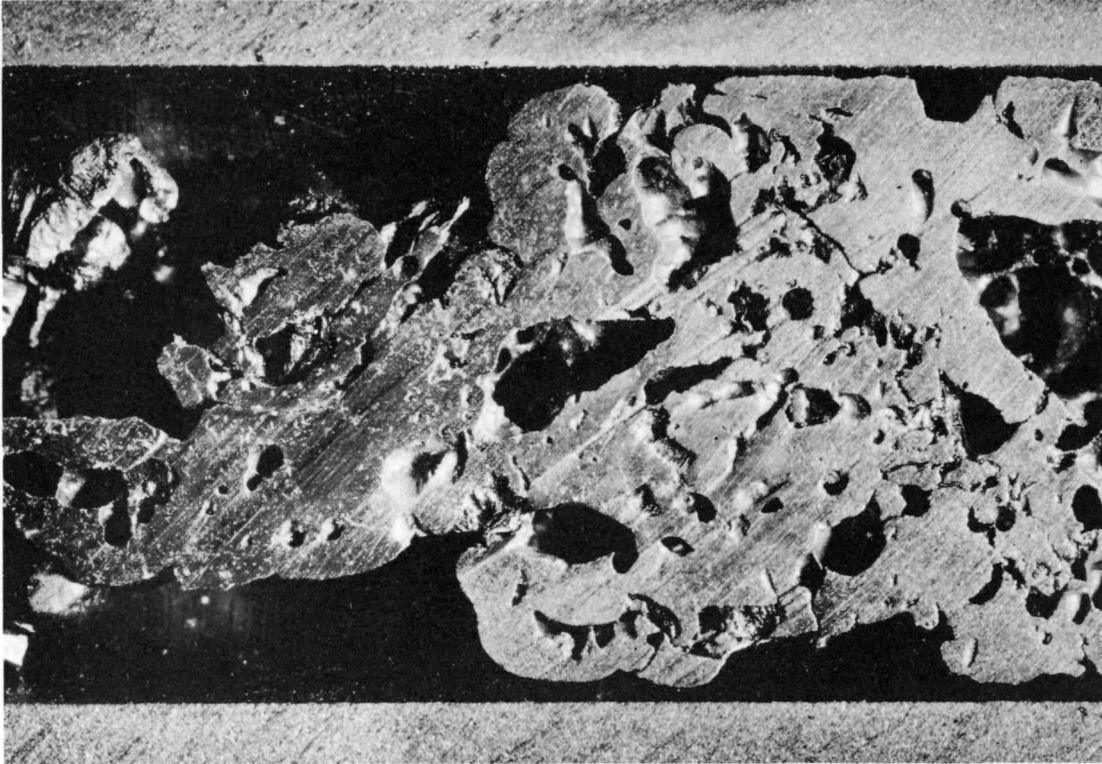
Figure 58. Cross section of second casting made by pouring uranium-iron alloy into NaK.

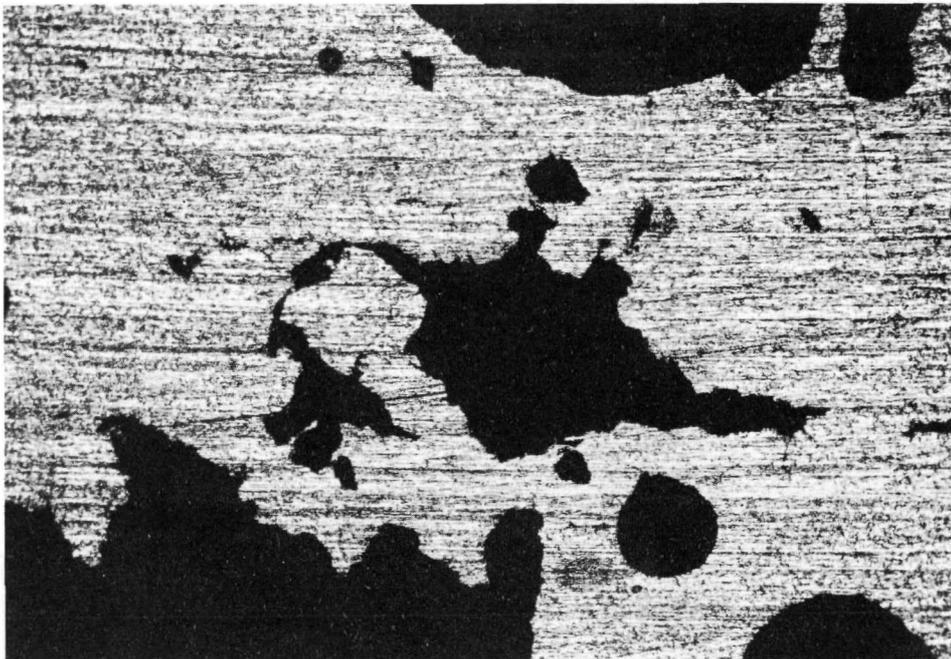
Figure 59. Metallographic section of above casting.

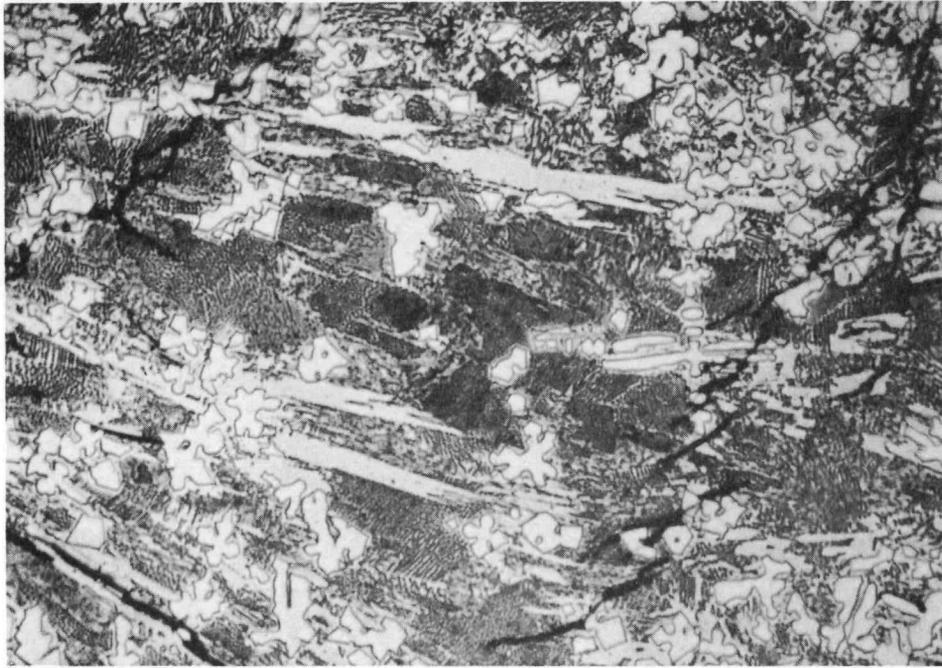
Figure 60. Microstructure of casting shown in Figure 58. The light phase was identified as UFe_2 and the dark phase is believed to be U_6Fe .
