LETTER REPORT FOR UNEXPLODED ORDNANCE AND ORDNANCE EXPLOSIVES CLEANUP AT GOVERNMENT AND COMMERCIAL FACILITIES

VOLUME 2

REFERENCES

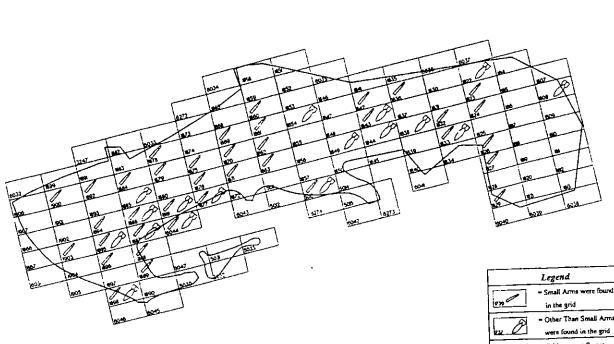
C-3 Ordnance Map

Grid was not Swept
 Grid was not Swept
 Grid was not Swept
 Check area write-up for
 additional information
