***Final Results Report,
In Situ Grouting Technology
for Application in Buried
Transuranic Waste Sites***

***Volume 1, Technology Description
and Treatability Study Results for
Operable Unit 7-13/14***

INEEL/EXT-02-00233

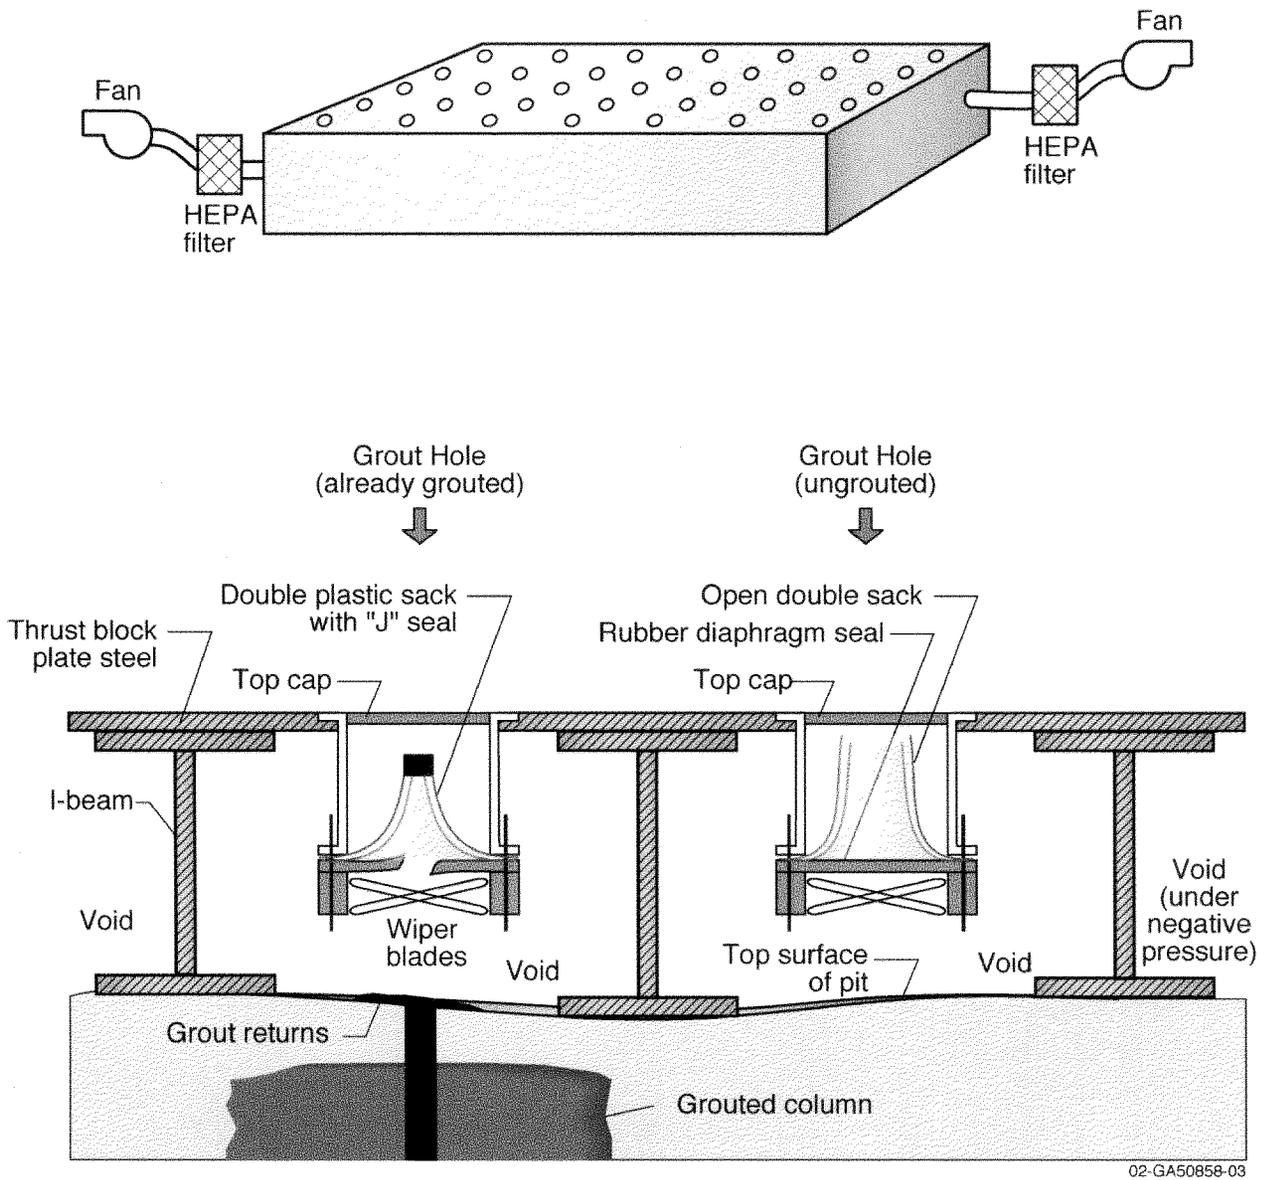
Figure 1. Thrust block design features.

For the single-component materials, grout is forced through two nozzles located 180 degrees apart on the bottom of the drill stem. The nozzles are offset 5 cm to maximize waste coverage in creating a column. At the bottom of the drill stem is usually a conical drive point to facilitate driving the rotating

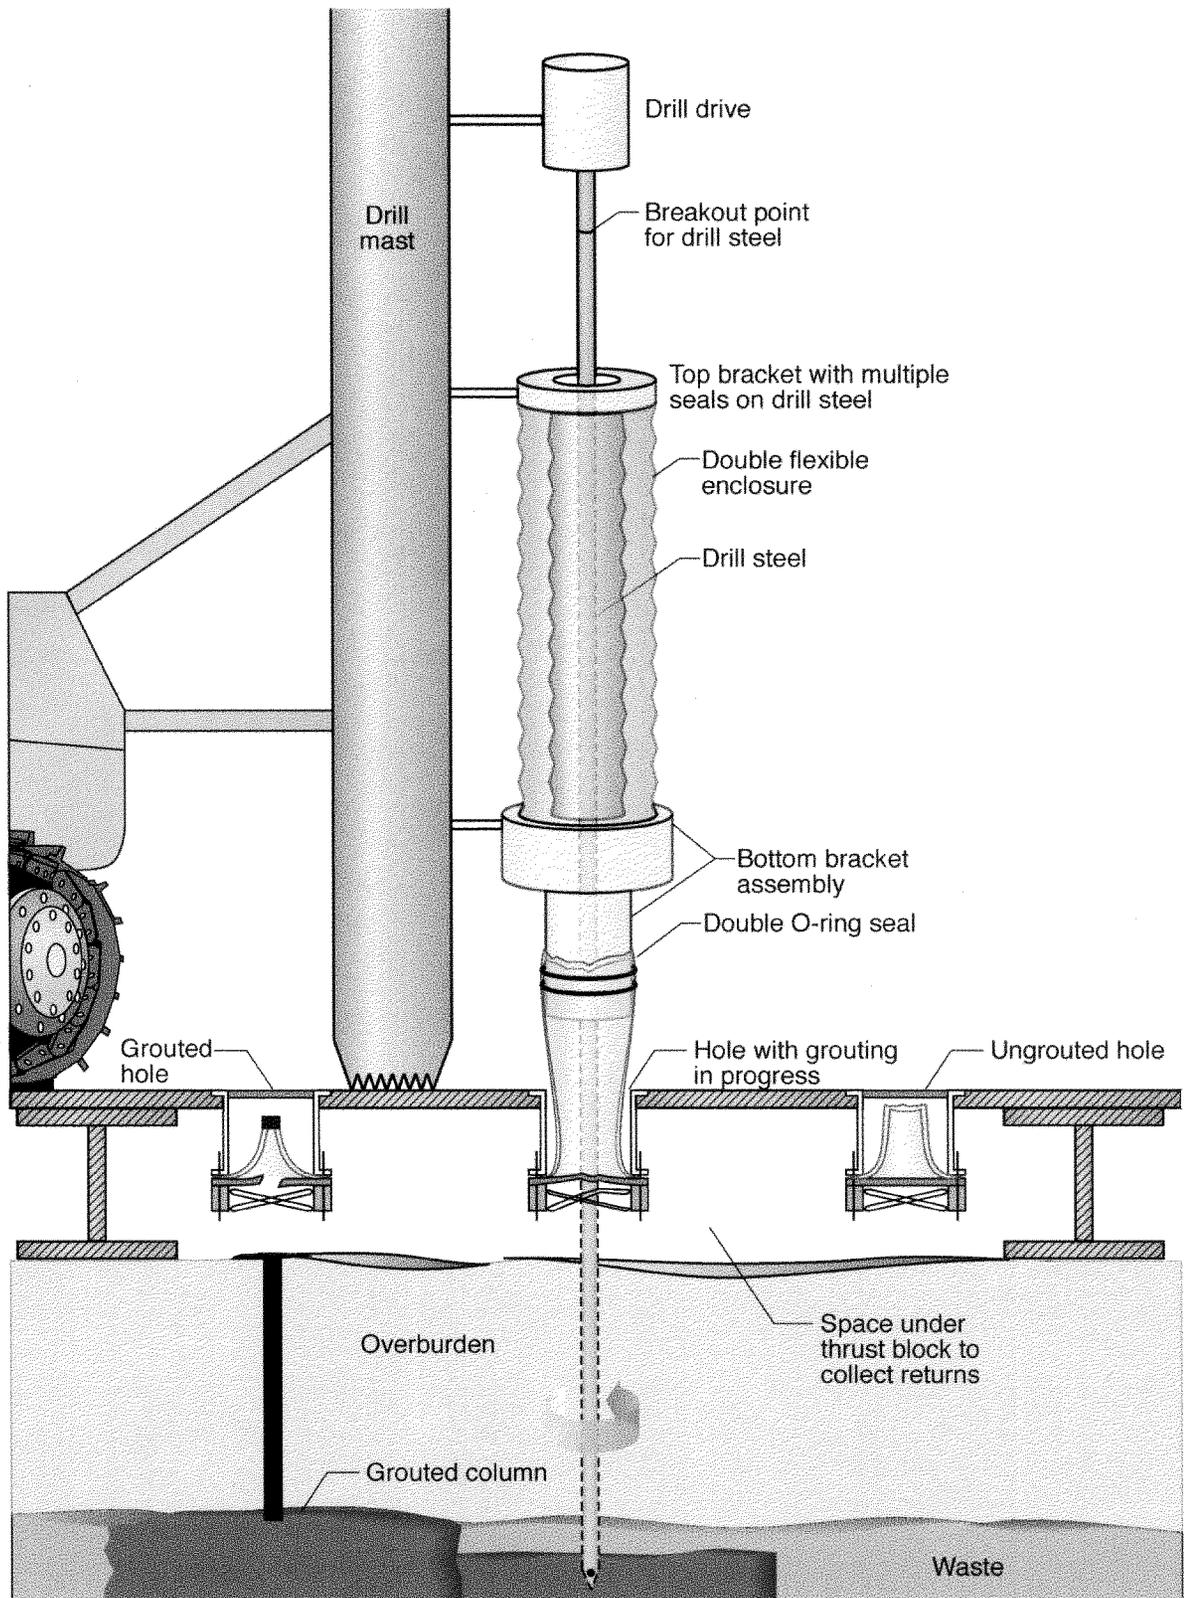
02-GA50858-01

Figure 2. Grouting process with contamination control.

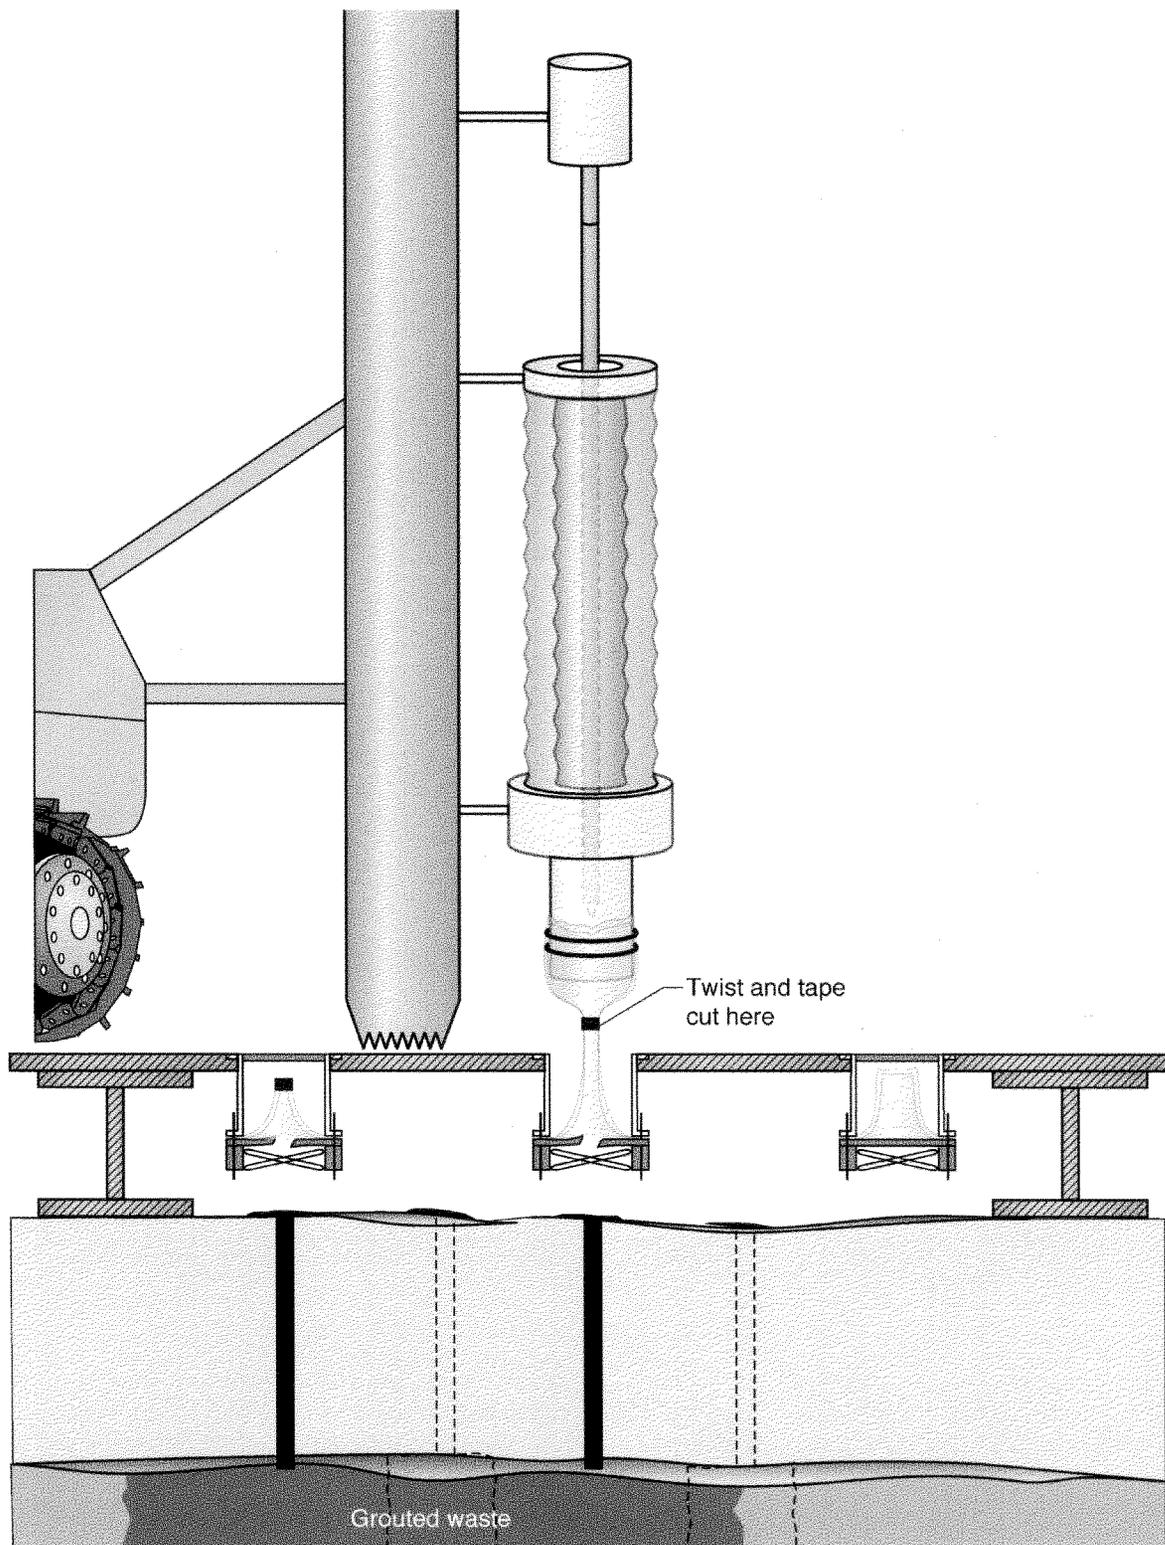
02-GA50858-02

Figure 3. Drill string withdrawn—preparing to move to a new hole.

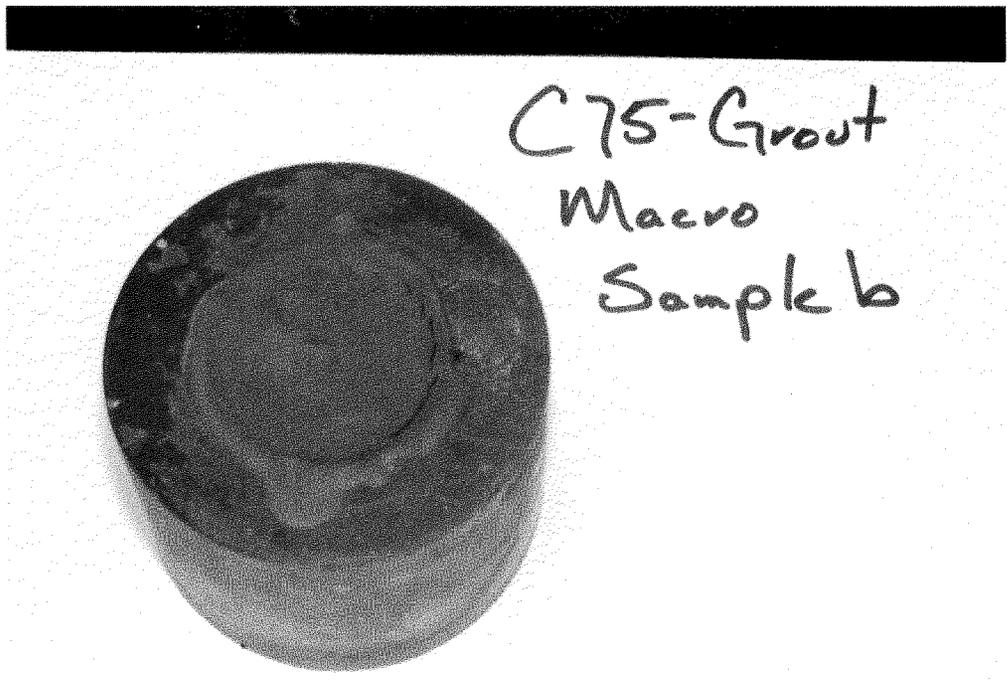
Figure 4. Macroencapsulation cylinder for GMENT-12 (C-75, Tank Closure Grout).

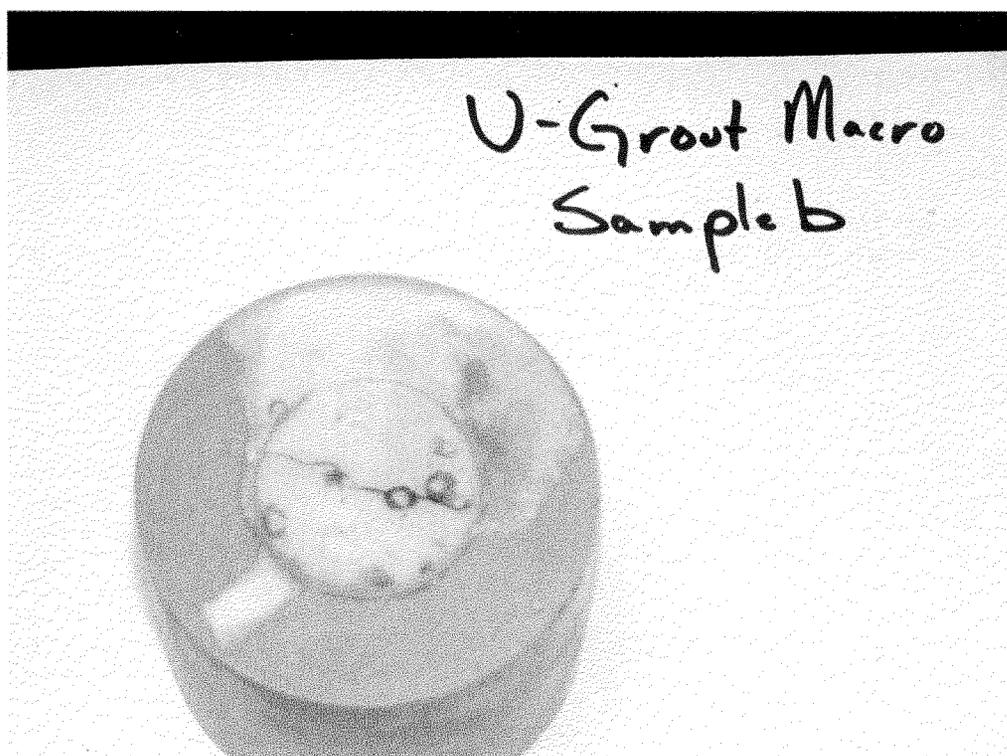
Figure 5. Macroencapsulation cylinder for U.S. Grout.

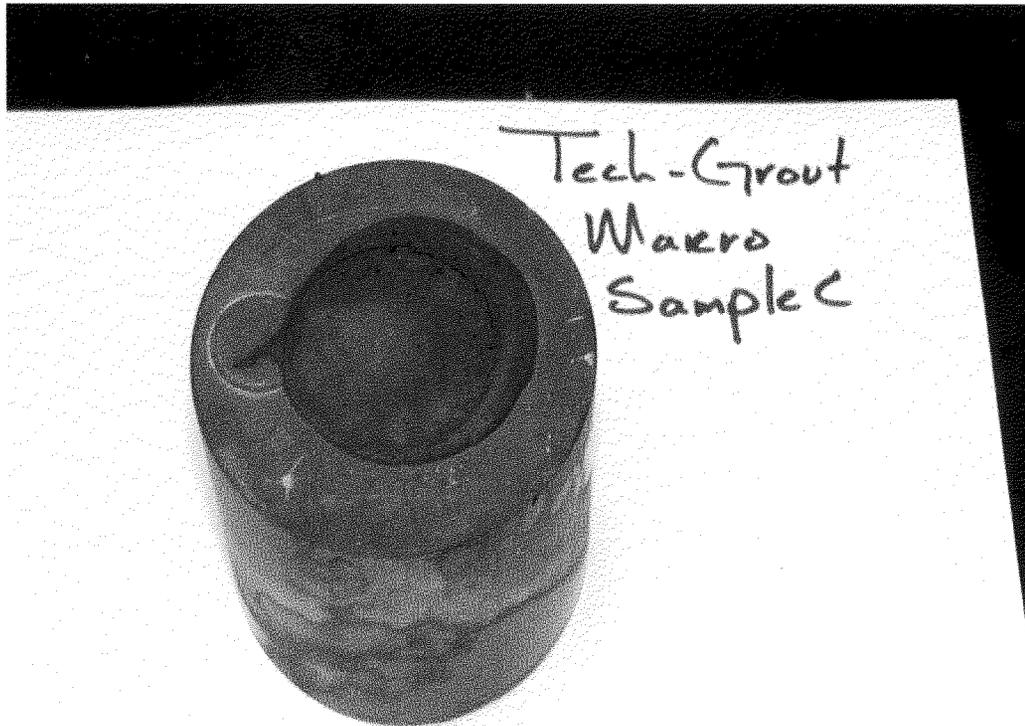
Figure 6. Macroencapsulation cylinder for TECT HG.

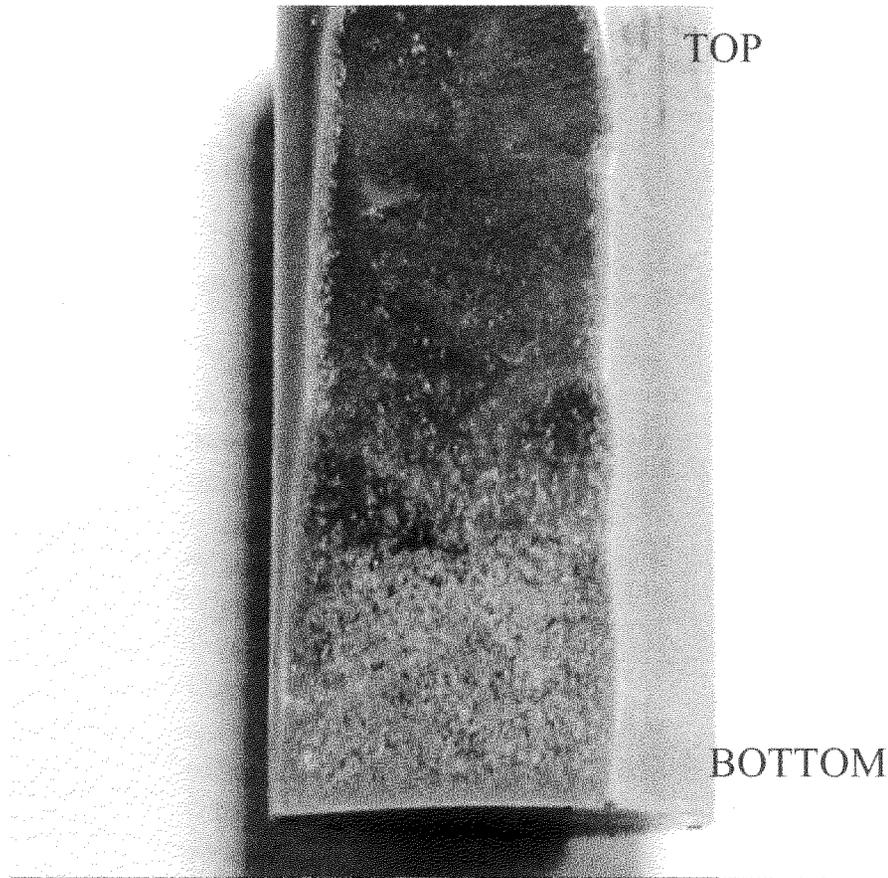
Figure 7. Separation of sodium tetraborate/glycerin during cooling in Waxfix.

example, the sample was mixed with 56 g of sodium tetraborate per liter of wax and the post cooling separation from samples analyzed with ICP-MS was top of the sample 18mg/L, middle of the sample 43mg/L and the bottom was 316 mg/L. These results suggest that a completely different introduction scheme be devised to first introduce the boron and then have it stay distributed during cooling.

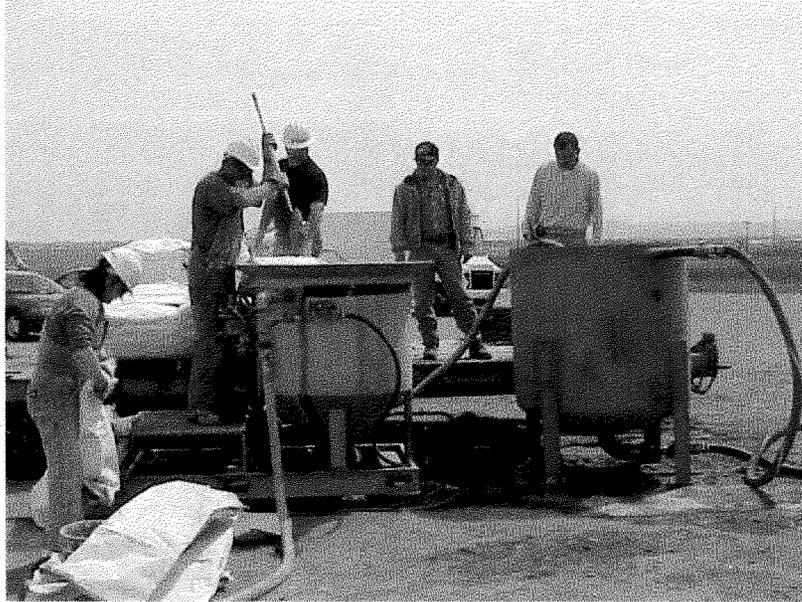
Figure 8. In-line vortex mixers.

The hardware consisted of water supply tanks, two in-series vortex mixers, and associated supply pumps, a JET 5 CASA GRANDE high-pressure injection pump, high-pressure injection lines, a CASA GRANDE C-6 rotopercussion drill jet grouting system, a typical mud balance, and the special thrust blocks discussed separately in this section. Figures 8, 9, and 10 show the Vortex mixer, high-pressure pump, and grout drilling rig set up on a thrust block, respectively.

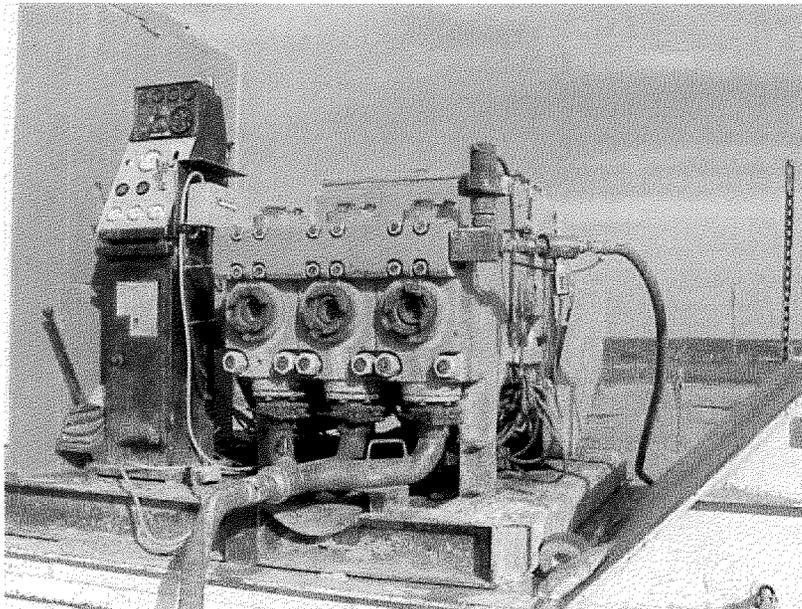
Figure 9. High-pressure pump.

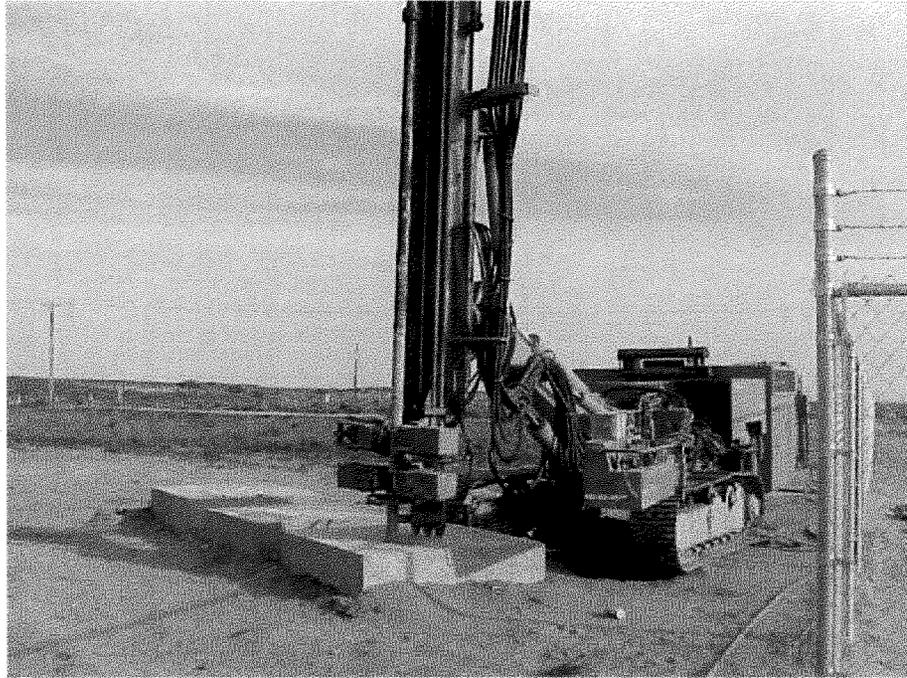
Figure 10. CASA GRANDE C-6 drill system on thrust block.

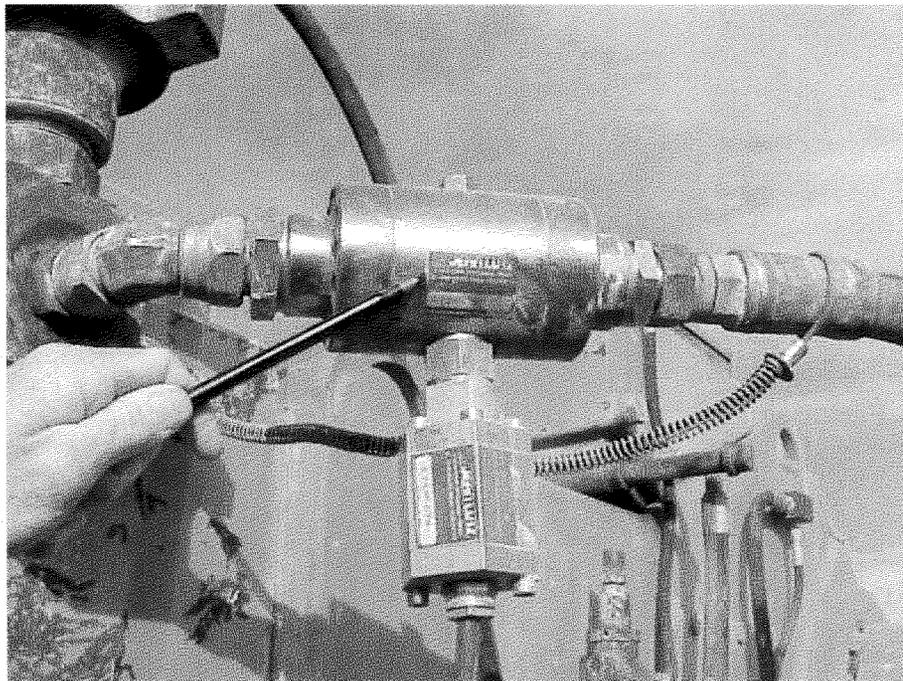
Figure 11. Jean Lutz pressure/flow meter.

To measure grout flow, two in-line high-pressure flow meters were used, one a Jean Lutz-LT3n, C16M-B74, SP100MC21 pressure/volumetric flow device that measures the number of strokes of the positive displacement pump, and the other an in-line Halliburton turbine meter (Figures 11–12 show these devices).

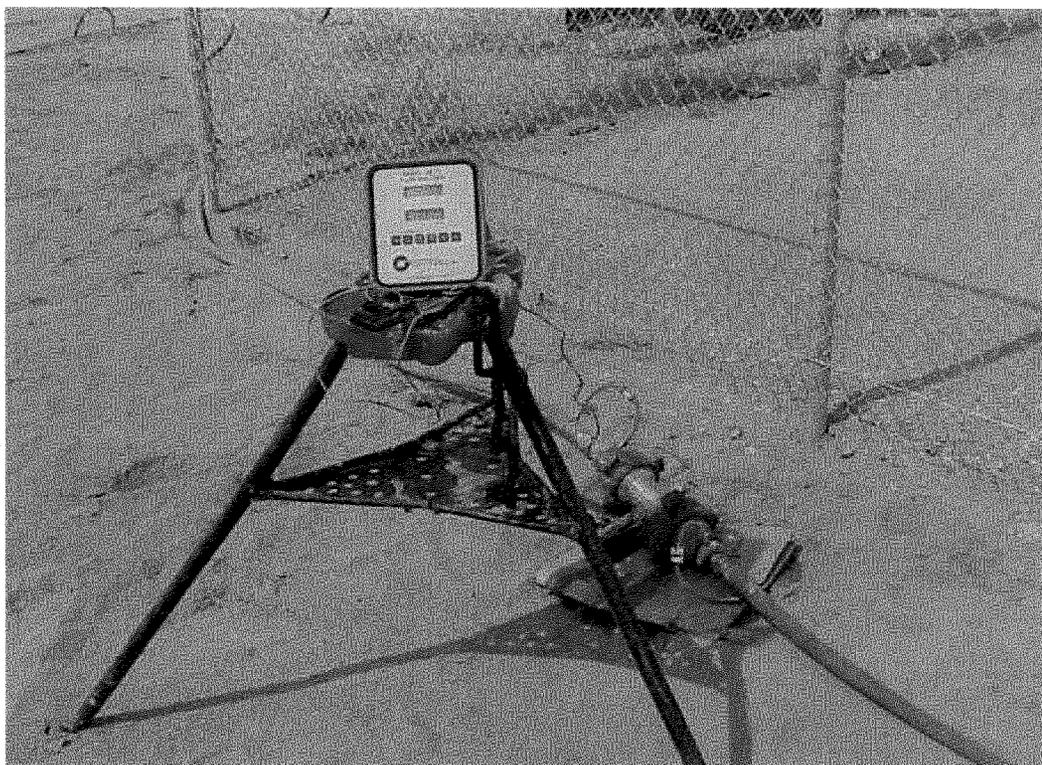
Figure 12. Halliburton in-line flow meter.

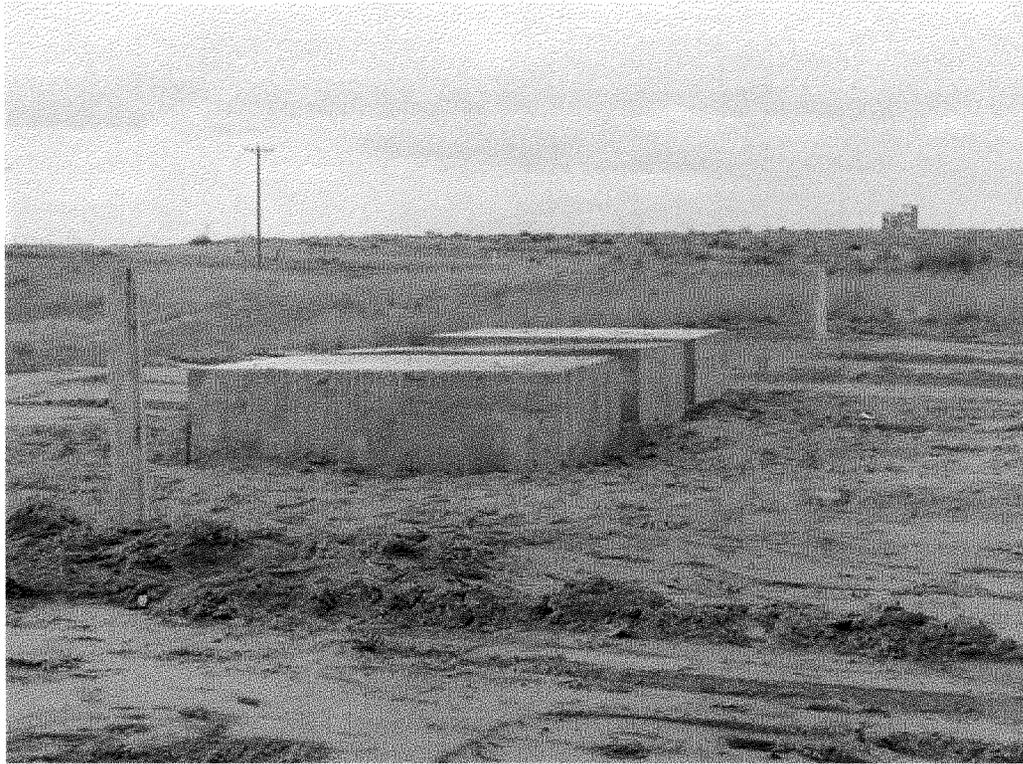
Figure 13. Thrust blocks in place on top of pit (without side berming).

Initial preparation tasks included construction of a test area similar to disturbed soil conditions expected at the SDA. A pit 6.6 m (21 ft) long was excavated 1.2 m (4 ft) wide by 3.3 m (11 ft) deep and backfilled with equivalent INEEL-RWMC-type silty-clay soil obtained from a site near Benton Washington. Representativeness was verified by comparative soil composition tests. The backfilling was a loose pack without machine packing—the intent being to create a site with 30-50% by volume free voids. Next, three specially prepared mock-up thrust blocks were arranged over the pit as shown in Figure 13.

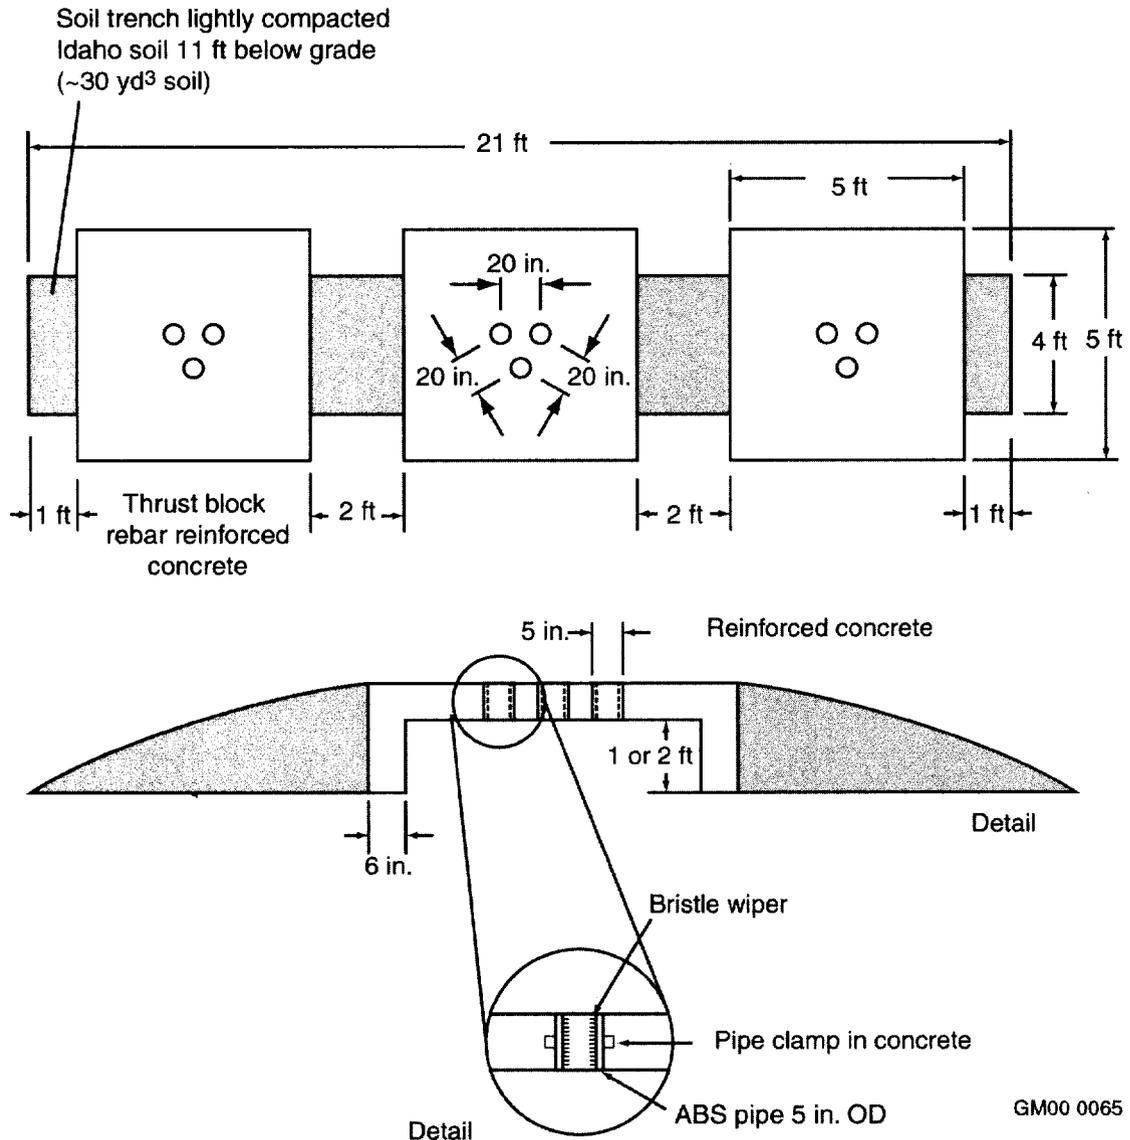
Figure 14. Implementability test layout.

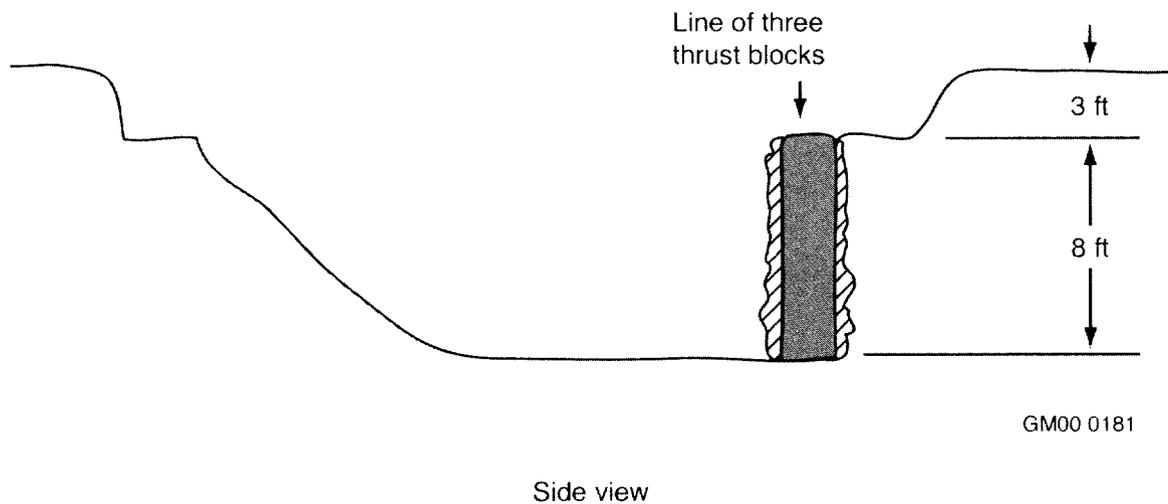
Figure 15. Side view of excavation of implementability tests.

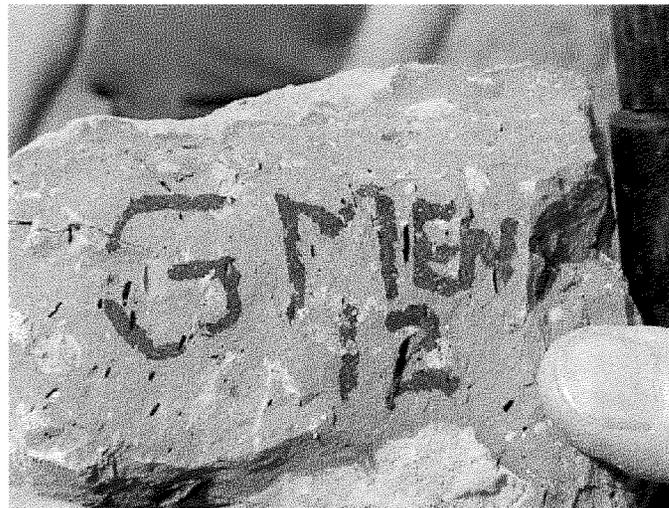
Figure 16. GMENT-12 mixtures of soil and grout.

For GMENT-12, use of a 2.4-mm nozzle resulted in achieving the desired pressure of 400 bar (6,000 psi), and a column was created with no grout returns. Based on preliminary calculations, the injection parameters included 5.1 s/step with a 5 cm step and 2 revolutions per step. Upon excavation following a 3-day cure, a cohesive column was revealed and removed in one cohesive piece using a standard backhoe. The measured dimensions of the column were 109 cm (43 in.) long and approximately cylindrical shaped, with an outside diameter averaging 63.5 cm (25 in.). With great difficulty, the column was broken in two pieces by dropping the bucket from a height of 0.61 m (2 ft) over 10 times. The column appeared to consist of mostly pure grout well mixed with soil, with some visible soil inclusions as shown in Figure 16. Some 0.5-cm diameter voids were found in the monolith (also shown in Figure 16). These pours were most likely from void redistribution in the soil and/or entrained air during grouting.

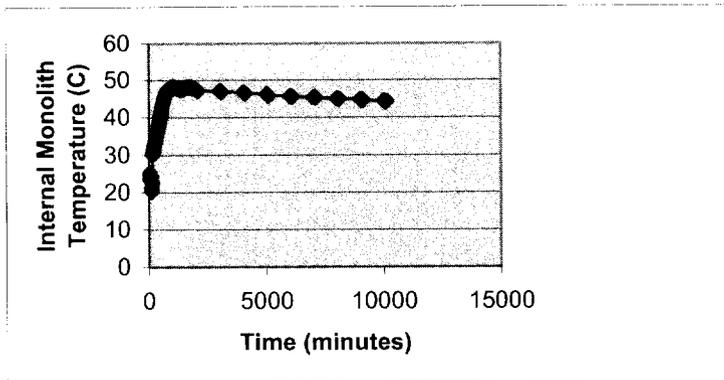
Figure 17. Curing temperature profile of U.S. Grout.

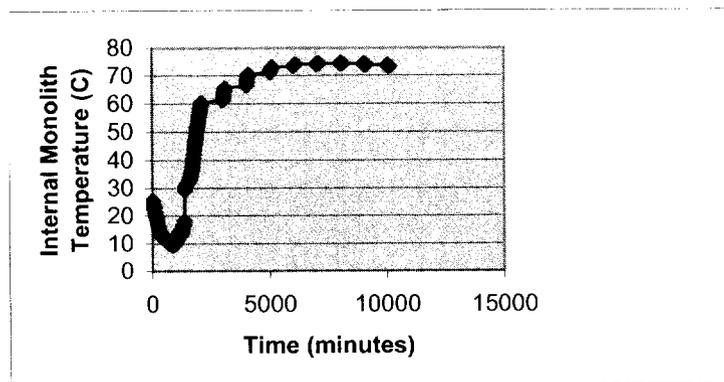
Figure 18. Curing temperature profile of TECT HG.

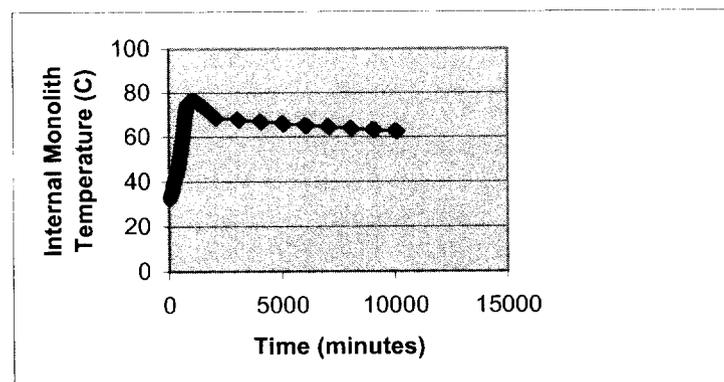
Figure 19. Curing temperature profile of GMENT-12.

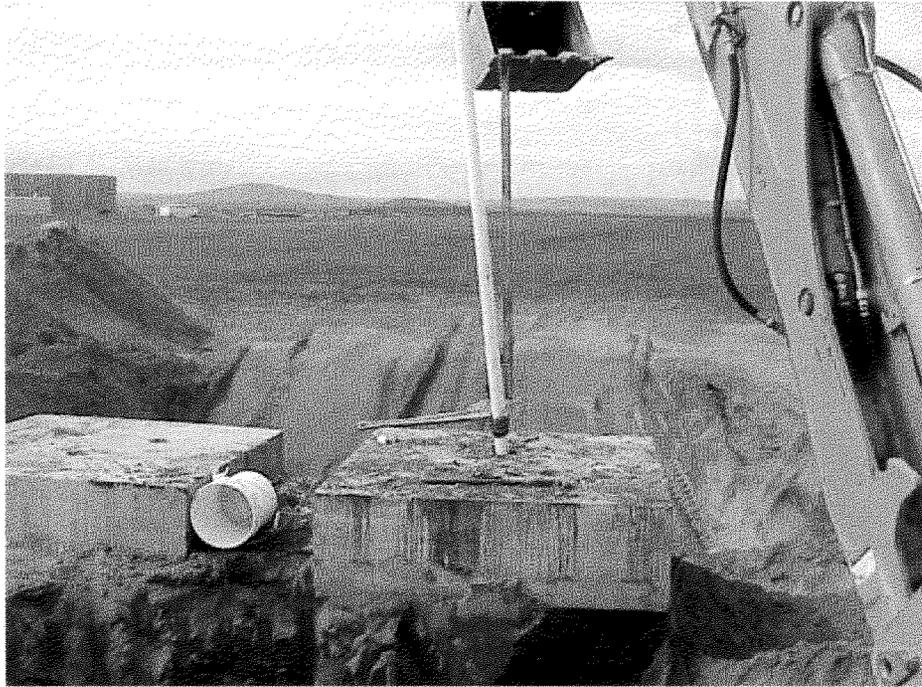
Figure 20. Lifting the polyethylene rod out of a grouted hole.

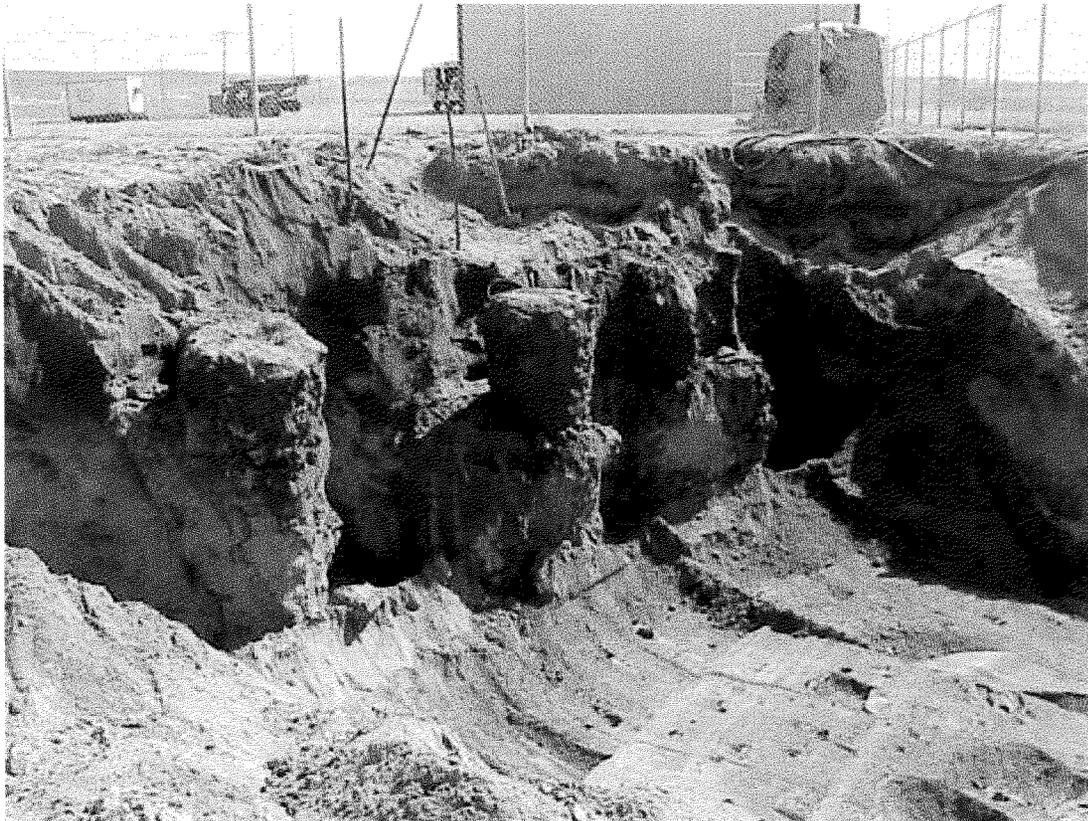
Figure 21. Excavation of the monoliths.

The destructive examination of the columns created under the thrust blocks first involved removing side burden material until the three monoliths were exposed as shown in Figure 21.

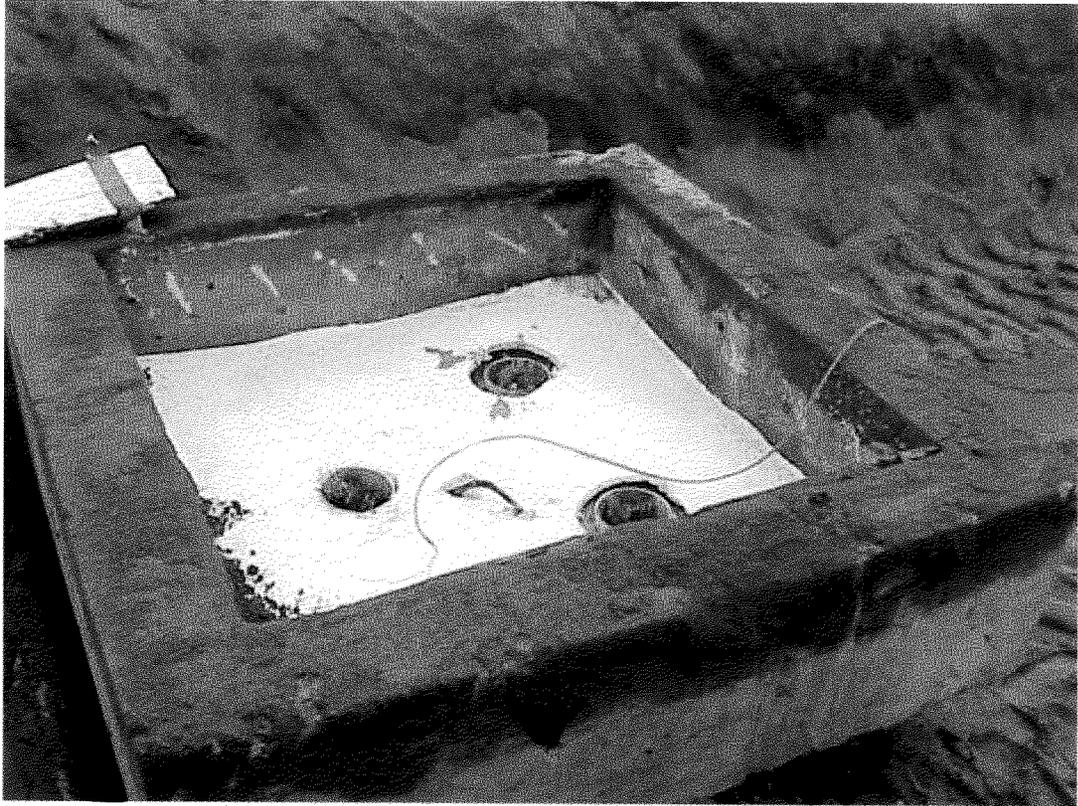
Figure 22. GMENT-12 thrust block (underside showing Styrofoam liner).

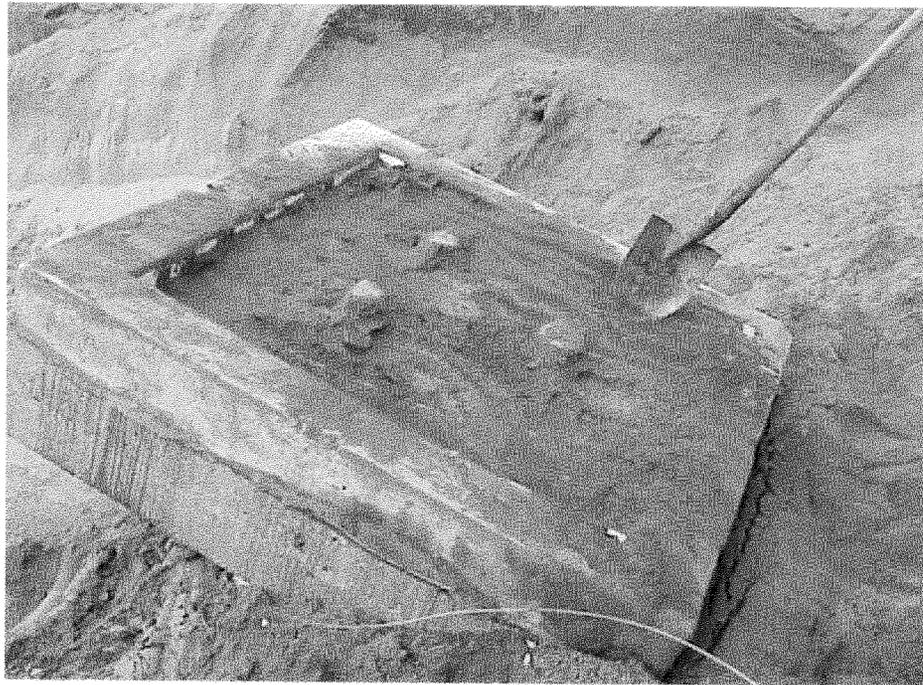
Figure 23. Underside of U.S. Grout thrust block.

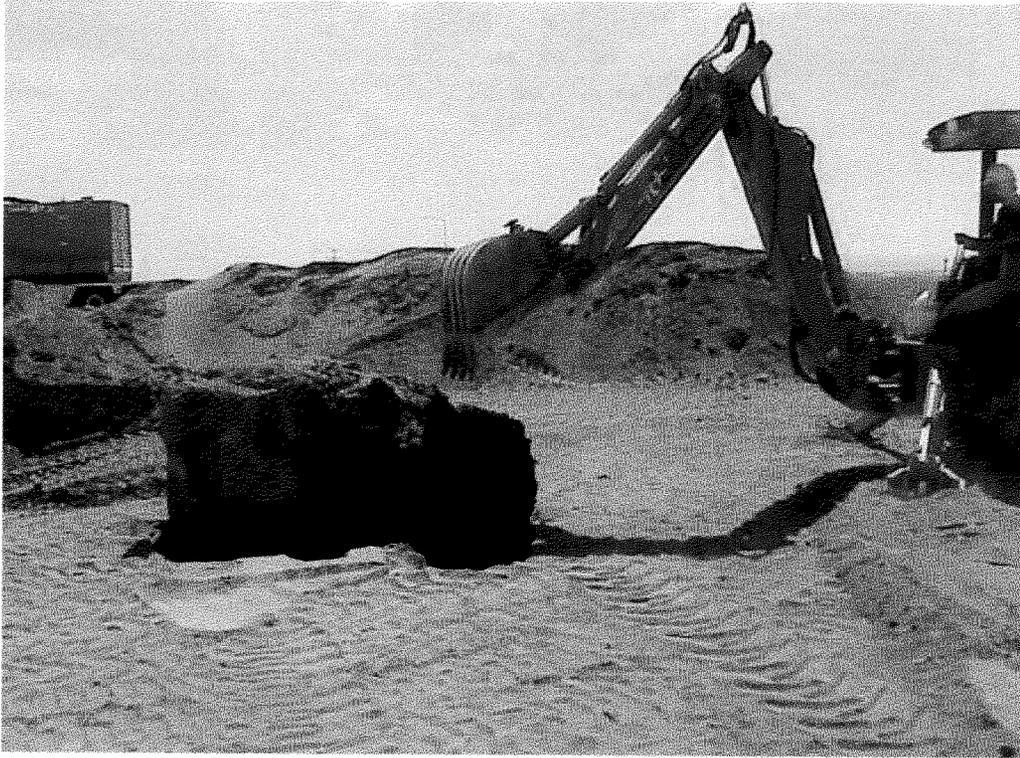
Figure 24. GMENT-12 monolith removed as one piece from the pit.

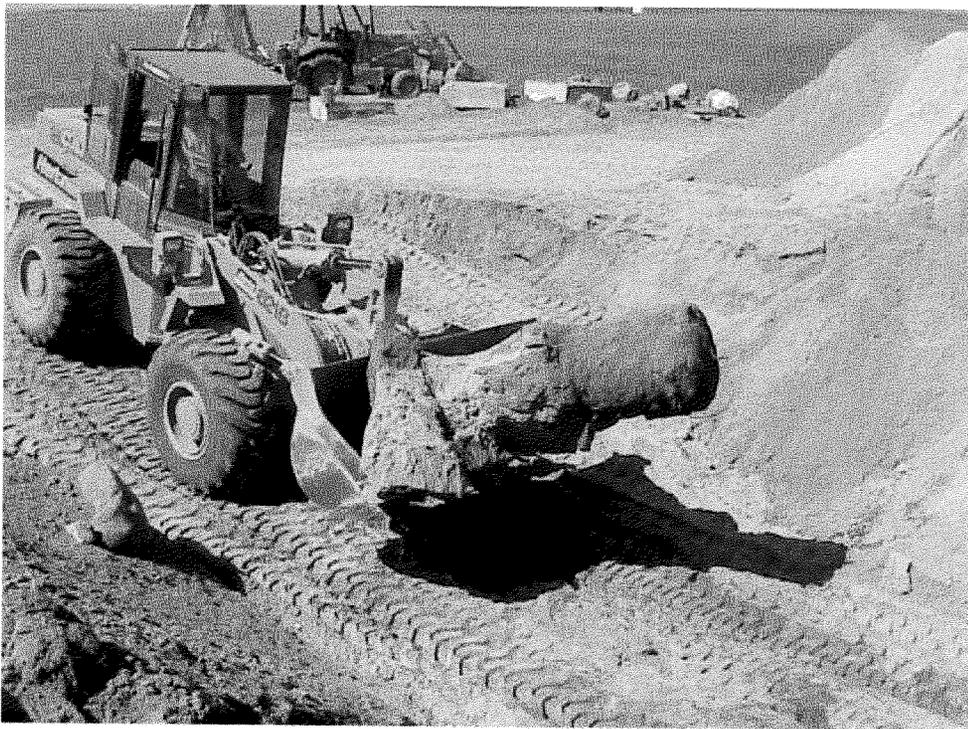
Figure 25. TECT HG monolith being moved as one piece.

The monolith created by the injection of TECT HG grout in a triplex column was a solid cohesive stand-alone monolith as shown being moved out of the pit in Figure 25.

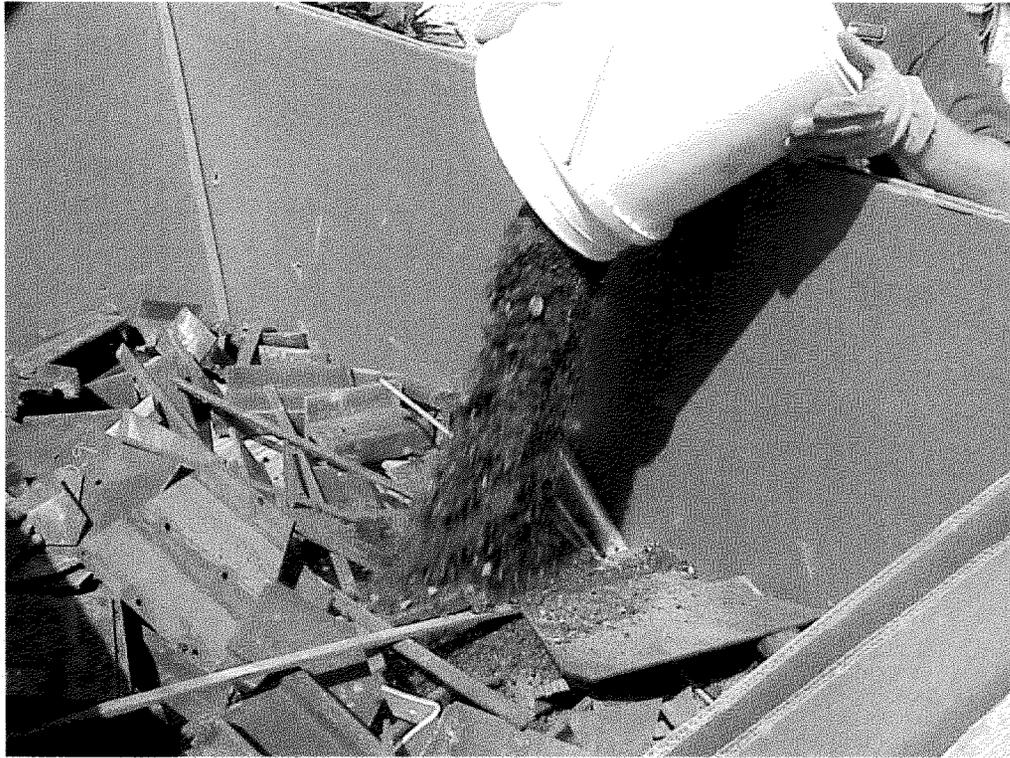
Figure 27. Box being filled with metal, wood, asphalt, and concrete.

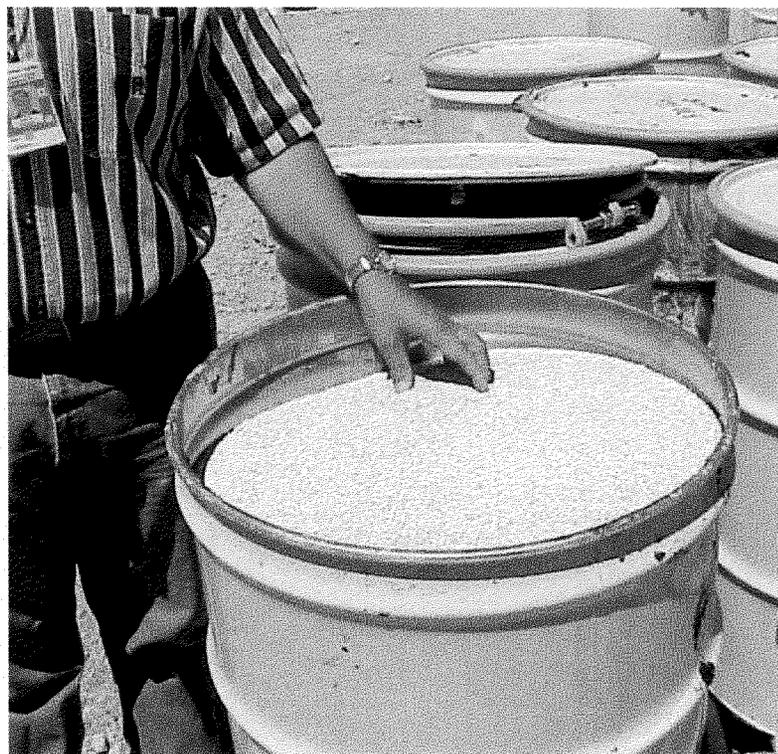
Figure 28. Drum filled with nitrate salts.

two of the nitrate drums were metal sided drums. All other drums were cardboard drums to simulate the aging process that is expected to have occurred in the SDA transuranic sites and trenches. Fourteen sacks were filled with cloth and paper. A terbium oxide tracer was placed in each container (except nitrate drums) to simulate the mechanical movement of plutonium during operations. The combustible drums contained 3.5 oz (100 g) of tracer, the boxes 14 oz (400 g), the inorganic drums 7 oz (200 g), the organic drums 1.75 oz (50 g), and the sacks 3.5 oz (100 g). On a one-for-one basis it is estimated that this tracer loading represents maximum plutonium loading in the actual transuranic waste.
