***Final Results Report,
In Situ Grouting Technology
for Application in Buried
Transuranic Waste Sites***

***Volume 1, Technology Description
and Treatability Study Results for
Operable Unit 7-13/14***

INEEL/EXT-02-00233

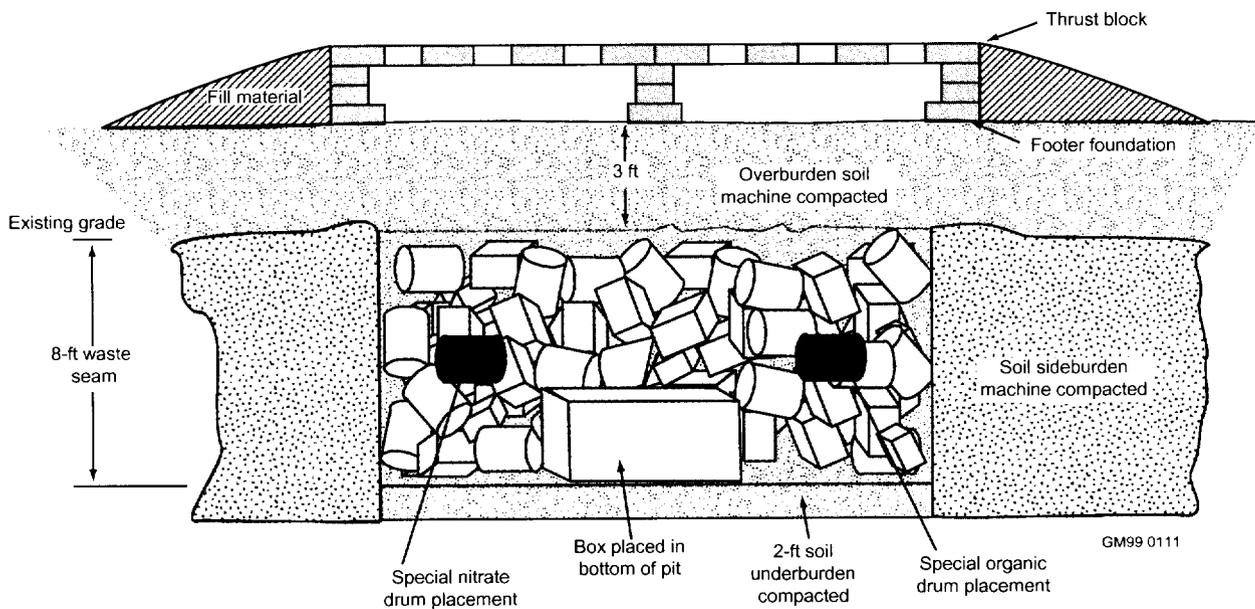
Figure 29. Design features of the long-term disposal pit.

There are two general waste composition types: (1) material that will not generally affect grout curing such as combustibles and debris (cloth, metal, soil, asphalt, concrete, and wood), and (2) material that could interfere with grout cure (nitrates and organics). Because of the proportionally small volume of organics and nitrate sources in the SDA, the most representative monolith hydraulic conductivity conditions are near these interference materials but not within an actual penetration of the interference drum. Based on historical data, the volume of the nitrate and organic interference is approximately 10% of the volume of the pit while 90% of the volume is void or containerized soil or cloth, paper, wood, asphalt, metal, glass, and other debris (Vigil 1990).

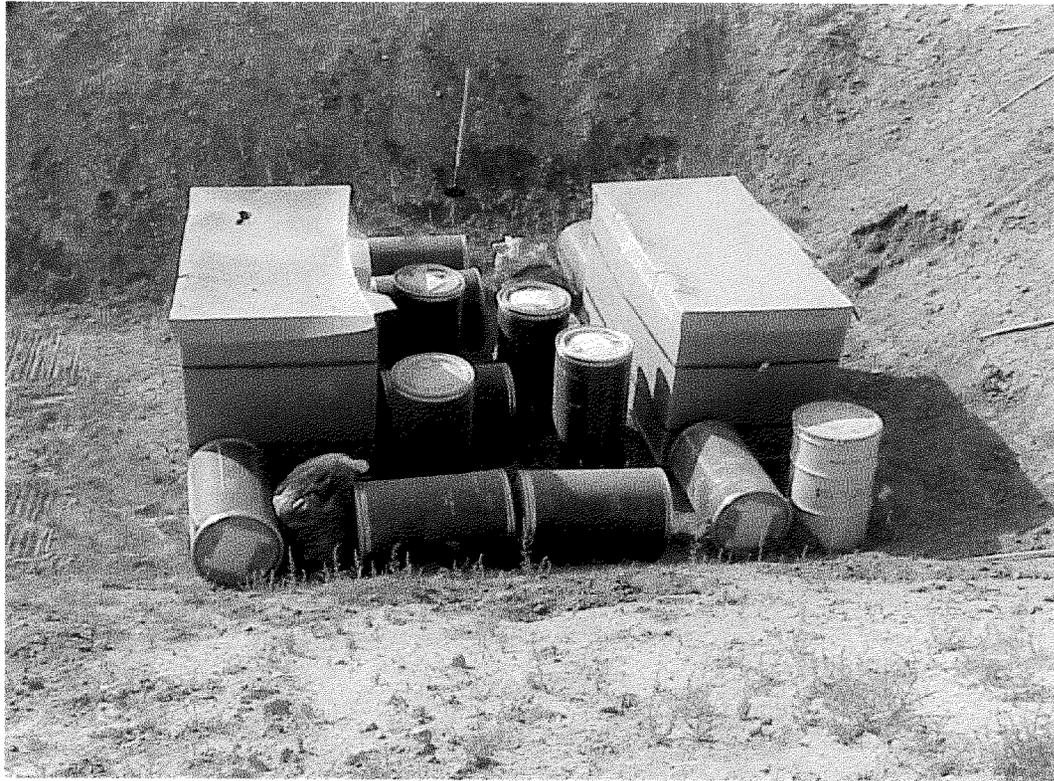
Figure 30. Lower-level 0–0.6 m (0–2 ft).

In Figures 30–34, the placement of simulated waste in four 0.6-m (2-ft) layers is shown. The position of each waste form was surveyed after placement. Figure 31 shows the corners of Layer 1 being surveyed after placement and after being covered with a layer of dirt. Basically, each simulated waste container was surveyed such that once buried a three dimensional map of the waste could be recreated. This three dimensional map of each waste form is in Appendix E.

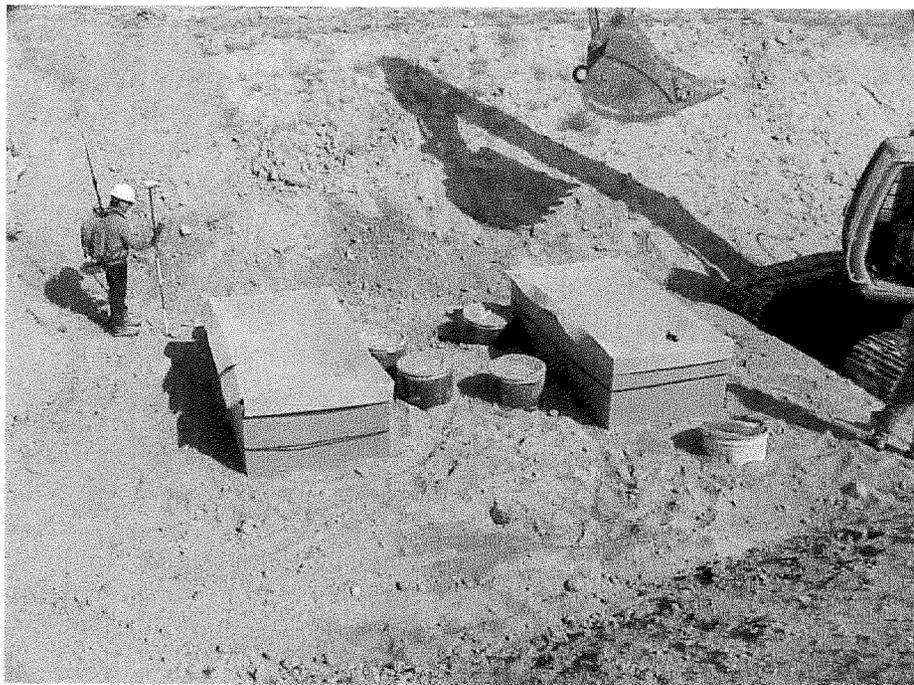
Figure 31. This picture shows the corners of Layer 1 being surveyed after being covered with a layer of dirt following placement.

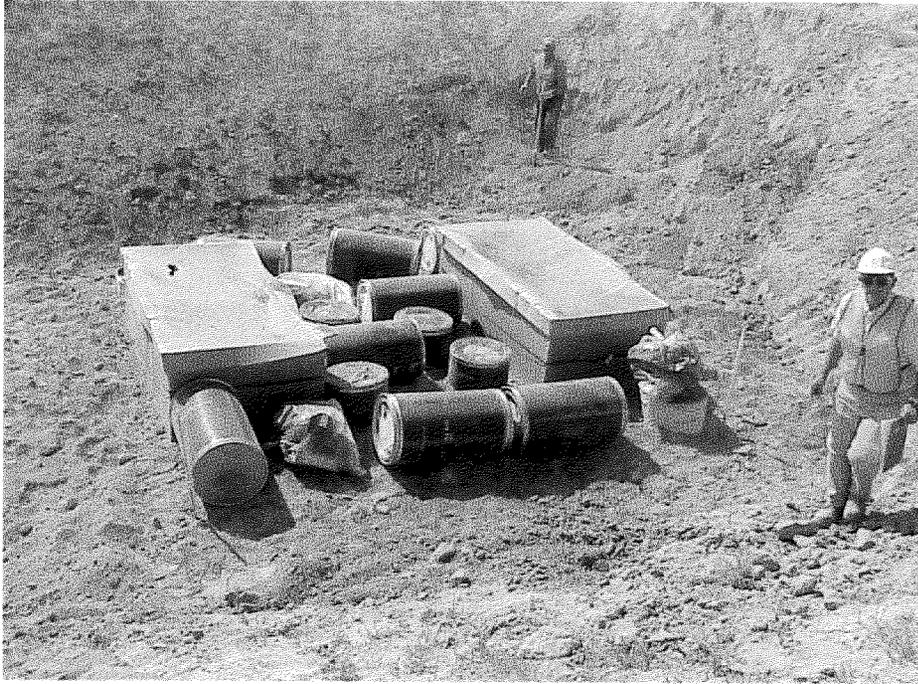
Figure 32. Layer 2, surrogate waste orientation 0.6–1.2 m (2–4 ft).

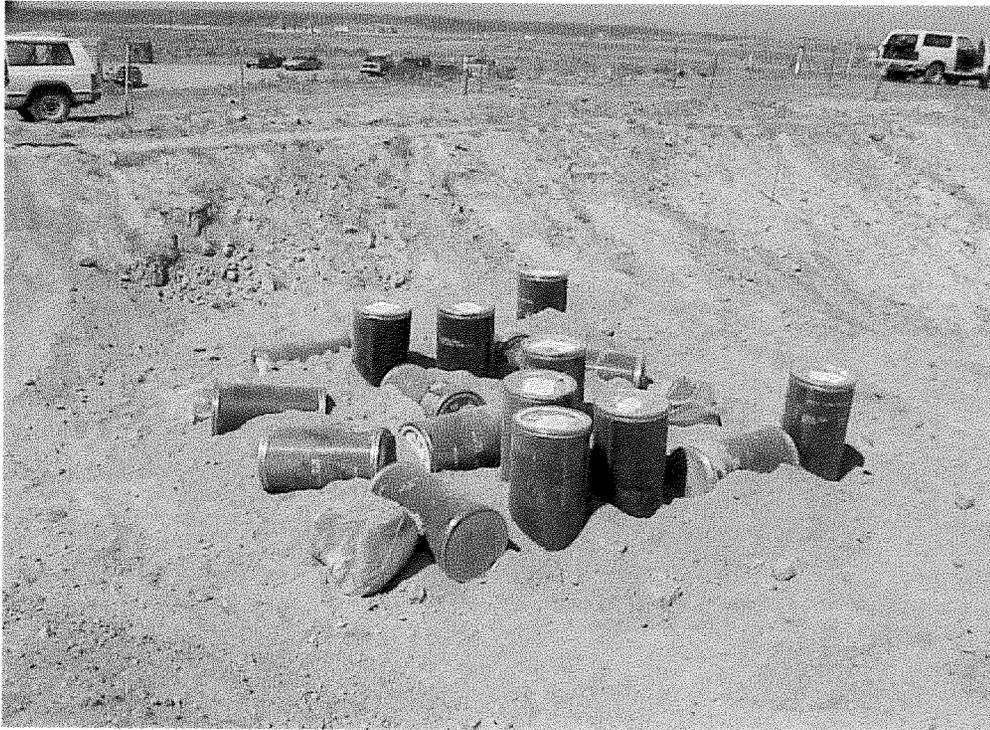
Figure 33. Layer 3, surrogate waste orientation 1.2–1.8 m (4–6 ft).

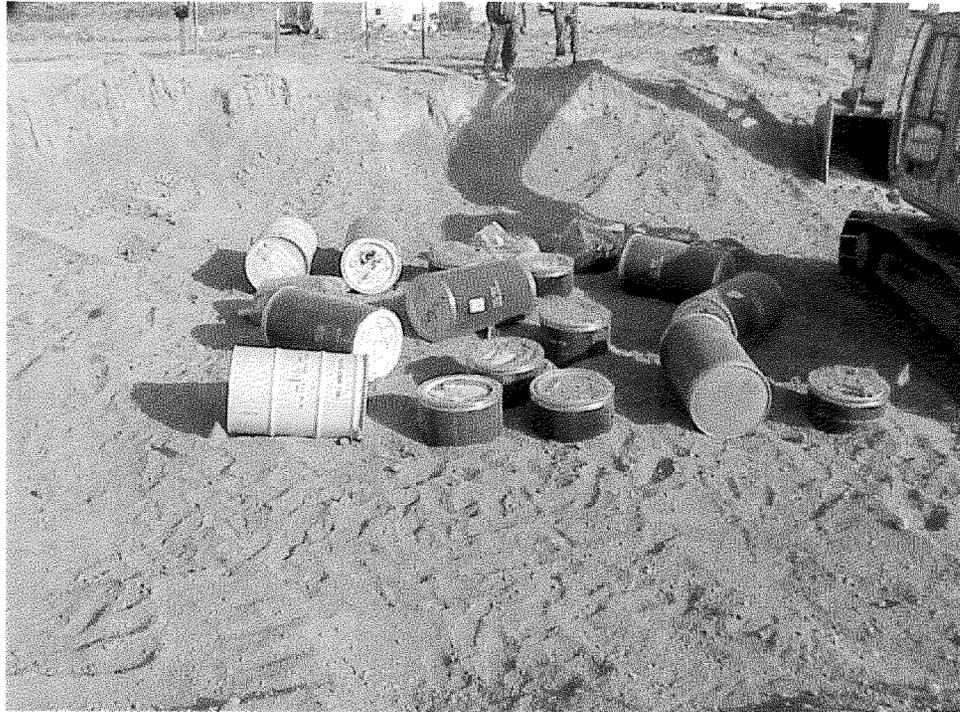
Figure 34. Top layer 1.8–2.4 m (6–8 ft).

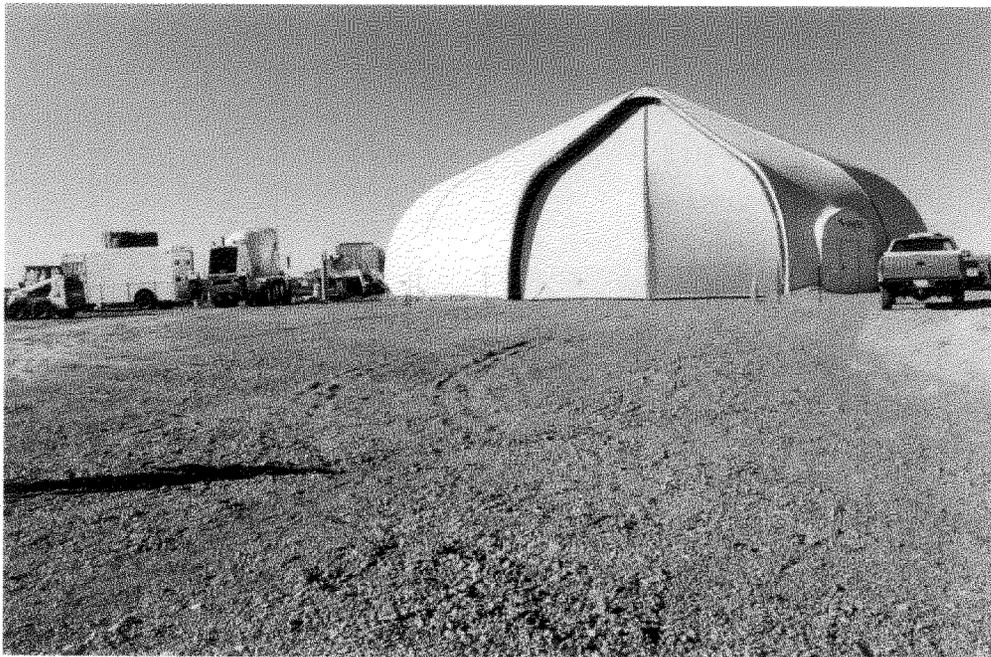
Figure 35. Weather structure constructed over the pit (Photo PNOL-520-1-1).

Once the pit was constructed by completing a backfill of INEEL soil, a large 80 x 122 ft. weather structure was constructed over the top of the pit as shown in Figure 35.

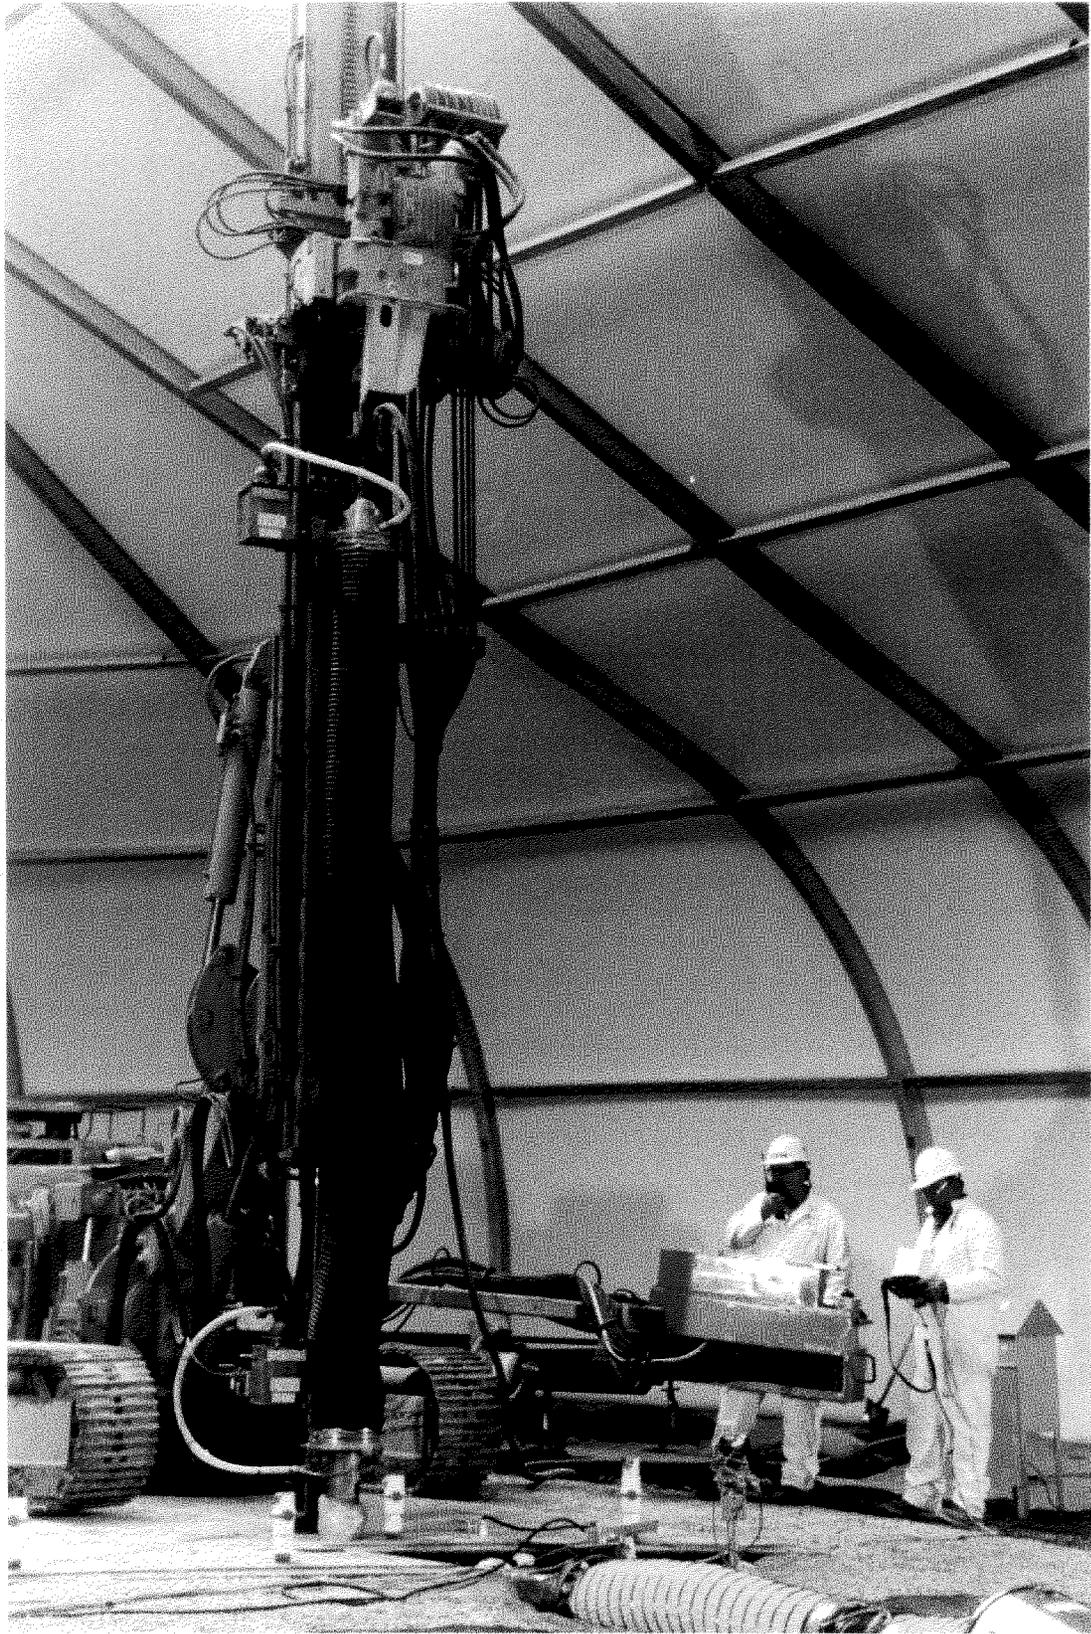
Figure 36. Drill string shroud in operation (Photo PN01-520-4-22).

The thrust block and shroud assembly on the drill string were specially designed to create a “glovebox” environment for the grouting process. The thrust block was made of carbon steel leaving a 43 cm (17 in.) vertical space to collect grout returns. By using carbon steel rather than concrete, allowed less support structures under the thrust block and more room for grout returns. Basically, the thrust block is a simple box with preformed holes on top that allowed insertion of the drill steel. The thrust block included elaborately designed double “plastic sleeve” ports for each hole in addition to a plastic diaphragm across the bottom of the hole. Referring back to Figure 2, details of the thrust block include the plastic sleeves, the diaphragm, a common pipe wiper to remove excess grout/soil/waste from the drill string when raising the drill steel out of the pit.

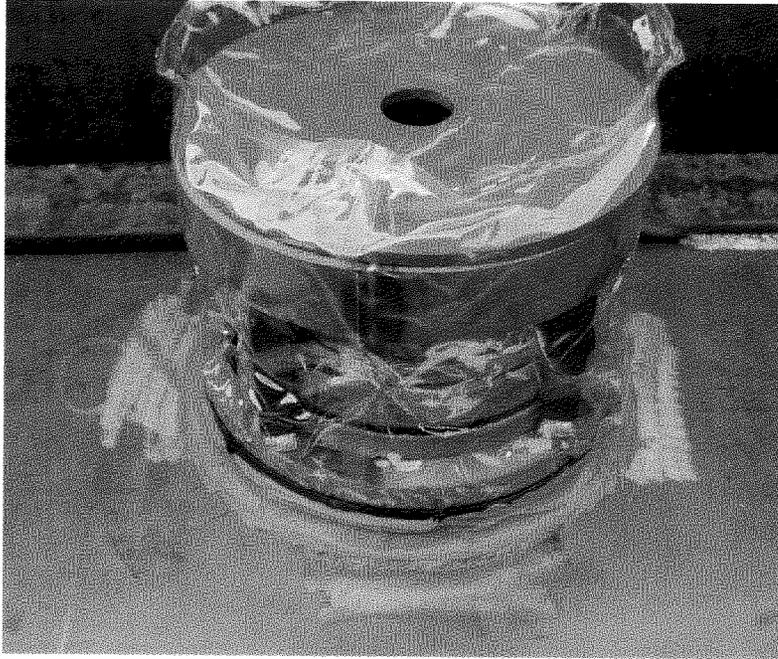
Figure 38. Detail of the underside of the thrust block showing plastic diaphragm and the rigid plastic plate.

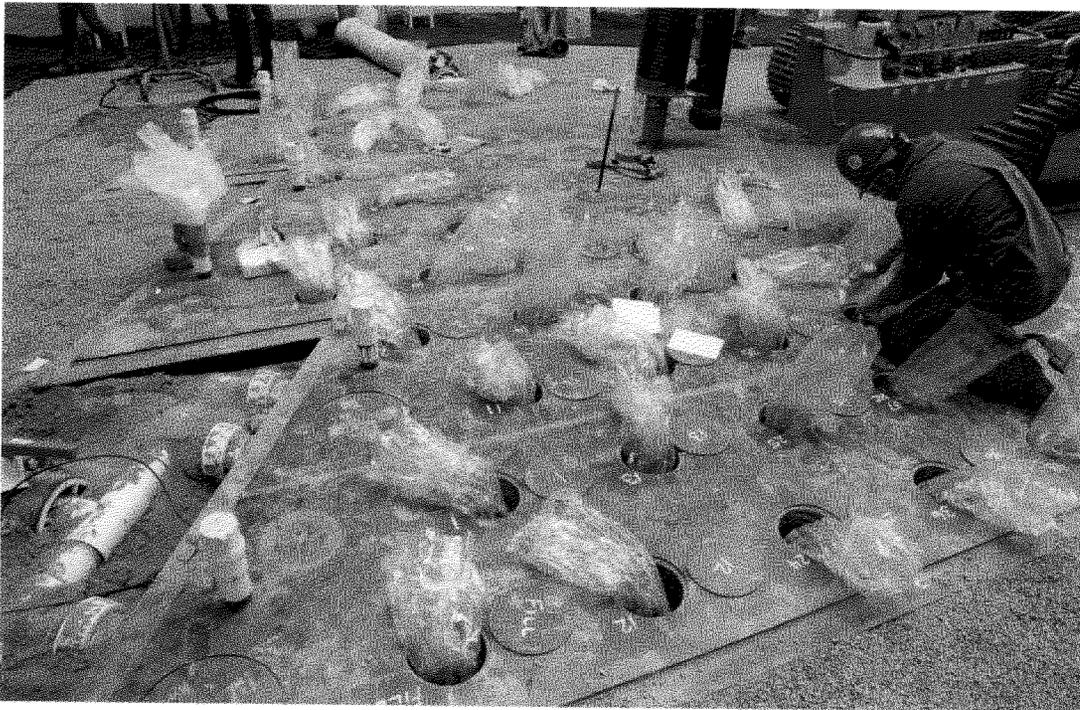
Figure 39. Plastic sleeves extended out of thrust block in preparation for testing (treated with talcum powder) (Photo PN01-520-3-5A).

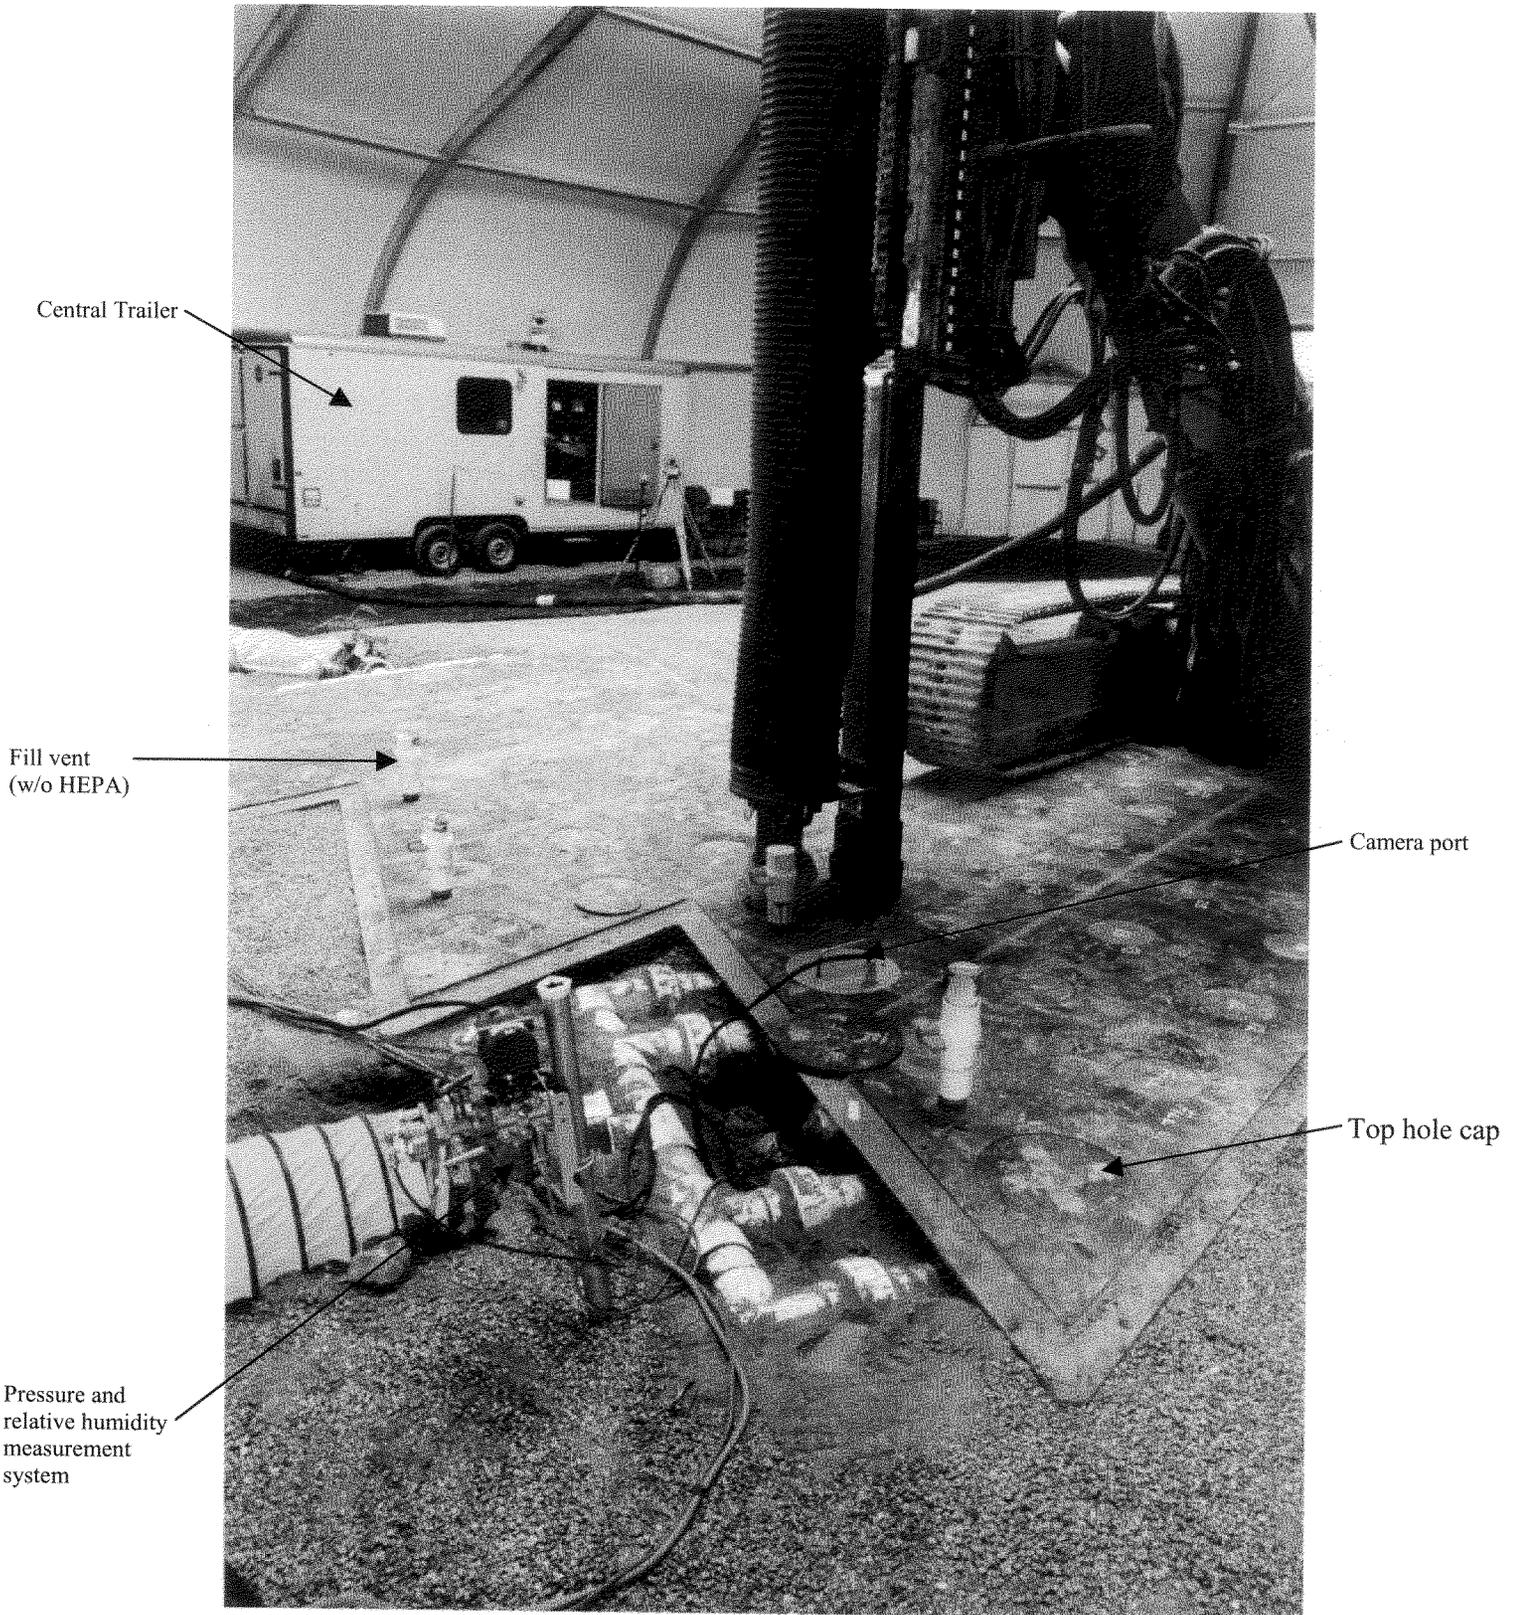
Figure 40. Drill string on top of thrust block (Photo PN01-520-4-15).

In the background, is a control trailer to which is fed the data from the HEPA filtration system (relative humidity, pressure relative to atmosphere under the thrust block) and most importantly the video taped view of the grouting operation under the thrust block. Also shown in Figure 40 are the holes with flush-mounted metal tops.

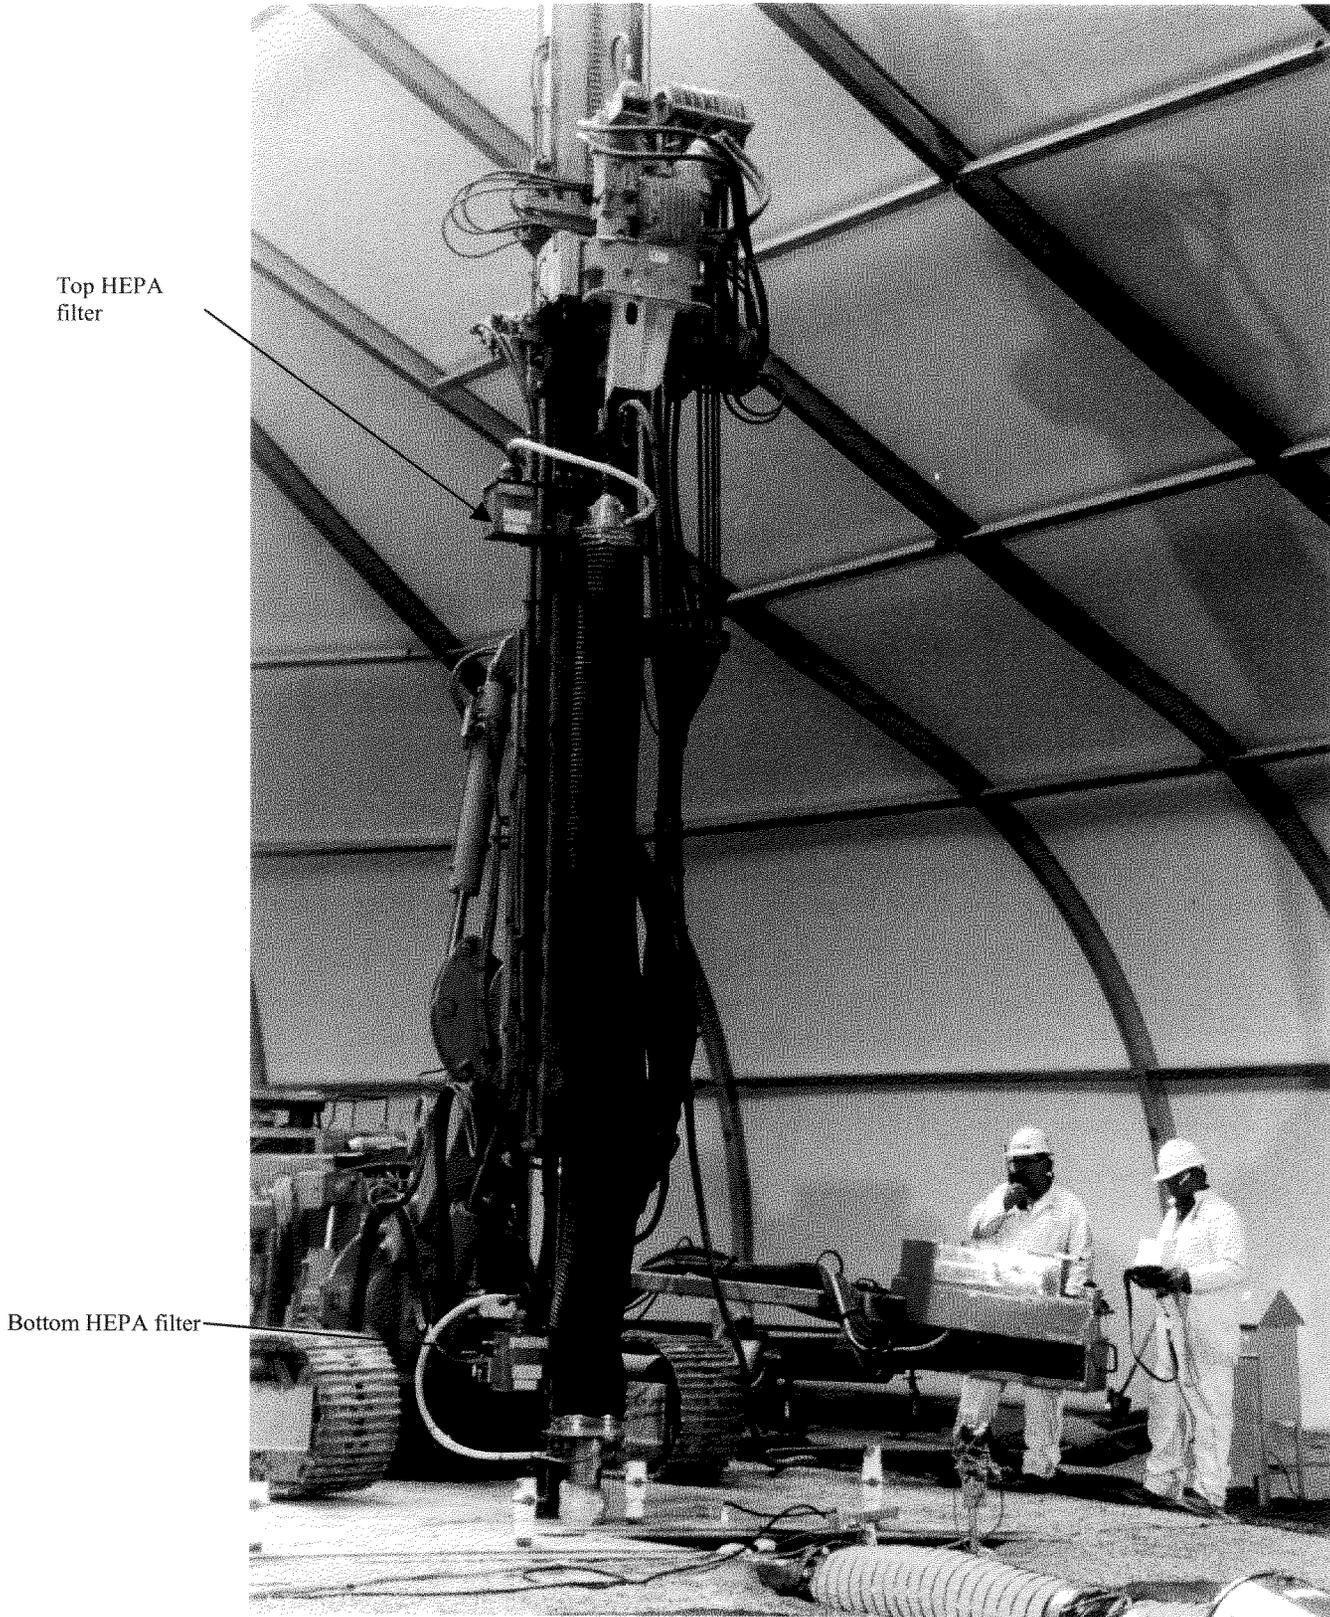
Figure 41. Drill string being inserted into waste pit (Photo PN01-520-4-22).

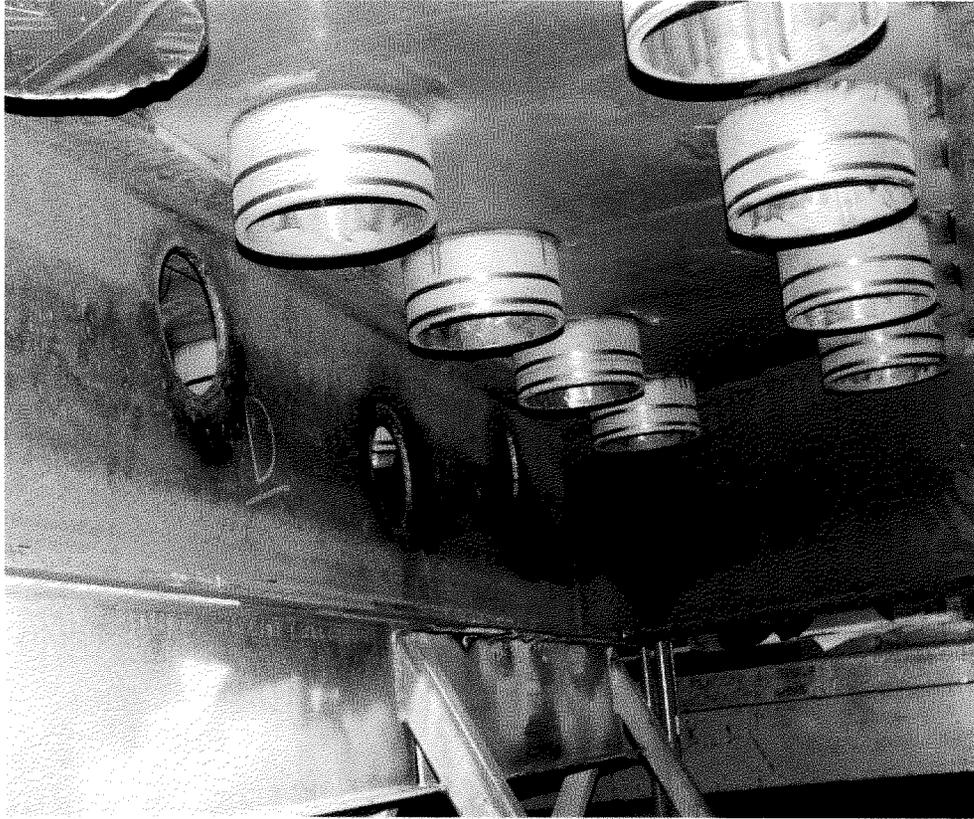
Figure 43. View underneath thrust block.

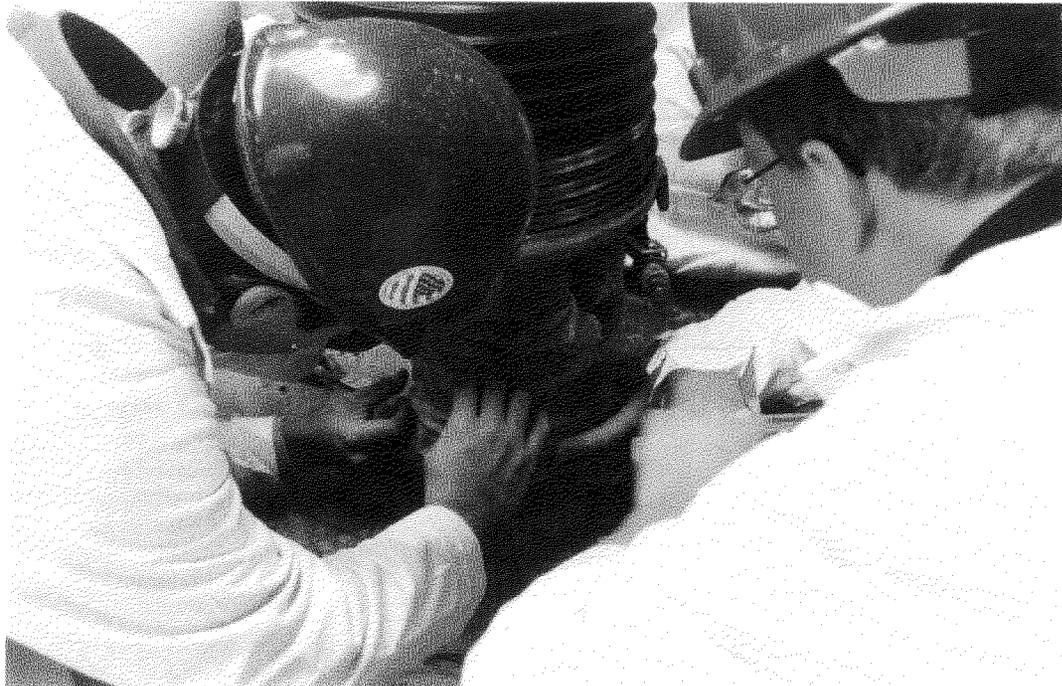
Figure 44. Placing plastic sleeve material on drill string stinger (Photo PN01-520-4-10).

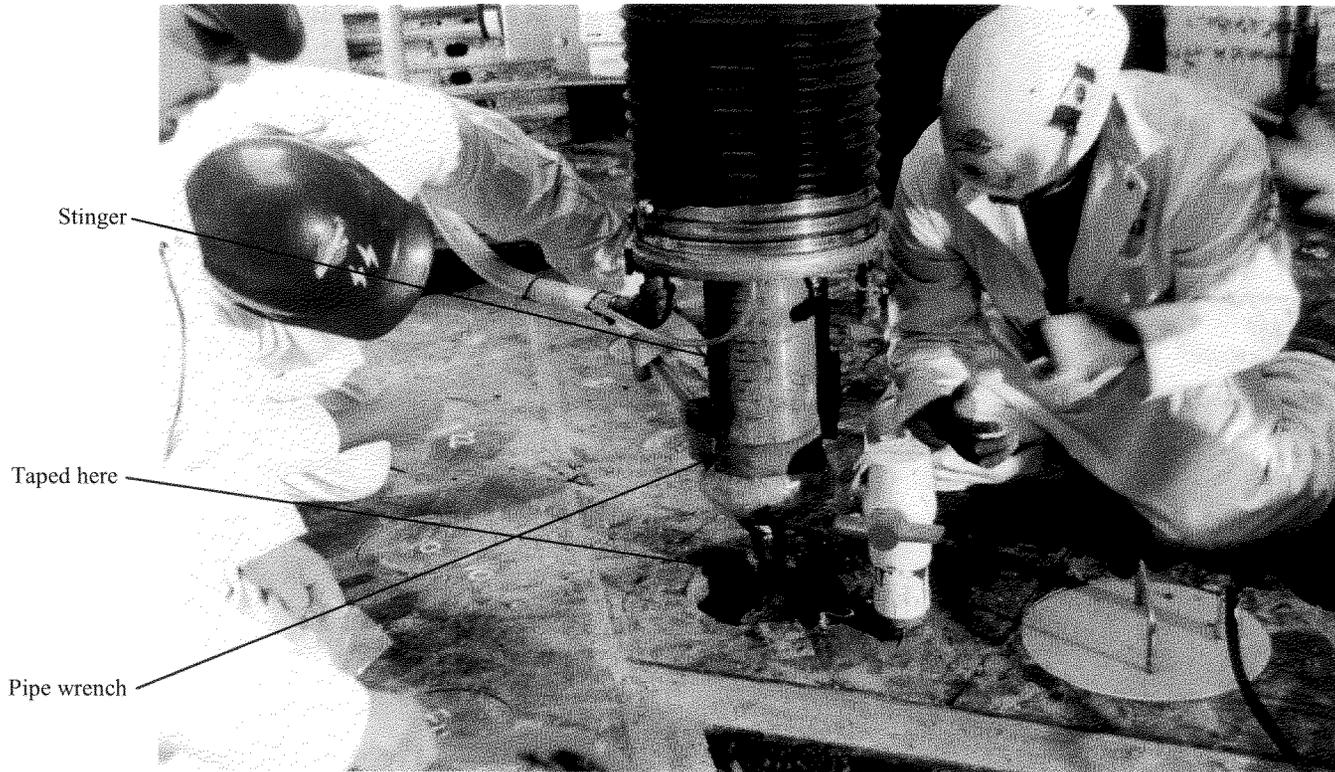
Figure 45. Twisted and taped plastic sleeves ready to cut (Photo PN01-520-5-2).

- The bag was twisted off and taped (shown in Figure 45).
- The twist off and taped area was cut with either a pipe shear or a special heat knife.

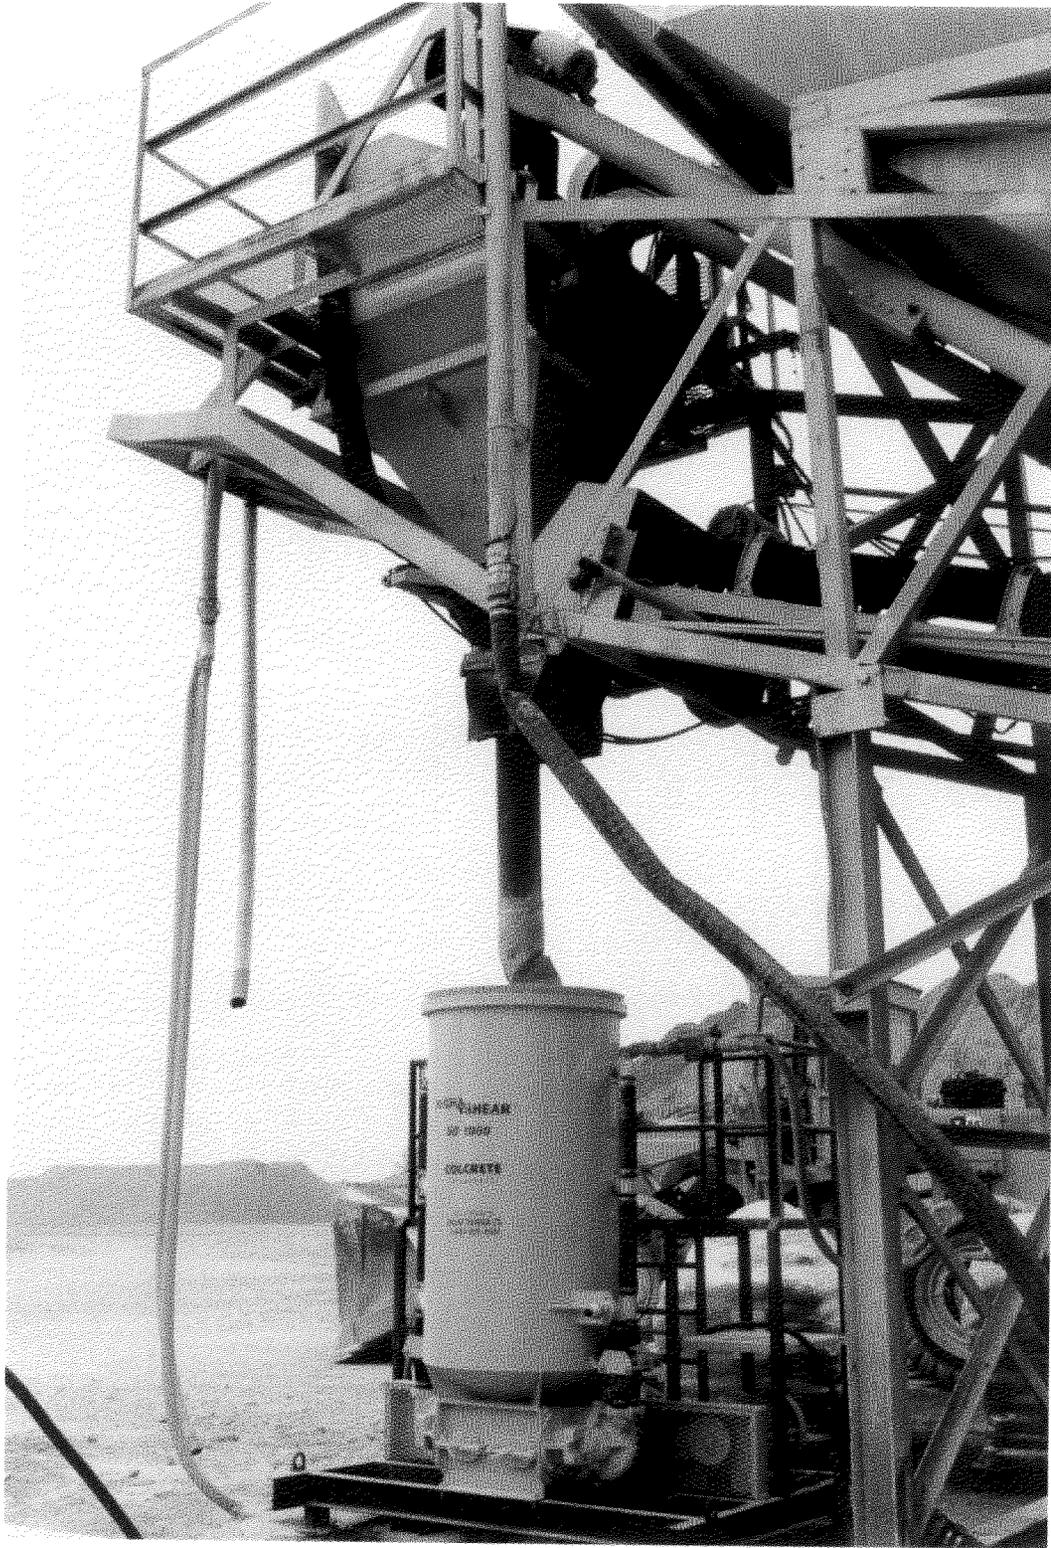
Figure 46. Batch mixing operation (Photo PN01-0520-8-9A).

All batches were 4.0 cubic yards.

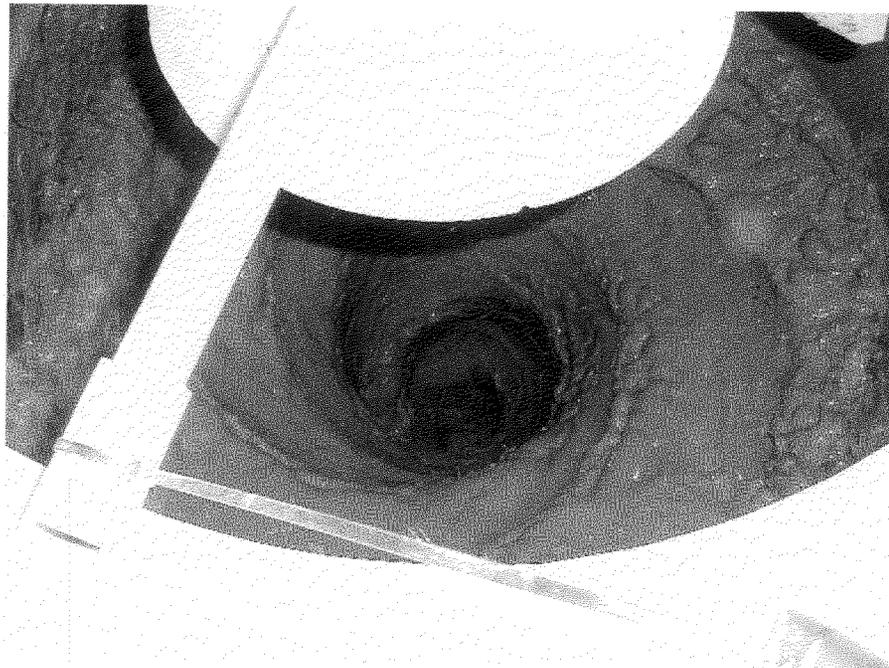
Figure 47. Grout mixer vortex view after 60 seconds of mixing.

Three batches of 1 cubic m (1.33 cubic yards) each were used to produce the 3 cubic m (4 cubic yard) loads that were used for the INEEL Cold Test Pit project. After the three batches of grout were loaded onto the concrete truck, the grout was blended by the concrete truck. Following the blending by the truck, the grout was sampled and tested. The specific gravity and Marsh funnel time were determined and recorded on the batch ticket. A time stamp was placed on the ticket prior to the truck leaving the plant. Mixing, screening, and testing of a 3 cubic m (4 cubic yard) batch took about 30 to 40 minutes.

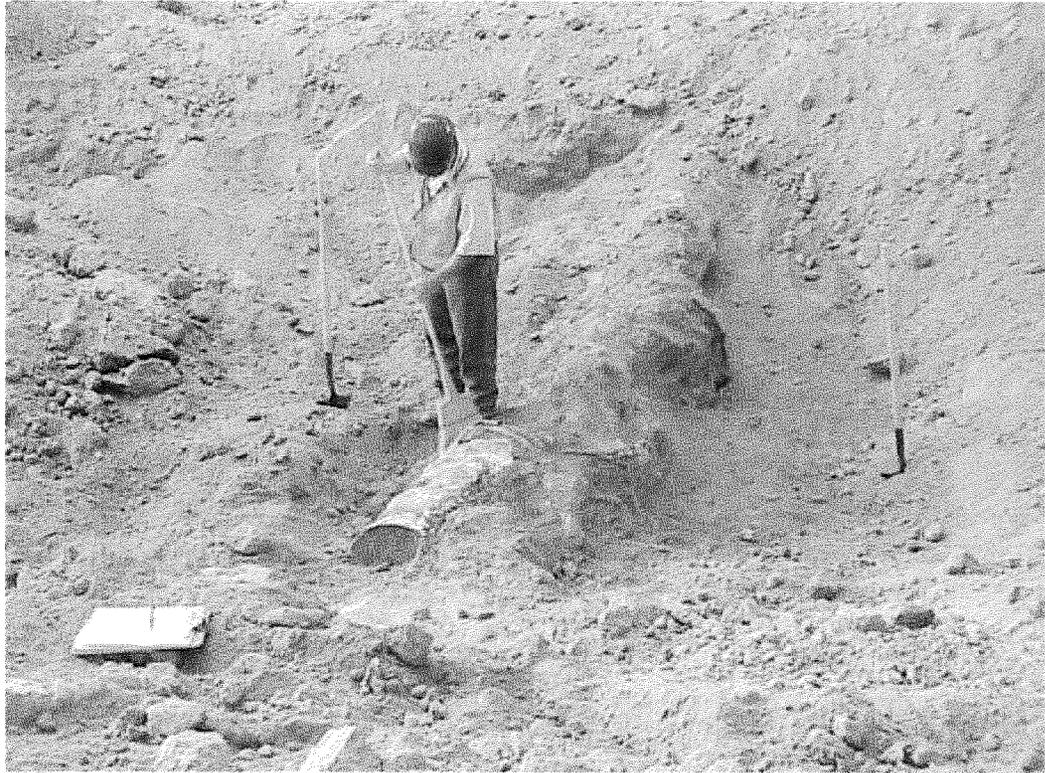
Figure 48. Top of monolith showing grouted drum embedded in northwest edge.

The drum had been weighed prior to building the Cold Test Pit and the recorded weight was 173 kg (381 lb_m). The drum was weighed following excavation and the drum weighed 204 kg (450 lb_m), indicating that a total of 31 kg (69 lb_m) of grout had entered the drum. The grout has a density of approximately 1.8 g/cc (112 lb_m/ft³) or 1.8 kg per liter (15 lb_m per gal). This 31 kg (69 lb_m) extra in the drum accounts for 17.3 L (4.6 gal) of grout delivered to the drum.

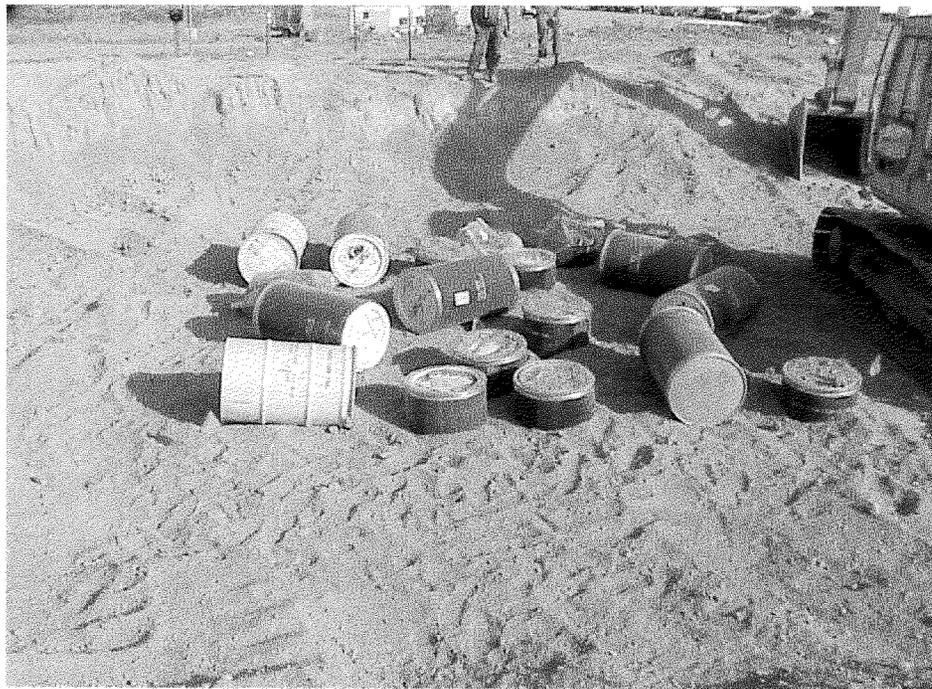
Figure 49. Top layer of in situ grouting pit during construction with white nitrate drum in corner.

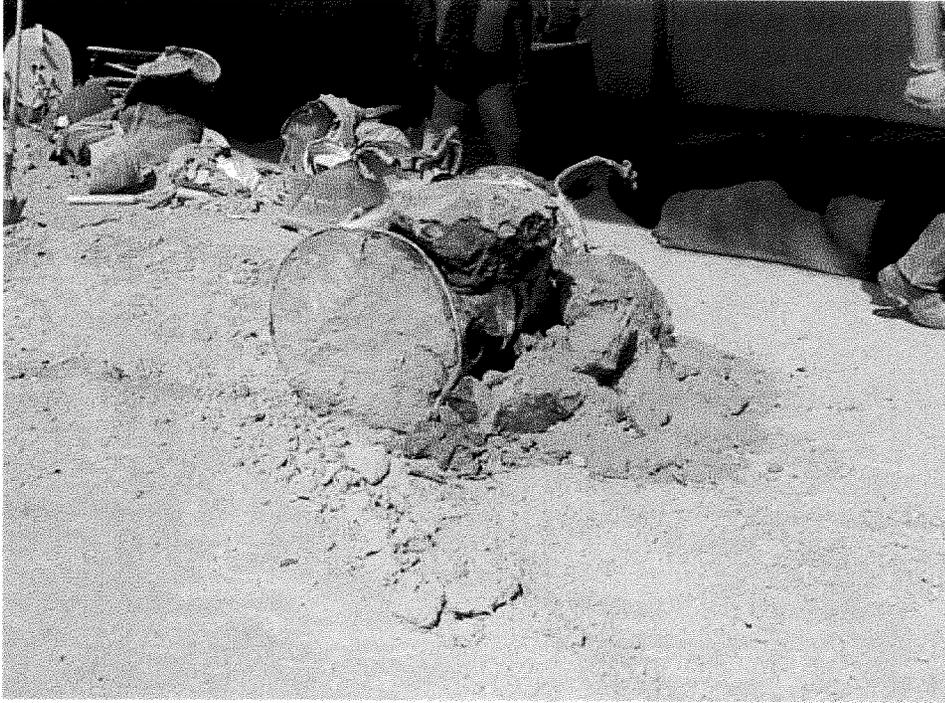
Figure 50. Nitrate drum removed from monolith with grout adhering to the surface of the drum.

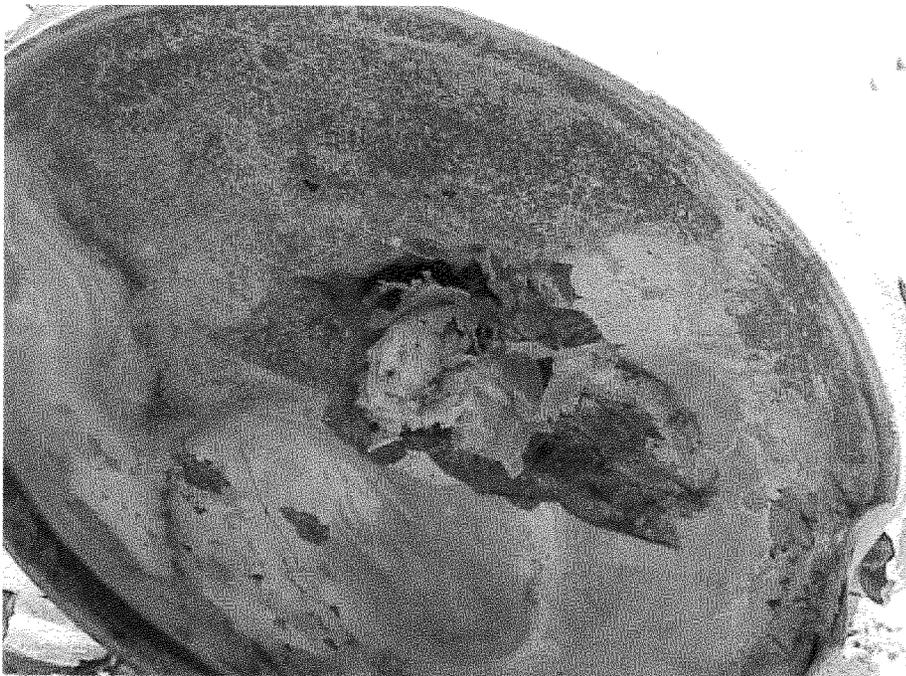
Figure 51. Drum with lid removed showing solid grouted interior with “J” seal visible about 12.7 cm (5 in.) into the top.

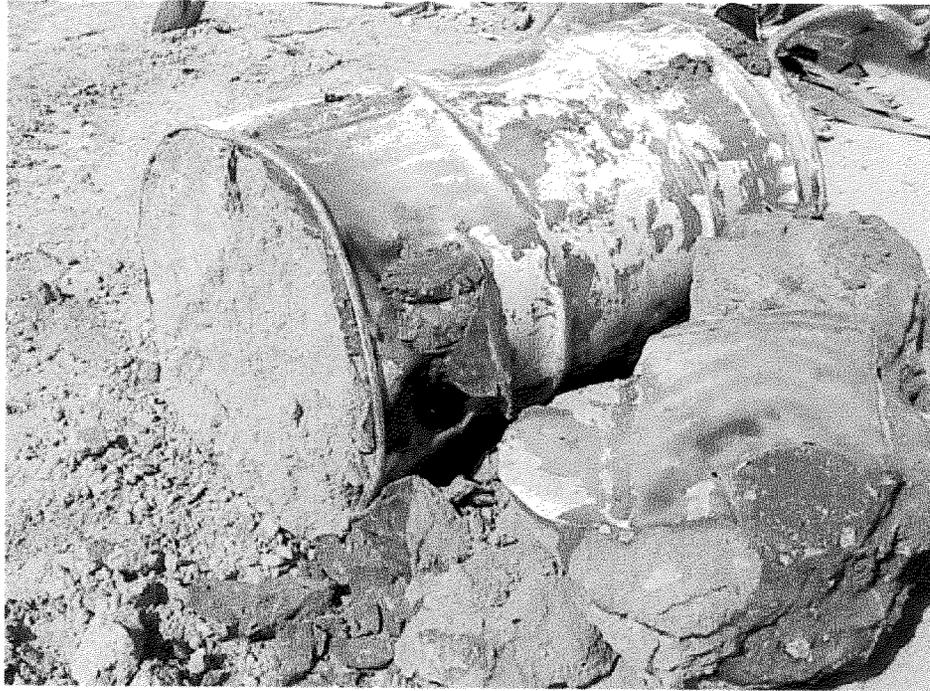
Figure 52. Puncture of drum by the drill steel (left-hand side of drum), showing the cylindrical shape of the drill steel.

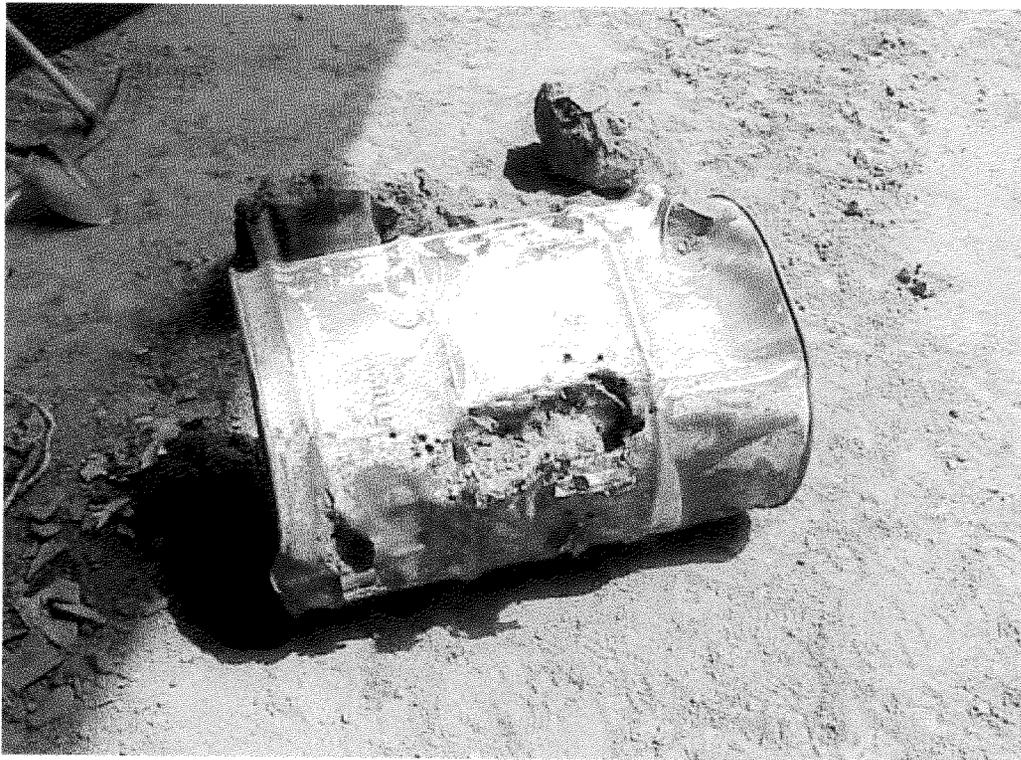
Figure 53. Hole in metal side of drum showing grouted nitrate salts in middle and neat grout on ends.
