***Final Results Report,
In Situ Grouting Technology
for Application in Buried
Transuranic Waste Sites***

***Volume 1, Technology Description
and Treatability Study Results for
Operable Unit 7-13/14***

INEEL/EXT-02-00233

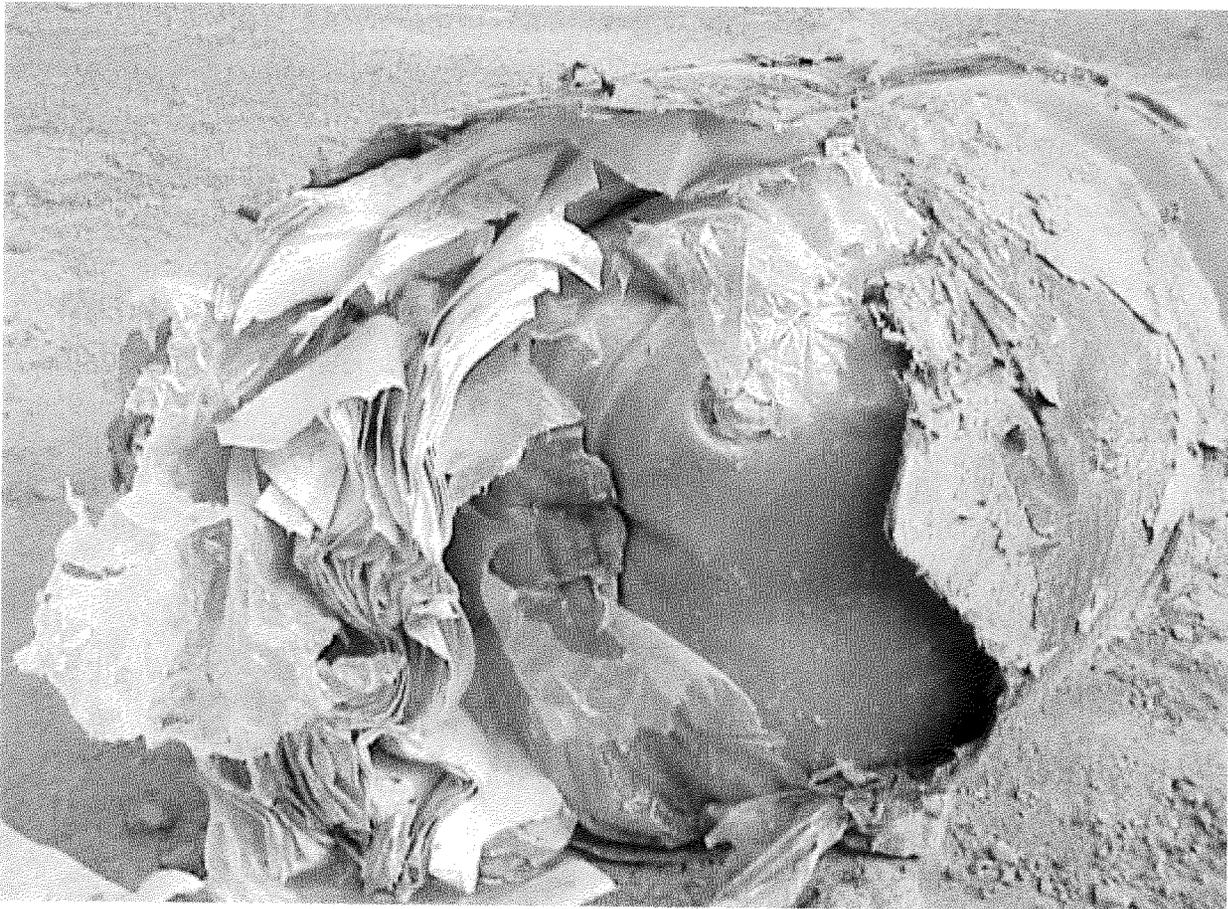
Figure 54. Grouted drum containing combustibles.

The fact that these two simulated waste containers had grout means that the terbium tracer in the containers could have spread to the top surface of the thrust block and to other positions within the contamination control system.

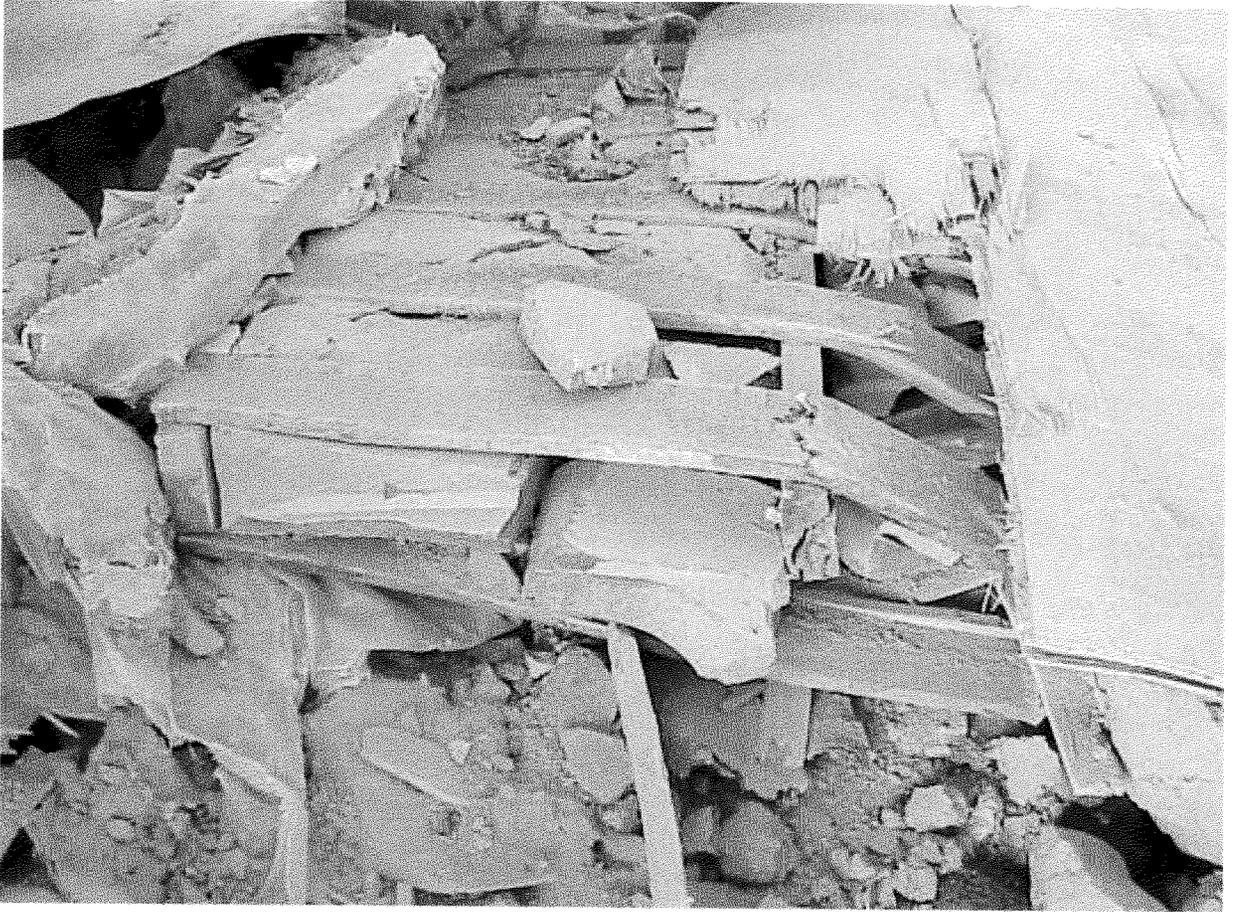
Figure 55. Grout in contents of 1.2 x 1.2 x 2.4-m (4 x 4 x 8-ft) box.

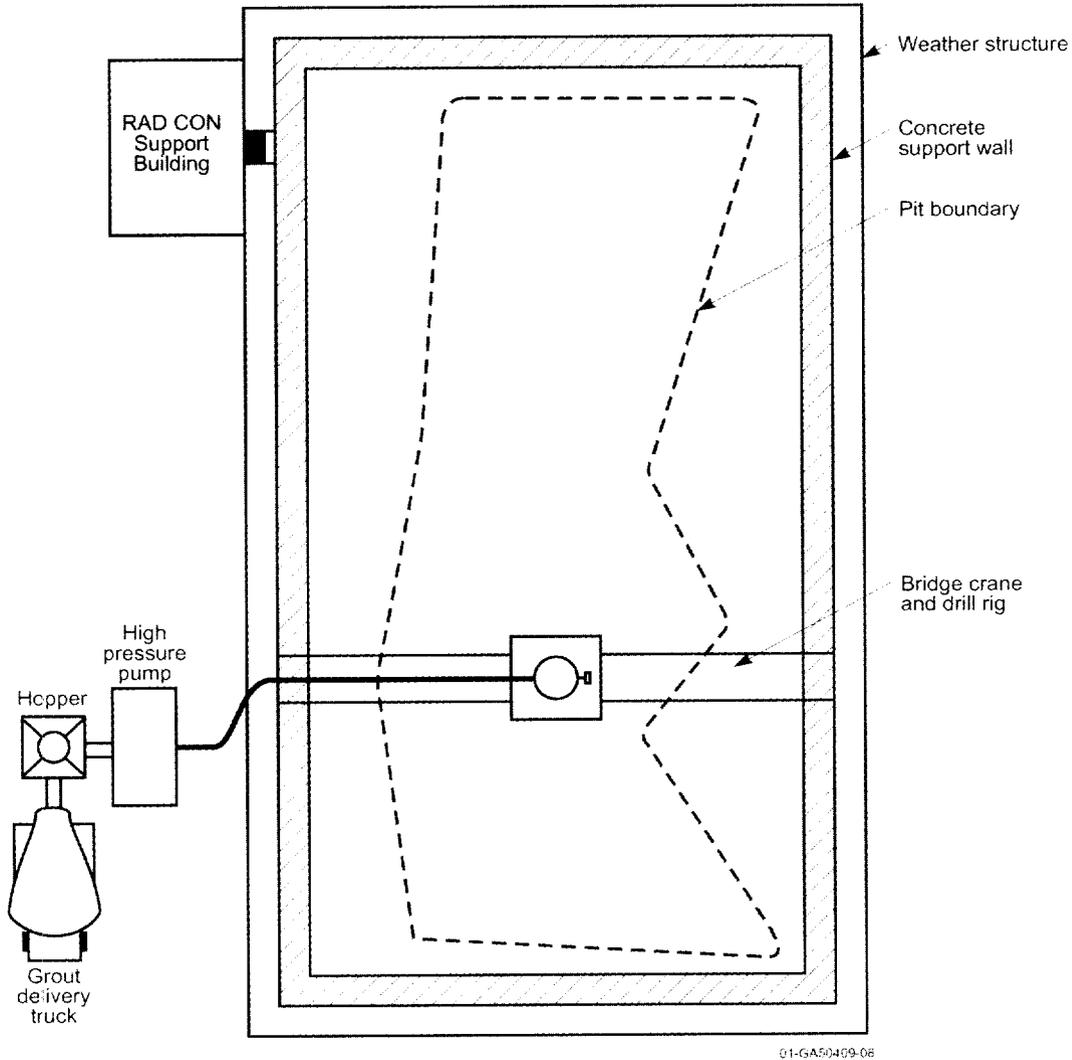
Figure 1. Top View Grouting Process.

rig. Figure 1 also shows a top view of the weather structure and the relative position of a RadCon support building which allows personnel entry for manned maintenance. The high-pressure injection pump, all hydraulic motors, and associated grout receiving hopper are also shown as being external to the grouting operation.

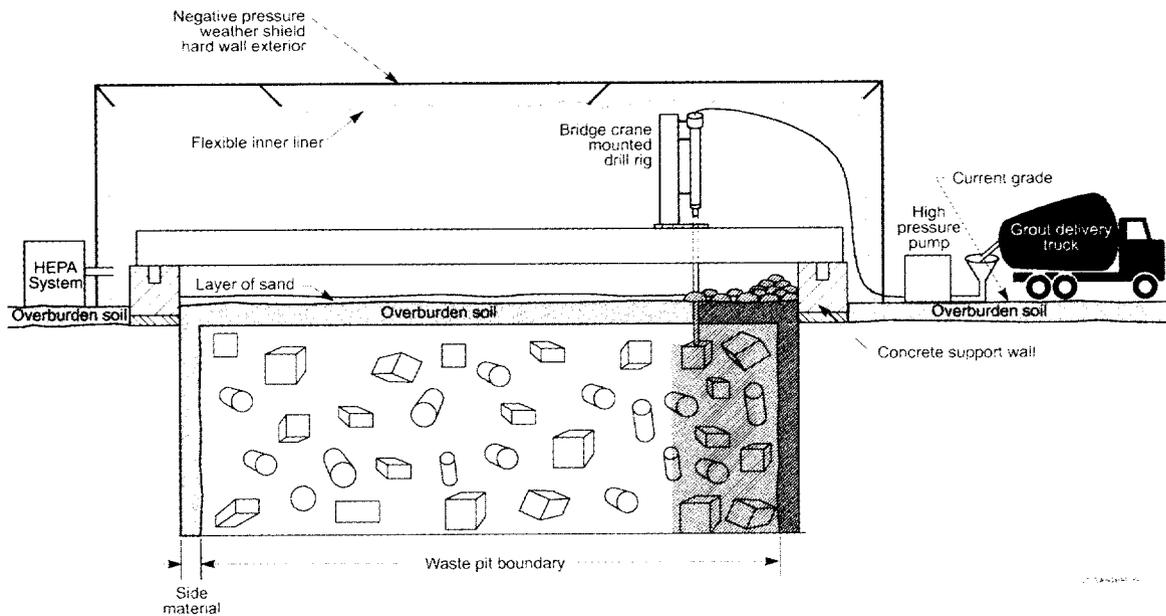
Figure 2. End View Grouting Operation.

is also assumed that there will be an inner flexible “plastomer” wall that is considered disposable and the outer building is rigid “Butler Building” type of construction. Pit-9-Phase II has developed adequate requirements for such a structure; however, the inner flexible disposable inner sheath would require fire resistance materials and minimum volume for disposal. It is intended that when grouting is completed that the inner sheath is placed in the space at the top of the pit and covered with a final grout cap. Figure 2 shows the conceptual operation in a side view with the HEPA ventilation system and the inner flexible shroud material.

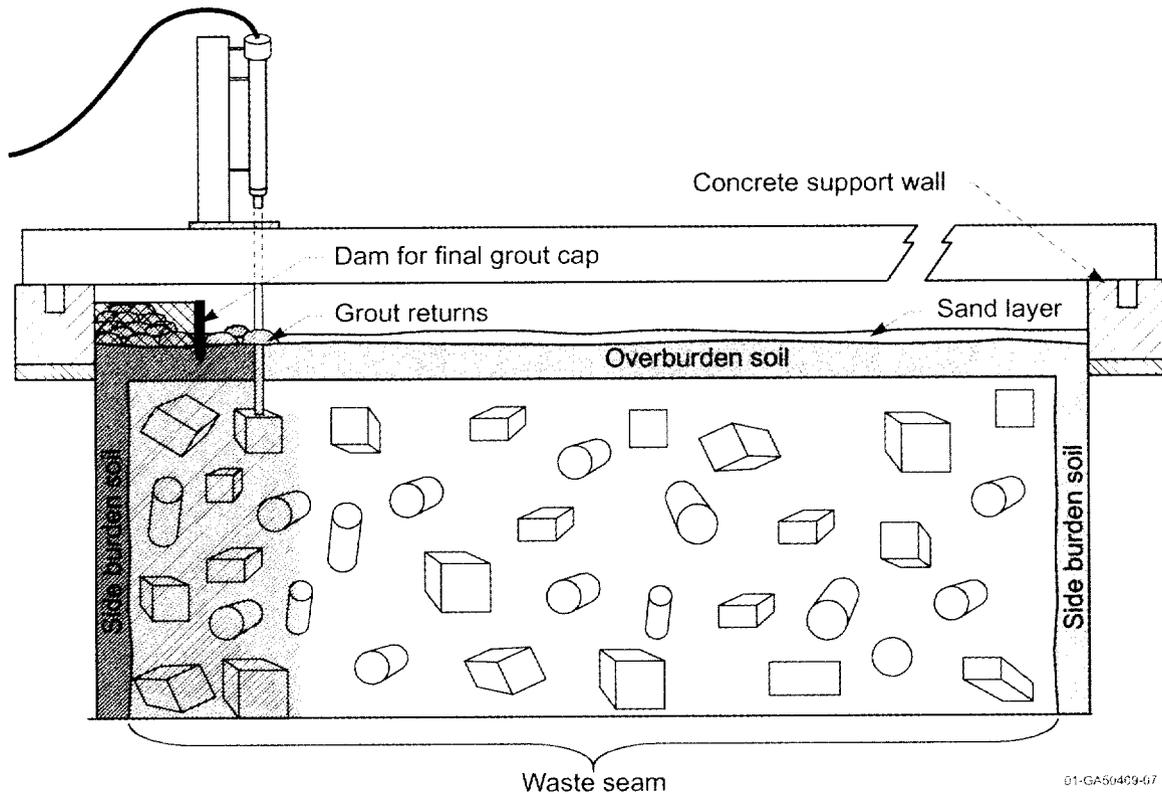
Figure 3. Detail of Grouting Side View.

Figure 3 shows details of the grouting operation including a layer of clean sand on top of the overburden to act as a containment for the grout stream as the very top positions of the overburden are grouted jet grouted under high pressure.

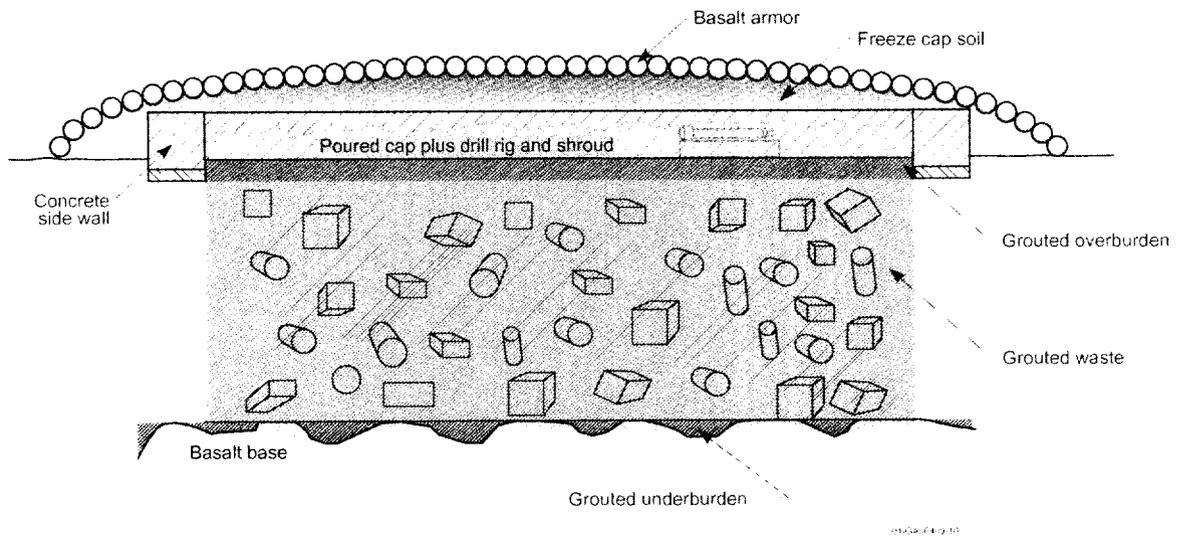
Figure 4. Monolith with Final Cap.

Following completion of grouting, the inner shroud assembly will be pulled into the remaining space provided by the wall and covered with a final pour of grout. To the extent possible, the drill string assembly will have been decontaminated prior to placing the shroud in the space. It is also possible that the drill string will simply also be disposed in the space provided by the wall prior to a final grout pour. In any case used or plugged drill steel will definitely be disposed of in the final pour. Following the final pour, the entire inner surface of the weather structure should be isolated from the contaminants and the weather structure can be removed for use on the next pit. Once the building has been removed, a final soil freeze cap will be placed to prevent freeze thaw cycles from degrading the monolith as shown in Figure 4.

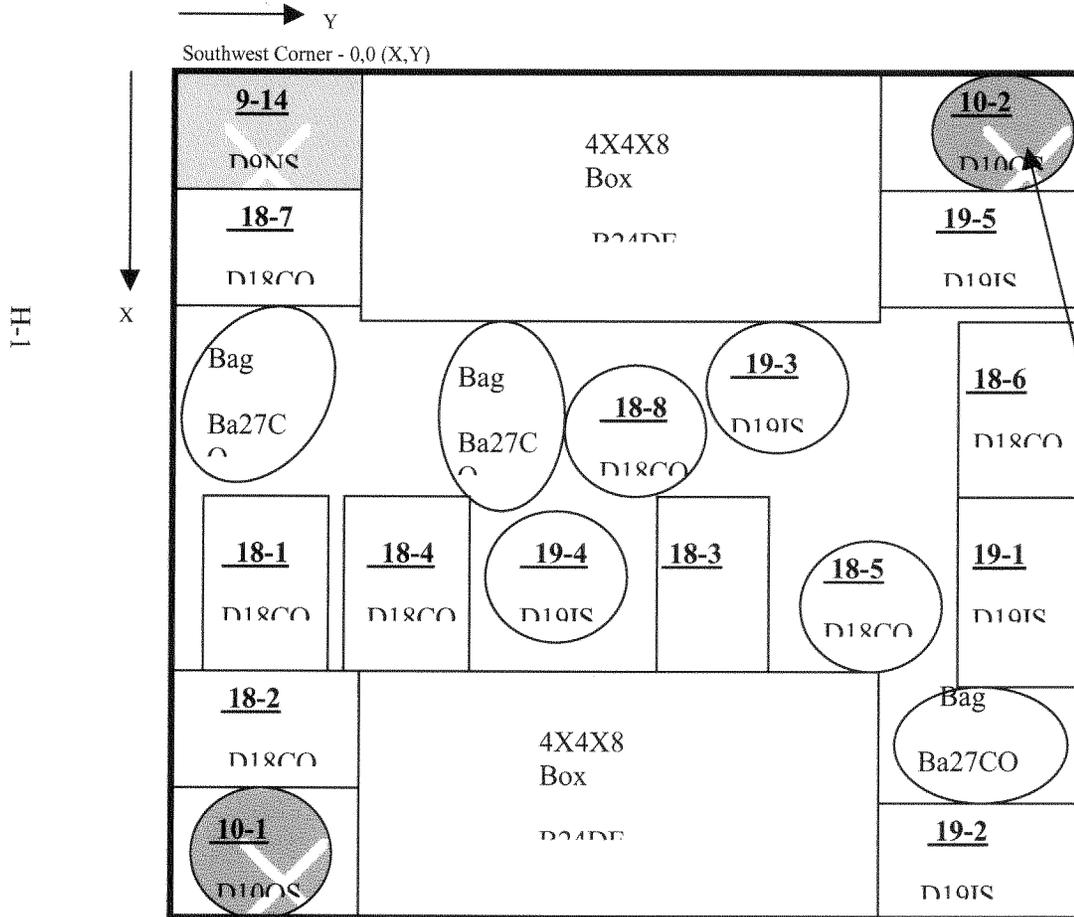
As-Built for LAYER 1, 0-2 FT., Includes
Numbers for Surrogate Waste Forms

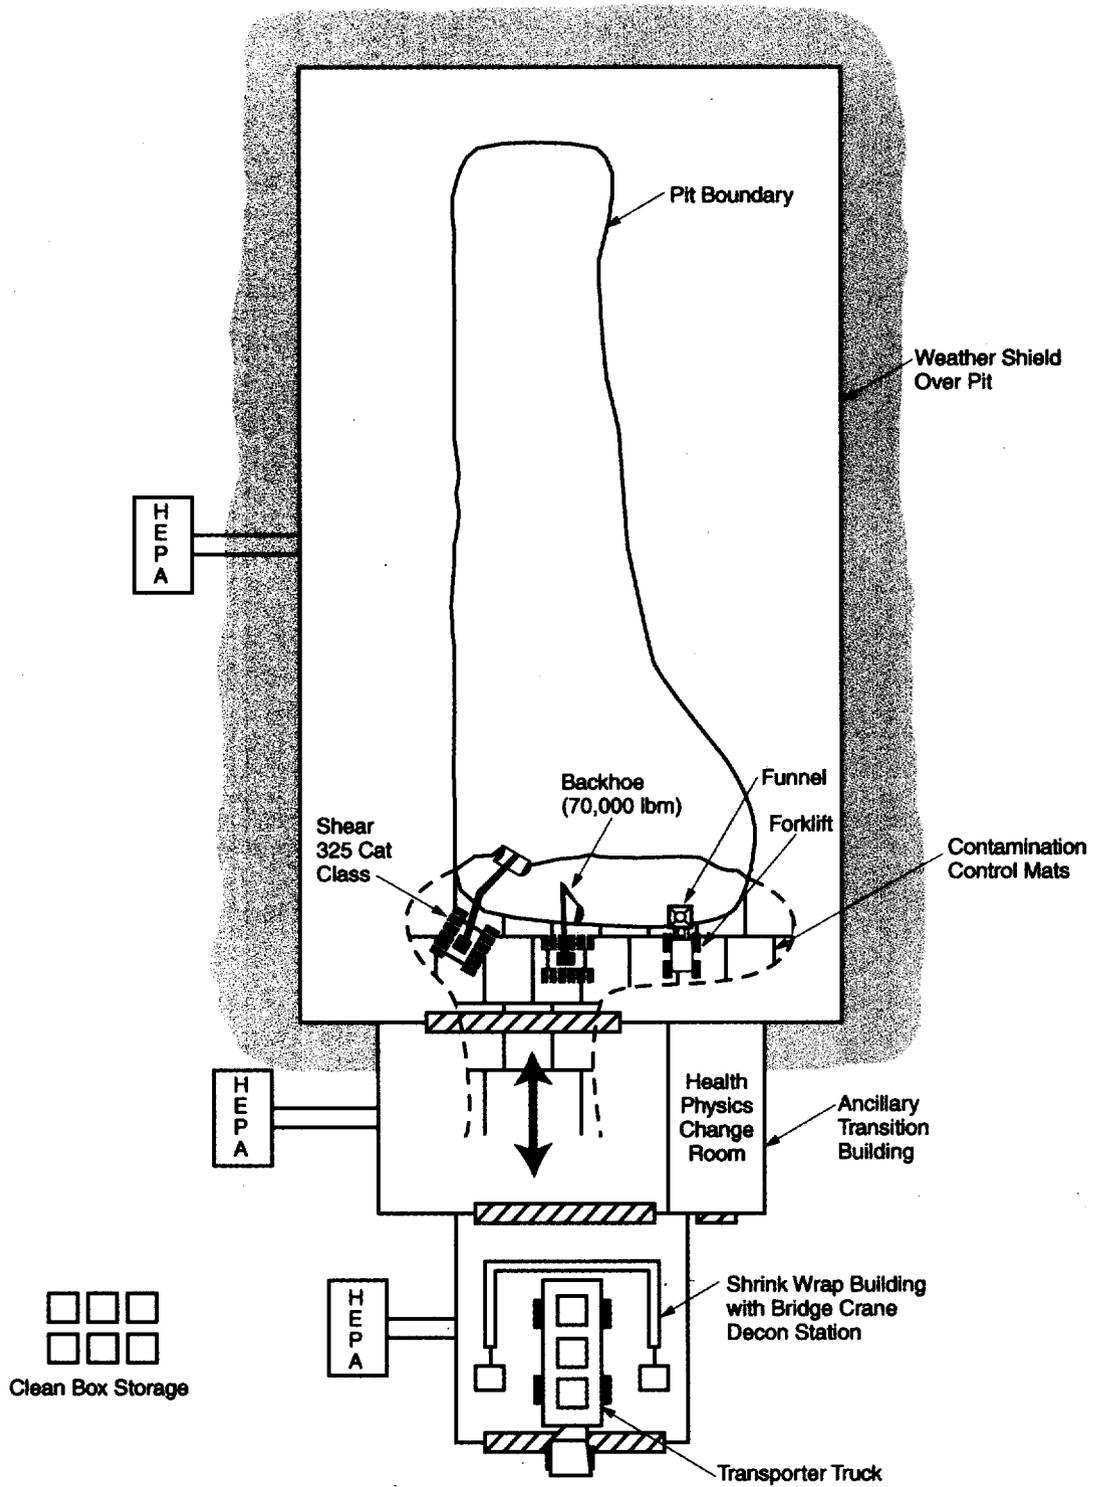
Figure 3. Retrieval will be performed from the bottom via an access ramp.

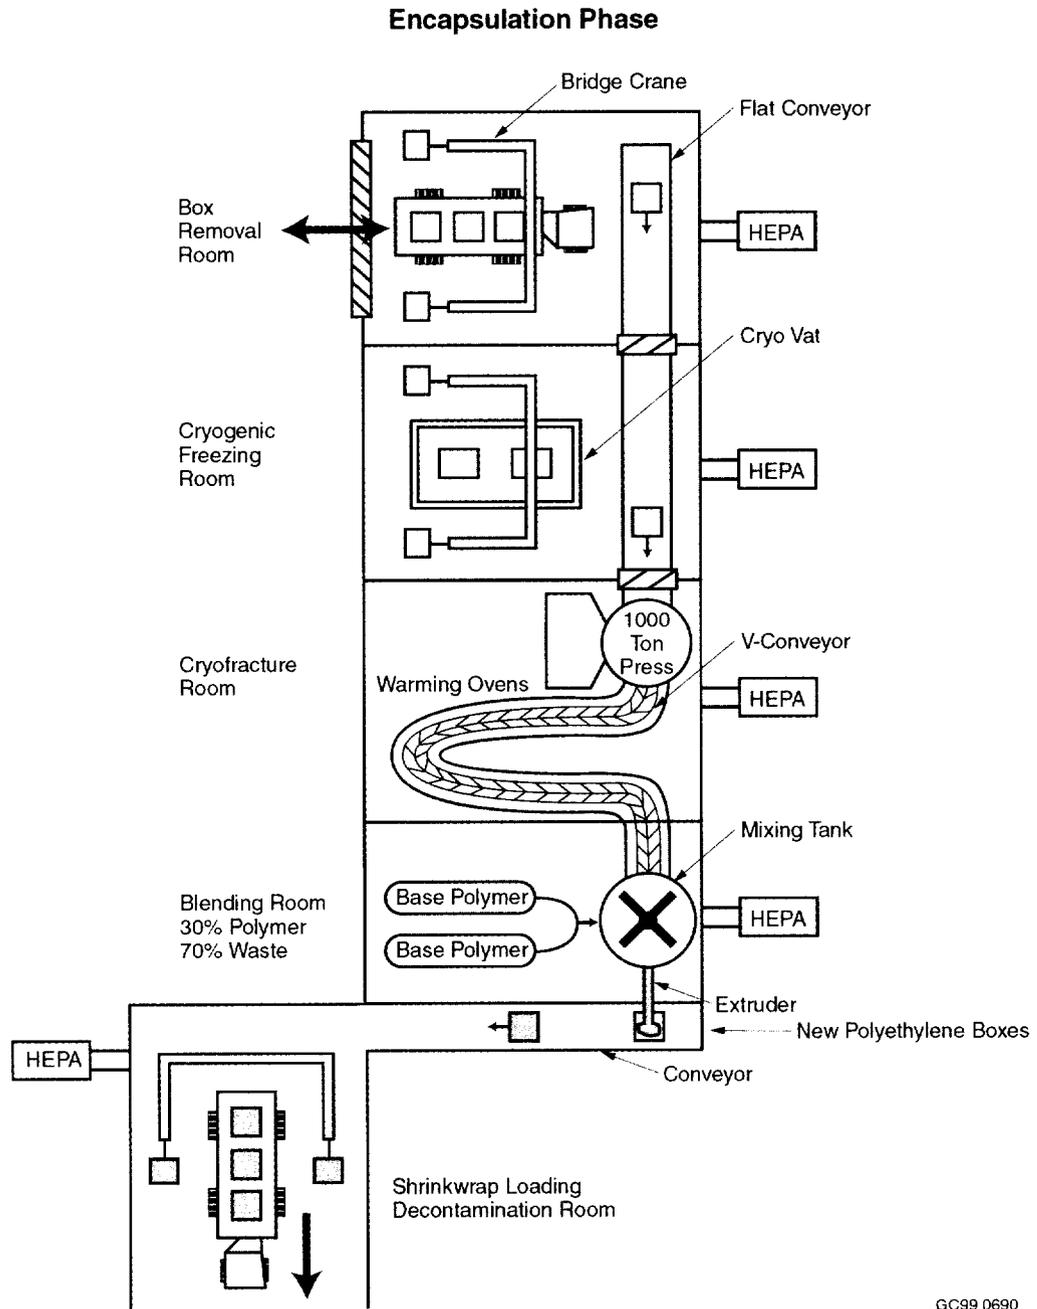
Figure 5. Encapsulation of the waste with low-melting temperature polyethylene.

The encapsulation phase, if used, improves the confinement of the retrieved waste by size reduction and then encapsulation of the waste with low-melting temperature polyethylene durability. A schematic of this process is shown in Figure 5. The size reduction and encapsulation processes are based on developmental research sponsored by the DOE Environmental Management Technology Development.¹⁴
