SOLID WASTE MANAGEMENT UNIT AND  
CONTINUING RELEASE INFORMATION AT  
THE INEL PER RCRA SECTION 3004(u)

Published  
1986

EG&G Idaho, Inc.  
Idaho Falls, Idaho 83415

Prepared for the  
U.S. Department of Energy  
Idaho Operations Office  
Under DOE Contract No. DE-AC07-76ID01570

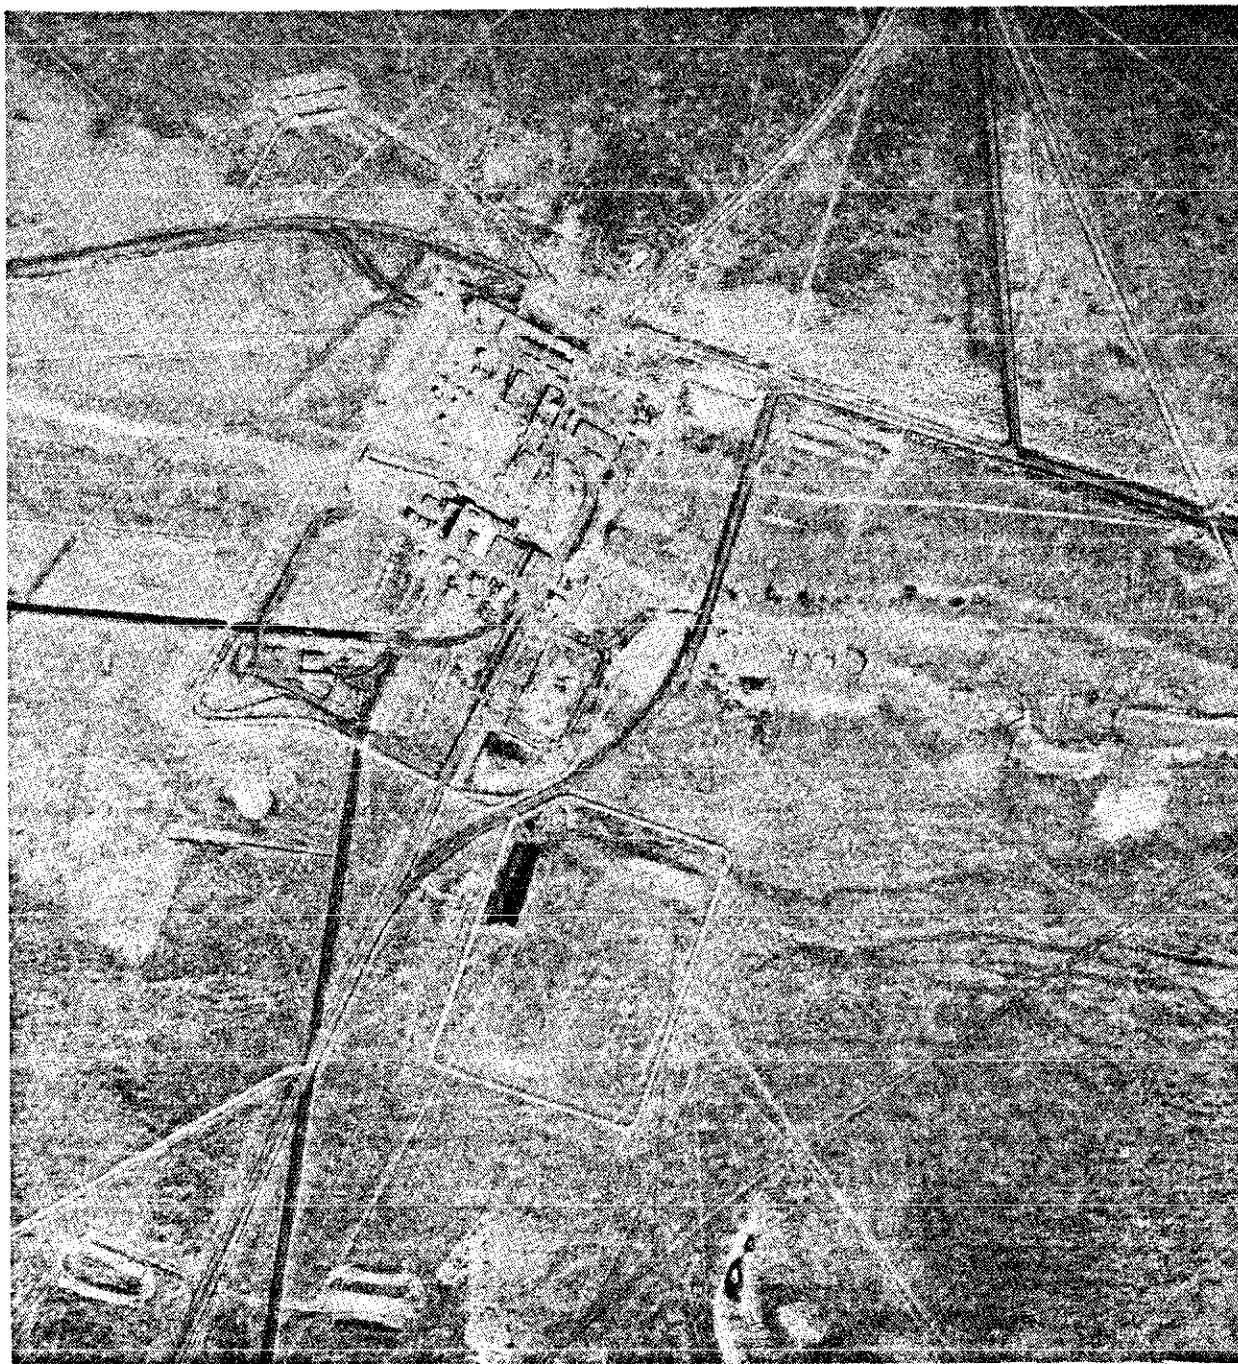
Figure 3.2.4. TAN/TSF burn pit.

northwest of the TAN/TSF area. Over the years it has also been the practice to dump construction rubble (i.e., concrete, asphalt, etc) in this area. The rubble is periodically covered. The last cover was put on about 4 or 5 years ago but more rubble has accumulated since then.

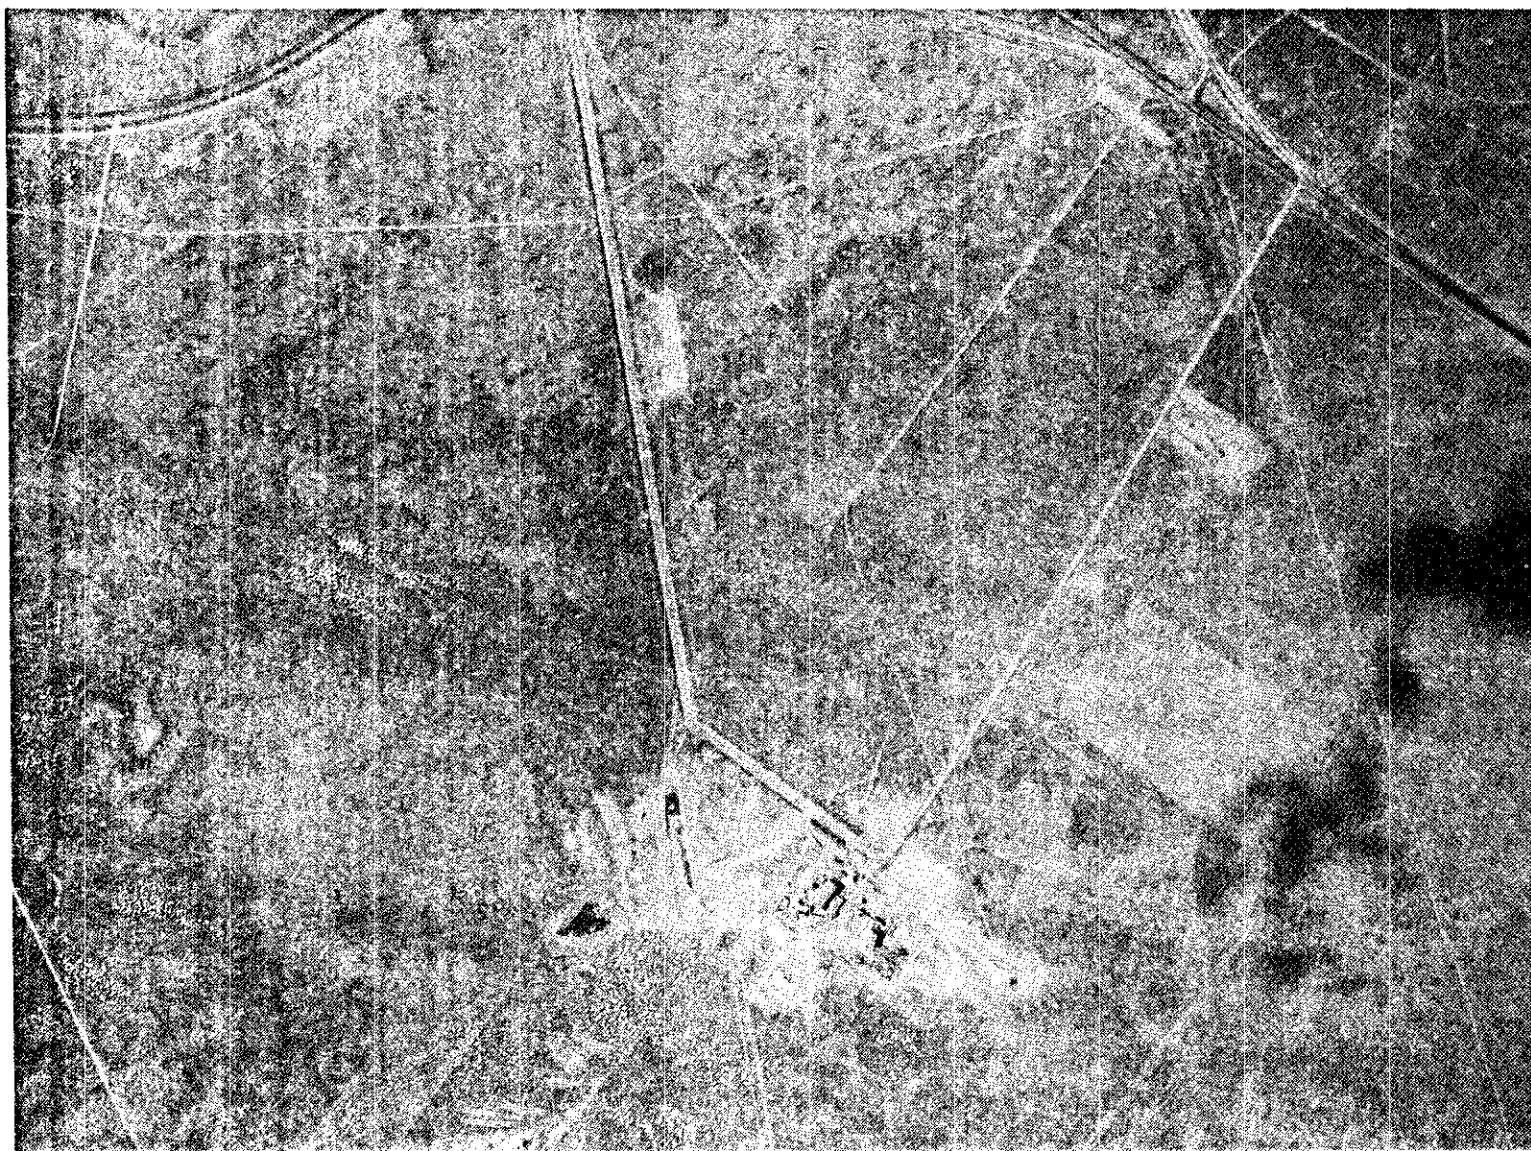
Figure 3.5.2. TAN/WRRTF Burn Site (1958 to 1966/67) location.

3.5.3.5.1 Description.--The WRRTF burn pit area was utilized from 1958 to the 1966/67 time frame. It was located on the east side of a small dirt road (now blocked) that ran north and south between WRRTF and State Highway 33 as shown in Figure 3.5.2. The area consisted of three pits for garbage and burnable debris and in 1961 or 1962 a fourth, smaller, pit was dug for liquid petroleum product wastes. The dimensions of the three larger pits, (all side-by-side) were approximately 6 m (20 feet) wide by 61 m (200 feet) long, 12 m (40 feet) wide by 61 m (200 feet) long, and 15 m (50 feet) wide by 76 m (250 feet) long. The smaller "waste oil" pit was about 0.5 m (18 inches) deep and 9 m (30 feet) wide by 15 m (50 feet) long.

The large pits were operated essentially as a cut-and-fill landfill; as a pit began to fill with rubble, it was covered and another pit was opened. However, the waste was burned every time something was put in the pit. The entire area has now been filled-in and graded. The only evidence of the burn pit area is a surface scar and a mound of unused fill material.

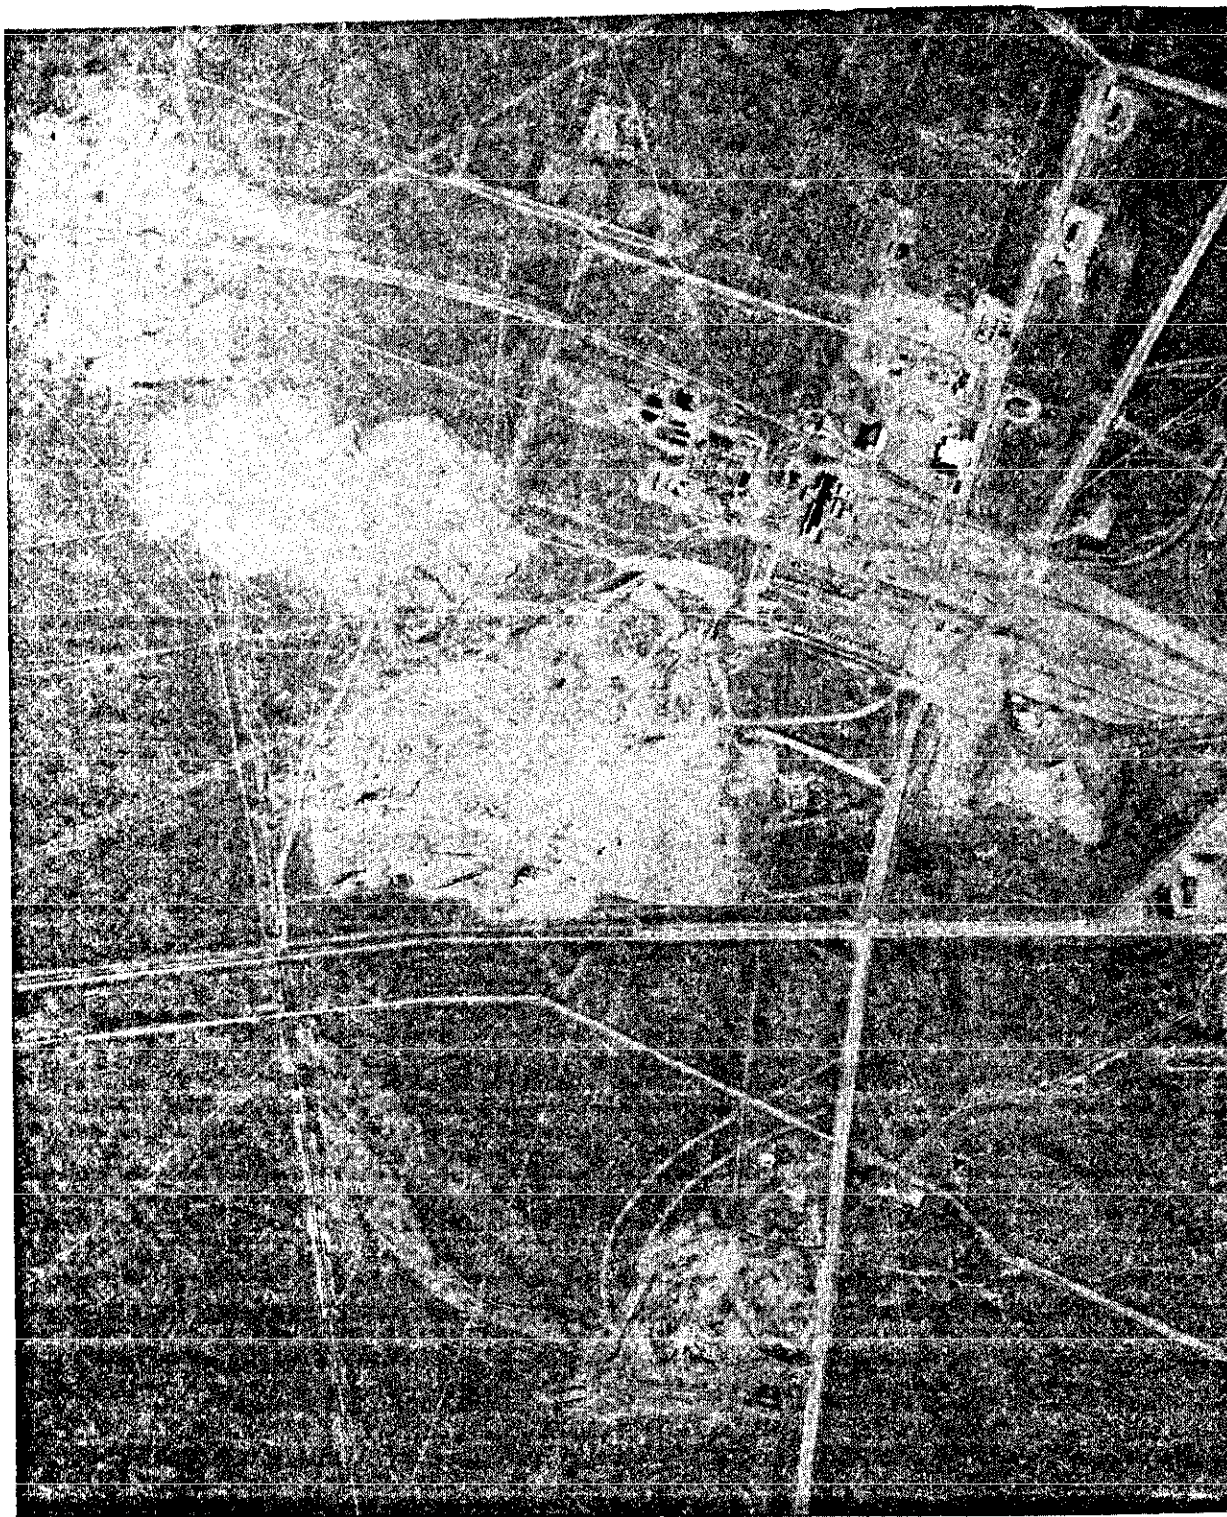
Figure 3.15.3. Aerial view of CFA landfill vicinity.

3.15.3.2.1 Description--As mentioned in Section 3.15.1.6, the sanitary landfill at CFA is designated the INEL landfill, and historically was located first on the west then the east of Lincoln Boulevard, but was recently moved back to the west side. The landfill is a cut and fill operation; that is, trenches are dug and waste is deposited. The trenches are then backfilled to cover the waste and new trenches are dug as necessary. Solid waste is brought from all over the site to this location. The aerial photograph in Figure 3.15.3 shows the approximate location of the CFA landfill.
