WASTE VITRIFICATION SYSTEMS

LESSONS LEARNED FE-8063

March 1999

U. S. D E P A R T M E N T O F E N E R G Y

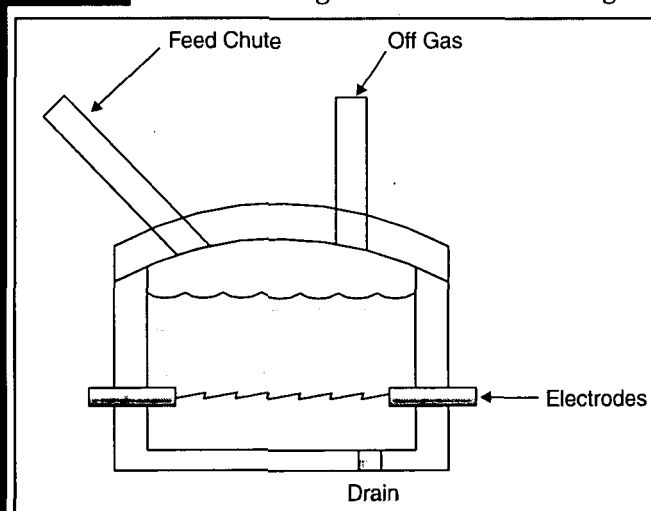
Figure 1. Simplified Diagram of Joule-Heated Melter

The Joule-heated melter furnace incorporates a process of heating the glass by conducting electric current through the glass matrix. Figure 1 shows a simplified diagram of the Joule-heated melter, more detailed drawings are contained in Chapters 4 and 5.

In a Joule-heated melter, vitrification is done in a single-step process. Both the waste concentrate and the glass former (including glass frit) are directly introduced into the melting chamber, thus forming a process zone where the glass melting reactions occur. The melter is the primary component of the vitrification process in the Joule-heated process. The melter is a water-jacketed stainless steel box insulated by multiple types of refractory with separate cavities for glass melting and pouring. Initial heat-up of the melt cavity is started by application of natural gas burners or

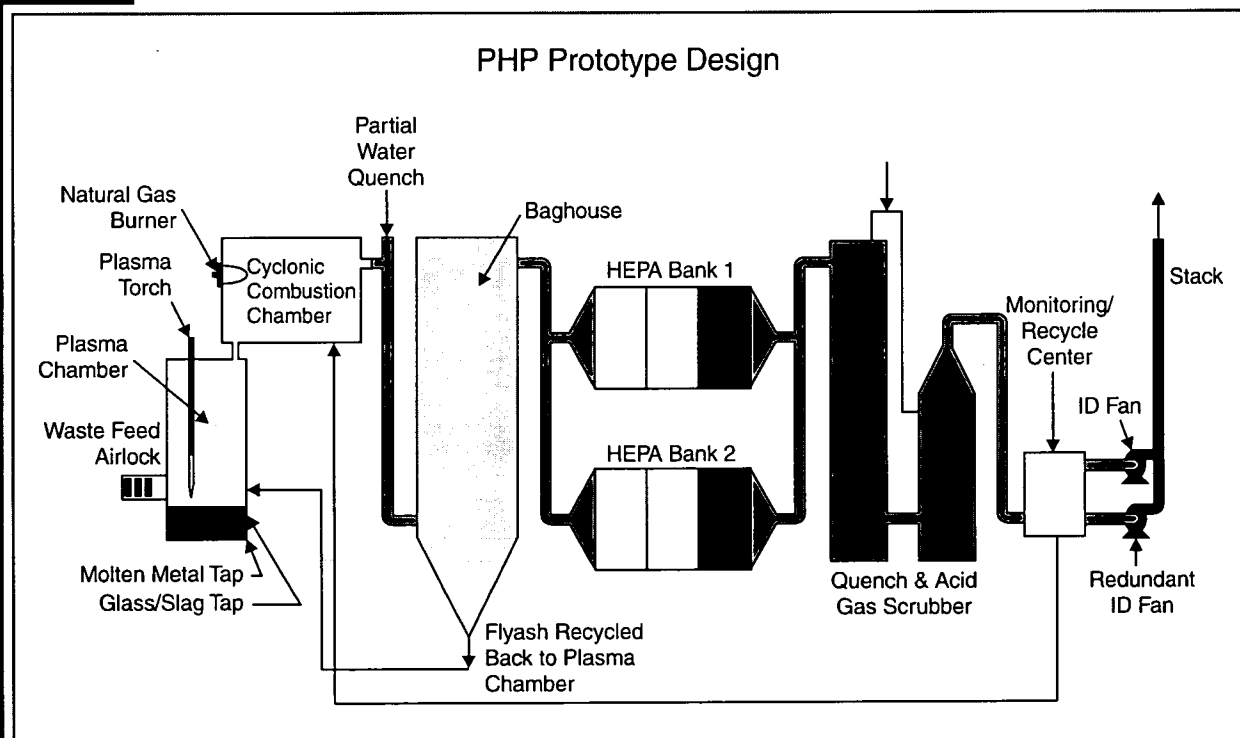
Figure 3. Plasma Hearth Process Vitrification Technology

Drummed waste is fed to the primary reaction chamber, where heat from the plasma torch initiates a variety of chemical and physical changes. Organic compounds in the waste are decomposed, volatilized, pyrolyzed, and/or oxidized. The remaining inorganic material, including the drum, is heated until it melts and separates into

molten slag and metal phase. Actinides and oxidized heavy metals migrate to the slag phase. Cooling and solidification of this material results in a high integrity final waste form. Off-gas from the primary reaction chamber is transported to a secondary combustion chamber for further combustion to ensure complete conversion of organic compounds to CO₂ and water. The off-gas is cleaned using conventional technologies capable of achieving a very high degree of removal of principal organic hazardous constituents (POHCs). Figure 3 shows a schematic prototype design of a Phase 3 PHP system.

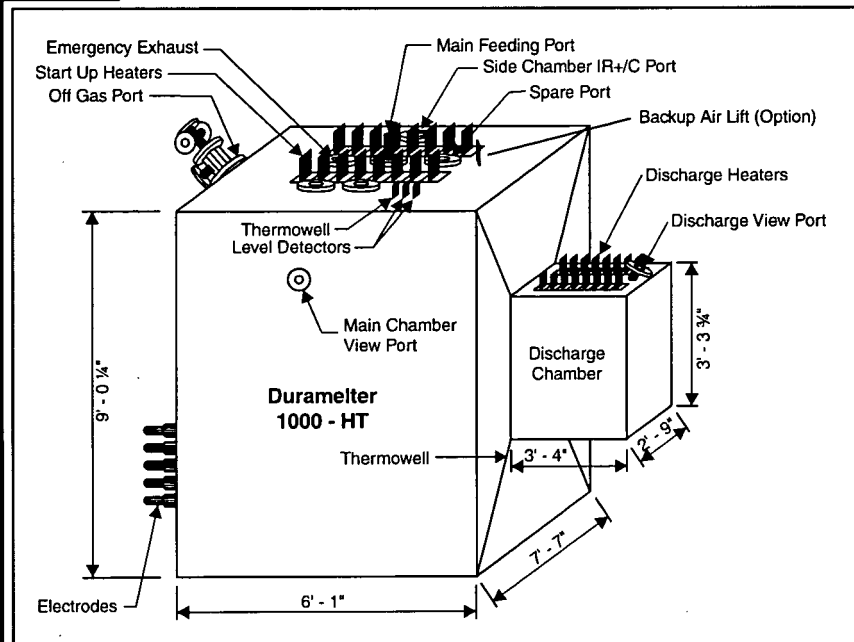
Figure 5. Fernald VITPP Melter

The melter is an electric furnace (Figures 5 and 6), which provides heat through molybdenum electrodes, creating a temperature of 1400°C. The unique three-chamber melter configuration isolates the molybdenum electrodes from the central melt area by refractory brick walls. The melter area is the central 27 cubic feet chamber, which is charged with the wastes and the glass forming materials. The two side chambers are each sized to house five molybdenum electrodes, which are shielded with benign molten glass. The side chambers are separated by the refractory brick walls (E-walls) from the main chamber where the waste glass resides. The heat is dispersed from the electrode chambers through high-conductivity Monofrax E refractory brick walls that transfer heat to melt materials without trans-

fer of corrosive waste elements to the electrodes. The molten waste glass is then lifted by the air lifter through the discharge riser. The discharge riser is located in a smaller chamber attached to the side of the melter.
