**POSTIRRADIATION EXAMINATIONS OF FUEL PINS  
FROM THE GCFR F-1 SERIES  
OF MIXED-OXIDE FUEL PINS  
AT 5.5 at. % BURNUP**

ANL-76-129

POSTIRRADIATION EXAMINATIONS OF FUEL PINS  
FROM THE GCFR F-1 SERIES  
OF MIXED-OXIDE FUEL PINS  
AT ~5.5 at. % BURNUP

Materials Science Division

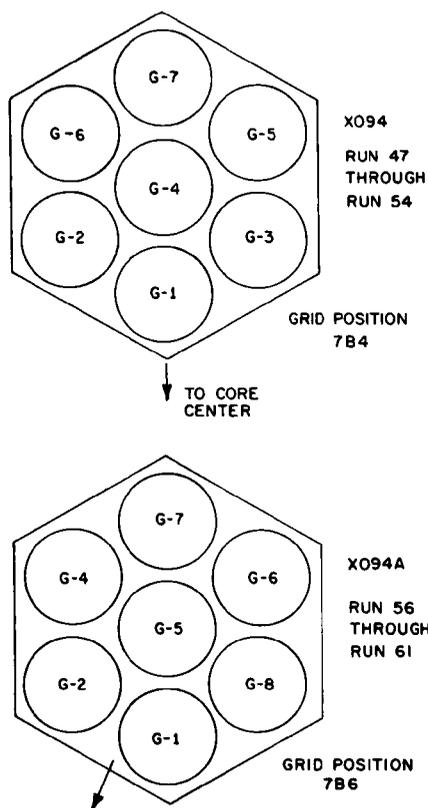
Fig. 3. Relative Fuel-pin Positions.  
MSD Neg. No. 63997.

The five capsules were irradiated in subassembly X094 and then X094A for Runs 47 through 54 and 56 through 61, respectively. The relative positions of the capsules in the subassemblies are shown in Fig. 3. The capsules were irradiated in row 7 of the reactor, which is the outer row of the expanded EBR-II core (the inner blanket region of the original 76 subassembly core). A steep flux gradient occurs across this row in EBR-II; therefore, the peak power of the fuel pins varied from 15.0 kW/ft for G-1 to 12.75 kW/ft for G-7 (for Run 51), although the fuel composition was the same in all fuel pins. The fission rate for each position in EBR-II is a function of the reactor loading for each run. Because of the relatively high ratio of experiments-to-driver-fuel subassemblies in EBR-II, the loading of the reactor changes quite frequently. As a result, the fission rate, and therefore the power rating of the fuel elements, is also subject to change for almost every run. The peak power for each fuel pin on a run-by-run basis is given in Table III. These

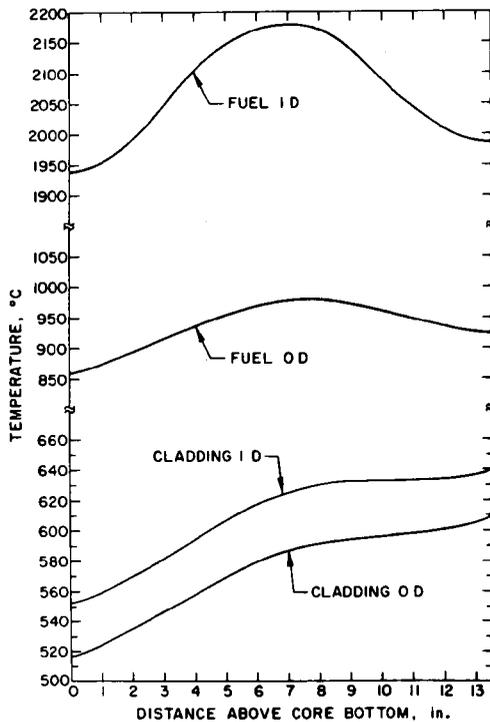
Fig. 8  
Axial Temperature Distribution for the Core Region of Fuel Pin G-7. MSD Neg. No. 63960.

The peak cladding temperature (inner surface just above the reactor midplane) of the fuel pins for each run is shown in Table IV. The approximate length of each of the runs (total length of the run, although most of the runs consist of two or more parts) in hours is also listed in the table. These times at temperature were used to calculate the time-averaged peak cladding temperature for the fuel pins. Axial temperature distributions for the cladding and fuel are shown in Figs. 4 through 8, using the power conditions in Run 51.

These results show that the temperature profile as well as the peak temperature are influenced by the power (location with respect to the reactor-core center) and the thickness of the thermal barrier. The thermal barriers have tended to cause relatively large axial thermal gradients in the lower half of the core region and quite flat profiles in the top half. The axial temperature distribution in most unencapsulated fuel elements in EBR-II is nearly linear over the core region because EBR-II has a nearly flat axial power profile (particularly after the stainless steel reflector was placed in the reactor beginning with Run 56).

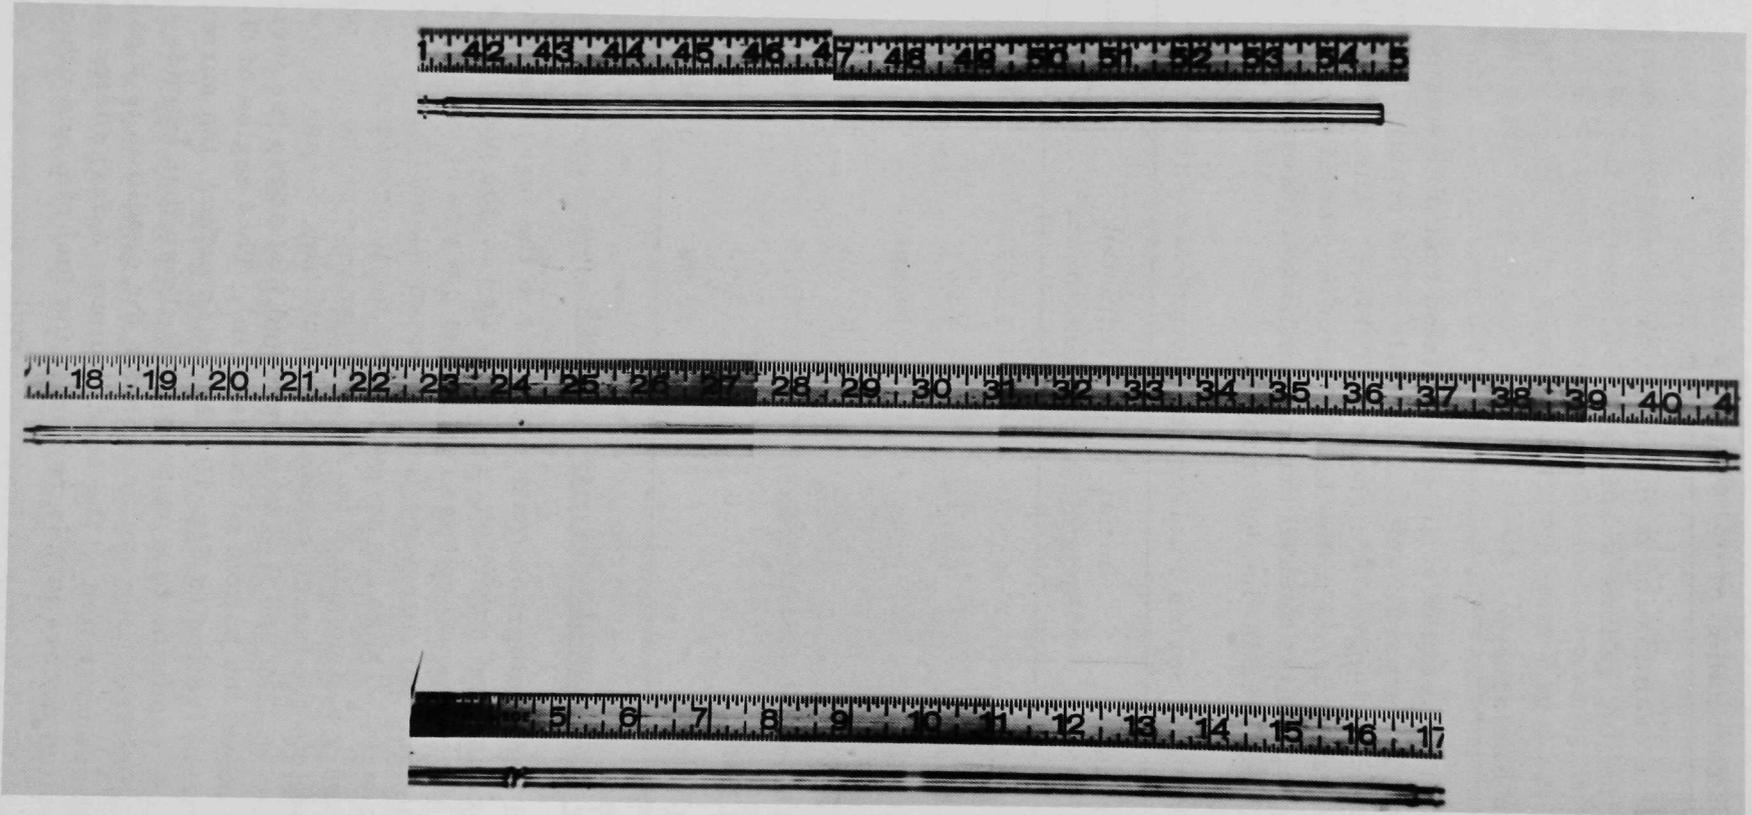
Fig. 9. Overall View of Fuel Pin G-1, with the Zero Point on the Ruler Placed Even with the Bottom of the Capsule. MSD Neg. No. 182696.

Visual and photographic examinations of the fuel pins showed that their surfaces were in good condition, as illustrated by the photographs of G-1 shown in Fig. 9. Minor discolorations that fit the pattern of the temperature monitors in the thermal barrier were found between 3 and 17 in. above the bottom end-fitting weld. These marks were also found previously on fuel pin G-3 but apparently had no effect on the performance of the fuel pin since they did not extend into the fueled region. A significant change in the appearance of the surfaces of G-1 and G-2 was observed just above the fuel-blanket interface (~35 in. above the bottom of the capsule). This region of G-1 is shown at higher magnification in Fig. 10. At the interface, the surface changes from the usual shiny condition to a matte or dull finish that extends ~3/4 in. upward from the interface. One explanation for the condition is that it is a result of plate-out of impurities in the bond sodium. A large temperature gradient in the sodium occurs in this region of the fuel pin, and other studies

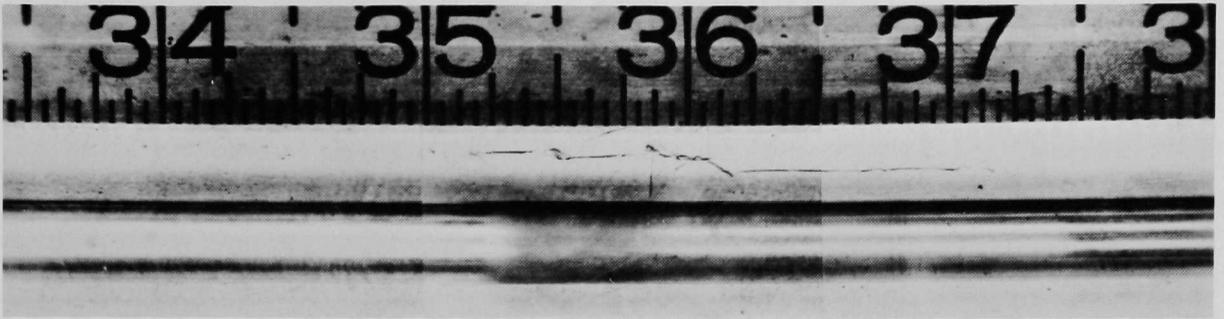
Fig. 10. Region at the Top of the Fuel Column of G-1 that Exhibited a Matte Finish. MSD Neg. No. 182697.

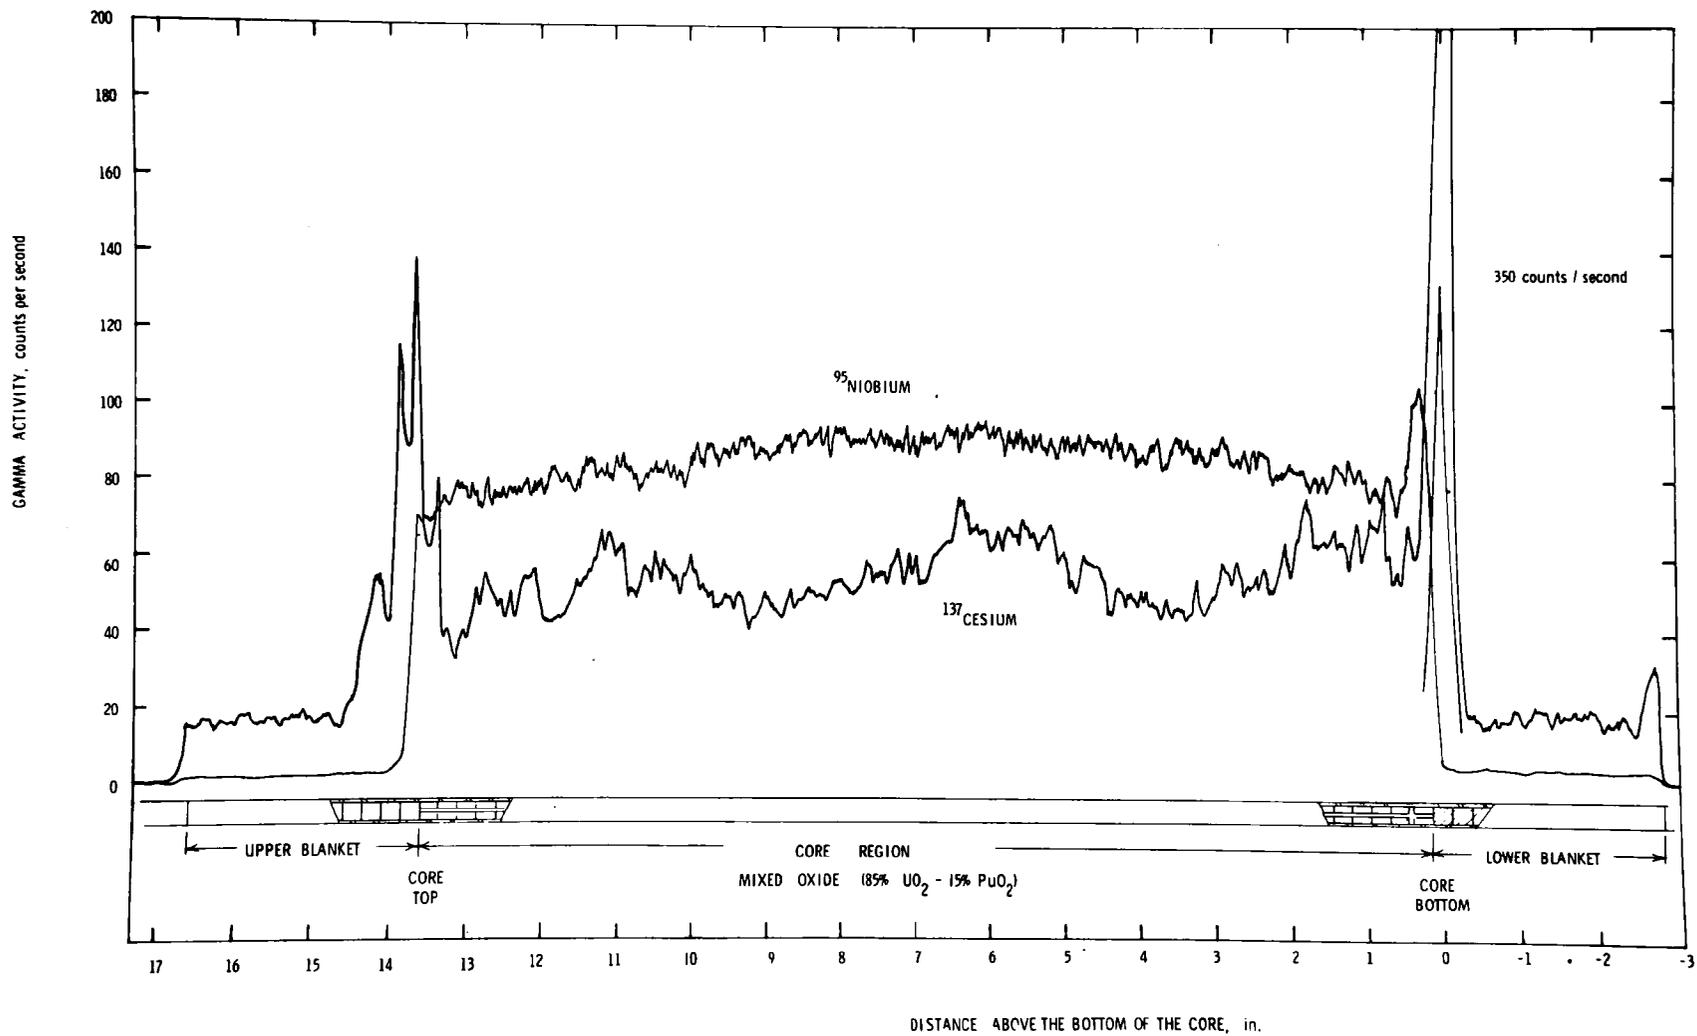
Fig. 11. Gamma Scans Showing the Relative Activity for <sup>137</sup>Cs and <sup>95</sup>Nb in the Fuel Column of G-1. MSD Neg. No. 168790.

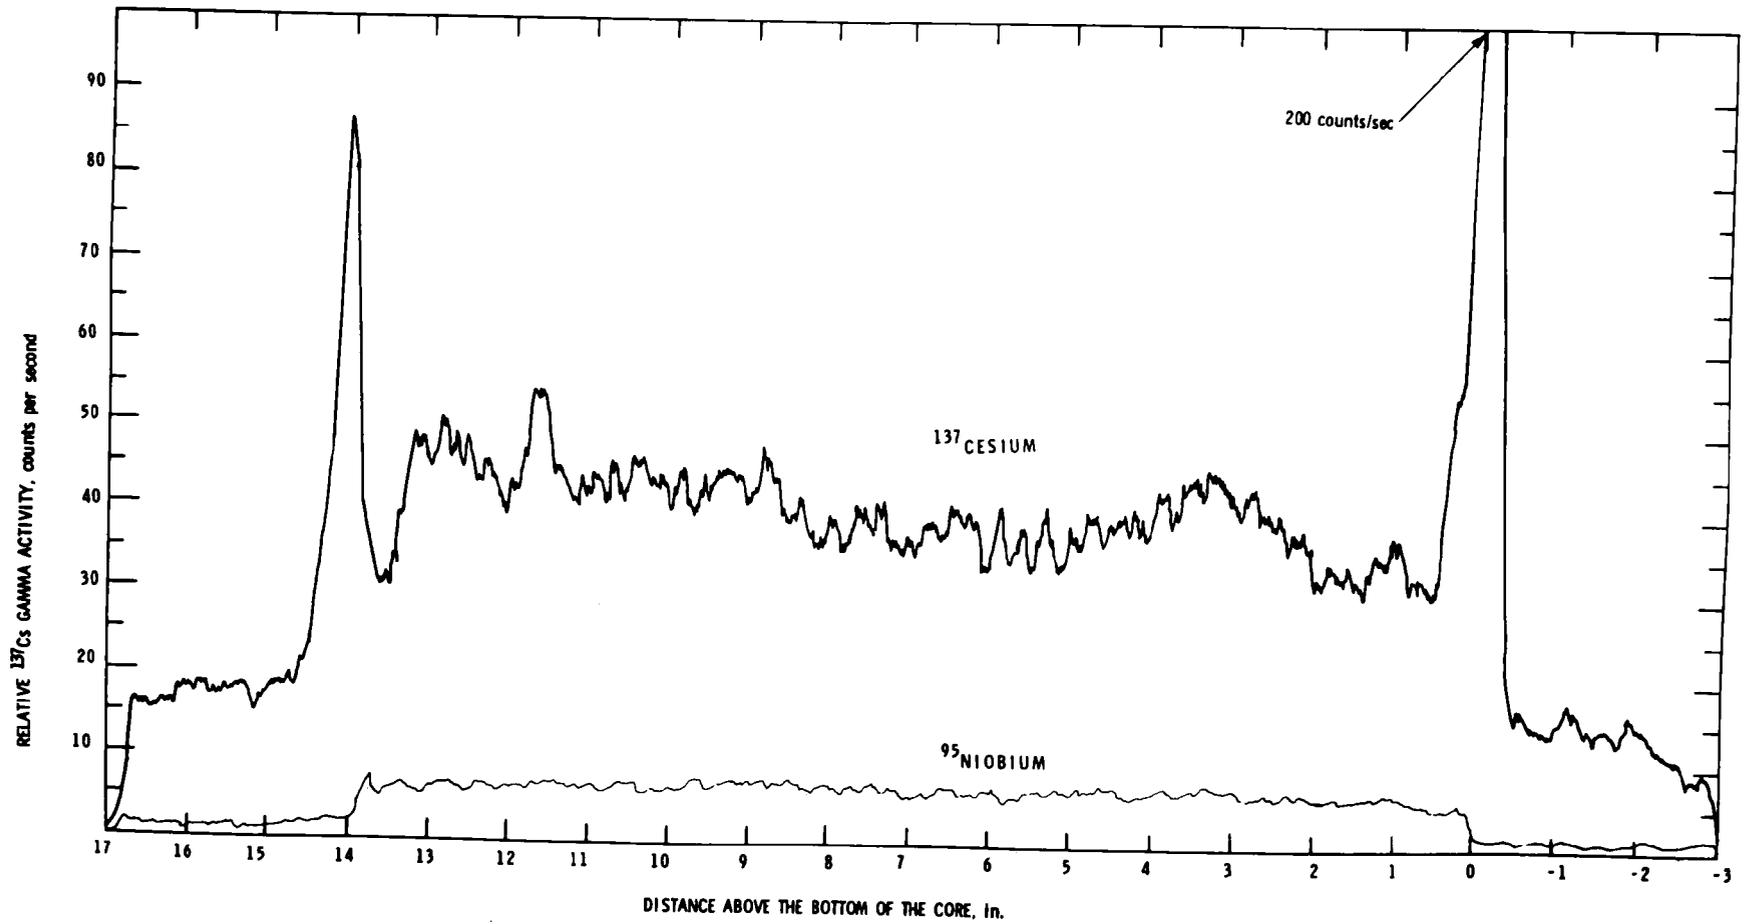
Fig. 12. Gamma Scans Showing the Relative Activity for  $^{137}\text{Cs}$  and  $^{95}\text{Nb}$  in the Fuel Column of G-2. MSD Neg. No. 182698.

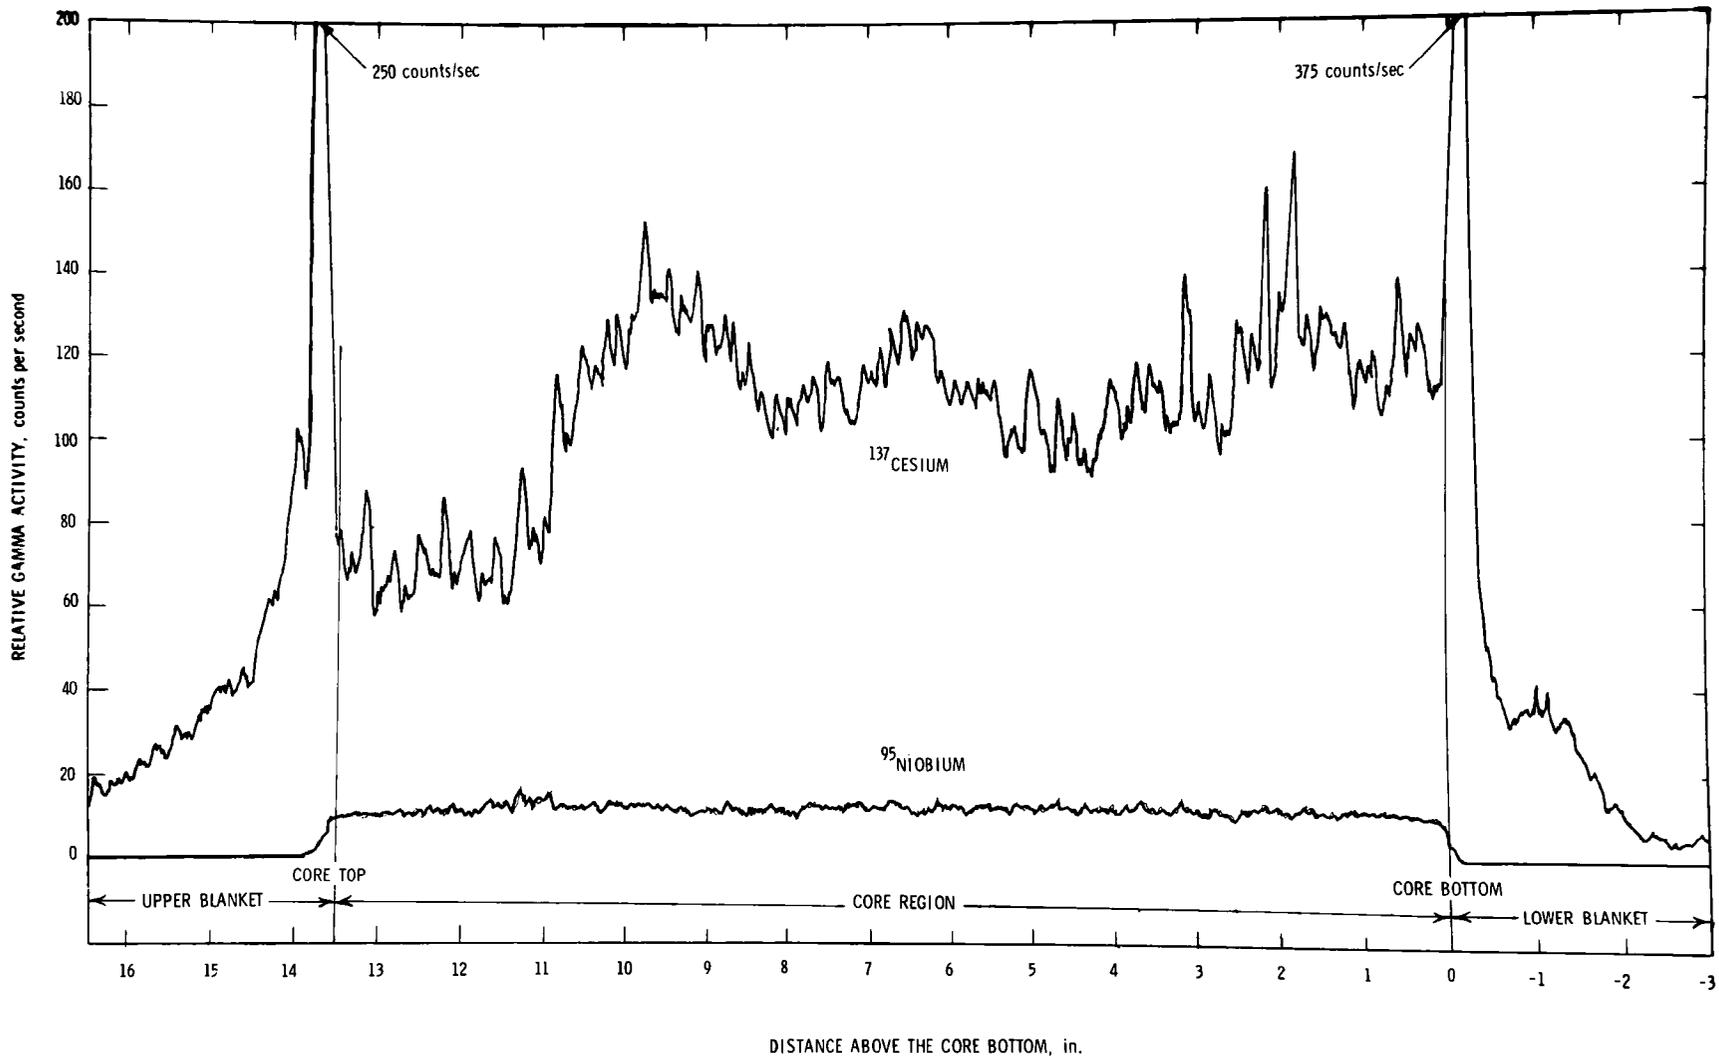
Fig. 13. Gamma Scans Showing the Relative Activity for  $^{137}\text{Cs}$  and  $^{95}\text{Nb}$  in the Fuel Column of G-5. MSD Neg. No. 182237.

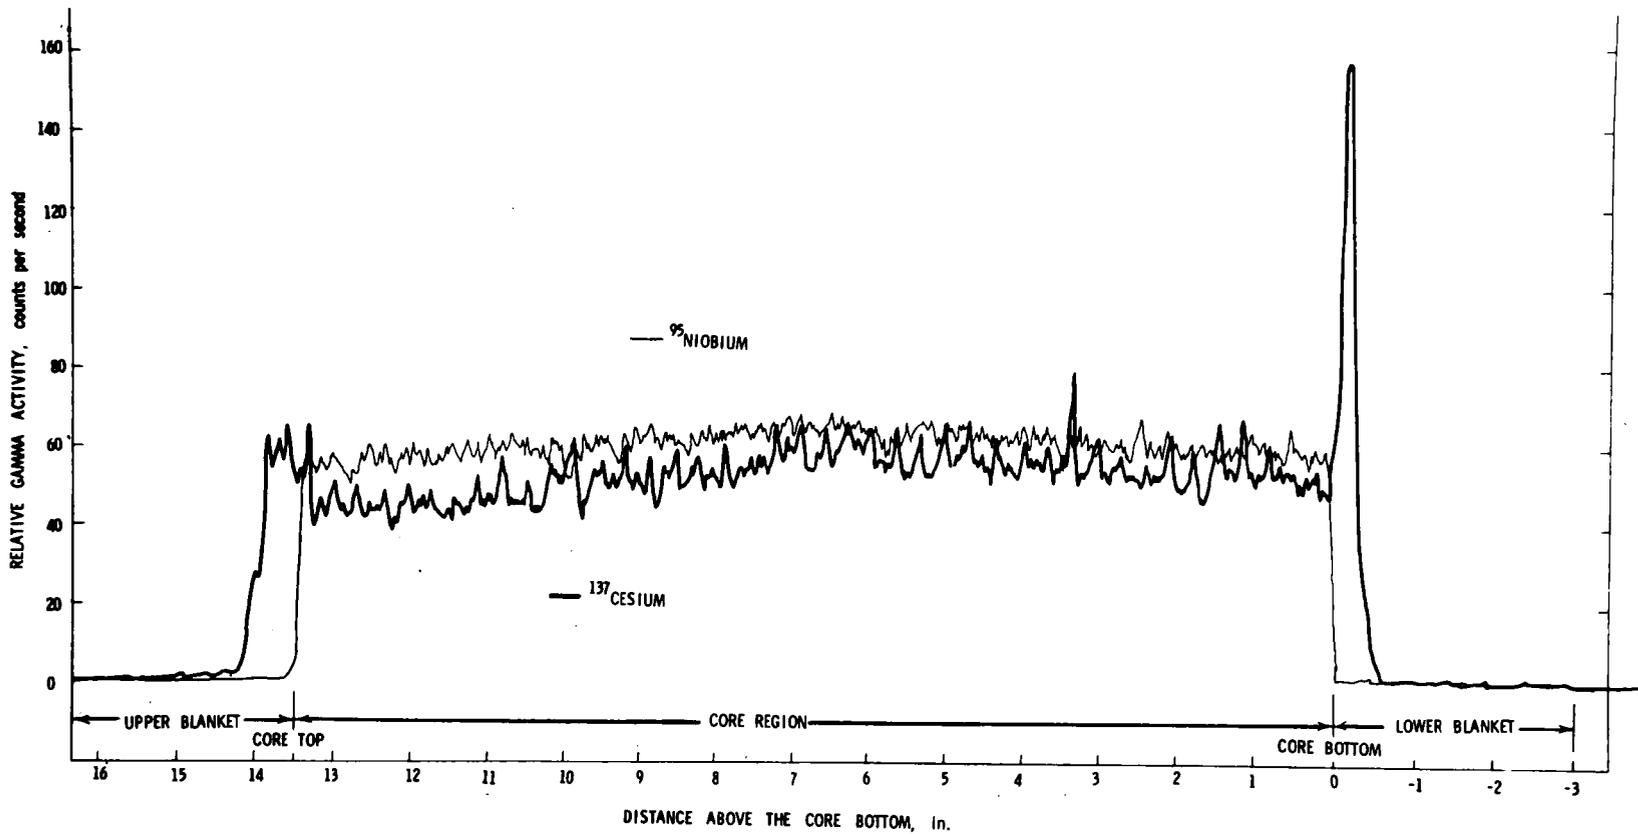
Fig. 14. Gamma Scans Showing the Relative Activity for  $^{137}\text{Cs}$  and  $^{95}\text{Nb}$  in the Fuel Column of G-6. MSD Neg. No. 169259.

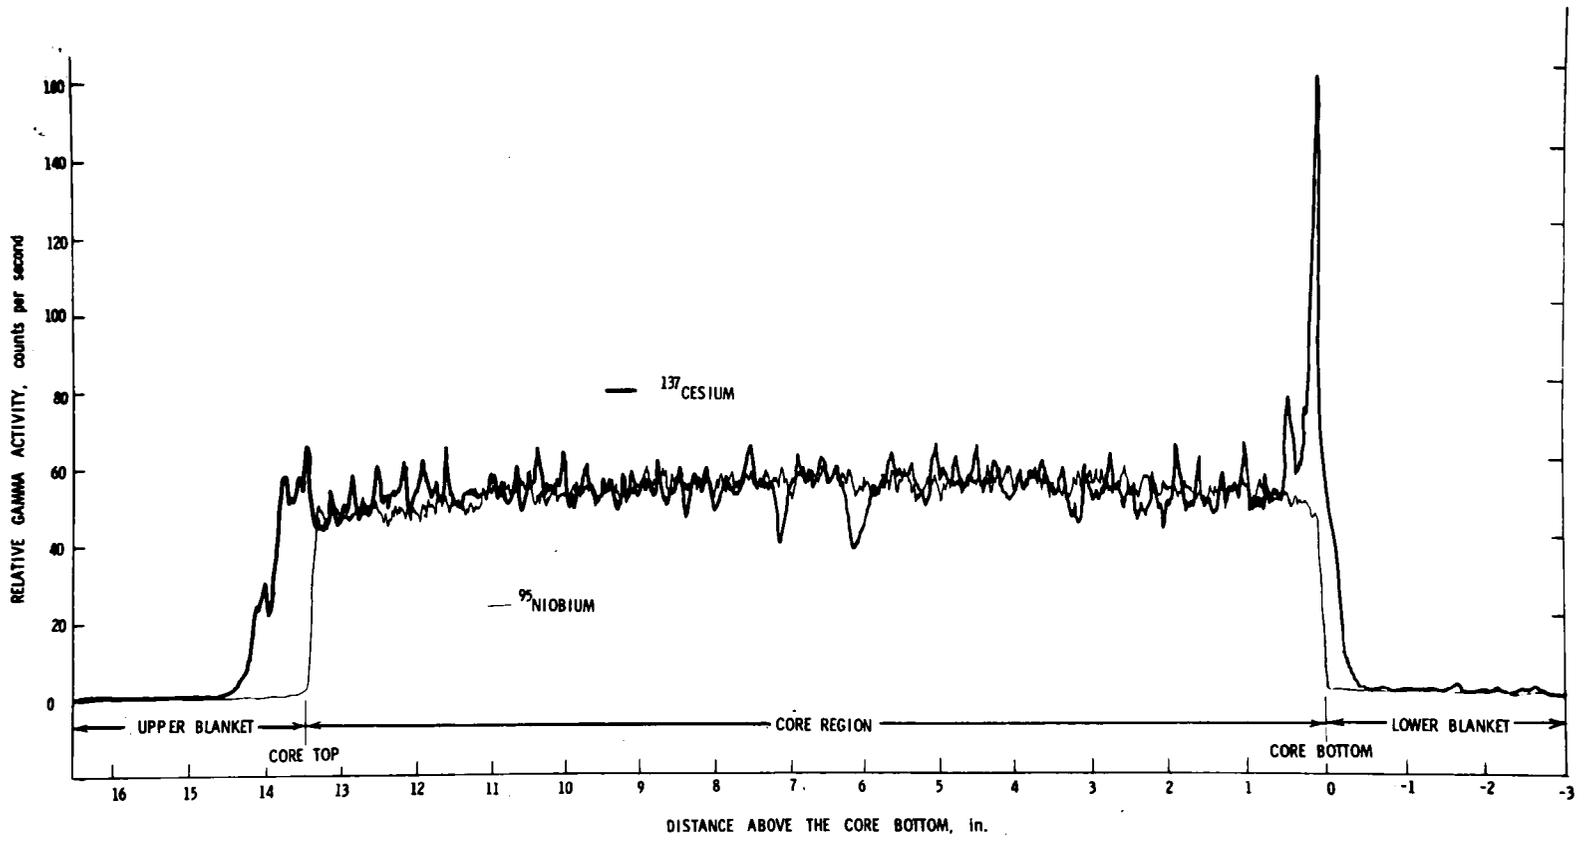
Fig. 15. Gamma Scans Showing the Relative Activity for  $^{137}\text{Cs}$  and  $^{95}\text{Nb}$  in the Fuel Column of G-7. MSD Neg. No. 162960.

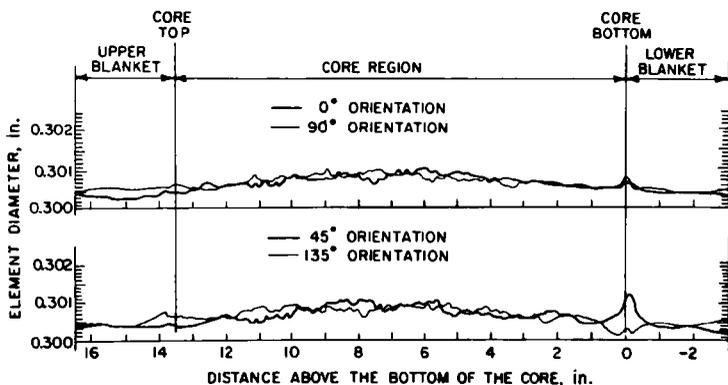
Fig. 16  
Postirradiation Diametral  
Profile of Fuel Pin G-1.  
MSD Neg. No. 168570.

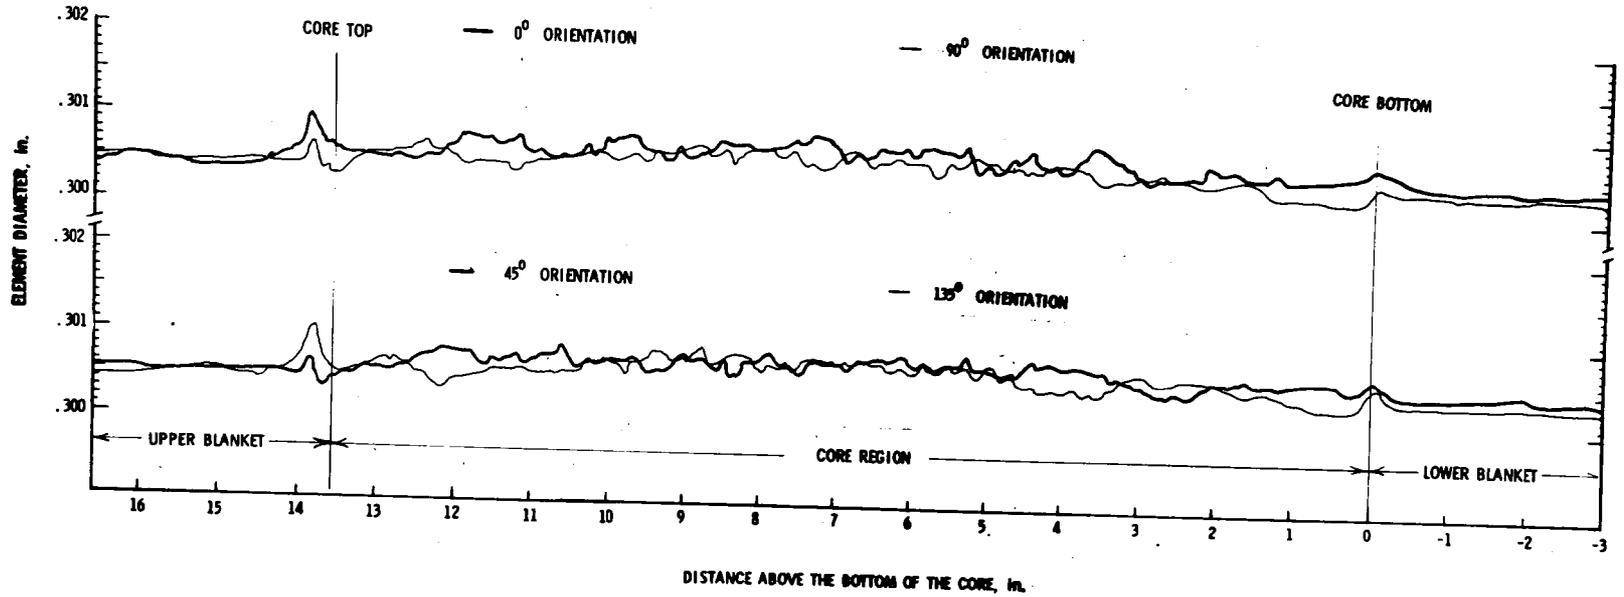
Fig. 17. Postirradiation Diametral Profile of Fuel Pin G-2. MSD Neg. No. 181301.

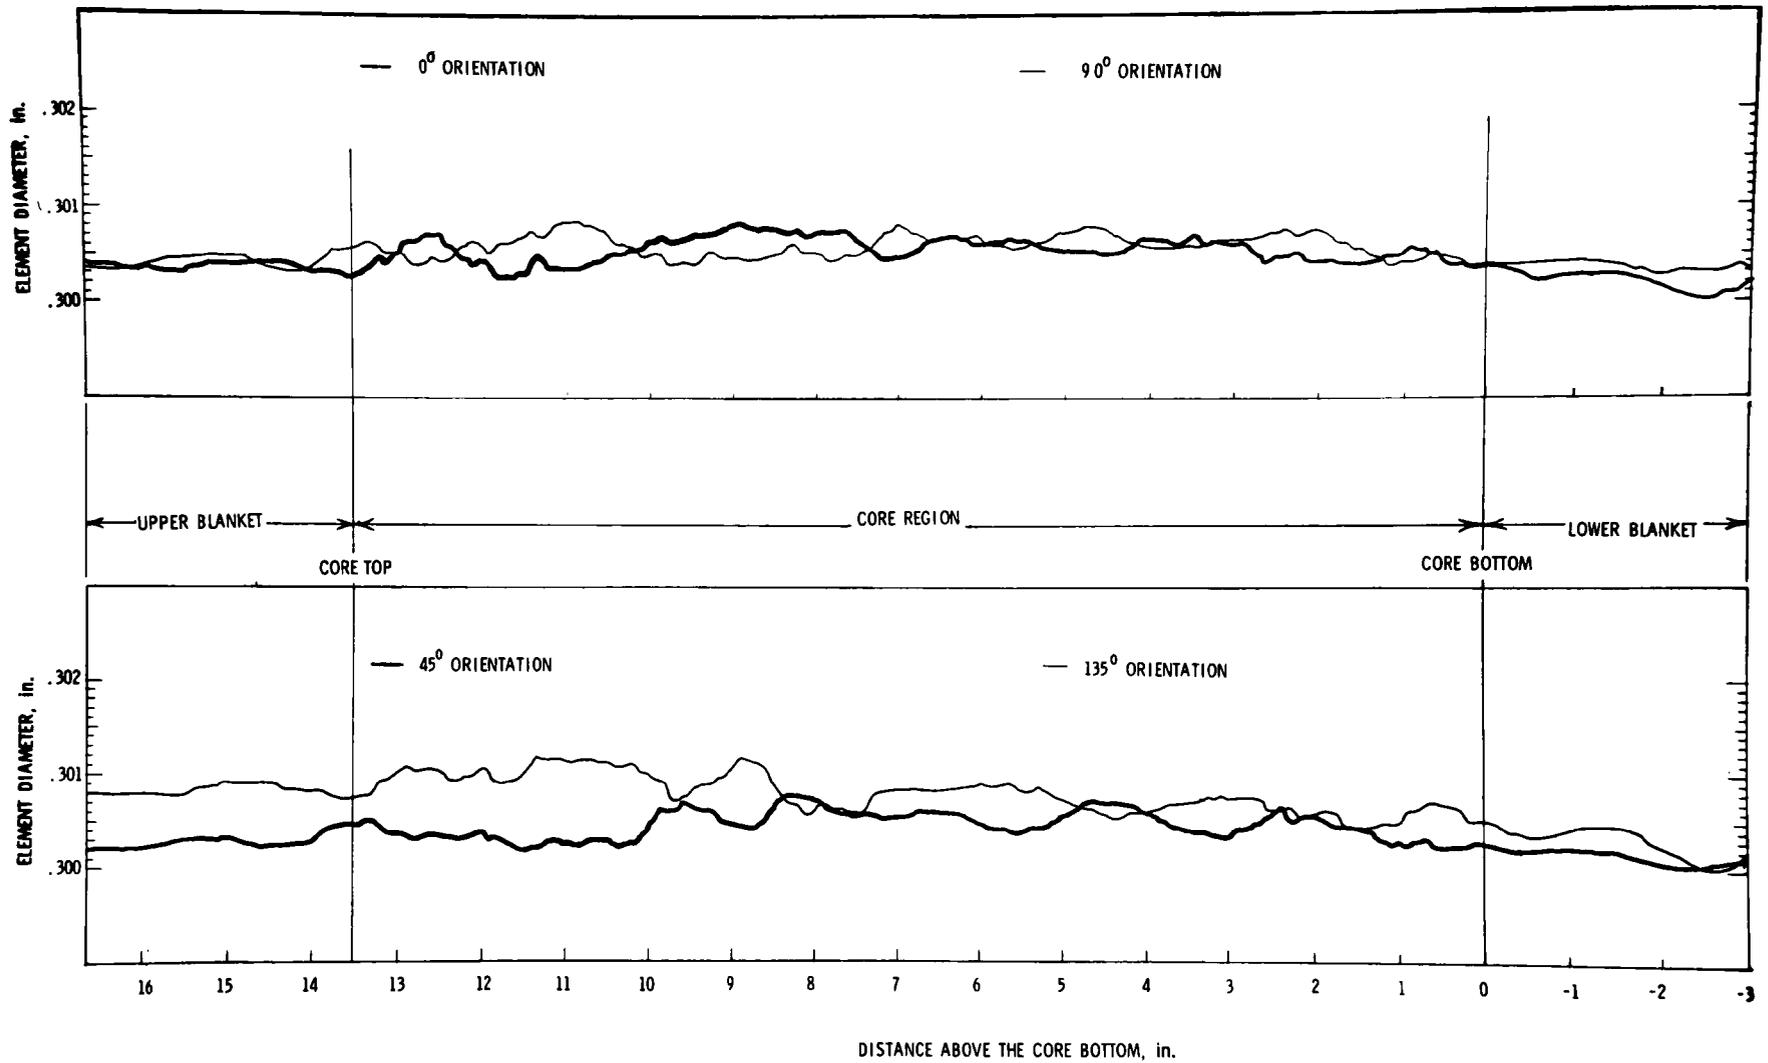
Fig. 18. Postirradiation Diametral Profile of Fuel Pin G-5. MSD Neg. No. 182236.

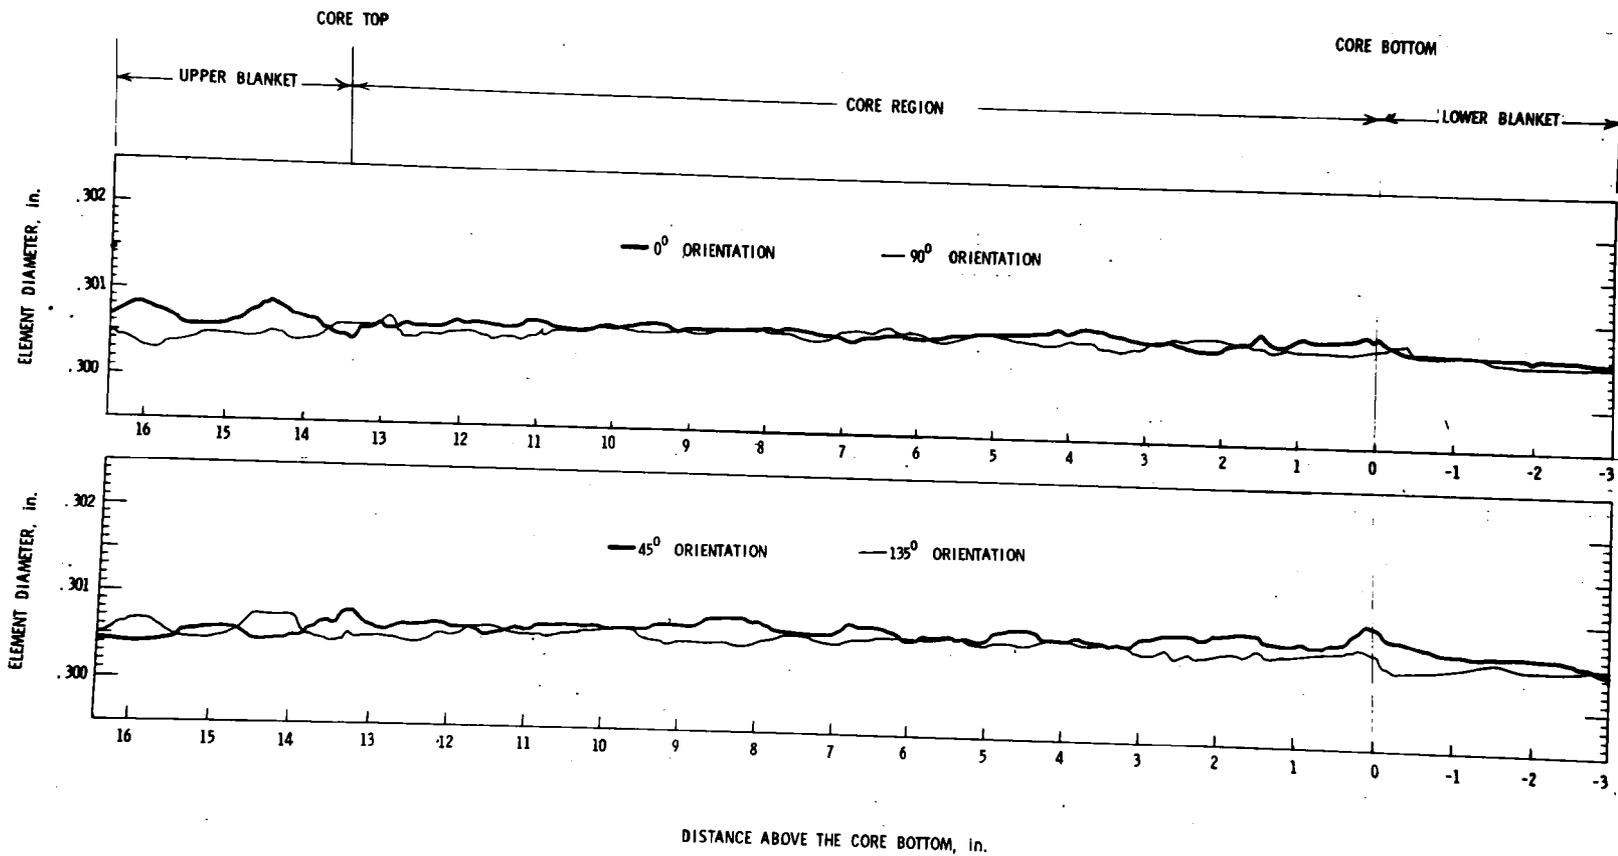
Fig. 20. Postirradiation Diametral Profile of Fuel Pin G-7. MSD Neg. No. 169262.

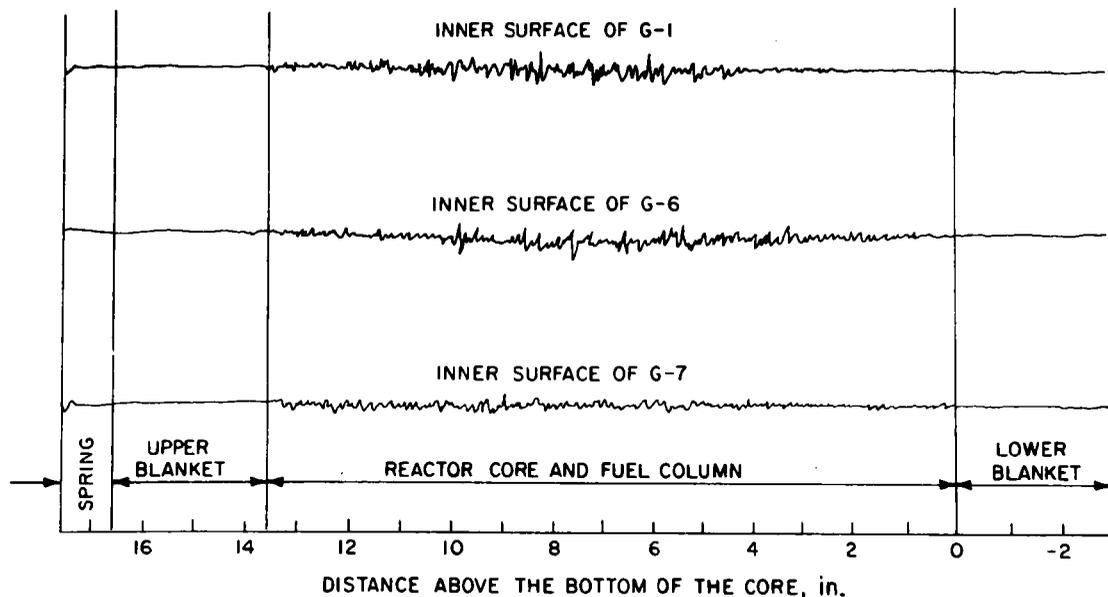
Fig. 21. Response of the Eddy-current Tester for Fuel Pins G-1, G-6, and G-7. MSD Neg. No. 182925.

The system utilizes a point probe that covers  $\sim 18^\circ$  of the circumference of the fuel pin. The entire surface is covered by scanning at  $15^\circ$  azimuthal intervals. The results of this method are qualitative in that the response to fission-product attack (many small defects) is cumulative and much greater than the response to large single flaws. Since the device is presently calibrated against small discrete flaws machined into tubing, the amplitude of the response is not a good measure of the depth or extent of cladding attack. The results of typical scans ( $0^\circ$  orientation) for fuel pins G-1, G-6, and G-7 are shown in Fig. 21. Subsequent metallography on sections from the three pins shows that the amplitude of the response from the eddy-current tester did not correspond to the depth of cladding attack. The attack in G-1 was more than twice as severe as the attack in G-6 and G-7. The attack in G-6 and G-7 was similar, although the eddy-current traces show similar responses for G-1 and G-6 and a less response for G-7. For the F-1 series of fuel pins, the eddy-current inspection method was quite sensitive to any alteration of the inner cladding surface, but the method was less than successful in indicating the severity of the alteration.

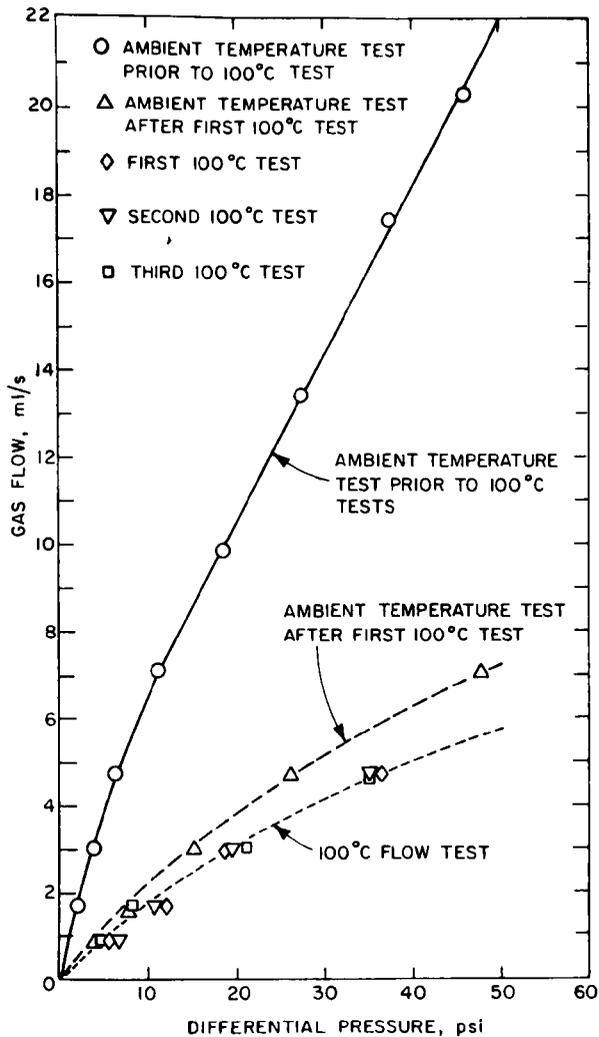
Fig. 25. High-pressure Test Results for G-7 Upper Interface. MSD Neg. No. 63995.

In addition, the flow rates across the upper interface of G-7 were less at 100°C than at ambient temperature (~30°C). This result was unexpected because the heating was expected to cause expansion of the cladding that would open the flow channels inside the fuel pin adjacent to the cladding. This anomaly underlines the difficulty of extrapolating these flow tests to conditions that will exist in an operating GCFR fuel pin.

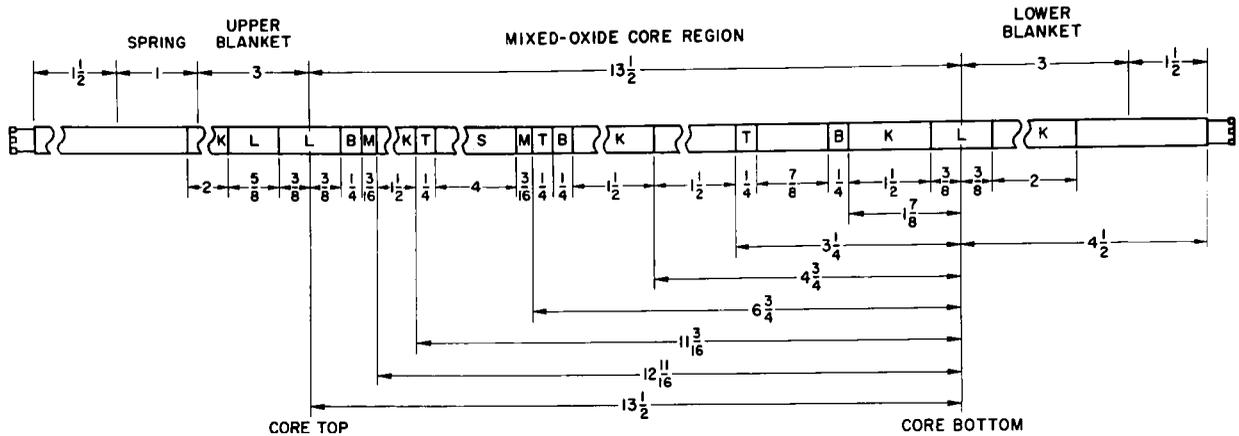
Fig. 26. G-1 Sectioning Diagram. B, burnup samples; K, samples for temperature determination; L, longitudinal metallographic samples; M, samples for detailed microprobe analysis; S, biaxial stress-rupture test specimen; and T, transverse metallographic samples. All dimensions are in inches. MSD Neg. No. 63947.

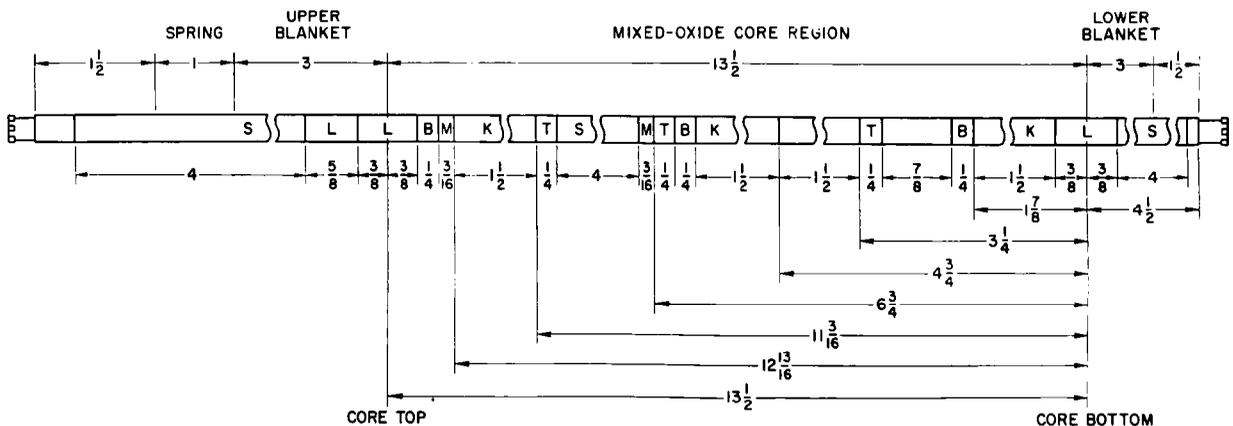
Fig. 27. G-2, G-6, and G-7 Sectioning Diagram. B, burnup samples; K, samples for temperature determination; L, longitudinal metallographic samples; M, samples for detailed microprobe analysis; S, biaxial stress-rupture test specimen; and T, transverse metallographic samples. All dimensions are in inches. MSD Neg. No. 63948.

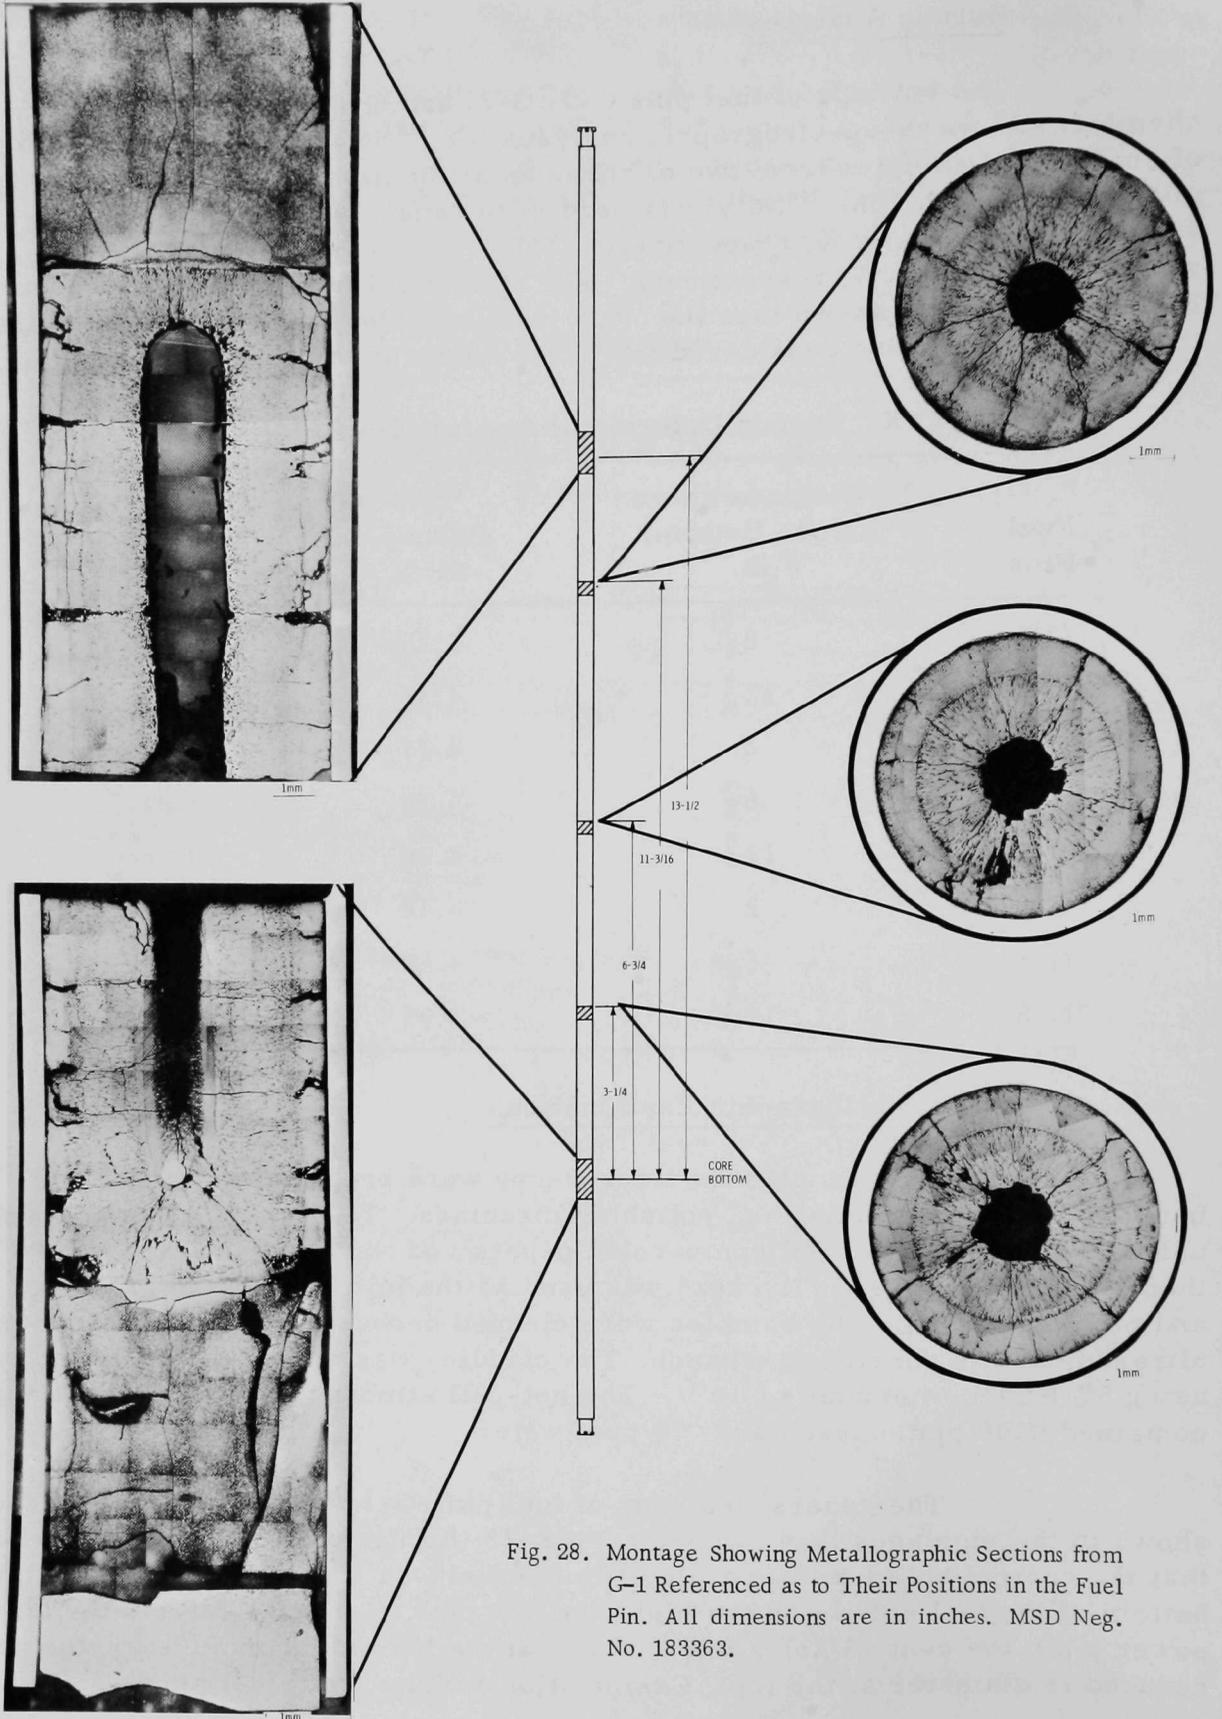
Fig. 28. Montage Showing Metallographic Sections from G-1 Referenced as to Their Positions in the Fuel Pin. All dimensions are in inches. MSD Neg. No. 183363.
