**POSTIRRADIATION EXAMINATIONS OF FUEL PINS  
FROM THE GCFR F-1 SERIES  
OF MIXED-OXIDE FUEL PINS  
AT 5.5 at. % BURNUP**

ANL-76-129

POSTIRRADIATION EXAMINATIONS OF FUEL PINS  
FROM THE GCFR F-1 SERIES  
OF MIXED-OXIDE FUEL PINS  
AT ~5.5 at. % BURNUP

Materials Science Division

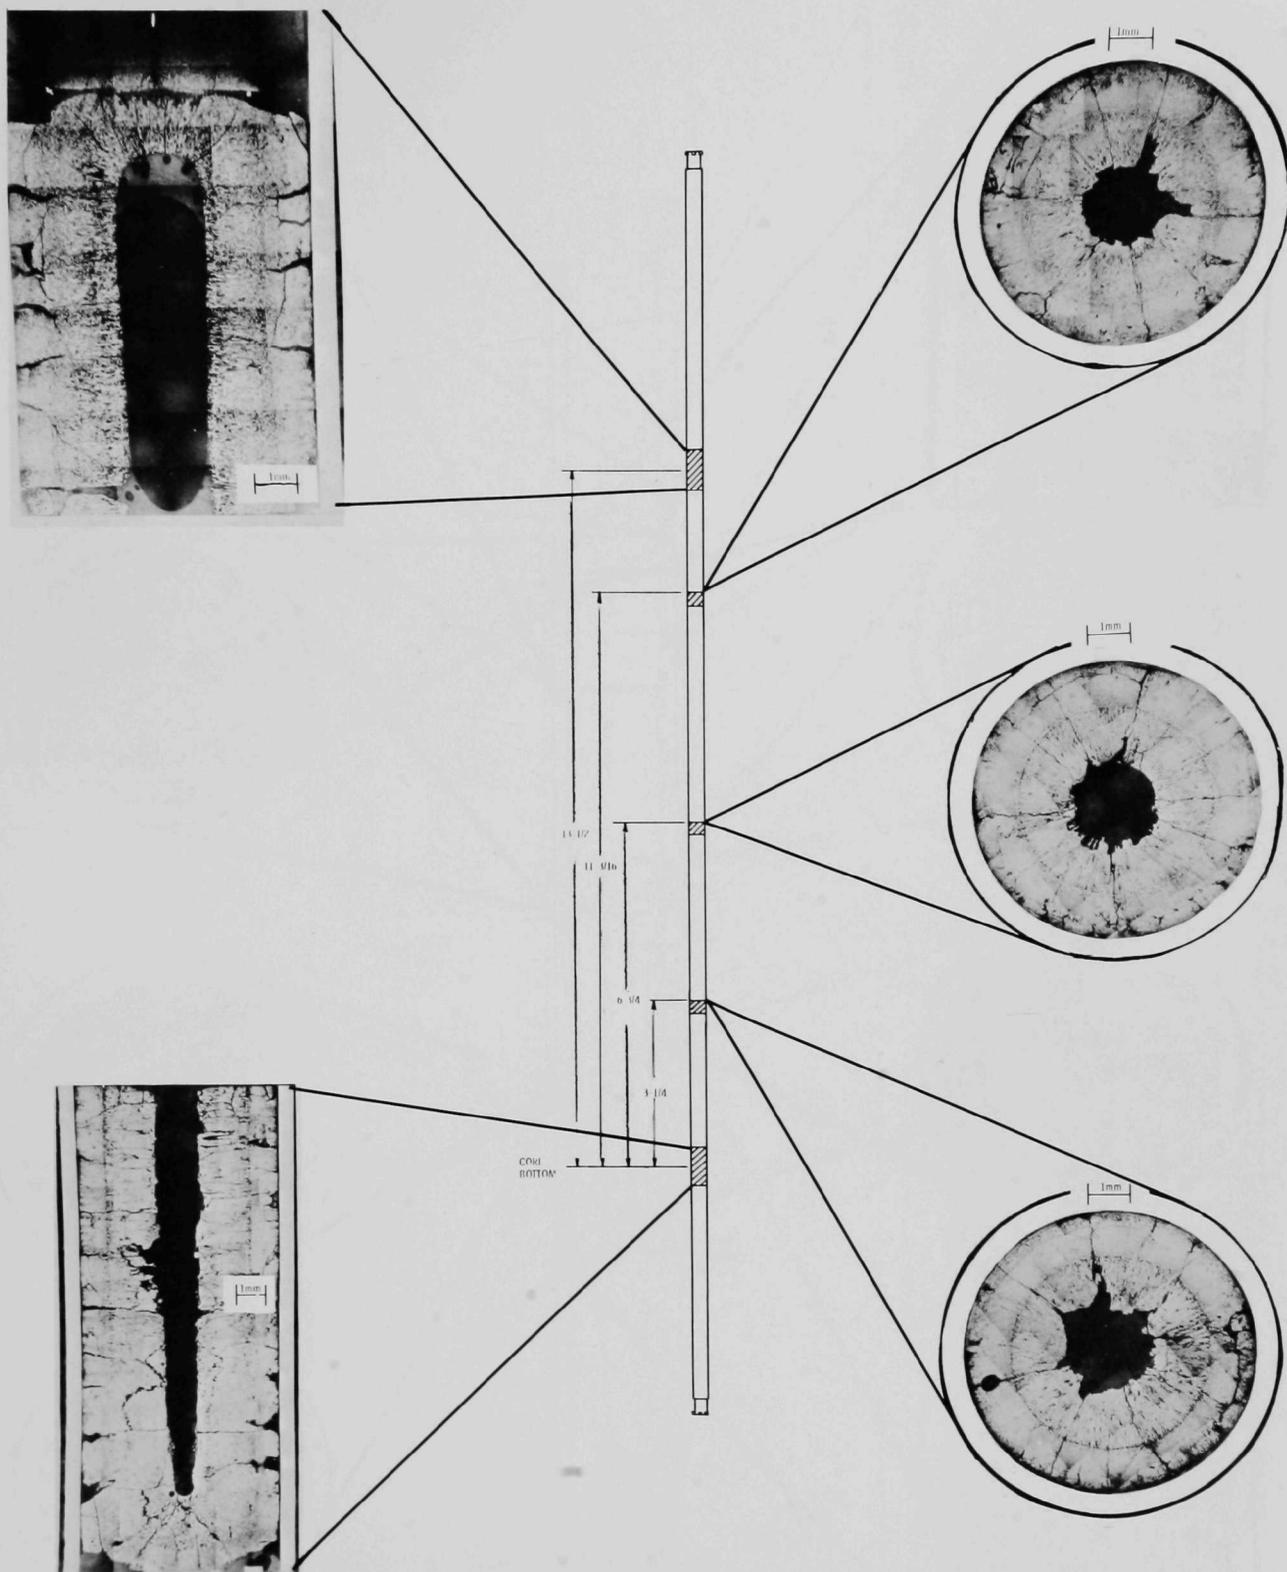
Fig. 29. Montage Showing Metallographic Sections from G-2 Referenced as to Their Positions in the Fuel Pin. All dimensions are in inches. MSD Neg. No. 183476.

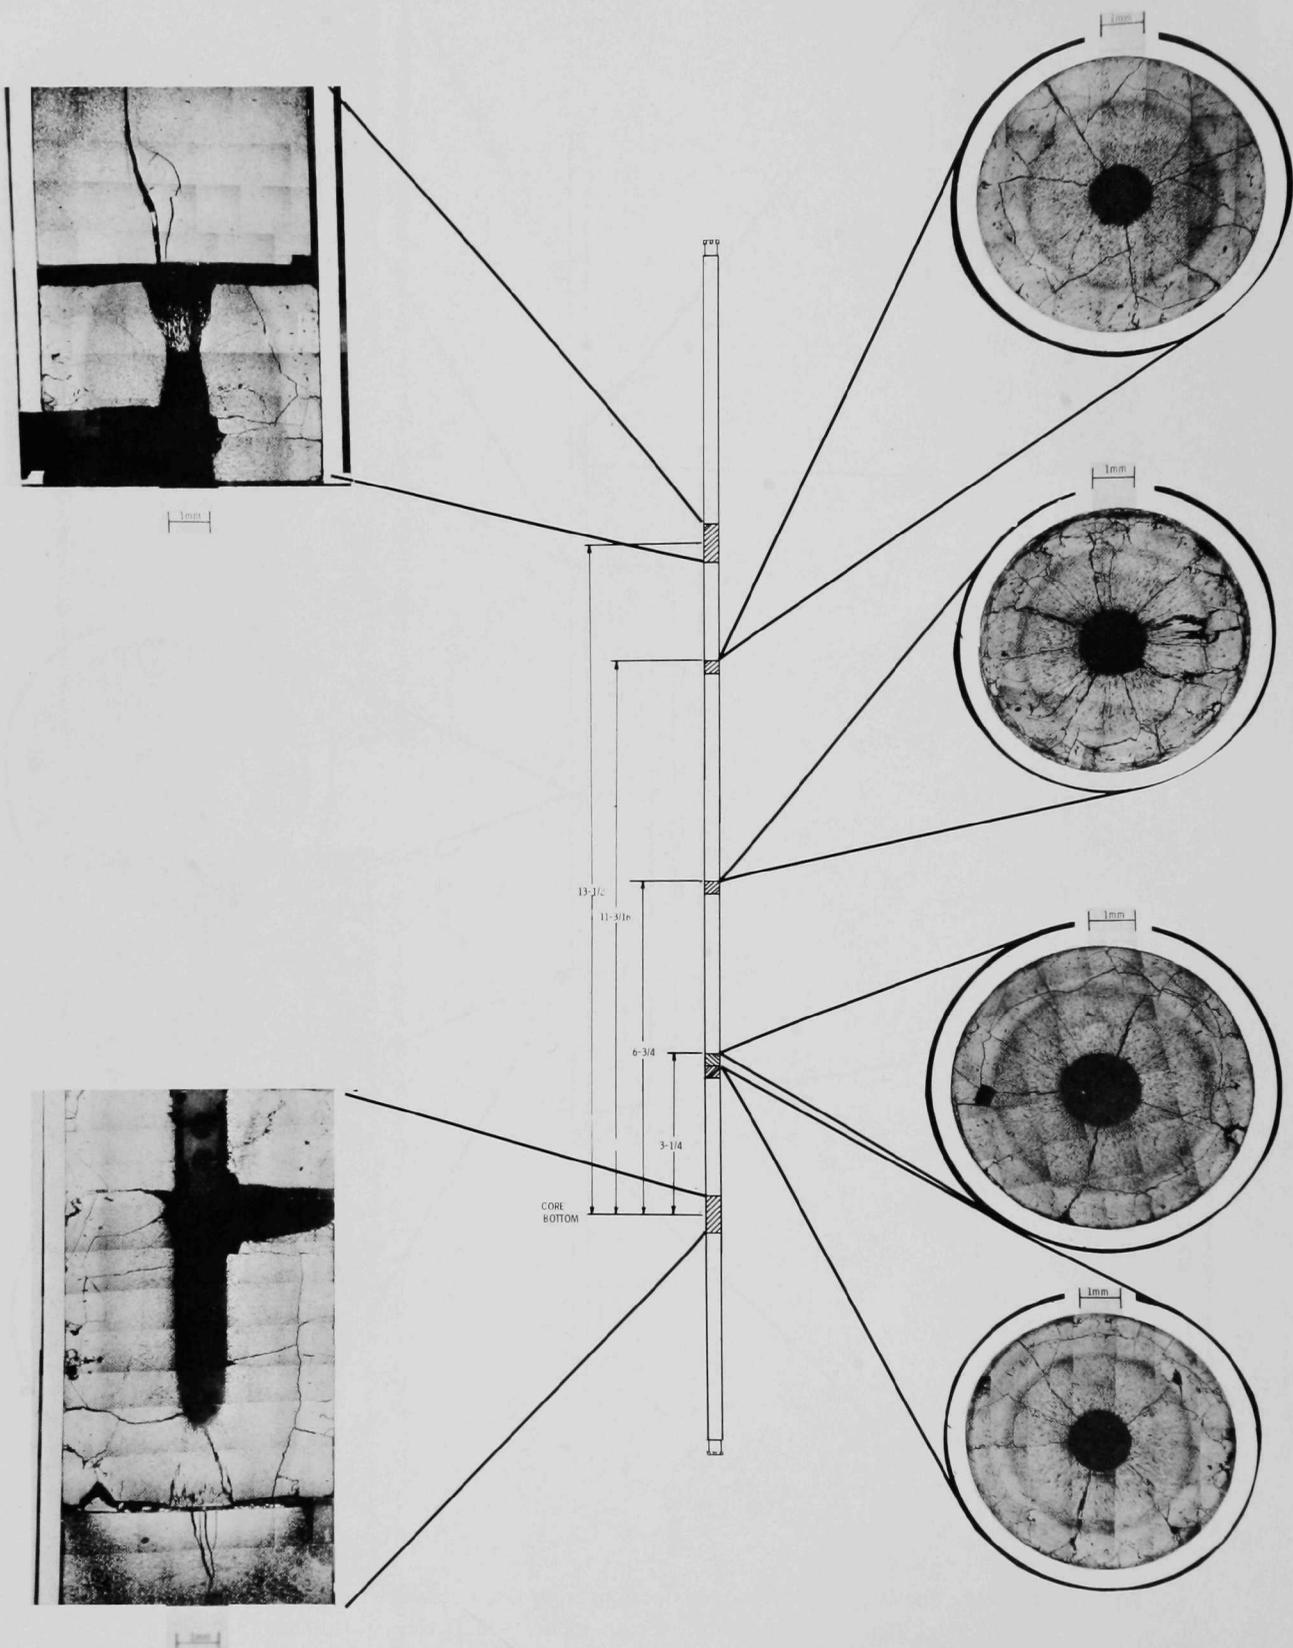
Fig. 30. Montage Showing the Metallographic Samples from G-6 Referenced as to Their Positions in the Fuel Pin. All dimensions are in inches. MSD Neg. No. 183475.

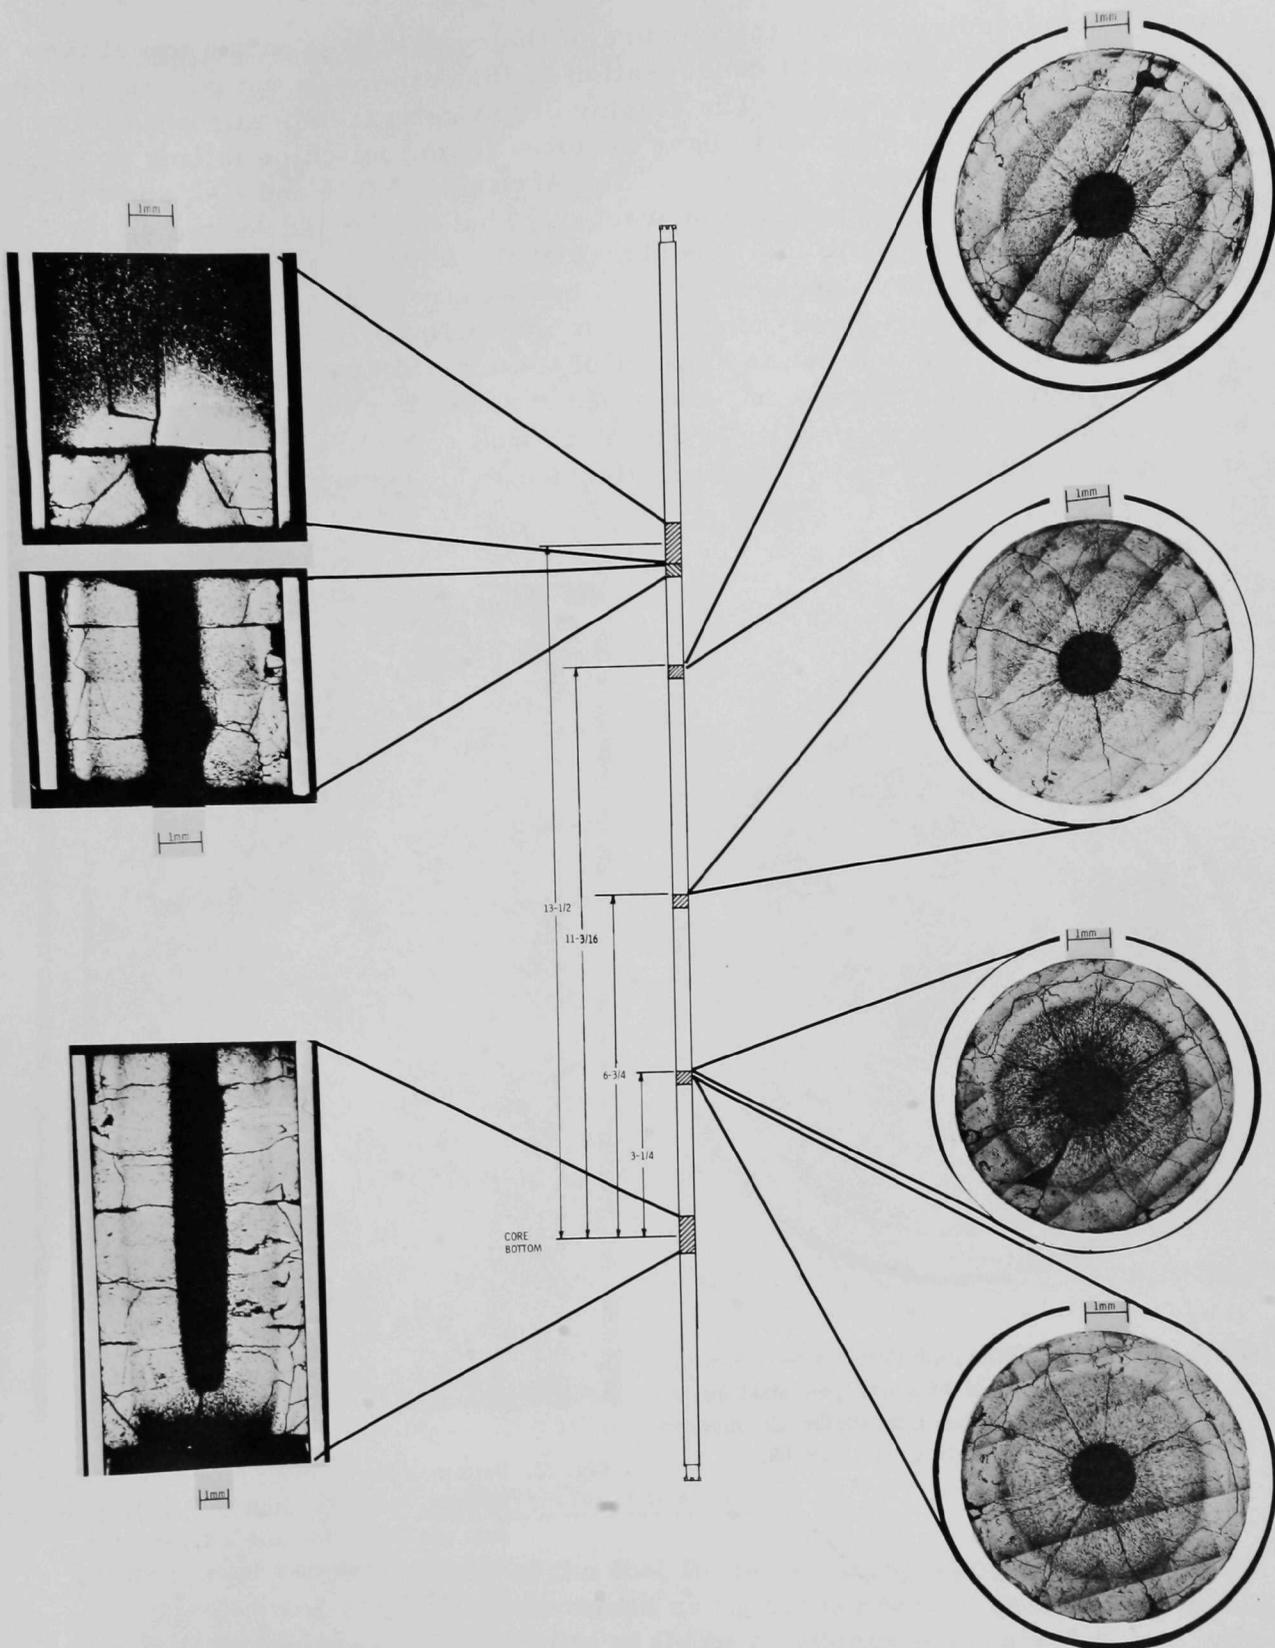
Fig. 31. Montage Showing the Metallographic Sections from G-7 Referenced as to Their Positions in the Fuel Pin. All dimensions are in inches. MSD Neg. No. 183465.

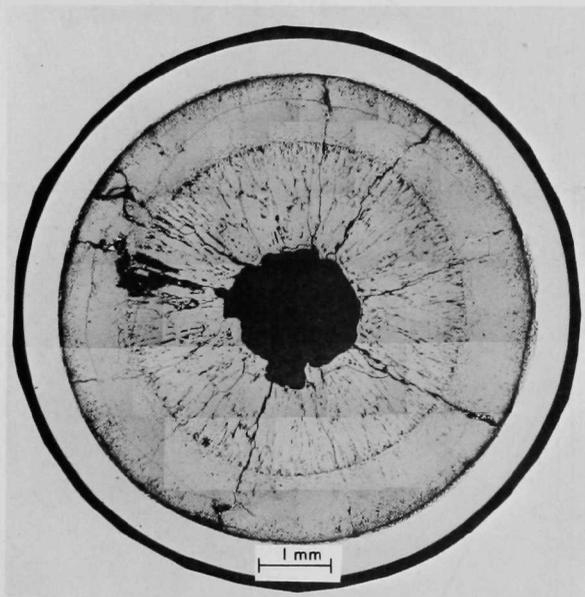
Fig. 32. Midplane Section from Fuel Pin G-1 Showing Uneven Edge on the Central Hole and Ring of Porosity at the Outer Edge of the Columnar-grain Zone. MSD Neg. No. 168568.

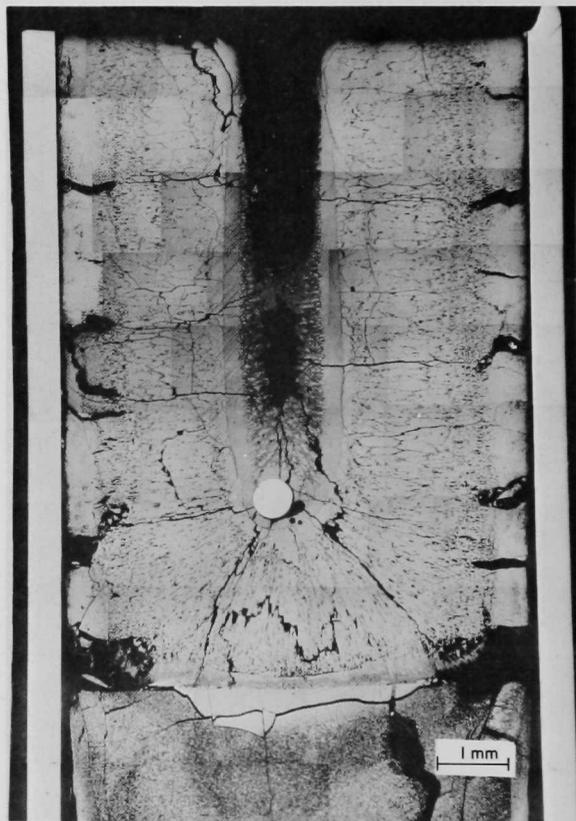
Fig. 33. Bottom of Fuel Column from Fuel Pin G-1 Showing Dendritic Structure in the Fuel near the Centerline and a Spherical, Metallic Fission-product Ingot. MSD Neg. No. 168785.

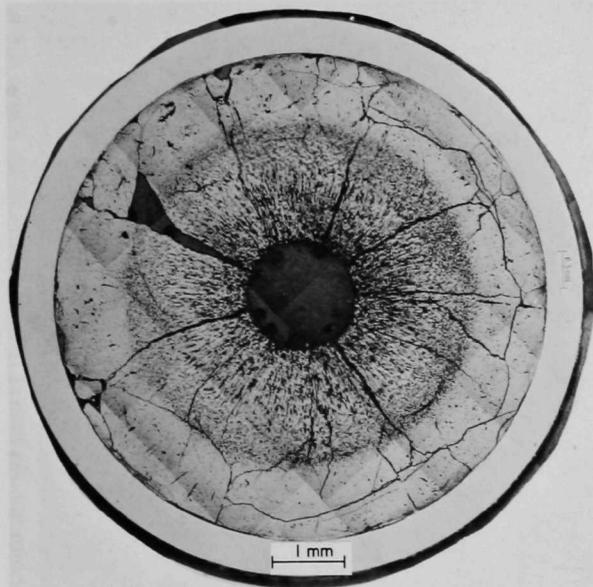
Figure 34 shows a transverse section through the G-7 pin 3.25 in. above the bottom of the fuel column. The columnar region of this section was generally more porous than that of other sections. Additional grinding, which removed  $\sim 0.03$  in. of fuel, produced the structure in Fig. 35. The closeness of the two sections is attested by the almost identical cracking patterns

The abrupt change in the fuel structures is attributed to the first section being cut through the dished end of the pellet. The porous structure resulted from the dish volume that was incorporated into the fuel during the restructuring of the fuel in the reactor.

Fig. 34. Transverse Section of G-7  $3\frac{1}{4}$  in. above Core Bottom. The section was apparently cut quite close to a pellet interface. MSD Neg. No. 182653.

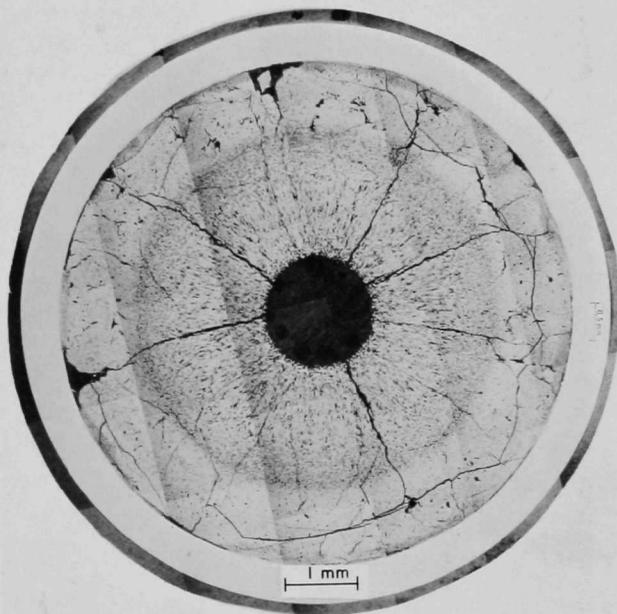
Fig. 35. Transverse Section of G-7 Shown in Fig. 34 after Regrinding and Polishing. MSD Neg. No. 182652.

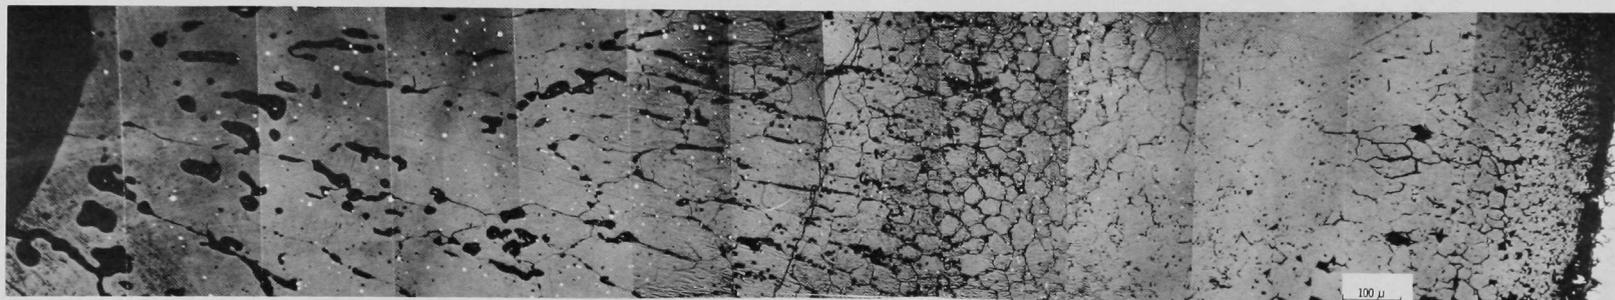
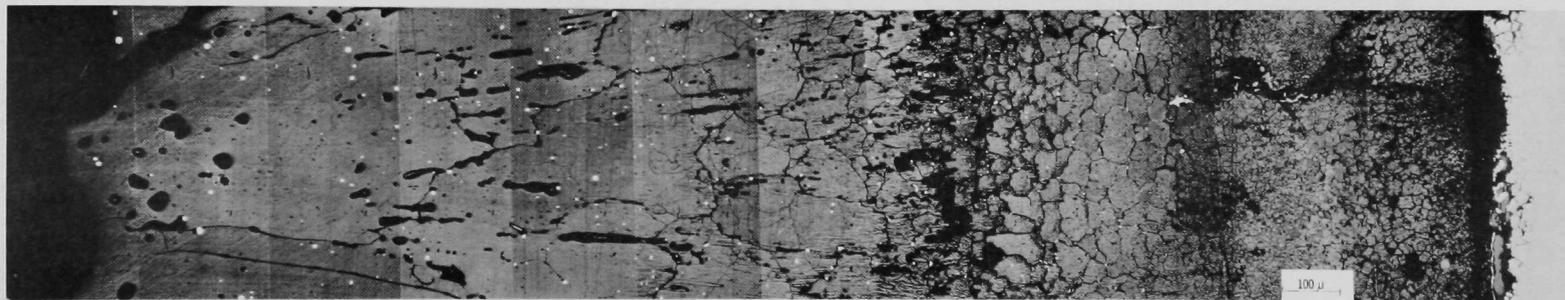
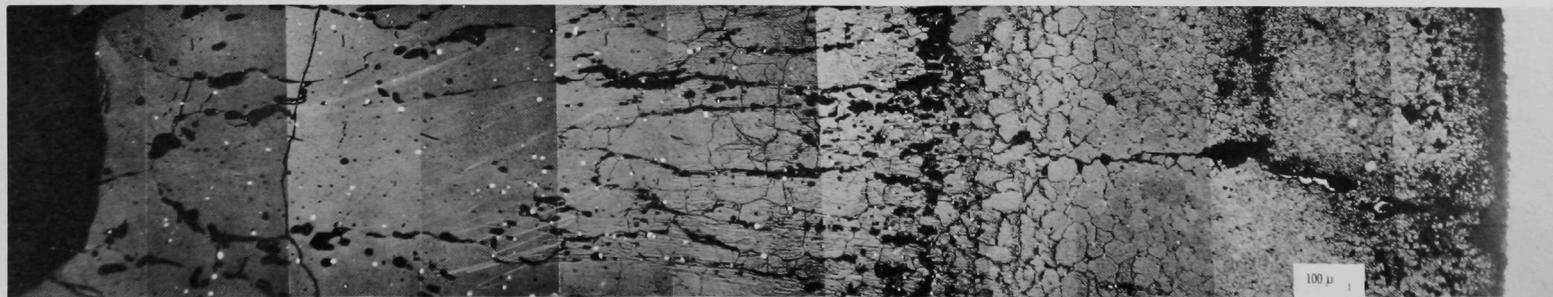
Fig. 36. Microstructure of Radial Strips of Fuel from Pin G-1 after Chemical Etching in a Solution of 10%  $\text{H}_2\text{SO}_4$  and 90%  $\text{H}_2\text{O}_2$ . (a) Radial strip of fuel 11.3 in. above the bottom of the fuel column. (b) Radial strip of fuel 6.75 in. above the bottom of the fuel column. (c) Radial strip of fuel 3.25 in. above the bottom of the fuel column. MSD Neg. No. 169257.

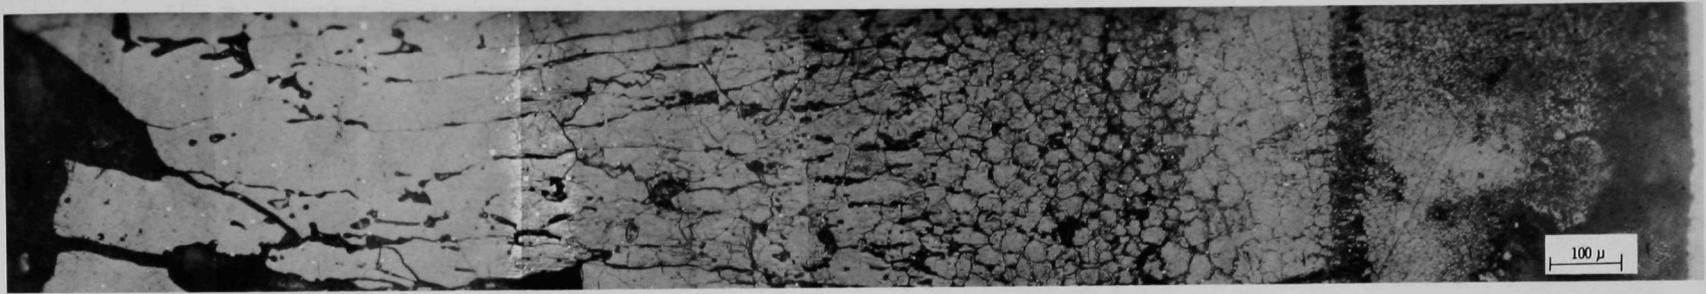
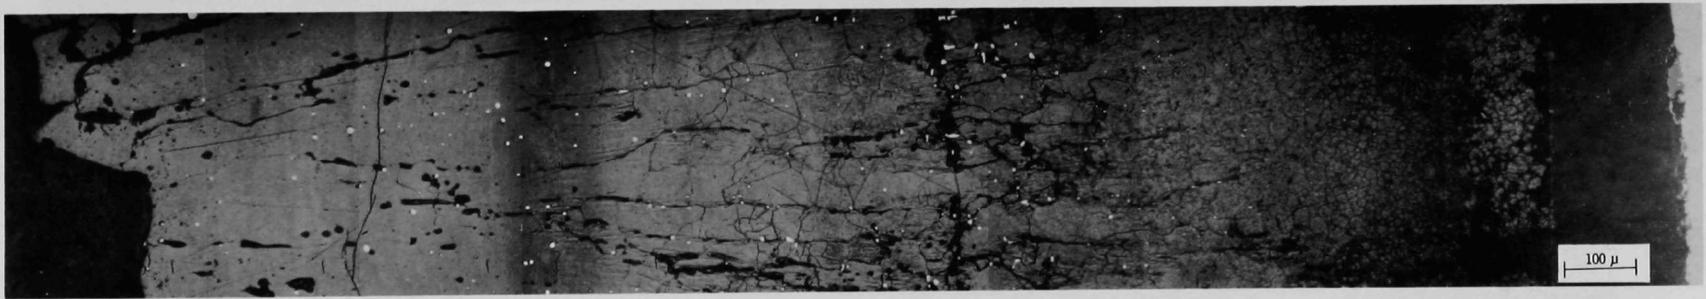
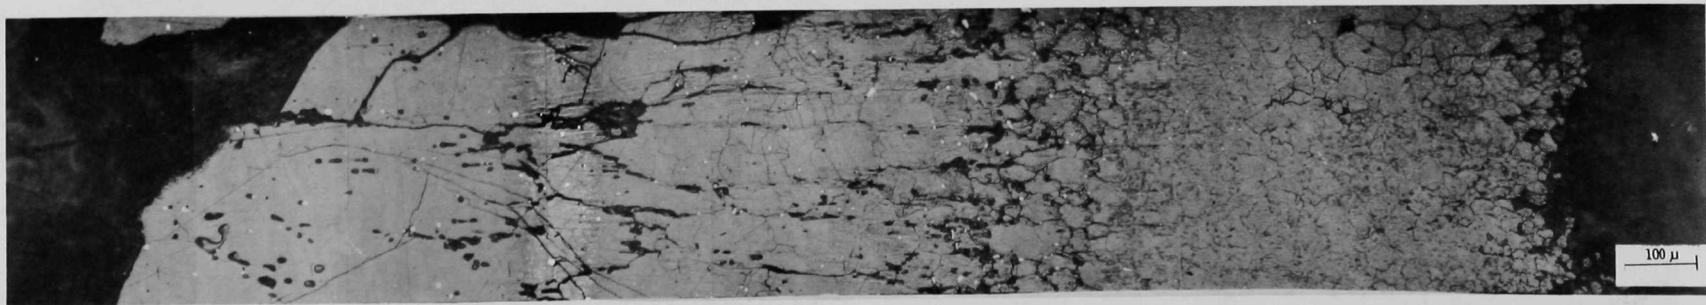
Fig. 37. Microstructure of Radial Strips of Fuel from Pin G-2 after Chemical Etching in a Solution of 10%  $\text{H}_2\text{SO}_4$  and 90%  $\text{H}_2\text{O}_2$ . (a) Radial fuel strip 11 $\frac{1}{4}$  in. above the core bottom. (b) Radial fuel strip at core midplane. (c) Radial fuel strip 3 $\frac{1}{4}$  in. above the core bottom. MSD Neg. No. 181893.

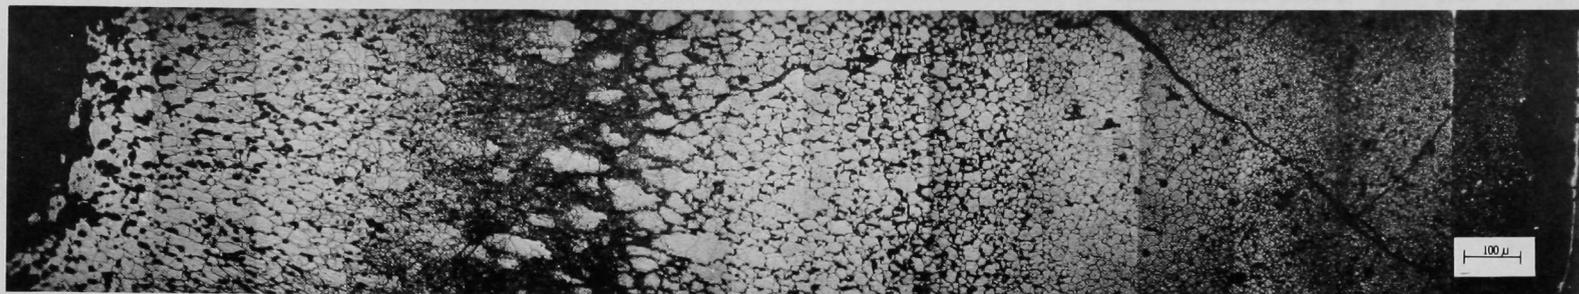
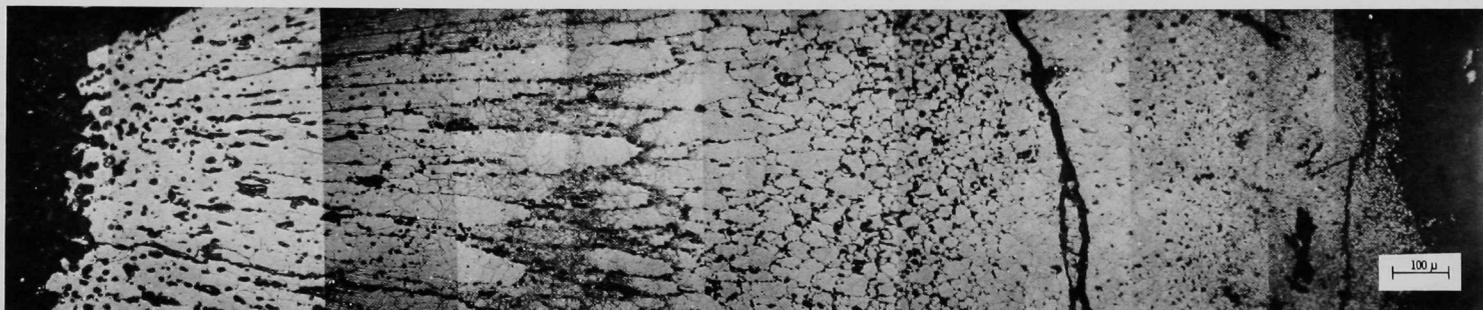
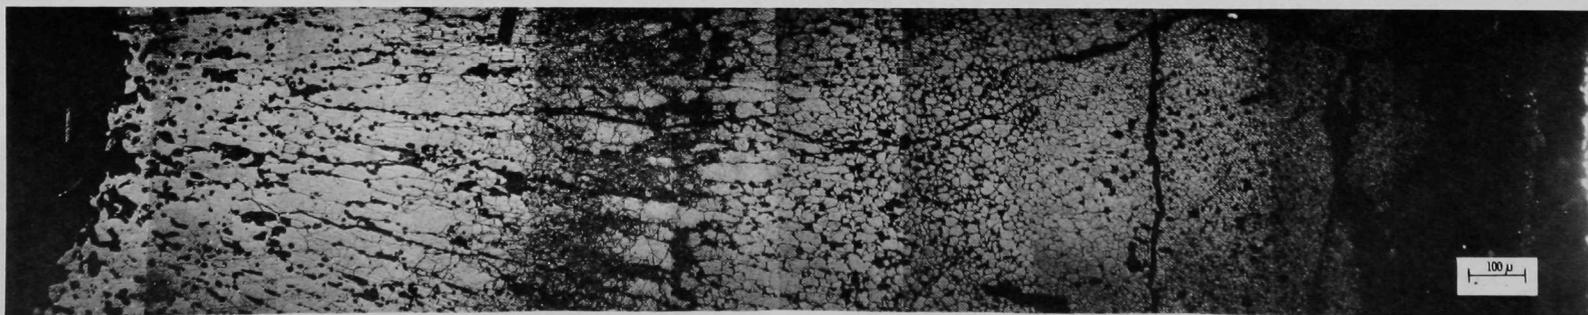
Fig. 38. Microstructure of Radial Strips of Fuel from Pin G-6 after Chemical Etching in a Solution of 10%  $\text{H}_2\text{SO}_4$  and 90%  $\text{H}_2\text{O}_2$ . (a) Radial strip of fuel 11.15 in. above the bottom of the fuel column. (b) Radial strip of fuel 6.75 in. above the bottom of the fuel column. (c) Radial strip of fuel 3.25 in. above the bottom of the fuel column. MSD Neg. No. 169959.

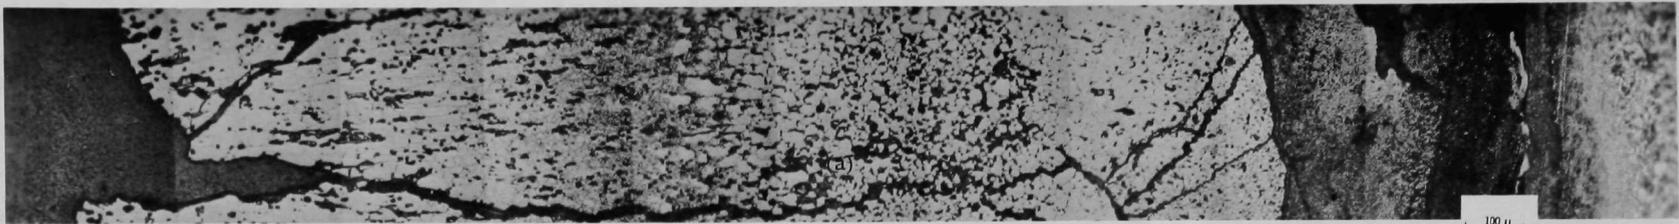
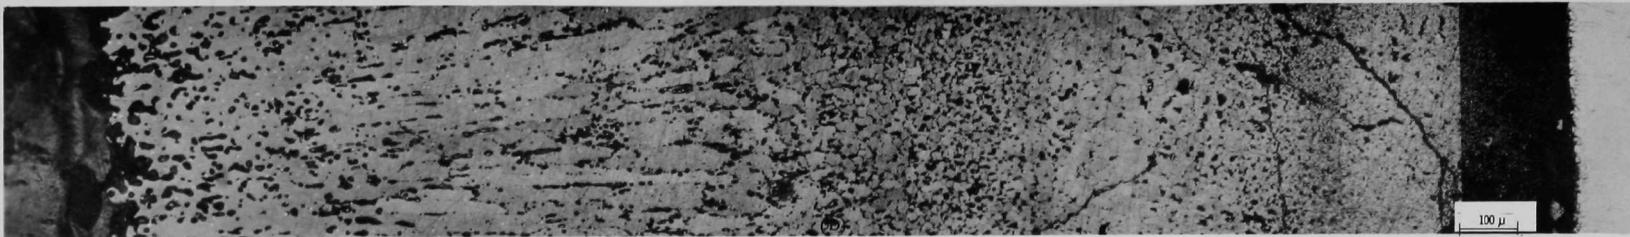
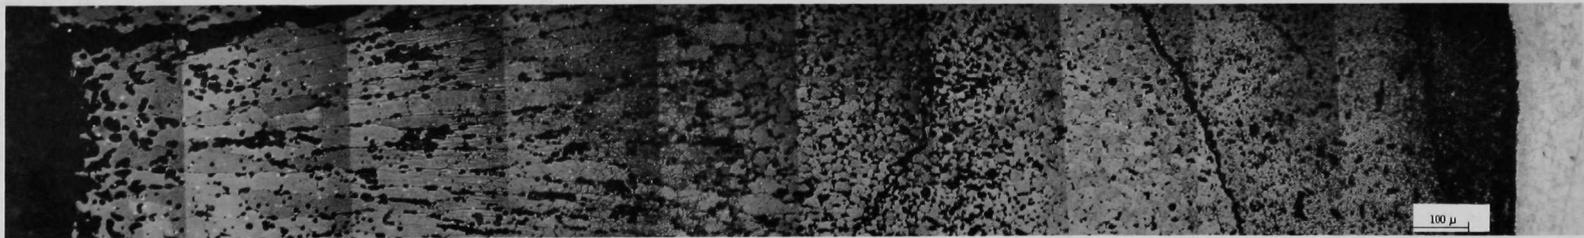
Fig. 39. Microstructure of Radial Strips of Fuel from Pin G-7 after Chemical Etching in a Solution of 10%  $\text{H}_2\text{SO}_4$  and 90%  $\text{H}_2\text{O}_2$ . (a) Radial fuel strip  $11\frac{1}{4}$  in. above the core bottom. (b) Radial fuel strip at core midplane. (c) Radial fuel strip  $3\frac{1}{4}$  in. above the core bottom. MSD Neg. No. 182655.

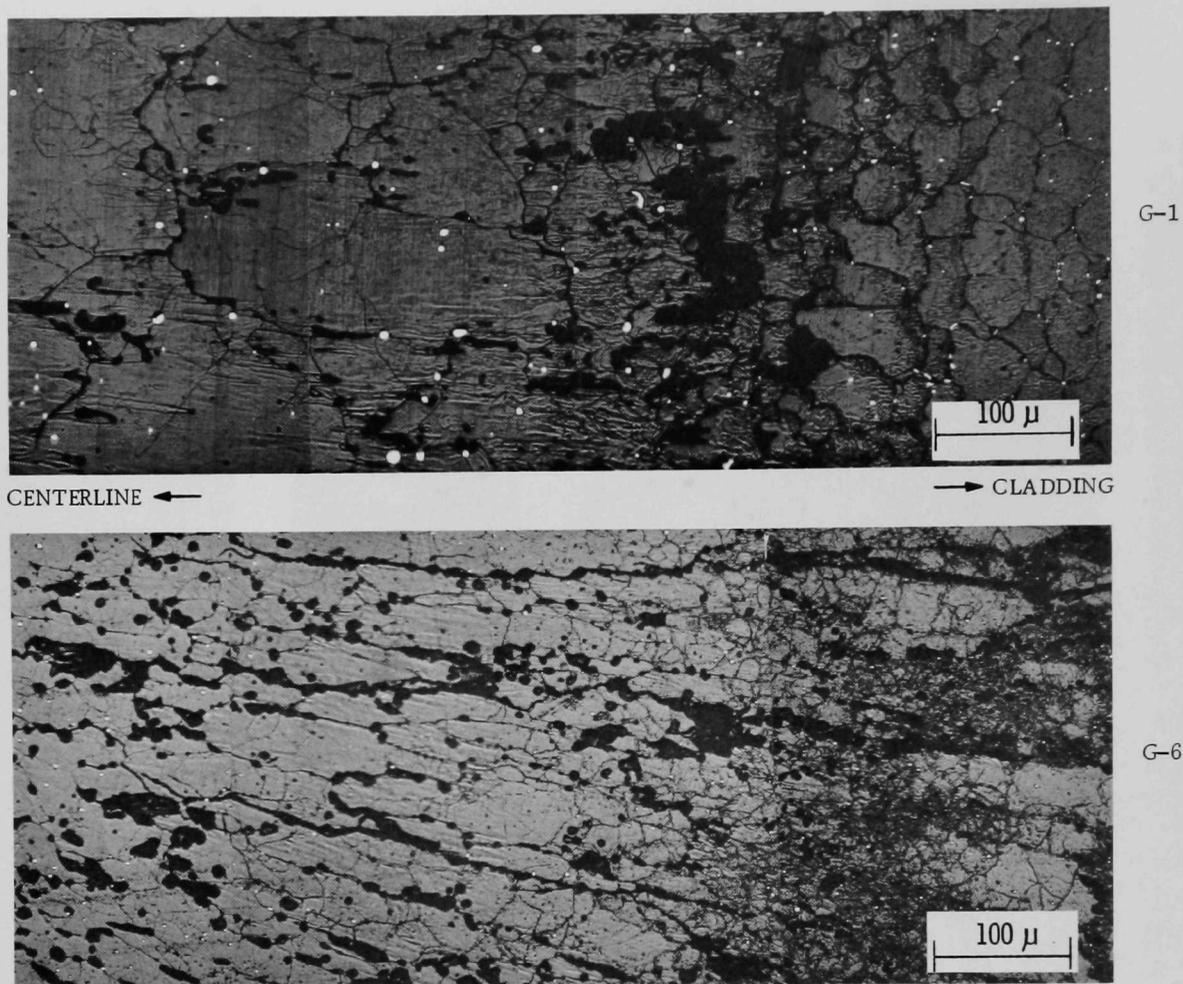
Fig. 40. Bubble Tracks in the Fuel from Pins G-1 and G-6, Indicating that the Bubbles Are Moving in Opposite Directions. MSD Neg. Nos. 169041-169044 (G-1); 169729-169732 (G-6).

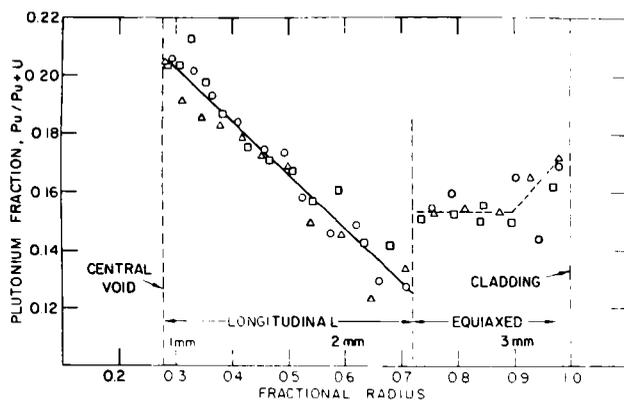
The radial distribution of Pu in the fuel cross section at the core midplane for fuel pin G-1 is shown in Fig. 41. The distribution of Pu in this cross section is characterized by a linear gradient from the inner edge of the central void to  $\sim 0.7$  of the fuel radius. At this point, the concentration changes suddenly to the approximate nominal composition of 15% Pu. Near the outer edge of the fuel the Pu composition also is higher than the nominal composition. The Pu content at the edge of the central void was  $\sim 20\%$ , and

Fig. 41. Radial Plutonium Distribution at the Core Midplane of G-1. MSD Neg. No. 63962.

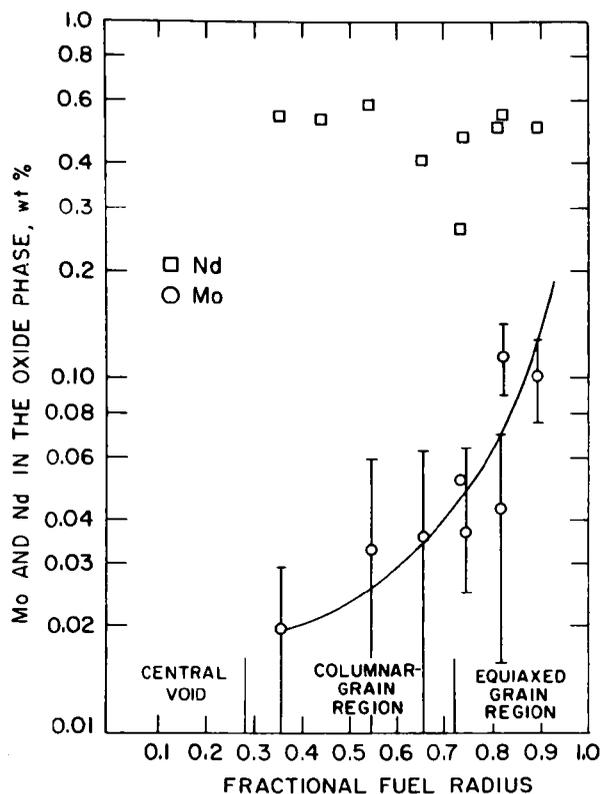
Fig. 44. Radial Mo and Nd Distribution in the Oxide Phase of the Fuel at the Core Midplane of G-1. MSD Neg. No. 63961.

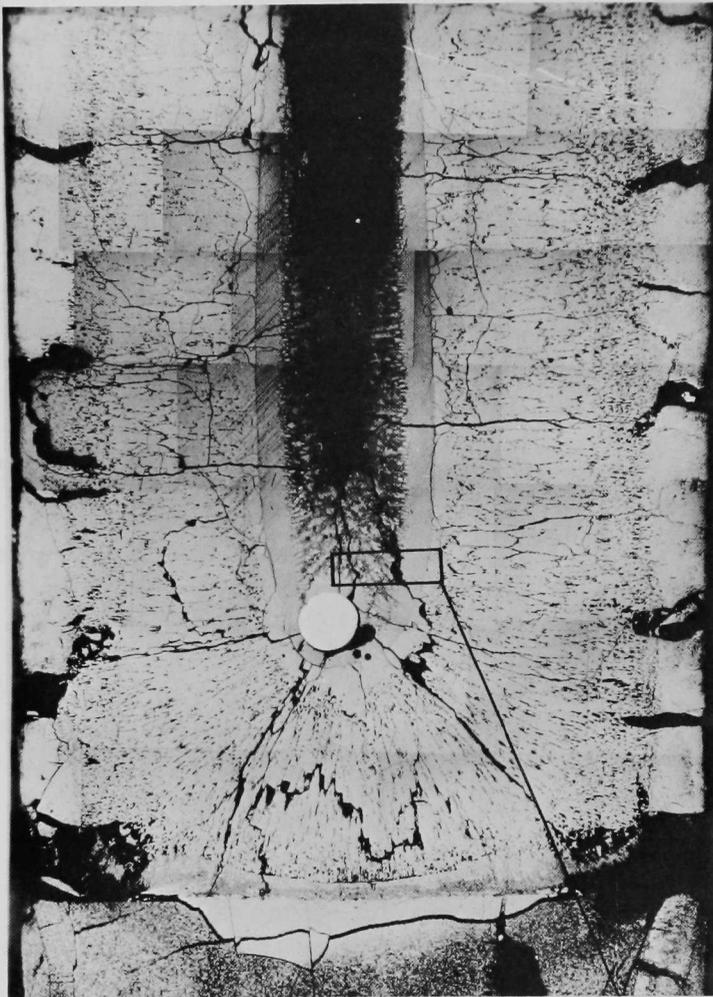
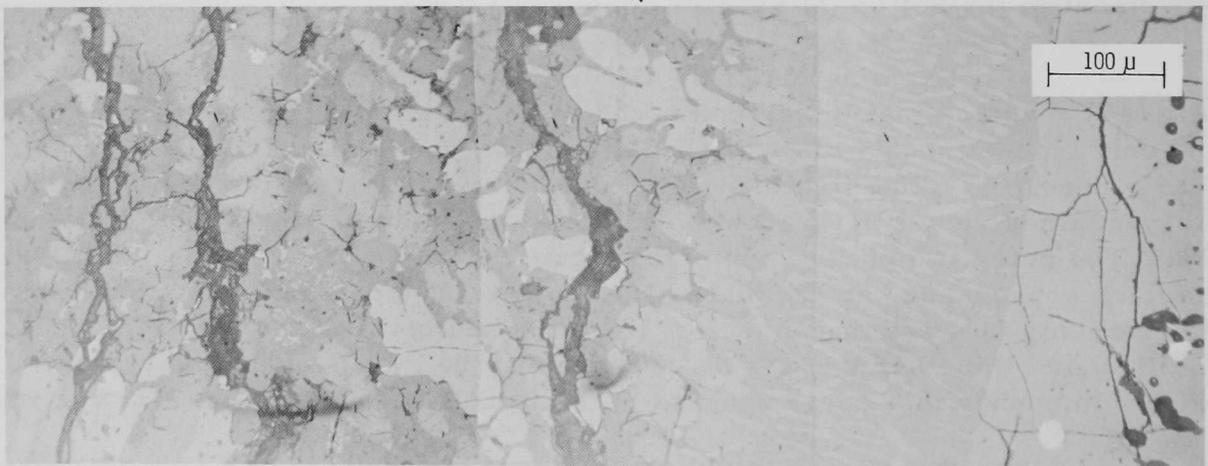
Fig. 45. Fuel Microstructure near the Bottom of the Fuel Column of G-1. MSD Neg. No. 181755.

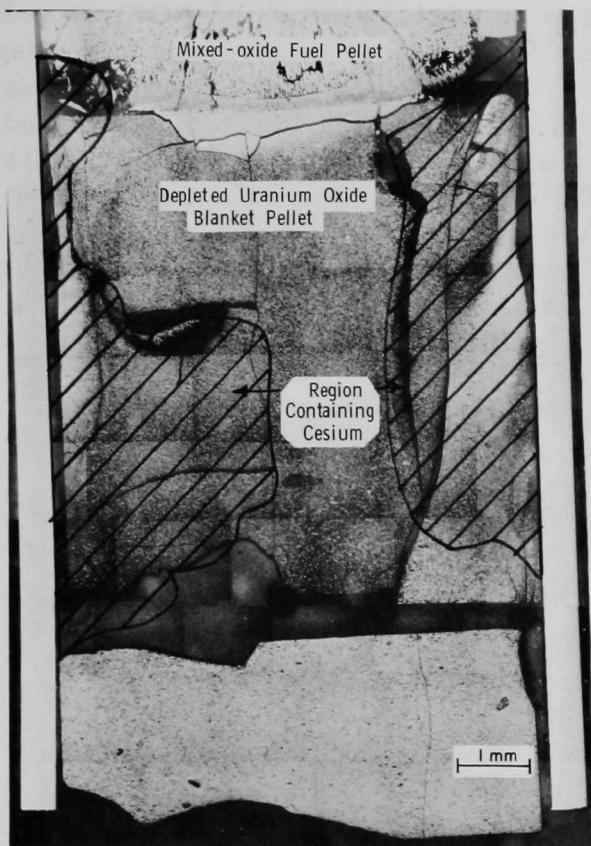
Fig. 46. Areas Containing High Cs Concentrations in the Blanket Pellet Adjacent to the Bottom of the G-1 Fuel Column. MSD Neg. No. 168786.

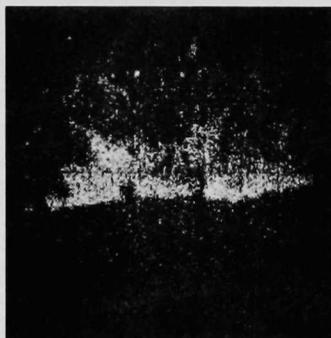
b. Cesium

c. Tellurium

g. Uranium-Plutonium

h. Manganese

The x-ray images from two regions of the deepest FCCI from G-1 are shown in Figs. 52 and 53. These results show a depletion of Fe and Ni and an enhancement of Cr, Mn, and Cs in the FCCI zone. Trace amounts of I and Te were also observed in the attack zone. No Mo was found in this zone, which is unusual when compared with previous postirradiation results. The FCCI in this section appears to be intergranular at its leading edge, but entire grains (matrix attack) near the fuel-cladding interface have been consumed or lost during sample preparation.

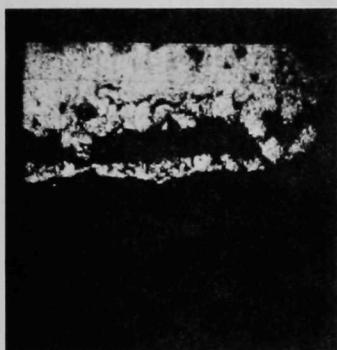
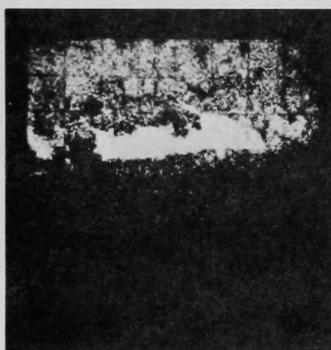
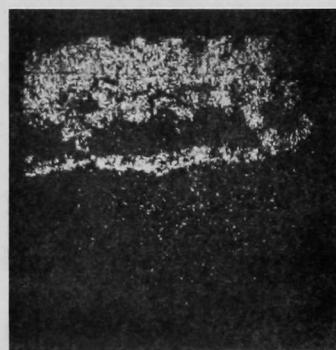
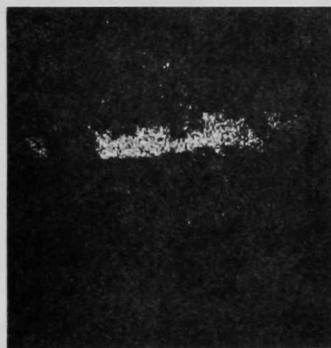
b. Cesium

c. Tellurium

d. Iron

e. Chromium

f. Nickel

g. Uranium-Plutonium

h. Manganese

i. Iodine

Fig. 53. Electron-microprobe Scanning Images of GA Fuel Pin G-1 from a Second Location on the Sample. All images  $190 \mu\text{m}^2$ . ANL Neg. No. 308-3862.

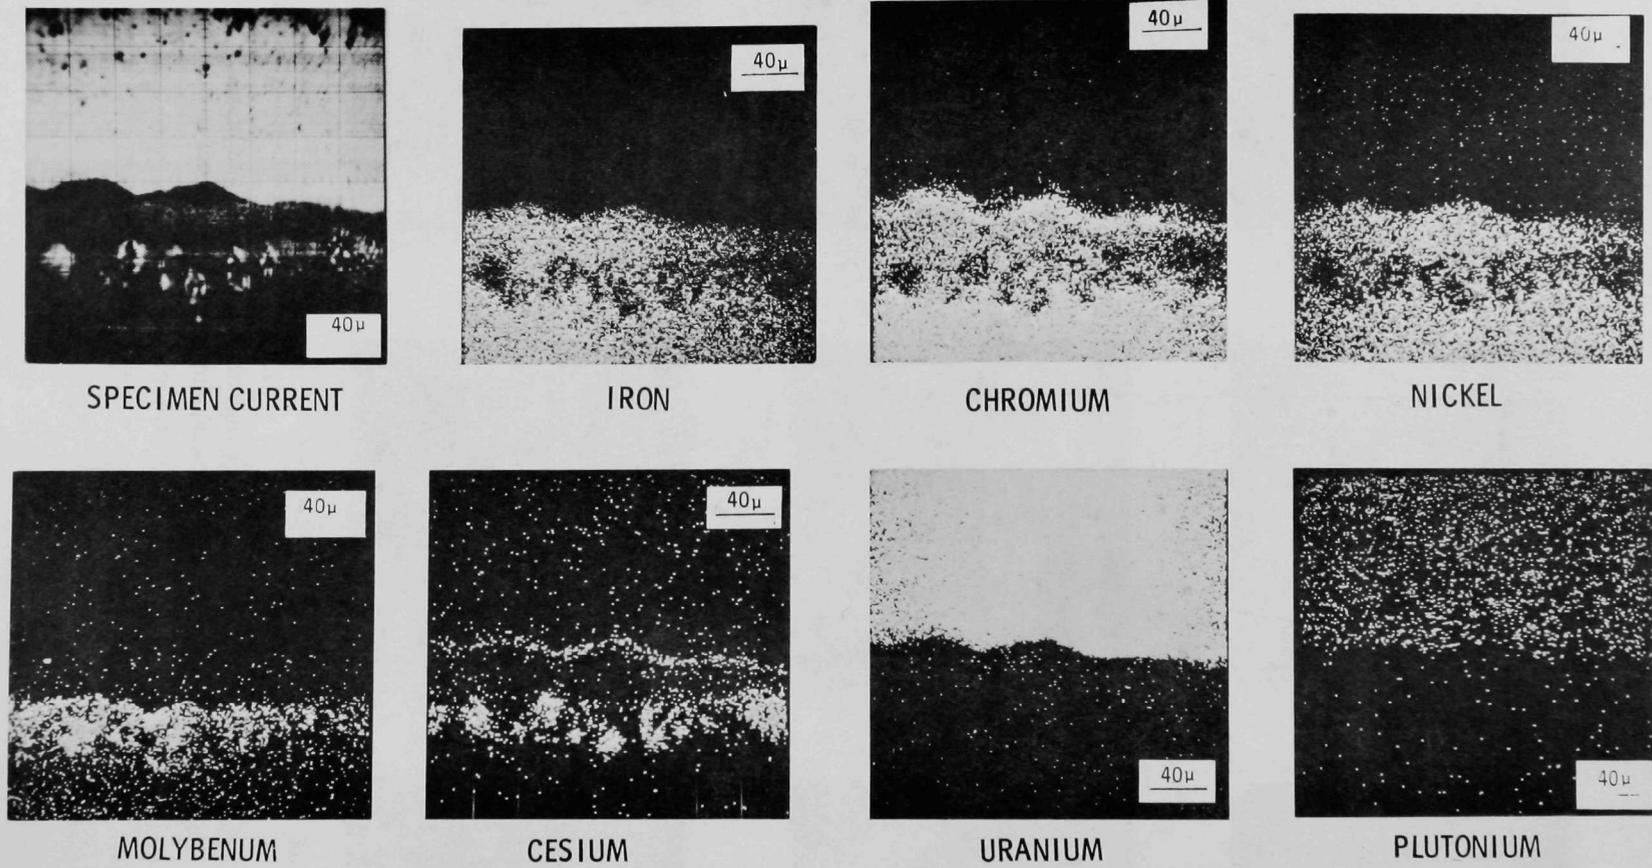
Fig. 54. Electron-microprobe Scanning Images of Typical FCCI at Core Midplane of G-6. MSD Neg. No. 181578.

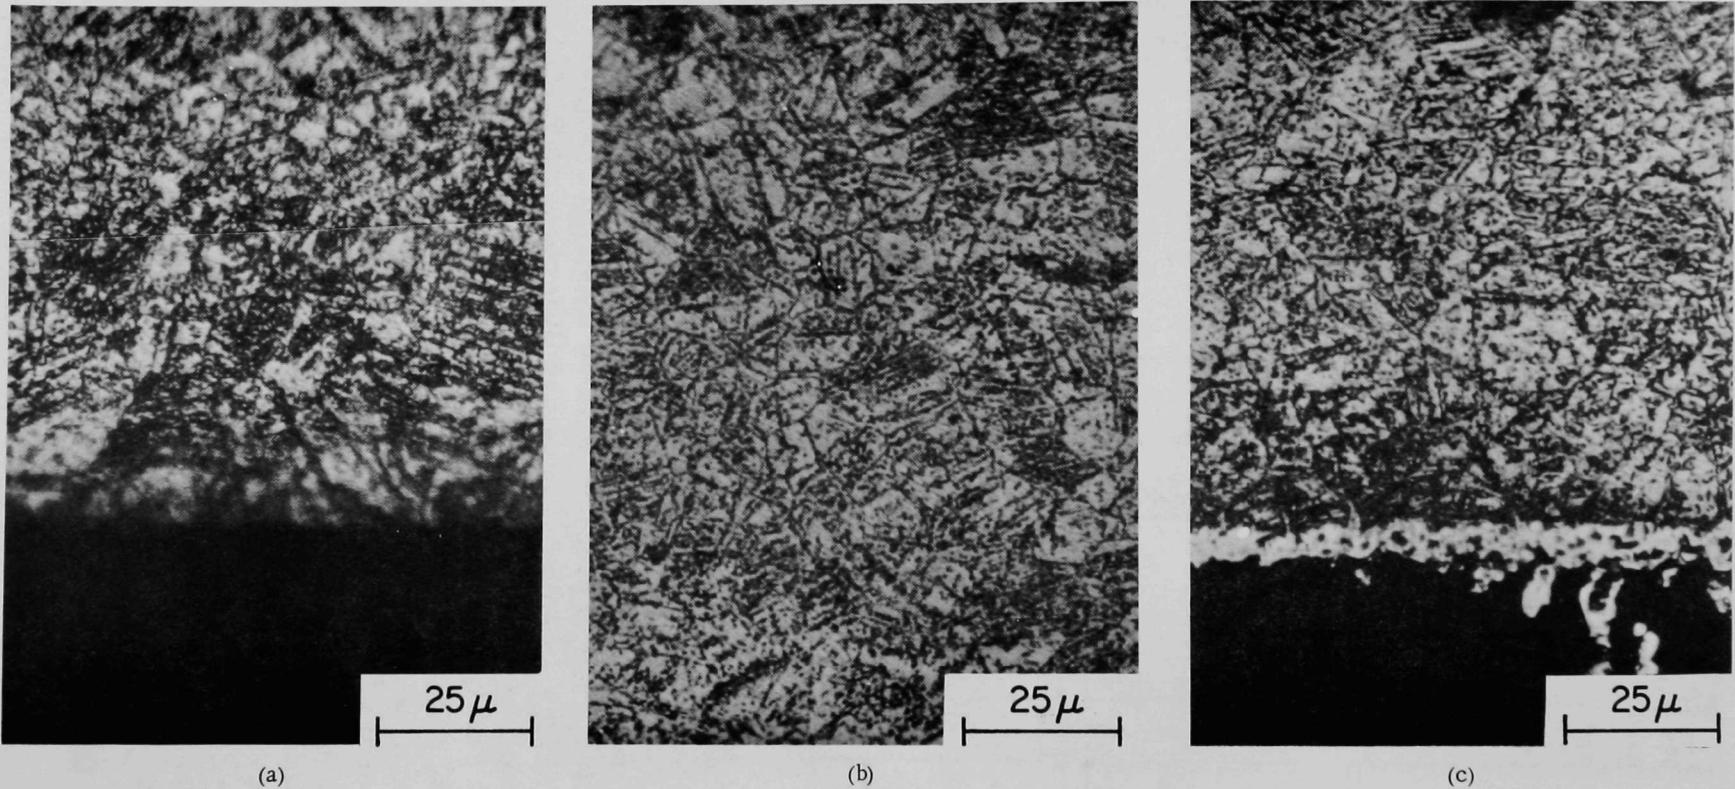
Fig. 56. Cladding Microstructure 3.3 in. above the Bottom of Core in G-1. Sample was electroetched in 5% HCl in methanol. (a) Cladding OD. MSD Neg. No. 169152. (b) Cladding midwall. MSD Neg. No. 169149. (c) Cladding ID. MSD Neg. No. 169148.
