**POSTIRRADIATION EXAMINATIONS OF FUEL PINS  
FROM THE GCFR F-1 SERIES  
OF MIXED-OXIDE FUEL PINS  
AT 5.5 at. % BURNUP**

ANL-76-129

POSTIRRADIATION EXAMINATIONS OF FUEL PINS  
FROM THE GCFR F-1 SERIES  
OF MIXED-OXIDE FUEL PINS  
AT ~5.5 at. % BURNUP

Materials Science Division

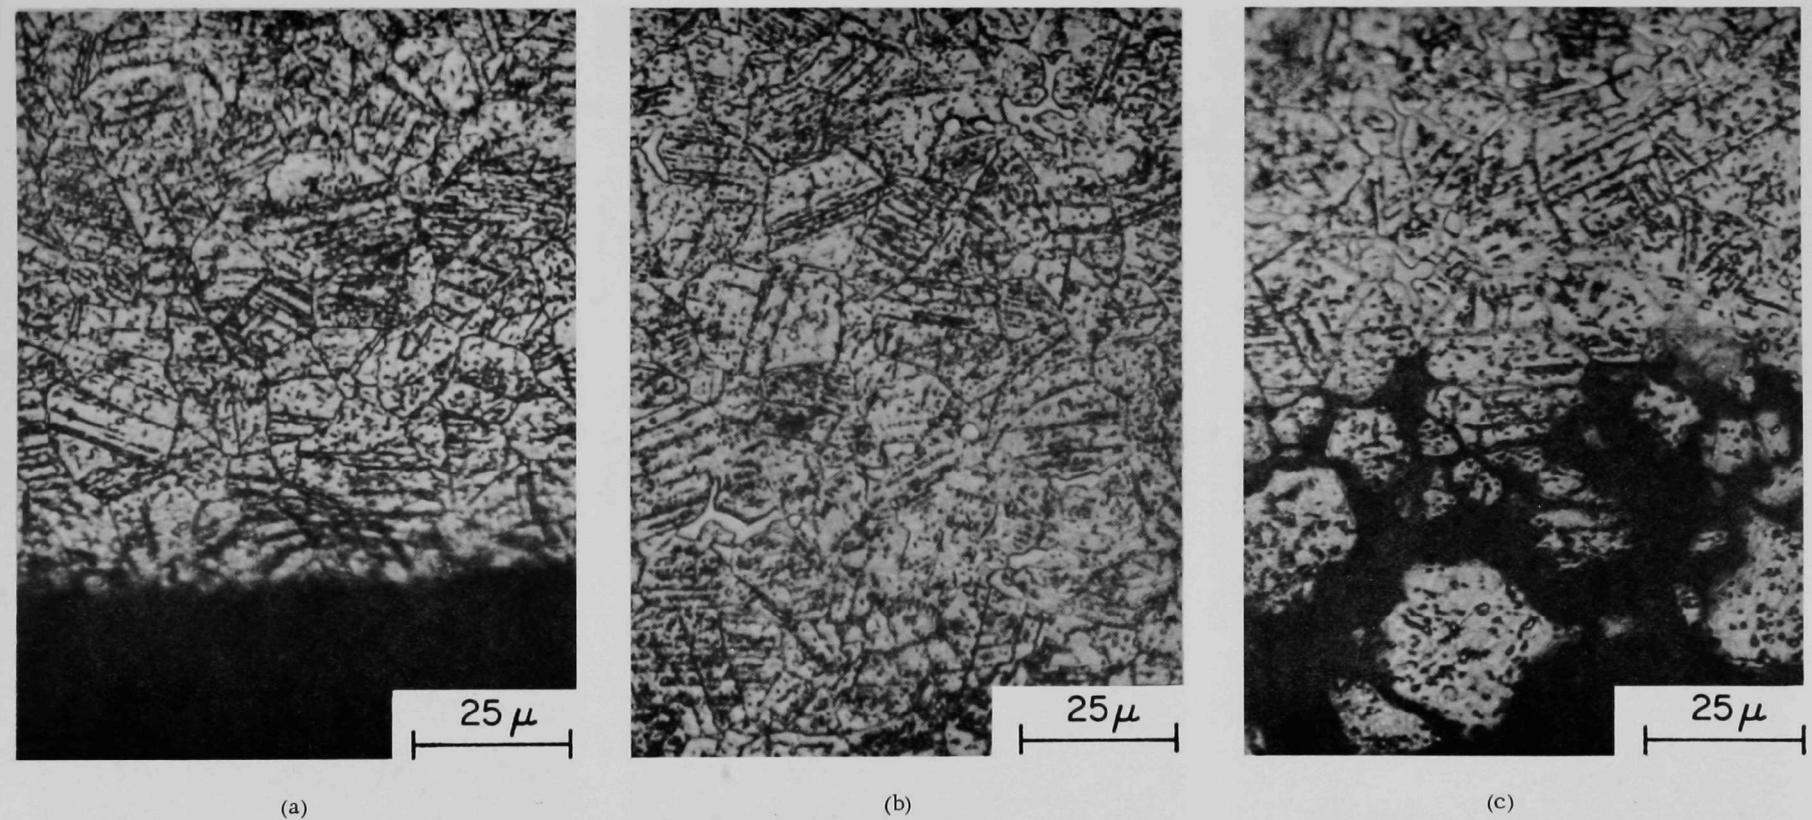
Fig. 57. Cladding Microstructure 6.75 in. above the Bottom of Fuel Column G-1. Sample was electroetched in 5% HCl in methanol. (a) Cladding OD. MSD Neg. No. 169158. (b) Cladding midwall. MSD Neg. No. 169156. (c) Cladding ID. MSD Neg. No. 169153.

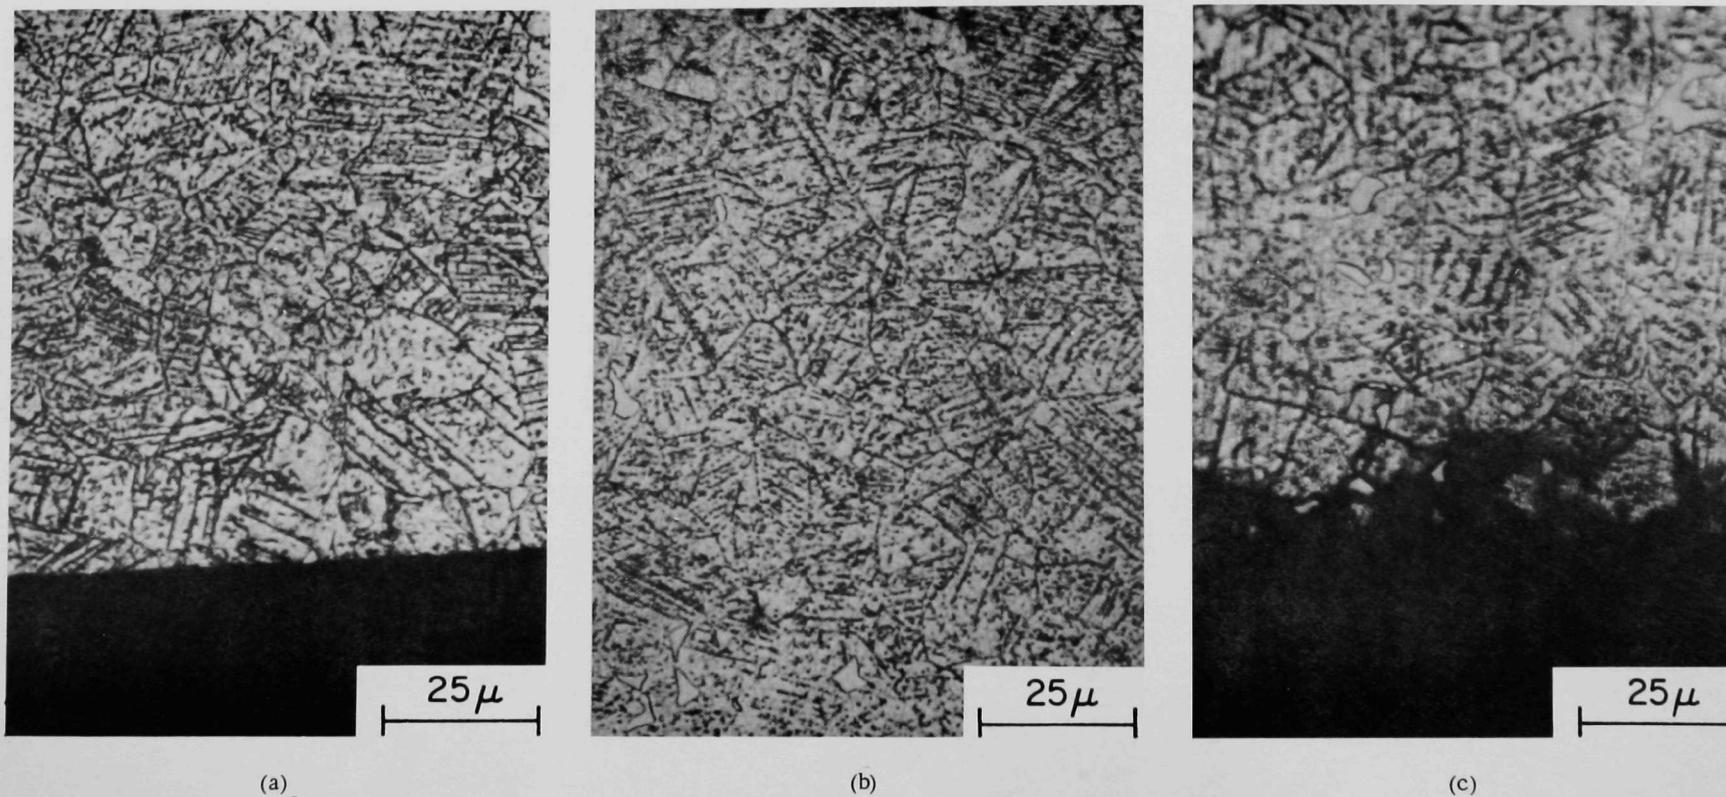
Fig. 58. Cladding Microstructure 11.3 in. above the Bottom of Fuel Column G-1. Sample was electroetched in 5% HCl in methanol. (a) Cladding OD. MSD Neg. No. 169164. (b) Cladding midwall. MSD Neg. No. 169161. (c) Cladding ID. MSD Neg. No. 169159.

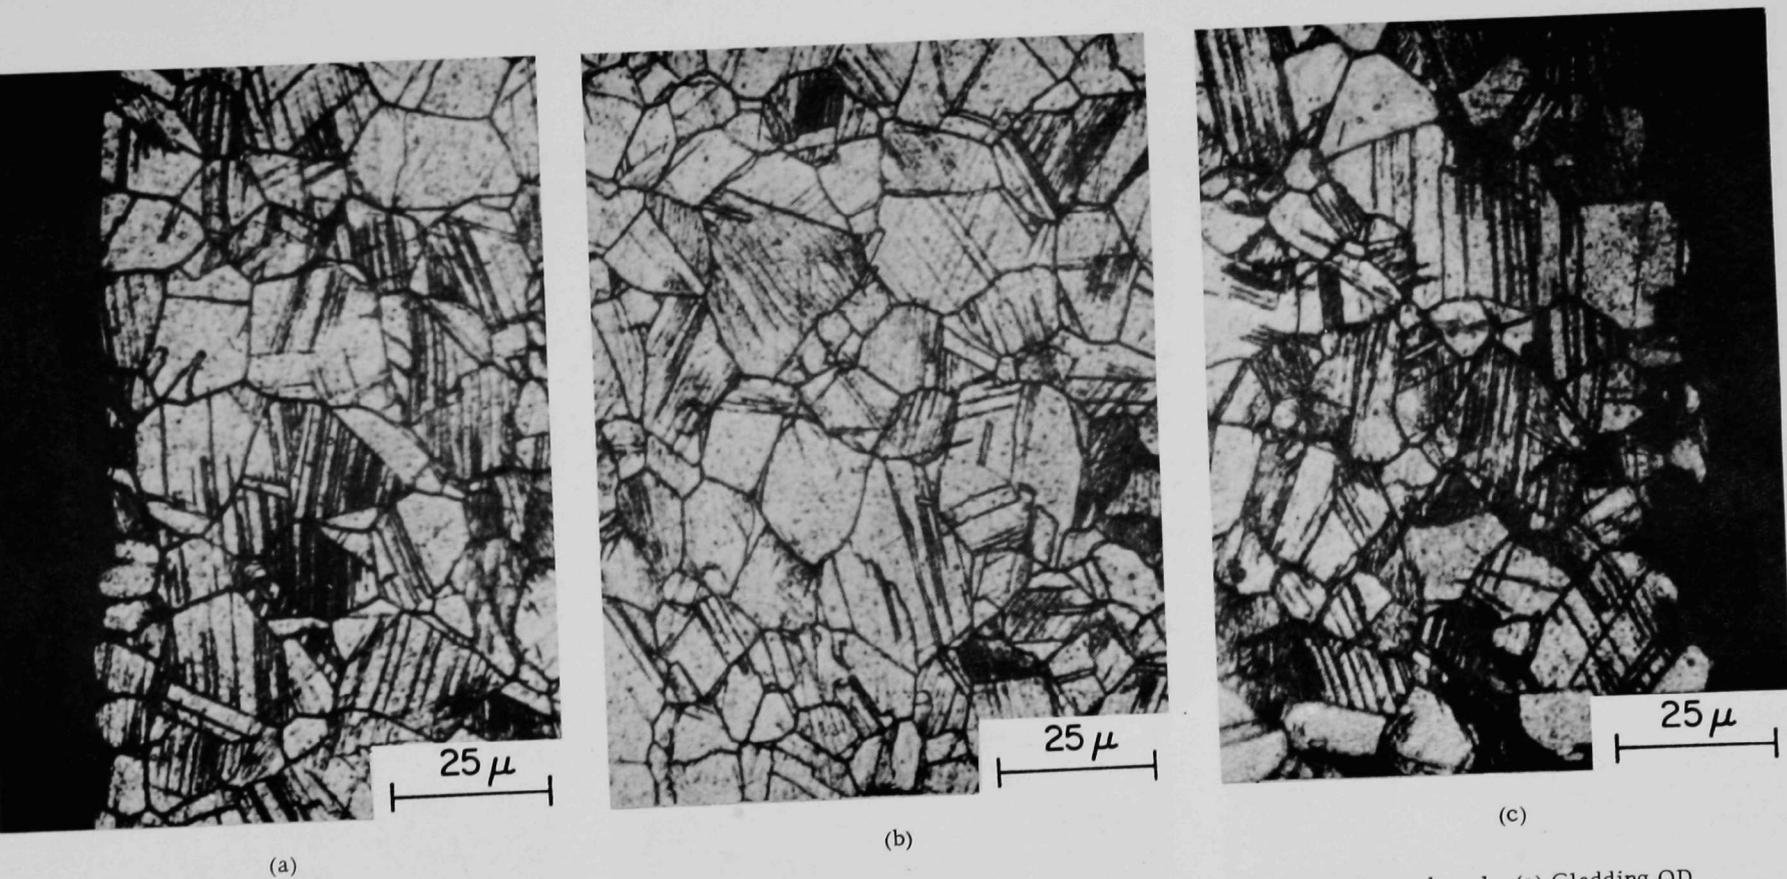
Fig. 59. Cladding Microstructure 3.25 in. above the Bottom of Core in G-6. Sample was electroetched in 5% HCl in methanol. (a) Cladding OD. MSD Neg. No. 169738. (b) Cladding midwall. MSD Neg. No. 169736. (c) Cladding ID. MSD Neg. No. 169734.

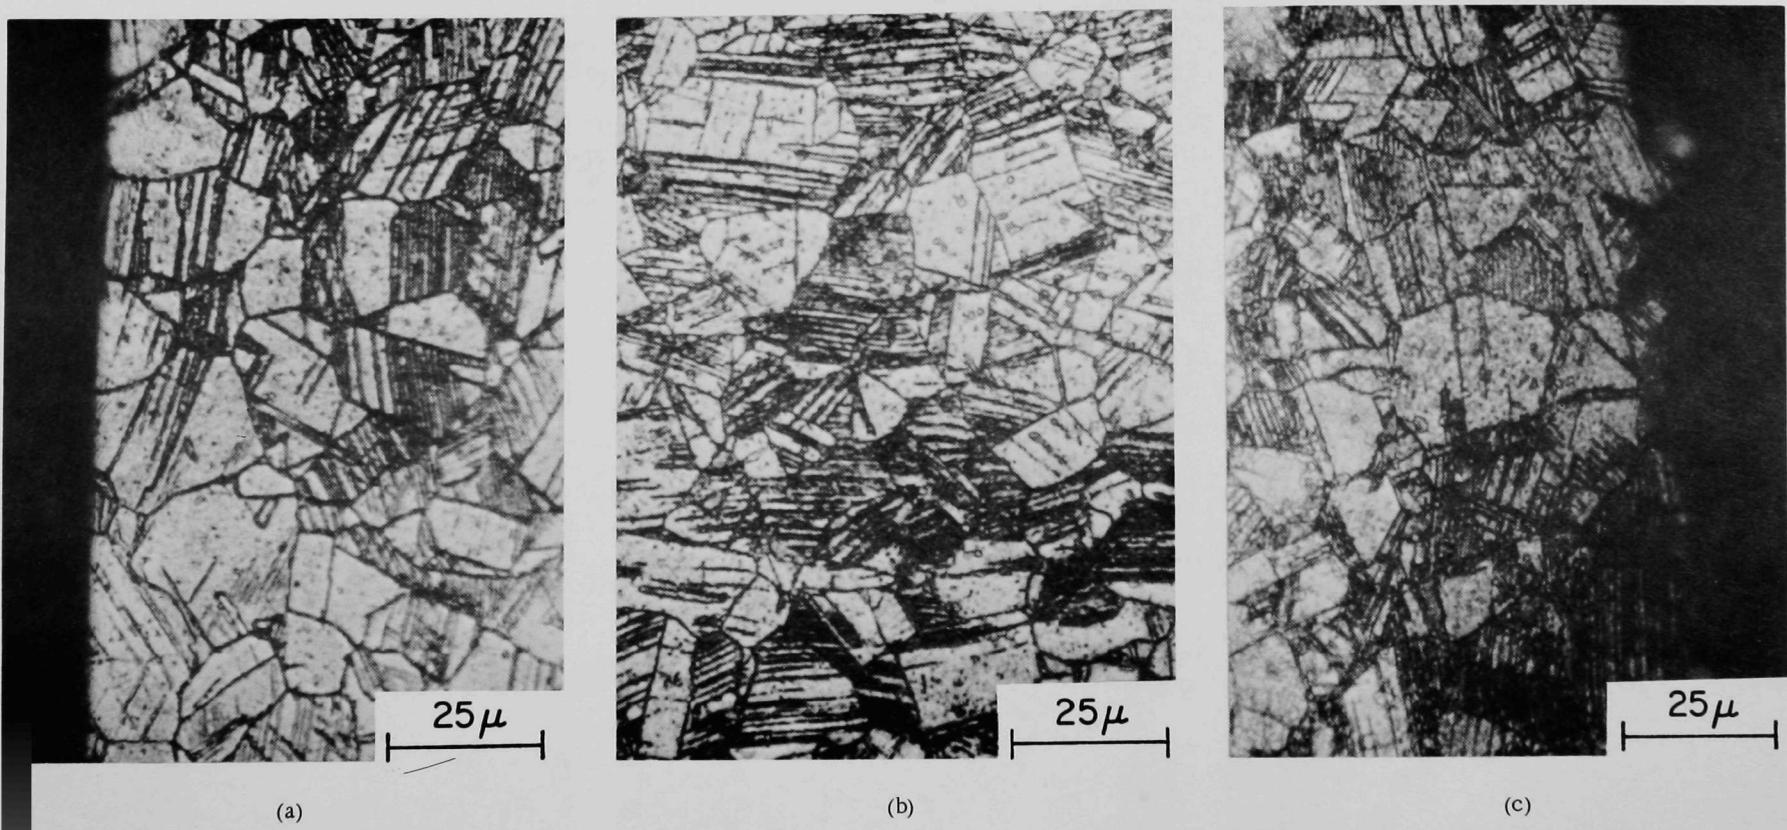
Fig. 60. Cladding Microstructure 6.75 in. above the Bottom of Core in G-6. Sample was electroetched in 5% HCl in methanol. (a) Cladding OD. MSD Neg. No. 169758. (b) Cladding midwall. MSD Neg. No. 169756. (c) Cladding ID. MSD Neg. No. 169753.

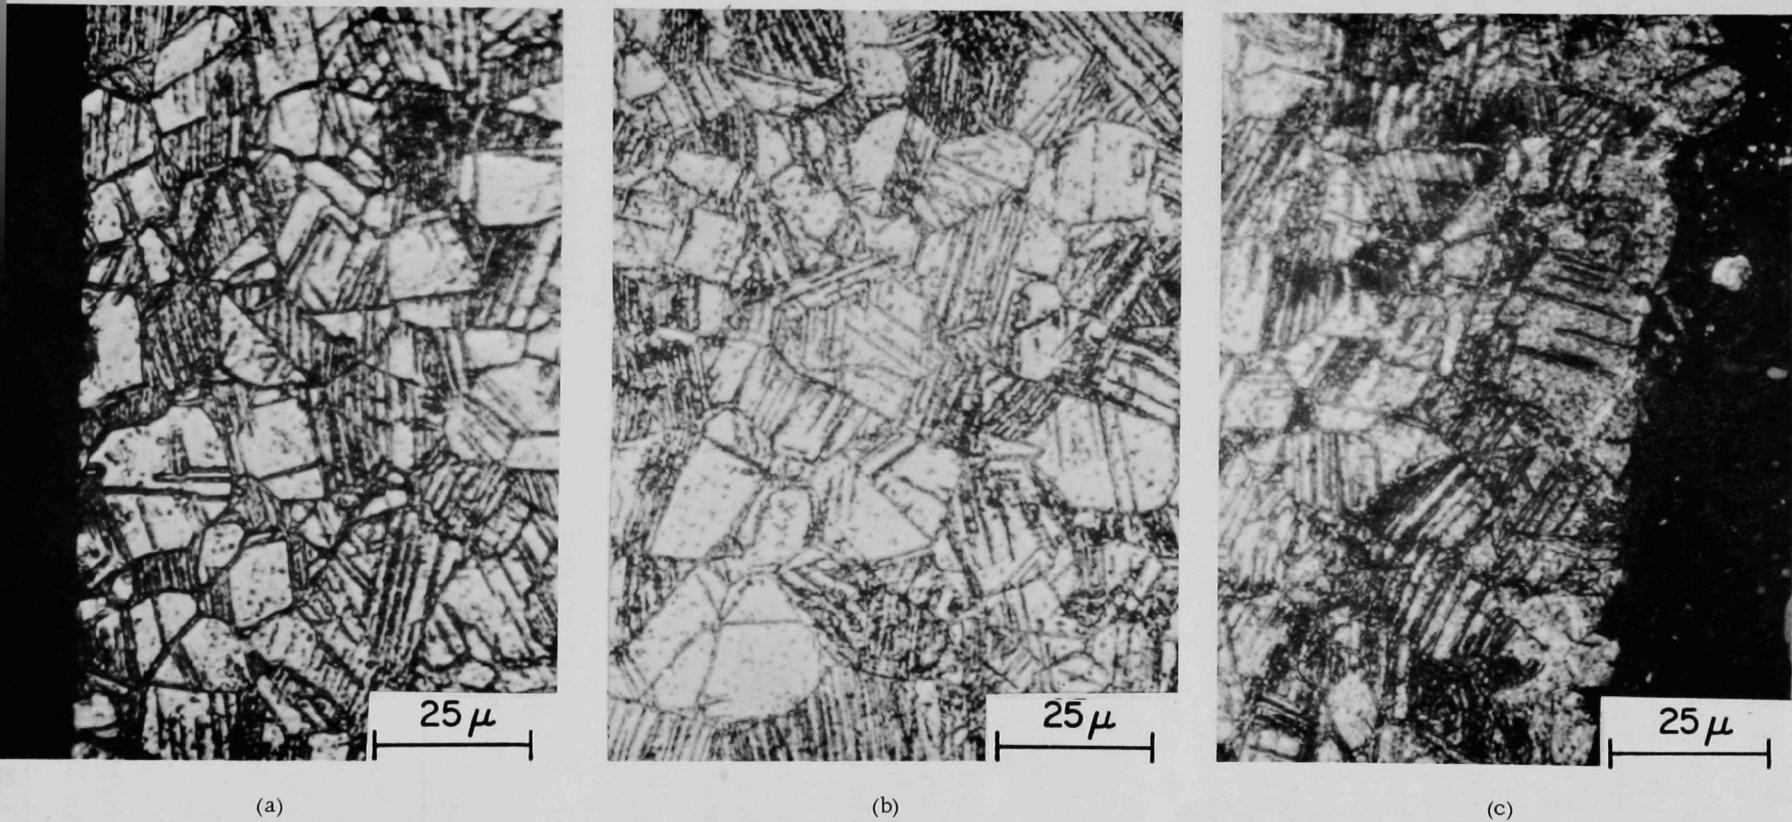
Fig. 61. Cladding Microstructure 11.15 in. above the Bottom of Core in G-6. Sample was electroetched in 5% HCl in methanol. (a) Cladding OD. MSD Neg. No. 169781. (b) Cladding midwall. MSD Neg. No. 169779. (c) Cladding ID. MSD Neg. No. 169776.

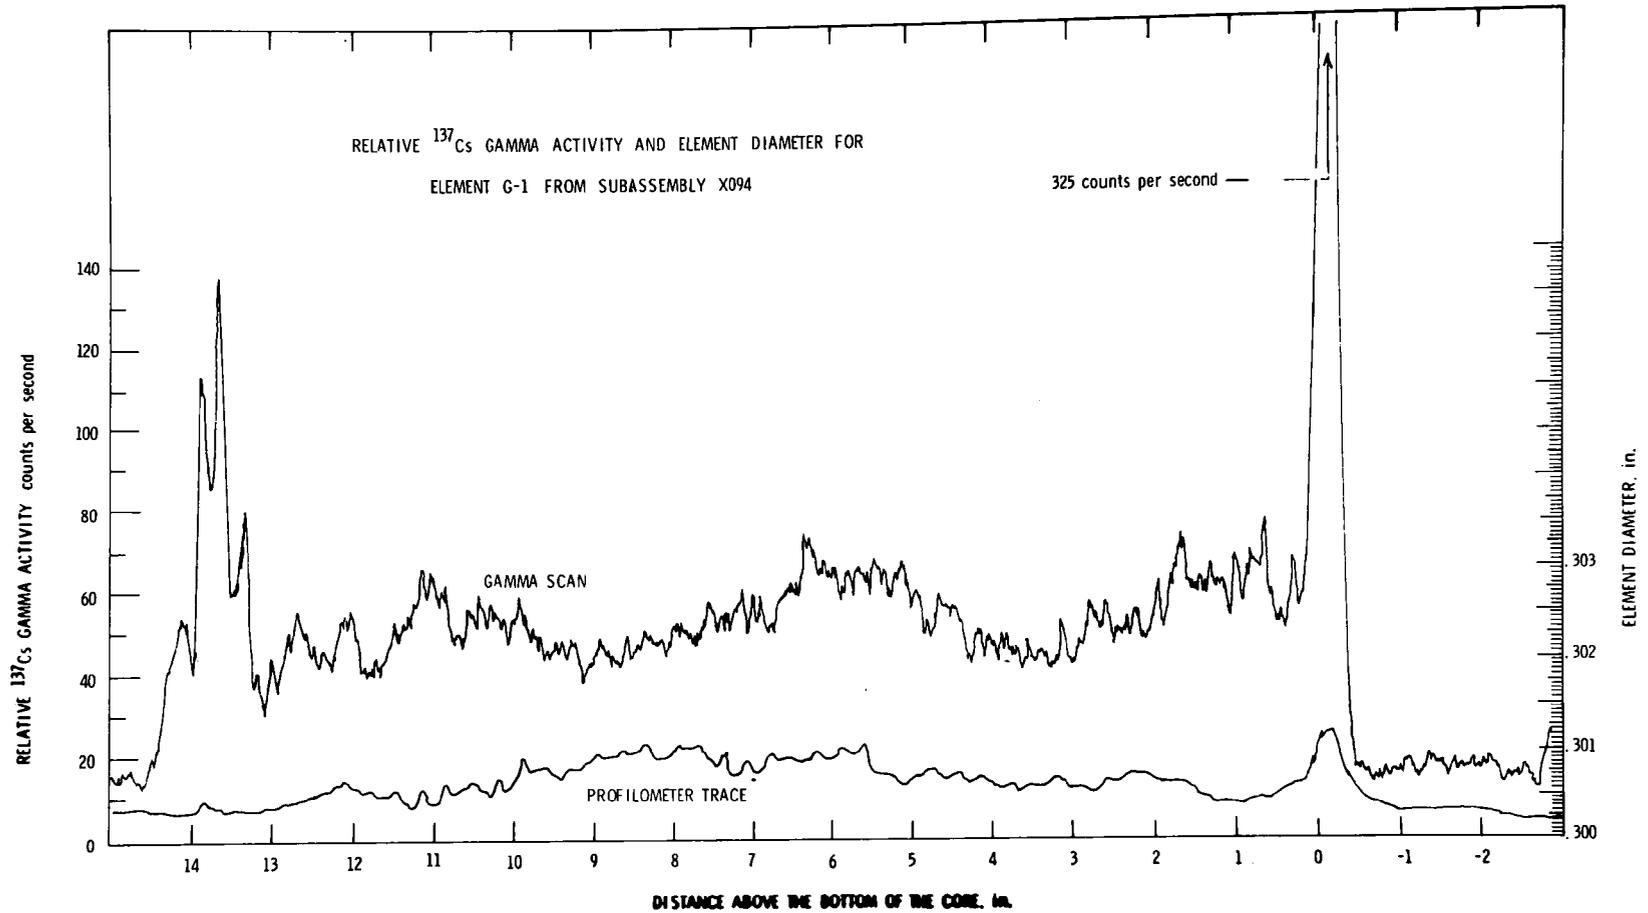
Fig. 62. Relative Axial  $^{137}\text{Cs}$  Gamma Activity and the Axial Diametral Profile of Pin G-1 Showing a Local Cladding Diametral Increase at the Same Axial Location as the Peak in the  $^{137}\text{Cs}$  Activity near the Bottom Fuel-Blanket Interface. MSD Neg. No. 182439.

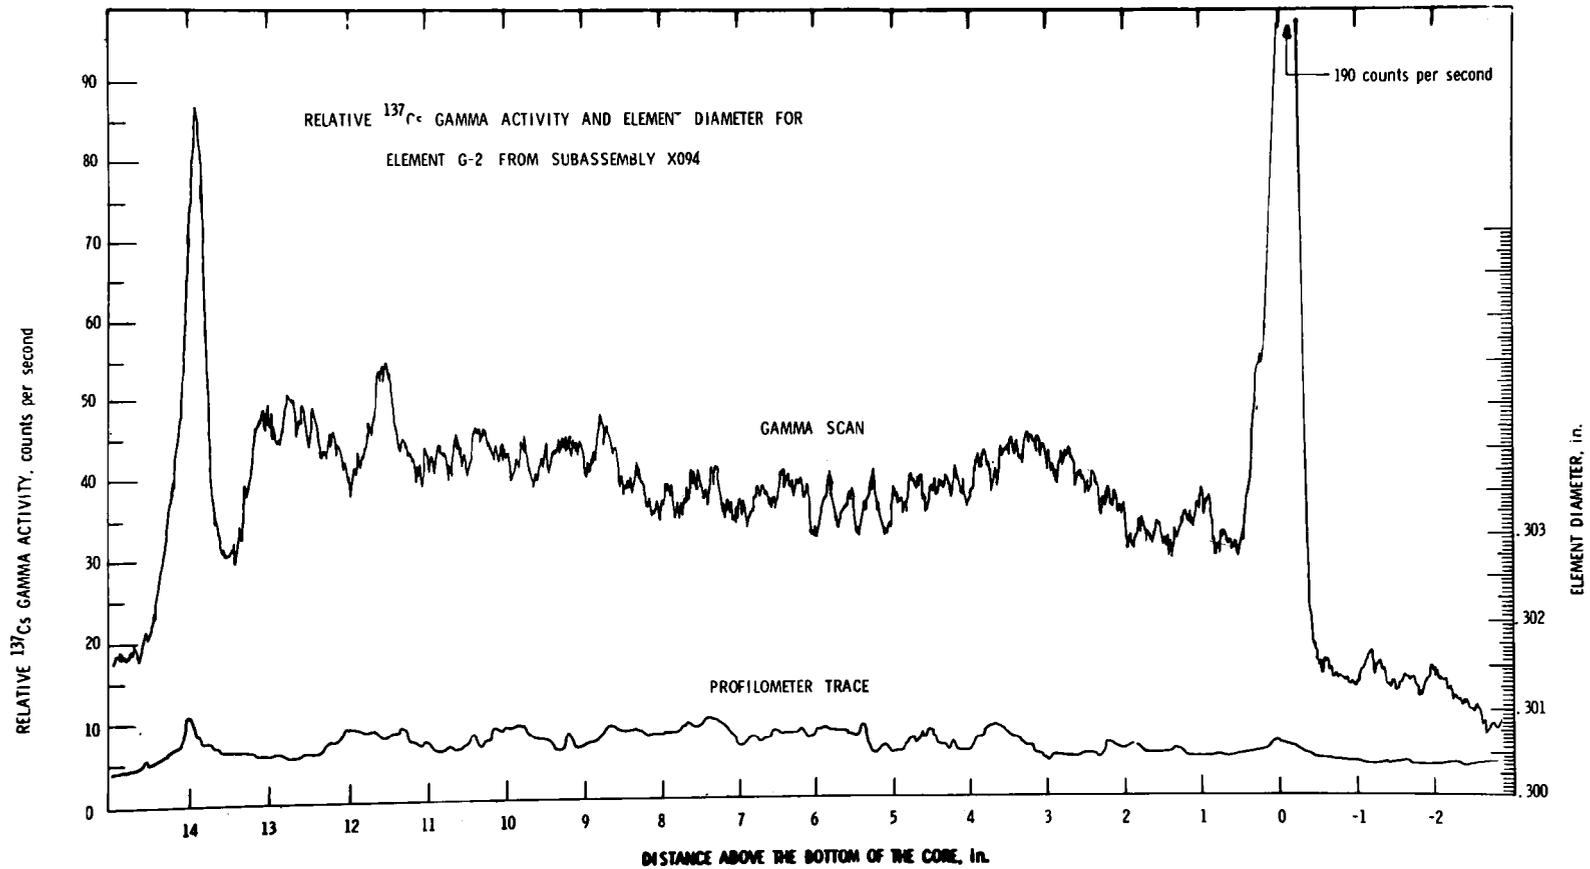
Fig. 63. Relative Axial  $^{137}\text{Cs}$  Gamma Activity and the Axial Diametral Profile for Pin G-2 Showing a Local Cladding Diametral Increase at the Same Axial Location as the Peak in the  $^{137}\text{Cs}$  Activity near the Top Fuel-Blanket Interface. MSD Neg. No. 182442.

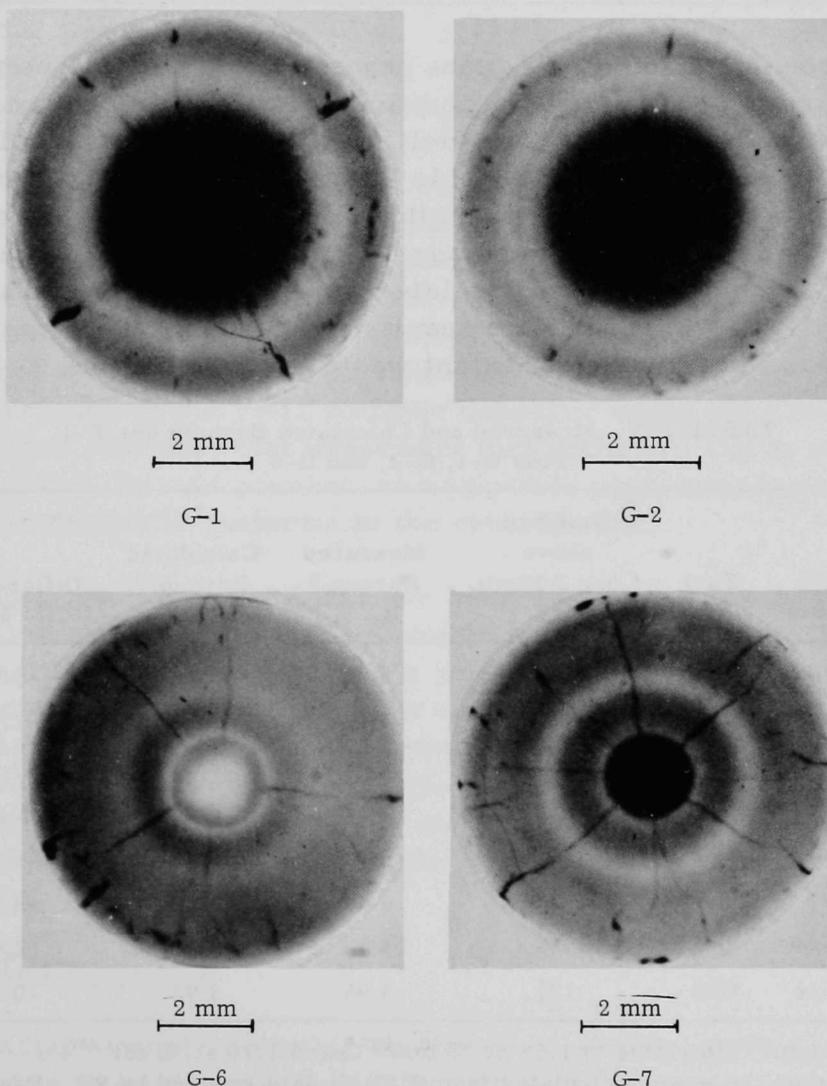
Fig. 64. Beta-Gamma Autoradiographs of the Midplane Cross Section from Fuel Pins G-1, G-2, G-6, and G-7. The dark areas represent areas of lower radioactivity. MSD Neg. No. 185614.

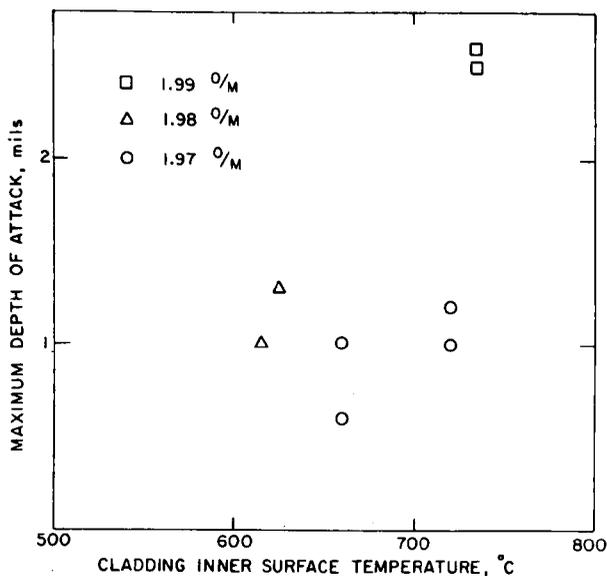
Fig. 66. Maximum FCCI Depth for the F-1 Series Fuel Pins at ~5 at. % Burnup. MSD Neg. No. 63991.

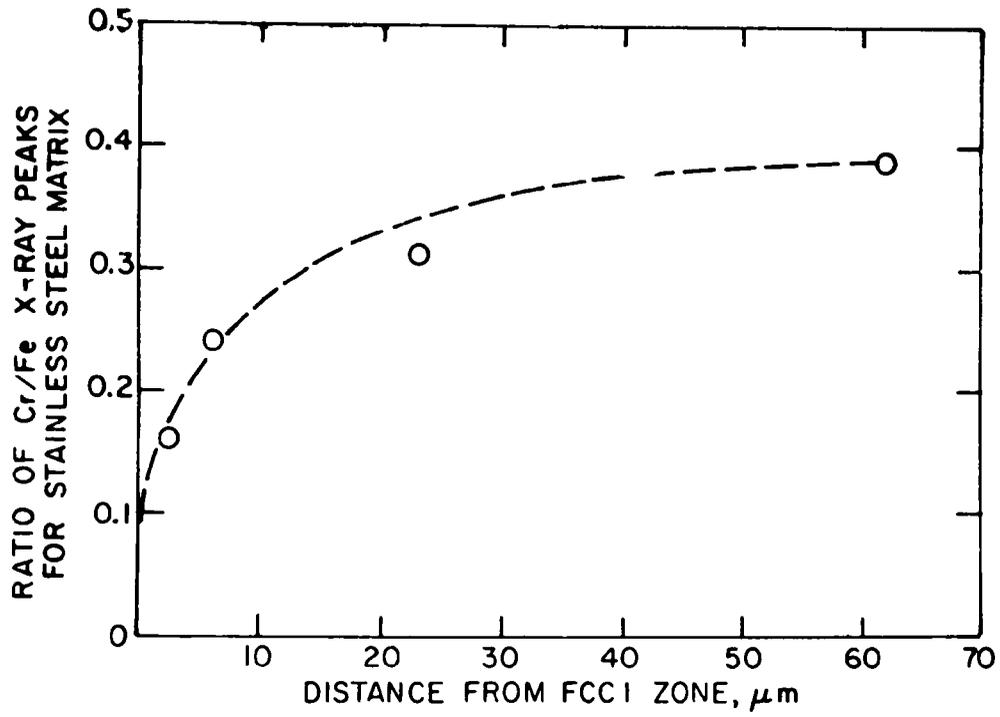
Fig. 69. Depletion of Cr Adjacent to the FCCI in the Cladding from the Midplane of Fuel Pin G-1. MSD Neg. No. 63989.

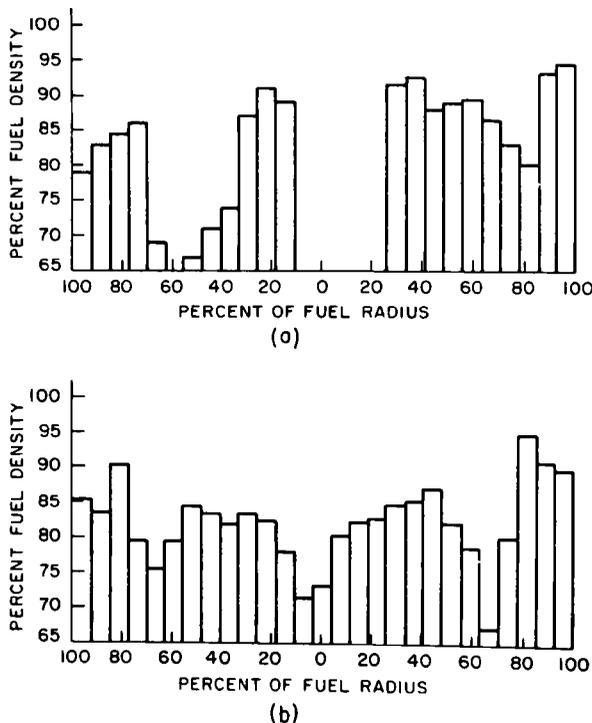
Fig. 70. Diametral Fuel-density Distribution for Top and Bottom of G-6 Fuel Column. (a) Top longitudinal section. (b) Bottom longitudinal section. MSD Neg. No. 63963.

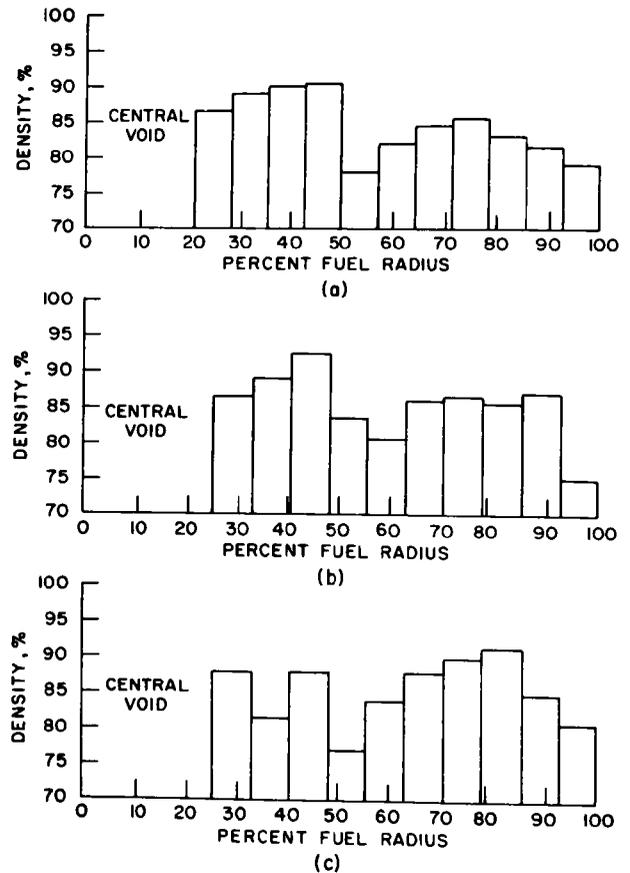
Fig. 71. Radial Fuel-density Distribution for the Transverse Sections from G-6. (a) 11.15 in. above core bottom. (b) 6.75 in. above core bottom. (c) 3.25 in. above core bottom. MSD Neg. No. 63965.
