# UPDATE

Volume 4, Number 2

June 15, 1984

## TMI Moves One Step Closer to Cleanup with Head Removal

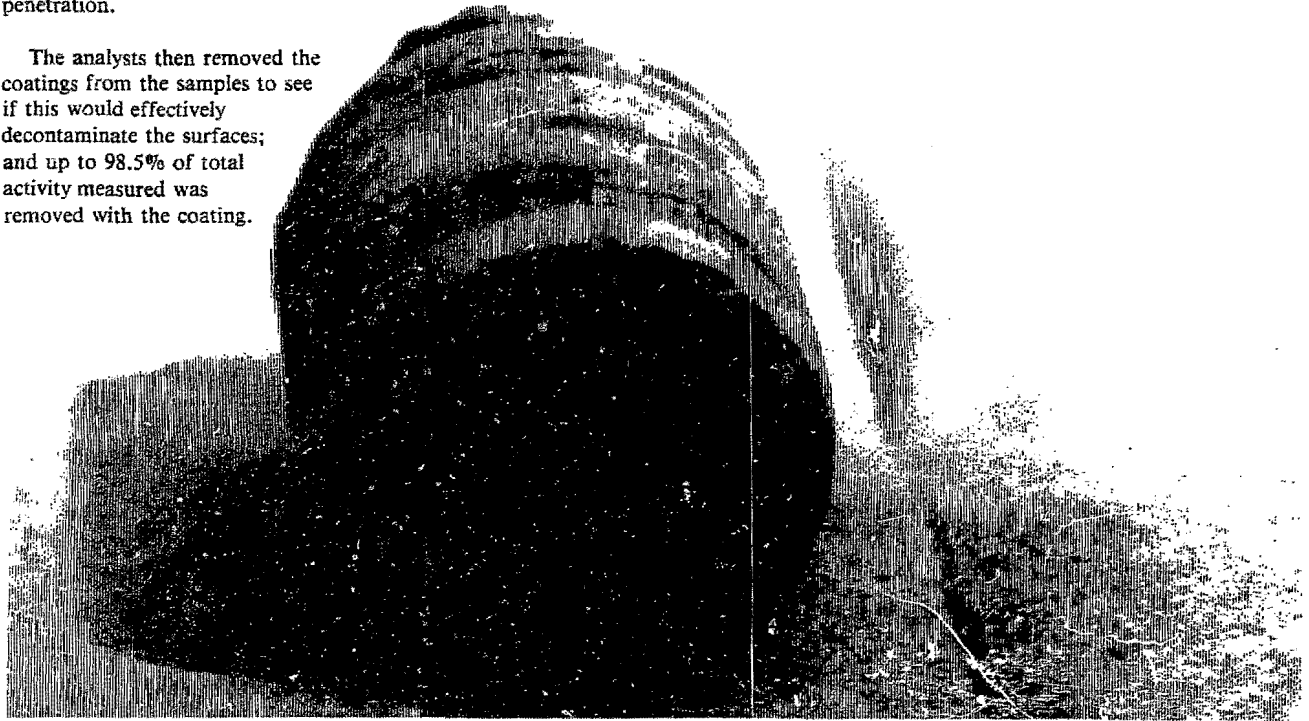
*Figure 5* This concrete core sample, whose coating was accidentally chipped during removal, was taken from the D ring wall at the 305-ft elevation. Its autoradiograph, at right, shows dark shading where the coating protected the concrete from radionuclide penetration.

The analysts then removed the coatings from the samples to see if this would effectively decontaminate the surfaces; and up to 98.5% of total activity measured was removed with the coating.

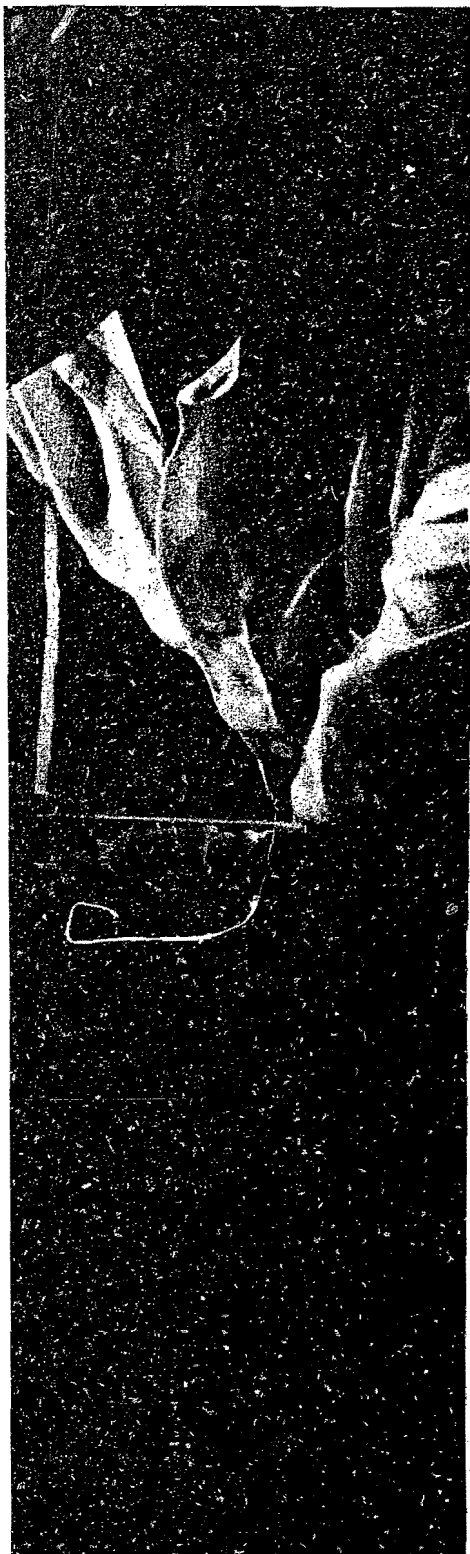
*Figure 9* Mike Martin, senior project engineer, explains the making of this clear plastic model of the core void, developed from nearly 500,000 data points.

Since then, these individual data points have been reconstructed into the three-dimensional clear plastic model pictured in *Figure 9*. This model is the first accurate map of the upper portion of the core, which experienced considerable damage during the accident.

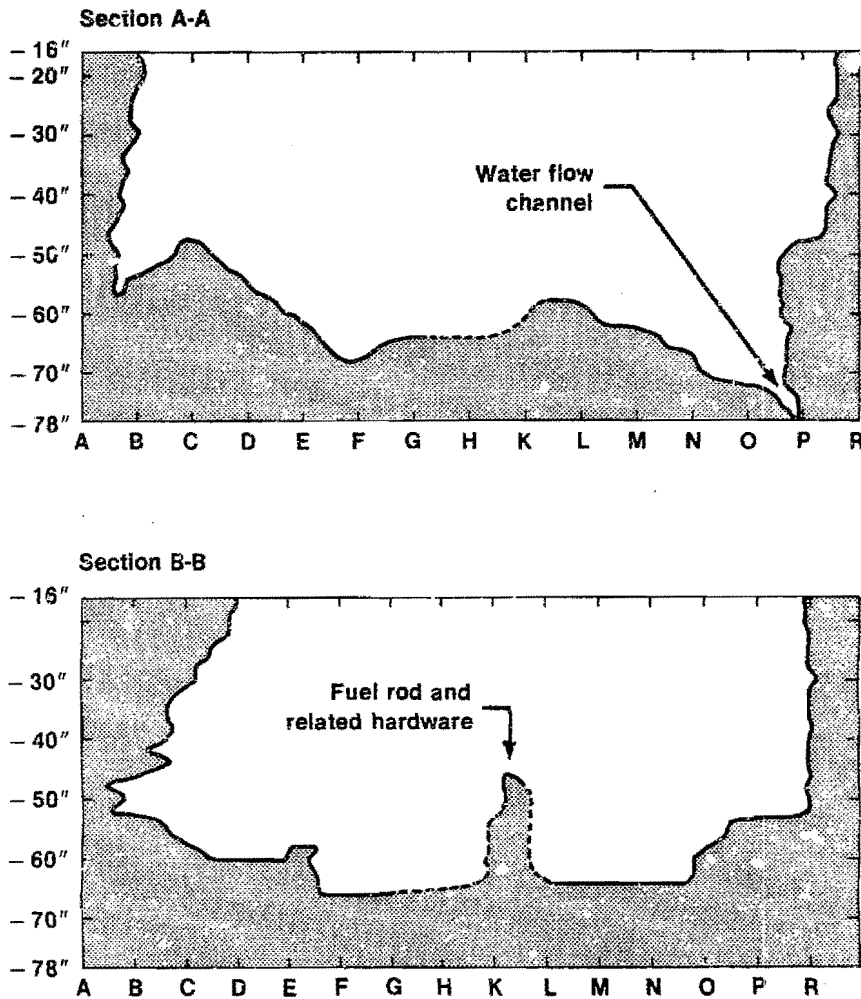
Using the data collected from the sonic sensing head, engineers also were able to plot cross sections of the void. Two such cross sections are presented in *Figure 15*. The solid lines in these drawings were produced from actual data, while the dashed lines are approximate locations obtained by extrapolation or interpolation. (A few areas of the rubble bed were not within the range of the acoustic transducers.)

Section A-A of *Figure 15* shows the deepest point of the void, at Position P, where water possibly flowed, as expirined earlier. The bottom of this narrow channel is about 2 m into the core. In Section B-B, the data points plotted in the center of the cross section jut up into the void. As videotapes of this region confirm, this protrusion is a partial fuel rod and its associated hardware, which fell from the plenum into the rubble bed.

As a result of this information, analysts have concluded that 135 of the total 177 fuel assemblies in Unit 2 are broken, thus creating the void in the top 1.5 m of the core. Of the remaining 42 assemblies, 19 are more than 50% intact (including the two possible fully intact assemblies), and 23 are less than 50% intact. Again, these numbers strictly pertain to the known 1.5 m of the core. This and other sonar topographic data are still being evaluated and will be useful in planning for plenum and fuel removal.
