EXAMINATION RESULTS ON TMI-2 LPM CHARGE CONVERTERS YM-AMP-7023 AND YM-AMP-7025

**Michael B. Murphy
Richard E. Heintzleman**

**Sandia National Laboratories
Albuquerque, New Mexico 87185**

November 1982

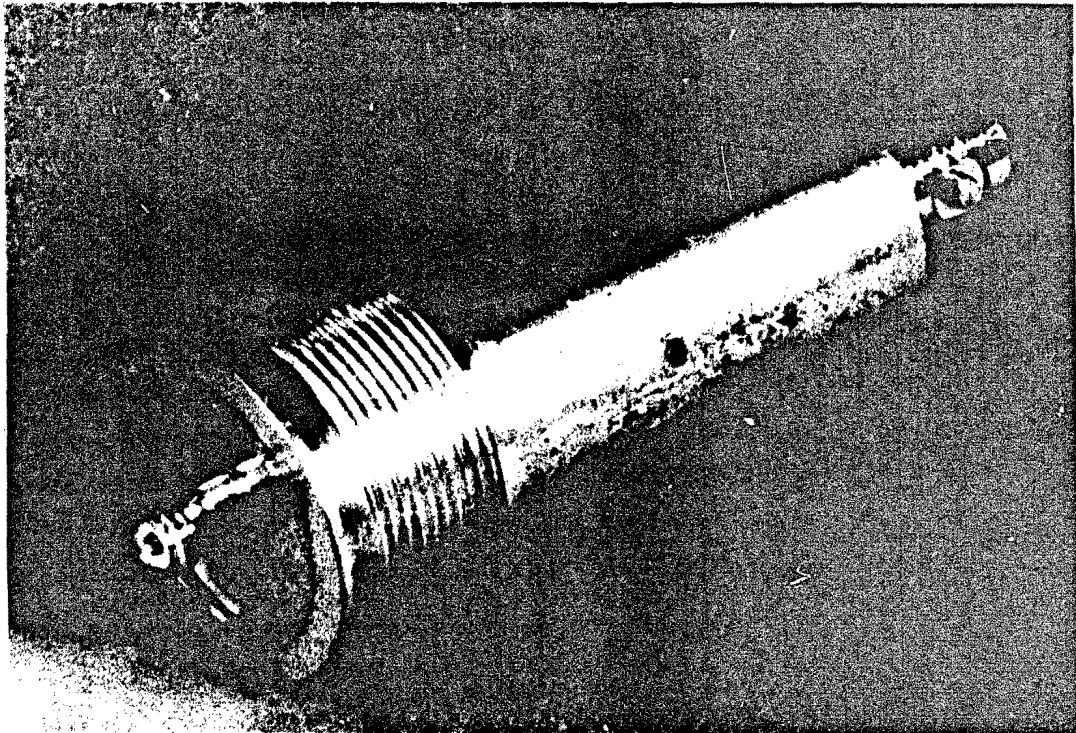
1. YM-AMP-7025 Remote Charge Converter. Actual size is 5.7 cm x 2.22 cm. Signal input connector shown.

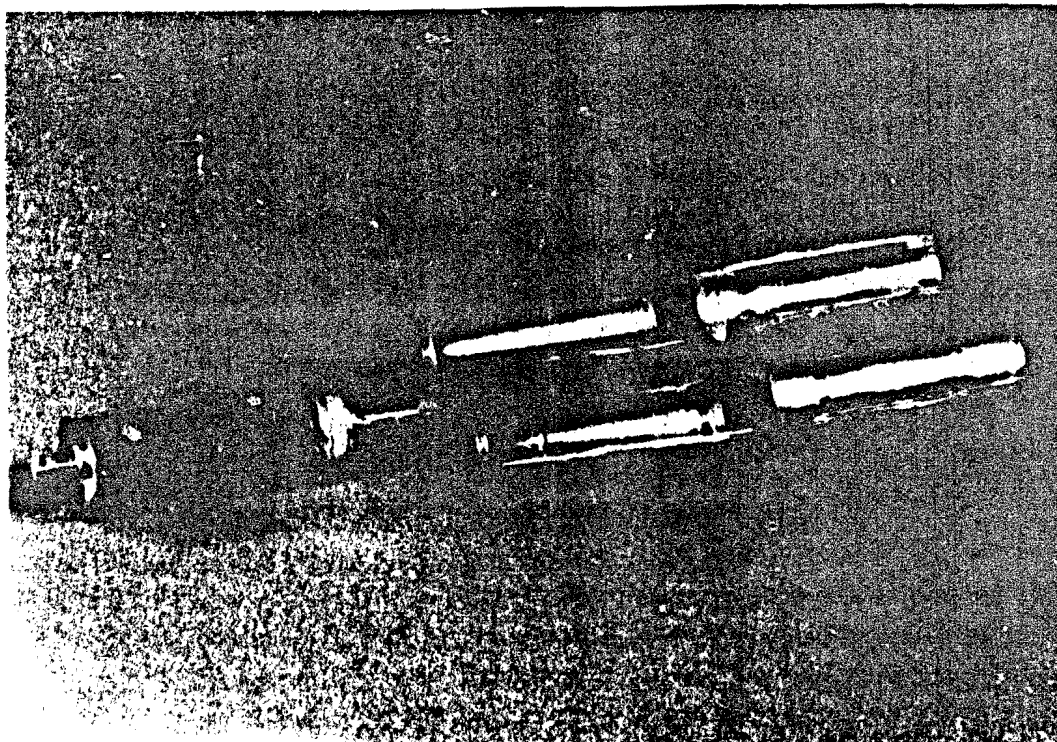
2. Disassembled Remote Charge Converter. The double shield is used to provide extra isolation from electromagnetic interference.

The Endevco Model 2652M4 charge converter is shown disassembled in Figure 2. This particular unit is YM-AMP-7025. The electronic circuitry is potted and housed inside a metal tubular case 4.6 cm long and 1.9 cm in diameter. The case is actually an outer housing over an inner shield housing with the two being electrically isolated from each other. The Microdot(R) connector and BNC connector are electrically grounded to the inner shield case. An outline drawing is given in Appendix B.

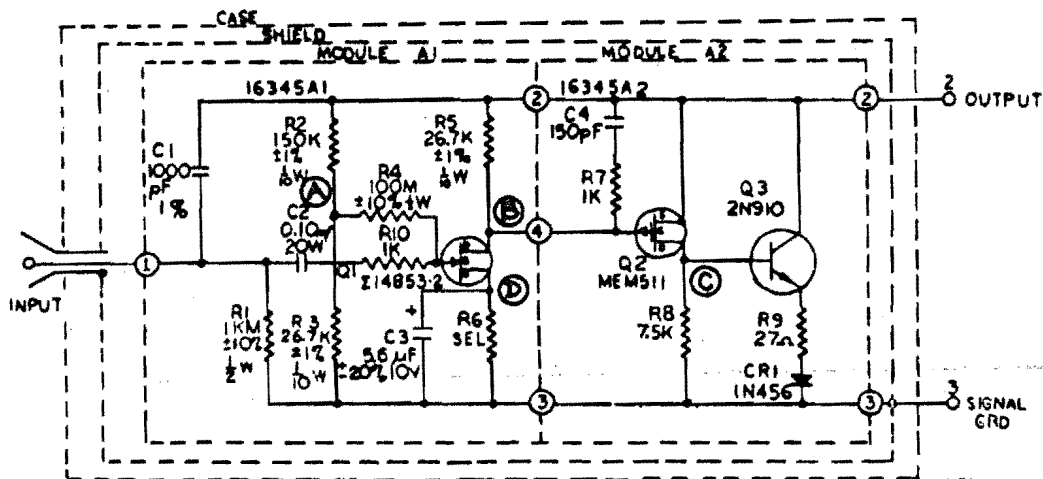
3. Charge Converter Schematic. The operating point measurements in Table 1 were made at the points indicated by letters A, B, C & D. Q2, an MEM 511 MOS transistor, was found to be degraded by radiation.

Figure 3 shows a schematic of the charge converter. The output line serves both to supply DC power to the device and to carry the AC output signal to the remote readout. The circuit consists of a very high input impedance input amplifier (Q1), a second amplifier (Q2), and a low output impedance line driver (Q3). In operation, the output AC voltage which occurs as a result of the charge input signal is fed back to the input via C1. The polarity is such as to maintain the voltage at the input near zero. This means that the input charge is stored on capacitor C1 and thus the output voltage $e_o(t)$ is given by

Analysis of the DC measurements indicated that a shift in the DC operating point had occurred. The output bias (voltage at pin 2) had shifted upward to 29.28 volts from a nominal value of 13.5 volts and the input current had decreased to 0.484 milliamperes from a nominal 8.0 milliamperes. The voltage at point C was insufficient to bias Q3 "on" ("on" being operational), explaining the low input current and high output DC voltage. Also, the clipping of AC output signals was easily explained as Q3 would require a relatively large positive input to produce an output. Measurements at points A,B and D indicated that Q2 had failed. The voltage at point B was sufficient to overcome the normal threshold voltage of Q2 and bias it on. This should, in turn, bias Q3 at a suitable operating point. Q2, an MEM 511 MOS field effect transistor, was removed for failure analysis and was found to have an out-of-spec $V_{GS_{th}}$. The specified range of $V_{GS_{th}}$ for a normal MEM 511 device is from -3 to -6 volts (Appendix C).

The performance of the converter was restored to within specification limits by the replacement of Q2. Post repair AC and DC measurements are shown in Figure 7 and Table 1, respectively, for comparison with the pre-repair data. The output bias voltage decreased to 11.42 volts and the input current increased to 7.886 milliamperes. These are both near nominal levels. The select resistor, R6, could probably be adjusted so that the output bias voltage and input current approached the nominal values of 13.5 volts and 8.0 milliamperes.

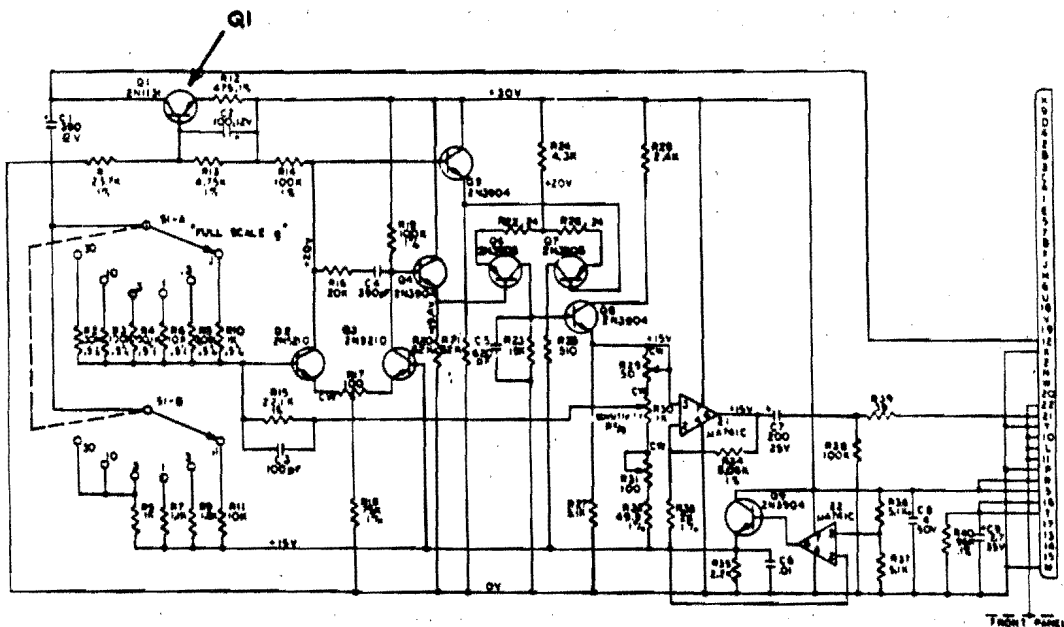
4. Model 4479.1 Line Driver Conditioner Schematic. Transistor Q1 is configured as a constant current generator providing the bias current to the Remote Charge Converter through pin 12 of the connector.

The 2652M4 is biased with the constant current source Q1 shown in Figure 4. This circuit nominally drives the 2652M4 with 8 milliamperes DC. The DC compliance voltage is set by selection of R6 in Figure 3 and is nominally 13.5 volts. Resistor R6 is used to adjust the drain current of Q1 so that the voltage drop across R5 is sufficient to overcome the gate-to-source threshold voltage ($V_{GS_{th}}$) of transistor Q2. The threshold voltage of the MEM 511 is nominally -4.5 volts. Since the circuit is being driven by a current source, the DC voltage (compliance voltage) appearing across the circuit from output to ground (Pin 2 to Pin 3) will rise until the circuit does in fact draw 8 milliamperes. This happens because an increase in the bias voltage tends to turn Q2 on harder and more base current is supplied to Q3 causing it to sink the required 8 milliamperes. This method of negative DC feedback is normally very good in stabilizing the operating points of the three transistors against variations in temperature and component parameters. As we will see later, the increase in $V_{GS_{th}}$ of Q2 caused by radiation results in the need for the compliance voltage to rise in order to keep Q2 on.

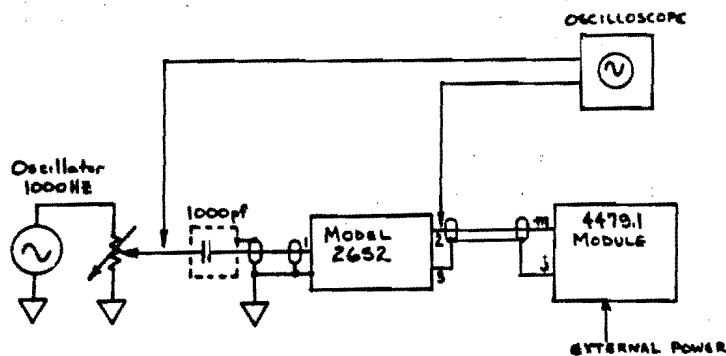
5. Model 2652 Set-up. This set-up is identical to that recommended by Endevco except that the Charge Converter output is monitored instead of the 4479.1 output.⁶

Electrical evaluation of the Model 2652 requires a charge generator to provide an input signal and a DC source to provide power. The test set-up shown in Figure 5 was used for testing as it is recommended by the manufacturer for 2652 operational checkout. A schematic of the Endevco 4479.1 signal conditioner used is shown in Figure 4.

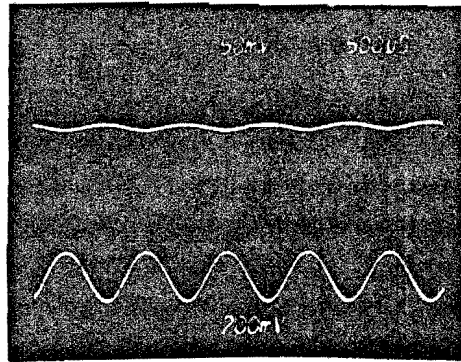
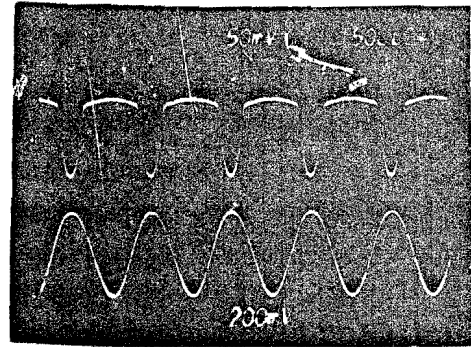
6. YM-AMP-7025 Oscilloscope/Tracings. These actual photographs of the Charge Converter input and output signals illustrate the non-linear operating mode of YM-AMP-7025. The waveforms shown in (a) are for an input level (lower trace) equivalent to 13 g's peak. For this input signal the output (upper trace) would indicate about 0.1g peak. Tracing (b) shows an equivalent input level of 20g's peak and the distorted output indicating perhaps 2.5g peak.

Initial AC measurements were made using a 1 kilohertz variable amplitude source. We found that the charge converter output was essentially zero until quite large input signals were applied. Even then the output was severely attenuated and distorted. The output positive going portion of the sine wave was found to be more attenuated than the negative going portion. This is shown in the oscilloscope pictures in Figure 6. Figure 7 shows a plot of the AC voltage transfer characteristic, where the amplitudes of the positive peaks and negative peaks are plotted for various input peak voltages. The amplitude of the negative going portion of the output signal is only correct at high signal levels. The amplitude of the positive going portion is always attenuated. At this point the unit was dissected, so that the DC operating points could be determined.

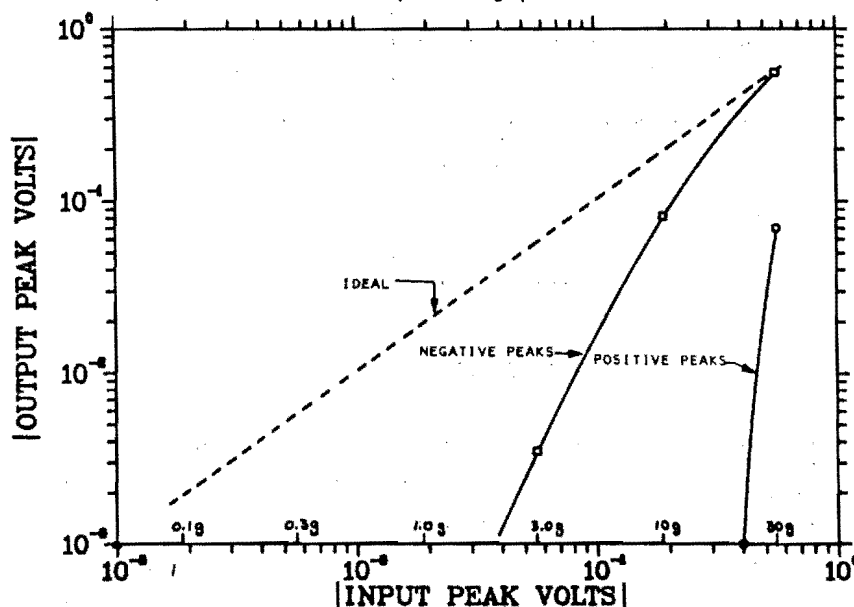
7. YM-AMP-7025 Transfer Characteristics. The charge amplifier output peak magnitude is plotted versus input peak amplitude. The ideal and post repair characteristic is shown dotted. With the degraded transistor both positive going peaks and negative going peaks are attenuated. Equivalent input g levels are also shown.

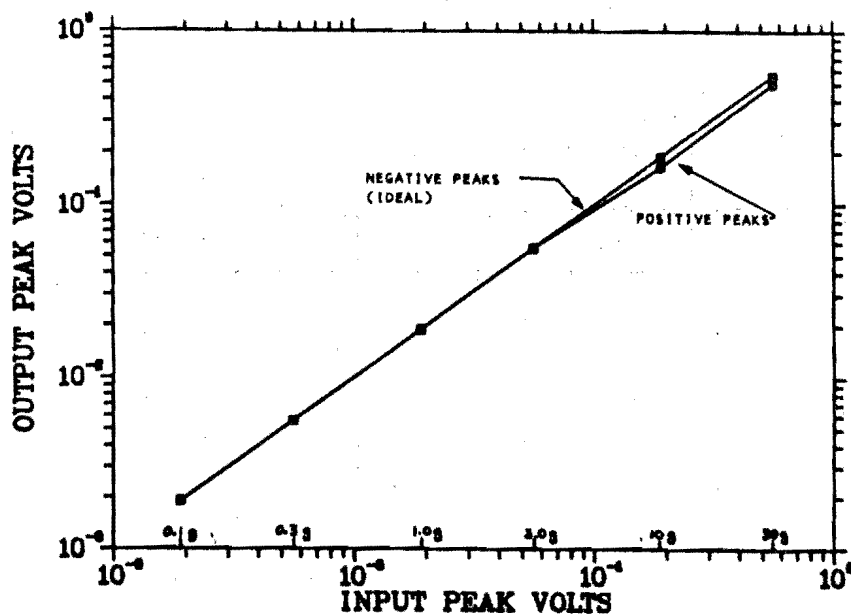
8. YM-AMP-7023 Transfer Characteristic. Unlike YM-AMP-7025 the negative going peaks are unattenuated. Only a slight attenuation is seen for positive going peaks.

YM-AMP-7023 was evaluated using methods identical to those used on YM-AMP-7025. The AC voltage transfer characteristic obtained is shown in Figure 8. The output was free from distortion and attenuation for low signal levels but was slightly distorted at higher levels. The charge converter operated properly for input levels up to 1g on the Endevco system. Negative input signals above this level produced outputs which were slightly attenuated due to the same clipping action exhibited by YM-AMP-7025. Positive input signals produced unattenuated outputs beyond the maximum 30g equivalent input level. Voltages at points A,B,C,D, pin 2, and the input current into pin 2 were measured after all points were exposed. The recorded values are listed in Table 1 under the heading; "DC Measurements, YM-AMP-7023, pre-repair".

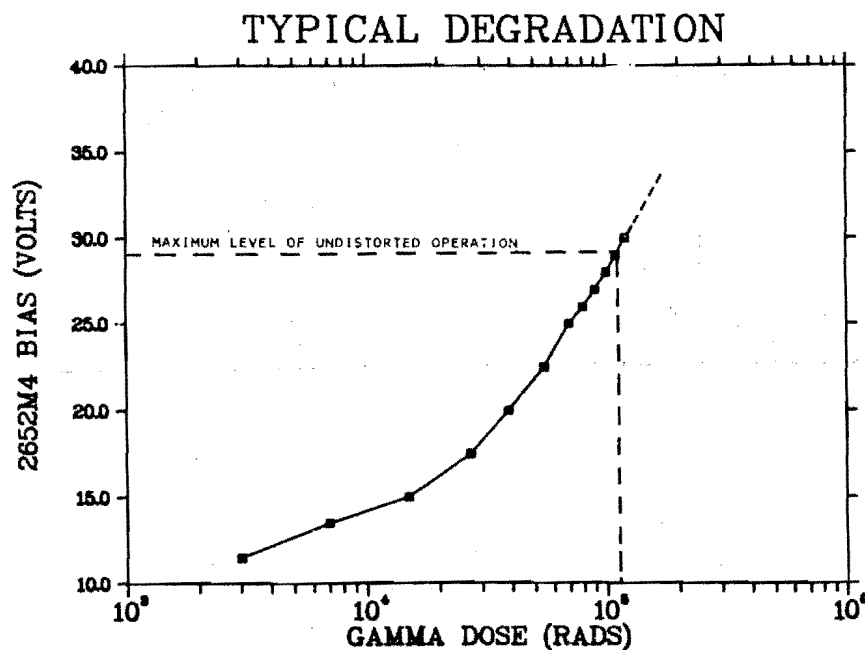
9. **Linear Operating Region vs. Gamma Dose.** For linear operation, the maximum bias voltage must be no greater than approximately 29 volts, assuming a 30 volt supply voltage. If the supply voltage were raised above 30 volts, the absolute maximum breakdown voltage specified for the MEM 511 would be exceeded. Thus, for a typical charge converter, the degradation of the output signal begins at 1×10^5 Rads.

We have quantified the effect of $V_{GS_{th}}$ increases in Figure 9. Here, we plot the expected upward shift in charge converter bias voltage as a function of radiation dose. (The variation of $V_{GS_{th}}$ with radiation dose for "typical" MEM 511 transistors is shown in Part IV in Figure 10.) Assuming a 30 volt supply and a half-volt drop across the current source transistor, we see that the distorted peak voltage amplitude would be 0.5 volts, for a radiation dose of 1×10^5 rads. Above approximately 29 volts bias, the output would be distorted (this corresponds to a 30 g input level). The maximum dose for undistorted outputs is therefore approximately 1×10^5 rads.

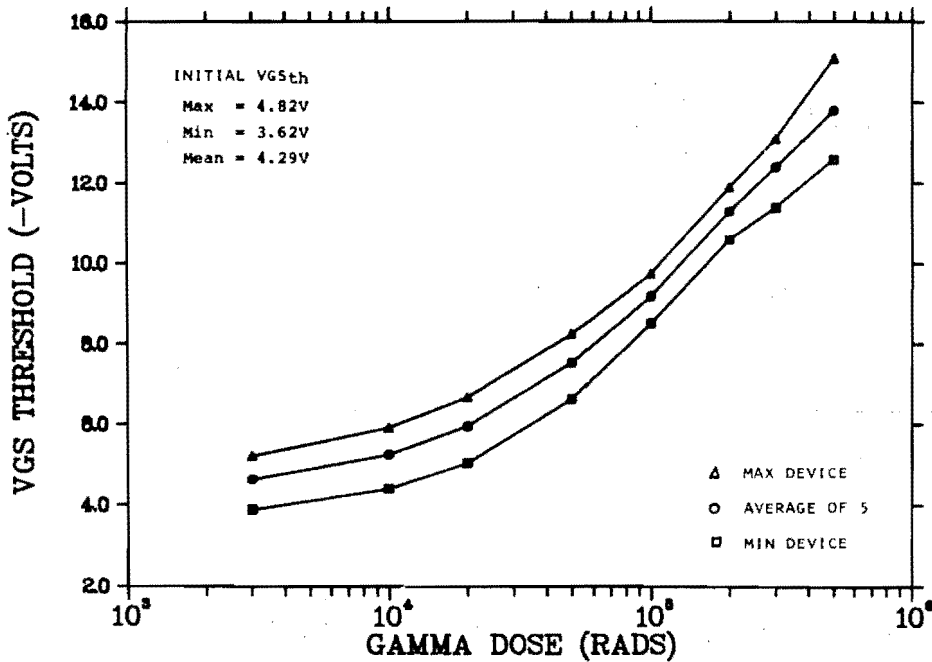
MEM 511 VGS THRESHOLD SHIFT

10. VGSth Shift with Gamma Dose. Five MEM 511 transistors (SN 21 through 25) were exposed in steps to a ^{60}Co source. VGSth was measured at a drain current of 10 microamperes. The upper curve is the maximum device tested, etc. These curves do not account for annealing.

effects and still estimate the total gamma dose received by the device. In the laboratory we exposed 5 MEM 511 transistors to gamma radiation from a ^{60}Co source and measured the resulting VGS_{th} as a function of dose. These data are plotted in Figure 10. Each transistor was biased during gamma exposure since it is felt that the majority of radiation damage at TMI-2 occurred when the charge converters were biased. The bias circuit used is shown in Appendix D. This circuit is similar to that of the charge converter and its external constant current bias circuit even including the aspect that, as the threshold voltage of the MEM 511 increases after irradiation, the bias or compliance voltage increases.

Unfortunately Figure 10 cannot be used directly to estimate the radiation total dose received because the annealing characteristics of the device must be taken into consideration. For an MOS transistor it is possible to anneal out practically all gamma induced damage by thermally baking the device.⁸ A combination of temperature and time will supposedly, through excitation of the trapped holes in the gate oxide, eventually rid the gate oxide of that charge. The problem is to first determine the temperature and time dependence and then estimate the amount of annealing which occurred before we were able to finally measure the threshold voltages of the charge converter transistors. To do this, we conducted an experiment where we baked 4 devices biased, as in Figure 11, and 4 devices passively at temperatures of 50°C and 70°C. The transistors were baked at 50°C for 287 hours, and then at 70°C for an additional 157.3 hours. Measurements of VGS_{th} were made at various intervals. The result is shown in Figure 12. For each temperature case the threshold voltage decreases rapidly at first, and then flattens out to some reasonably constant steady-state value. It appears that a certain amount of damage is annealed in the first few hundred hours at a given temperature and then after that a very slow annealing process takes place. We have further evidence of this threshold stabilization. Table 2 shows long term data we collected on the transistors used to generate Figure 10.

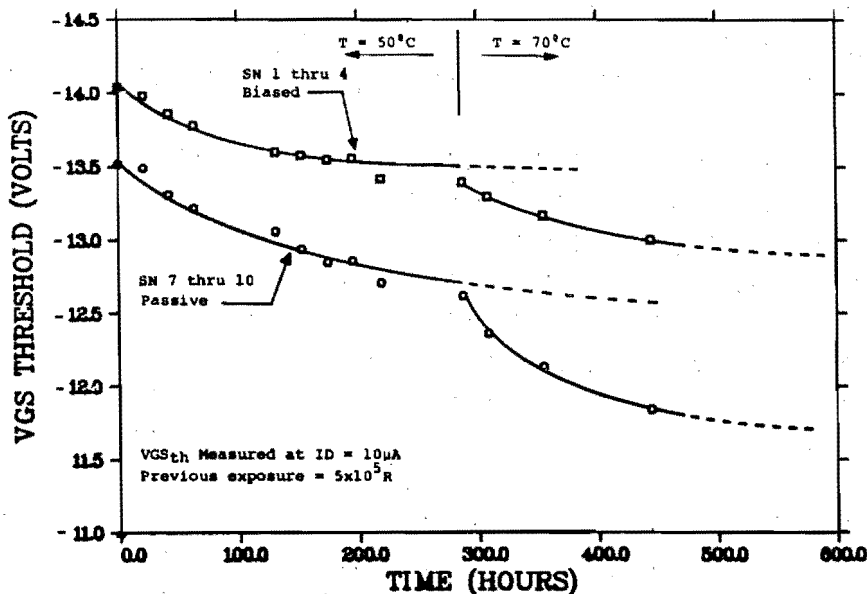
MEM 511 ANNEALING

11. MEM 511 Annealing Characteristics. Eight MEM 511 transistors which had previously been exposed to $5 \times 10^5 \text{ R}$ were annealed at first 50°C and then at 70°C. Notice the early, rapid decrease in threshold voltage and then a leveling out thereafter at each temperature. No particular significance is attached to the fact that the passive devices annealed further than the active ones. (The step decreases at 219 and 287 hours are believed to be measurement errors incurred possibly during computer recalibration.)

These transistors were stored at room temperature for hundreds of days and only minor changes in $V_{GS_{th}}$ occurred. Interestingly, neither TMI transistor $V_{GS_{th}}$ changed during the 242 days between our first to last measurements. We can speculate that trapped charges from deeper and deeper in the oxide layer are released as the temperature is increased. Eventually, possibly all the damage will be annealed; however, for the times and temperatures of interest here long-term annealing is not a significant factor.

To make our total dose estimates we assume that at TMI-2 annealing took place in a state of bias during the first few hundred hours after the accident at a temperature of 50°C. For the next two years, until we measured them they annealed passively to their present states. Figure 10 is essentially the unannealed case since measurements were made almost directly after exposure to the ^{60}Co source. Using the appropriate curves of Figure 11 and the passive values from Table 2 along with Figure 10 we estimate that the gamma doses received were approximately as shown below.

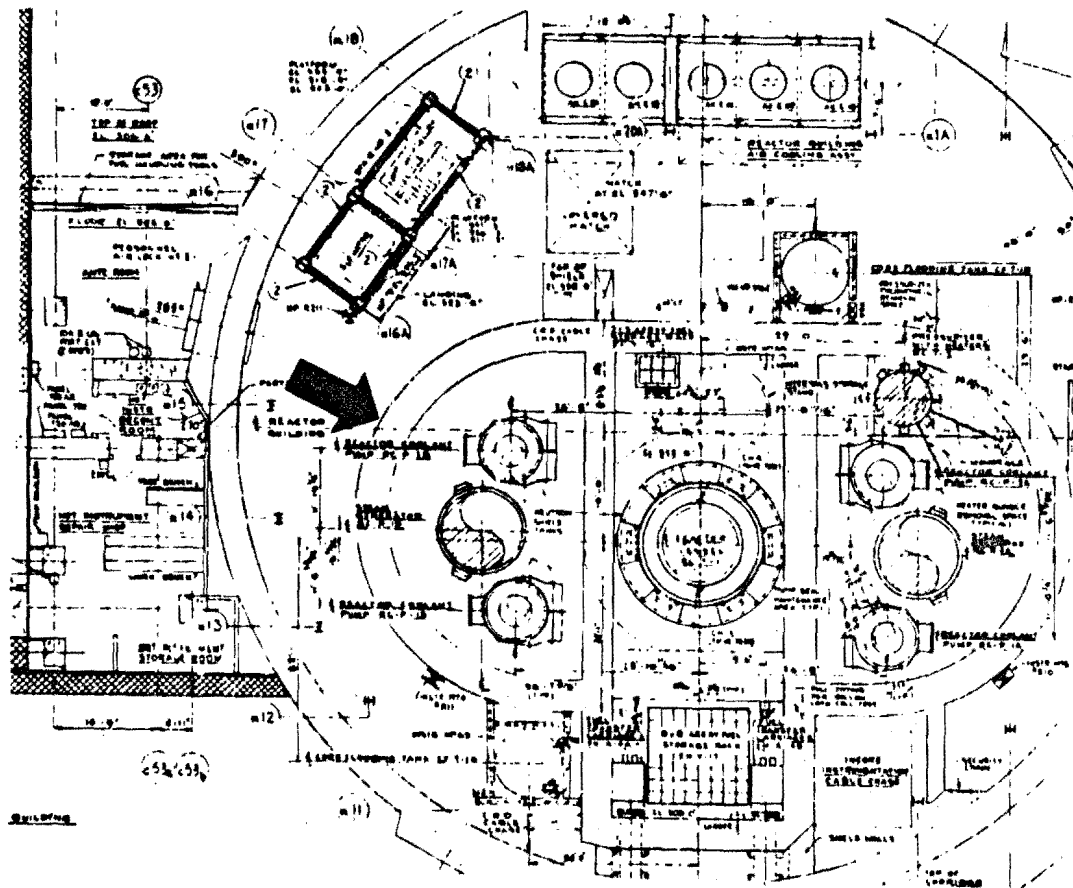
Appendix A. Unit 2 305' Elevation Floor Plan

The approximate locations of the two remote charge converters used in the loose parts monitor system in Unit 2 are shown above in the 305' elevation plan view.

The charge converters were mounted inside protective boxes on the outside of the "D" ring wall on the 305 foot elevation near the personnel hatch of the TMI-2 containment building (see Appendix A). They were removed for laboratory examination because they had failed, they contain radiation sensitive MOS transistors known to be useful as radiation dosimeters, and they were easily accessible. This report is not meant to evaluate the entire LPM system. Here, we discuss the cause of failure of the charge converters and the implications of this on loose parts monitoring. We also make estimates of the total gamma radiation doses received by each charge converter.

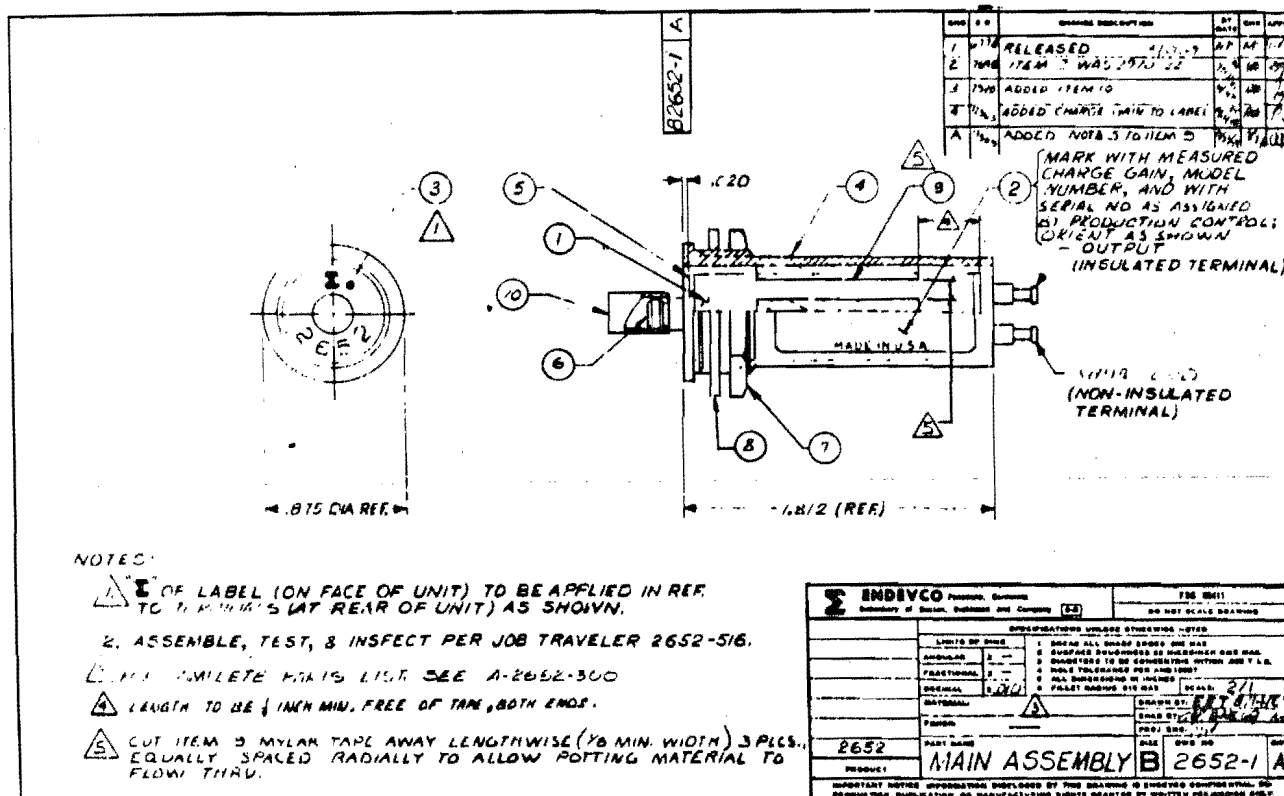
Appendix B. Outline Drawing of the Endevco Remote Charge Converter

The standard output terminals shown in the drawing may be replaced with an optional BNC type connector. Both YM AMP 7023 and YM AMP 7025 had the BNC type output connector.

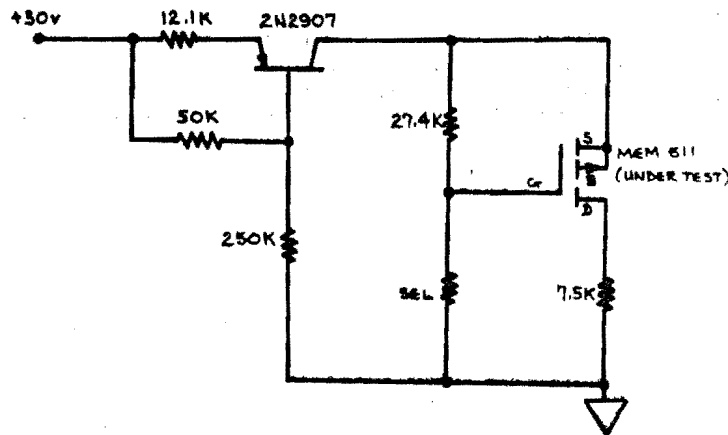
APPENDIX D. MEM 511 BIAS CIRCUIT

The circuit shown below was used to bias MEM 511 transistors being irradiated in steps to estimate the gamma dose received by TMI-2 MEM 511 transistors. The circuit simulates the changing bias condition of the TMI-2 device. The select resistor (approximately $45\text{K}\Omega$) is initially adjusted to produce a 12 volt bias on the MEM 511. The constant current source initially supplies approximately $300\mu\text{A}$ to the MEM 511 being exposed to gamma radiation.
