GEND-INF-023  
Volume II

**ESTIMATED TEMPERATURES OF ORGANIC MATERIALS  
IN THE TMI-2 REACTOR BUILDING DURING HYDROGEN BURN**

December 1982

Maximum surface temperatures attained by certain materials during the hydrogen burn associated with the March 1979 accident at TMI-2 are estimated, using photographs and material samples from the reactor building. Thermal degradation, melting, and charring noted in the photographs, and the chemical and thermal analyses of polymeric and organic materials indicated an increase in temperature with elevation in the reactor building. The maximum material surface temperatures estimated ranged from 360 to 500°F (455 to 533 K). Analyses were performed to estimate the damage to electrical cables and insulation. Based on temperatures reached and approximate duration, greater than 90% of cable insulation life remains.

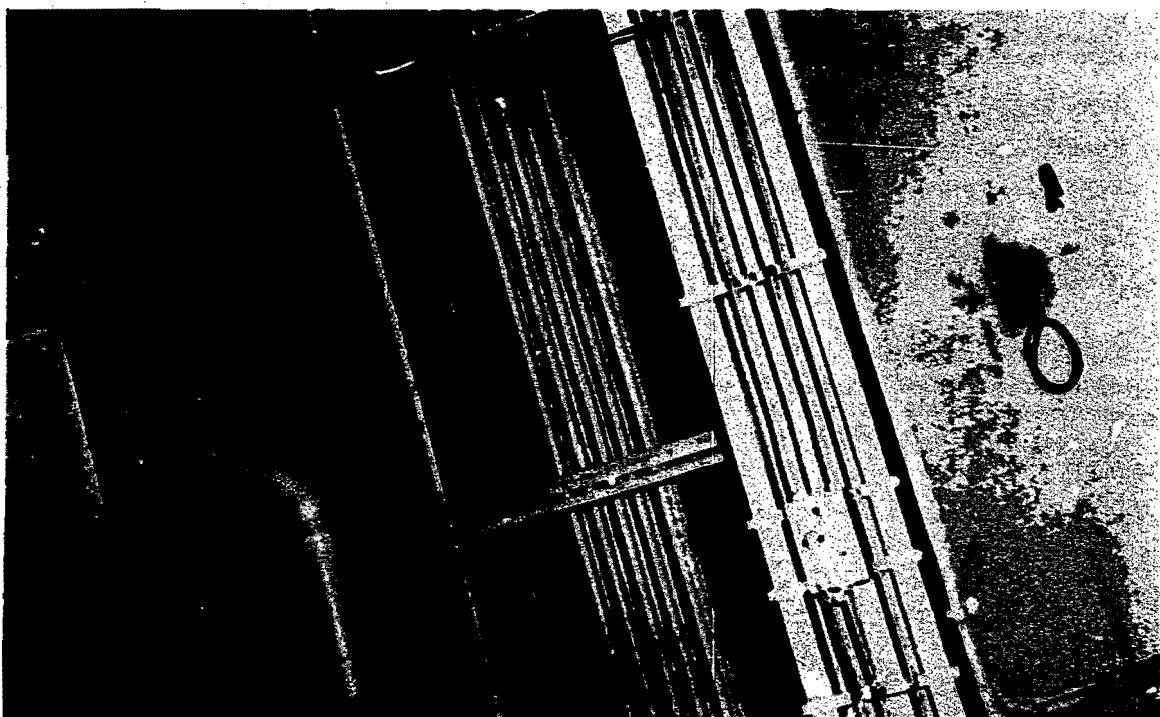
**Figure A-3. (I-2-20)--Conduit; red wall phone with coils relaxed. The phone and headset are ABS, the dial acrylic cord, insulation PVC. Temperature would have been 165 to 200°F (347 to 366 K).**

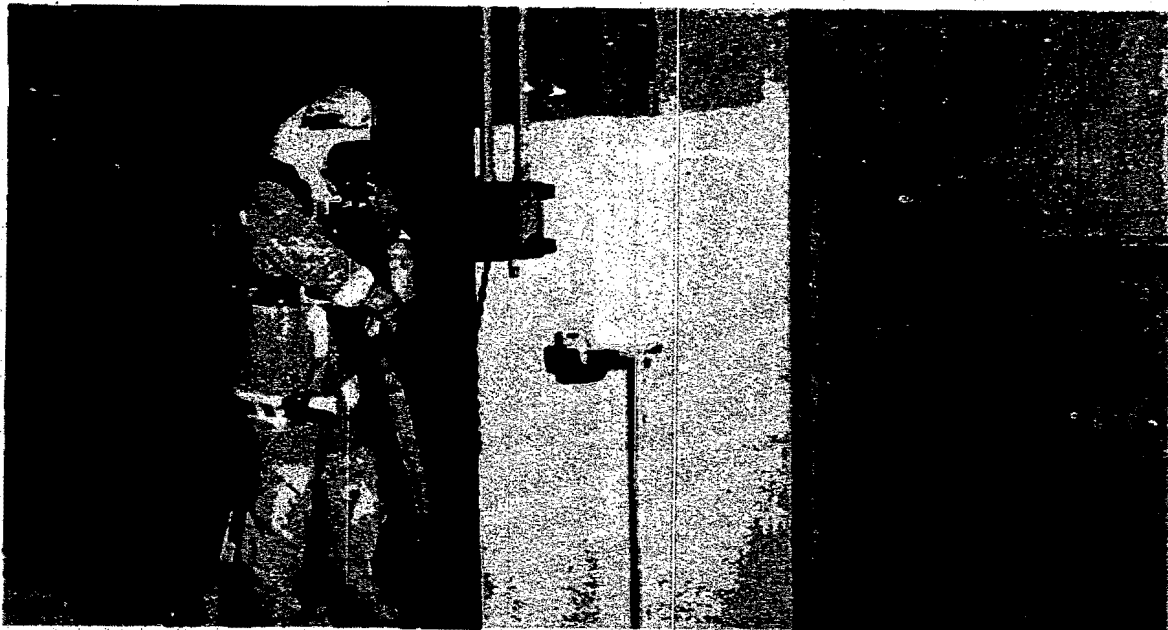
**Figure A-6. (II-1-0)--A better view of the red telephone with relaxed cord noted in Figure A-4. Temperature was between  $165$  and  $200^{\circ}\text{F}$  ( $347$  to  $366\text{ K}$ ).**

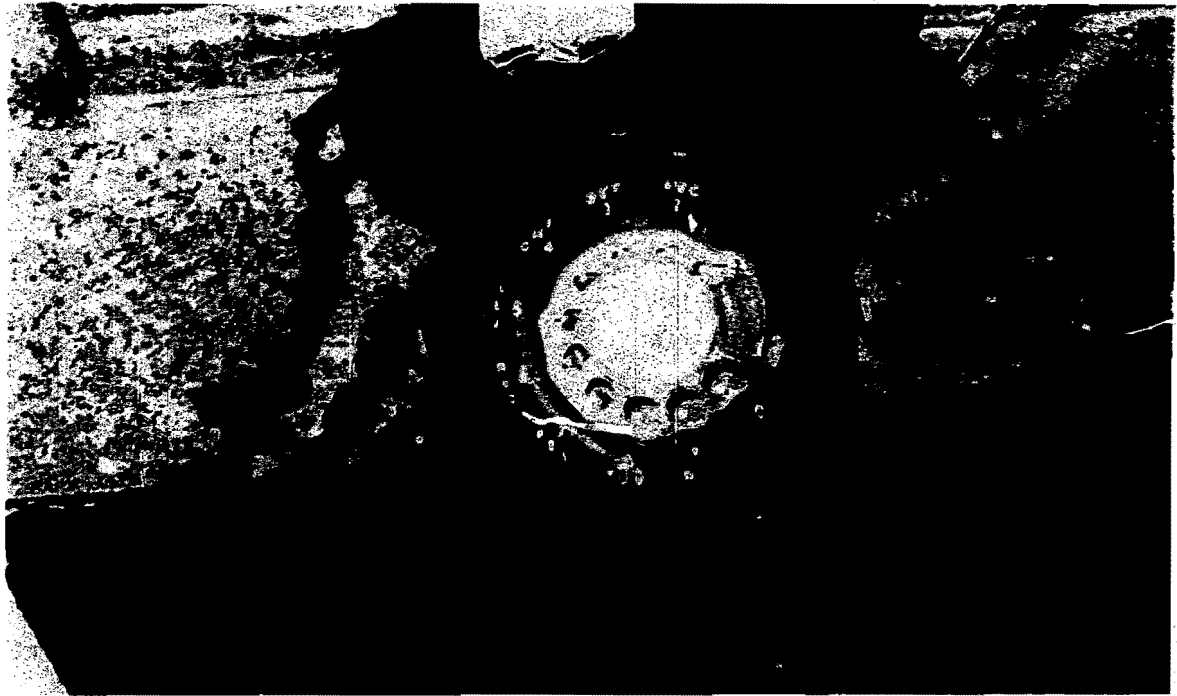
Figure A-30. (IV-NRC-15)--A close-up of the telephone described in Figure A-23; temperature was from 200 to 220°F (366 to 378 K).

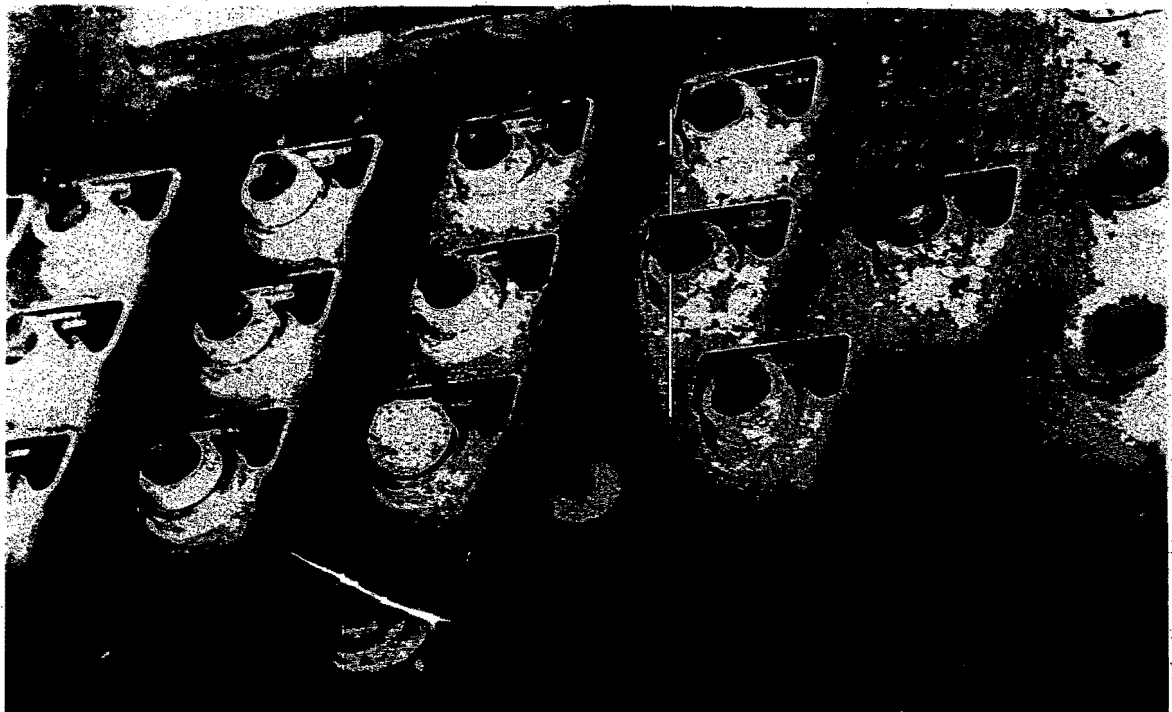
Figure A-31. (V-2-1)--A close-up of the softened buttons on the auxiliary fuel handling bridge control panels. See Figures A-25 and A-29.
