TEST DATA REPORT FOR QUARTER SCALE NUPAC 125-B RAIL CASK MODEL

Test Data Report for Quarter Scale NuPac 125-B Rail Cask Model

This report describes the testing conducted and presents the data obtained by Sandia National Laboratories on a quarter scale model of the NuPac 125-B Rail Cask. Three 30-ft free-fall impact tests and two 40-in. free-fall drops onto a puncture bar were performed. The 30-ft drop tests consisted of one end drop onto the bottom impact limiter, an oblique drop onto the closure-end impact limiter, and a flat drop onto both impact limiters on the exterior of the package. The 40-in. puncture tests were directed at the centers of the side and closure end of the package. The five tests were conducted to verify the structural adequacy of the package for the hypothetical accident conditions specified in 10CFR71 and to define the accident damage as initial conditions for the thermal, shielding, and criticality analyses.

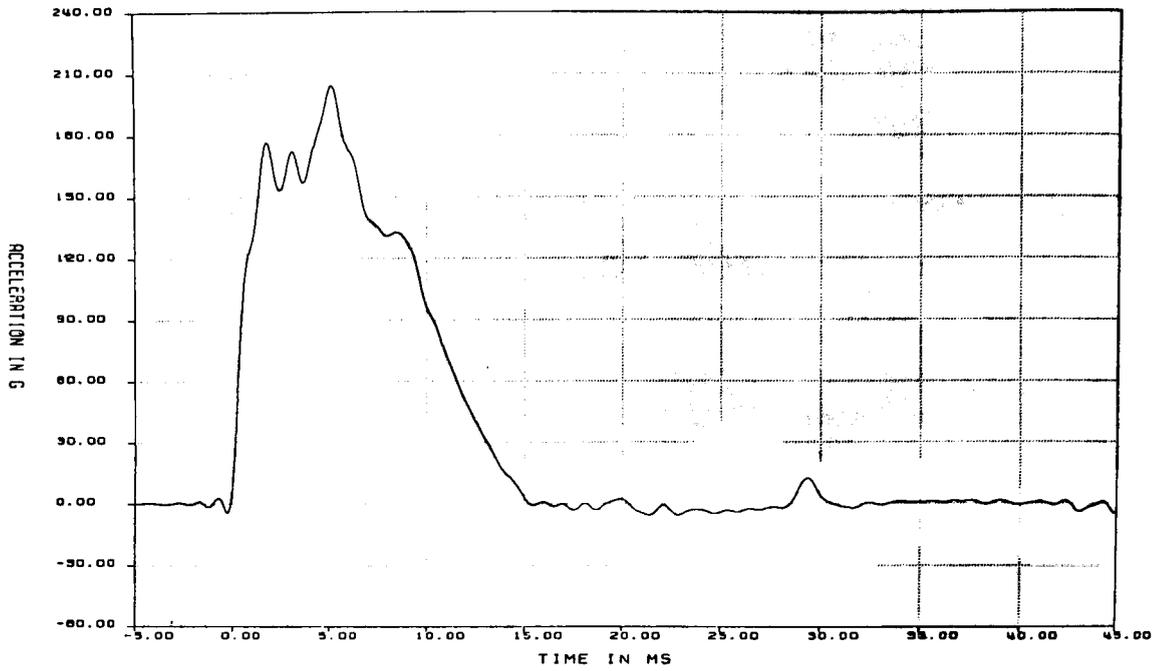
Figure B1-1. Acceleration vs Time for Gage AZ1 for 30-ft Bottom End Drop Test (filtered at 1000 Hz)

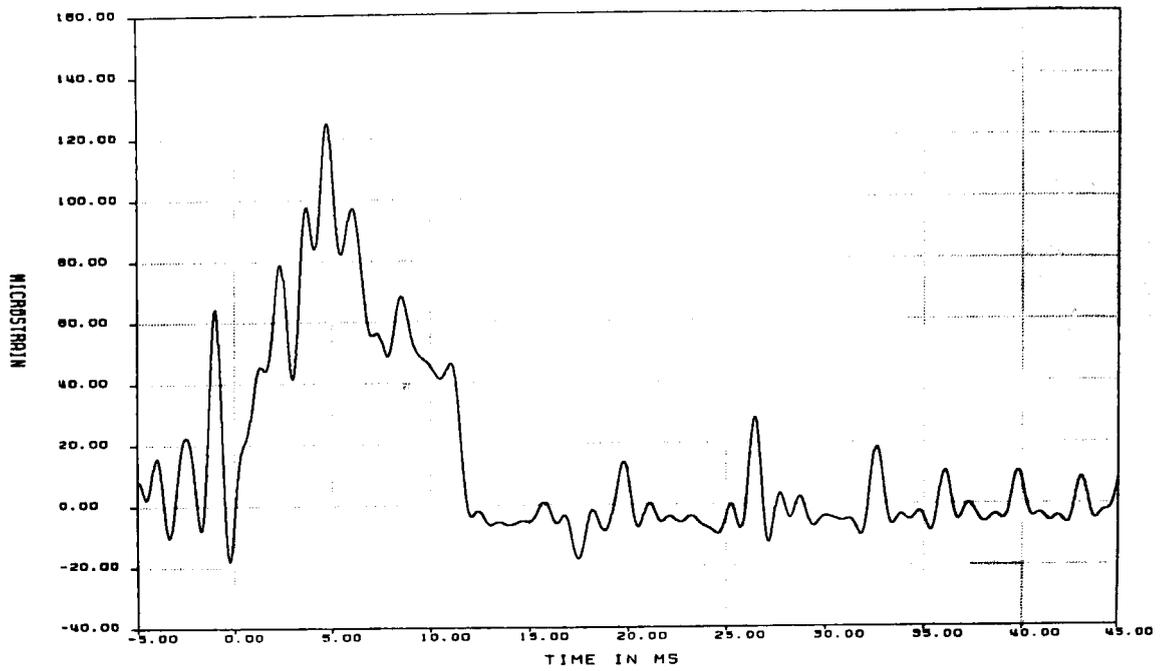
Figure B1-9. Microstrain vs Time for Gage SR1-Y for 30-ft Bottom End Drop Test (filtered at 1000 Hz)

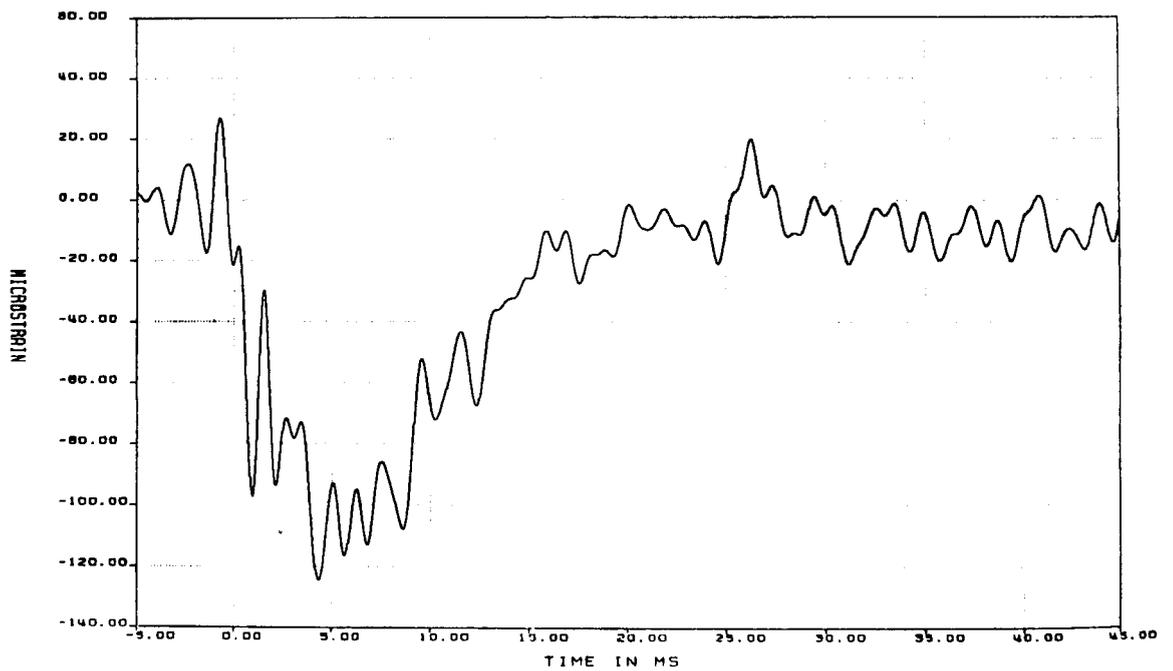
Figure B1-10. Microstrain vs Time for Gage SR1-YZ for 30-ft Bottom End Drop Test (filtered at 1000 Hz)

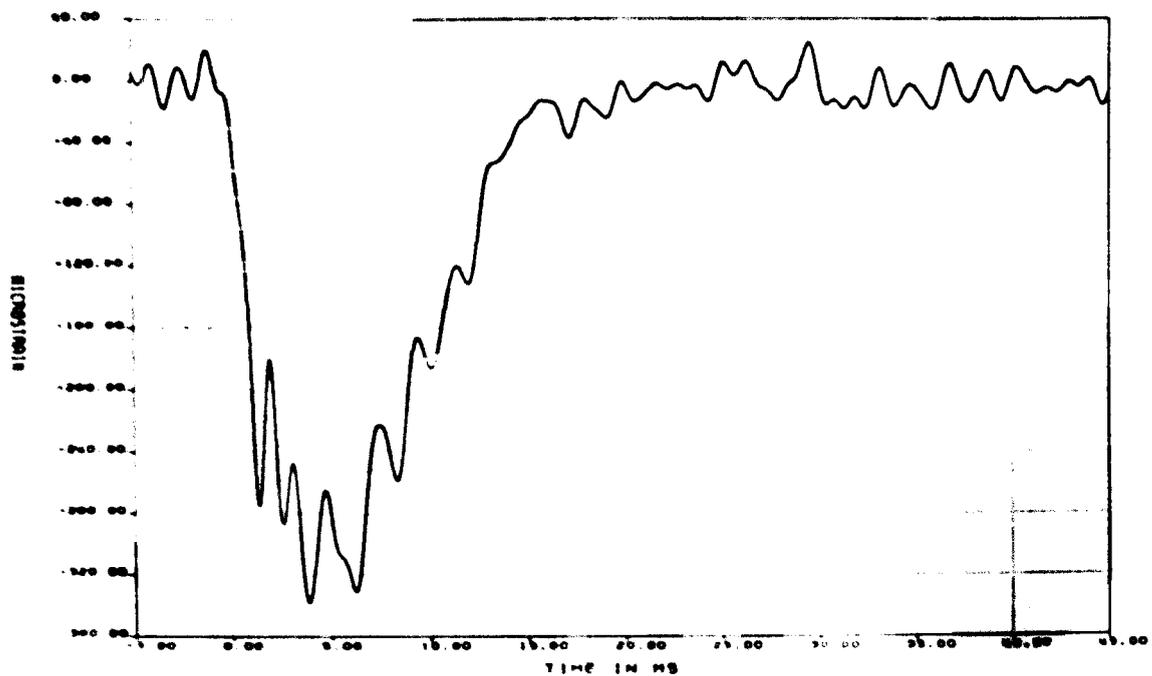
Figure B1-11. Microstrain vs Time for Gage SR1-Z for 30-ft Bottom End Drop Test (filtered at 1000 Hz)

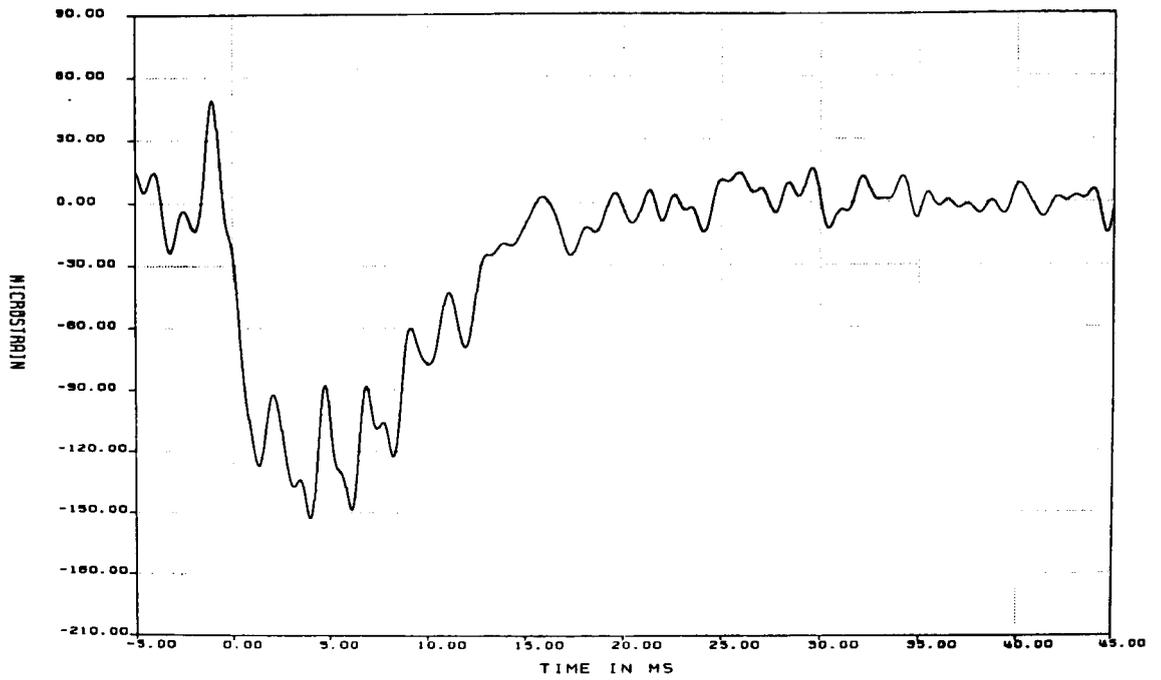
Figure B1-13. Microstrain vs Time for Gage SR2-YZ for 30-ft Bottom End Drop Test (filtered at 1000 Hz)

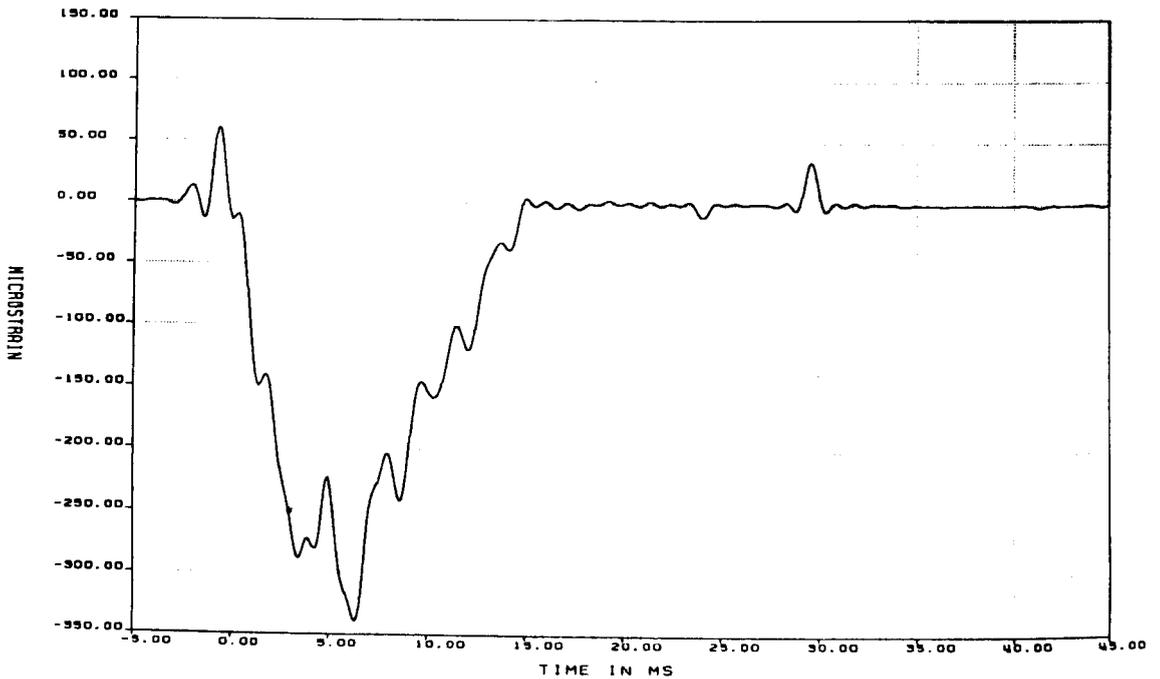
Figure B1-14. Microstrain vs Time for Gage SR2-Z for 30-ft Bottom End Drop Test (filtered at 1000 Hz)

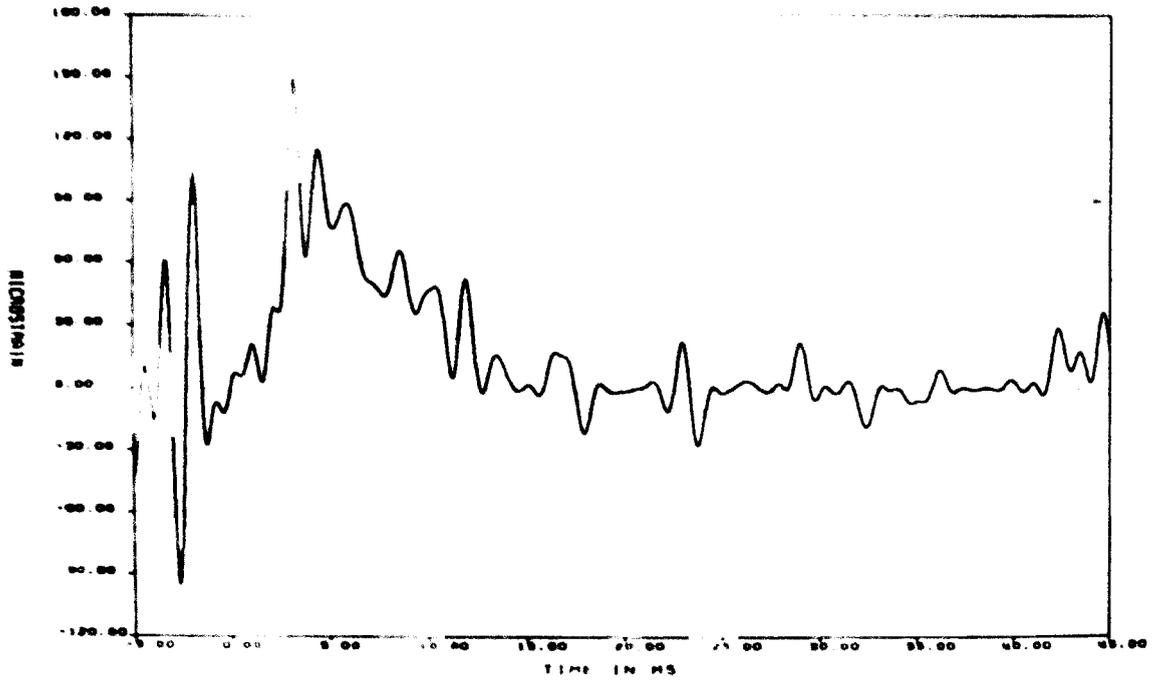
Figure B1-15. Microstrain vs Time for Gage SR3-Y for 30-ft Bottom End Drop Test (filtered at 1000 Hz)

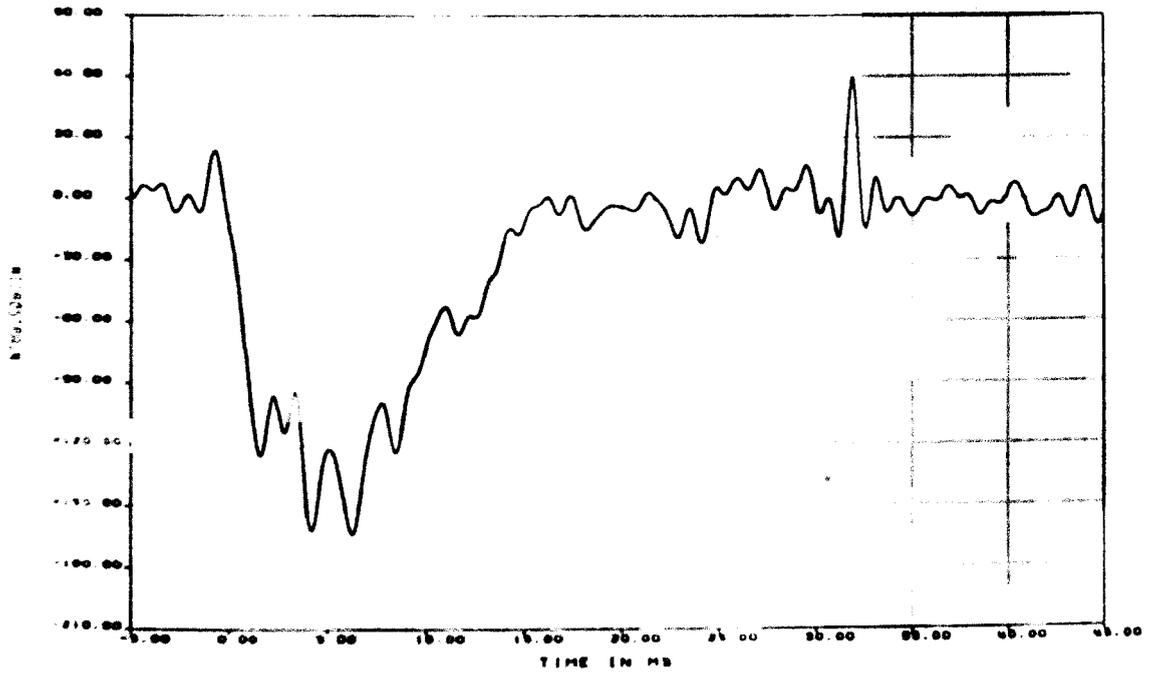
Figure B1-16. Microstrain vs Time for Gage SR3-YZ for 30-ft Bottom End Drop Test (filtered at 1000 Hz)

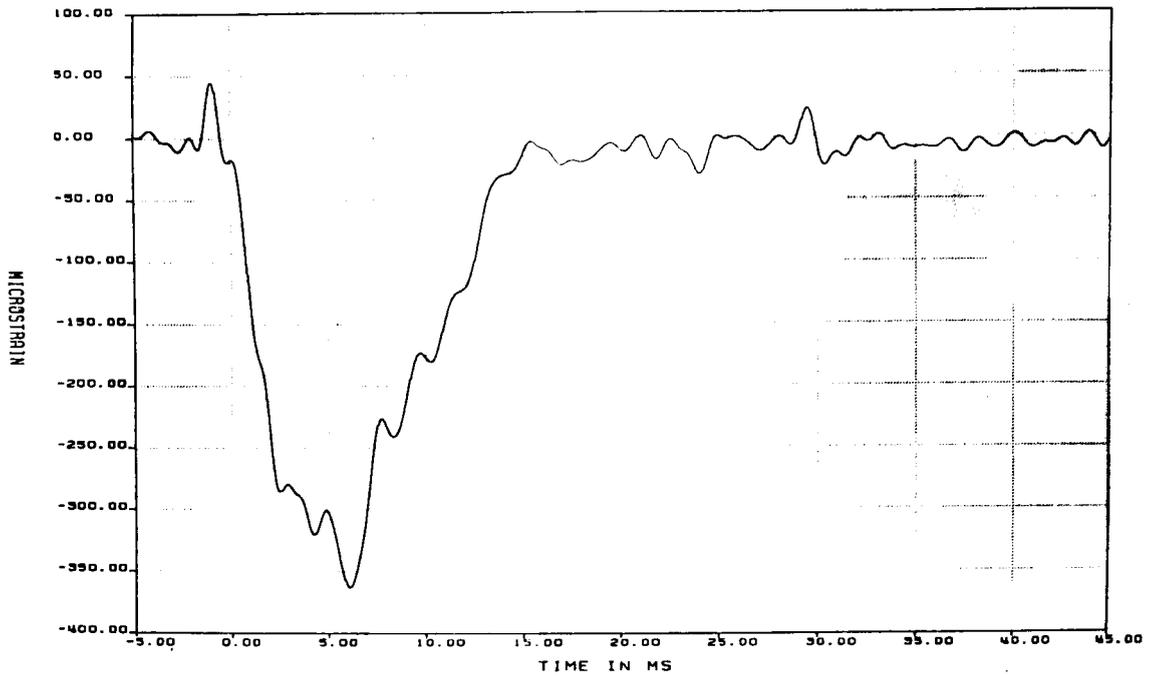
Figure B1-17. Microstrain vs Time for Gage SR3-Z for 30-ft Bottom End Drop Test (filtered at 1000 Hz)

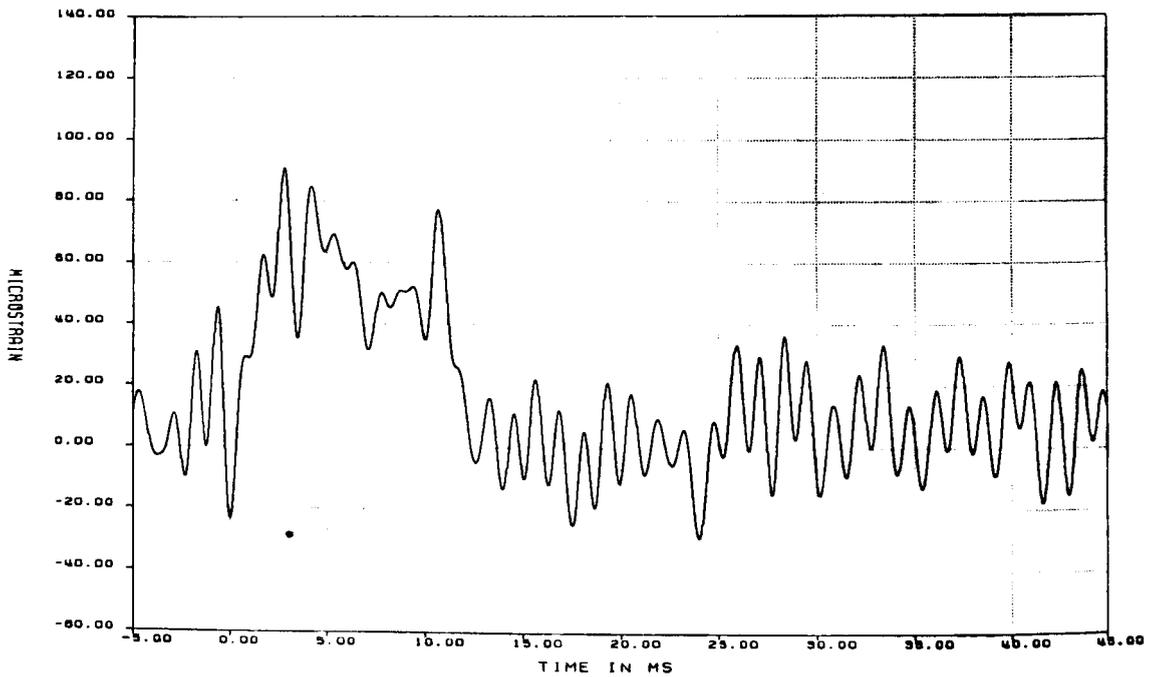
Figure B1-18. Microstrain vs Time for Gage SR4-Y for 30-ft Bottom End Drop Test (filtered at 1000 Hz)

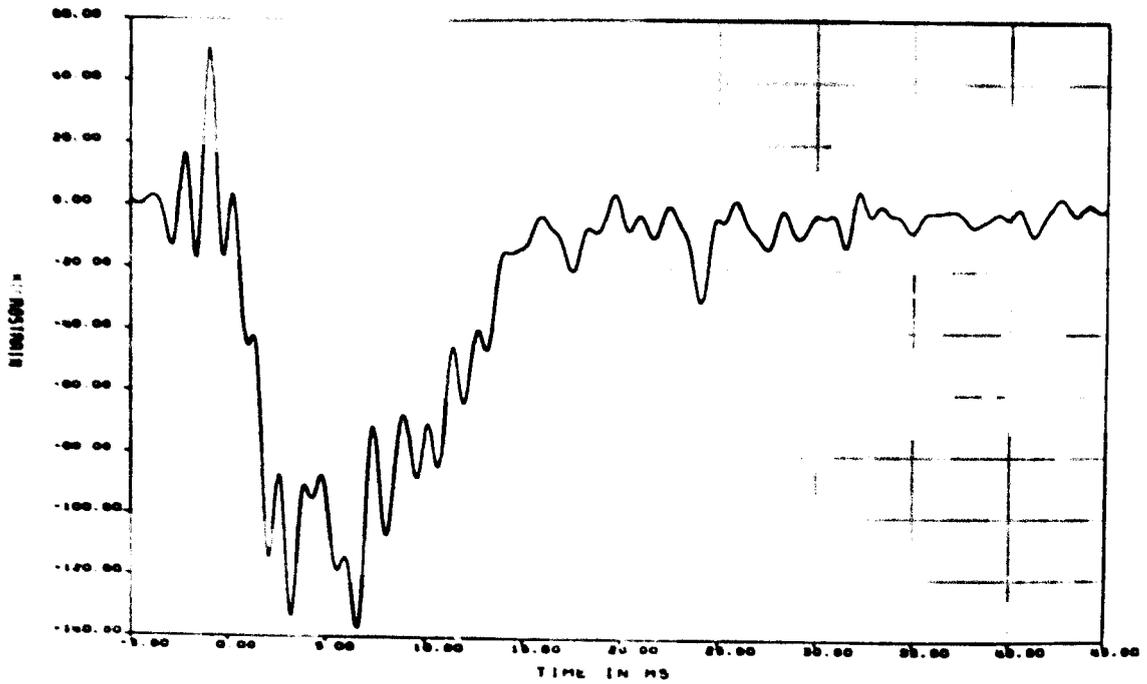
Figure B1-19. Microstrain vs Time for Gage SR4-YZ for 30-ft Bottom End Drop Test (filtered at 1000 Hz)

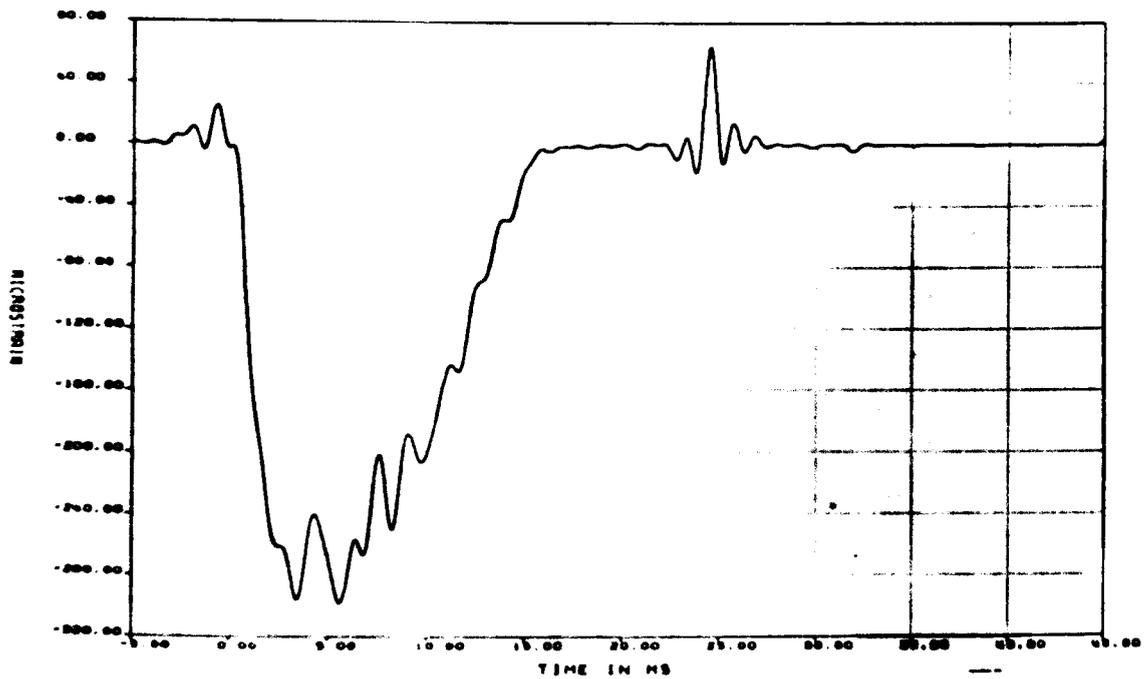
Figure B1-20. Microstrain vs Time for Gage SR4-Z for 30-ft Bottom End Drop Test (filtered at 1000 Hz)

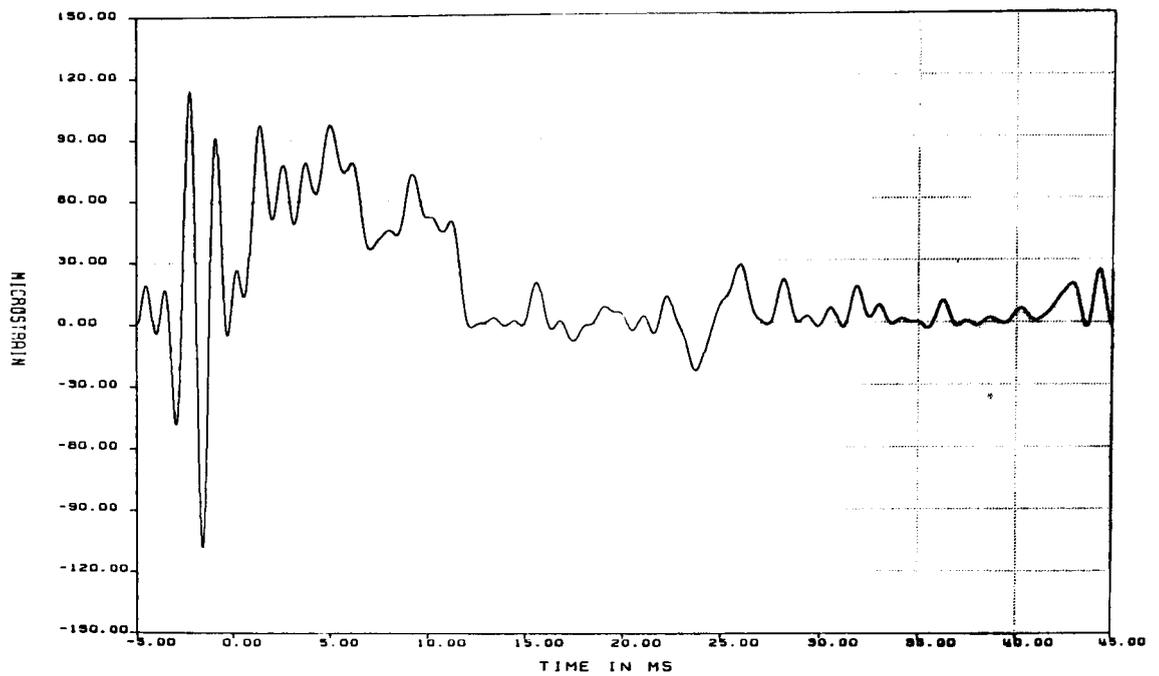
Figure B1-21. Microstrain vs Time for Gage SR5-Y for 30-ft Bottom End Drop Test (filtered at 1000 Hz)

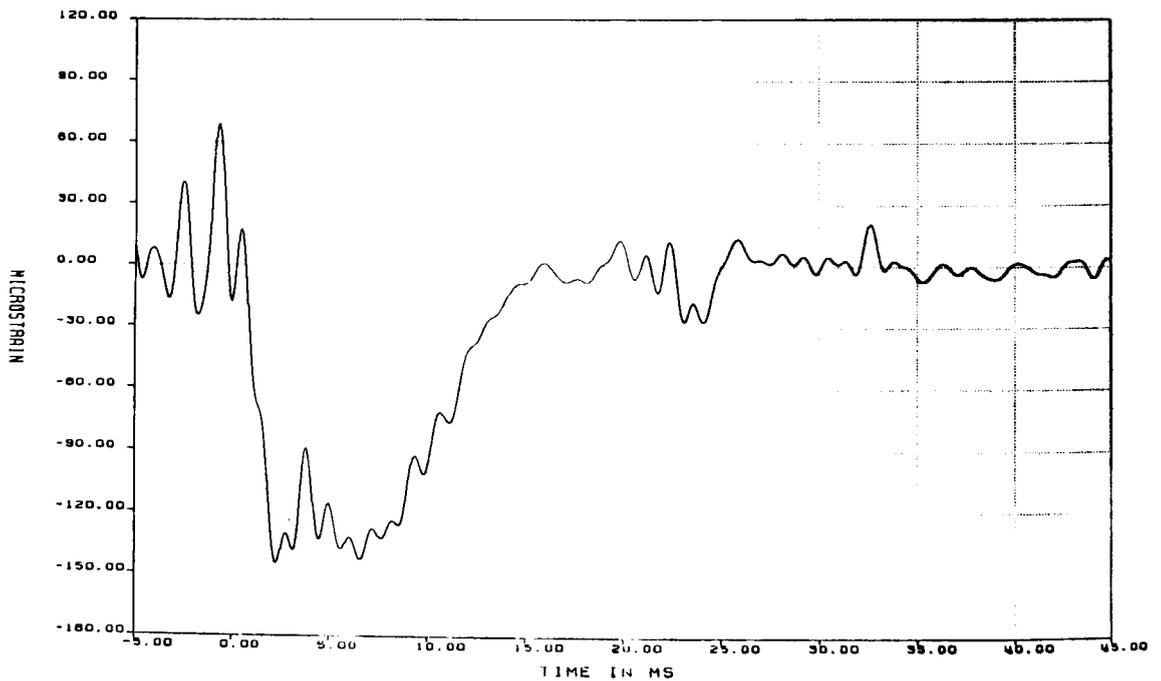
Figure B1-22. Microstrain vs Time for Gage SR5-YZ for 30-ft Bottom End Drop Test (filtered at 1000 Hz)

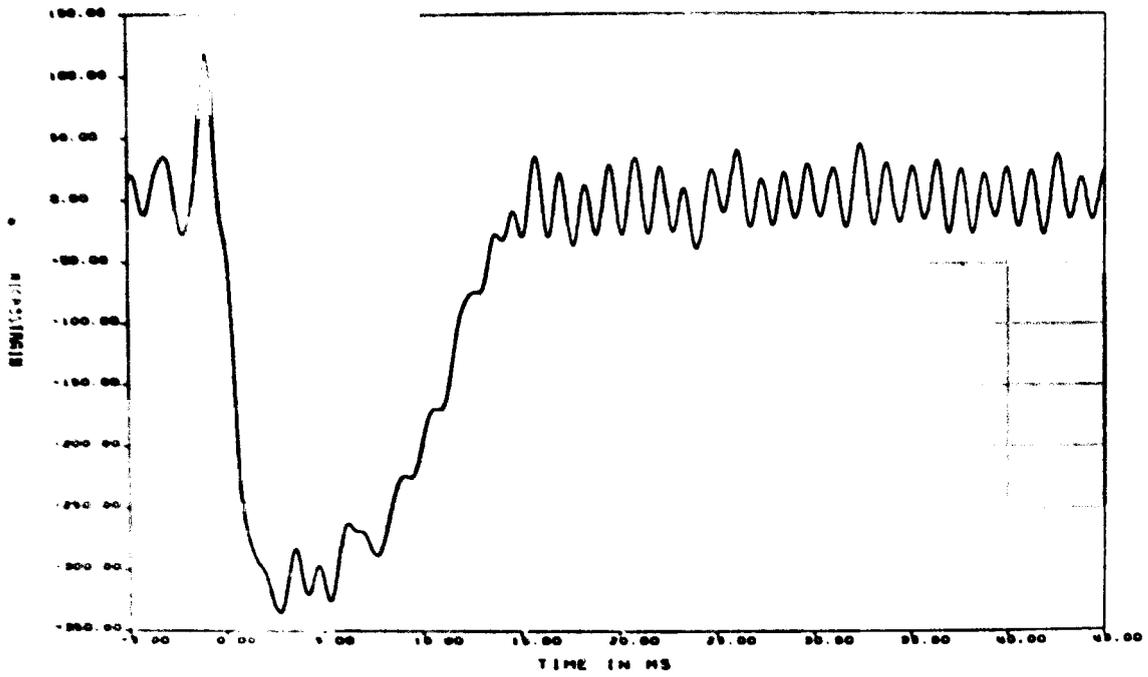
Figure B1-23. Microstrain vs Time for Gage SR5-Z for 30-ft Bottom End Drop Test (filtered at 1000 Hz)

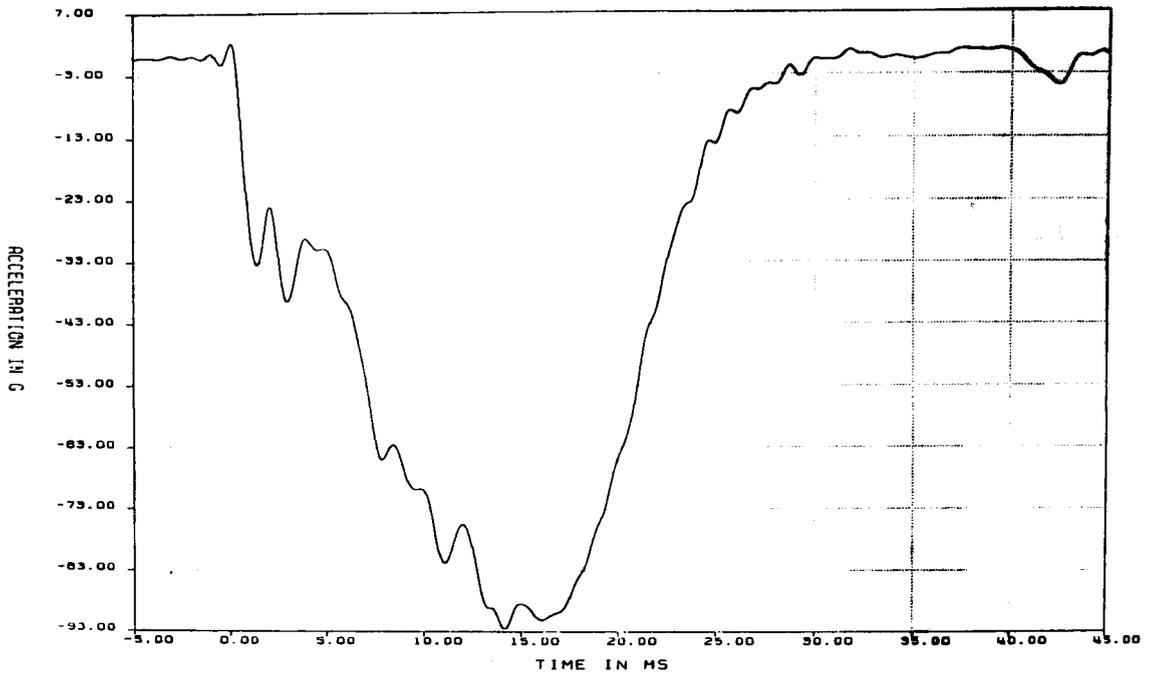
Figure C1-1. Acceleration vs Time for Gage AZ1 for 30-ft Oblique Drop Test (filtered at 1000 Hz)

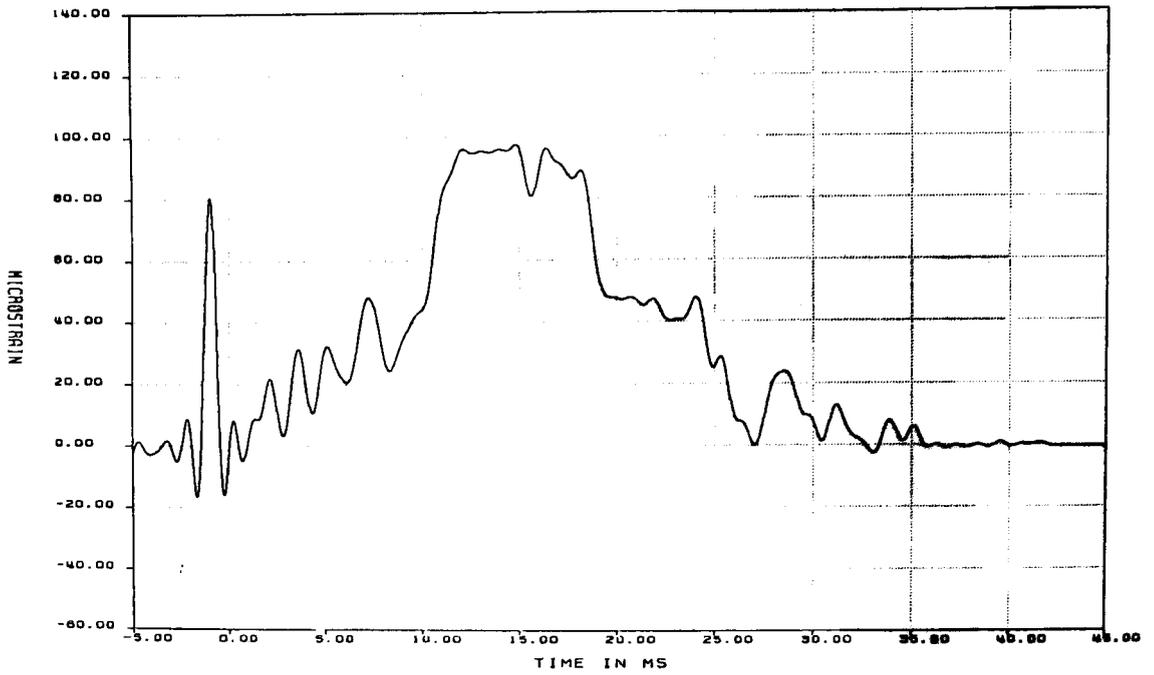
Figure C1-9. Microstrain vs Time for Gage SR1-Y for 30-ft Oblique Drop Test (filtered at 1000 Hz)

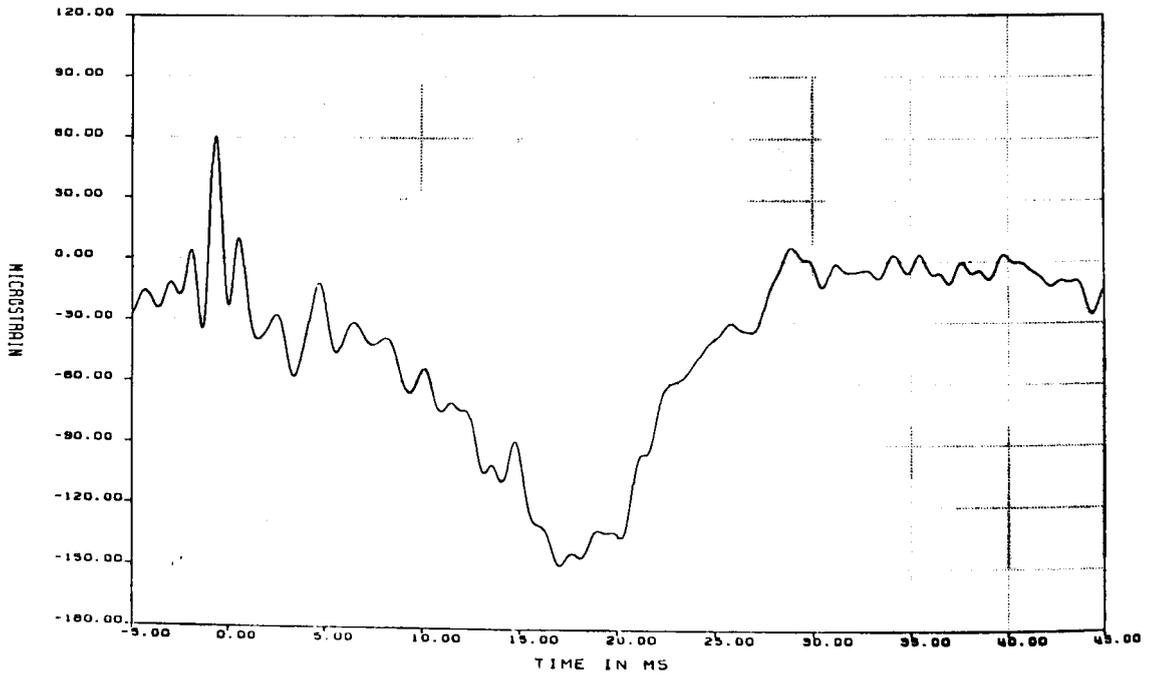
Figure C1-10. Microstrain vs Time for Gage SR1-YZ for 30-ft Oblique Drop Test (filtered at 1000 Hz)

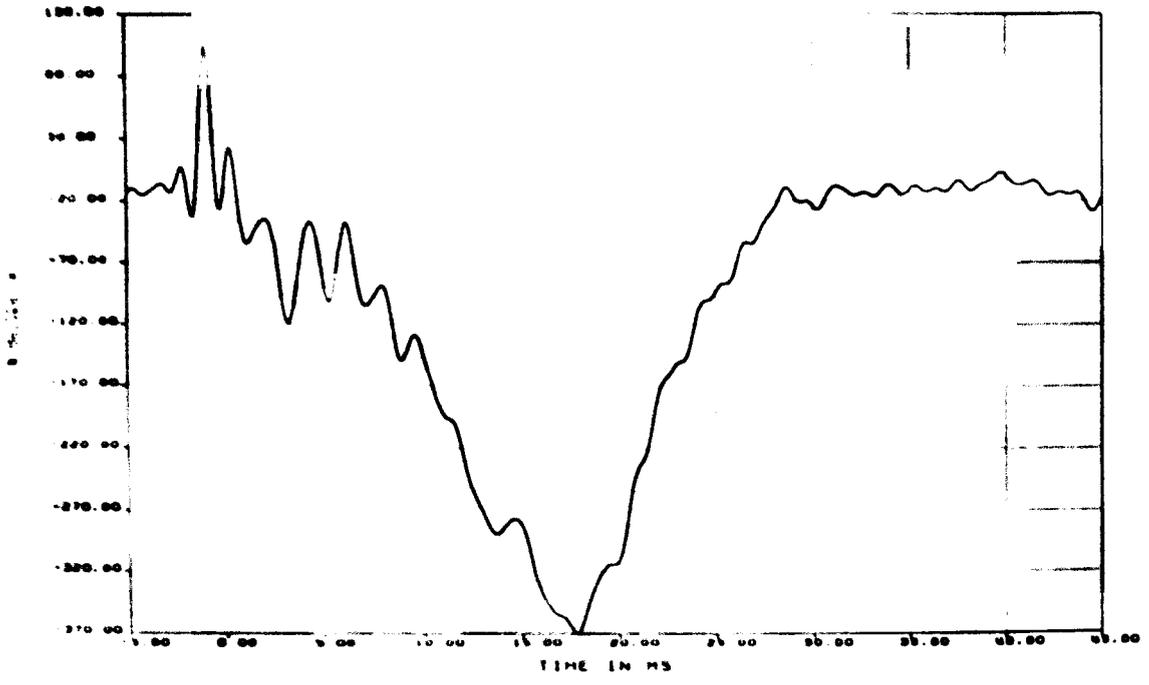
Figure C1-11. Microstrain vs Time for Gage SR1-Z for 30-ft Oblique Drop Test (filtered at 1000 Hz)

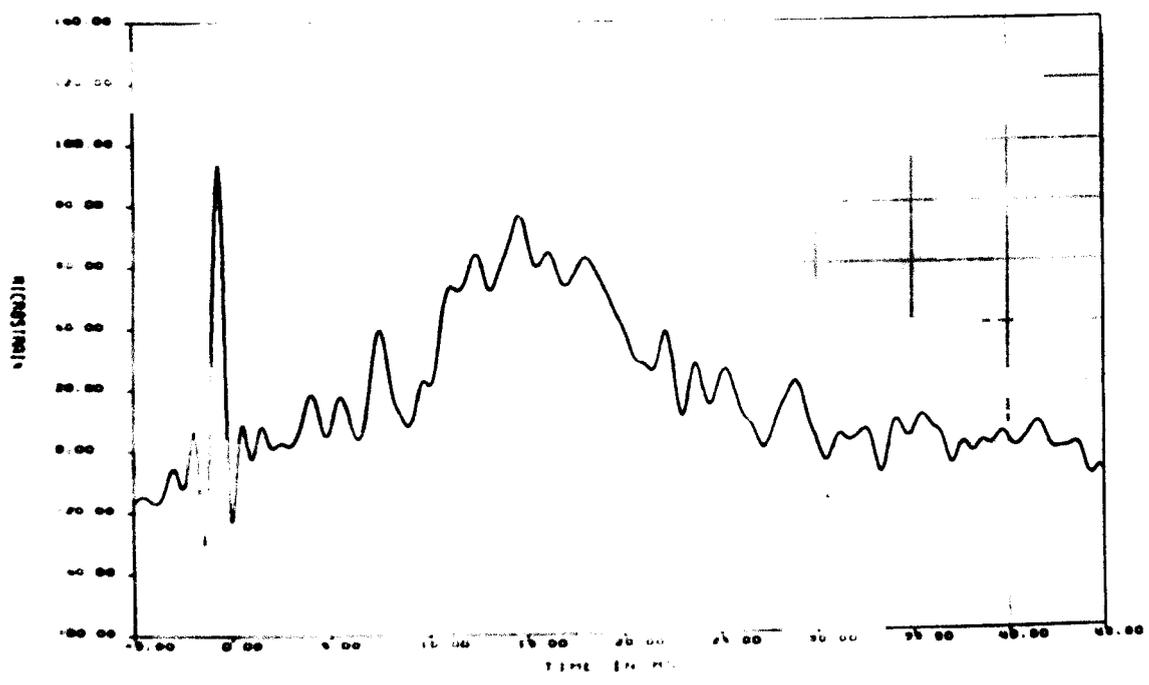
Figure C1-12. Microstrain vs Time for Gage SR2-Y for 30-ft Oblique Drop Test (filtered at 1000 Hz)

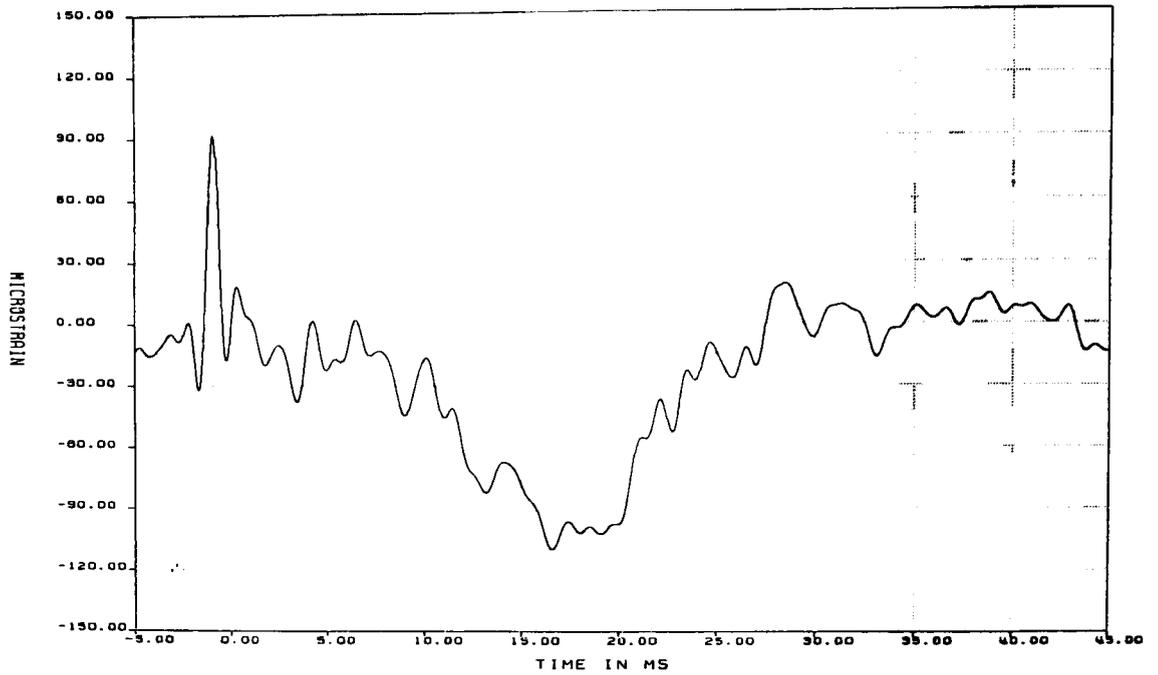
Figure C1-13. Microstrain vs Time for Gage SR2-YZ for 30-ft Oblique Drop Test (filtered at 1000 Hz)

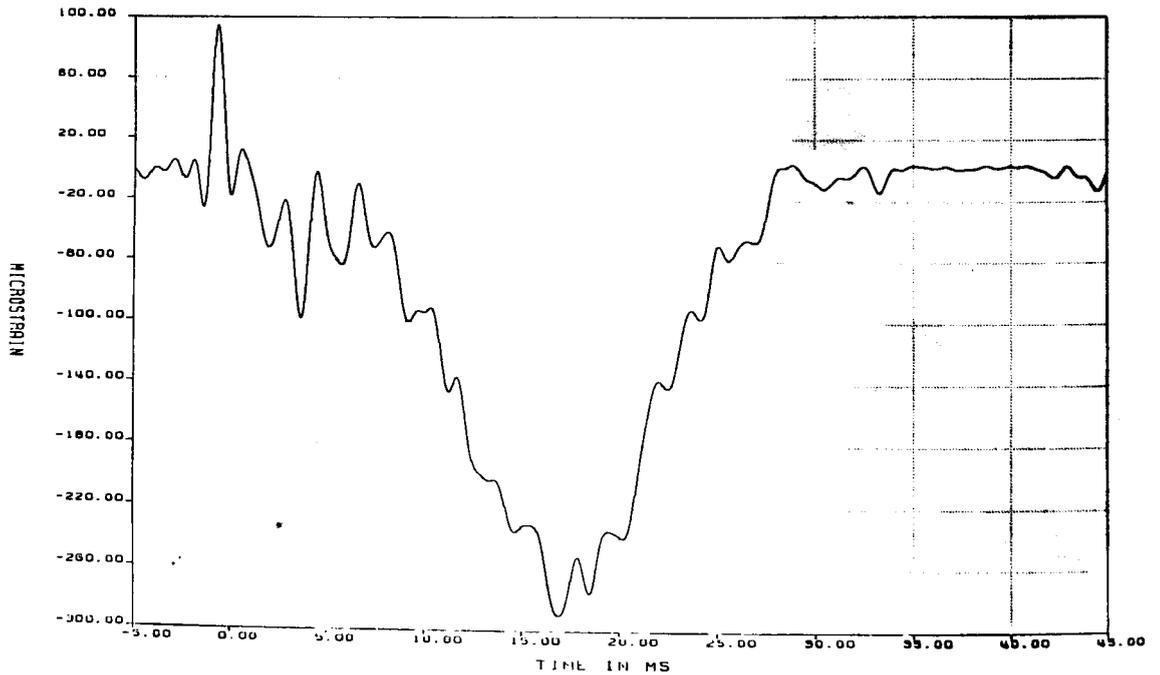
Figure C1-14. Microstrain vs Time for Gage SR2-Z for 30-ft Oblique Drop Test (filtered at 1000 Hz)

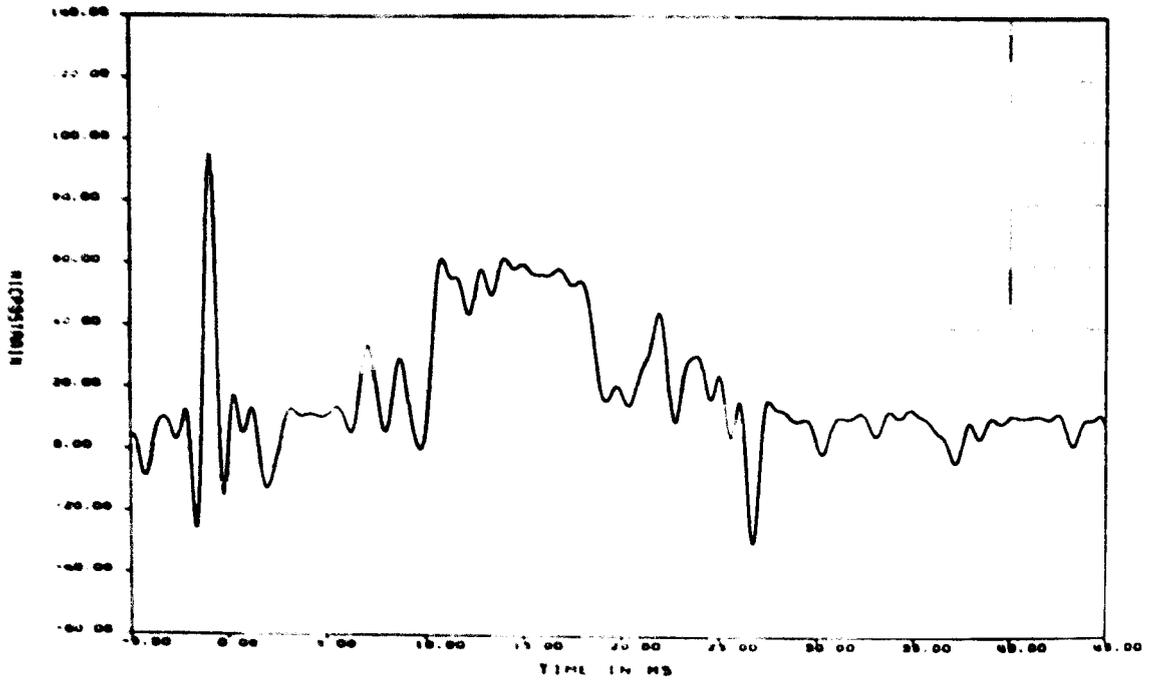
Figure C1-15. Microstrain vs Time for Gage SR3 Y for 30 ft Oblique Drop Test (filtered at 1000 Hz)

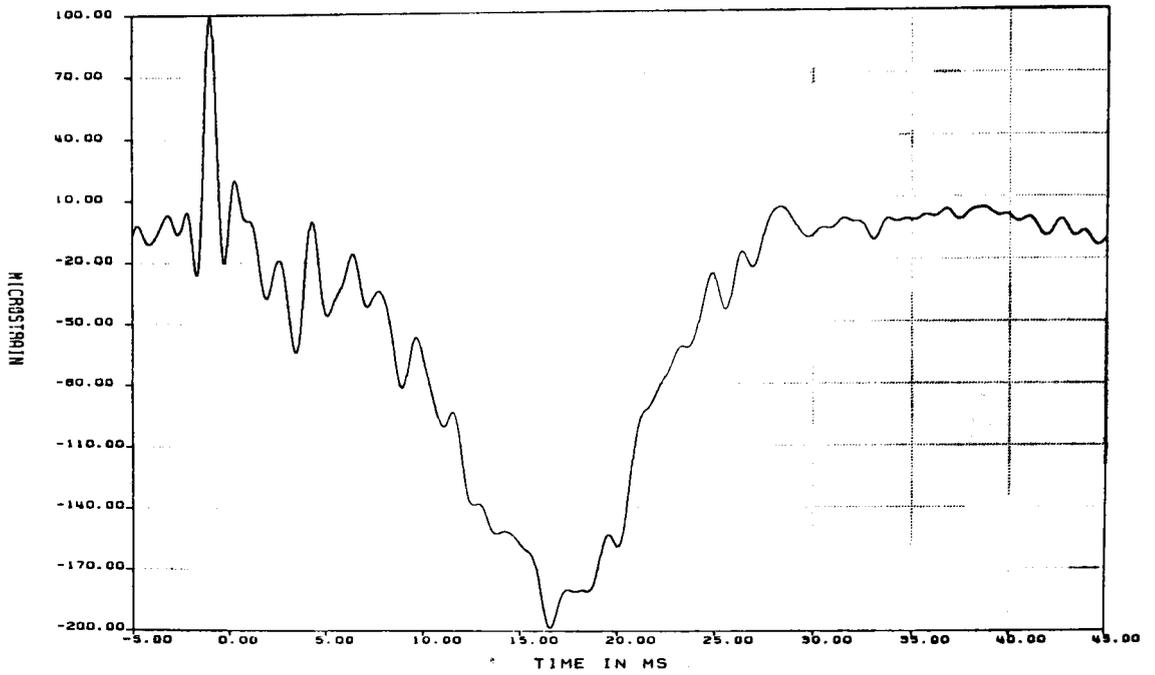
Figure C1-17. Microstrain vs Time for Gage SR3-Z for 30-ft Oblique Drop Test (filtered at 1000 Hz)

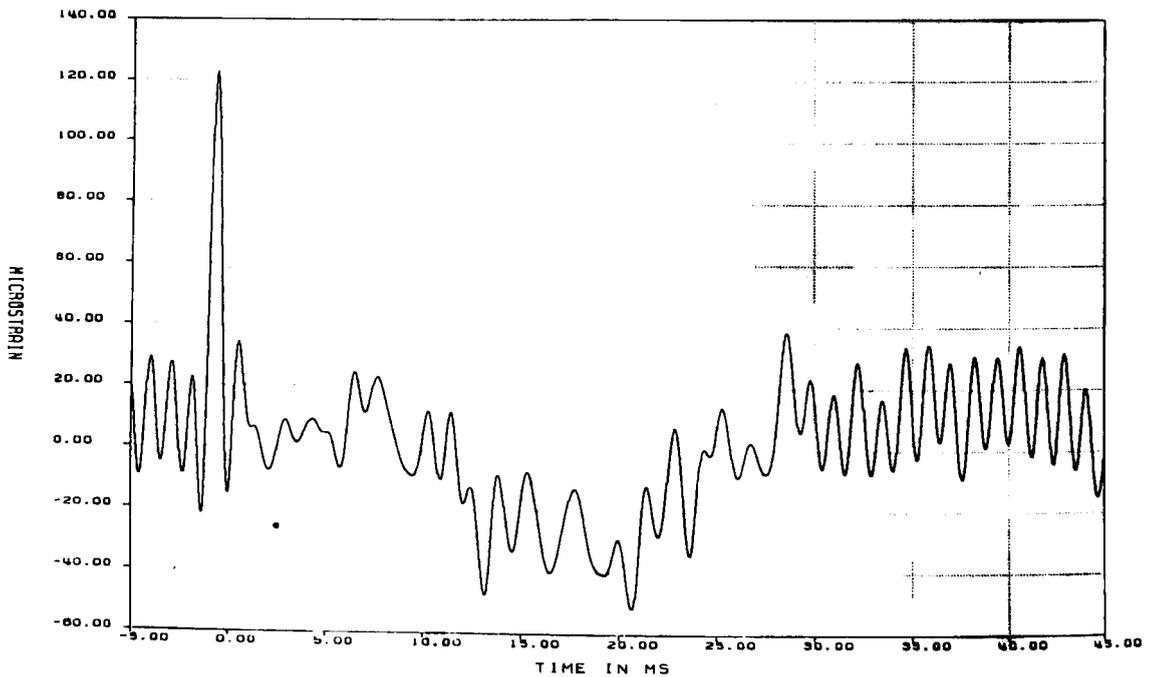
Figure C1-18. Microstrain vs Time for Gage SR4-Y for 30-ft Oblique Drop Test (filtered at 1000 Hz)

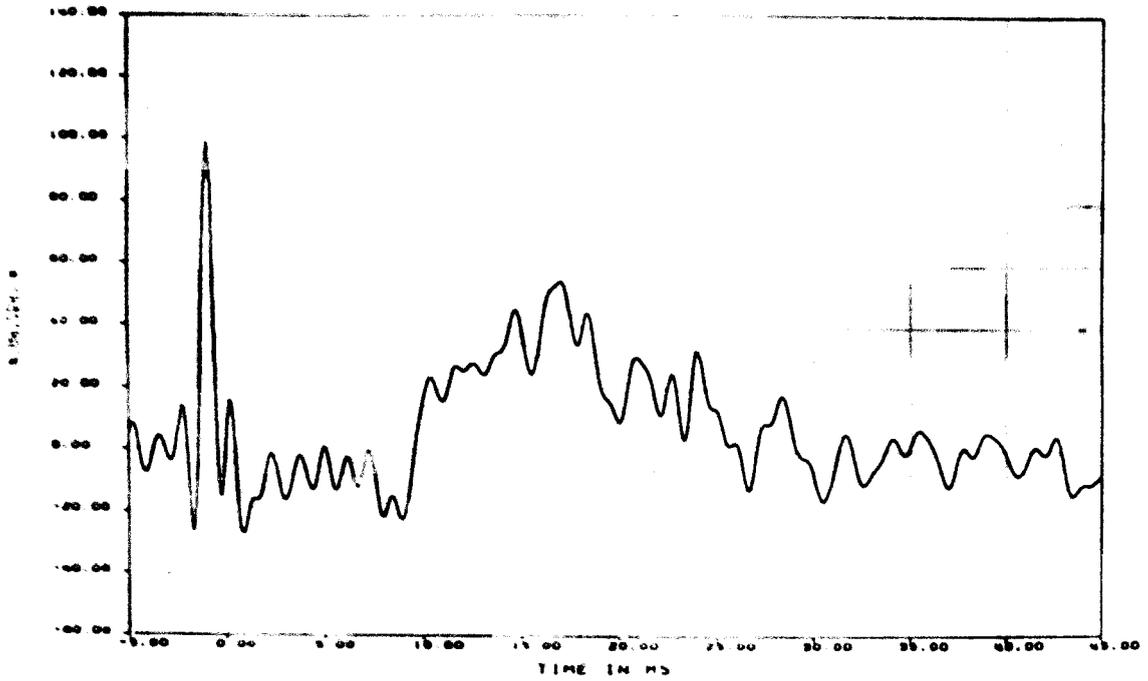
Figure C1-19. Microstrain vs Time for Gage SR4-YZ for 30-ft Oblique Drop Test (filtered at 1000 Hz)

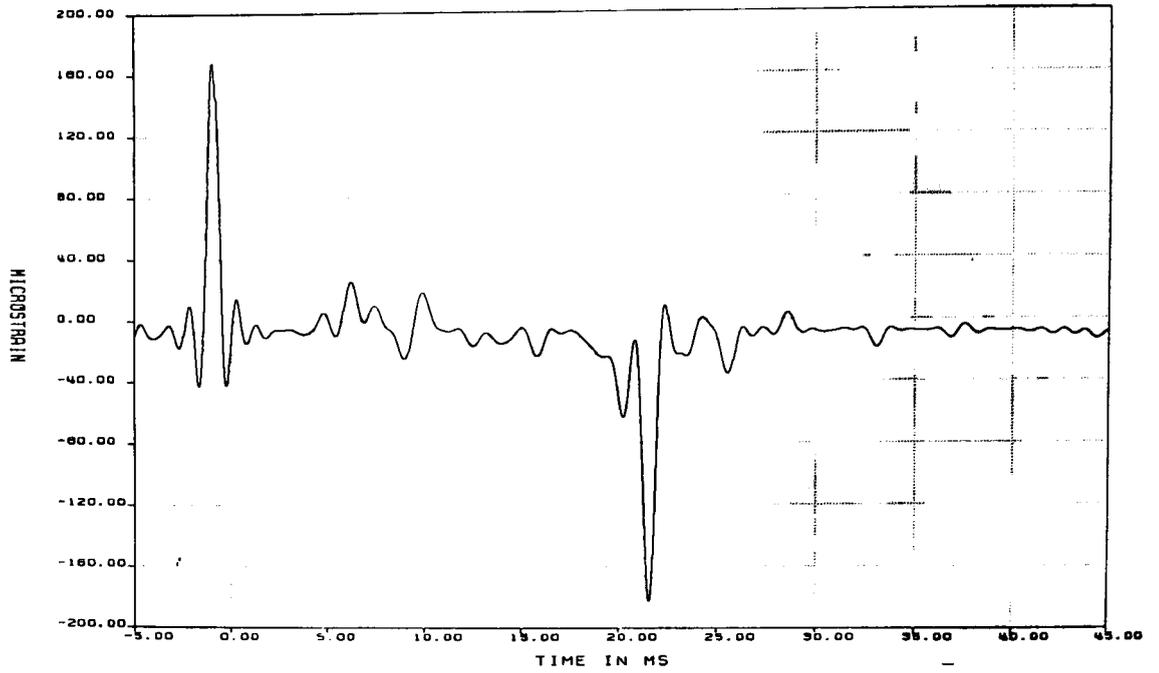
Figure C1-21. Microstrain vs Time for Gage SR5-Y for 30-ft Oblique Drop Test (filtered at 1000 Hz)

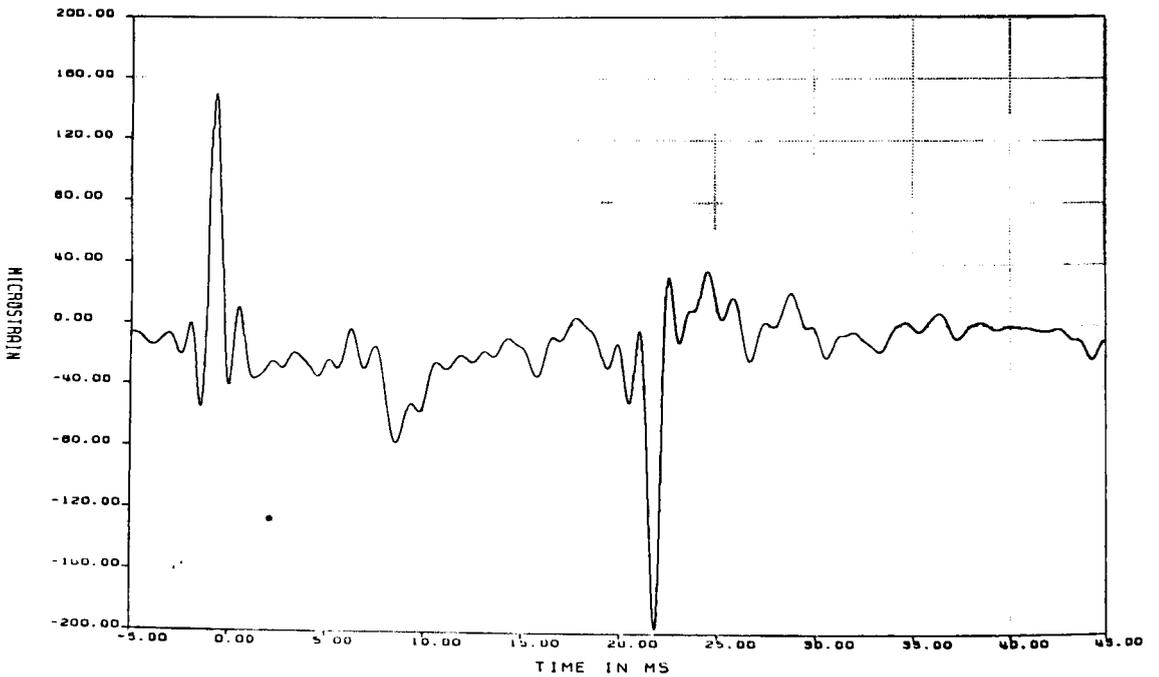
Figure C1-22. Microstrain vs Time for Gage SR5-YZ for 30-ft Oblique Drop Test (filtered at 1000 Hz)
