TEST DATA REPORT FOR QUARTER SCALE NUPAC 125-B RAIL CASK MODEL

Test Data Report for Quarter Scale NuPac 125-B Rail Cask Model

This report describes the testing conducted and presents the data obtained by Sandia National Laboratories on a quarter scale model of the NuPac 125-B Rail Cask. Three 30-ft free-fall impact tests and two 40-in. free-fall drops onto a puncture bar were performed. The 30-ft drop tests consisted of one end drop onto the bottom impact limiter, an oblique drop onto the closure-end impact limiter, and a flat drop onto both impact limiters on the exterior of the package. The 40-in. puncture tests were directed at the centers of the side and closure end of the package. The five tests were conducted to verify the structural adequacy of the package for the hypothetical accident conditions specified in 10CFR71 and to define the accident damage as initial conditions for the thermal, shielding, and criticality analyses.

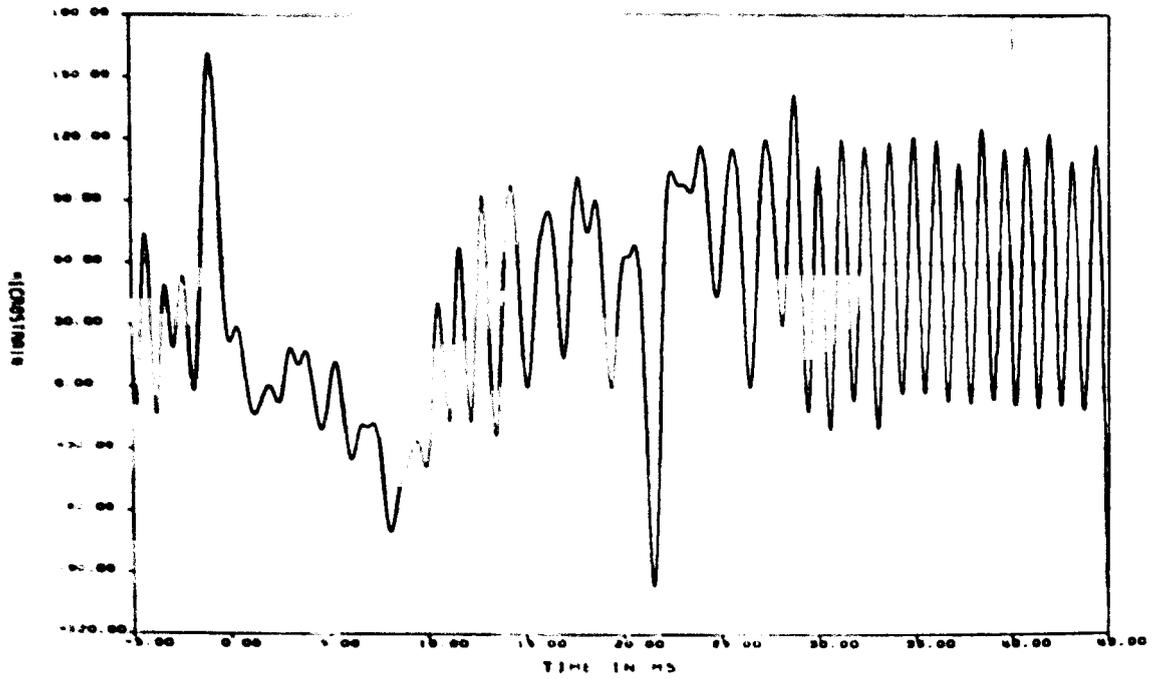
Figure C1-23. Microstrain vs Time for Gage SR5 Z for 30-ft Oblique Drop Test (filtered at 1000 Hz)

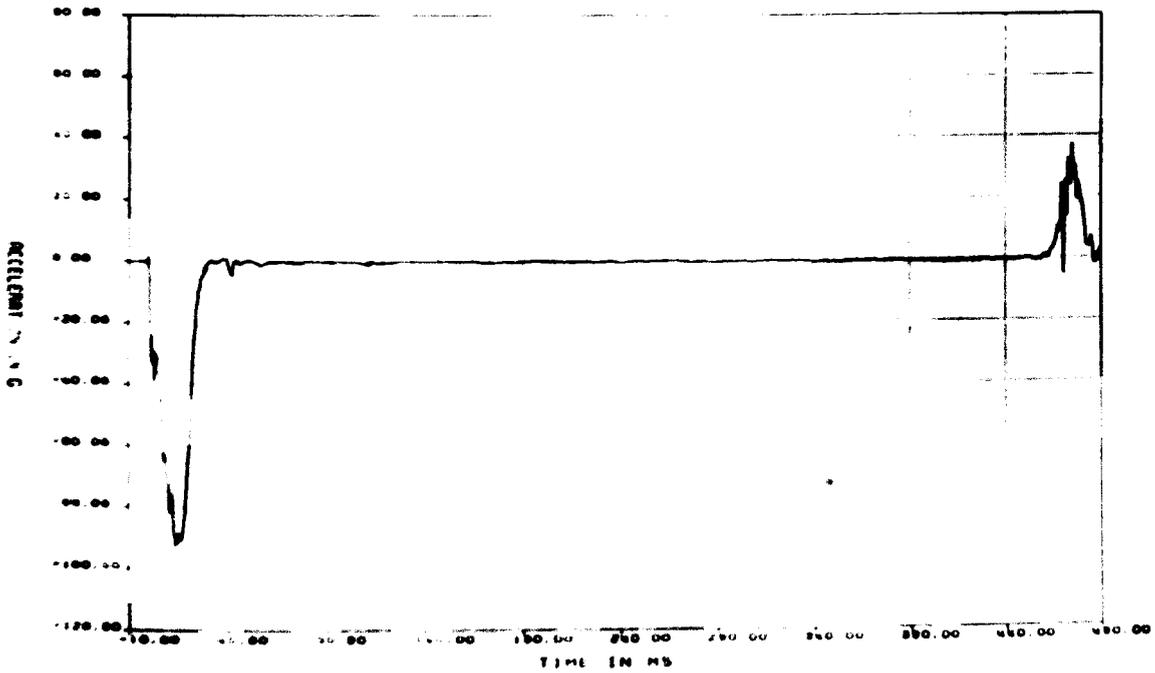
Figure C1-24. Acceleration vs Time for Gage AZ1 for 30-ft Oblique Drop Test, Including Primary and Secondary Impacts

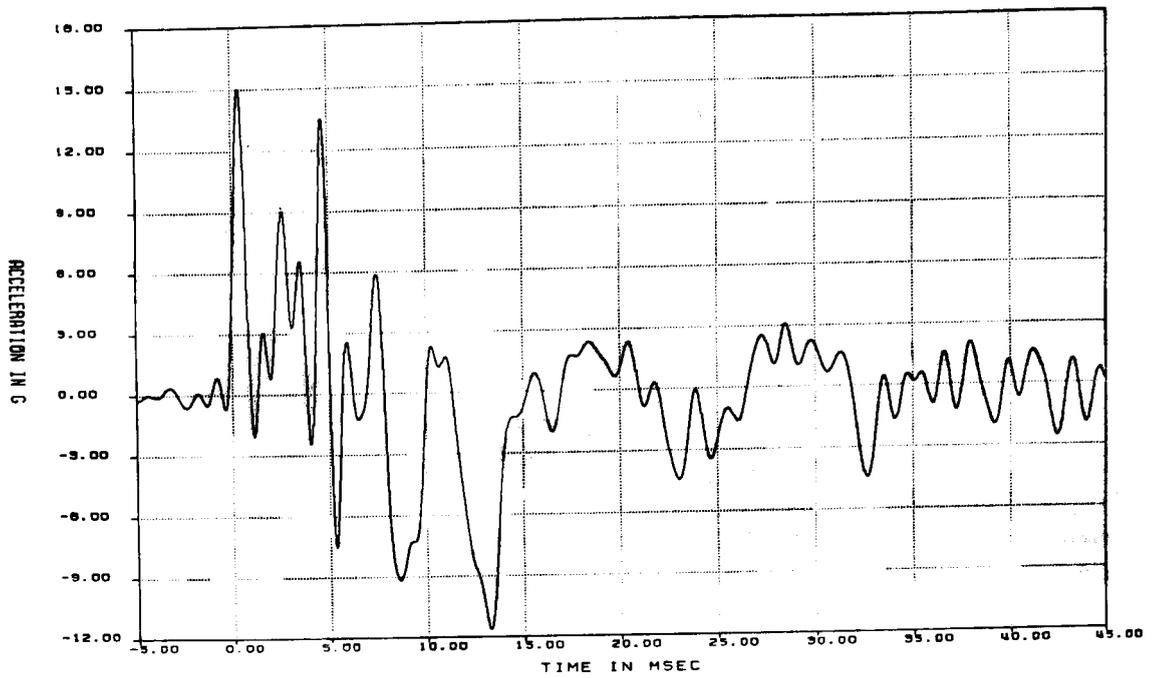
Figure D1-1. Acceleration vs Time for Gage AZ1 for 30-ft Side Drop Test (filtered at 1000 Hz)

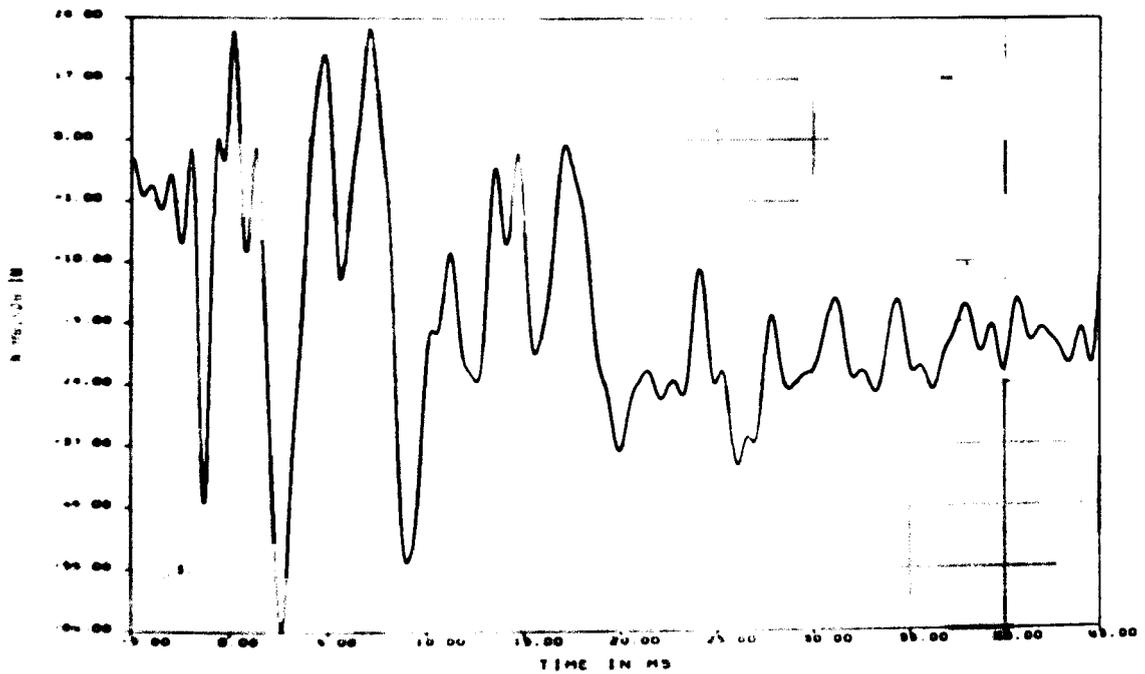
Figure D1-12. Microstrain vs Time for Gage SR1 Y for 30-ft Side Drop Test (filtered at 1000 Hz)

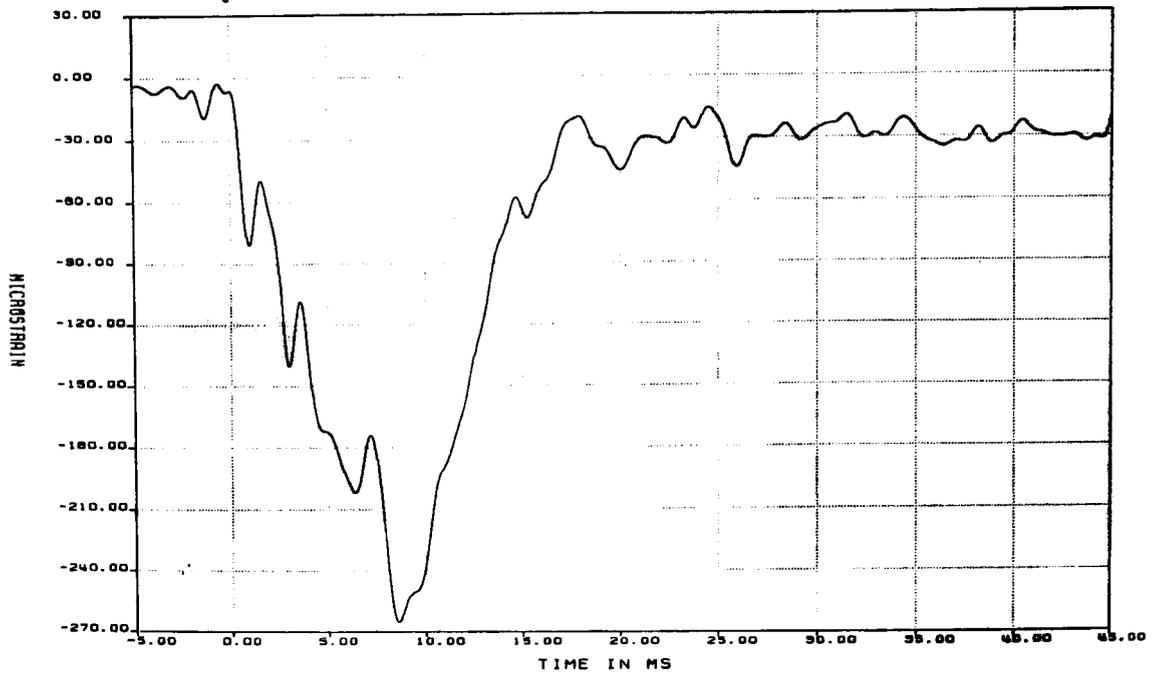
Figure D1-13. Microstrain vs Time for Gage SR1-YZ for 30-ft Side Drop Test (filtered at 1000 Hz)

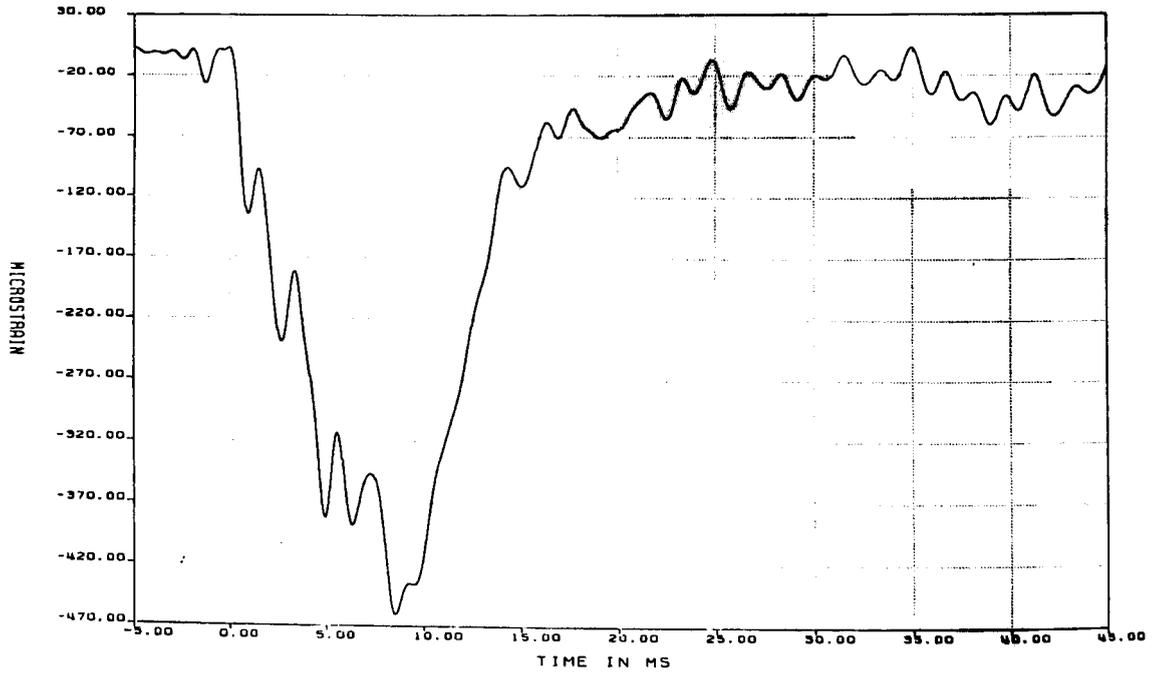
Figure D1-14. Microstrain vs Time for Gage SR1-Z for 30-ft Side Drop Test (filtered at 1000 Hz)

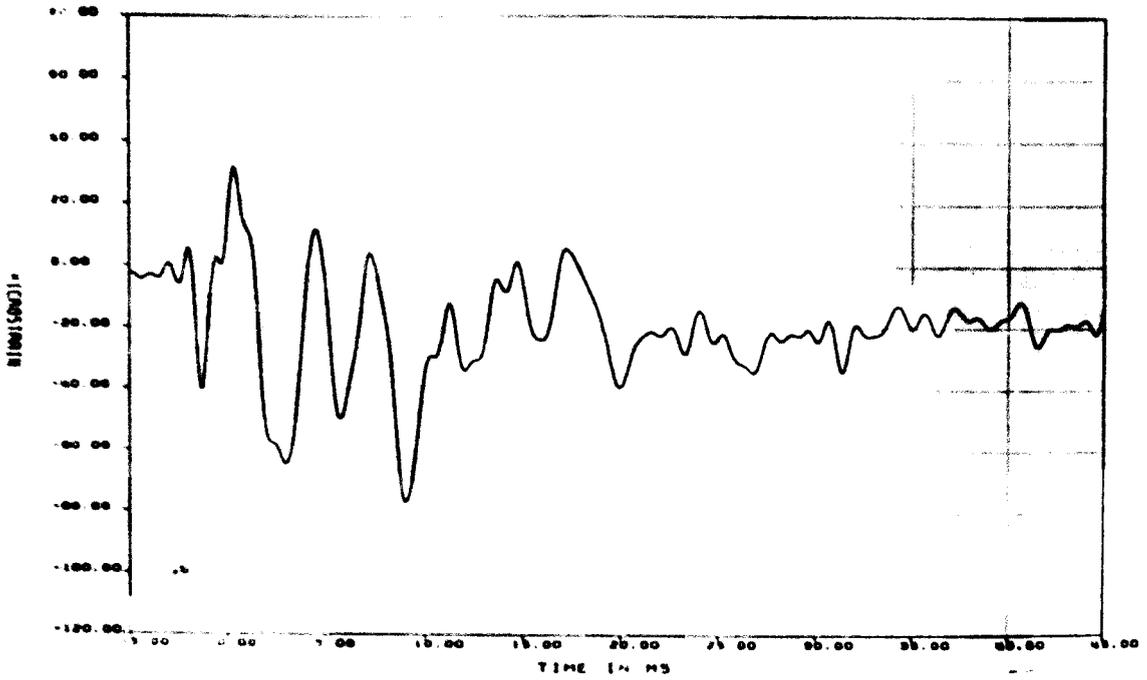
Figure D1-15. Microstrain vs Time for Gage SR2-Y for 30-ft Side Drop Test (filtered at 1000 Hz)

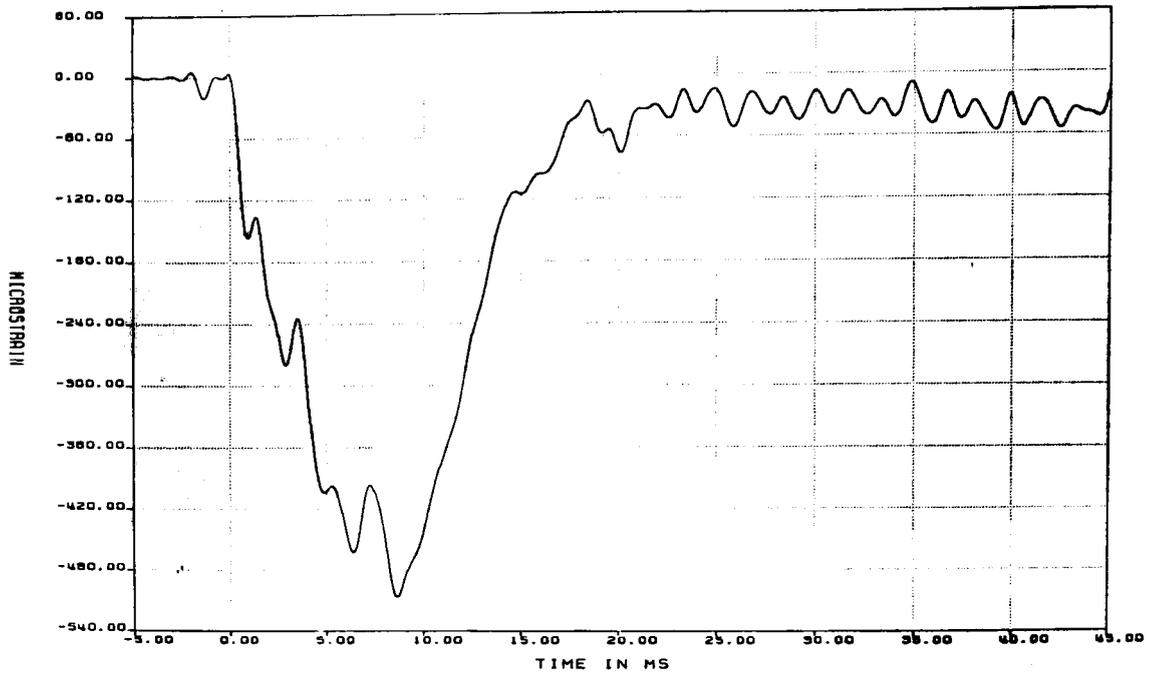
Figure D1-17. Microstrain vs Time for Gage SR2-Z for 30-ft Side Drop Test (filtered at 1000 Hz)

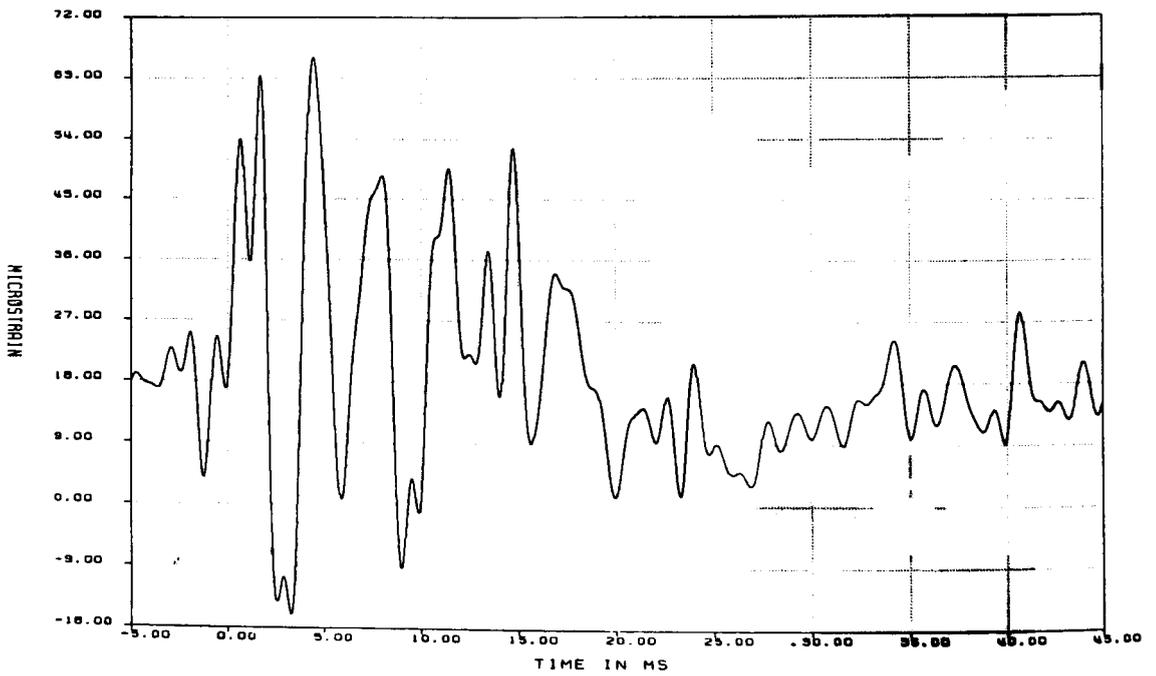
Figure D1-18. Microstrain vs Time for Gage SR3-Y for 30-ft Side Drop Test (filtered at 1000 Hz)

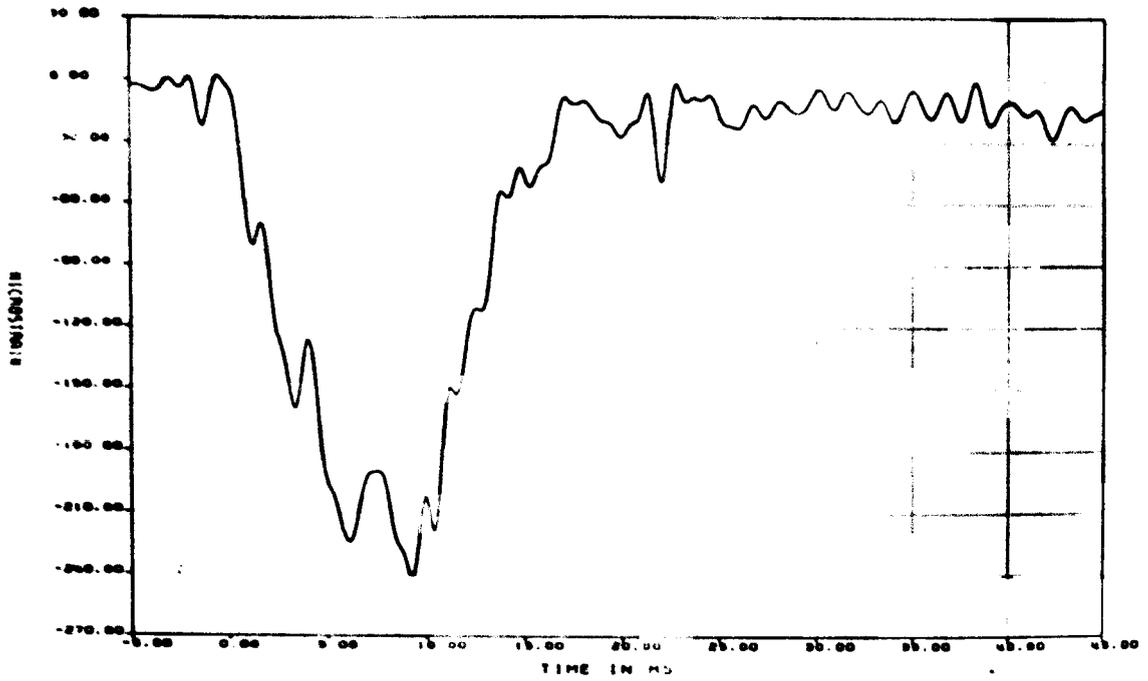
Figure D1-19. Microstrain vs Time for Gage SR3-YZ for 30-ft Side Drop Test (filtered at 1000 Hz)

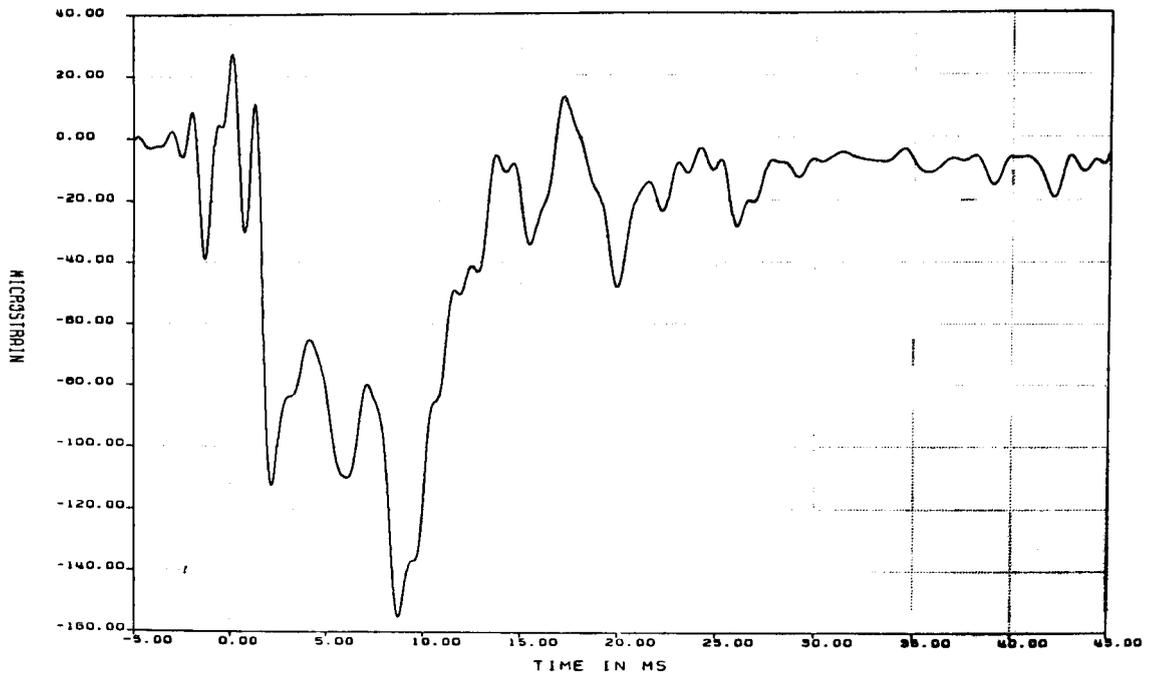
Figure D1-21. Microstrain vs Time for Gage SR4-Y for 30-ft Side Drop Test (filtered at 1000 Hz)

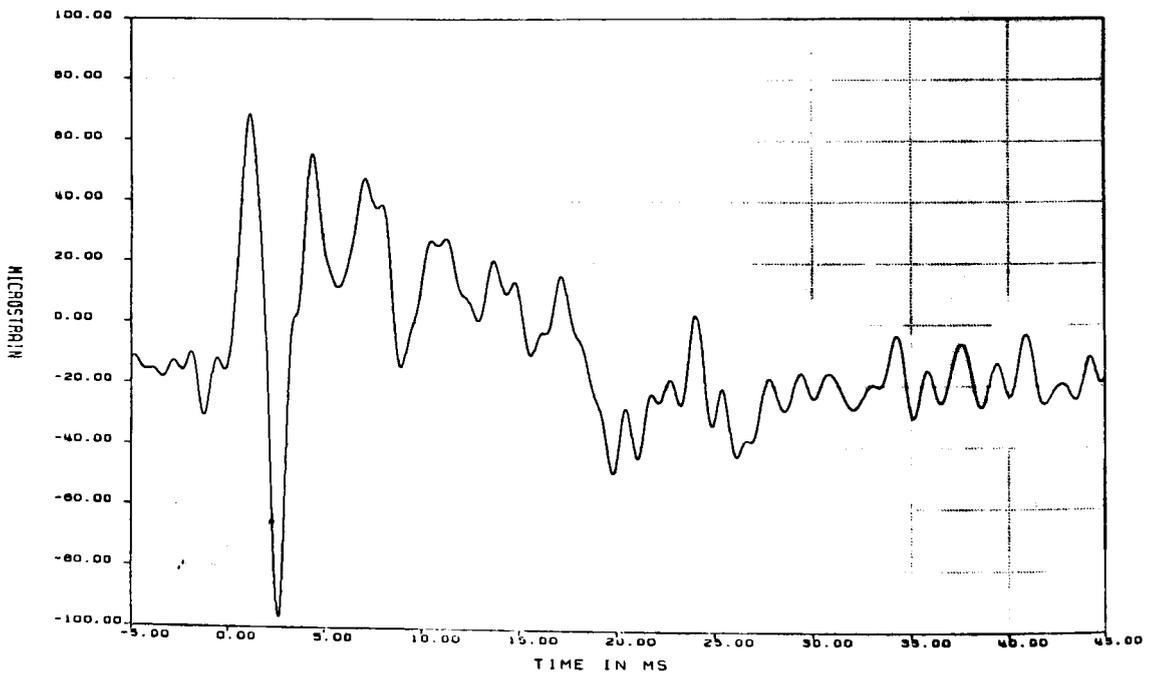
Figure D1-22. Microstrain vs Time for Gage SR4-YZ for 30-ft Side Drop Test (filtered at 1000 Hz)

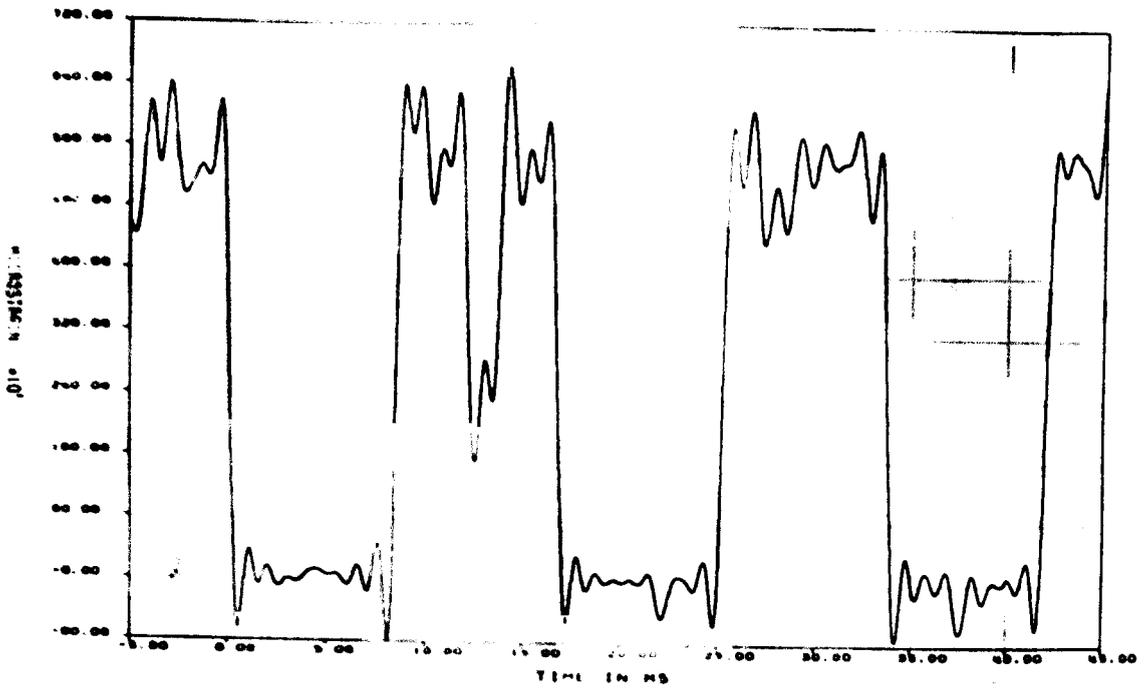
Figure D1-23. Microstrain vs Time for Gage SR4-Z for 30-ft Side Drop Test (filtered at 1000 Hz)

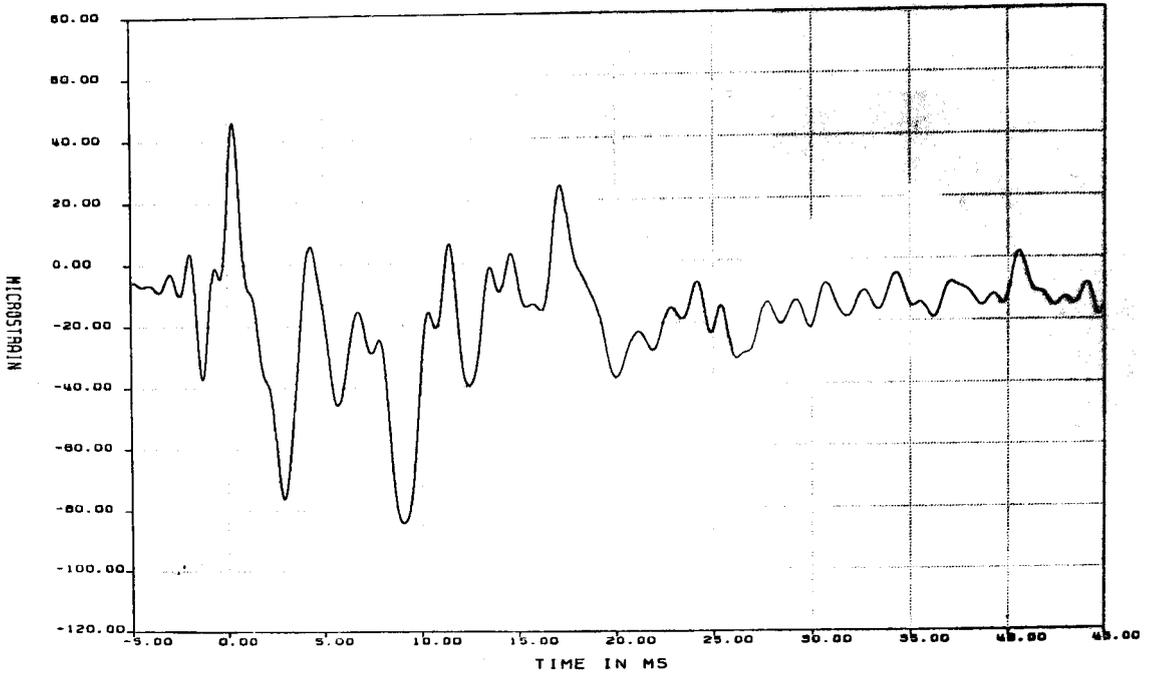
Figure D1-25. Microstrain vs Time for Gage SR5-YZ for 30-ft Side Drop Test (filtered at 1000 Hz)

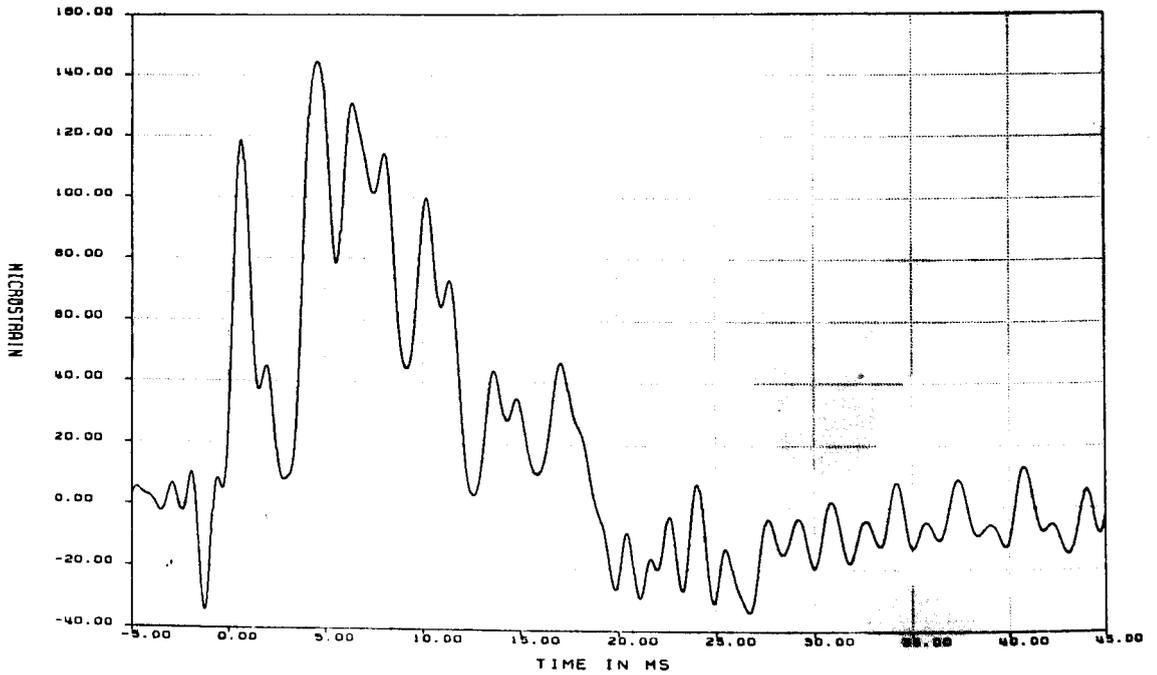
Figure D1-26. Microstrain vs Time for Gage SR5-Z for 30-ft Side Drop Test (filtered at 1000 Hz)

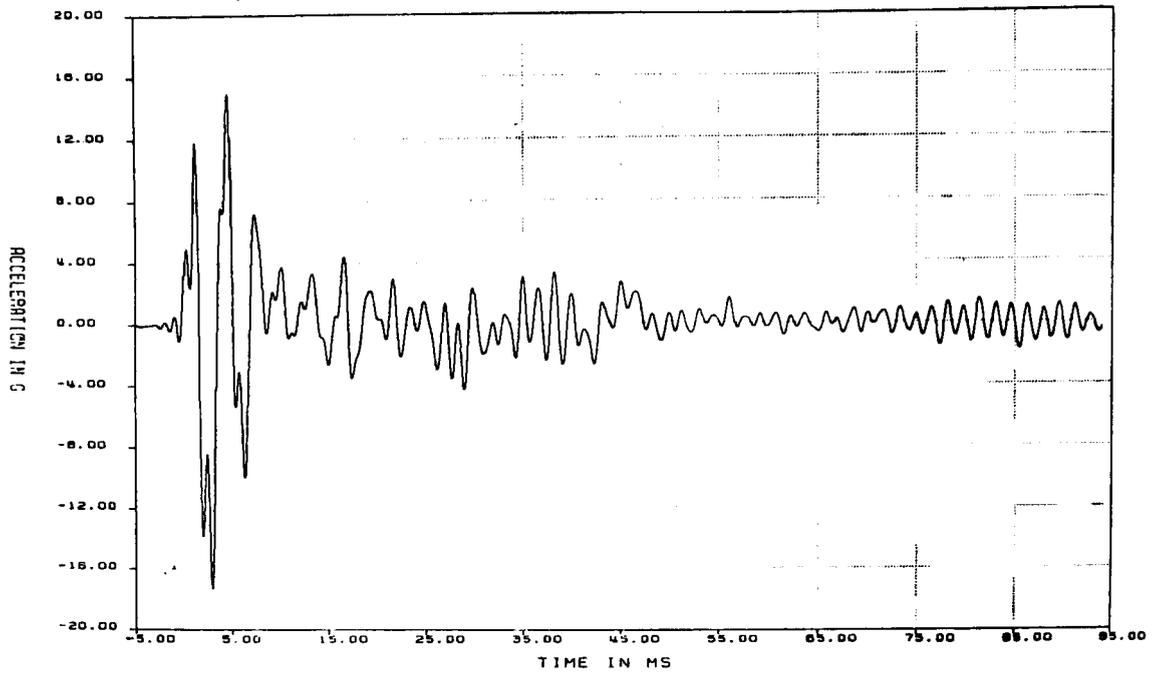
Figure E1-1. Acceleration vs Time for Gage AZ1 for 40-in. Side Puncture Test (filtered at 1000 Hz)

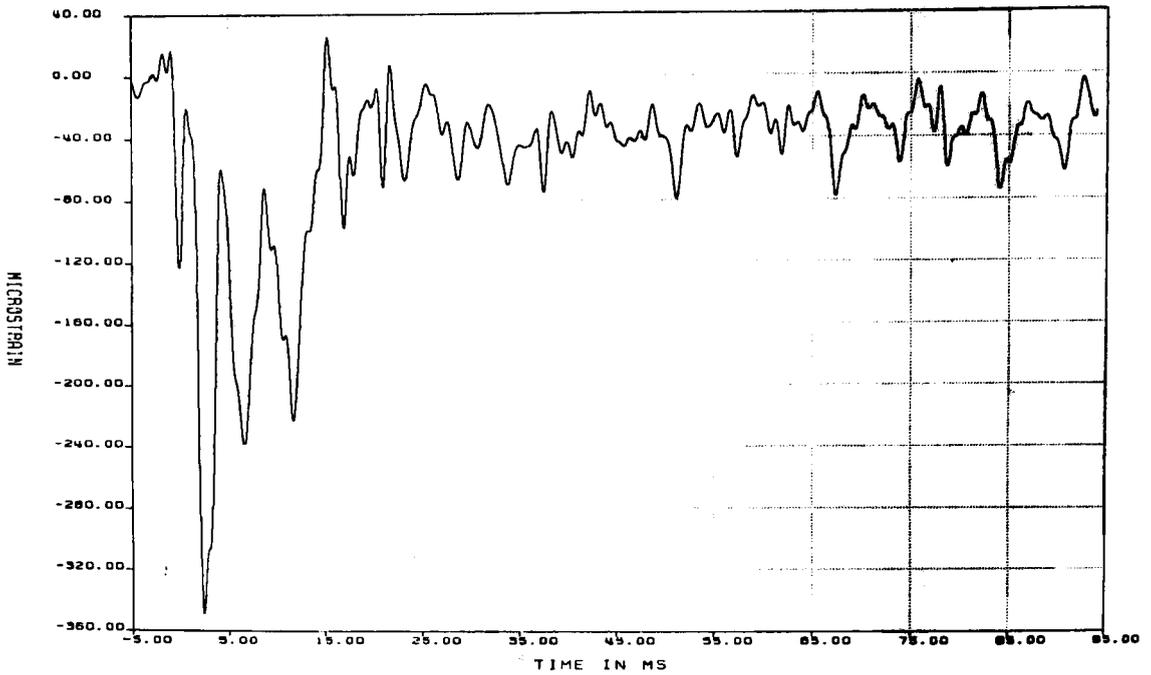
Figure E1-13. Microstrain vs Time for Gage SR1-YZ for 40-in. Side Puncture Test (filtered at 1000 Hz)

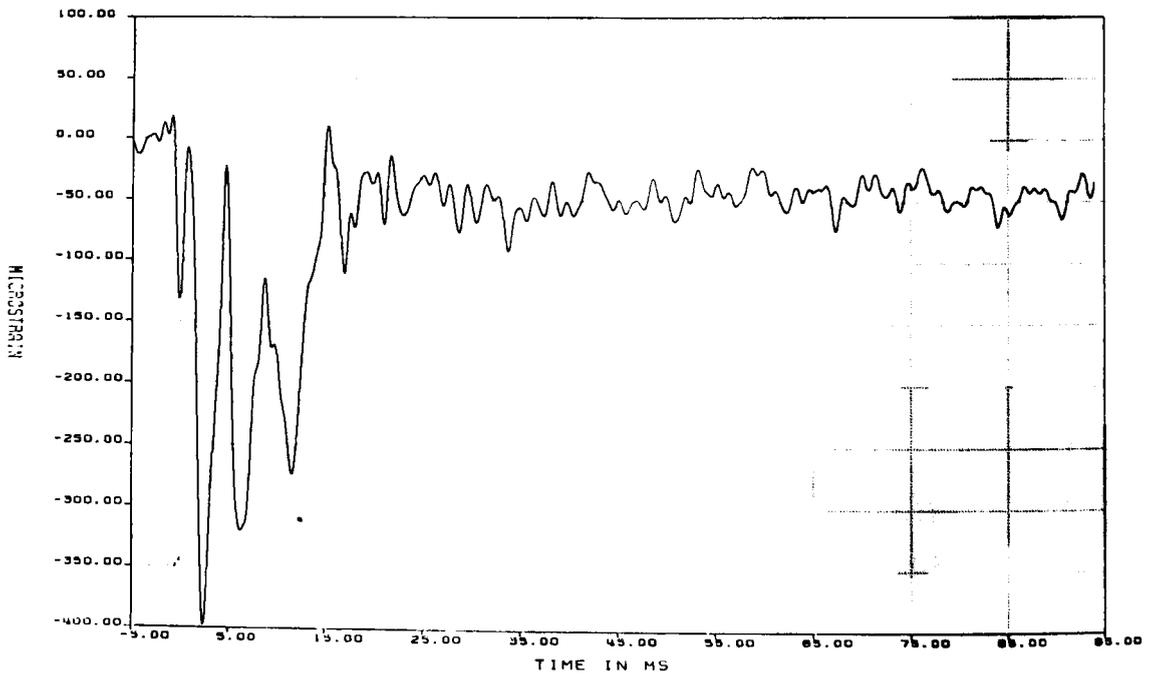
Figure E1-14. Microstrain vs Time for Gage SR1-Z for 40-in. Side Puncture Test (filtered at 1000 Hz)

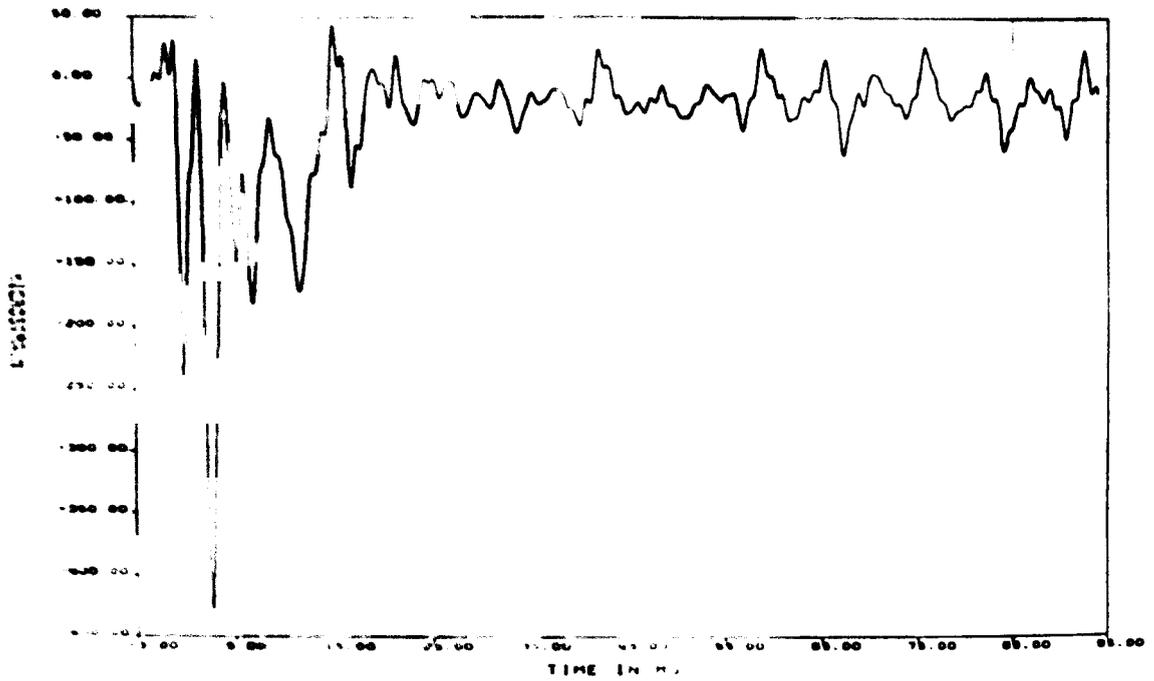
Figure E1-15. Microstrain vs Time for Gage SR2-Y for 40-in. Side Puncture Test (filtered at 1000 Hz)

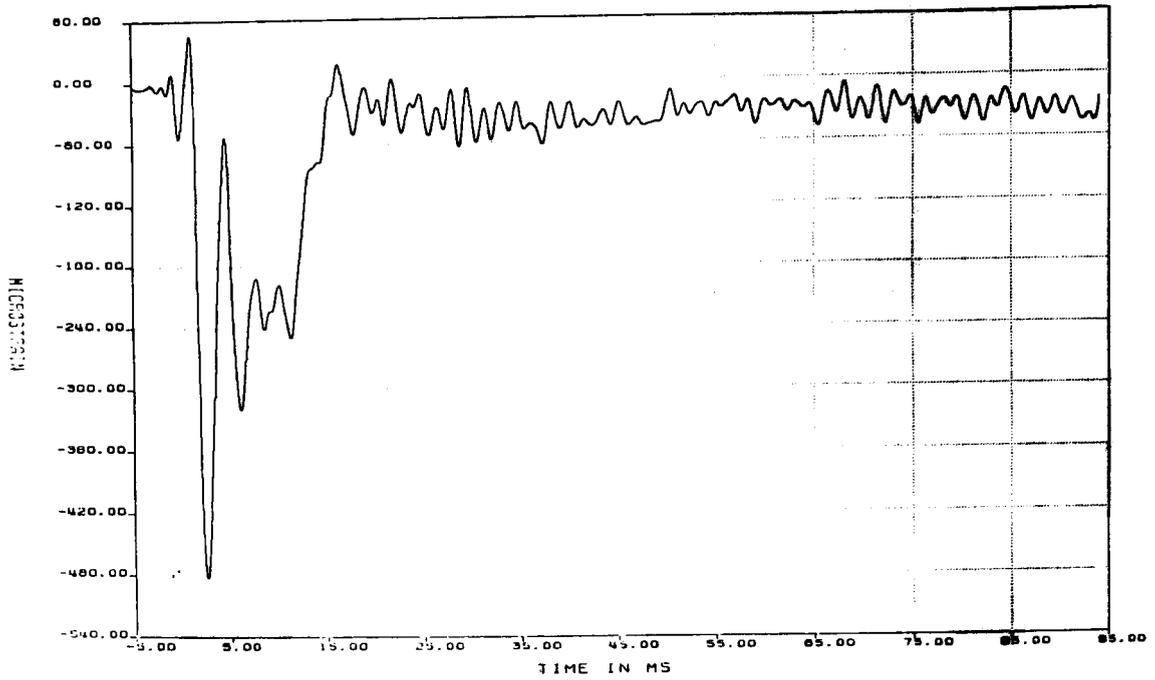
Figure E1-17. Microstrain vs Time for Gage SR2-Z for 40-in. Side Puncture Test (filtered at 1000 Hz)

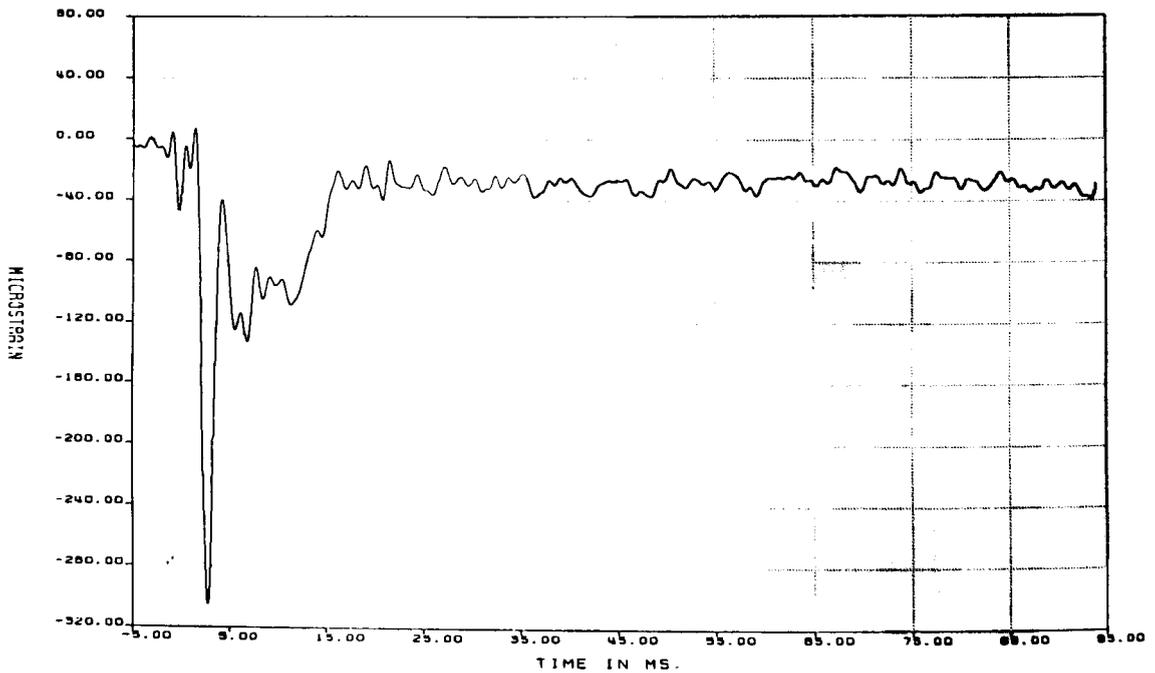
Figure E1-18. Microstrain vs Time for Gage SR3-Y for 40-in. Side Puncture Test (filtered at 1000 Hz)

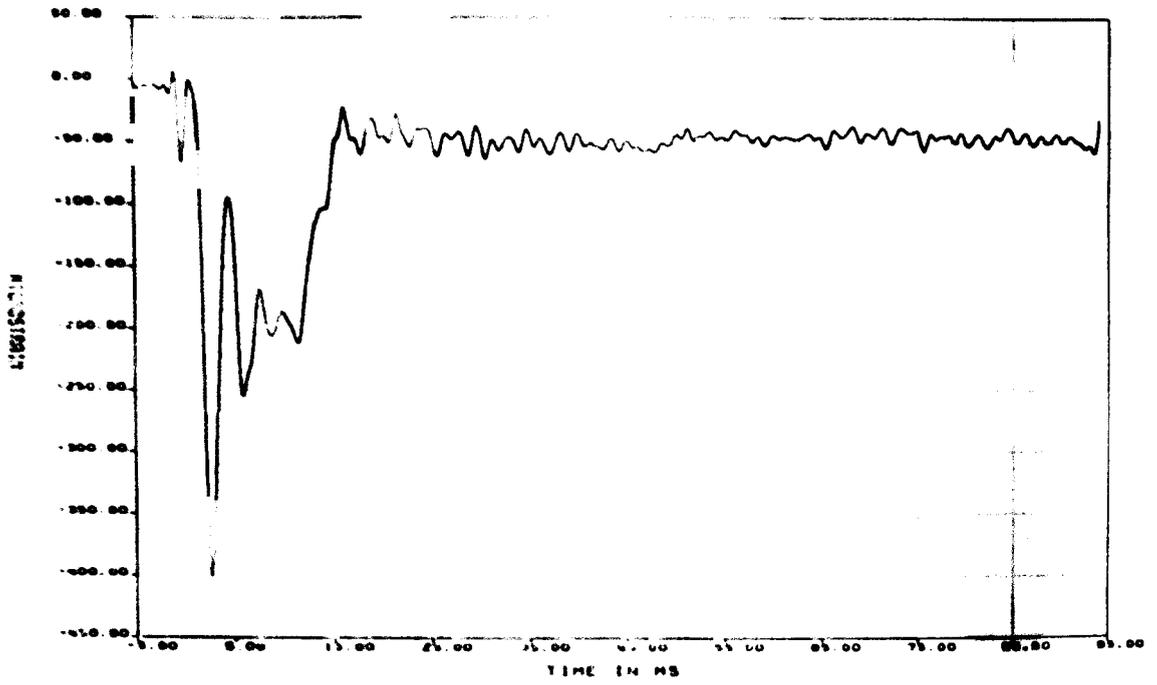
Figure E1-19. Microstrain vs Time for Gage SR3-YZ for 40-in. Side Puncture Test (filtered at 1000 Hz)

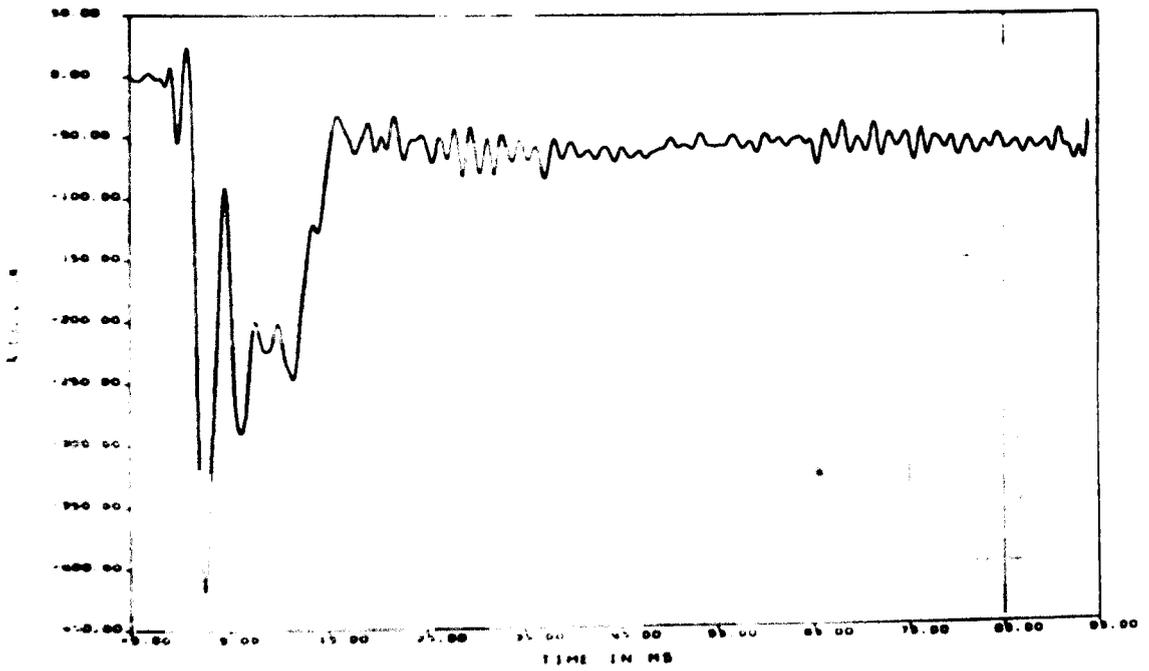
Figure E1-20. Microstrain vs Time for Gage SR3-Z for 40-in. Side Puncture Test (filtered at 1000 Hz)

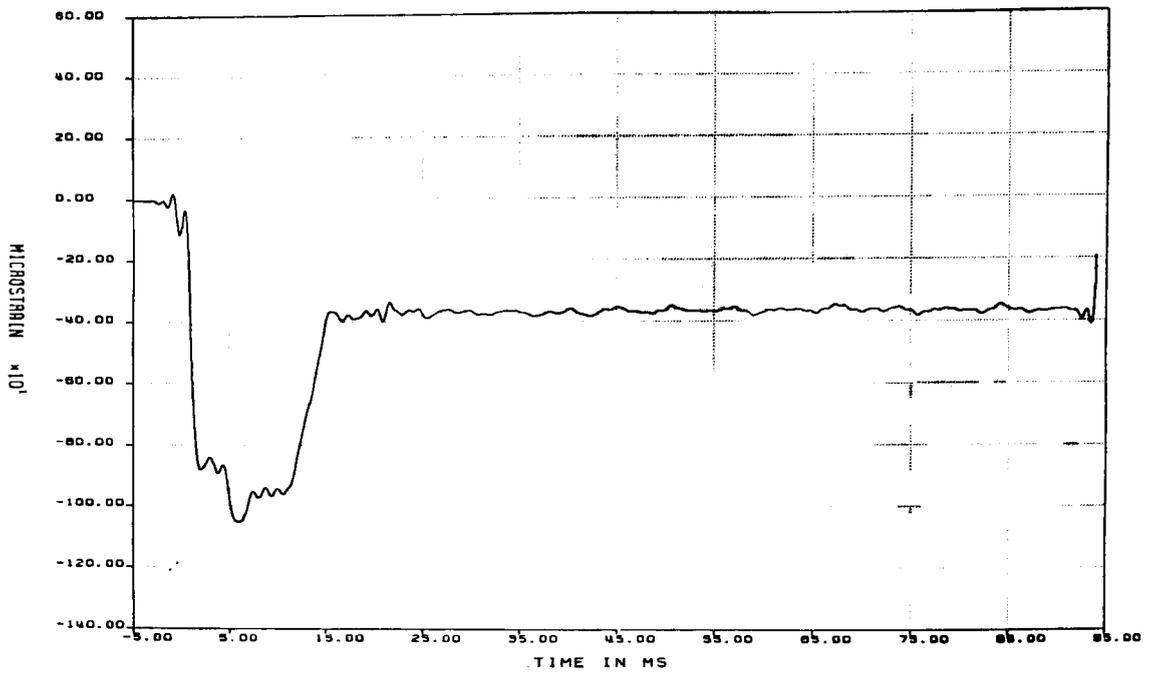
Figure E1-21. Microstrain vs Time for Gage SR4-Y for 40-in. Side Puncture Test (filtered at 1000 Hz)

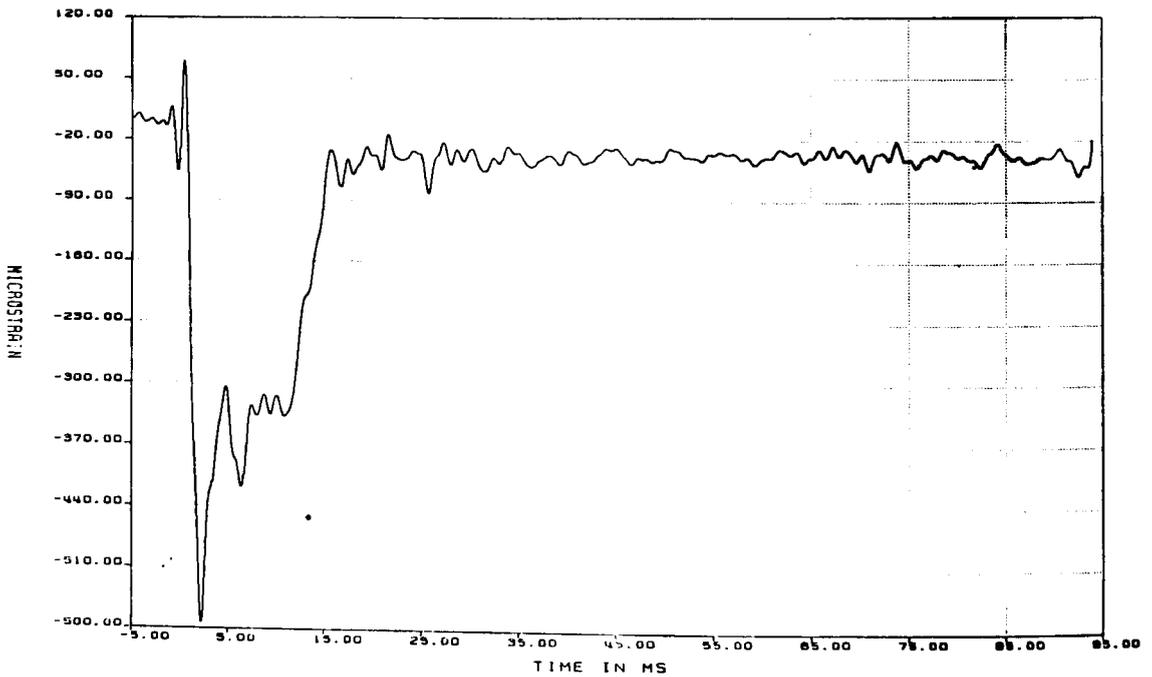
Figure E1-22. Microstrain vs Time for Gage SR4-YZ for 40-in. Side Puncture Test (filtered at 1000 Hz)

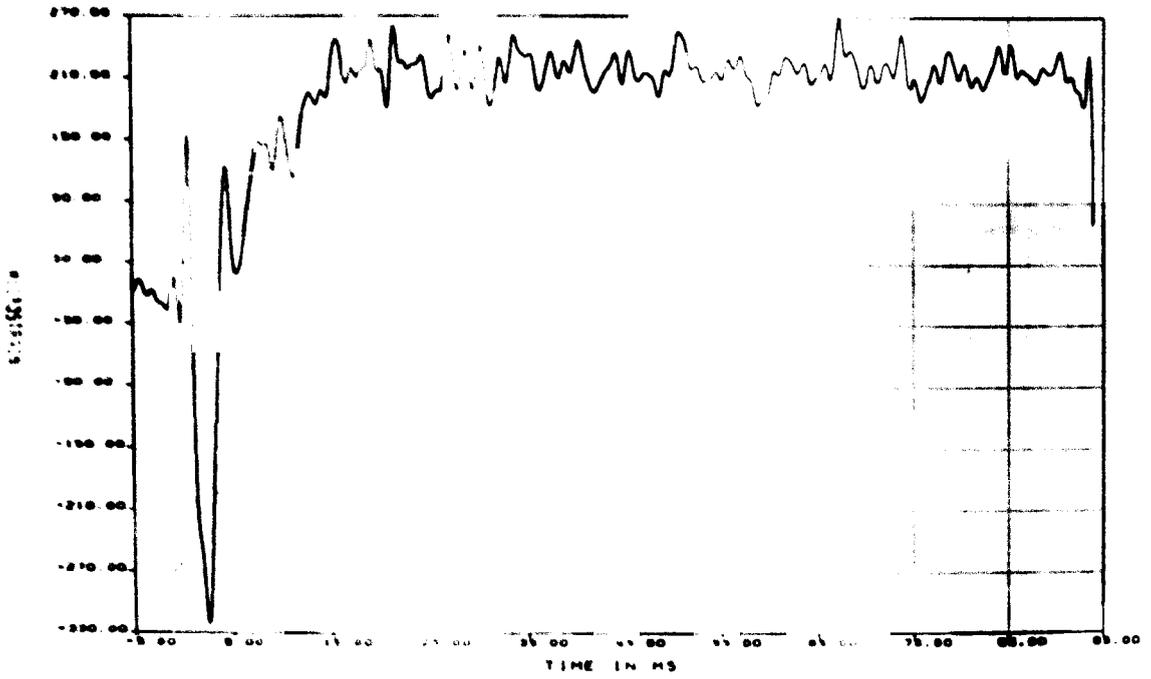
Figure E 1-23. Microstrain vs Time for Gage SR4-Z for 40-in. Side Puncture Test (filtered at 1000 Hz)

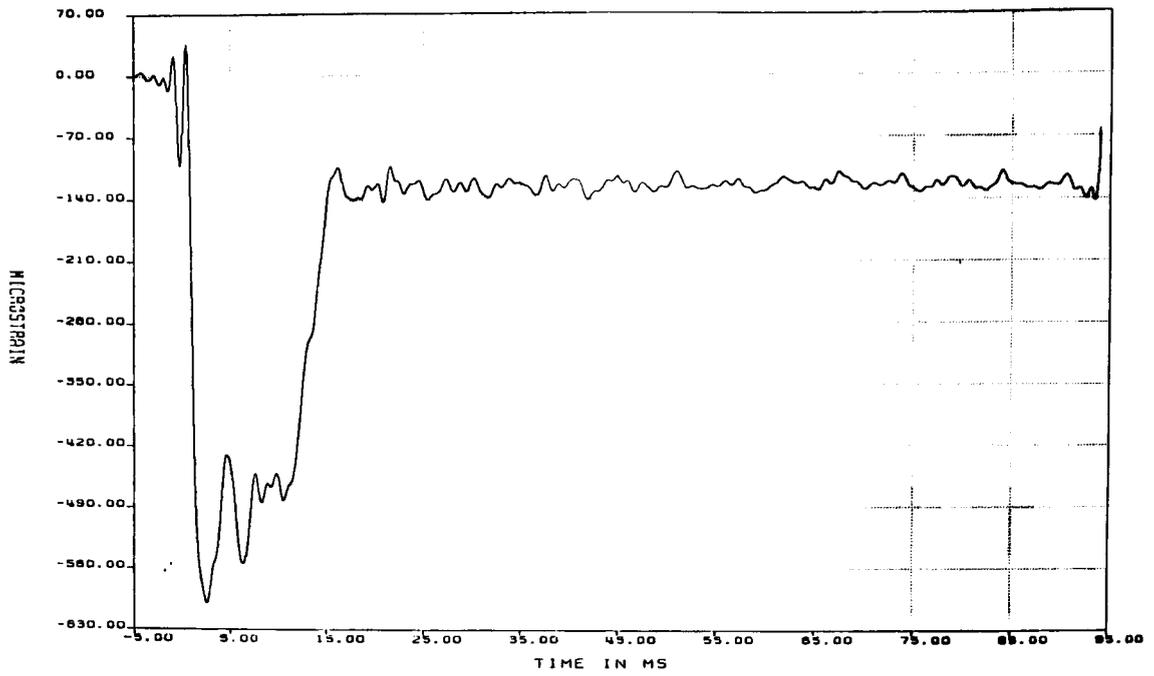
Figure E1-25. Microstrain vs Time for Gage SR5-YZ for 40-in. Side Puncture Test (filtered at 1000 Hz)

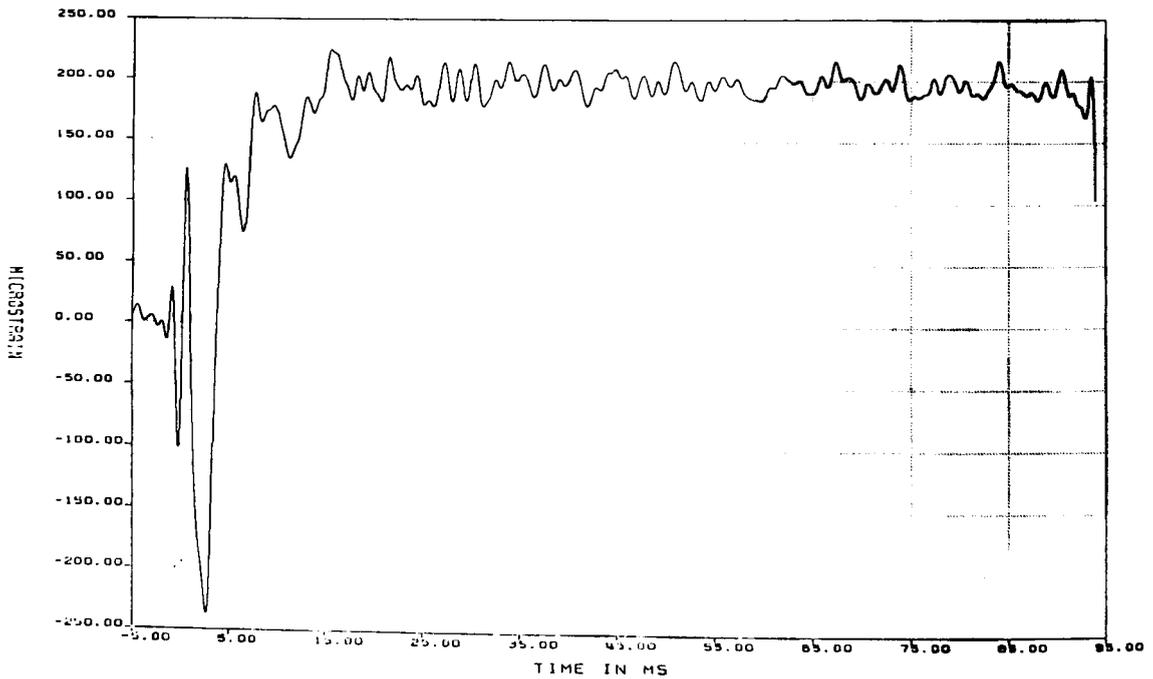
Figure E1-26. Microstrain vs Time for Gage SR5-Z for 40-in. Side Puncture Test (filtered at 1000 Hz)
