TEST DATA REPORT FOR QUARTER SCALE NUPAC 125-B RAIL CASK MODEL

Test Data Report for Quarter Scale NuPac 125-B Rail Cask Model

This report describes the testing conducted and presents the data obtained by Sandia National Laboratories on a quarter scale model of the NuPac 125-B Rail Cask. Three 30-ft free-fall impact tests and two 40-in. free-fall drops onto a puncture bar were performed. The 30-ft drop tests consisted of one end drop onto the bottom impact limiter, an oblique drop onto the closure-end impact limiter, and a flat drop onto both impact limiters on the exterior of the package. The 40-in. puncture tests were directed at the centers of the side and closure end of the package. The five tests were conducted to verify the structural adequacy of the package for the hypothetical accident conditions specified in 10CFR71 and to define the accident damage as initial conditions for the thermal, shielding, and criticality analyses.

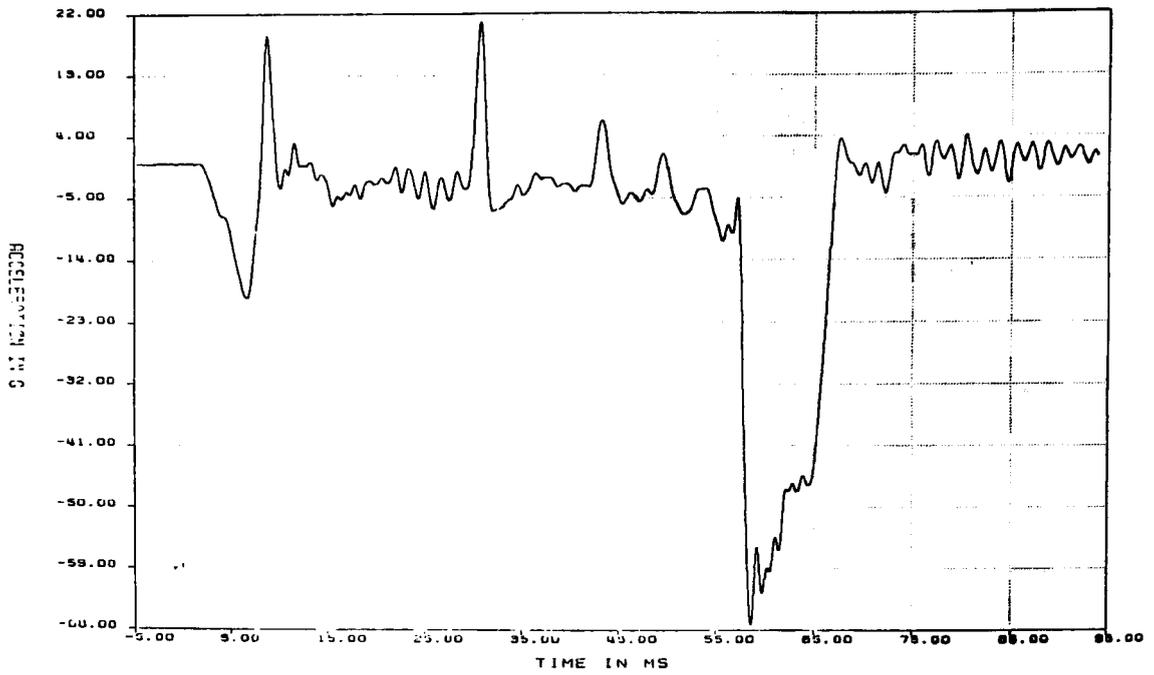
Figure F1-1. Acceleration vs Time for Gage AZ1 for 40-in. Closure End Puncture Test (filtered at 1000 Hz)

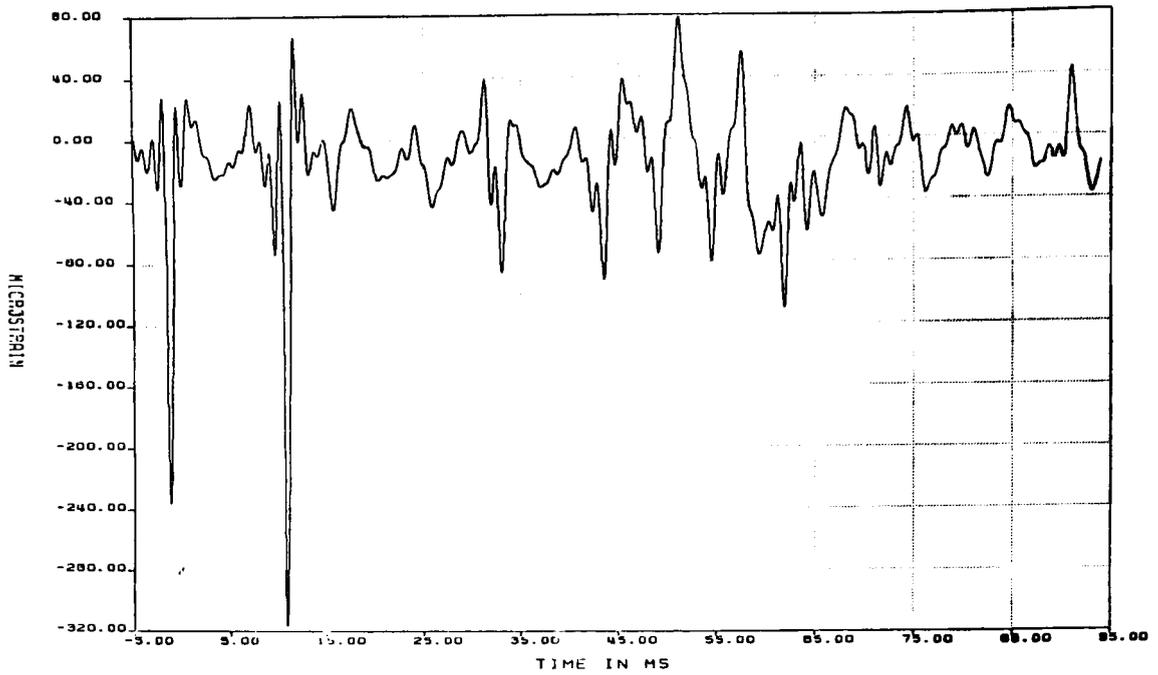
Figure F1-13. Microstrain vs Time for Gage SR1-YZ for 40-in. Closure End Puncture Test (filtered at 1000 Hz)

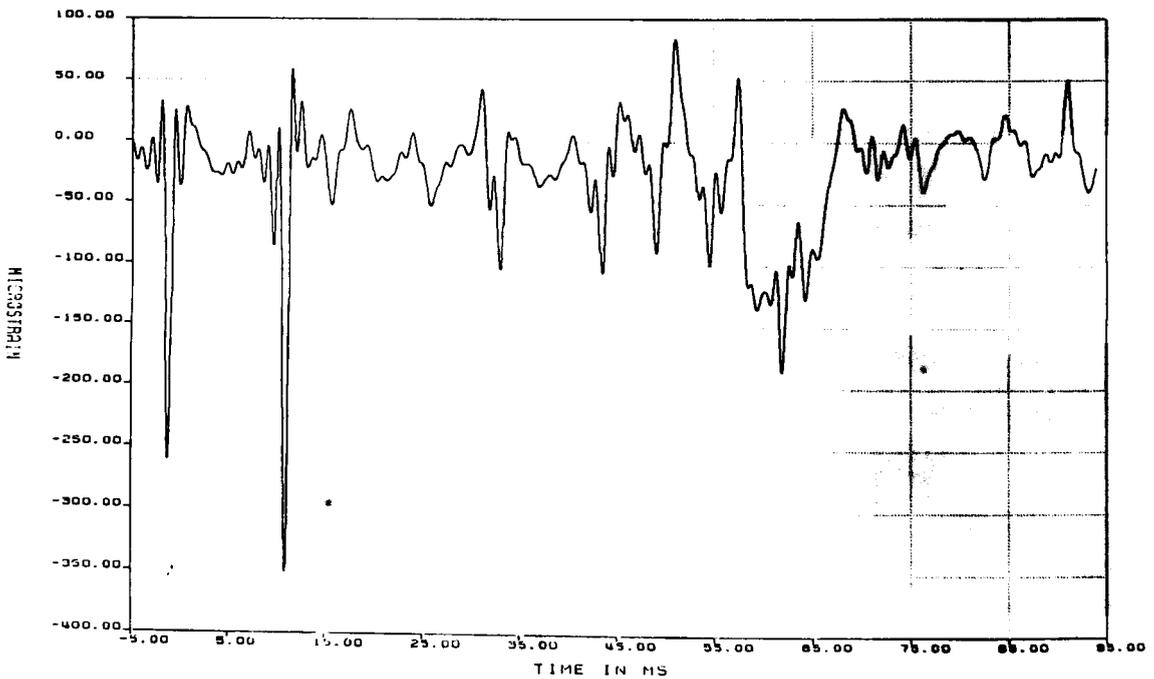
Figure F1-14. Microstrain vs Time for Gage SR1-Z for 40-in. Closure End Puncture Test (filtered at 1000 Hz)

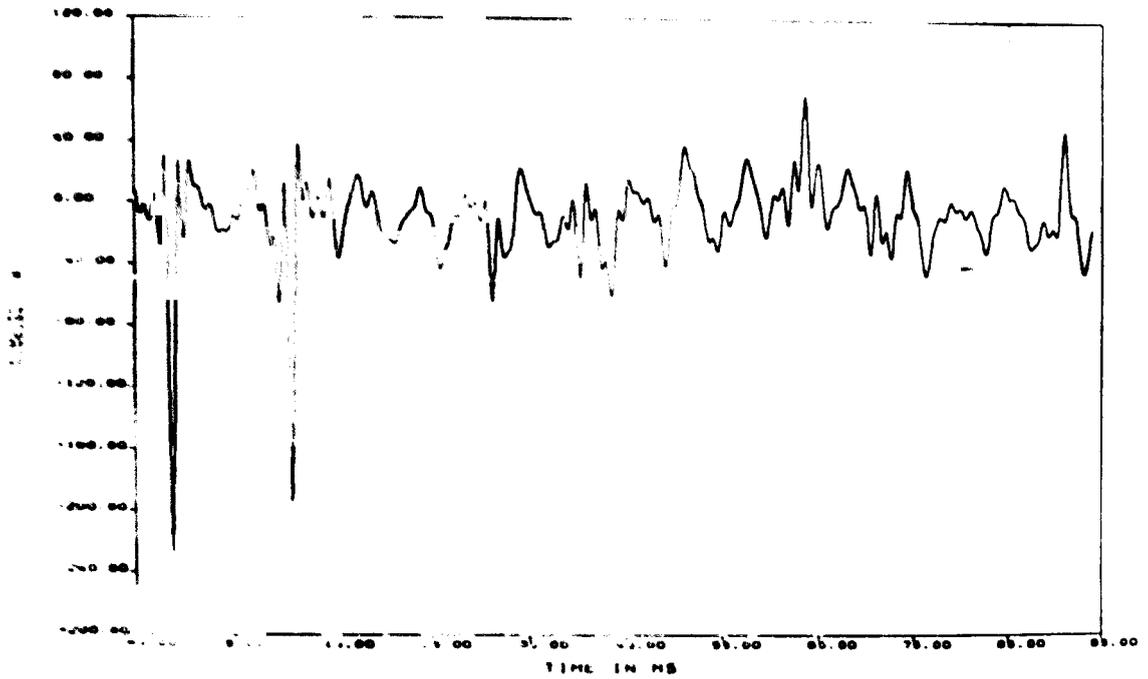
Figure F 1-15. Microstrain vs Time for Gage SR2 Y for 40-in. Closure End Puncture Test (filtered at 1000 Hz)

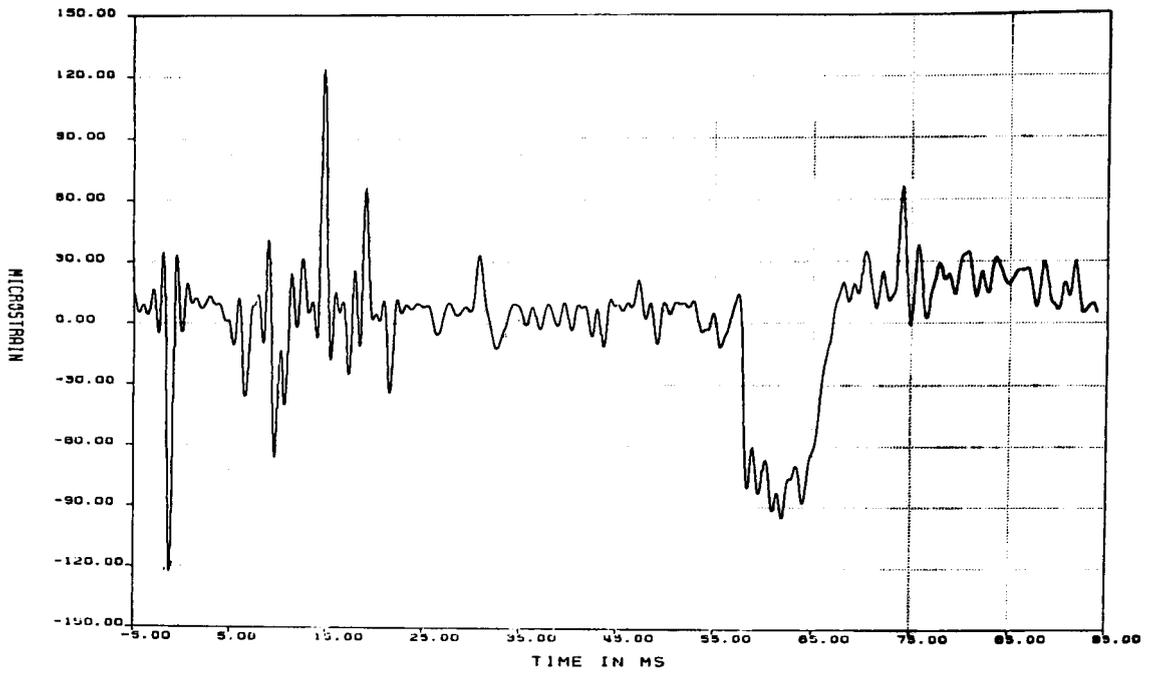
Figure F1-17. Microstrain vs Time for Gage SR2-Z for 40-in. Closure End Puncture Test (filtered at 1000 Hz)

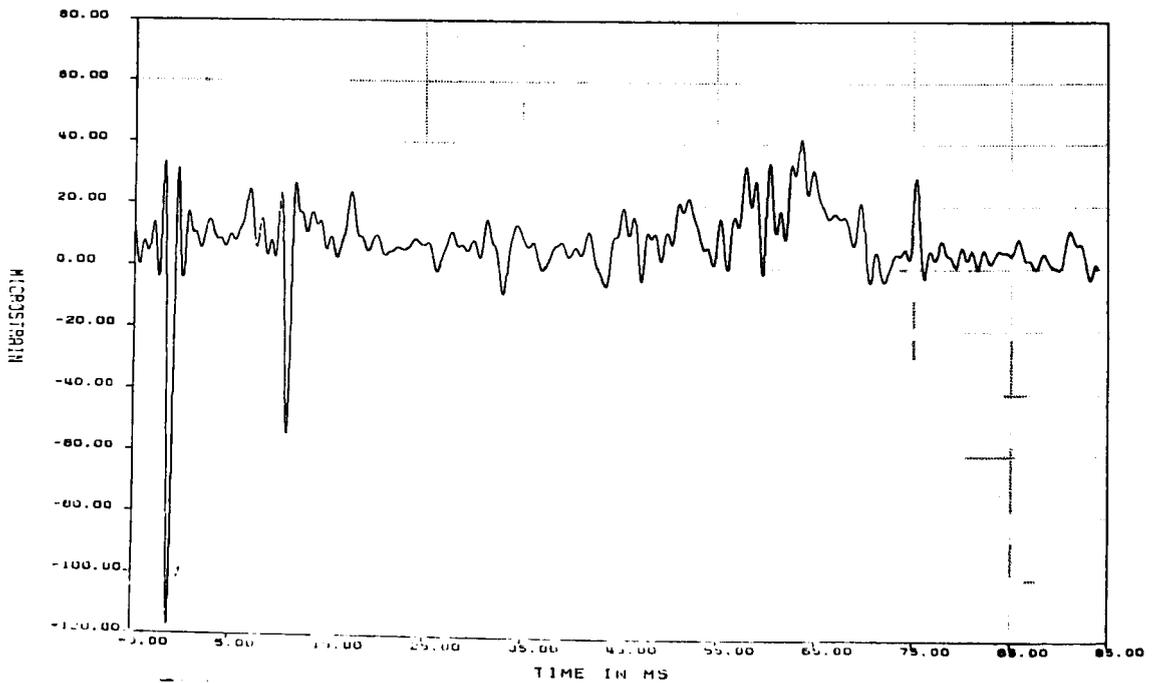
Figure F1-18. Microstrain vs Time for Gage SR3-Y for 40-in. Closure End Puncture Test (filtered at 1000 Hz)

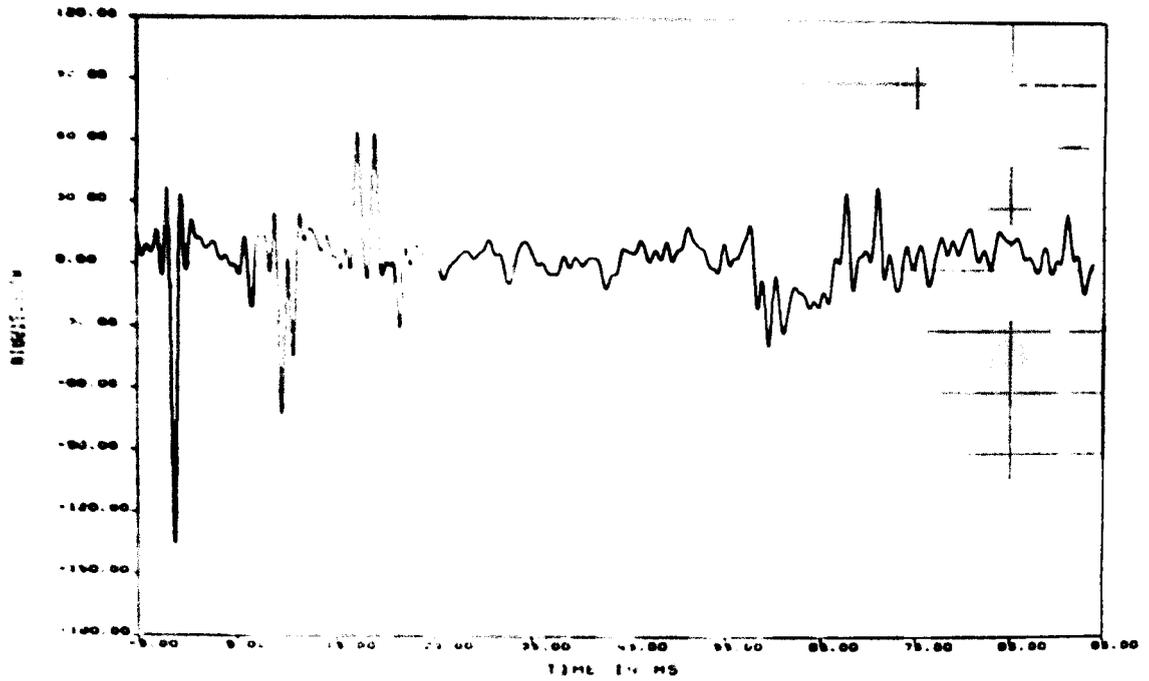
Figure F 1-19. Microstrain vs Time for Gage SR3-YZ for 40-in. Closure End Puncture Test (filtered at 1000 Hz)

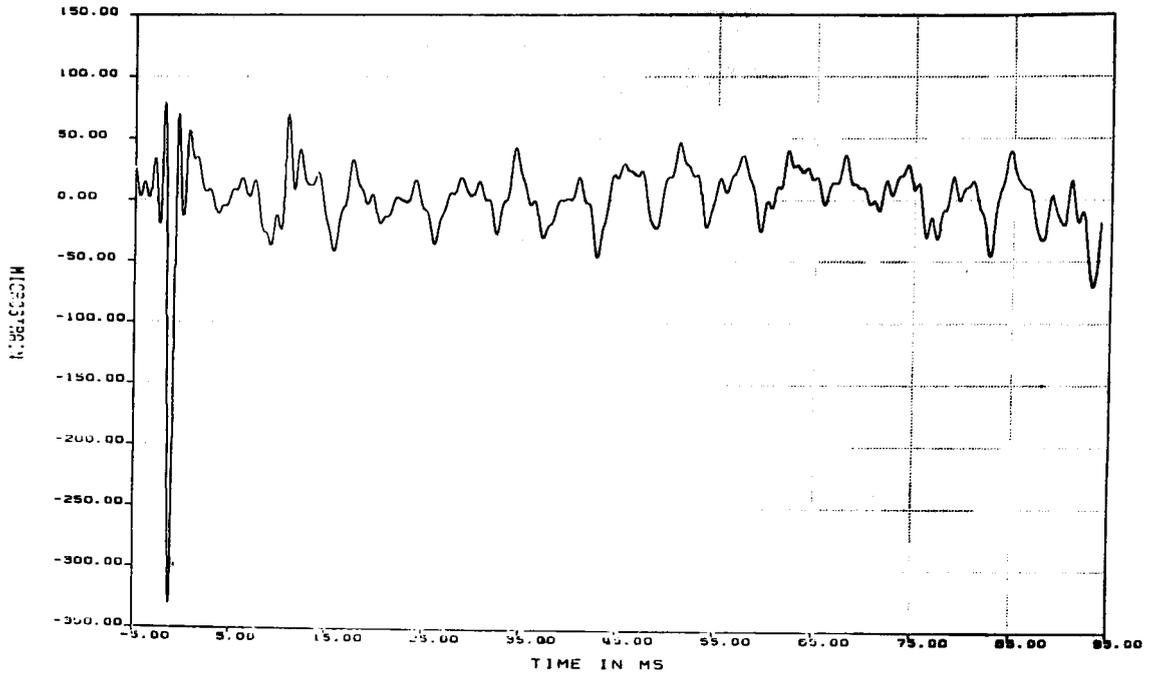
Figure F1-21. Microstrain vs Time for Gage SR4-Y for 40-in. Closure End Puncture Test (filtered at 1000 Hz)

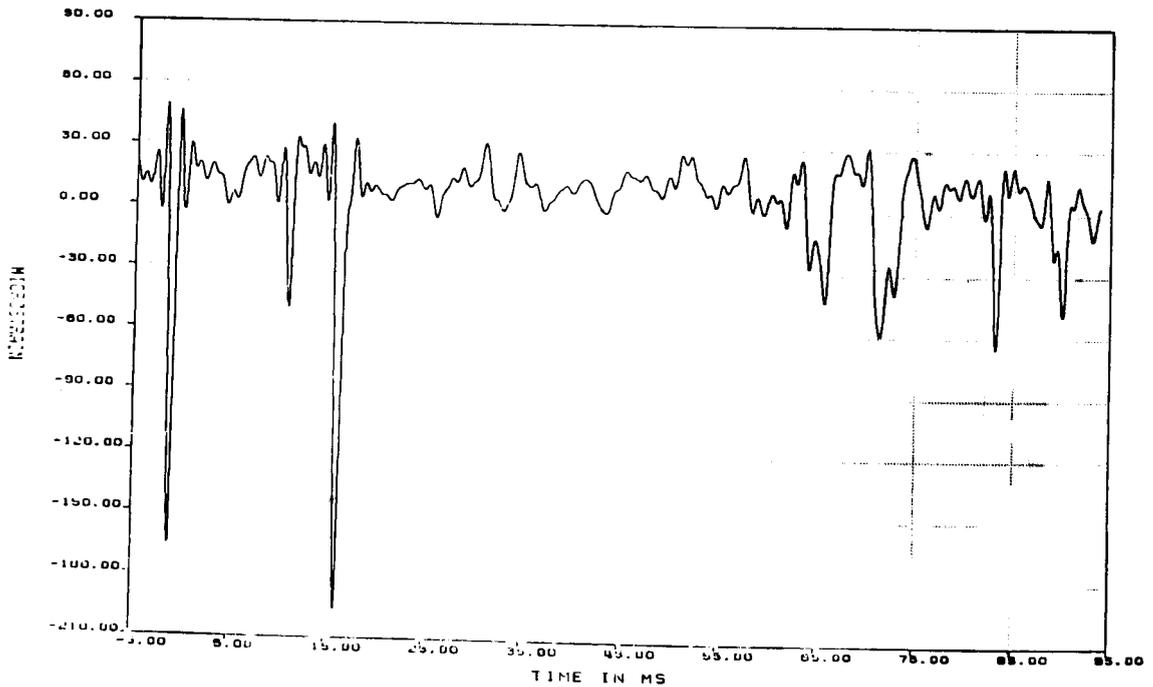
Figure F1-22. Microstrain vs Time for Gage SR4-YZ for 40-in. Closure End Puncture Test (filtered at 1000 Hz)

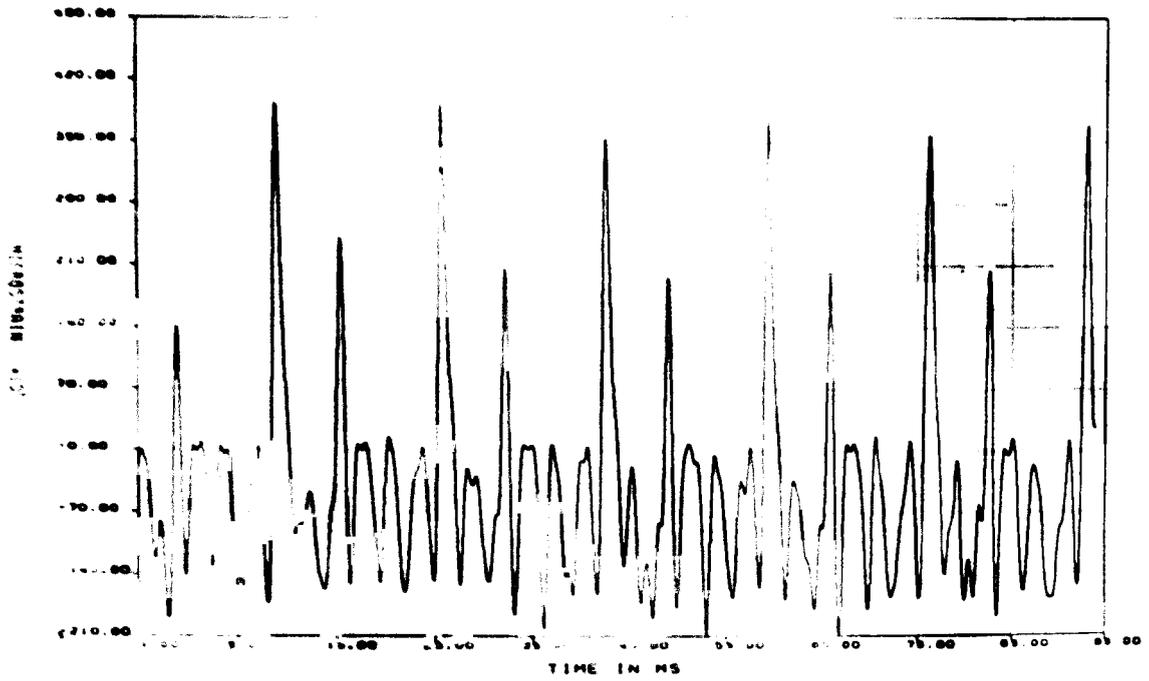
Figure F 1-23. Microstrain vs Time for Gage SR4-Z for 40-in. Closure End Puncture Test (filtered at 1000 Hz)

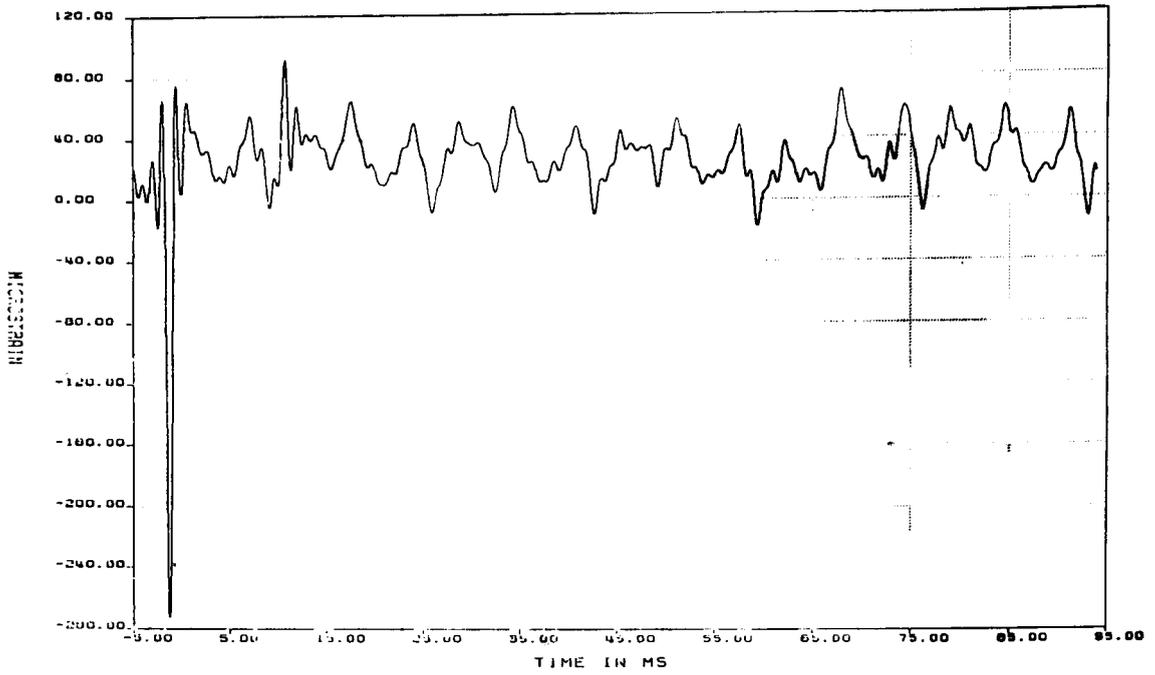
Figure F1-25. Microstrain vs Time for Gage SR5-YZ for 40-in. Closure End Puncture Test (filtered at 1000 Hz)

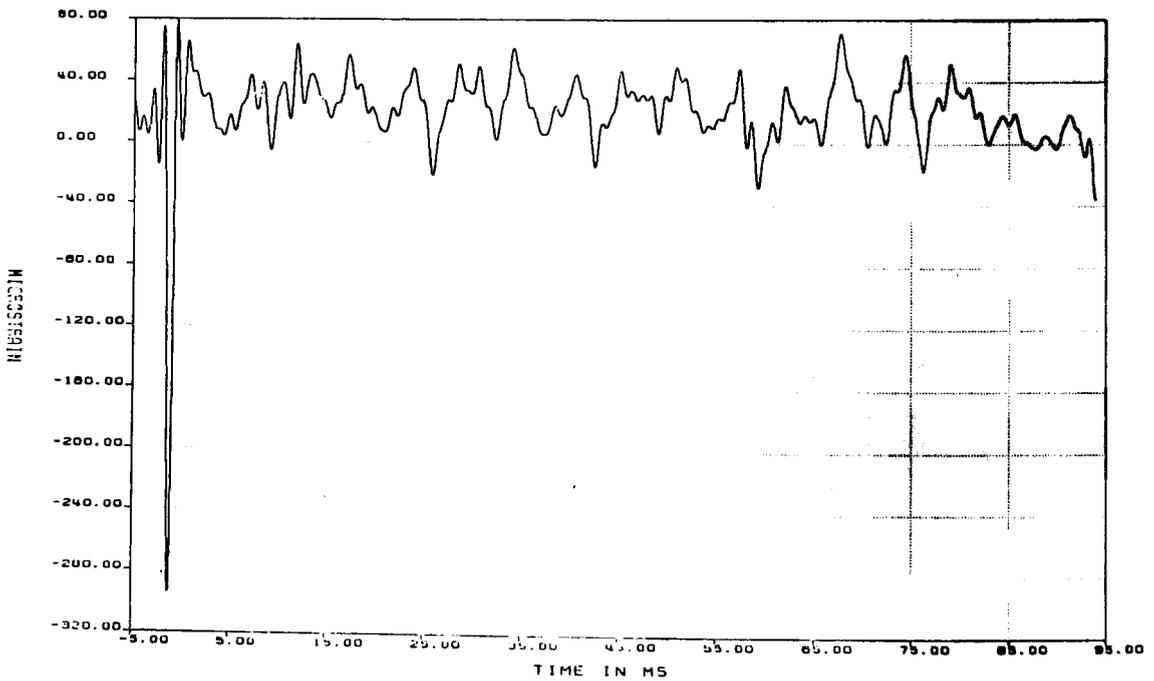
Figure F1-26. Microstrain vs Time for Gage SR5-Z for 40-in. Closure End Puncture Test (filtered at 1000 Hz)

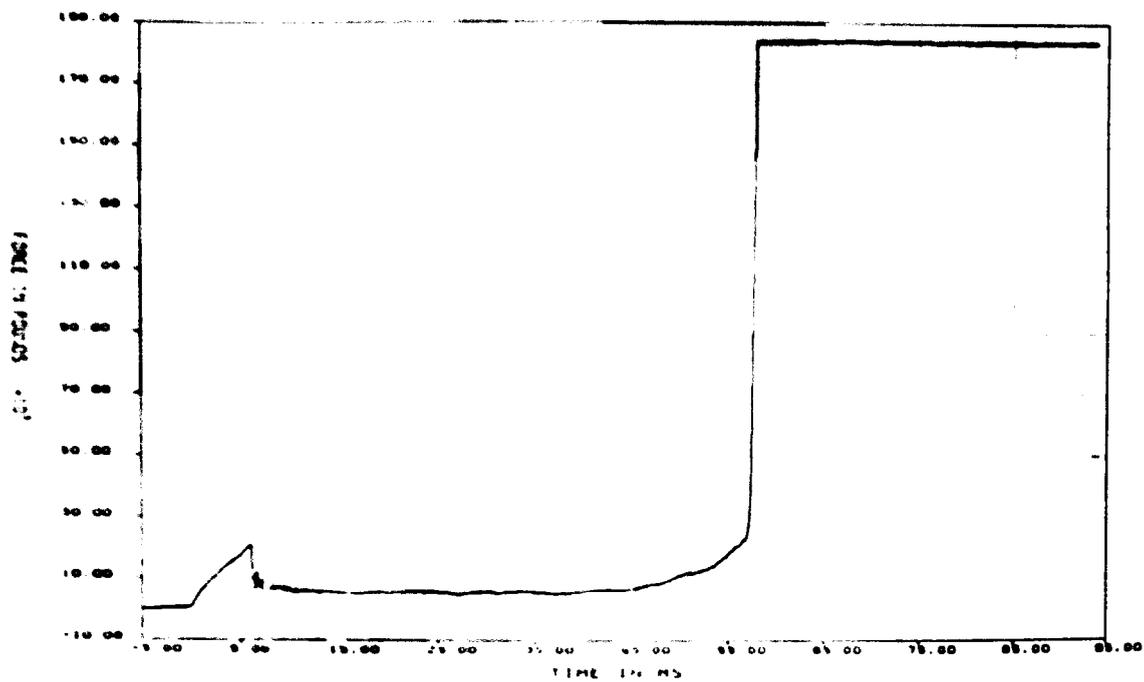
Figure F-1-27. Force vs Time for Gage F-1 on Puncture Bar for 40-in. Closure End Puncture Test (raw data)
