# Lessons Learned from MARVEL Initial Fabrication and Testing

INL/RPT-25-84647

Department of Energy—  
Microreactor Program

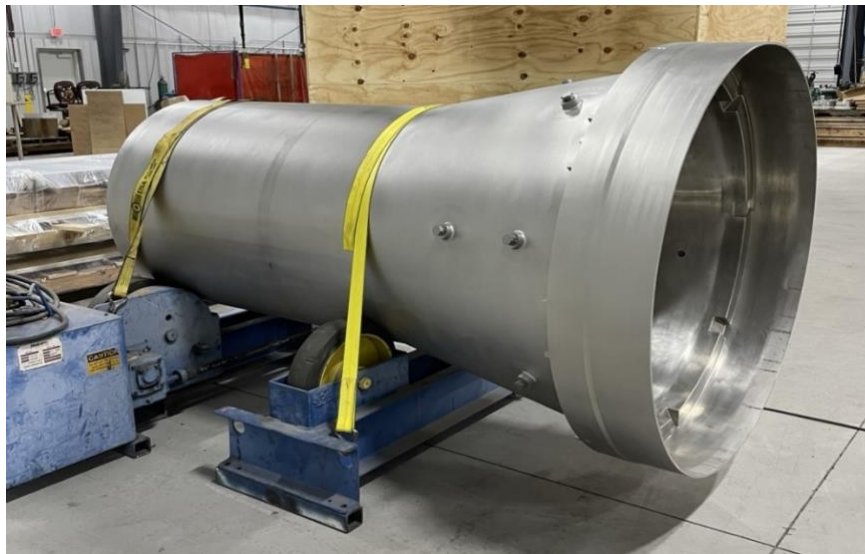
Figure 2. Completed MARVEL guard vessel (picture taken 01/2025).

This fabrication started in late January 2024 and was completed in late August 2024. Final testing (pneumatic pressure and helium leak tests) was completed in October 2024. A picture of the finished product is shown in Figure 2. Throughout guard vessel fabrication, INL assigned a resident quality engineer at the supplier's facility to witness all key fabrication, inspection, and test activities.

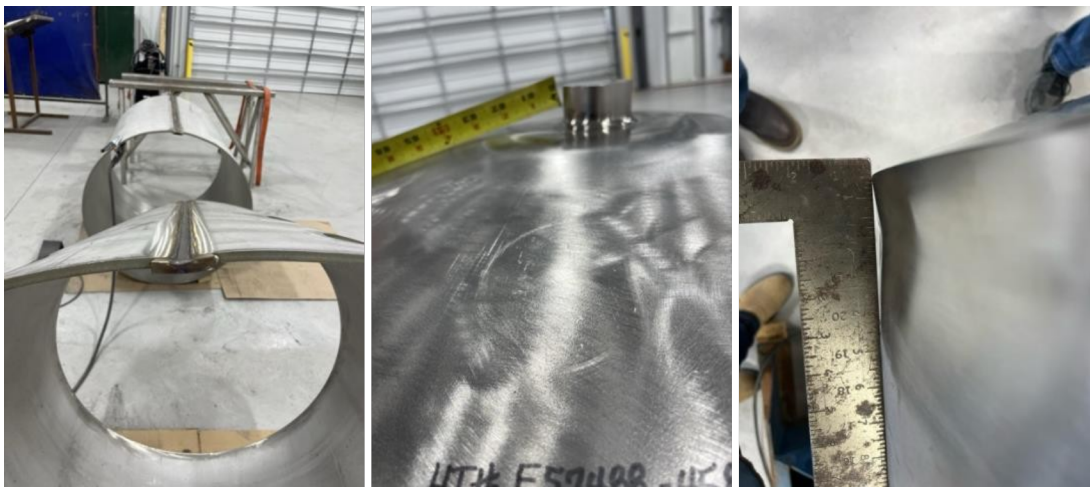
Through the initial fabrication phases, weld distortion was a recurring issue. Excessive distortion occurred on the longitudinal seam of the tapered vessel wall, the flanged sump into the conical bottom, and the conical transition to the vessel wall. A principle contributor to this distortion may have been the fabricator not employing traditional restraint techniques such as strongbacks (temporary stiffening attachments) or heat sinks as shown in Figure 3. It is appropriate to mention that the fabricators weld procedure for welding these seams was the gas tungsten arc welding process. On account of weld travel speed and weld filler deposition rates, this process typically introduces more heat than a semiautomatic process.

These particularities highlighted the need for specifications to include stringent requirements for weld distortion mitigation plans, encouraging suppliers to adopt proven fabrication techniques to control distortion. In defense of the fabricator, 316H-grade stainless steel has a propensity to distort more during welding—more than traditional 304/304L and 316/316L grades. The resulting distortions are shown in Figure 4.

Figure 4. (Left) First occasion of weld distortion on the upper conical section of the guard vessel, where temporary attachments would have retained “roundness” and mitigated distortion (January 2024). (Center) Second occasion of weld distortion after welding the sump to the bottom cone, where the sump “sank” into the mating cone, which should have been restrained (April 2024). (Right) Third occasion of weld distortion following the welding of the lower transition ring on the bottom of the guard vessel (May 2024).

After three instances of excessive, and preventable weld distortion, the MARVEL project mandated that a weld distortion mitigation plan must be in effect for all future welding on the vessel. This plan required the use of strongbacks and chill blocks to dissipate heat from the weld seam. The fabricator was receptive to developing a weld plan, and subsequent welding was successful. A cohesive and a well developed weld plan proved crucial in constructing a design-compliant guard vessel and minimizing rework.

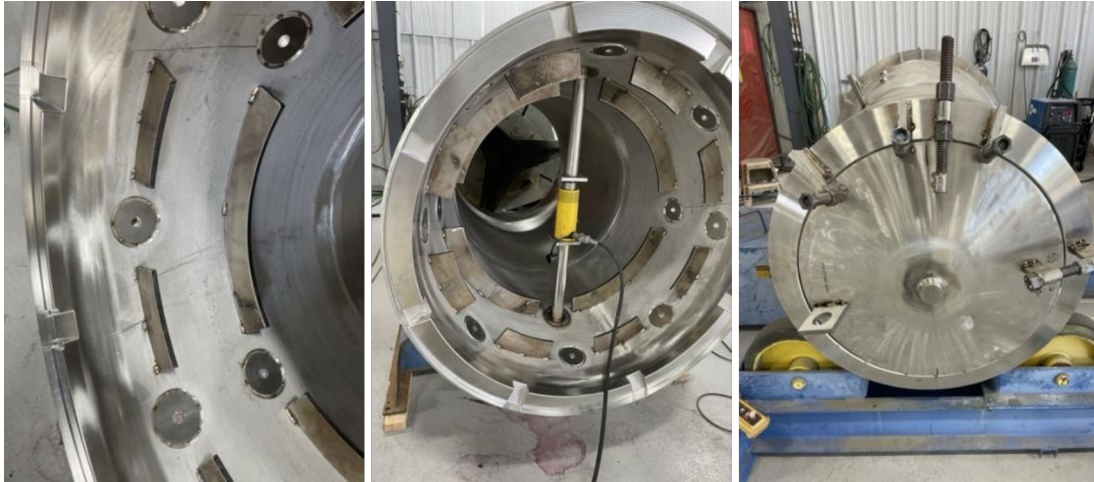
Figure 5. (Left) Strongbacks inside the guard vessel prior to welding the flanged couplings (April 2024). (Center) **A hydraulic jack used in concert with strongbacks to maintain pressure on the flanged couplings during weld out**, which prevented the “sinking” that had been evidenced on the sump plug to the lower cone weld (April 2024). (Right) Strongbacks and stiffeners prior to welding of the bottom cone of the guard vessel (August 2024).

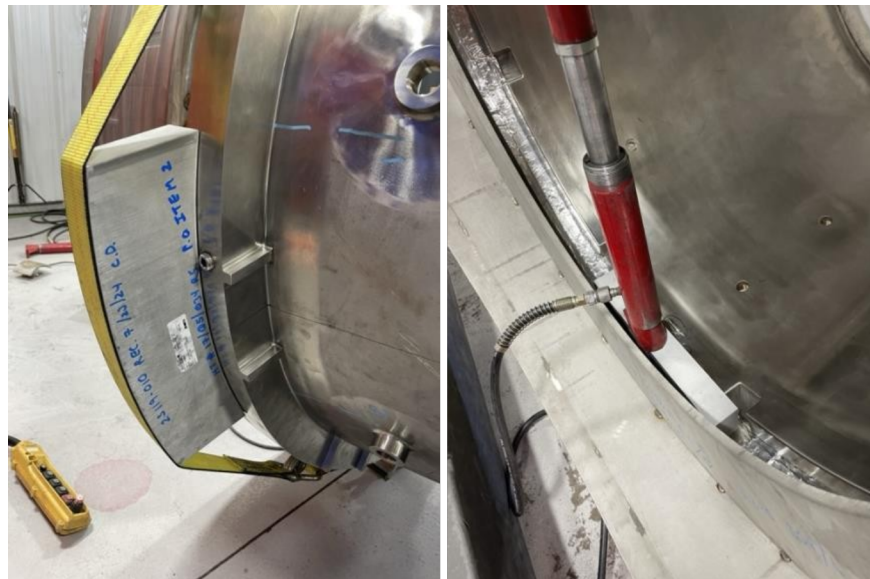
Figure 6. The top ring of the guard vessel necessitated finite tolerancing as this component served as the primary interface with the mating primary coolant system. Minimizing weld distortion in this zone was critical for functionality of the system. Note that the supplier used chill blocks on the inside (left image) and outside (right image) of the weld seam.

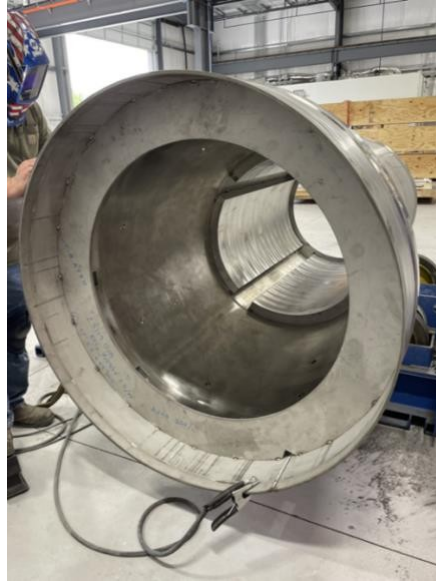
Figure 7. Fit-up of the internal shield plates to the vessel shell. Note that the supplier tack welded a temporary stiffener ring.

In addition to an INL request for the supplier to implement temporary fixturing and chill blocks, the fabricator was also proactive in suggesting additional solutions. The original drawings specified a single vee weld joint design for all weld seams on the guard vessel. A single-vee design provides a full penetration weld joint with all welding from one side; however, the ASME/BPVC Section III code also allows for a double-vee joint (i.e., welding from both sides). This approach equalizes the heat input to the joint, thus providing a more even distribution of heat. **To this end, the MARVEL engineering team reevaluated all remaining weld joints on the vessel and issued a drawing change specifying a double vee joint versus single-vee joint where appropriate.** This was a positive lesson learned, contributed to a compliant guard vessel, and further assisted in minimizing weld distortion.

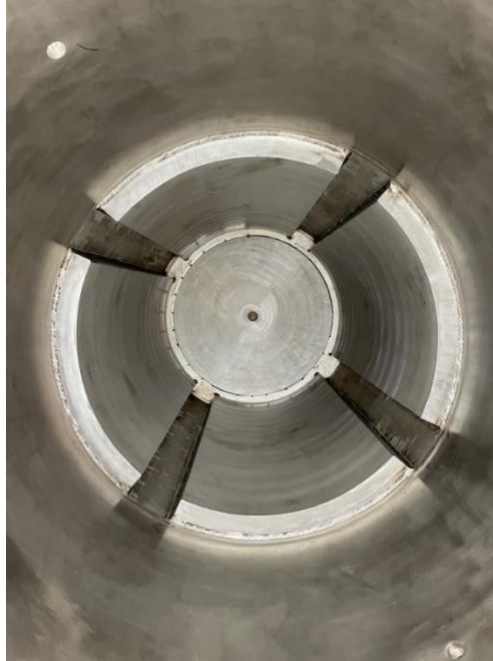
An advantage of the spray transfer mode is that it provides good fusion at the toes of the weld, whereas the short circuit mode deposits the filler metal at a colder setting. Thus, upon final inspection of the fillet welds, and although they met the required inspection criteria, it was evident that an alternative transfer mode (such as spray transfer or pulse spray transfer) would have yielded a fillet weld with less weld spatter and a faster deposition rate. To this end, the supplier was strongly encouraged to develop and qualify a procedure using these alternate transfer modes. Nonetheless (regardless of transfer mode), using the GMAW process did minimize heat shrinkage of the vessel wall.

Figure 10. Completed fillet welds on the internal shield plates.

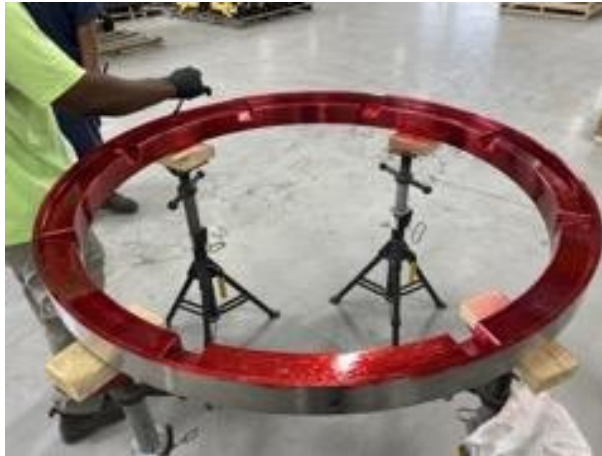
Figure 12. The plenum support ring was machined from billet 316H forging material (ASME SA182), requiring 100% liquid penetrant examination per Section III.

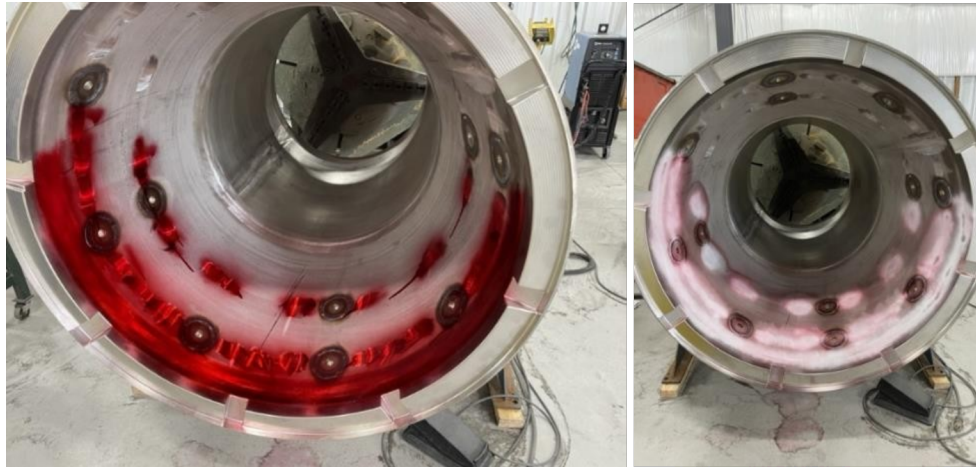
Another nuance in ASME Section III, was the requirement for liquid penetrant examination following the removal of temporary attachments. **While there are a few unique requirements that exist in ASME/BPVC Section VIII, Section III necessitates that liquid penetrant examination applies to the removal of *all* temporary attachments (reference ASME/BPVC Section III, Div. 1, Article NB4435). In addition, this requirement in Section III is more prescriptive than its Section VIII counterpart—where each location is required to be identified, marked, recorded and inspected.** Again, this should be a noteworthy consideration for other reactor developers.

Figure 13. Dye penetrant inspection following the removal of temporary attachments.

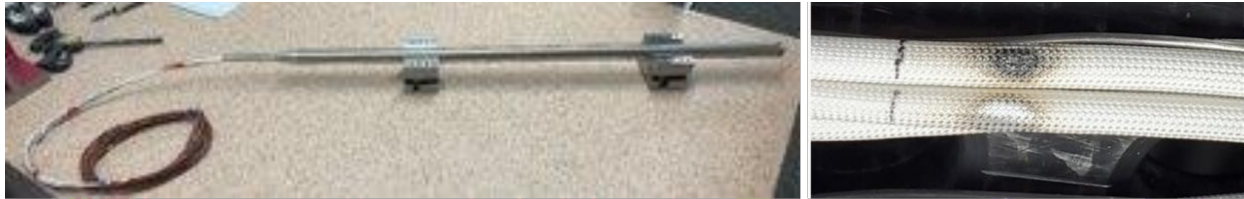
Figure 16. (Left) PCAT heater tube and cartridge heater pigtail and (right) heater insulation damage due to end cap welding.

During final inspection, it was discovered that the heat generated from welding the end caps damaged the heater assemblies, which proved to be more significant than the insulation damage. This was more significant because later bowing and twisting during heat up of PCAT could lead to heater failure if the heaters made contact. Further, the uncertain dimensions of the coolant channels between the heaters could introduce unquantified errors into the RELAP5-3D (Reactor Excursion and Leak Analysis Program) model validation that is dependent on MARVEL data. Examples of bowing are shown for one heater in Figure 17.

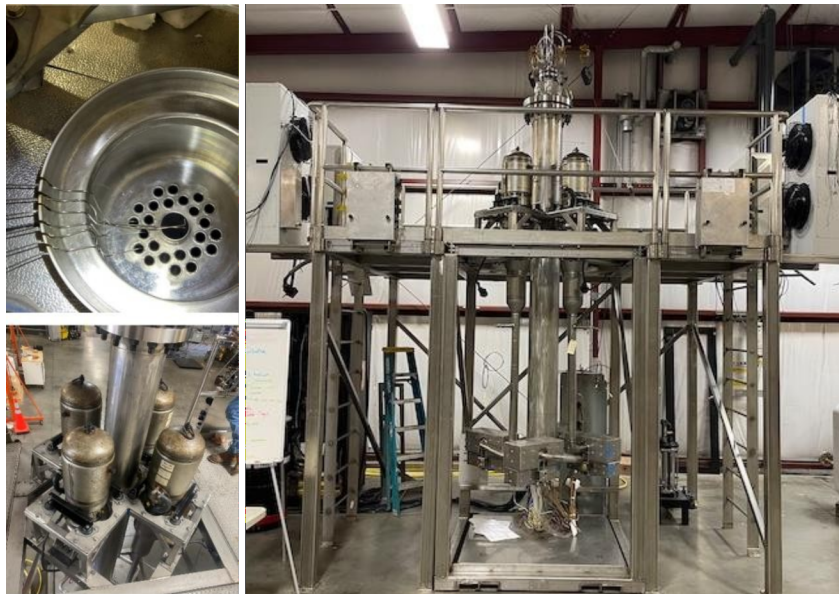
Key parts of the PCAT setup are shown in Figure 19. Thermocouple (TC) wires are shown routed to the intermediate heat exchanger, which would subsequently be filled with LBE. The entire assembled PCAT is shown, without insulation. Blowers on either side of the platform remove heat from the Stirling engines. In September 2023, the PCAT system and associated instrumentation were deemed ready for testing.

Figure 19. MARVEL assembly and setup at Creative Engineers Incorporated (CEI), including (top left) TC wires inside heat exchanger, (bottom left) Stirling engines installed, and (right) PCAT assembled and setup at CEI (without insulation).

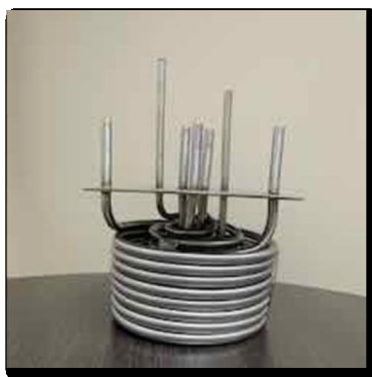
Alternative heat extraction methods were evaluated. The goal was to select the least obtrusive option to meet the goals of operating PCAT. Ultimately, the team tested a coiled heat extraction loop shown in Figure 22. The alternative heat extraction loop was designed to fit in the location of the former Stirling engines with minimal reconfiguration and utilized the same propylene glycol and water mix and heat offtake as the Stirling engines.

Figure 22. Alternative heat extraction for PCAT.

This initial prototype showed promising results and allowed the team to extract approximately 30 kW of heat from PCAT. With the concurrence of the MARVEL design authority and program sponsor, the team proceeded with the fabrication and installation of the remaining three cooling loops. This work was completed in January 2025. Following the installation of the test loops, portions of the EQT again needed to be repeated. In addition, several of the instruments needed dispositioned in terms of calibration. The team decided to proceed with recalibrating some of the instruments and issuing an NCR to evaluate these instruments for potential calibration after testing if needed.
