**Lessons Learned: Using Low Cost, Un-Cooled
Infrared Cameras For The Rapid Liquid Level
Assessment Of Chemical UXO And Storage
Vessels**

Kevin L. Young

The UXO/Countermines Forum 2002

Idaho National Engineering and Environmental Laboratory, Idaho Falls, Idaho

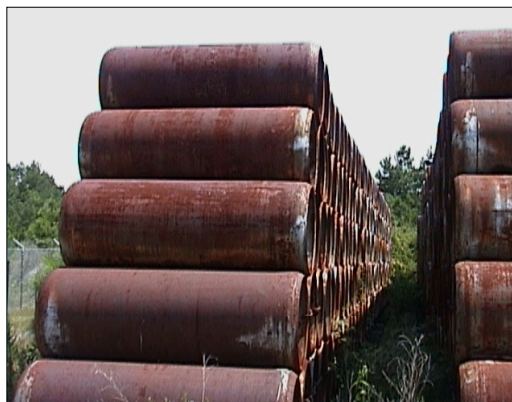
Figure 1-1. Old Chemical Weapons Material Storage Tanks

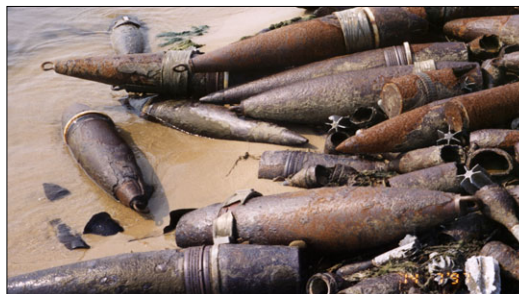
Figure 1-2. Old Chemical Warfare Munitions

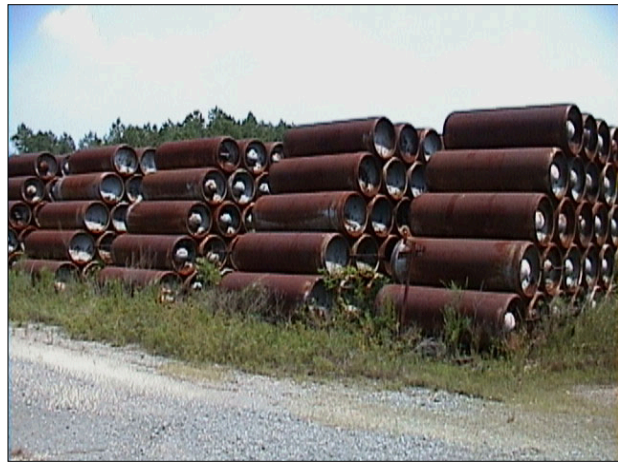
Figure 2-1. Ton Chemical Warfare Agent Storage Tanks

In a secure storage yard on Pine Bluff Arsenal, Arkansas, 3190 chemical weapons material storage containers have been stored for more than 40 years. The containers are made of mild steel, approximately the size of a large household water heater and have a side wall thickness of 0.41 inches with the end walls measuring 0.75 inches thick. They are stored in rows from one to five high and exhibit varying degrees of corrosion (see Figure 2-1).

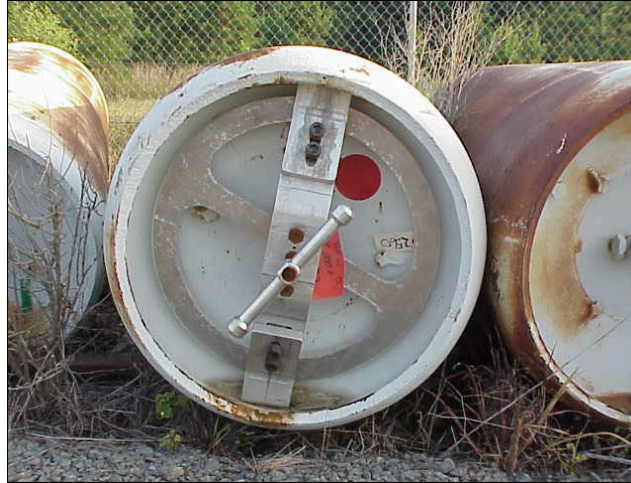
Figure 2-2. Ton Container With Fixture Securing End Plugs

Mission planners decided the safety and environmental concerns would be best addressed by using a special fixture to secure the corroded end plugs on any container prior to movement if that container was suspected of holding liquid (see Figure 2-2). The workers would also dress in a higher level of personal protective equipment (PPE) whenever moving a container with liquid inside. A hands-off approach was needed to quickly determine which containers held liquid and which did not. If a technique could not be found to identify those containers with liquid

The next step for the Army was to use a crane to lift the containers onto a flatbed truck for transport to the decontamination staging area. Any container tagged red or yellow would be fitted with the end plug restraining device (see Figure 2-2) as an added safety precaution. A scale would be in line with the crane hook to weigh the ton container as it was being lifted. An empty ton container weighs approximately 1600 lbs. A weight greater than 1600 lbs would indicate the presence of liquid or some other fill material.

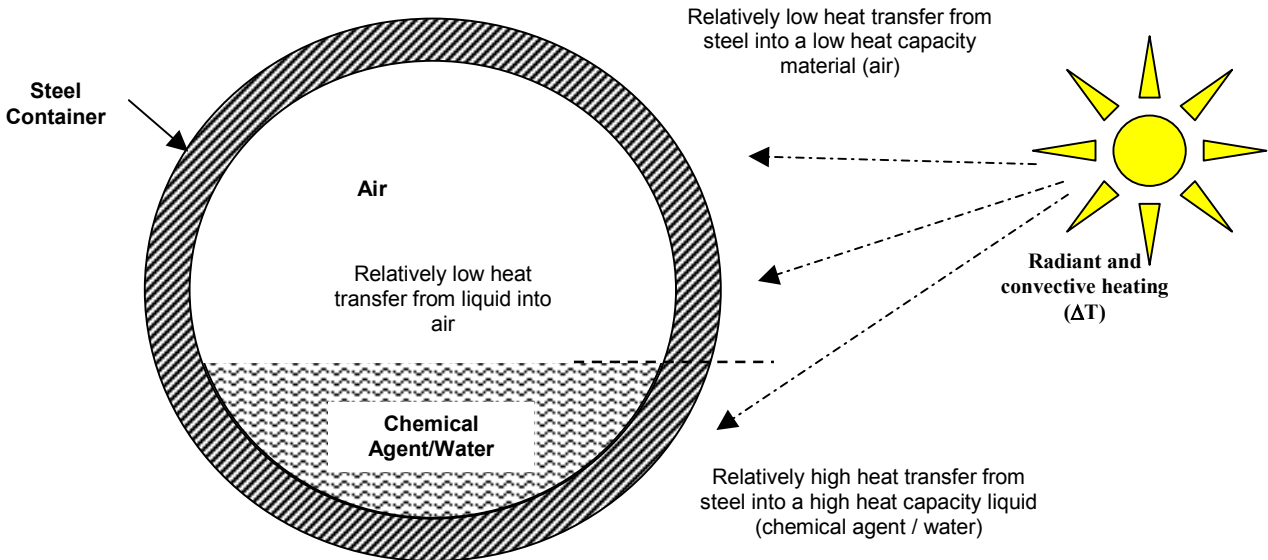
Figure 3-1. Cross Sectional Diagram of the Ton Shipping Container Showing the Thermal System

Materials with high specific heat capacity will heat up and cool down more slowly and store more heat energy than materials with a lower specific heat capacity. Figure 3-1 shows a cross sectional diagram of the ton shipping container representing the thermal system.

Since water has a high heat capacity it heats more slowly than the air above it and acts as a “heat sink” for the steel container below the water line. As the ambient temperature increases, the outer surface of the tank above the waterline will heat more rapidly than the surface below the waterline. Depending on the temperature gradient, the amount of water in the tank, the headspace in the tank and the emissivity of the container surface, a thermal camera can “see” this water line. An excellent example of this is shown in Figure 3-2. A visible light image and a thermal image of the same water tower are shown.

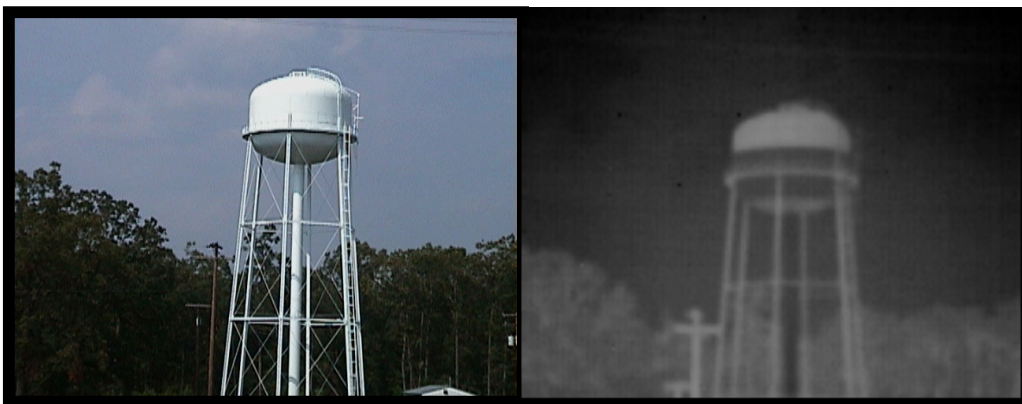
Figure 3-2. Visible Image, on left, of Water Tower During Summer Morning and Infrared Image, on Right, Taken at Approximately the Same Time Showing the Tank’s Liquid Level

The images were taken within seconds of each other on a summer morning in Arkansas as the day's temperature was increasing. The thermal image clearly shows the water level inside the tank. In the thermal image, light areas are hotter than dark areas.

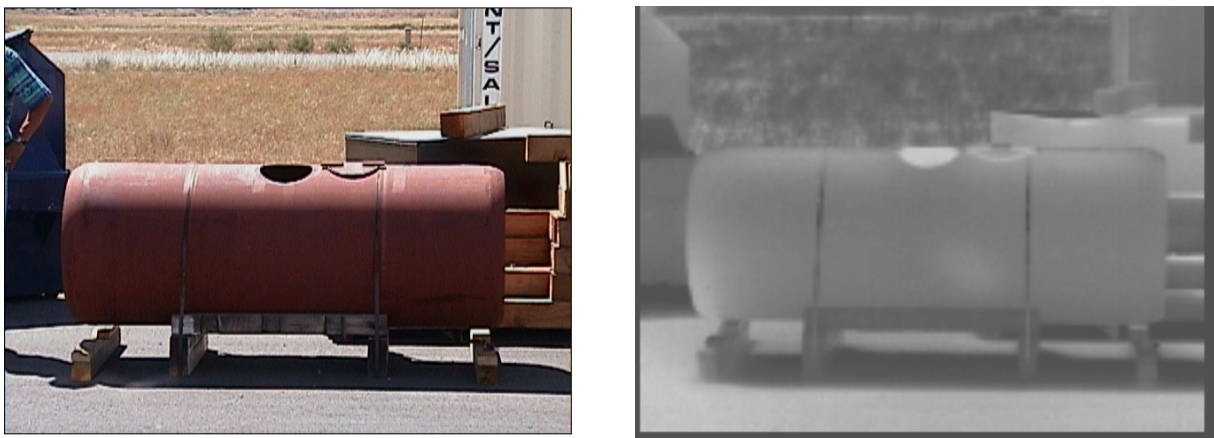
Figure 4-1. Empty Test Container Visible Image is Shown on the Left and the Associated Thermal Image is Shown on the Right. Notice the Cavity Effect in the Thermal Image

Before the Army purchased an infrared camera, they wanted to make sure it would work for their application. A camera was obtained on loan from a distributor for testing at the INEEL in Idaho Falls, Idaho. An actual ton container was obtained from Dugway, UT to be used as the test target. This container had been modified for testing purposes. It contained a portal on top for adding liquid easily and a valve on the low point allowing liquid to be easily drained. A visible and thermal image of the empty test container is shown in Figure 4-1.

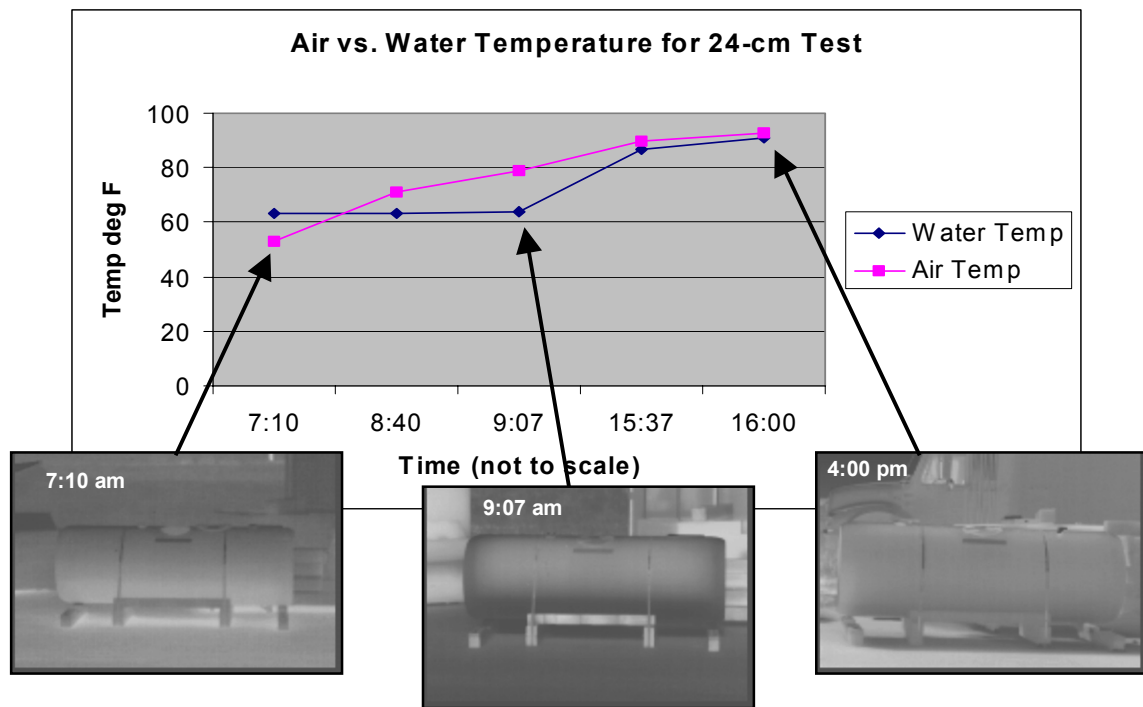
Figure 4-2. Graph Showing Diurnal Cycle and Associated Thermal Images for 24-cm Water Height Test

The thermal imaging camera was able to identify the liquid level in the ton test container for both fill levels. In each test, the liquid level was most easily detected with the thermal camera whenever the ambient temperature was changing faster than the temperature of the liquid within, such as during sun rise. Figure 4-2 shows the graph and associated thermal images for the 24-cm test. As was expected, the liquid line was easier to see in the 24-cm water height test due to the larger thermal mass of water.

A fourth lessons learned came from extrapolating the air temperature versus water temperature graph into the night time hours and studying the early morning thermal images taken during the tests, especially for the 24-cm height

water test. The information suggests that another optimal time to look for water lines with a thermal camera would be sometime during the night while the air temperature is cool and the water temperature still holds heat from earlier in the day. Unfortunately, we were not able to obtain the extra funding to perform nighttime testing, and the Army indicated they prefer the testing take place during the day.

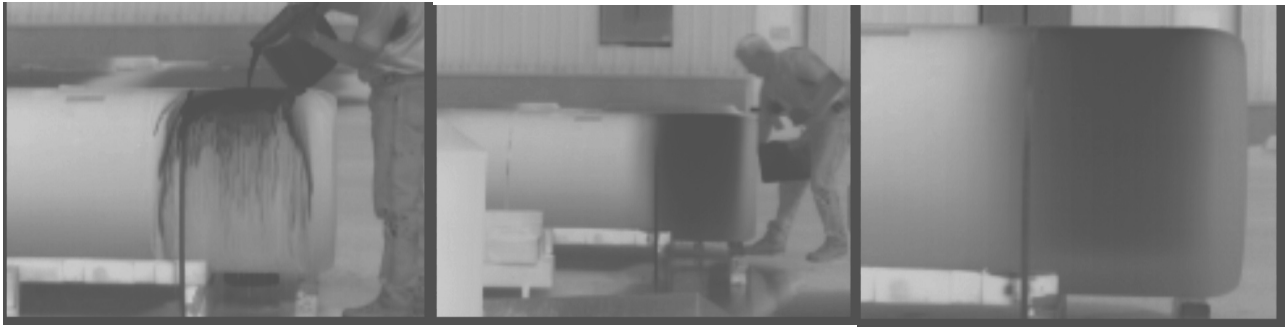
Figure 4-3. Pouring Cold Water Over the Hot Container is One Way to Enhance the Visibility of the Water Line

The third lessons learned was that cooling the container during the hottest part of the day by pouring cold water over the surface greatly enhanced the ability to see a liquid line. Figure 4-3 shows the effects of pouring cold water over the container. This idea of enhancing the liquid line on a hot container was proposed to the Army but rejected on the grounds that for environmental purposes, no additional liquid was permitted to be sprayed on the containers and allowed to fall onto the ground.

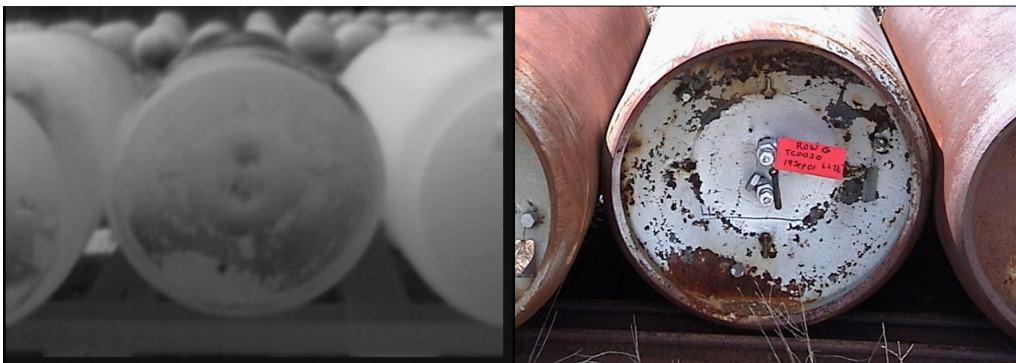
Figure 5-1. Thermal Image and Visible Image of a Container Indicating Liquid Line

Figure 5-1 shows a thermal image and it's associated visible image for one of the containers tagged red.
