# **Radiographic Inspection of Fueled Clads**

**Idaho National Laboratory  
Physics Department  
Idaho Falls, Idaho 83415**

Five general purpose heat source (GPHS) fueled clads were radiographically inspected at the Idaho National Laboratory (INL). The girth weld region of each clad had previously passed visual examination, ring gauge test, and leak test but showed “positive” indications on the ultrasonic (UT) test. Positive ultrasonic indications are allowable under certain weld conditions; radiographic inspection provides a secondary nonintrusive means of clad inspection and may confirm allowable anomalies from the UT inspection. All the positive UT indications were found to exhibit allowable weld shield fusion or mismatch conditions. No indication of void defects was found. One additional clad (FCO371) was deemed unacceptable for radiographic inspection due to an unknown black substance that obscured the angular origin on the weld so that the angular offset to the UT indication could not be found.

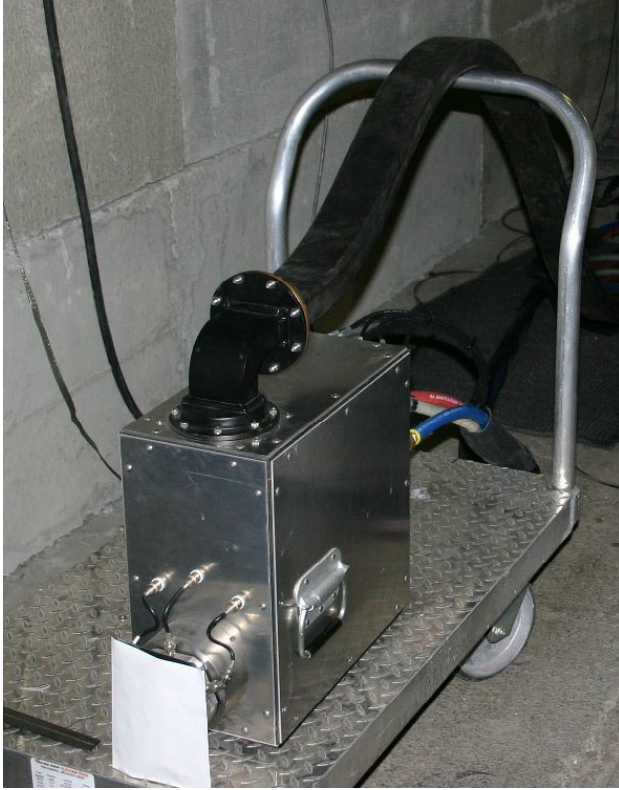
Figure 2. Components used for radiographic testing at the Idaho Accelerator Center Annex in Pocatello, ID. Left: Linear accelerator and waveguide (the paper does not attenuate much radiation!). Right: Rotational stage used for holding and angular positioning fueled clads. A full-scale surrogate is in the clad holder and pieces of another surrogate are at the sides.

Figure 2 shows the business end of the linear accelerator and a photograph of the rotational stage as used in the preliminary tests at the IAC.
