Underground Corrosion After 32 Years: A Study Of Fate And Transport, Annual Report For EMSP #86803

Idaho National Laboratory

Annual Report for EMSP # 86803

Underground Corrosion after 32 Years: A Study of Fate and Transport

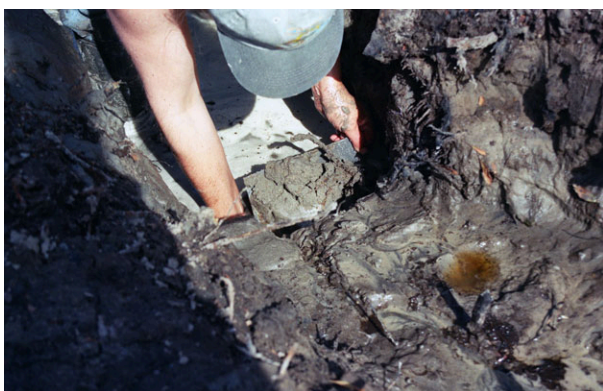
Figure 1. Specimen being recovered.

Site D specimen recovery, near Wildwood, N.J. A total of 53 stainless steel specimens were removed from one of the 1970 trenches in April 2004. The specimens were recovered about 3 ft below land surface, spaced about 1 ft apart, from approximately 2 ft below the water table (Figure 1). Roots were entwined around some specimens. (When originally buried, neither ground water nor plant roots were a concern.)

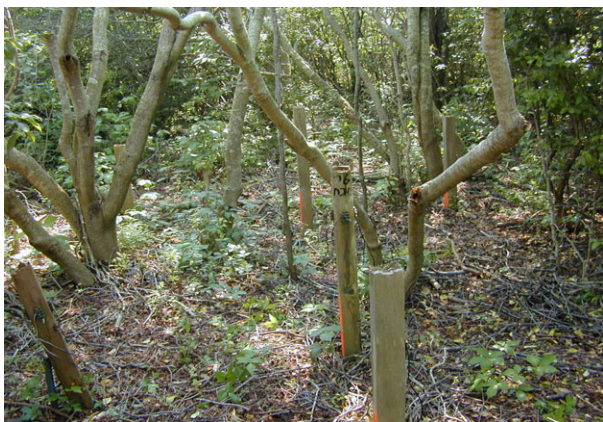
Figure 2. Sand and organic material support shrubs and medium sized trees.

into soils coastal progression occurs and as trees and shrubs replace beach grasses and supply abundant organic material (Figure 2). The slightly acidic groundwater (pH 4.7), high in iron and low in chromium and nickel, sustains localized reducing zones. During the 35-year test duration, climate change has factored in the underground corrosion activity.

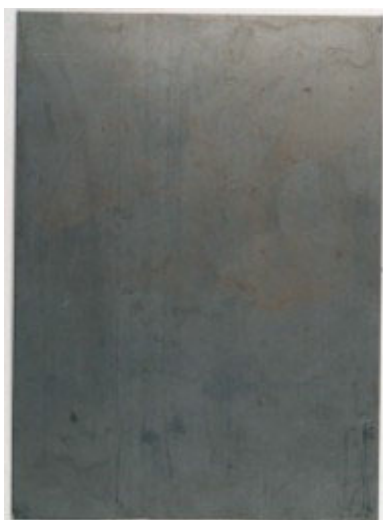
Figure 3. Annealed Type 316 plate with little visible corrosion.

Specimen Mass Loss. Visual observations indicate that most specimens show little or no corrosion, regardless of type, treatment, or configuration. Most specimens were retrieved from the wet sand—shiny and clean (Figure 3). The notable exceptions were the sensitized Types 301 and Type 304 specimens.

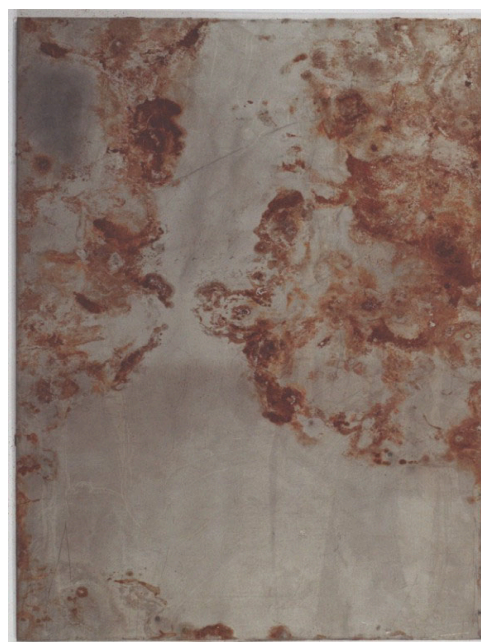
Figure 4. Corroded surface of Type 301 plate.

Specimens were divided among various investigators where specimens and adhering material have been carefully examined. Specimens are being visually examined, cleaned, weighed, measured, and photographed—all leading to mass loss determinations. NIST personnel are assisting in providing a methodology to determine mass loss uncertainty. Results indicate that the sensitized specimens—Types 304 and Type 301—sustained the greatest corrosion, whether U-bend or plate. To a lesser degree, the 400 series (Types 409, 410, and 434) evidenced local corrosion. Rust and black staining was observed on these specimens; sandy corrosion product adhered to localized areas; and pitting was evident. Most attacks occurred in localized areas as shown in Figure 4.

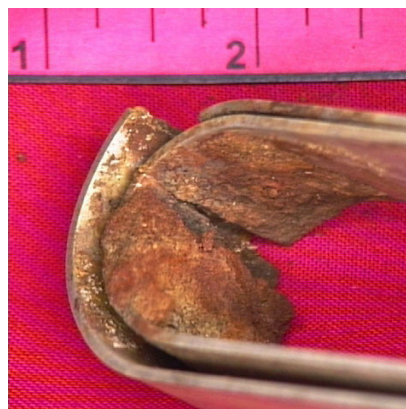
Figure 5. Sensitized Type 301 specimen showing stress corrosion cracks through stressed end.

Figure 5. Fractured stress corrosion specimen.

Stressed-specimen Investigation. The surfaces and cross sections of each U-bend specimen were examined in both stressed and unstressed areas, including the crevices created by the double U-bend specimens. Only sensitized Types 301 and 304 specimens exhibited significant corrosion. The sensitized and passivated, unwelded, half-hardened double U-bend Type 301 specimen fractured through the entire thickness of both U-bends in the stressed area (Figure 5). The fracture was intergranular and occurred along one side of the apex of the bends. The specimen was pitted on all surfaces, and significant pitting

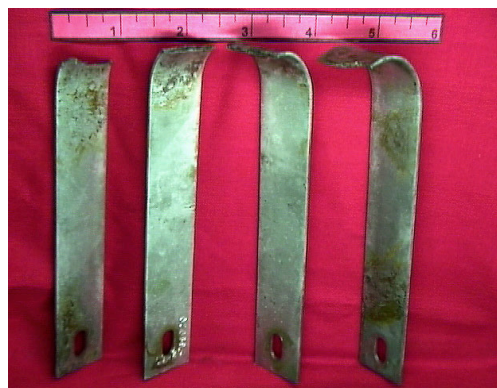
Figure 6. Cleaned stress corrosion specimen.

(average of 10 mils deep) was found close to the edges and also on the surfaces in the stressed areas. Shallower pits were found on the unstressed surfaces, away from the edges. Intergranular attack occurred in stressed and unstressed areas. When cleaned, the specimen separated along the fracture (Figure 6). Examination of the sensitized and passivated, double U-bend Type 304 specimen, intergranular stress corrosion cracking was clearly evident in the stressed area on the top surface of the outer U-bend and also on the top surface (crevice side) of the inner U-bend. Staining was obvious on the crevice side of both the inner and outer U-bend coupons. Cracks and pits were within the stained areas. A cross section through a cracked area showed that the coupon interior corroded away substantially, with very little indication of attack initiation on the surface of the coupons. Instead, the edges of coupons seemed to be the most likely starting point for corrosion. Sensitization of these specimens prior to burial was most likely the reason for the extent of corrosion. The other stress specimens exhibited minor attack. Superficial intergranular attack (less than one mil deep) was seen on their surfaces.
