# **Underground Corrosion Of Activated Metals 6- Year Exposure Analysis**

**National Association of Corrosion  
Engineers 2006 Annual Conference**

M. K. Adler Flitton  
T. S. Yoder

March 2006

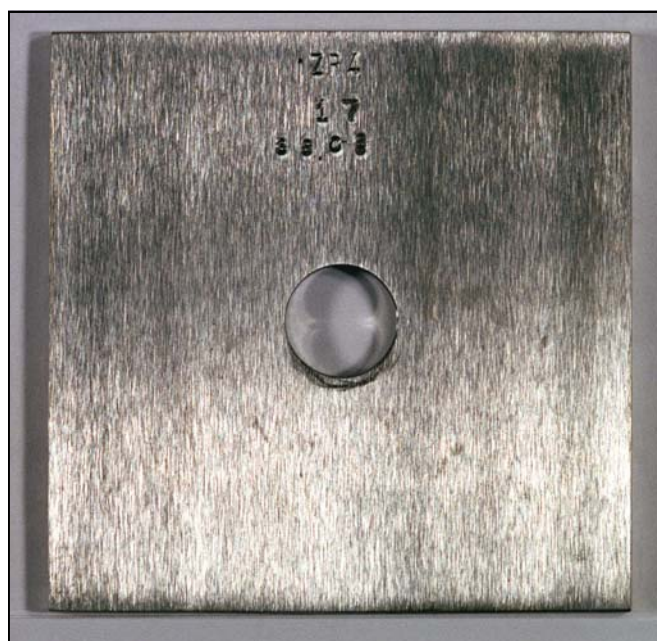
**FIGURE 1 – Zirconium Alloy Before Cleaning, 6-year exposure at 1.22 m**

The duplex stainless steel, 304L stainless steel, 316L stainless steel, nickel-chromium alloy, and zirconium alloy coupons required no further cleaning. Figure 1 shows a typical zirconium alloy coupon after 6-years of exposure and Figure 2 shows the same coupon after cleaning (color differences are an artifact of lighting). The carbon steel, aluminum, and beryllium coupons were chemically cleaned according to the appropriate method defined in Table A1 of ASTM G 1 (in addition to the wash/brush process) as follows: carbon steel — C.3.5, aluminum — C.1.1, and beryllium (as recommended by the material vendor) — C.5.2 (for the coupons exposed 1 year) and C.1.1 (for the coupons exposed 3 and 6 years).

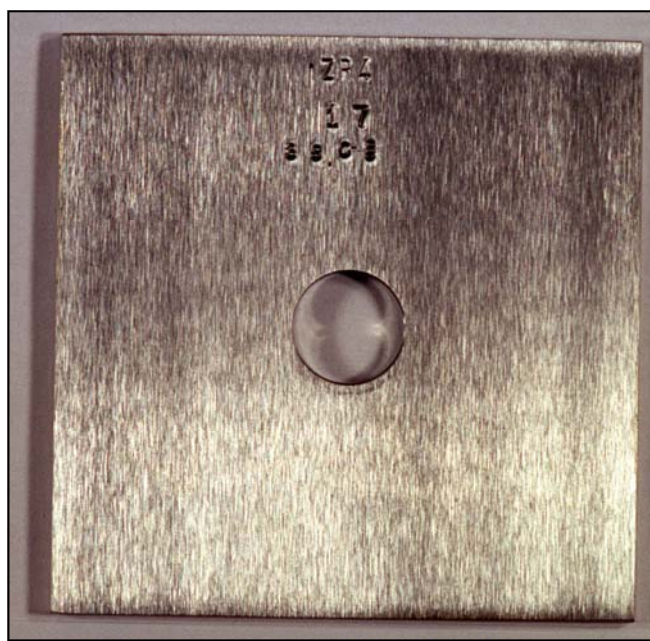
**FIGURE 2 – Zirconium Alloy After Cleaning, 6-year exposure at 1.22 m**

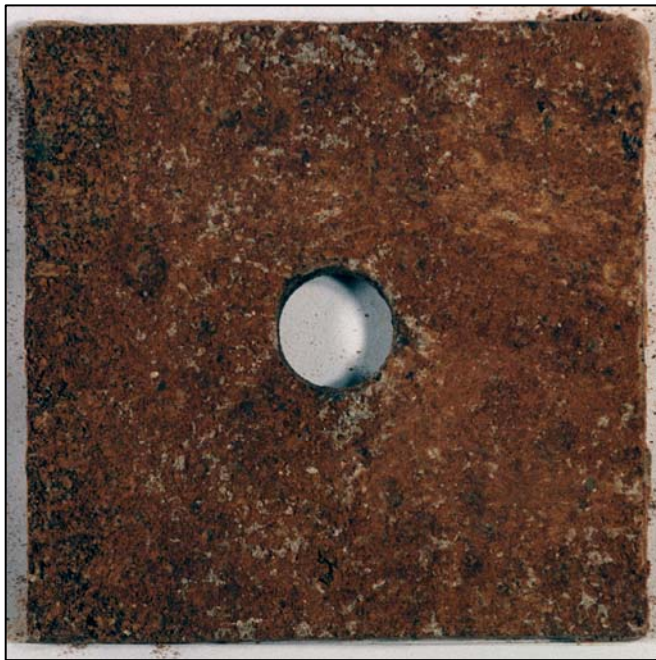
**FIGURE 3 - Carbon Steel Coupon Before Cleaning, 6-year exposure at 3.05-m**

Pitting was evident in the aluminum, beryllium, and carbon steel coupons. Figures 3 and 4 are photographs of one carbon steel coupon, before and after cleaning (from the 10-ft (3.05-m)). Likewise, Figures 5 and 6 are photographs of beryllium coupons before and after cleaning (from the 10-ft (3.05-m)). Figures 7 and 8 are photographs of aluminum coupons before and after cleaning (from the 4-ft (1.22 m) depth. Table 4 details the pit depth measurements from 16 coupons with visibly deep-pitted surfaces. Aluminum exposed for one year showed no evidence of pitting and was not measured.

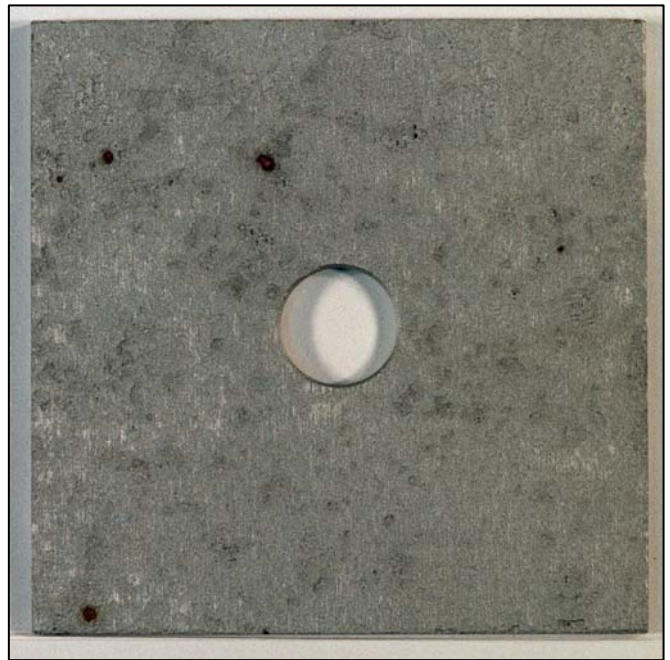
**FIGURE 4 - Carbon Steel Coupon After Cleaning, 6-year exposure at 3.05-m**

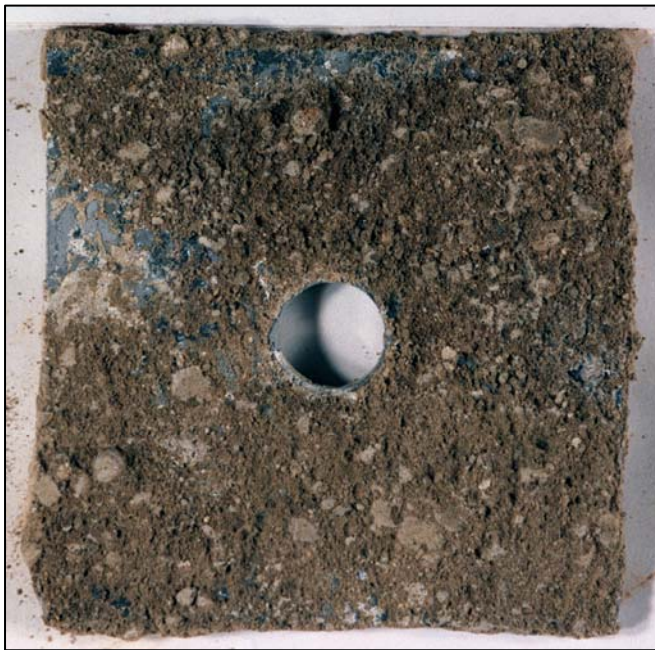
**FIGURE 5 - Beryllium Coupon Before Cleaning, 6-year exposure at 3.05-m**

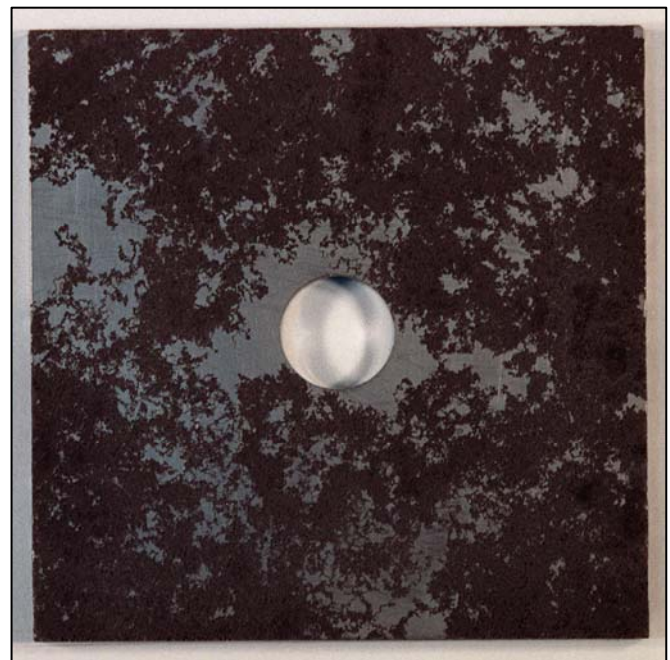
**FIGURE 6 - Beryllium Coupon After Cleaning, 6-year exposure at 3.05-m**

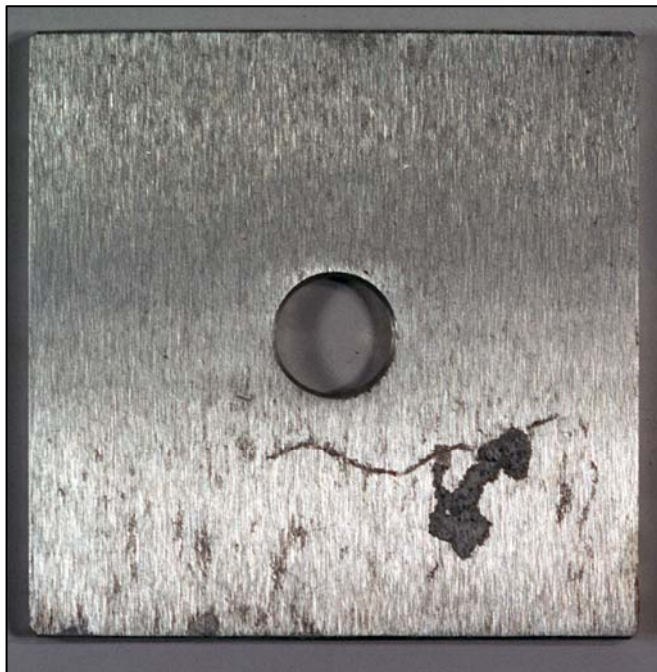
**FIGURE 7 - Aluminum Coupon Before Cleaning, 6- year exposure at 3.05-m**

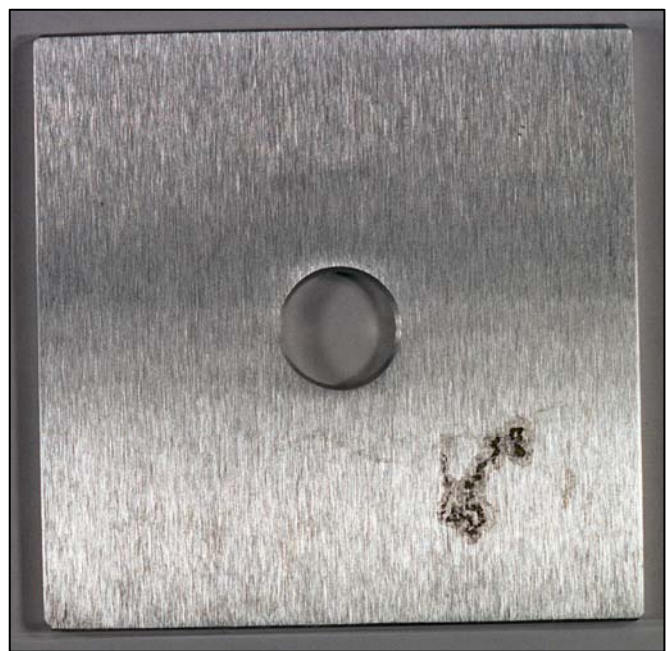
**FIGURE 8 - Aluminum Coupon After Cleaning, 6-year exposure at 3.05-m**
