Oil Bypass Filter Technology Evaluation Tenth
Quarterly Report – January-March 2005

**Oil Bypass Filter Technology Evaluation
Tenth Quarterly Report
January–March 2005**

**Idaho National Laboratory
Transportation Technology Department
Idaho Falls, Idaho 83415**

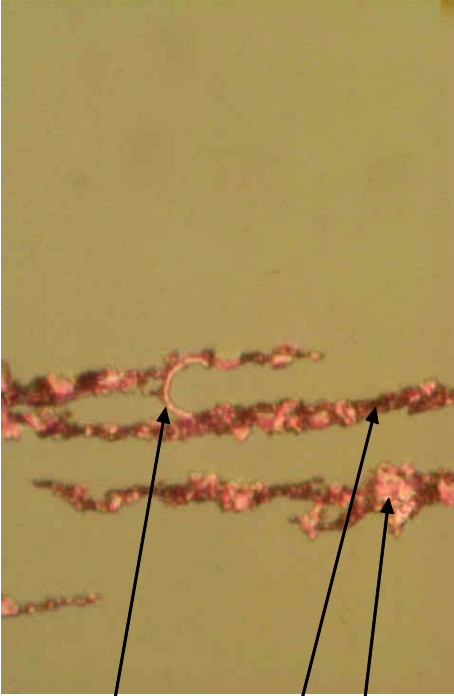
Idle Test Ferrograms								
Bus Number	Oil Source	Sample Date	NTS Sample Number	Test Stage	Total Miles and Hours on the Oil	Magnification	Photograph Number	Region of Slide
73433	Used oil	12/20/04	87940	Baseline	79053	500x	97940 -B	Entry Point 7
Comments	Ferrogram shows a light amount of fine (<10 µm) ferrous particulate, typical of normal rubbing wear. A light amount of ferrous cutting wear, ferrous laminar and sliding wear particulate (~50 microns), soot particles, dark metallo oxide, fibers and sand/dirt was noted.							
Special Features	Please see attached images of ferrous cutting wear and of sliding wear
