Vibration Monitoring of Power Distribution Poles

2006 Symposium on the Application of Geophysics to Engineering and Environmental Problems

April 2006

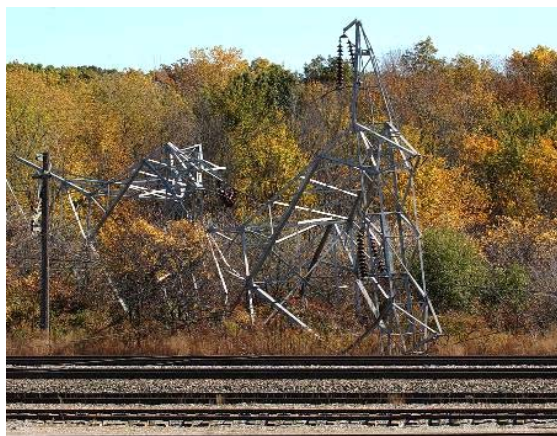
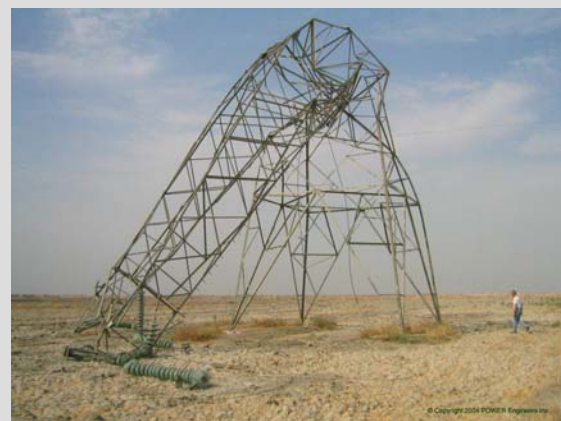
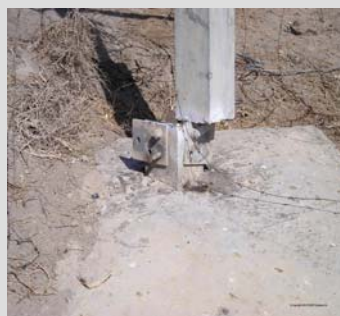
Figure 1: Images from recent transmission tower attacks. The image on the left is from news reporting on two towers that were downed in Oak Creek Wisconsin on October 9, 2004. These towers collapsed after having the bolts removed at the base of the towers. More extensive damage occurred to distribution networks in Iraq (images on right) when towers were toppled and destroyed to get at the transmission cables for the recyclable metals.
