Fiscal Year 2009 Revegetation Assessment

Michael G. Lewis

October 2009

**Prepared for the
U.S. Department of Energy
Office of Nuclear Energy
Under DOE Idaho Operations Office
Contract DE-AC07-05ID14517**

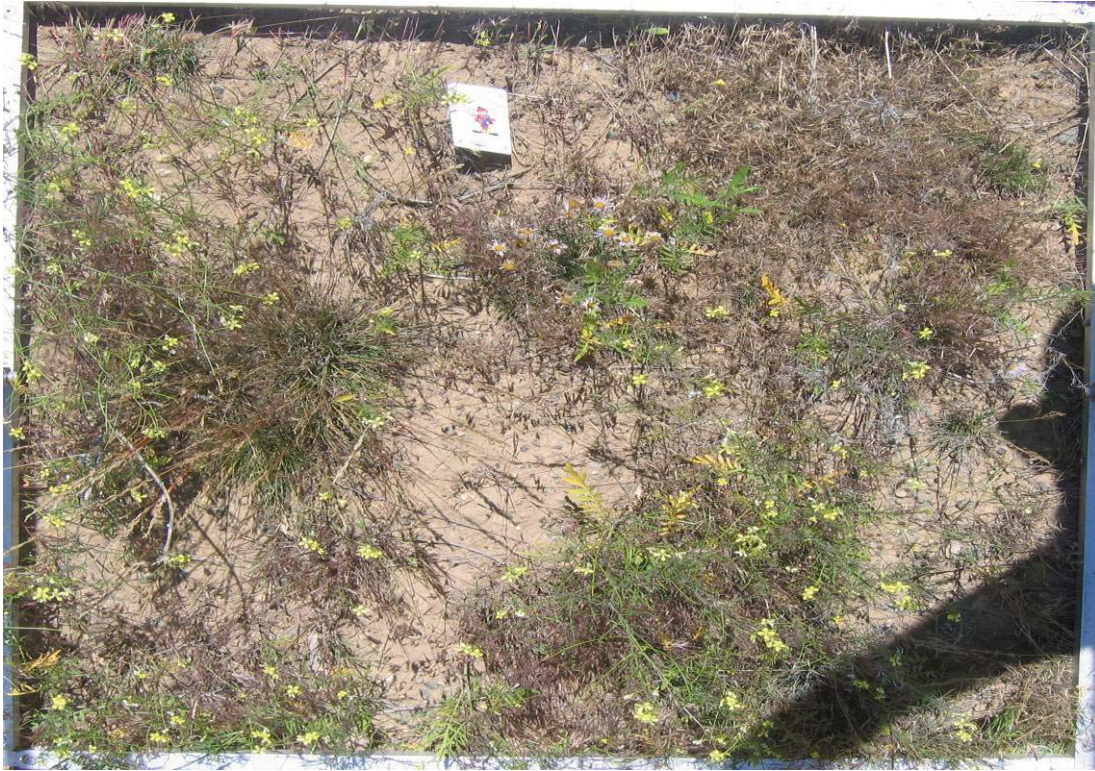
Figure B-1. Revegetation plot in the southwest Big Loop Trench showing native grass, forbs and cheatgrass.

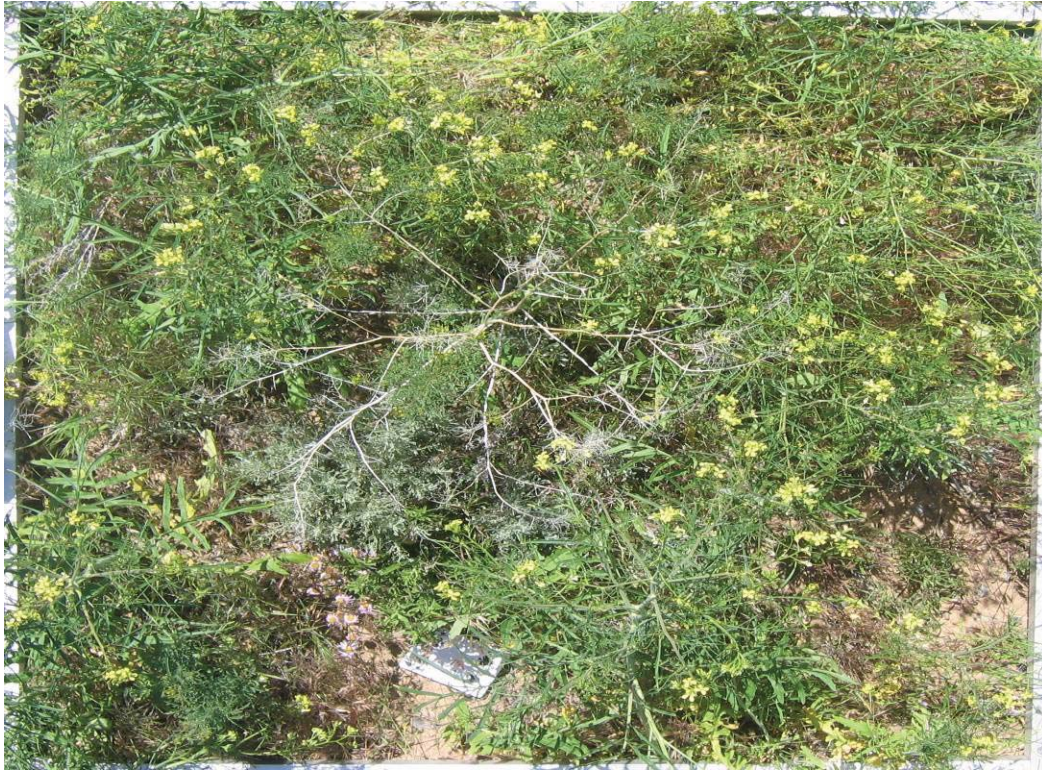
Figure B-2. Revegetation plot in the middle Big Loop Trench showing sagebrush seedlings and forb establishment.

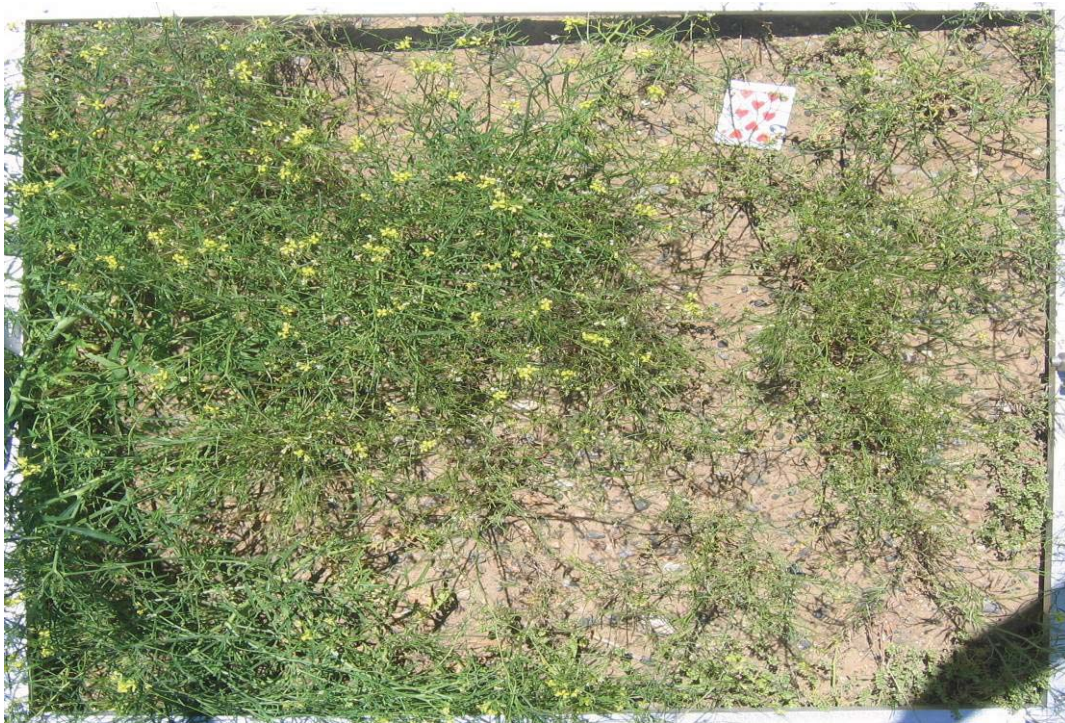
Figure B-3. Revegetation plot on the northeast Big Loop Trench showing tansymustard and Russian thistle.

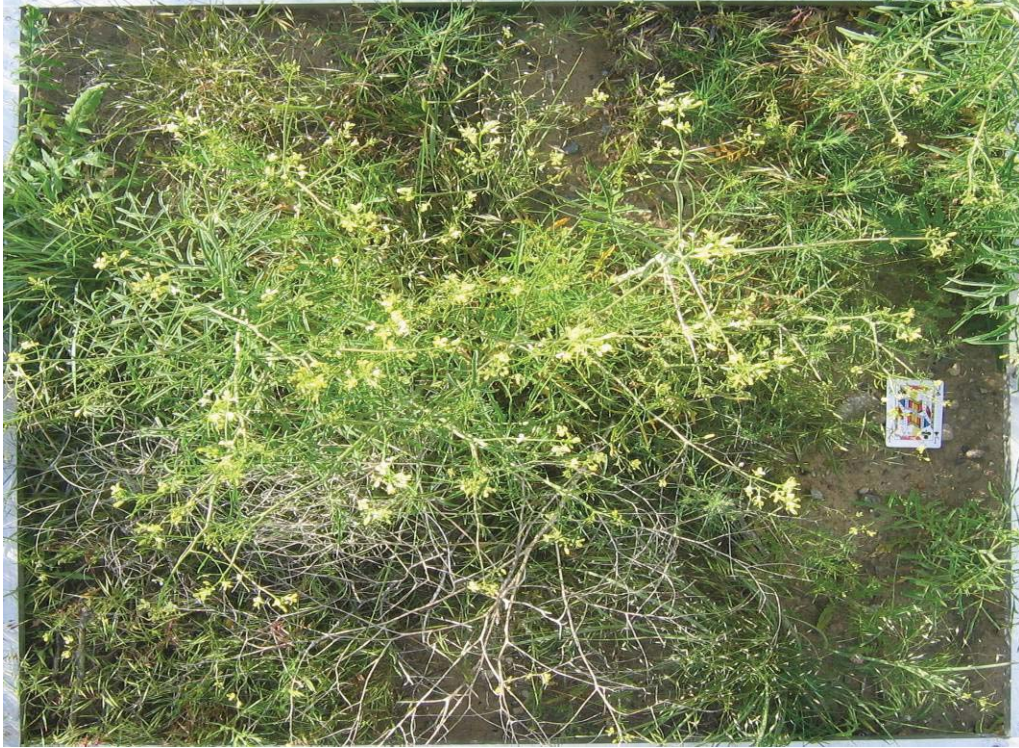
Figure B-4. Revegetation plot on the long Saddle Trench showing Indian rice grass production.

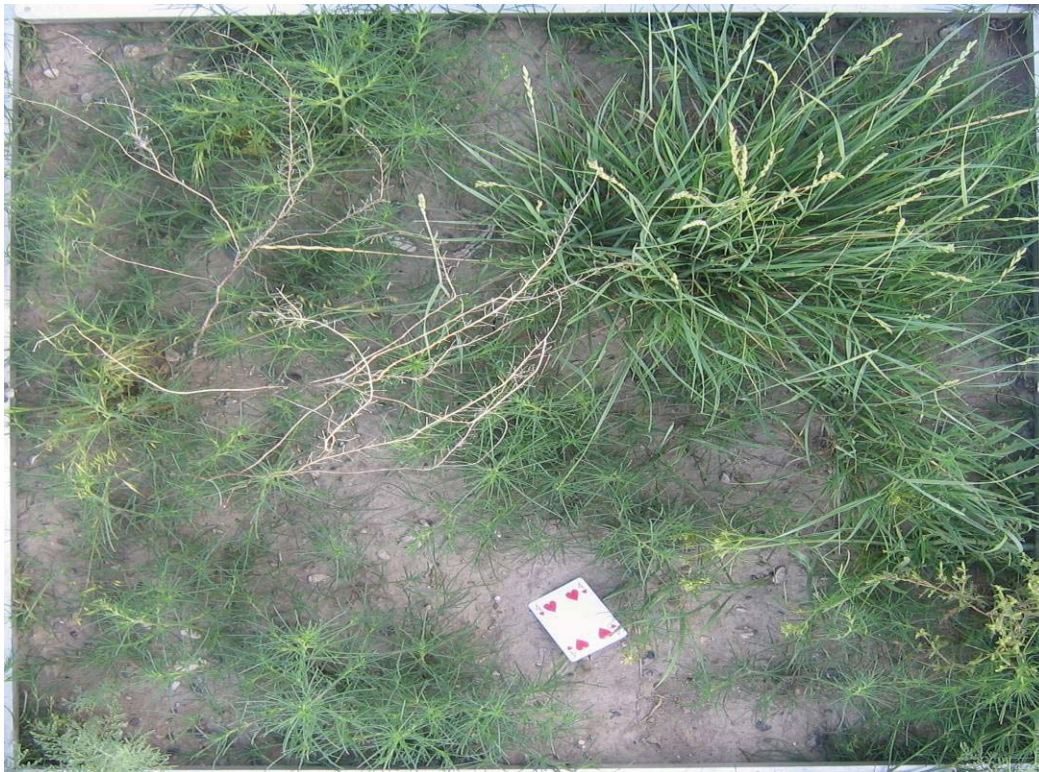
Figure B-5. Revegetation plot on west Saddle Trench depicting native grass and Russian thistle.

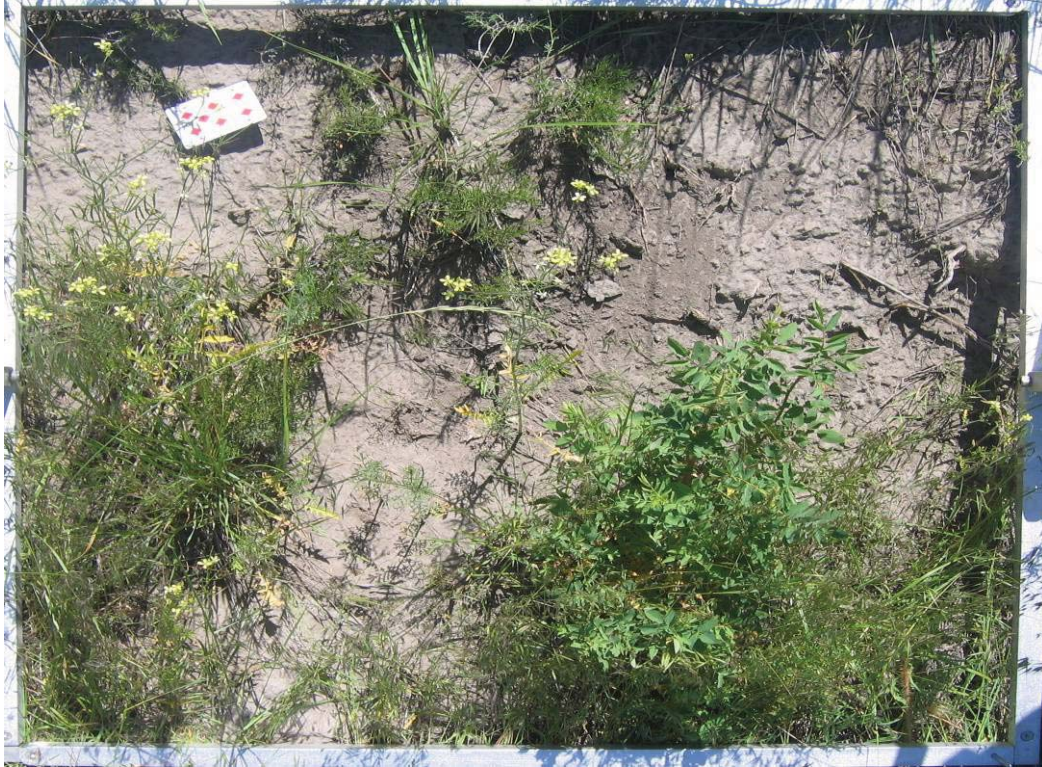
Figure B-6. Revegetation on east Saddle Trench showing grass and shrub establishment.

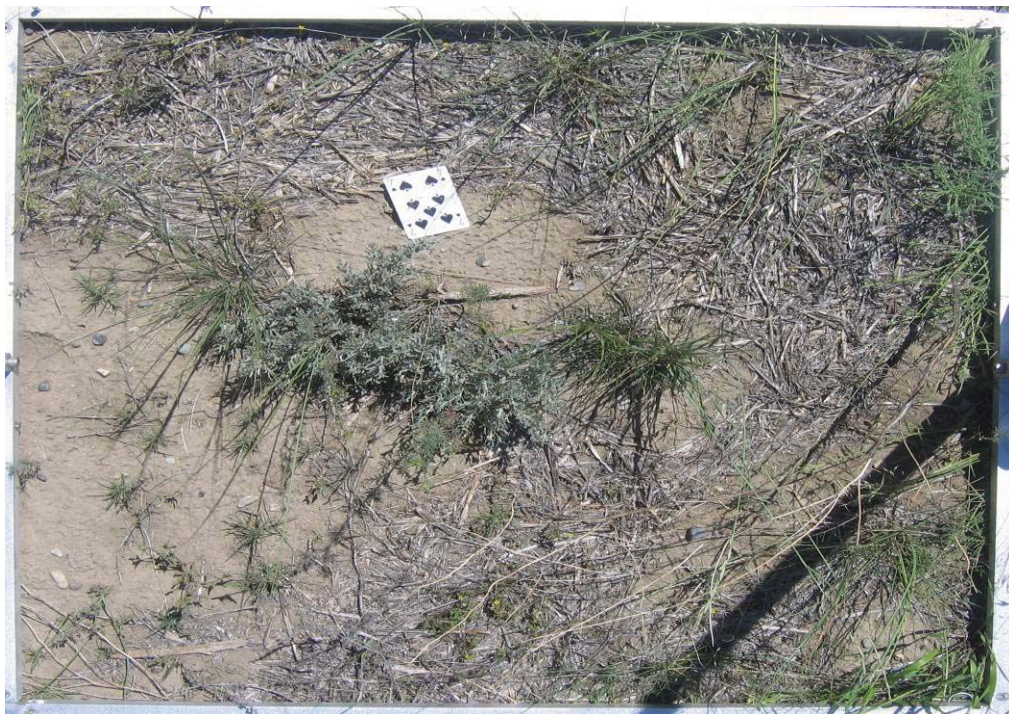
Perennial needle and thread grass and Indian rice grass are dominant grass species in these disturbed areas. Green rabbitbrush and sagebrush are also reestablishing. Very little cheatgrass and no Jim Hill tumble or western tansymustard were observed. Figure B-7 depicts current vegetation on the disturbed area.

Figure B-7. Revegetation on BLR-8 Trench showing sagebrush establishment.

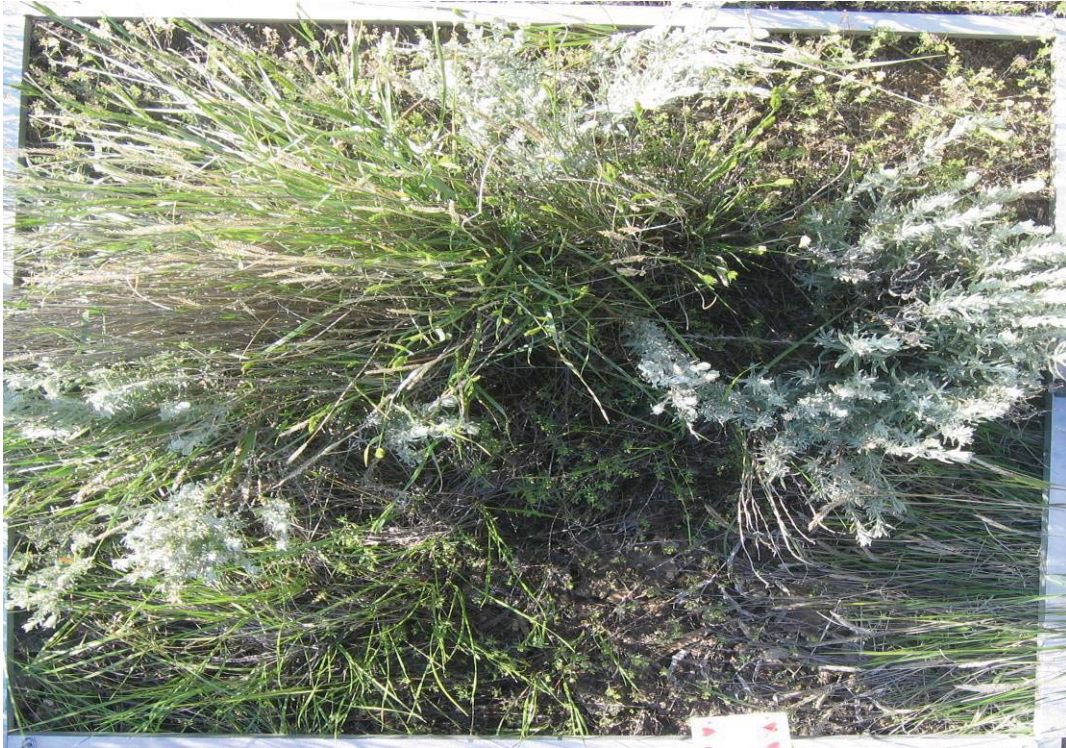
Total cover over the four transects at the UAV ranged from 82.82% to 124.35% of background as shown in Tables A-8 through A-11, and Figures B-10 through B-12. It is important to note that biological soil crusts, which can be seen in Figure B-10, appear to be reestablishing in the disturbed area. Soil crusts were not included in the data for this assessment, but they are generally regarded as indicators of healthy landscapes due to imparting resistance to erosion in the soil surface.

Figure B-10. Revegetation plot on UAV transect T1 showing grass and shrub establishment.

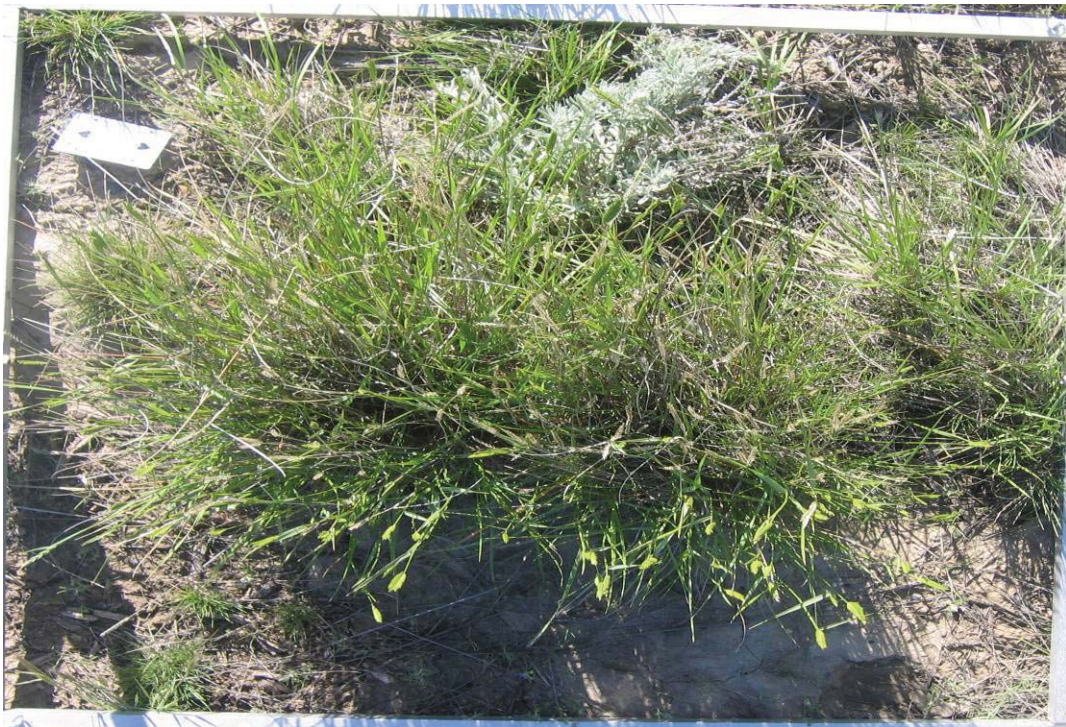
Figure B-11. Revegetation plot on UAV transect T2 showing grass and shrub establishment.

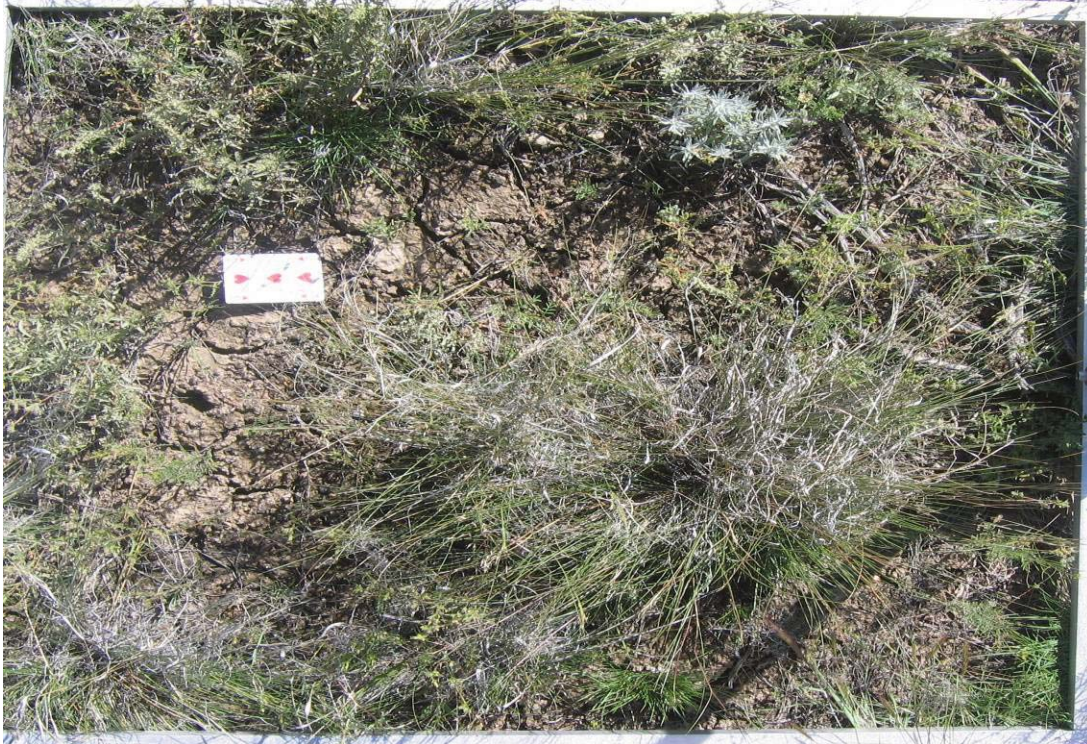
Figure B-12. Revegetation plot on UAV transect T3 showing grass, shrub and biological soil crust establishment.

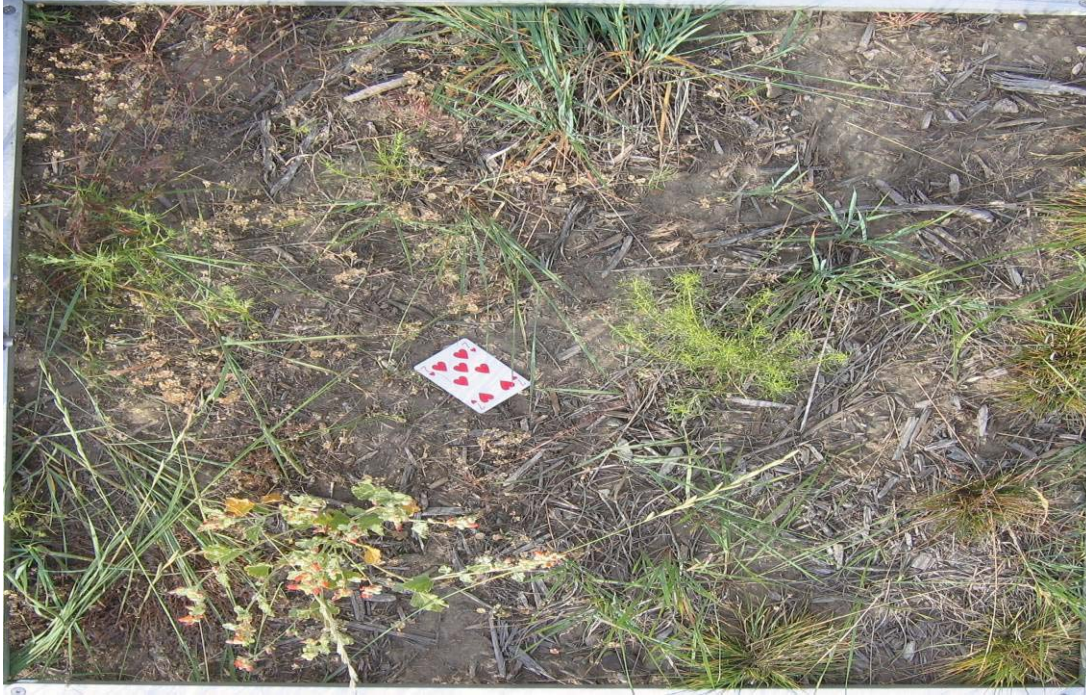
Indian rice grass, thickspike wheatgrass, green rabbitbrush, globemallow, and shaggy fleabane are some of the perennial species observed at the site. Figure B-14 shows revegetation at this location. Cheatgrass is present in the understory at this location where litter is adequate to promote germination, and Russian thistle is prolific near the two track road and should be controlled. Final stabilization has been achieved at this location.

Figure B-14. Plot at VZRP wells 208, 191, and 193 showing grass, forb, and shrub establishment.

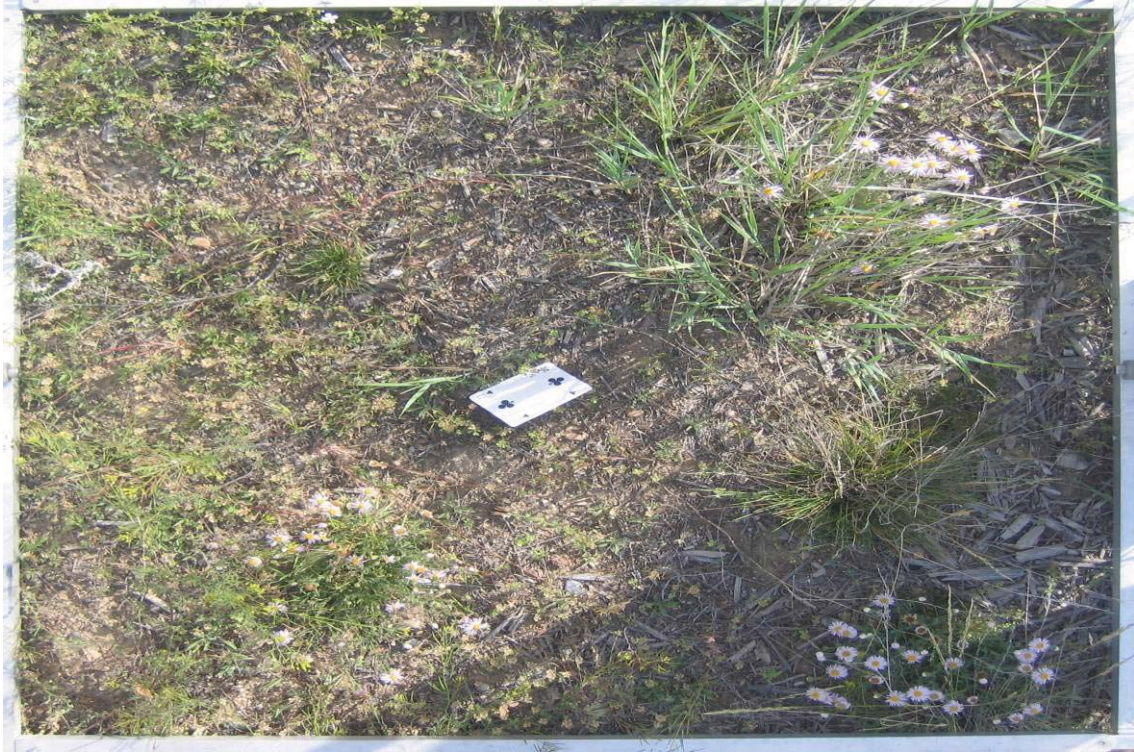
Wells 164A and 164B are located within a large burn area, and background vegetation was established in the revegetating burn area. Cover is 79.55% of background (Table A-15). Desert alyssum, western tansymustard, and halogeton account for the high percentage of forbs in the disturbed area (Figure B-16). The wellhead areas are not establishing well. Other species reestablishing here include sagebrush, thickspike wheatgrass, bottlebrush squirreltail, shaggy fleabane, Russian thistle, and cheatgrass.

Figure B-16. Plot at VZRP wells 164A and 164B showing grass and forb production and western tansymustard.

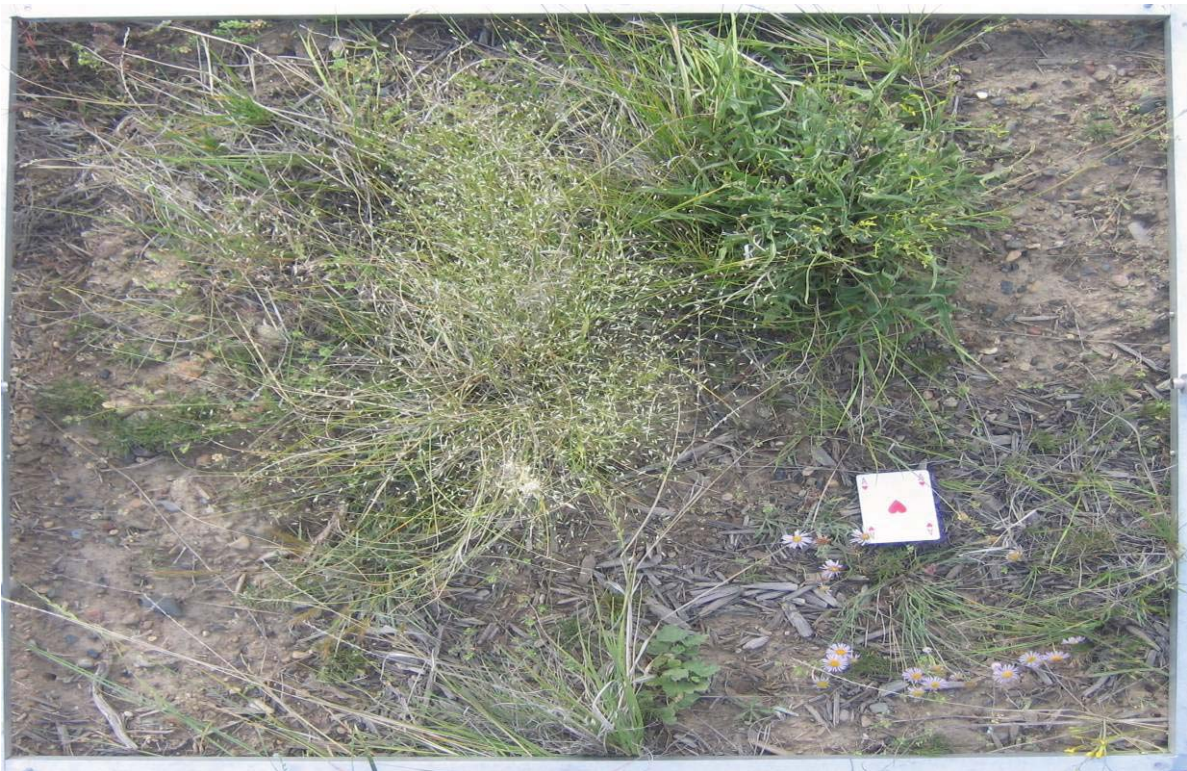
These wells are also located within the burned area, and seem to be recovering well. Species reestablishing the disturbed area around the wells include desert alyssum, shaggy fleabane, globemallow, Indian rice grass, tapertip hawksbeard, bottlebrush squirreltail, needle and thread grass, green rabbitbrush, and some tansymustard (*Descurainia Sophia*). Figure B-17 is representative of the location.

Figure B-17. Plot at VZRP wells 194, 195, 214, and 167 with grass and forb establishment.

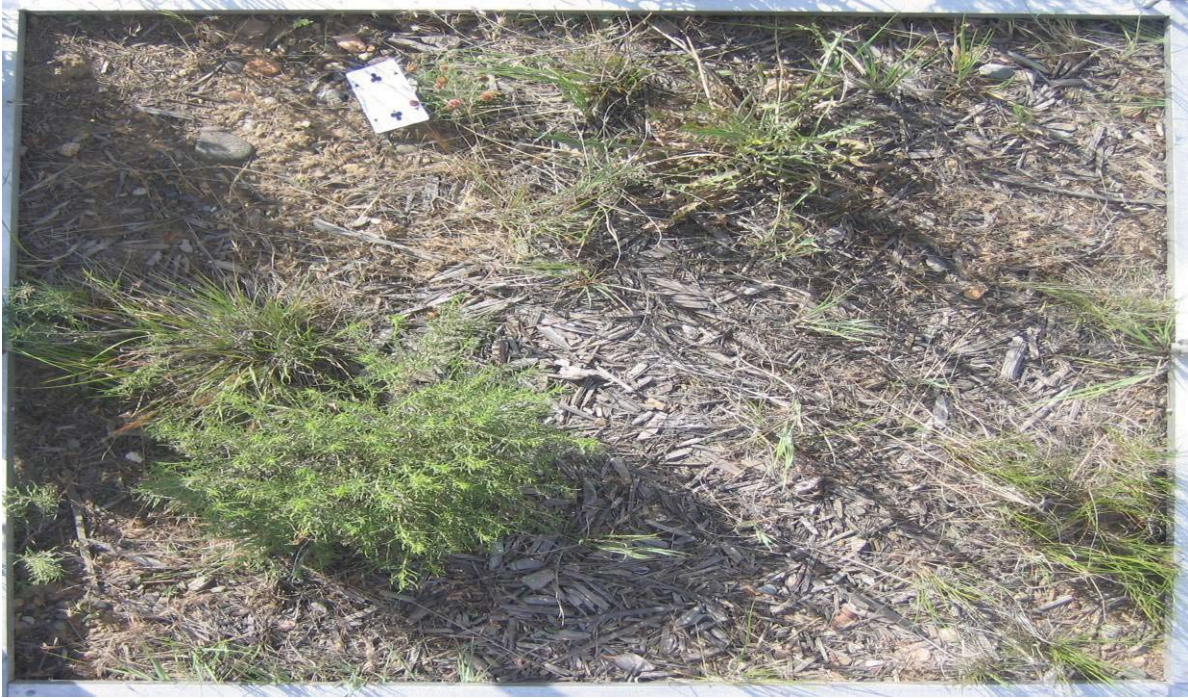
The disturbed area of these wells is nearly indistinguishable from background, and the site has reached final stabilization. Cover here is 184.62% of background. Grass and forb cover also exceed background levels (Table A-17). Species observed include green rabbitbrush, Indian rice grass, crested wheatgrass, needle and thread grass, bottlebrush squirreltail, shaggy fleabane, and thickspike wheatgrass. Mushrooms were observed in the understory. Figure B-18 depicts the vegetation that is characteristic of the location.

Figure B-18. Plot at VZRP wells 196, 197, and 198 showing shrub, forb, and grass establishment.

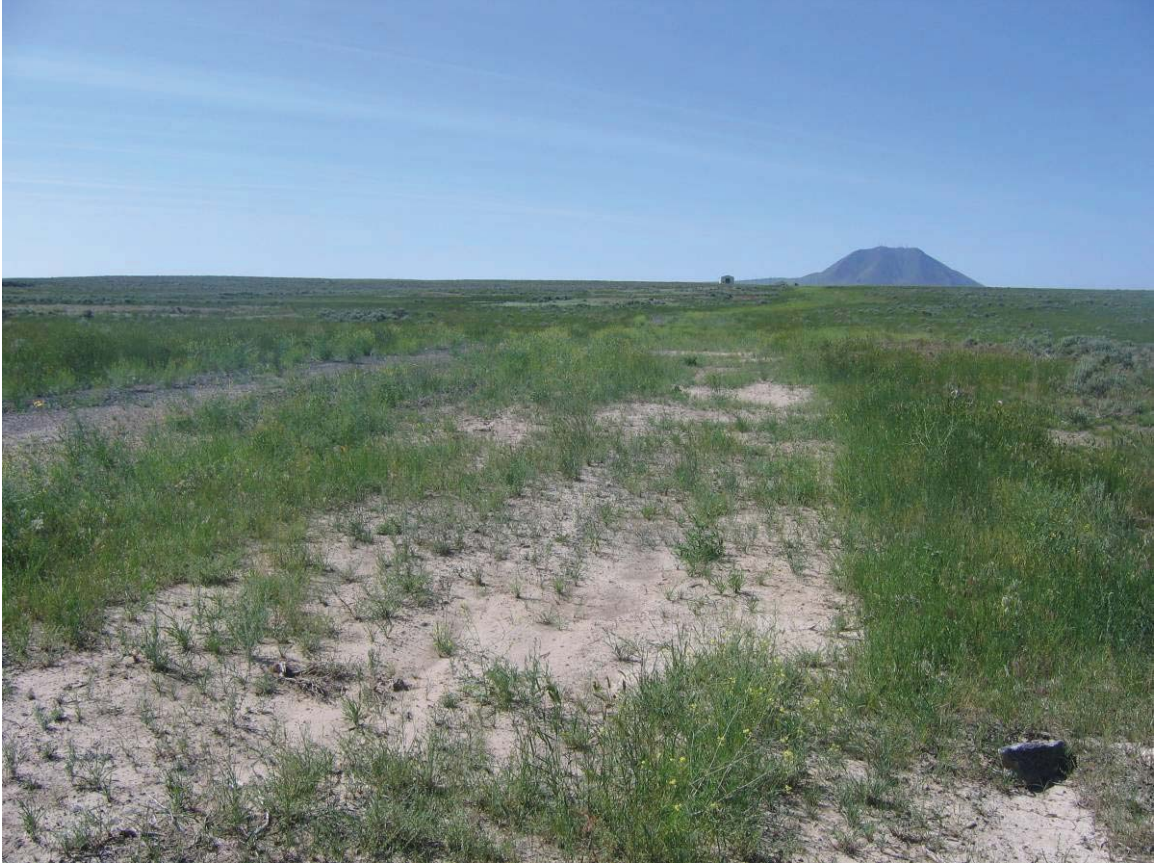
Vigorous plant growth in both the disturbed and undisturbed areas was evident. Several bare spots exist along the corridor (Figure B-22). Grass along the power cable corridor is predominantly crested wheatgrass, which dominates the surrounding area. Other grasses observed include thickspike wheatgrass, bottlebrush squirreltail, and cheatgrass.

Figure B-22 Photo shows cable corridor with bare spots looking south towards the Equipment Enclosure and Search Station building.

Perform a visual evaluation in 2010. It is recommended that crested wheatgrass be allowed to become re-established on the disturbed sites and be used to determine final stabilization.

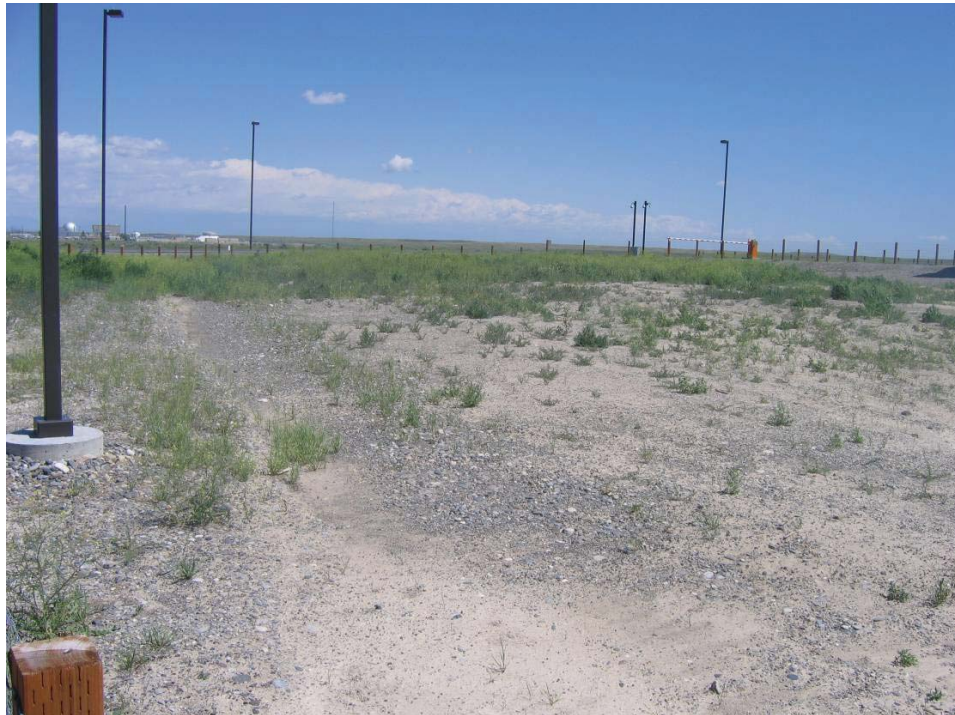
There are large bare areas inside and outside the fenced area between buildings MFC-735 and MFC-736 (Figures B-23 and B-24). This area is approximately 350 ft x 120 ft. Kochia and Jim Hill tumble mustard are the dominant forbs. Grass growth is spotty (Figure B-25) and the plants are not as vigorous as those in other areas disturbed by the project, e.g., the power cable corridor. No shrubs were observed.

Figure B-23 Photo shows bare spots in disturbed area between buildings MFC-735 and MFC-736.

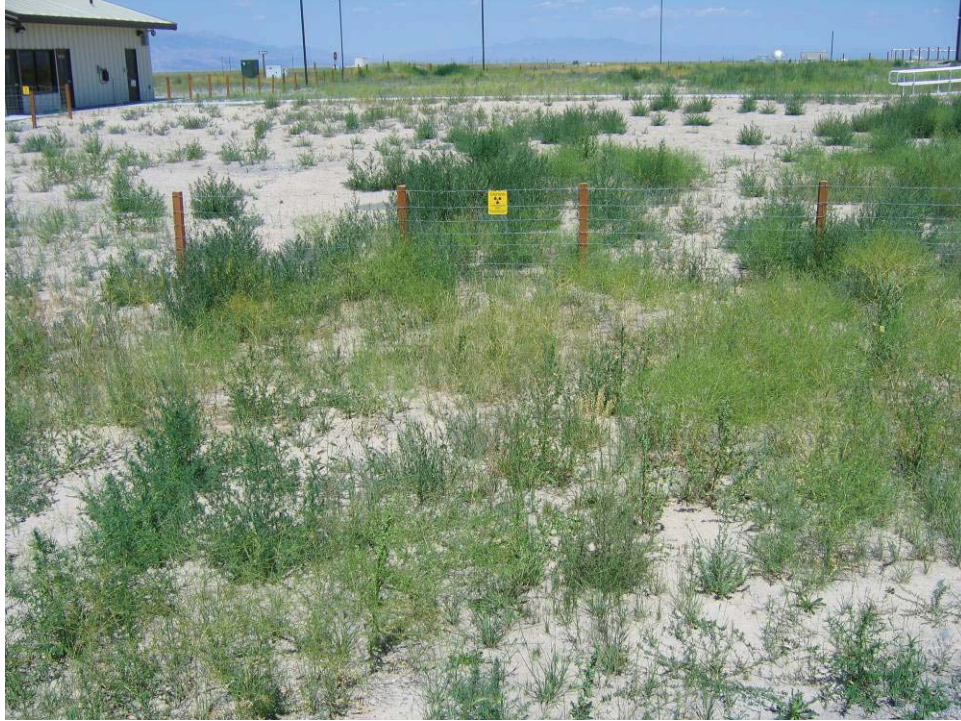
Figure B-24. General view of disturbed area between MFC-735 and MFC-736 looking north towards MFC.

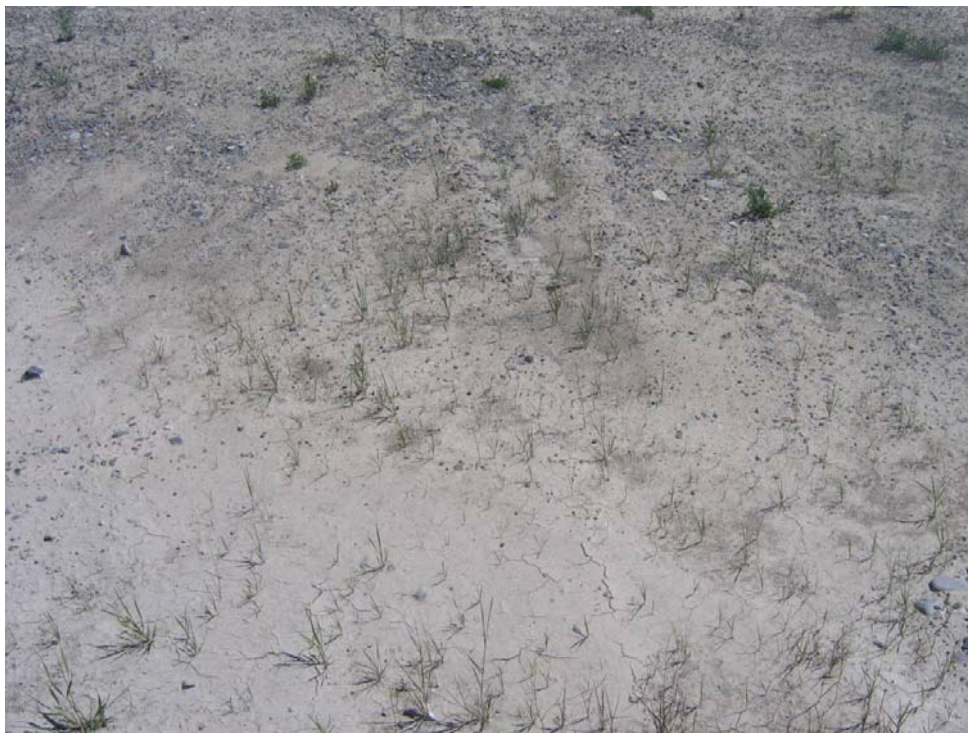
Figure B-25. Photo shows spotty grass growth in area located between buildings MFC-735 and MFC-736.

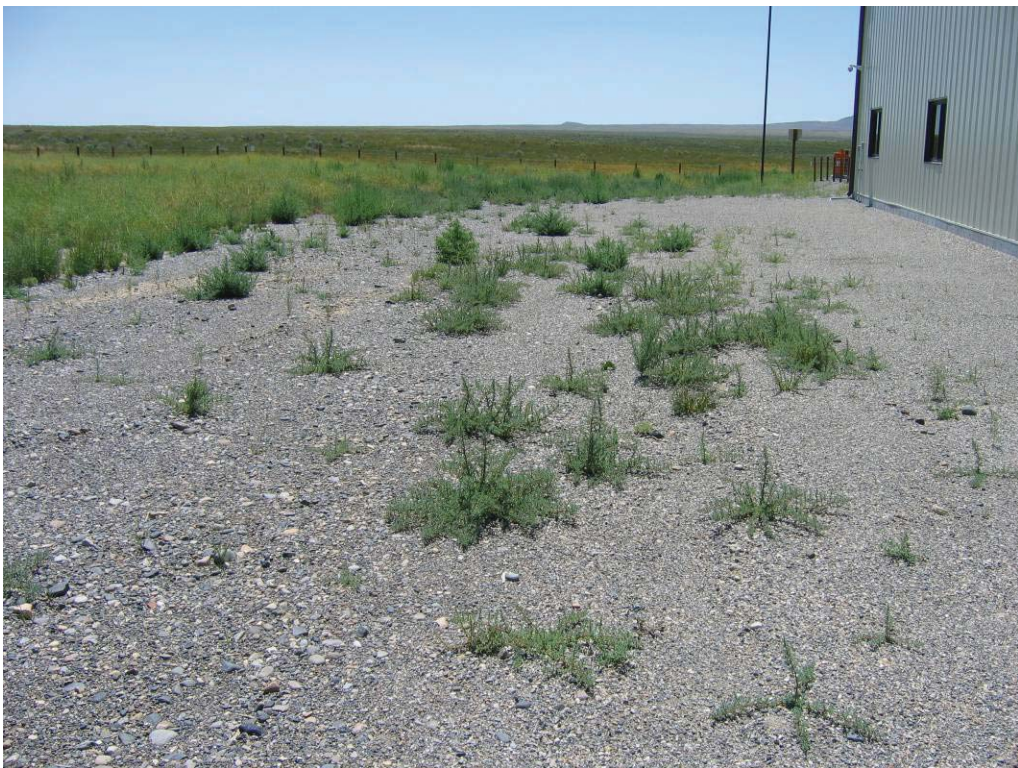
Figure B-27. Graveled area within the disturbed site located on the east side of MFC-736. Halogeton was the most common species growing in the gravel area.

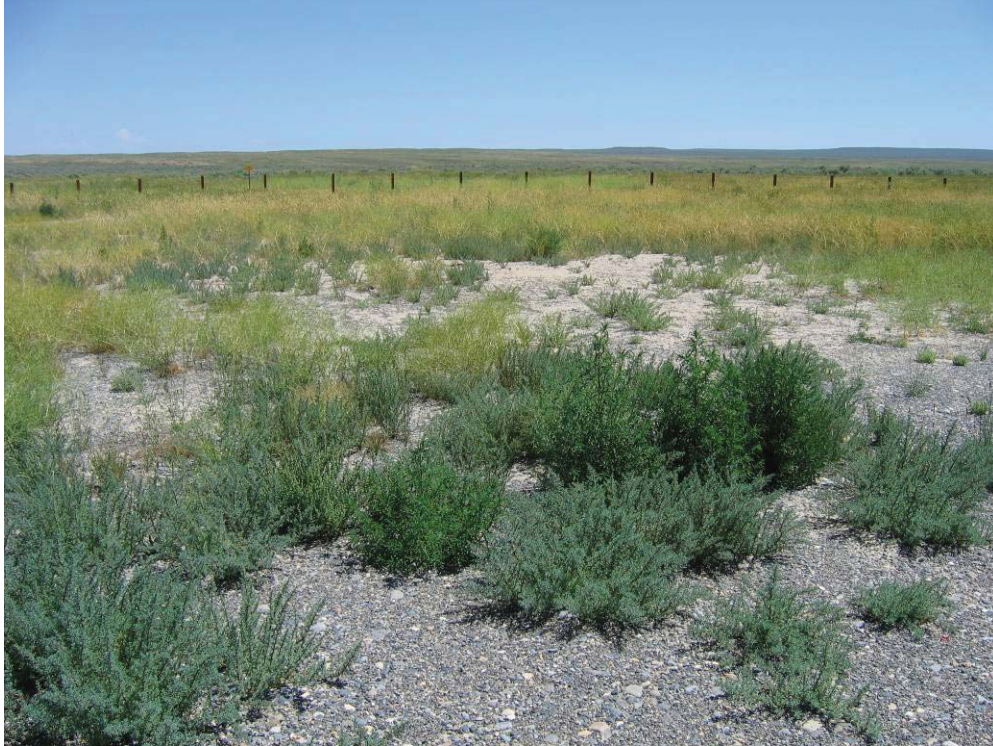
Figure B-28. Photo shows Jim Hill tumble mustard, kochia, and halogeton on the north end of the disturbed area located east of building MFC-736.

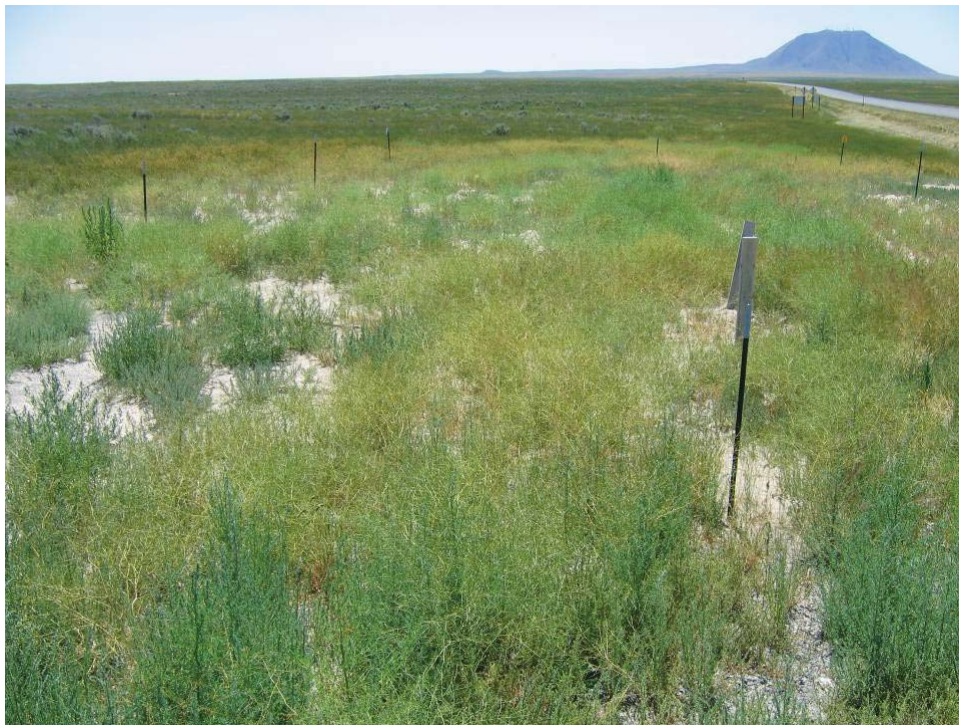
The septic tank drain field is approximately 58 ft x 105 ft. Forbs include kochia, Jim Hill tumble mustard and halogeton (Figures-B-29 and B-30). Crested wheatgrass is the dominant grass at this site. No shrubs were observed.

Figure B-29. View of septic drain field (for building MFC-735) showing kochia and Jim Hill tumble mustard.

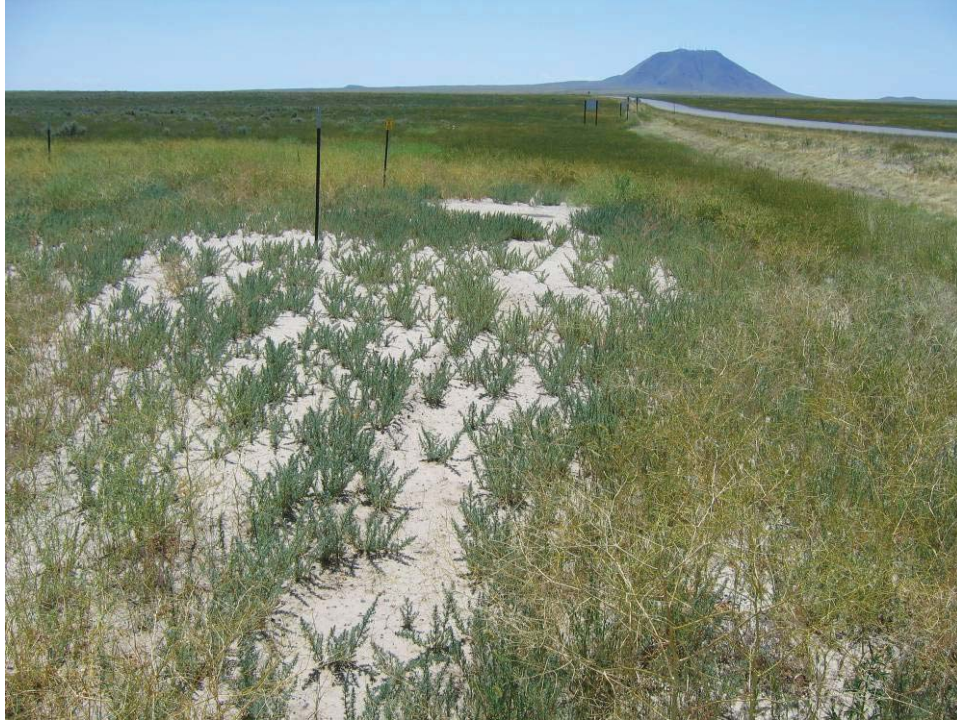
Figure B-30. View of west side of the septic drain field (for building MFC-735) where halogeton is more prevalent.

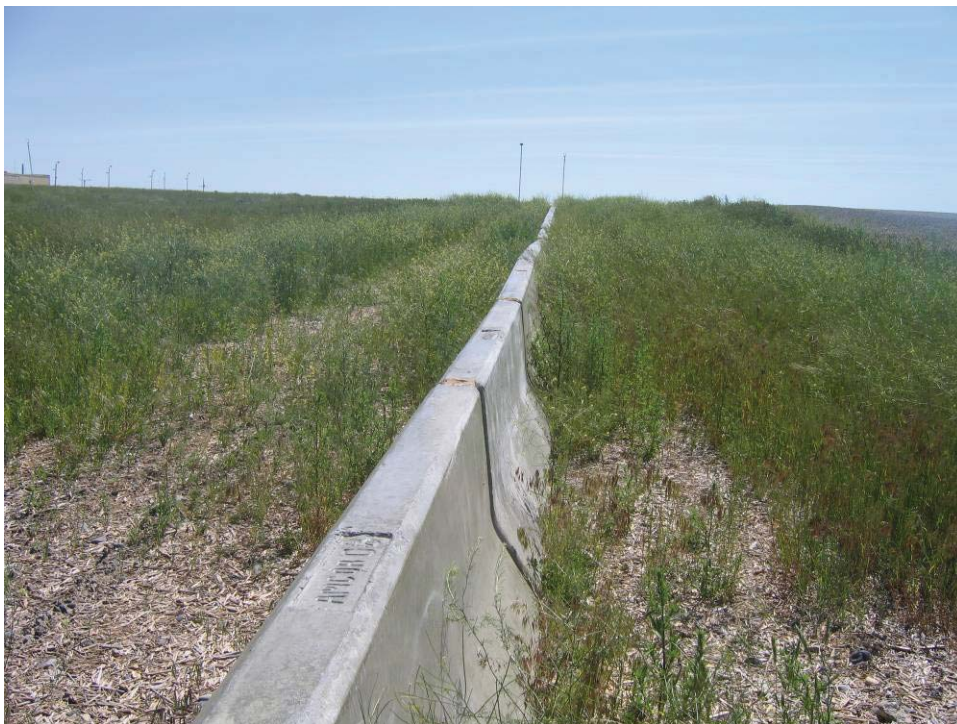
The vegetation assessment was performed on July 8, 2009 by visual observation. Due to the fall and spring weather conditions, desert plant growth in the area was vigorous (Figures B-31 and B-32). Dominant forbs are kochia and Jim Hill tumble mustard (Figures B-31 and B-32). Tansymustard and halogeton are also present in lesser numbers. Grasses include crested wheatgrass, cheatgrass, and bottlebrush squirreltail. Crested wheatgrass was the most prominent grass species. No shrubs were observed.

Figure B-31. Photo showing MFC DBT vehicle barrier on the south side of MFC and running east and west.

A visual evaluation should be performed in 2010. It is recommended that crested wheatgrass be allowed to become re-established on the disturbed sites and used to determine final stabilization. Musk thistle (*Carduus nutan*) is a noxious weed and should be eradicated. The Laboratory Support Complex organization that provides INL weed control has been notified of the location.

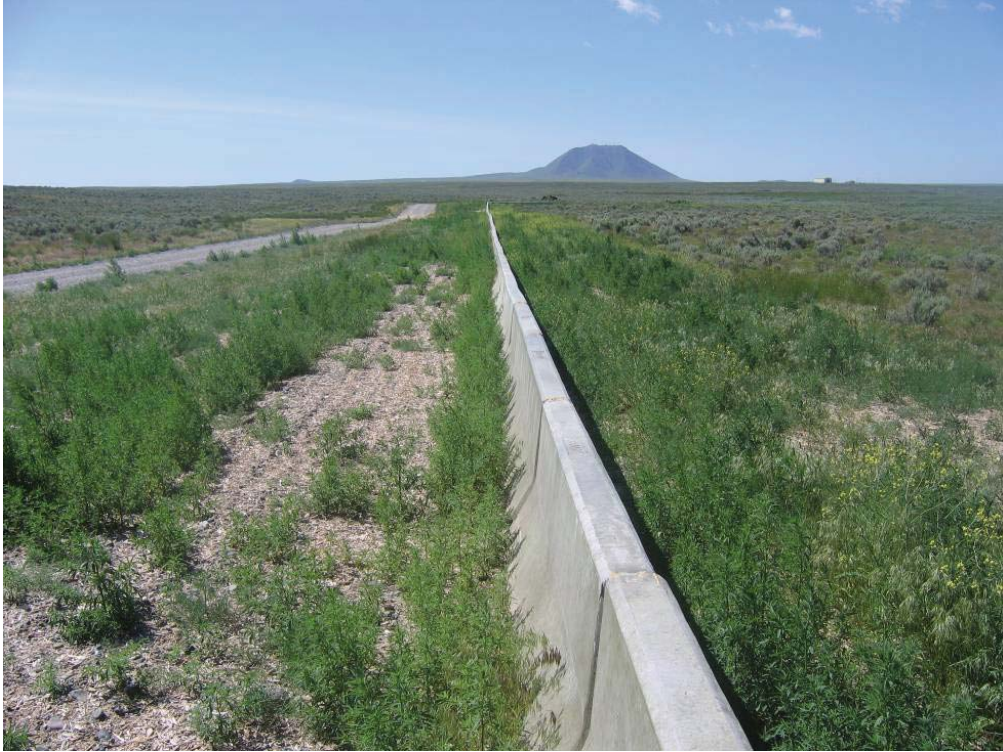
Figure B-32. Photo showing MFC DBT vehicle barrier on the east side of MFC running north and south.

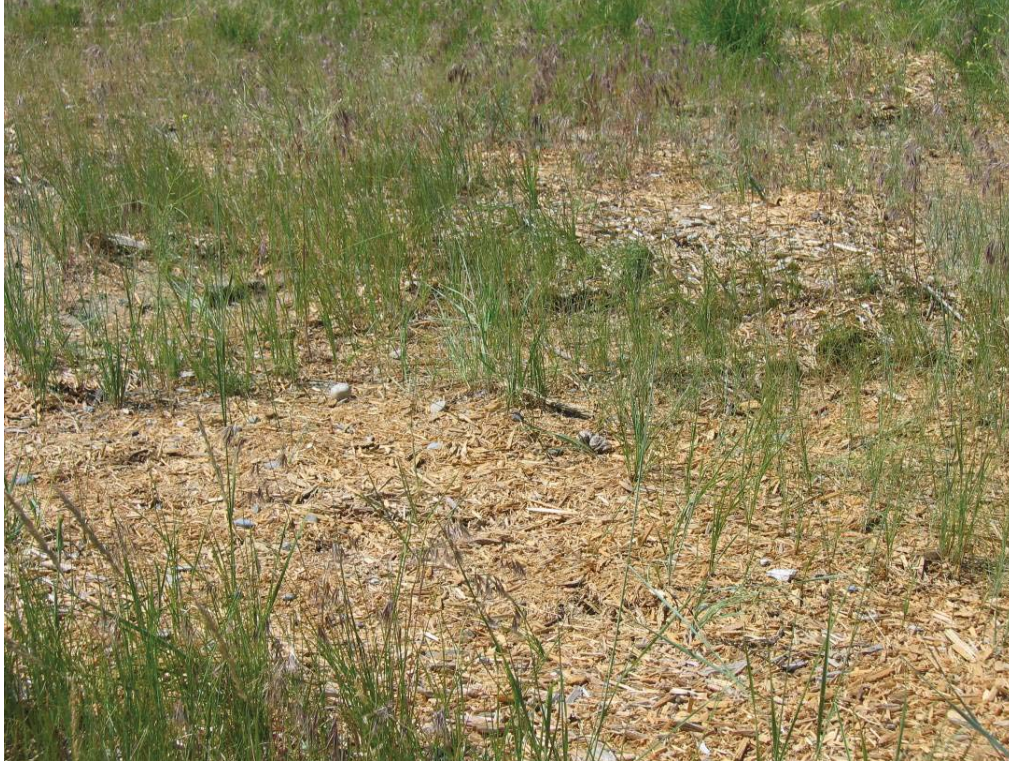
Figure B-34. Photo shows good grass re-establishment occurring at the disturbed area north of power pole 170 and west of the T-25 road.

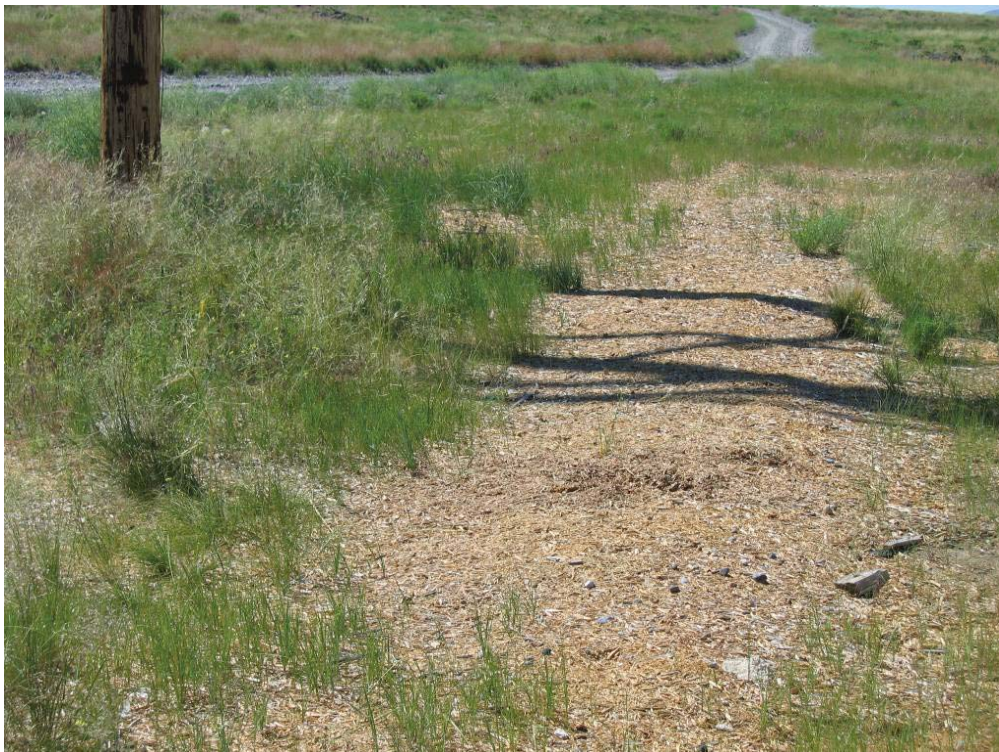
Figure B-37. Photo showing heavy application of wood chips at the power pole 176 turn around site.

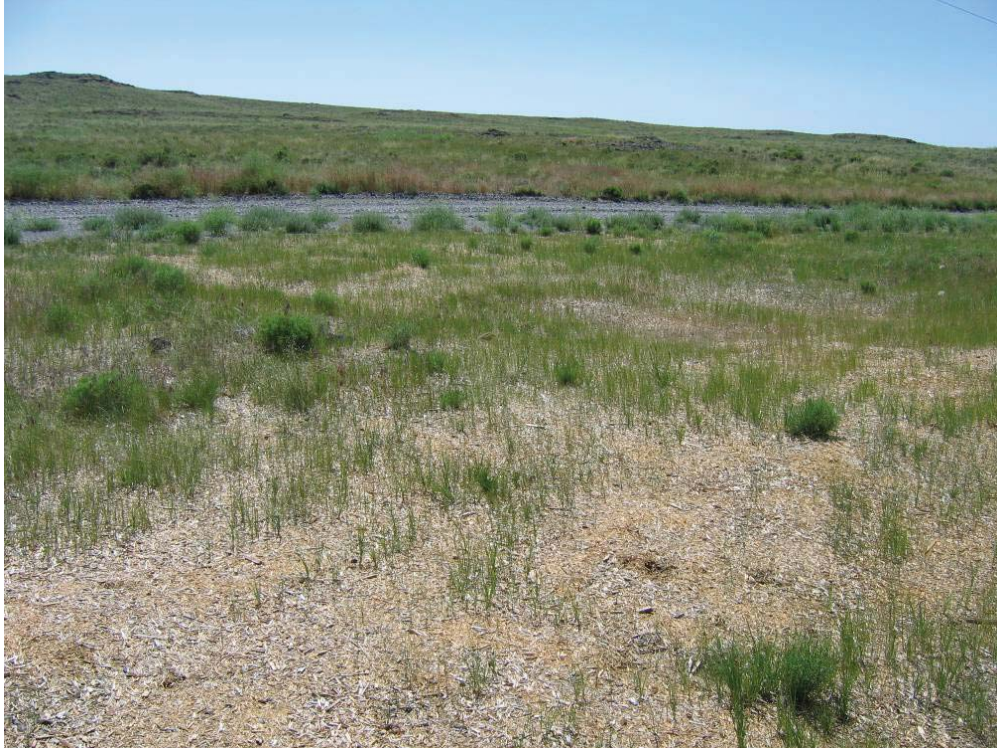
Figure B-38. Photo shows new grass growth and small green rabbit brush plants at the turn around located near power pole 176.
