Fiscal Year 2009 Revegetation Assessment

Michael G. Lewis

October 2009

**Prepared for the
U.S. Department of Energy
Office of Nuclear Energy
Under DOE Idaho Operations Office
Contract DE-AC07-05ID14517**

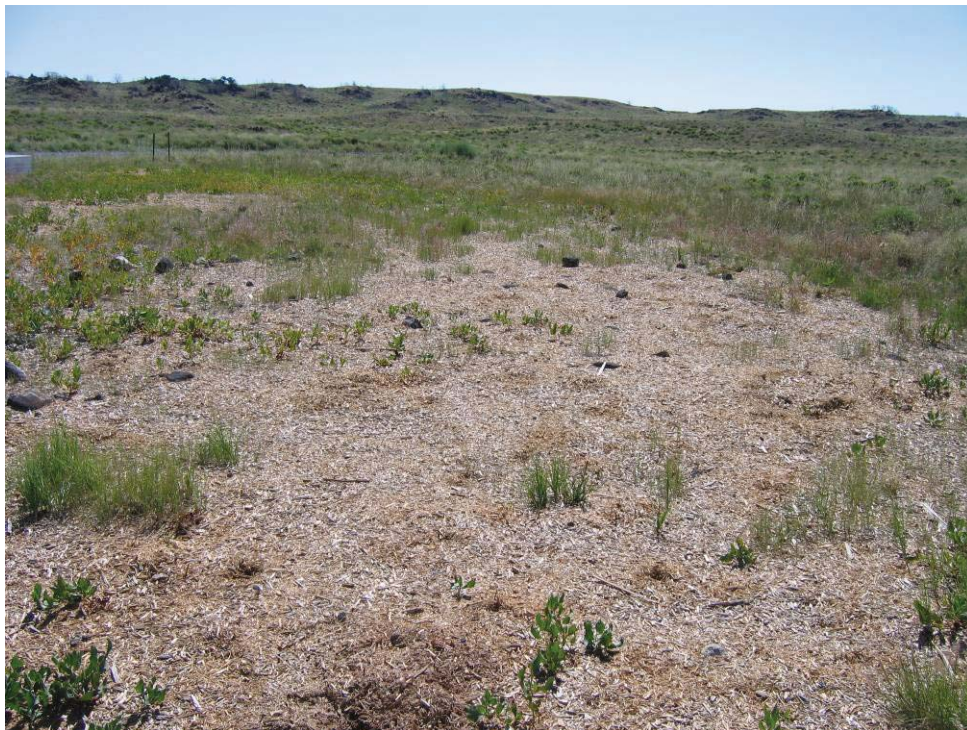
Figure B-43. Photo shows heavy application of wood chips at the disturbed area located south side of the turn-off at the east end of the National Security Test Range access road.

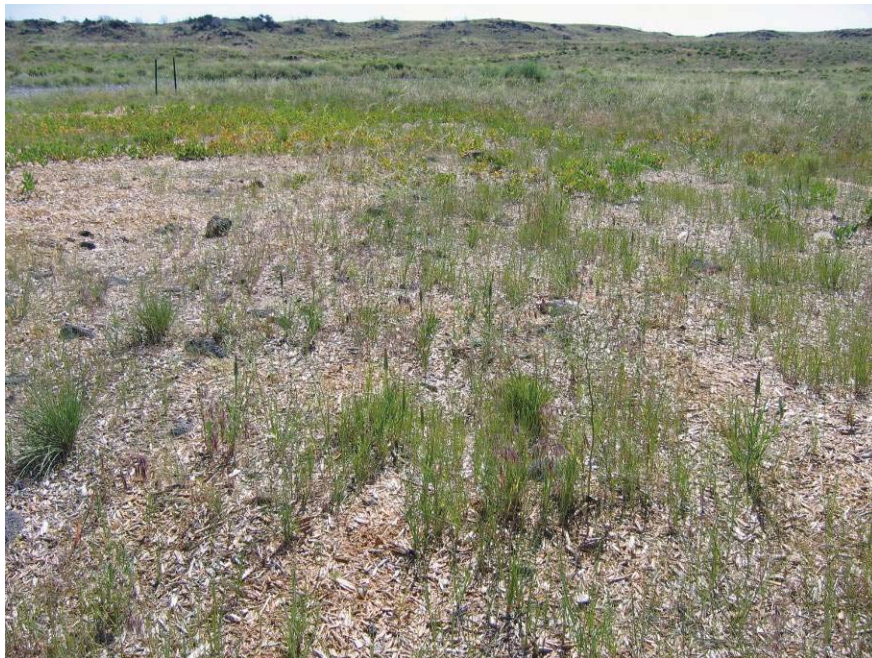
Figure B-45. Photo shows grass production occurring at the disturbed area located south side of the turn-off at the east end of the National Security Test Range access road.
