Creep-Fatigue of Advanced Austenitic Alloys

Laura Carroll
Julian Benz
Richard Wright

August 2010

**Idaho National Laboratory
Idaho Falls, Idaho 83415**

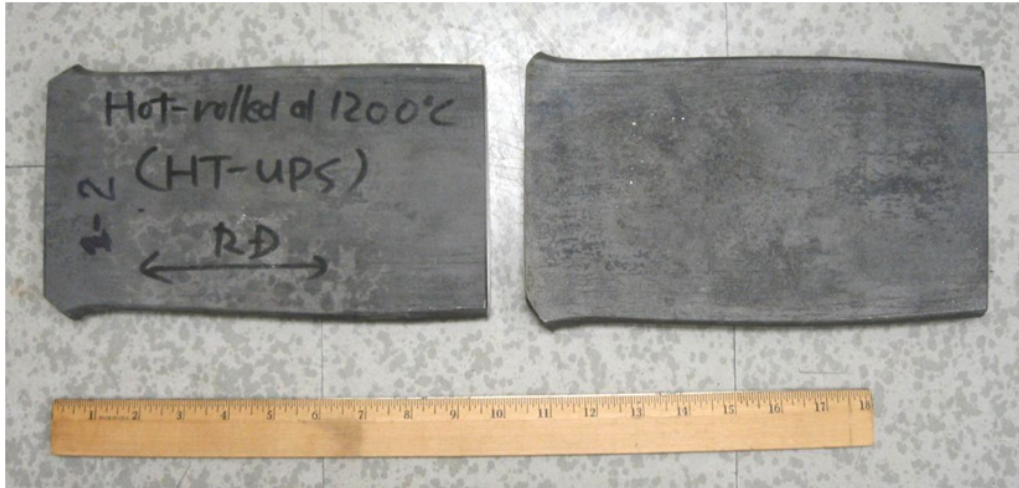
Figure 1. As-received hot-rolled plates of HT-UPS steel.

An ingot of HT-UPS steel was cast into the dimensions 4" in diameter and 5" in length, as shown in Figure 1. The ingot was annealed at 1200°C for 4 hours in an argon and 4% H₂ gas atmosphere. The plate was hot forged at 1200°C to a thickness of approximately 2" and then hot rolled at 1200°C to a thickness of 0.8". The plates were air cooled following the hot forging and hot rolling steps. After reducing the plates to a final thickness of 0.8", the plates were sandblasted to remove the oxide scales and the edges were removed. The chemistry of the HT-UPS steel plate is given in Table 1. Bar stock of 316 stainless steel was purchased in the form of 0.75 inch round bar in the annealed, pickled, and cold drawn state. The composition for this heat of 316 stainless steel is also included in Table 1.

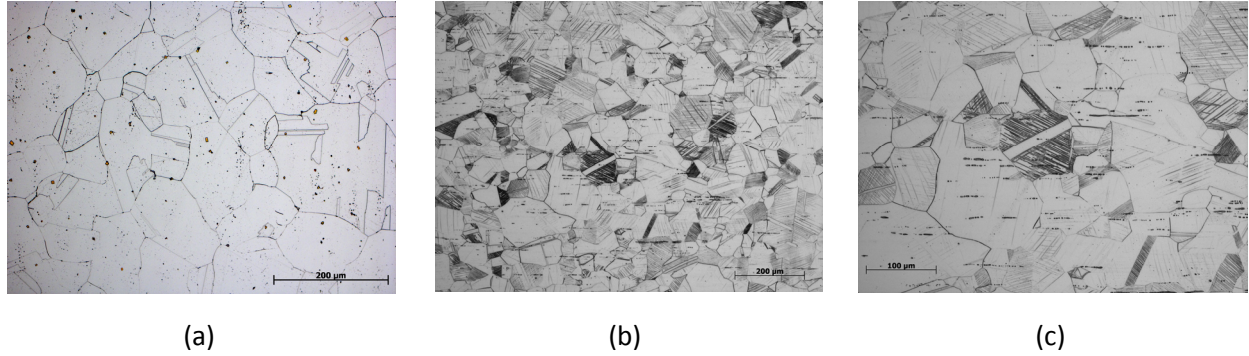
Figure 2. Optical micrograph of HT-UPS base material (a) and the 316 stainless steel base material (b, c). The rolling direction is perpendicular to the plane of the page (a) and the longitudinal axis of the rod is perpendicular to the plane of the page (b, c).

The microstructure of the as-received HT-UPS plate was relatively homogenous. An optical image perpendicular to the rolling direction is shown in Figure 2(a). All three orientations of one of the plates were examined and the microstructure and grain size were consistent, as shown in a three-dimensional reconstruction of the microstructure in Figure 3. The grain size was approximately 100 μm and twins were observed throughout the grain structure. Also visible optically were Ti(C,N) precipitates that were typically cuboidal in shape and on the order of a micron on edge.

The microstructure of 316 stainless steel base material is shown in Figure 2(b) and (c). Slip lines are present in many of the grains, evidence of the cold working prior to receipt of the material. The prior deformation is also visible parallel to the rolling directions in wavy lines (image not shown). The grain size of the stainless steel was not quantified, though the grains are smaller than the HT-UPS material. TEM micrographs of the as-received materials are shown in Figure 6 and reveal a small fraction of secondary phases within the grains. Images of the grain boundaries were also acquired. A low grain boundary and the associated dislocation network are shown in Figure 6; the boundary is void of second phase particles.

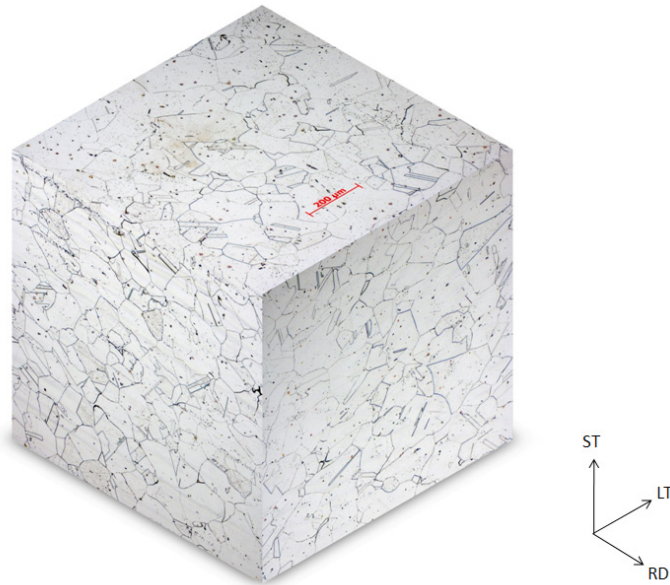
Figure 3. Three-dimension reconstruction of HT-UPS base material. The reference directions are shown as short transverse, long transverse, and rolling direction.

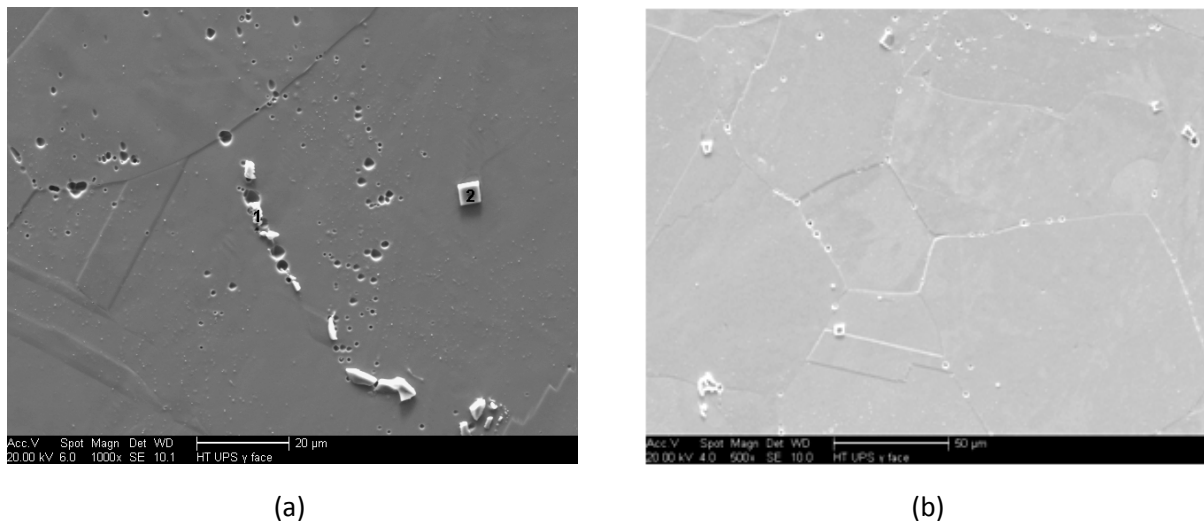
Figure 4. SEM images of the HT-UPS steel after electrolytically etching with an oxalic etch. The etch resulted in pitting in the material that was visible in the SEM. The cuboidal precipitate marked with the number “2” in (a) is a Ti-rich precipitate, likely a Ti(C,N) .

The base HT-UPS material was difficult to etch without causing extensive grain boundary and intragranular pitting and thus imaging the alloy with the SEM was challenging. The commonly used stainless steel etchants that were used resulted in pitting that was visible in the SEM. An SEM image showing pitting is shown for HT-UPS etched with an oxalic etch in Figure 4. The pitting was not observed in the as-polished base material. A light etch with Vilella's reagent was found to not result in pitting, however, the light etch did not sufficiently reveal the grain structure for optical microscopy. SEM work was performed on lightly etched specimen and optical microscopy was completed on specimen etched for longer times.

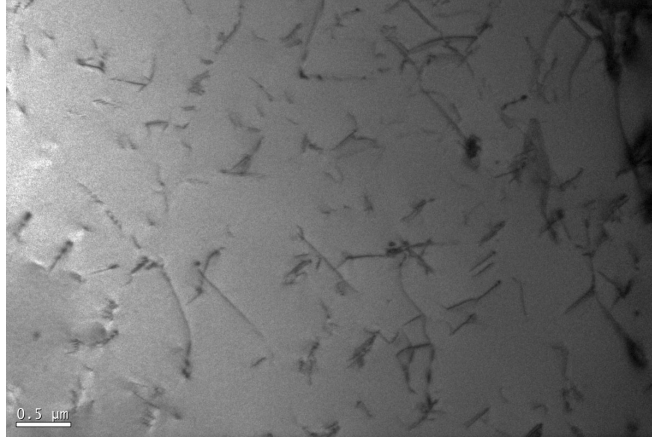
Figure 5. TEM micrograph of HT-UPS in the as-received condition showing the dislocation microstructure and the presence of a few secondary particles within a grain.

Transmission electron microscopy (TEM) of the as-received HT-UPS material was completed to characterize secondary phases and obtain a baseline microstructure for later analysis of creep-fatigue samples. Figure 5 shows a bright-field TEM image of the as-received material showing dislocations within one grain. As expected, the dislocation density is very low due to the final hot rolling of the material. Also, very few secondary particles are present. A small number of particles which are approximately 50 nm in diameter, most likely MC carbides, were found adjacent to intragranular dislocations as indicated by the arrows in Figure 5.

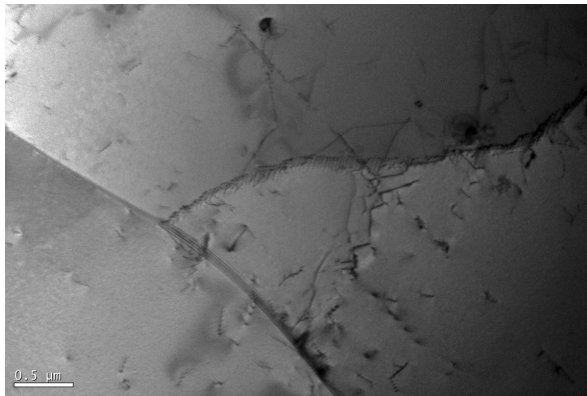
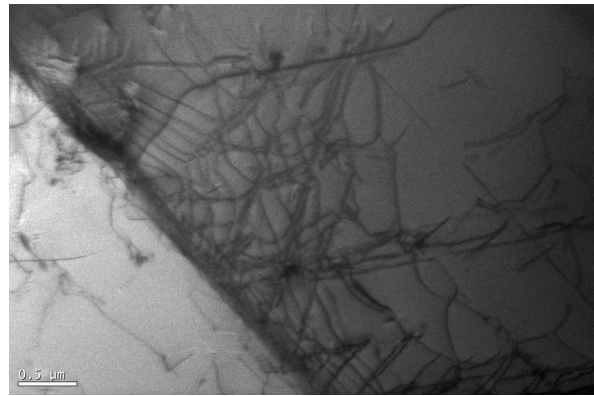
Figure 6. TEM micrographs of grain boundaries and associated dislocation structures in the as-received 316 stainless steel.

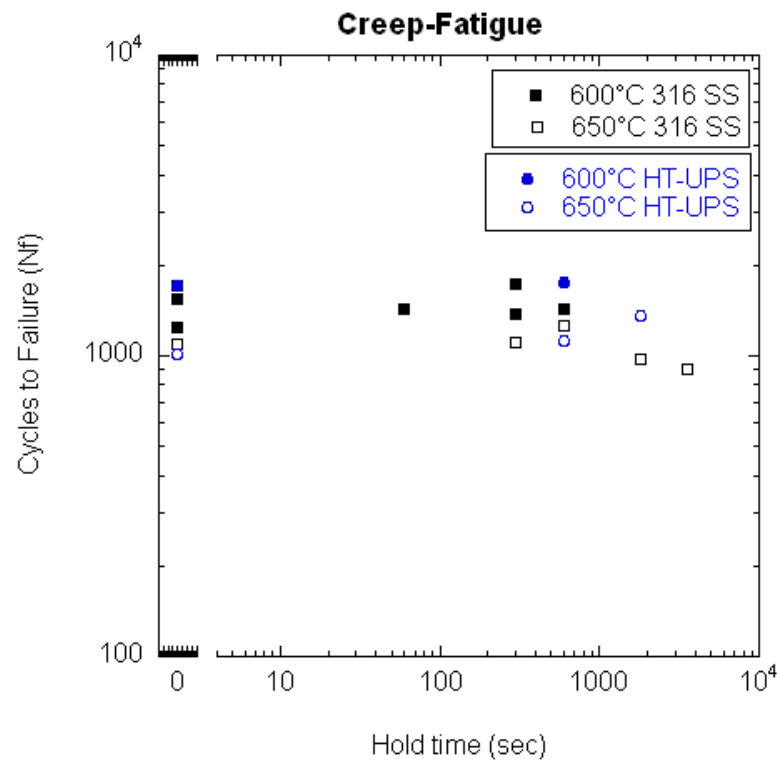
Figure 7. Continuous cycle and creep-fatigue behavior of 316 stainless steel and HT-UPS steel at 600°C and 650°C.

The fatigue and creep-fatigue lives of the HT-UPS and the 316 stainless steel alloy were similar, although the deformation behavior during cycling was quite different. A summary of the fatigue and creep-fatigue results are given in Table 2. As illustrated in Figure 7, the number of cycles to failure of the 316 stainless steel and the HT-UPS steel were similar at 600°C and 650°C. The cycles to failure at the higher temperature, 650°C, were slightly less than at 600°C. At these conditions, increasing hold times of up to 10 minutes did not degrade the creep-fatigue life of either alloy. For the 316 stainless steel, longer hold times of 30 and 60 minutes at 650°C resulted in cycle lifetimes that were slightly lower than observed for the shorter hold times. The HT-UPS creep-fatigue specimen tested with a 30 minute hold time at peak tensile strain failed in a similar number of cycles as the continuous cycle and shorter hold time tests. A 60 minute hold time HT-UPS creep-fatigue test is currently in progress. Creep-fatigue tests with hold times in excess of 10 minutes were not conducted at the 600°C temperature.

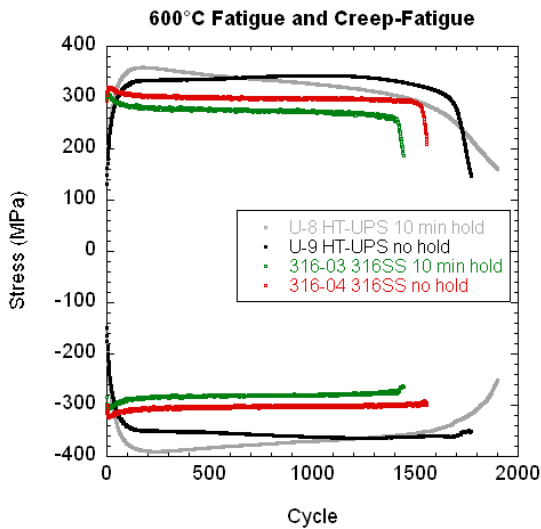
Figure 8. Peak tensile and compressive stresses during continuous cycle fatigue and creep-fatigue deformation of 316 stainless steel and HT-UPS steel at 600°C.

Although the cycles to failure were similar for the two steels, differences were observed in the cyclic hardening behavior. The peak stresses for the continuous cycle and 10 minute hold creep-fatigue tests are shown as a function of cycle in Figure 8 and Figure 9, at 600°C and 650°C, respectively. In low cycle fatigue at 600°C, the HT-UPS alloy exhibited relatively low tensile and compressive peak stresses initially and then significant hardening was observed as the peak tensile and compressive stresses more than doubled during the first 250 cycles. The peak tensile stress increased from approximately 130 MPa to greater than 300 MPa. The 316 stainless steel had a higher peak stress, approximately 310 MPa, in the initial fatigue cycles, then exhibited minimal hardening for the first 50 cycles, followed by softening for a hundred cycles and finally stabilizing at a stress of 300 MPa. The peak stresses of 316 and HT-UPS during creep-fatigue deformation at 600°C were initially similar to those exhibited during fatigue. However, the HT-UPS alloy continued to cyclically soften throughout the creep-fatigue test, whereas during the fatigue test a stabilized stress was established, also shown in Figure 8. Cyclic softening during deformation was much less pronounced in the 316 stainless steel at 600°C.

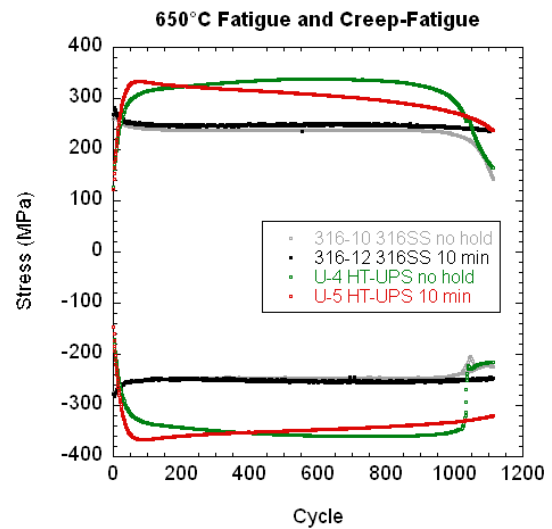
Figure 9. Peak tensile and compressive stresses during continuous cycle fatigue and creep-fatigue deformation of 316 stainless steel and HT-UPS steel at 650°C.

At 650°C, the cyclic stress response of the HT-UPS steel during fatigue and creep-fatigue deformation was similar to that at 600°C. However, the 316 material at 650°C did not initially harden as was observed at the lower temperature, instead cyclic softening occurred for approximately 50 cycles at which point both the fatigue and creep-fatigue tests achieved a stable peak tensile and compressive stress until macrocrack initiation, as shown in Figure 9.

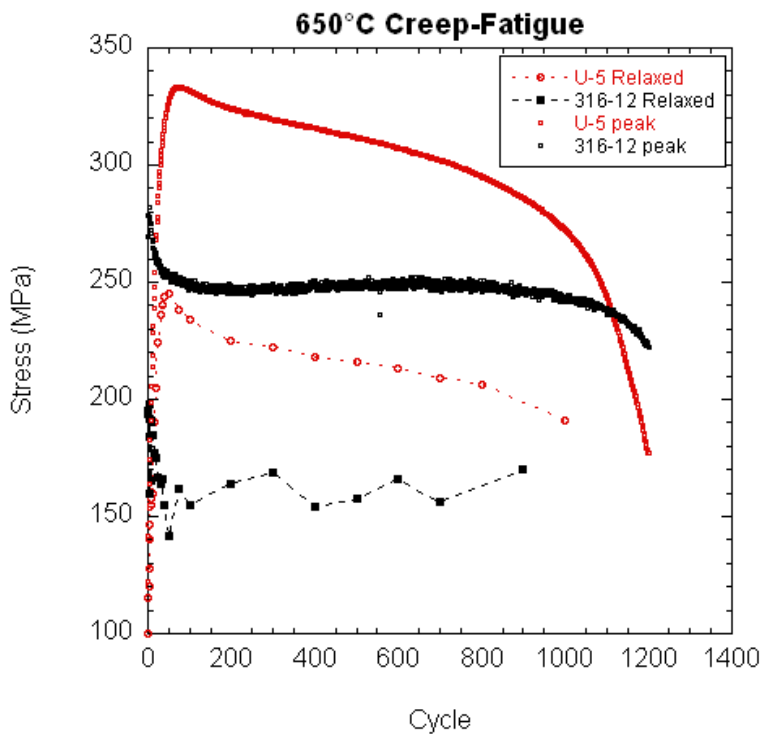
Figure 11. Relaxed stress, the stress at the completion of a hold period, shown along with the peak tensile stress, the stress at the start of a hold period, as a function of cycle for creep-fatigue of 316 stainless steel and HT-UPS steel at 650°C.

It is also informative to compare the creep or tensile hold portion of the cycle for the two alloys, although this is somewhat difficult given the large differences in the peak stresses. It has been well documented that the creep strength of the HT-UPS alloy is significantly higher than conventional stainless steels¹ on the order of 100 times at 700°C.³ The relaxed stresses or the stress at the completion of the hold period are shown with the peak tensile stresses for creep-fatigue at 650°C and a 10 minute hold in Figure 11. The stress at the end of the hold period for both 316 and HT-UPS vary as a function of the peak stress. For example, the peak stresses of HT-UPS initially increase and then slowly decrease, the relaxed stresses follow a similar trend. The relaxed stresses observed for the 316 stainless steel are significantly lower than the relaxed stresses observed for the HT-UPS alloy. As shown in Figure 10(d) for the HT-UPS alloy, the difference in the peak stress and the relaxed stress is relatively small in the initial cycles and becomes more significant by the 100th cycle.

Interestingly, the relaxed stresses varied as a function of cycle and were directly dependent on peak tensile stresses experienced. The higher the peak tensile stress, the higher the relaxed stress for both the HT-UPS steel and the 316 stainless steel, shown graphically in Figure 11. The stress relaxation period is during which the creep damage accumulates and is quantified as such by the ASME Code procedures. The stress relaxation behavior at this temperature is different than that observed in solid solution nickel-base alloys, such as Alloy 617, at high temperatures (above 850°C). The stresses of Alloy 617 at high temperature are observed to rapidly decrease to a relatively constant stress, regardless of the peak stress.

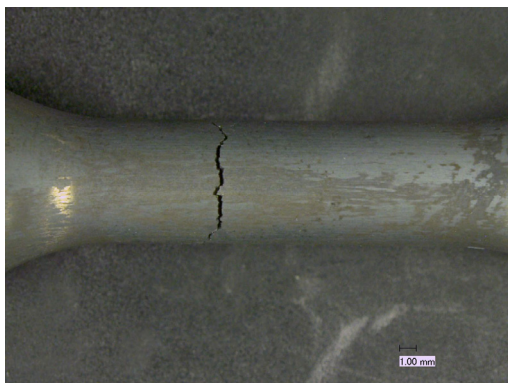
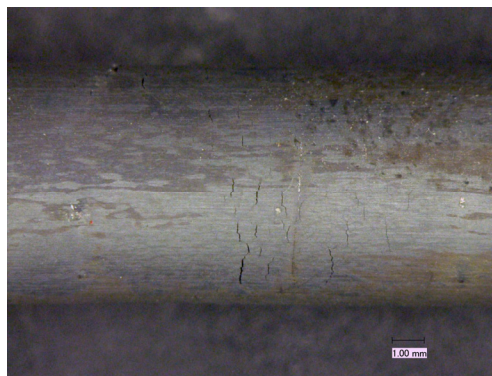
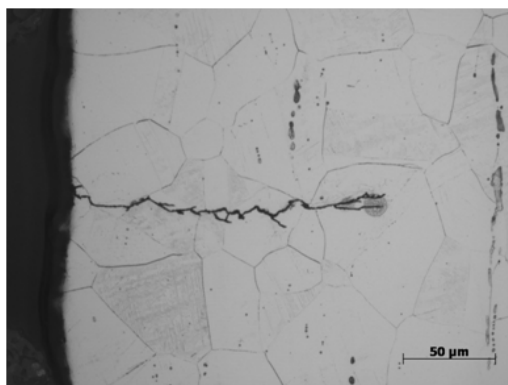
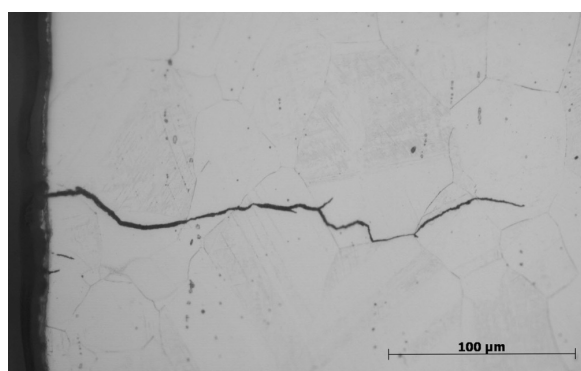
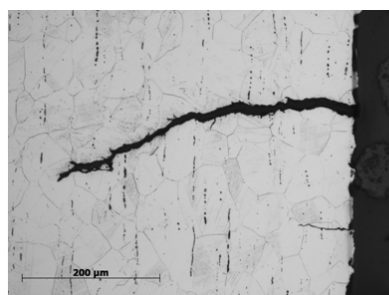
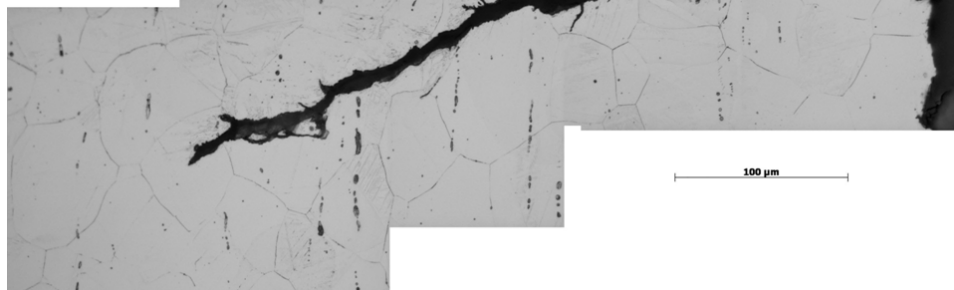
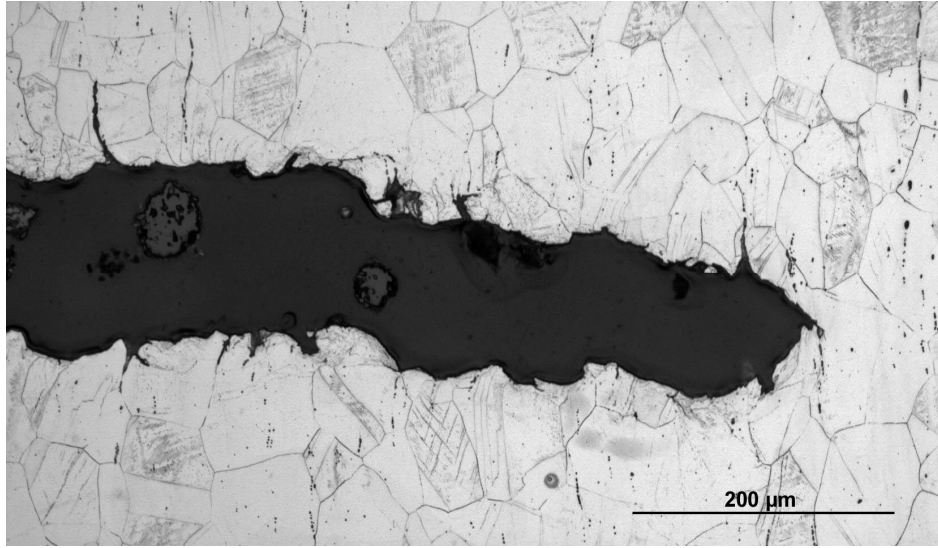
Figure 12. A 316 stainless steel fatigue specimen after testing at 600°C and a 1% total strain. A large crack as well as multiple finer cracks and discoloration due to environmental damage are visible on the specimen surface (a) and (b). Longitudinal imaging reveals that the fine cracks are several grain diameters in depth and typical start transgranularly and propagate in a transgranular manner (c) and (d). The large macrocrack is shown in (e).

The 316 fatigue specimen cycled at 1% total strain and 600°C exhibited a single large macrocrack as well as finer cracking throughout the gage section, as shown in Figure 12(a) and (b). The specimen surface had a well adhered oxidation product. Optical microscopy of a face parallel to the stress axis and perpendicular through the largest macrocrack revealed multiple fine cracks that extended to a depth of several hundred microns into the specimen. These cracks, shown in Figure 12(c) and (d), were transgranular and appeared to have a thin oxide layer on the surface; extensive environmental damage was not observed in the cracks. The image of the large macrocrack in Figure 12(e) shows the thin oxide layer on the crack surface. The comparable 316 creep-fatigue specimen, tested at 600°C and 1% total

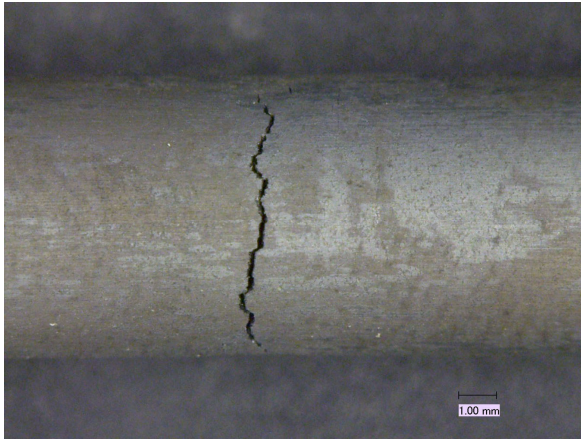
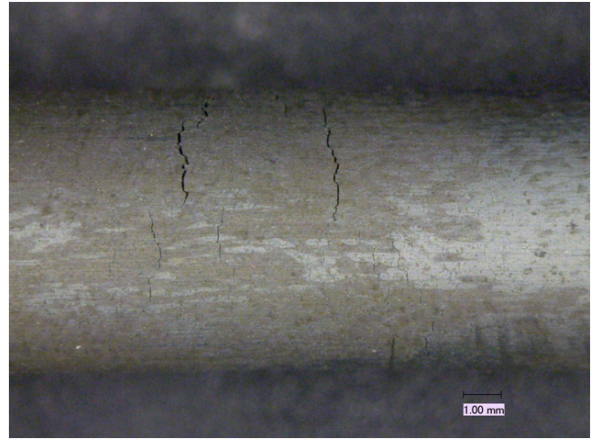
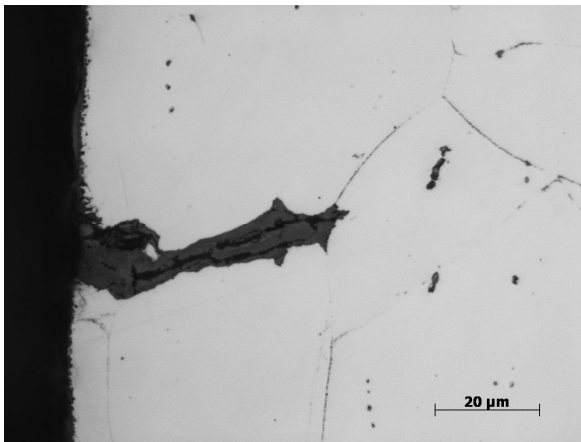
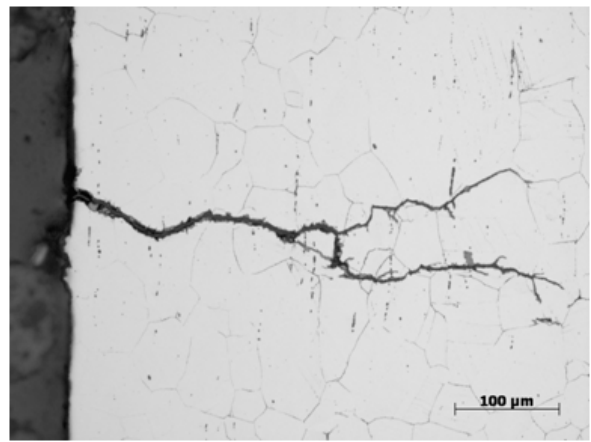
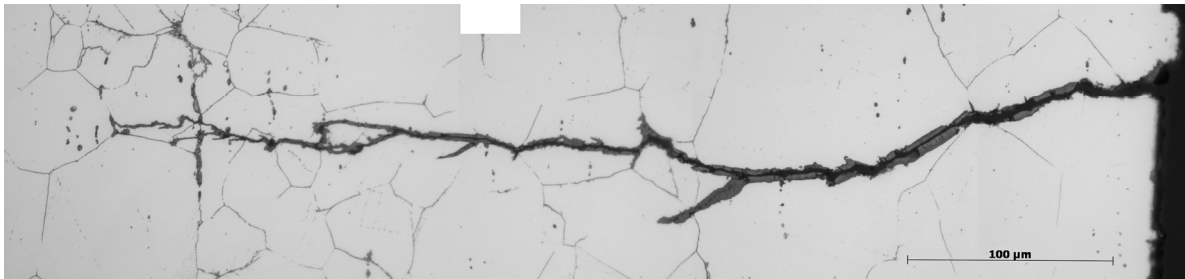
Figure 13. A 316 stainless steel creep-fatigue specimen after testing at 600°C, 1% total strain, and a 10 minute hold time at peak tensile strain. A large crack as well as multiple finer cracks and discoloration due to environmental damage are visible on the specimen surface (a) and (b). Longitudinal images reveal that the fine cracks are many grain diameters in depth and typical start intergranularly and propagate in a transgranular manner (c) and (d) and (e).

strain range and a 10 minute hold at peak tensile strain, is shown in Figure 13. From the specimen surface, the failed 316 stainless steel creep-fatigue specimen appears similar to the fatigue specimen. However, the cracking in the creep-fatigue specimen appears to initiate intergranularly and significantly more oxidation is present along the crack surface, visible in Figure 13(c) and Figure 13(e), respectively. Crack propagation is in a predominately transgranular manner, although intergranular cracking is present, as evidenced in Figure 13(d) and (e). There was no evidence of creep cavitation on the grain boundaries in the bulk of the material. Comparison of the optical micrographs in Figure 12(c), (d), and (e) to Figure 13(c), (d), and (e) clearly shows that additional environmental damage has occurred during creep-fatigue cycling relative to the continuous cycle fatigue. The thicker oxide layer is consistent with the increased time at temperature, approximately 250 hours, experienced by the creep-fatigue specimen.

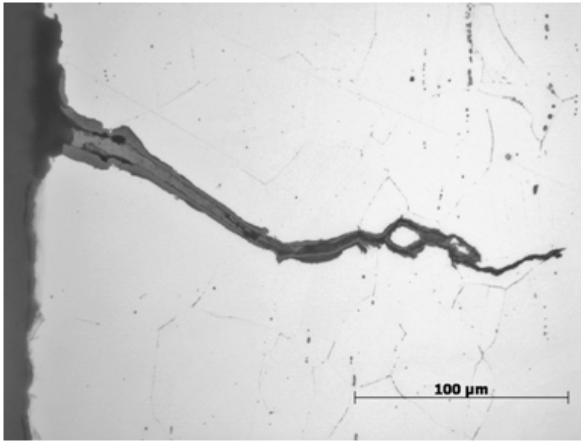
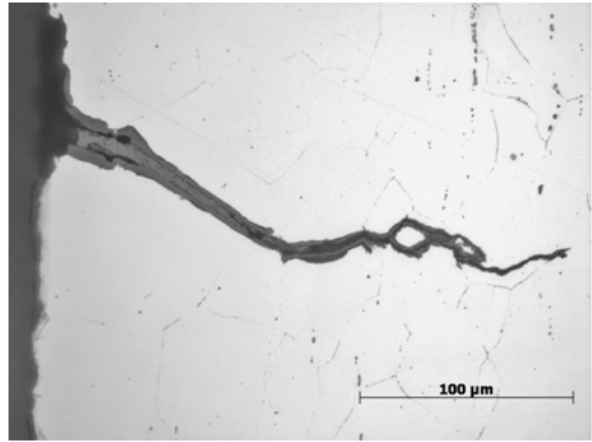
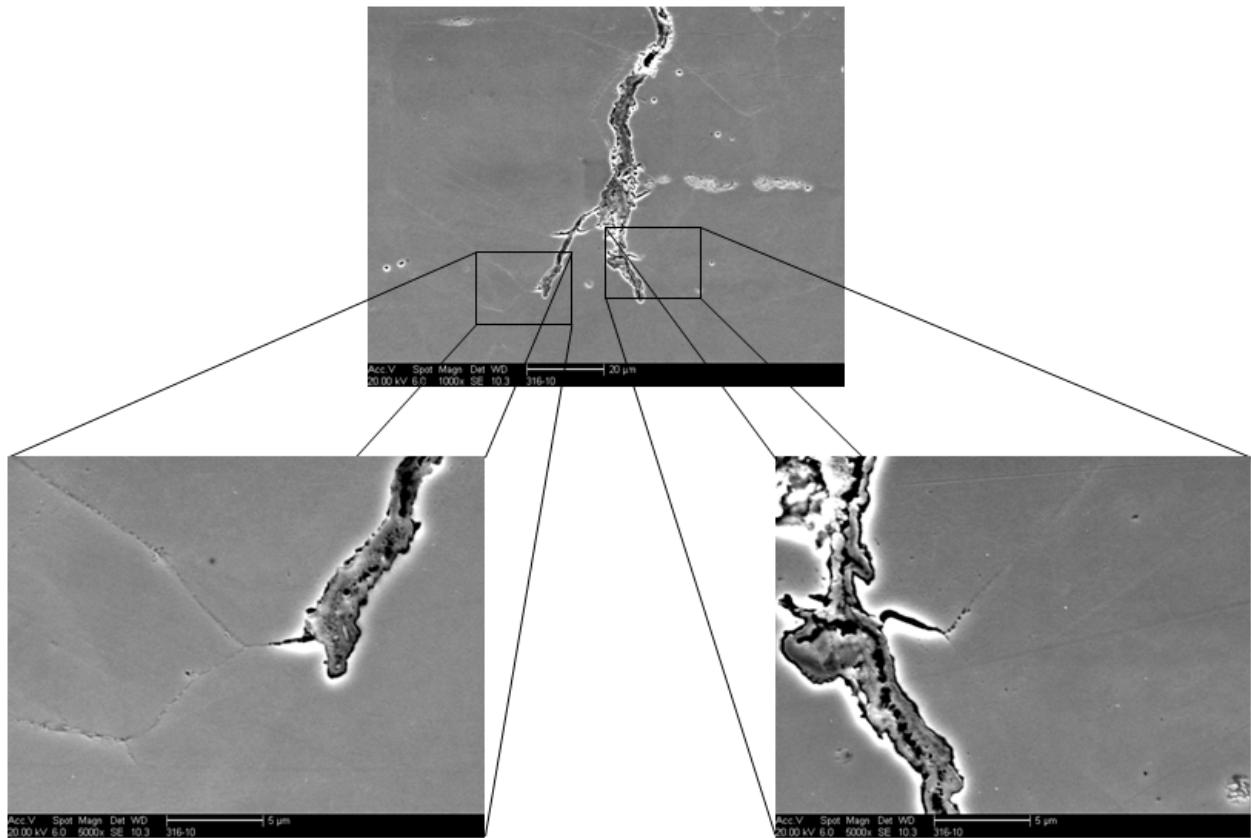
Figure 14. A 316 stainless steel fatigue specimen after testing at 650°C and a 1% total strain. Longitudinal images reveal that the fine cracks are several grain diameters in depth and typical start intergranularly and propagate in a predominately transgranular manner (a) and (b), despite the presence of small branches at intersecting grain boundaries. There is a significant amount of oxidation visible in the crack (c).

Significantly more oxide is also present in the fatigue and creep-fatigue specimens of 316 stainless steel tested at the higher temperature, 650°C. The cracks are filled with oxide and there is greater separation between the crack flanks, as shown for the fatigue specimen in Figure 14 and Figure 15 and the creep-fatigue specimen in Figure 16. The oxide-filled cracks extend several grain diameters in depth from the specimen surface. Branching is observed along the cracks and is particularly common at intersecting grain boundaries, as shown in Figure 14(b) and (c), although the crack continues to propagate in a transgranular manner despite the branching at oxidized grain boundaries. SEM images in Figure 15 reveal a higher magnification view of the oxide/s present in the crack. The cracks appear to contain at least two types of oxide. The oxide (labeled 1) nearest to the base metal extends along the outer surface of the crack and is rich in both Cr and Fe but also contains a significant amount of Ni. A more porous oxide (labeled 2) is present in the inner region of the crack and appears to be sandwiched between the outer oxide layers. The inner oxide is Fe-rich with relatively low amounts of both Cr and Ni. A small amount of Mn is present in both oxides, but little Si or Mo is present.

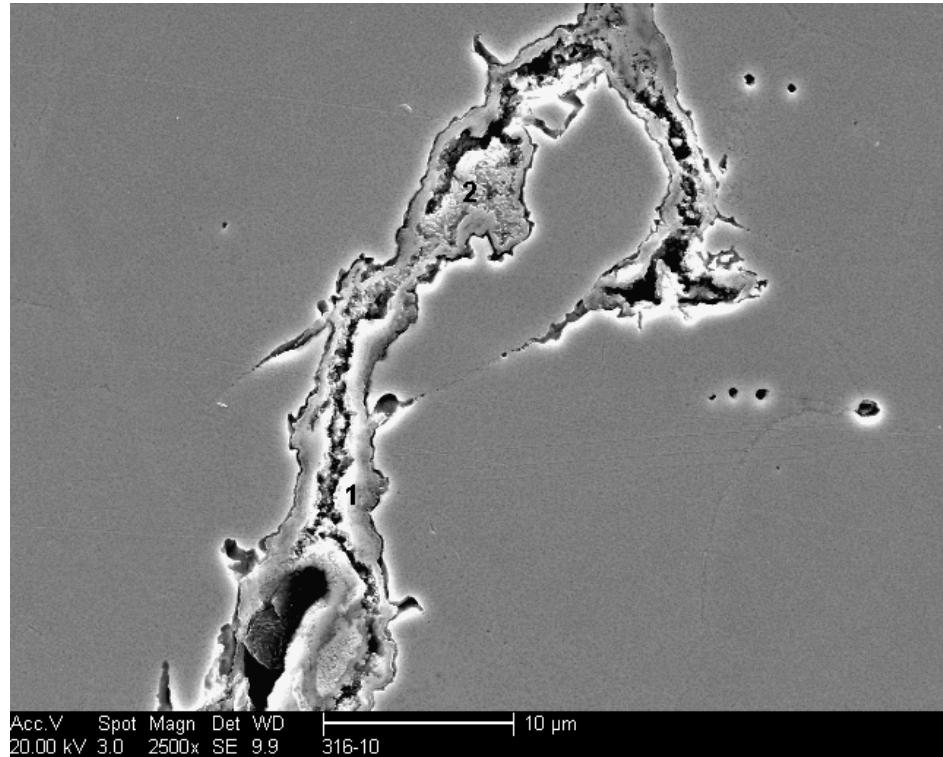
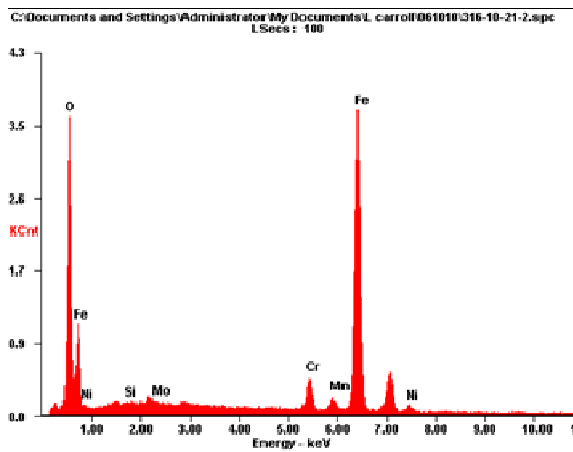
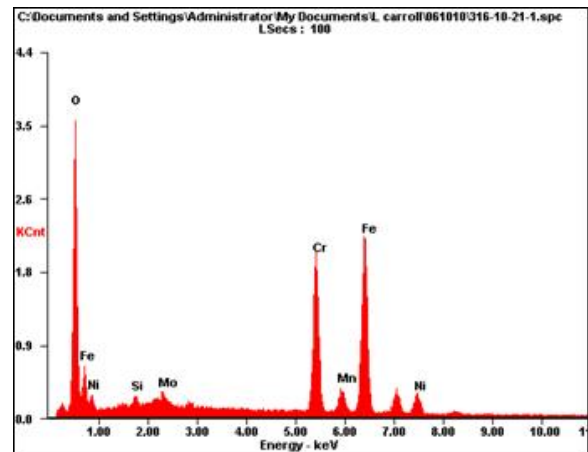
Figure 15. Oxide in the crack of a 316 stainless steel fatigue specimen after testing at 650°C and a 1% total strain. The number “1” and “2” in (a) correspond to the EDS spectra in (b) and (c), respectively.

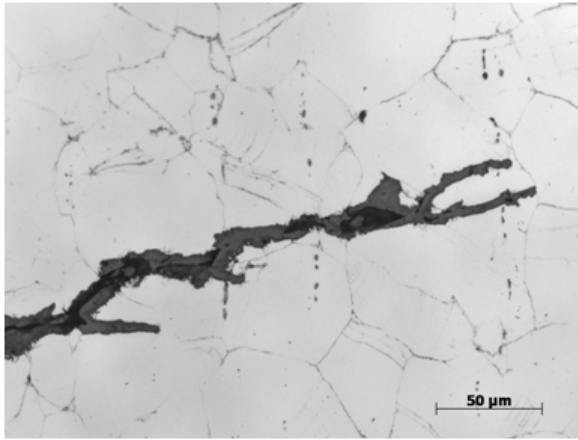
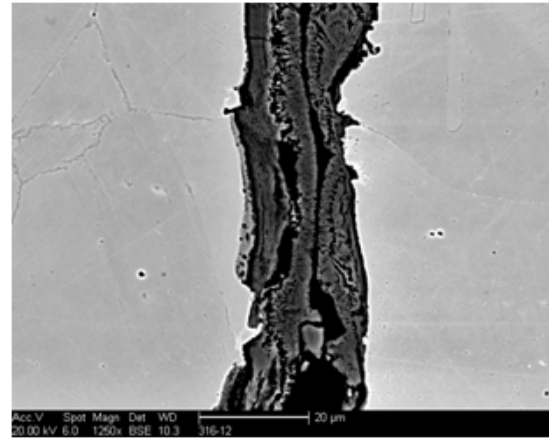
Figure 16. A 316 stainless steel creep-fatigue specimen after testing at 650°C, 1% total strain, and a 10 minute hold. Longitudinal images reveal that the fine cracks extend several grain diameters in depth from the specimen surface and typical start intergranularly and propagate in a predominately transgranular manner (a) and (b), despite the presence of small branches at intersecting grain boundaries. There is a significant amount of oxide visible in the crack (c).

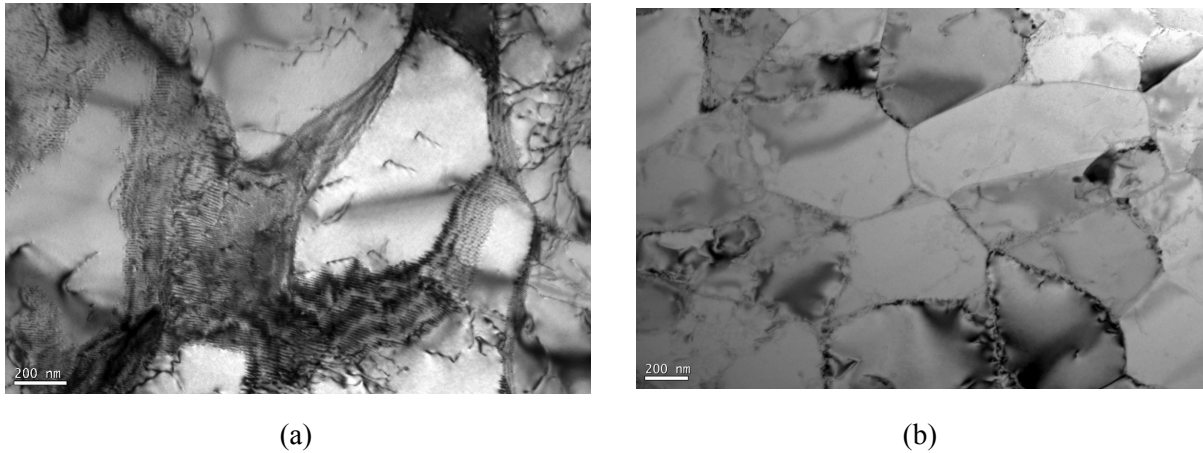
Figure 18. TEM bright field micrographs of 316 stainless steel after creep-fatigue testing showing the dislocation arrangements and cellular pattern (a) and the fine equiaxed substructure (b) which emerges.

TEM observations from the gage section of a 316 creep-fatigue specimen tested at 650°C with a 1.0% total strain range and 5 minute tensile hold. TEM micrographs in Figure 18 clearly show the formation of an equiaxed cellular dislocation structure. These dislocation microstructures consist of cell walls with large dislocation densities and cell interiors which are relatively free of dislocations. Furthermore, the cell interiors in these substructures contain a very low density of second phase particles. There is also evidence that the dislocation substructure has partly annealed during creep-fatigue testing due to the climb of dislocations and their subsequent rearrangement. Figure 18(a) shows possible rearrangement of dislocations in the cell walls into more orderly structures. These boundaries contrast the relatively narrow walls shown in the structure in Figure 18(b). In areas of the specimen which did not contain a defined cellular structure, a high density of dislocation tangles are present within the grains, as shown in Figure 19. Also shown are second phase particles along the grain boundary. The morphology of these particles indicates that they are most likely carbides of the M_{23}C_6 variety.

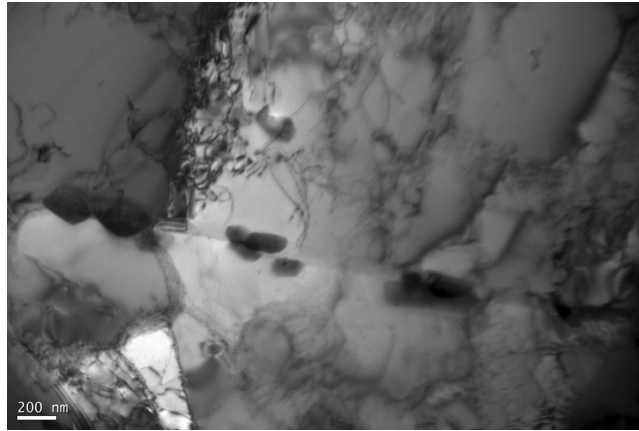
Figure 19. A 316 creep-fatigue specimen showing grain boundary carbides, likely $M_{23}C_6$, and dislocation tangles within the grains.

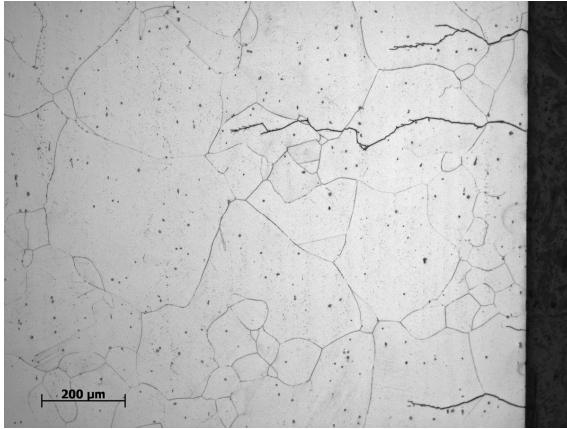
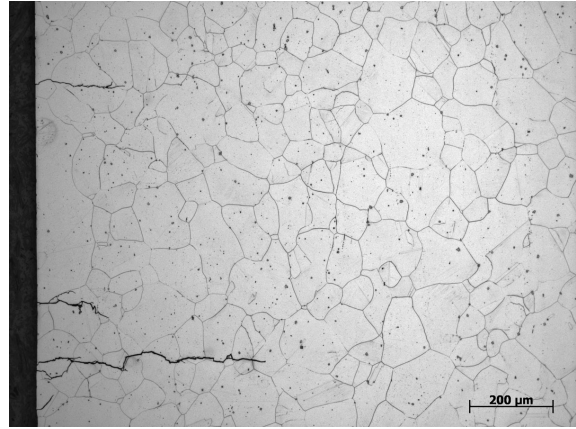
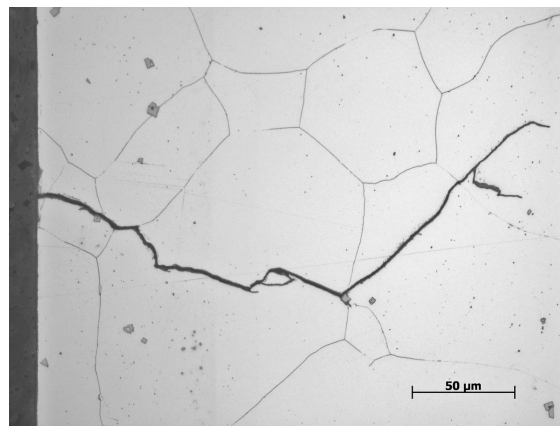
Figure 20. Optical micrographs of a HT-UPS specimen after fatigue deformation at 600°C and 1% total strain.

The HT-UPS specimen cycled in fatigue at 600°C and a 1% total strain is shown in Figure 20. Fine cracks are observed along the outer specimen surface initiating and propagating in a transgranular manner. There is no oxide layer visible in the optical micrographs. The addition of a 10 minute hold time results in a visible fine oxide layer along the crack surfaces. The secondary cracking is observed to initiate both intergranularly and transgranularly, and then propagates in a transgranular manner, as shown in detail in Figure 21. Similar crack propagation behavior was observed for fatigue and creep-fatigue of the HT-UPS alloy at 650°C, shown in Figure 22 through Figure 25. Continuous cycling resulted in cracking initiating at the surface within a grain and creep-fatigue cycling resulted in cracking often initiating intergranularly, illustrated in Figure 22 and Figure 24. In both cases, crack propagation was transgranular.

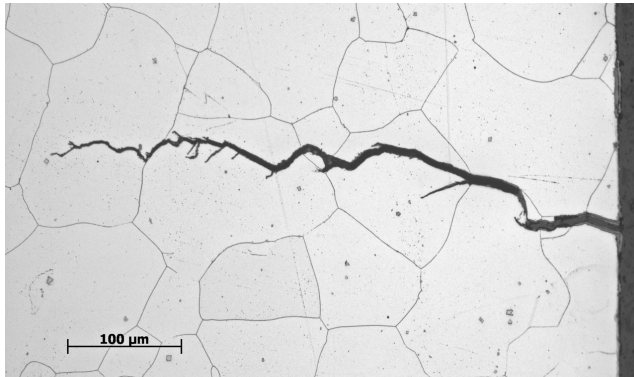
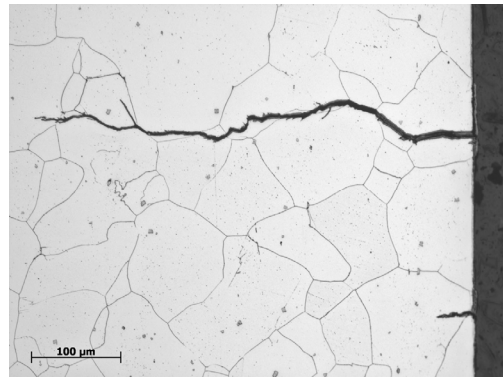
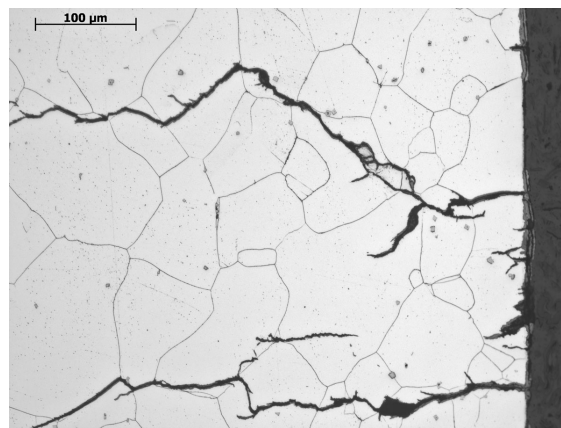
Figure 21. Optical micrographs of a HT-UPS specimen after creep-fatigue deformation at 600°C, 10 minute hold, and a 1% total strain. Cracks are observed to initiate both intergranularly (a) and transgranularly (b). Crack paths are independent of grain boundaries, propagating in a transgranular manner.

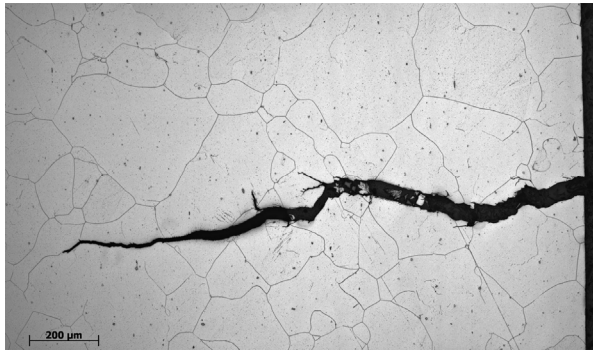
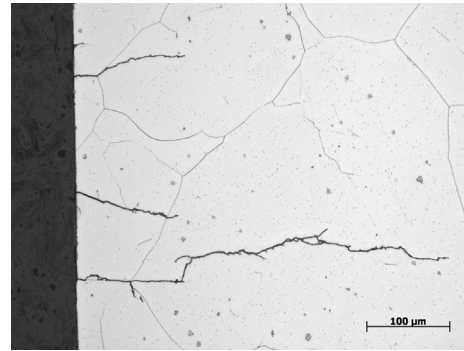
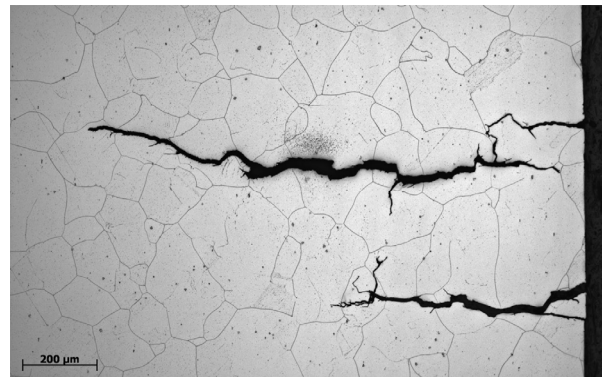
Figure 22. Optical micrographs of a HT-UPS specimen after fatigue deformation at 650°C and a 1% total strain. Cracks are observed to initiate and propagate transgranularly.

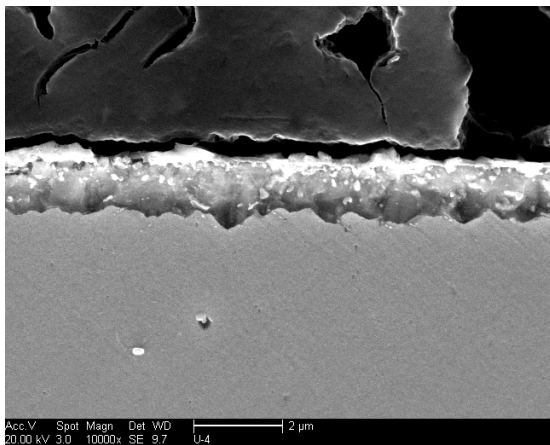
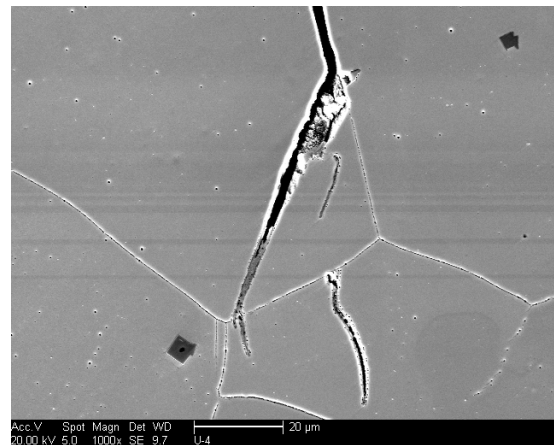
Figure 23. SEM micrographs of a HT-UPS specimen after fatigue deformation at 650°C and a 1% total strain. The surface oxide is shown in (a) and an oxide-filled tip of a secondary crack is shown in (b).

The surface oxide and oxide formed along the crack surfaces are shown in SEM images for both the continuous cycle fatigue and the creep-fatigue test with a 10 minute hold in Figure 23 and 25, respectively. The surface oxide is approximately 1 micron in thickness for the fatigue specimen and 2 microns in thickness for the creep-fatigue specimen. A fine second phase has appeared to precipitate in the case of the creep-fatigue specimen, although this phase is too fine to analyze with the SEM. A small amount of oxide is observed in the cracks of the fatigued specimen and, not surprisingly, a thicker oxide is present in the cracks of the 10 minute hold creep-fatigue specimen. The oxide consists of two types, which are indicated by number in Figure 25(b). Similar to the 316 stainless steel, the oxides filling the cracks in the HT-UPS steel are an Fe-rich oxide that is sandwiched between a Fe-Cr rich oxide. Figure 25(c) clearly shows the oxide-filled crack having propagated initially along the grain boundary and then diverging from the boundary several hundred micron below the specimen surface. Also evident in the HT-UPS creep-fatigue specimen is the presence of small precipitates along the grain boundaries. Again, these precipitates are too small to analyze using SEM techniques.

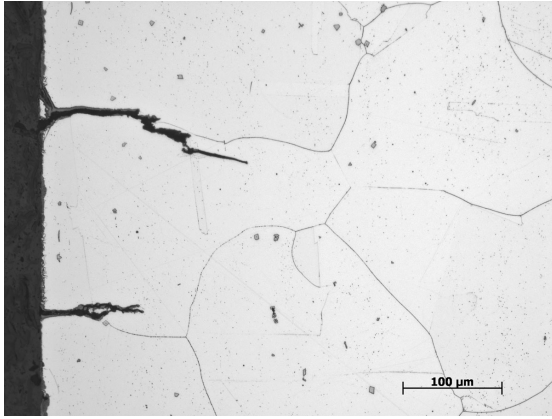
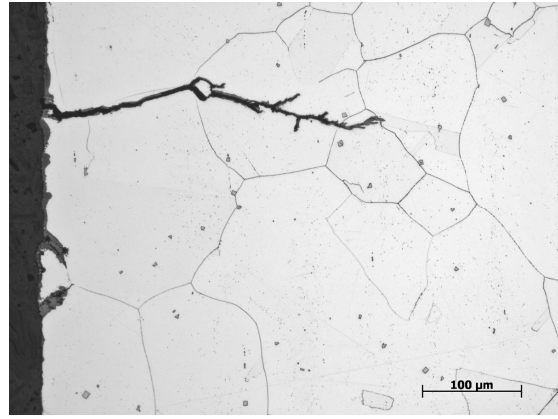
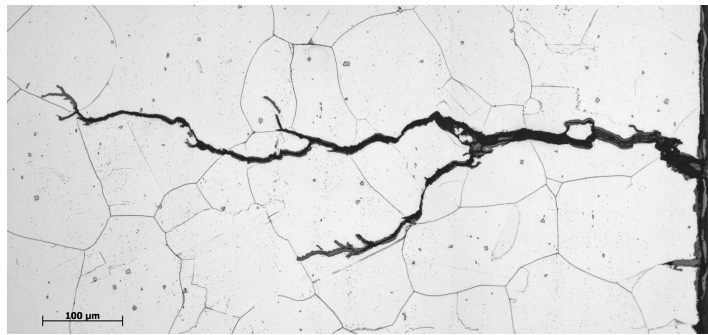
Figure 24. Optical micrographs of a HT-UPS specimen after fatigue deformation at 650°C, 10 min hold, and a 1% total strain. Cracks are observed to initiate intergranularly and propagate in a transgranular manner.

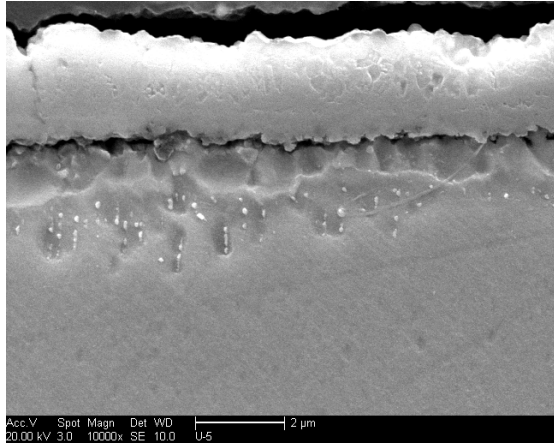
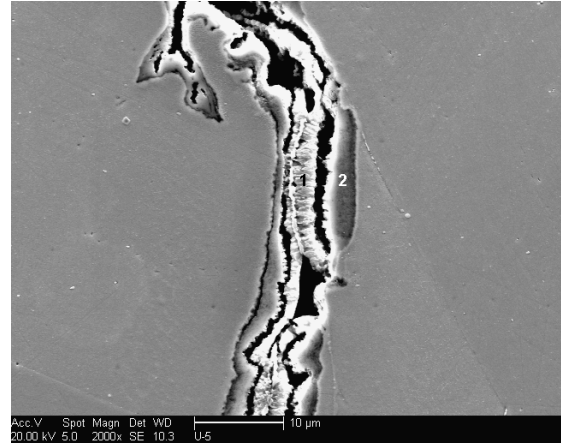
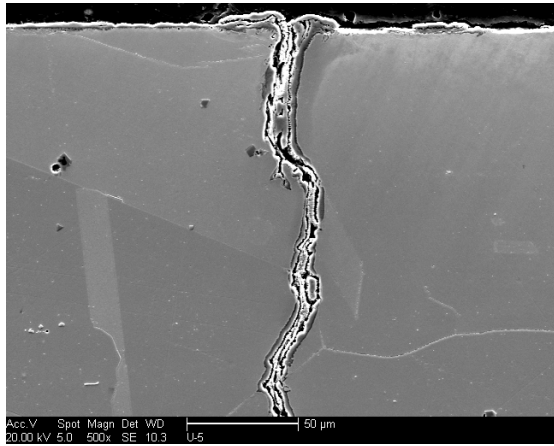
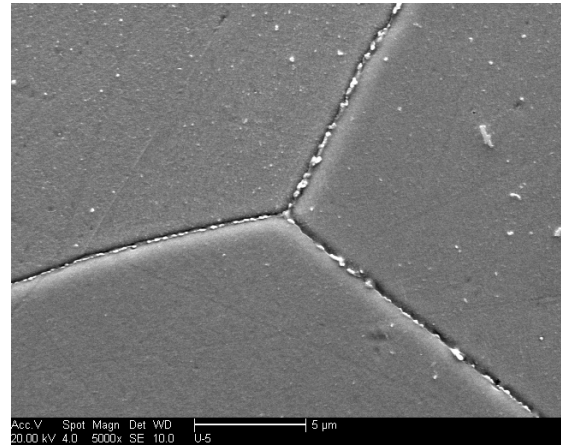
Figure 25. SEM micrographs of a HT-UPS specimen after fatigue deformation at 650°C, 10 min hold, and a 1% total strain. An oxide that has formed on the specimen surface is shown in (a) and oxide-filled cracks are shown in (b) and (c). Fine precipitates are present on the grain boundaries (d).

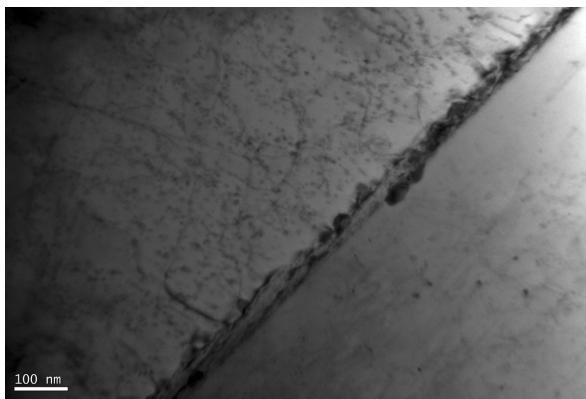
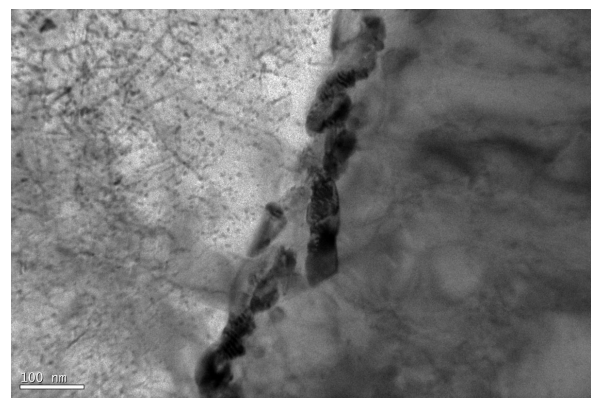
Figure 26. TEM micrographs of second phase particles, likely $M_{23}C_6$ carbides, which have precipitated on grain boundaries in the post creep-fatigue HT-UPS material.

TEM observation of the creep-fatigue specimen tested at 650°C, 1% total strain range, and 1 minute tensile hold time. Similar to the 316 stainless steel, precipitation of larger M_{23}C_6 carbides on the grain boundaries is observed in the HT-UPS material, as shown in Figure 26. However, a number of
