Creep-Fatigue of Advanced Austenitic Alloys

Laura Carroll
Julian Benz
Richard Wright

August 2010

**Idaho National Laboratory
Idaho Falls, Idaho 83415**

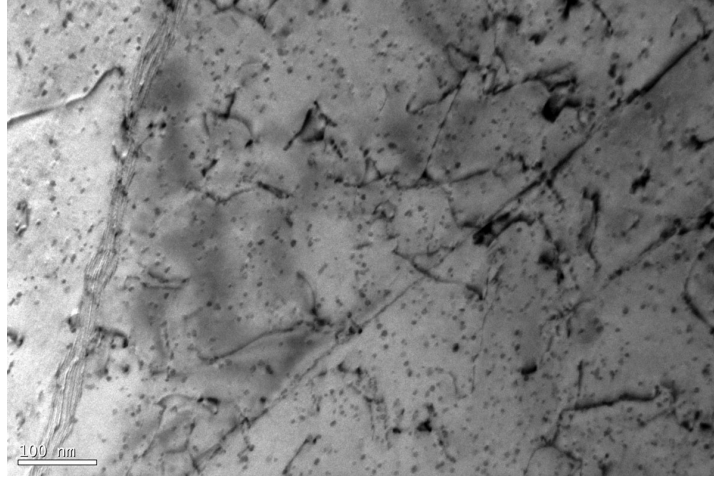
Figure 27. TEM micrograph of HT-UPS stainless steel showing nanometer sized MC carbides within the grains after creep-fatigue testing.

microstructural observations in this material contrast those in 316 stainless steel. The first difference is the presence of a relatively high density of (Nb,Ti,V)C which have precipitated within the grains during deformation, shown in Figure 27. This is an expected observation as the alloy contains additions of Nb, Ti, and V to form nanometer-sized particles to pin dislocations during plastic deformation. The micrographs shown in Figure 28 clearly illustrate the pinning of dislocations by second phase particles during high temperature deformation. A second difference between the two steels likely results from this dispersion of MC carbides in the HT-UPS material. In 316 stainless steel, there are less obstacles to dislocation motion and therefore the dislocations are more mobile and able to arrange themselves into orderly low energy configurations due to the lack of fine second phase intragranular particles. In the HT-UPS material, however, at these conditions a cellular substructure within the grains is not formed likely due to the lack of dislocation mobility.

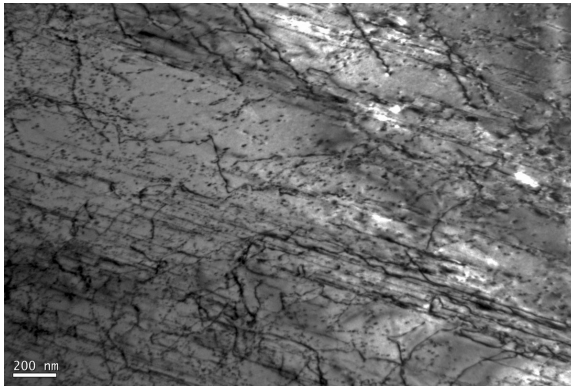
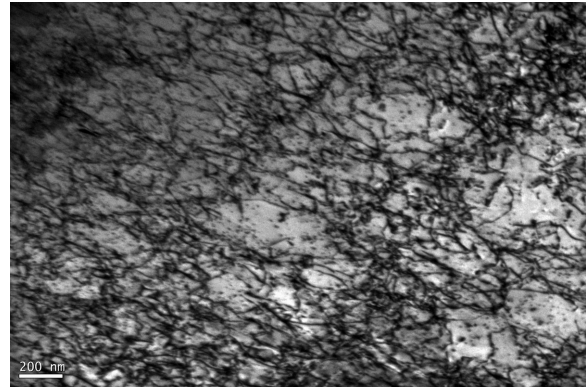
Figure 28. Dislocations pinned within the grains by the large percentage of MC carbides in HT-UPS material.
