Behavior of Concrete Panels Reinforced with Synthetic Fibers, Mild Steel, and GFRP Composites Subjected to Blasts

Structures 2012 Congress

March 2012

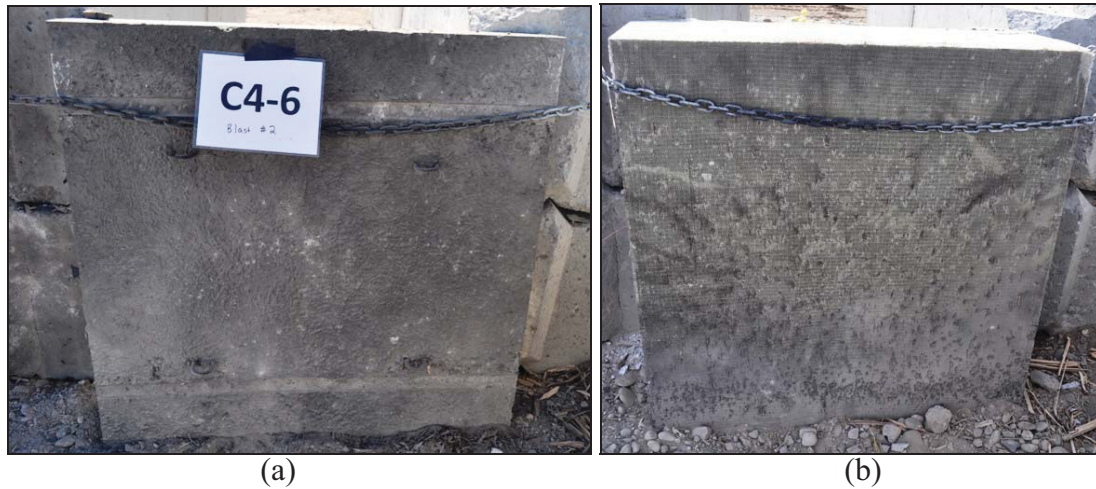
Figure 4. Immediate Occupancy (IO) performance level: (a) front of panel C4-6 after second blast; (b) front of panel E4-14 after blast.

The damage in this category is such that it could be possible to resume normal activities in a structure with the characteristics of the panels described and the charge used for the respective blast. The structure should retain its pre-blast strength and stiffness. The immediate occupancy (IO) performance category was met by Type C panels (C4-6, C4-10, C4-14) and panel E4-14. Panel Type C was designed to determine the effects of using the macro-synthetic fibers in addition to traditional steel rebar as reinforcement. Panel C4-6 experienced minimal damage with a largest measured crack width in the panel of 1 mm. Since the panel was not visibly damaged, it was tested a second time. The panel again experienced minimal damage as shown in Fig. 4(a). The largest measured crack width after the second blast was only 2mm with few new cracks. Panels C4-10 and C4-14 behaved similar to C4-6 with even smaller crack widths as shown in Table 3. Thus, thicker panels are shown to absorb a blast more efficiently.

Panel E4-14 had two GFRP laminate layers on each side of the panel. Due to the considerable thickness of 356 mm, Panel E4-14 had very few signs of damage. The front face GFRP laminate sustained no visible damage and did not debond from the concrete, as shown in Fig. 4(b). The back face GFRP overlay debonded from the concrete surface except in a few locations. The only sign of cracking was on the side of the panel where a crack was visible starting from the back face and progressively closed as the crack propagated to the front face of the panel. The maximum measured
