Twelve Year Study of Underground Corrosion of Activated Metals

NACE International Corrosion Conference and Expo 2012

M. Kay Adler Flitton
Timothy S. Yoder

March 2012

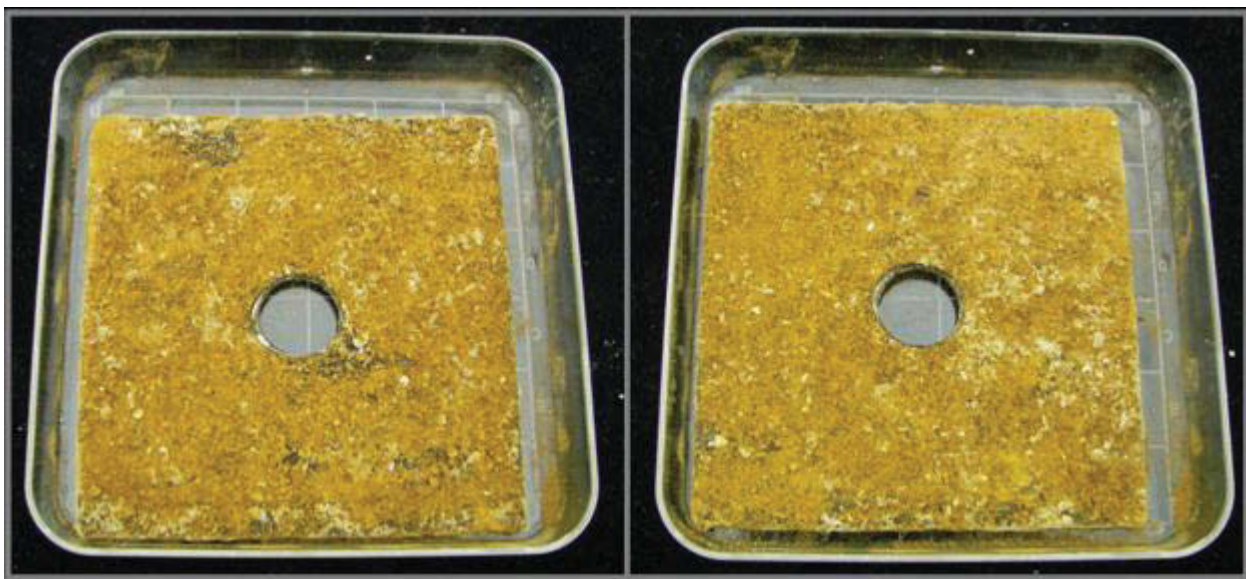
Figure 3: Carbon steel coupon before cleaning (front and back views).

Pitting was evident in the aluminum, beryllium, and carbon steel coupons. Figures 3 and 4 are photographs of one carbon steel coupon, before and after cleaning (from the 10-ft (3.05-m)). Likewise, Figures 5 and 6 are photographs of beryllium coupons before and after cleaning (from the 10-ft (3.05-m)). Figures 7 and 8 are photographs of aluminum coupons before and after cleaning (from the 4-ft (1.22 m) depth. Table 4 details the pit depth measurements from 16 coupons with visibly deep-pitted surfaces. Aluminum exposed for one year showed no evidence of pitting and was not measured.

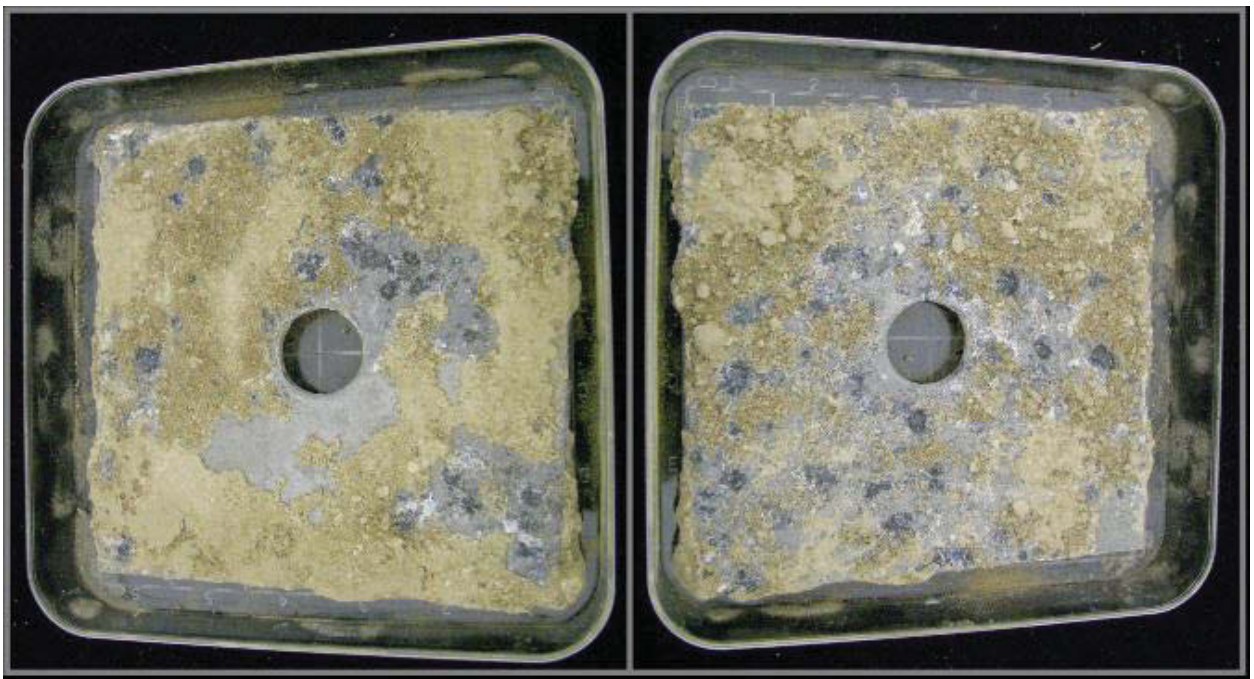
Figure 5: Beryllium coupon before cleaning (front and back views).

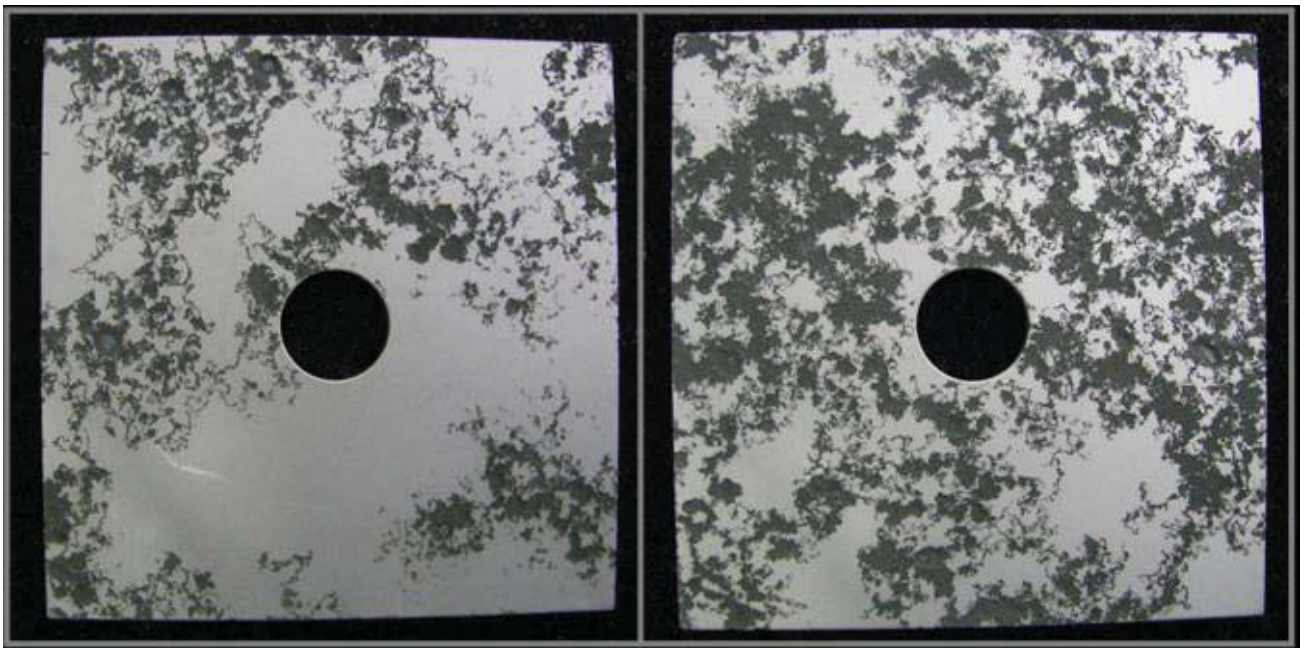
Figure 6: Beryllium coupon after cleaning (front and back views).
