Pre-Irradiation Testing and Analysis to Support the LWRS Hybrid SiC- CMC-Zircaloy-4 Unfueled Rodlet Irradiation

Isabella J. van Rooyen

September 2012

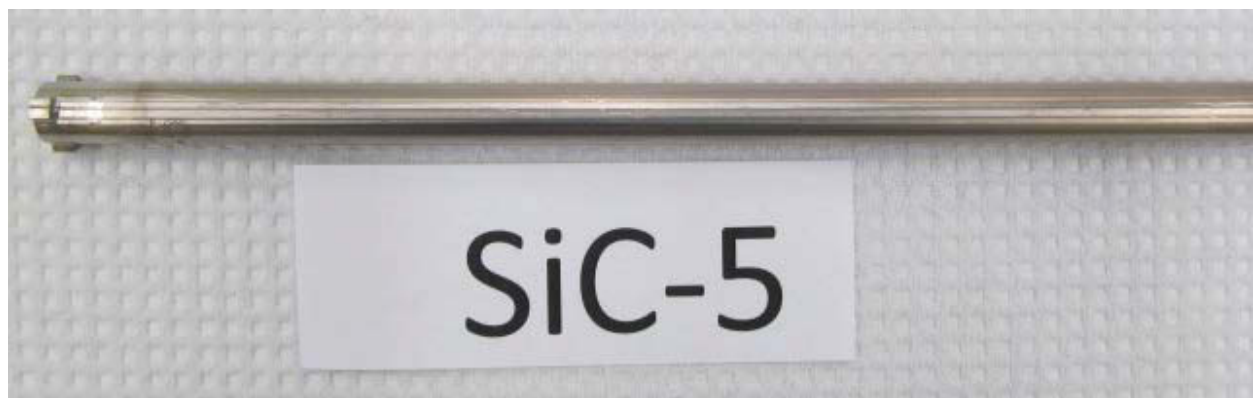
Figure 55. No significant corrosion or discoloration is noted on the Zr-4 mock up sample at the end of the 10 day HWFC test.
