Corrosion Evaluation of RERTR Uranium Molybdenum Fuel

A. K. Wertsching

September 2012

**Idaho National Laboratory
RERTR
Idaho Falls, Idaho 83415**

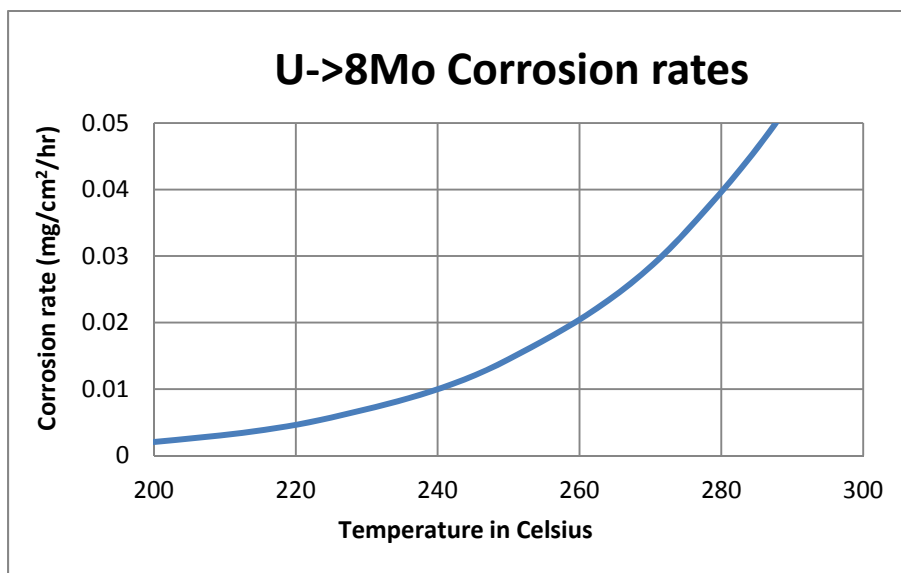
The corrosion rate for UMo alloys under hydrothermal conditions before discontinuous failure is well established. Hilton at Argonne National Laboratory (ANL) compiled a report of corrosion data from a variety of metallic reactor fuels [2]. The corrosion rates of U-Mo alloys with greater than 8 weight percent molybdenum were interpolated to provide rough estimates of corrosion at higher temperatures. The temperature dependence of the U->8 wt%Mo/H₂O reaction rate was calculated as follows: $k_f = 1.58 \times 10^6 \exp[(-80.5 \pm 10.6 \text{ kJ/mol})/RT]$ mg metal/cm²/hr at 302-440°C (Figure 1, with Gas Constant R = 0.008314 kJ/mol K, and T is in Kelvin) [2].

Figure 1. Corrosion rate as a function of temperature based on relationship established by ANL report.

The rate is only valid to the point of discontinuous failure and to actual burnups of 2.9×10^{20} fissions/cc for clad U-10Mo and 1.17×10^{20} fissions/cc for bare U-10Mo. This assumes that the observations of no change in corrosion rate up to those burnups by Westinghouse apply to Hilton's interpolation [2,3]. By extending the interpolation below 304°C, to 250°C, a conservative maximum corrosion rate for U-10Mo would be 0.015mg/cm²/hr, which is greater than Westinghouse observed at this lower 250°C temperature range [13]. Therefore, during a typical ATR 56 day run (1344 hours) at a center-line temperature of 250°C with a 0.01 cm² exposed fuel surface area via a cladding defect, and ignoring all other factors (such as cladding), the expected mass loss is approximately 0.2 mg of metal. If a blister with a pinhole formed with an area of 1 cm², then the loss would be approximately 20 mg. This corrosion rate does not take into account the possible reduction in rate due to the protective effects of either cladding or galvanic interactions (see Section 5) and represents a worst-case scenario. It also assumes that the fuel does not heat above 250°C center-line temperature due to inadequate cooling from thick oxide formation on cladding or reduced coolant flow (see Section 5). The fuel swelling encountered at high burnup is below 100%, but by using this value, a four-fold increase in surface area would occur over uniform expansion. Although pore size tends to increase at the fuel interface, an overall increase of surface area of four times provides a simple accounting of dimensional changes due to swelling and a potential range of corrosion loss at high burnups. Only in the case of increasing interconnected (open) porosity does corrosion increase dramatically in metallic uranium fuels, as was the case for high-burnup EBR-II fuels [14,15]. However, at this point, increased interconnected porosity has not been observed for this RERTR configuration at high burnups and is not expected to be a factor.

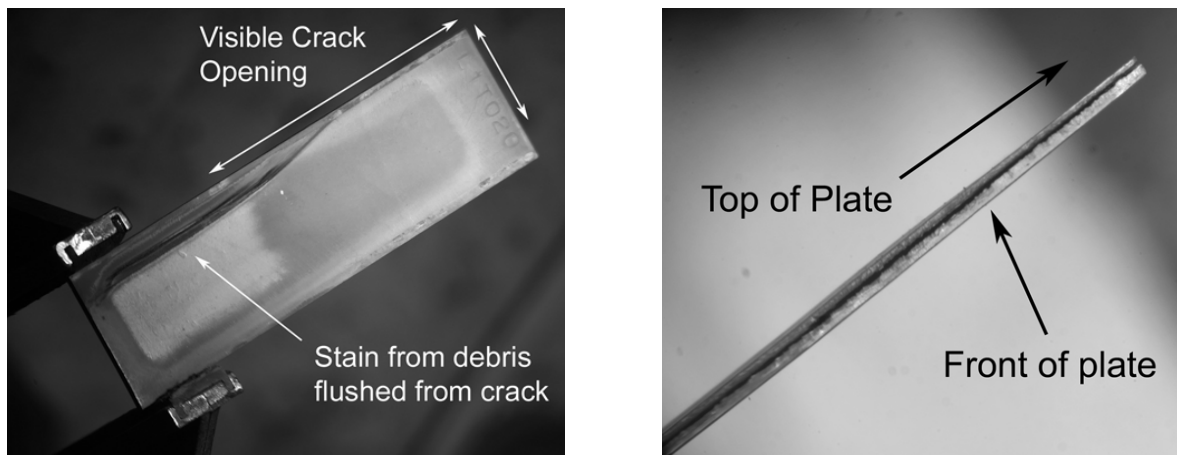
In a previous design (RERTR-7A), which did not include the zirconium diffusion barrier, post irradiation examination revealed that a crack developed along the top and side edge of the plate during an ATR irradiation experiment [25]. The crack formed from a combination of pressure from fuel swelling and silicon contamination in the weld. This split along the weld line allowed water flowing at 10 to 12 m/s from above to interact with the U-10Mo fuel (see Figure 2).

Figure 2. Damaged RERTR-7A Mini-plate.

Since water flowed from above upon the mini-plate crack, more than half of the fuel material was eroded away. The evidence for erosion is a black stain (debris) found on the aluminum cladding evident in the left photograph in Figure 2. The black stain suggests that the fuel was eroded and rapidly oxidized within the cladding. Uranium metal exposed to water vapor at $\sim 250^{\circ}\text{C}$ produces UO_2 as a fine powder [26]. After the dispersed uranium oxide exited the crack, turbulent flow slows as it approaches closer to the surface of the aluminum cladding, depositing a thin layer of black UO_2 . The starting point of the stain suggests that approximately $1/4$ of the fuel meat eroded away before conditions were sufficient to produce dispersed particles of uranium oxide. It appears that after $\sim 1/4$ of the fuel was lost, internal water current developed, with a slowing of overall flow for concurrent erosion and corrosion to occur. In Figure 2, white thick oxide can be seen on the bottom third of the aluminum cladding. Without the zirconium diffusion barrier, the interface between fuel and cladding was more susceptible to corrosion than was the fuel. Diffusion of fuel into the cladding creates less corrosion-resistant inter-metallic species within the interface and, as the interface corroded, heat conduction was reduced. This event increased both the

temperature of the cladding and the level of cladding-surface corrosion. The release of approximately 3.4 grams of fuel and fission product was seen radiologically in the coolant chemistry, and lead to premature termination of the ATR operating cycle. Once the failed mini-plate was identified, it was removed and examined. A cross-section of the plate reveals the oxidation of the interface and evidence of a water current eroding the fuel meat. Note that the oxidized interface was pulled away during the metallographic process see Figure 3. The fuel was at the end of its burnup cycle, with approximately 8×10^{21} fissions/cc for sections of the plate closest to the reactor core.

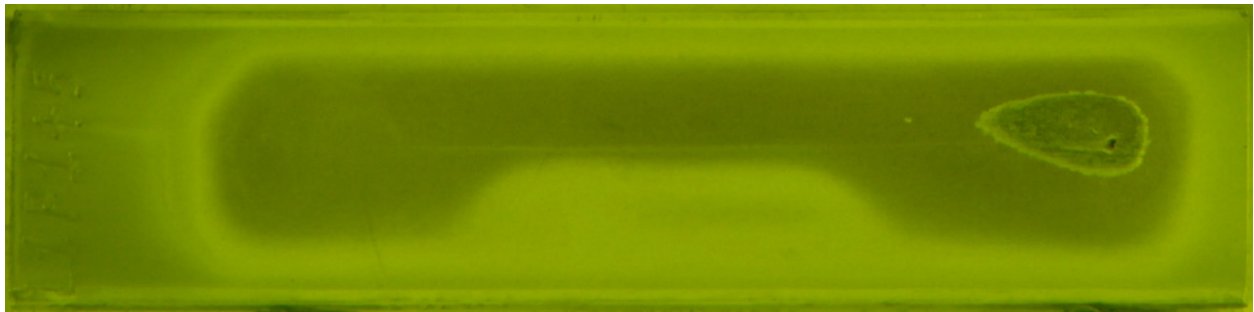
A second mini-plate failure occurred with the RERTR-10A fuel configuration with minor cladding adjustment, aluminum silicate layer as a diffusion barrier instead of zirconium. A blister formed early within the burn-cycle during startup [27]. This damage produced a minor radiological release in the form of fission gases and upon further examination damage was visually detected and the mini-plate removed for further inspection, see **Error! Reference source not found.** The location of the damage prevented gross erosion forces as seen in the previous failure to occur. A thickening of the surface oxide film on the cladding is evident as before.

Figure 4. RERTR-10A mini-plate blister failure.

A cross-sectional examination view of the mini-plate shows the extent of the damage, see Figure 4. Although the damage appears massive no significant loss of fuel meat occurred. Unfortunately the metallographic process can distort the final image of any cross-section as the oxide products are easily removed or lost. This example of damage is more typical of the ongoing issues associated with blistering from fuel and cladding separation. The fuel appears to be distorted due to increased heating from poor heat conduction to the cladding. Once cladding separates from the fuel the heat flow increases to the opposite, still bonded, cladding surface which in turn heats that cladding side producing increased cladding corrosion and a blister. RERTR-10A cladding corrosion damage produced a blister with pin-hole allowing water ingress. The fuel itself is distorted and some cracking may have occurred which can be a function of cold working. Fission gases tend to migrate to interfaces at high temperature and are

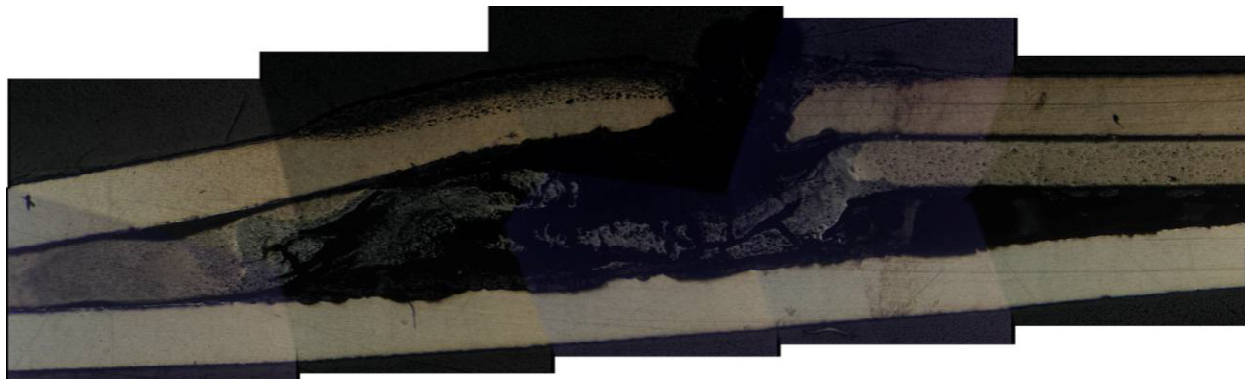
Figure 5. Cross-section of RERTR-10A blister damage.

indicators of penetrating cladding damage. However, release of fission gases alone without ancillary water soluble fission products indicates little corrosion occurred.

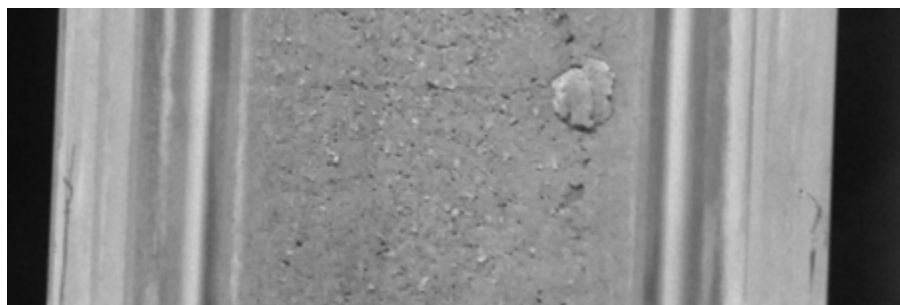
The AFIP-6 is larger than the mini-plate and has the current design configuration incorporating the zirconium diffusion barrier. The AFIP-6 plate has an overall dimension of 45.00×2.235 in. and failed by overheating due to excessive oxide formation on the cladding [28]. The oxide formed because of restricted water flow over the plate, which is not expected to be an issue for the final RERTR fuel design. As the cladding oxide thickened, blisters formed, producing penetrations through the cladding. This resulted in released fission gases that were detected in the ATR stack. The timeframe from initial fission-gas detection to reactor shutdown was over 7 days. Over that time, new blisters would form then release a new source of fission gases, see Figure 6. The reduction of heat transference over the entire length of the fuel plate produced temperature spikes beyond the maximum center-line temperature of $\sim 250^{\circ}\text{C}$ along certain sections of the plate. Calculated temperatures potentially reached as high as 550°C . Whether individual cladding failures along the plate reached these temperatures is uncertain. However, if they did, the conditions within the blister would produce steam. Bettis Plant testing of unclad U-10.5Mo samples under 400°C steam failed within 3 days [12]. Defected zirconium clad U-10.5Mo fuel survived undamaged for 24 days under steam. Again, no other water-soluble fission products were detected, indicating that throughout the 7 days, fuel corrosion was limited.

Figure 6. Thick cladding oxide layer with blister damage.
