# Advanced Test Reactor Complex Sewage Lagoon Evaluation

August 2013

J-U-B ENGINEERS, Inc.  
275 South 5<sup>th</sup> Ave, Suite 220  
Pocatello, ID 83201

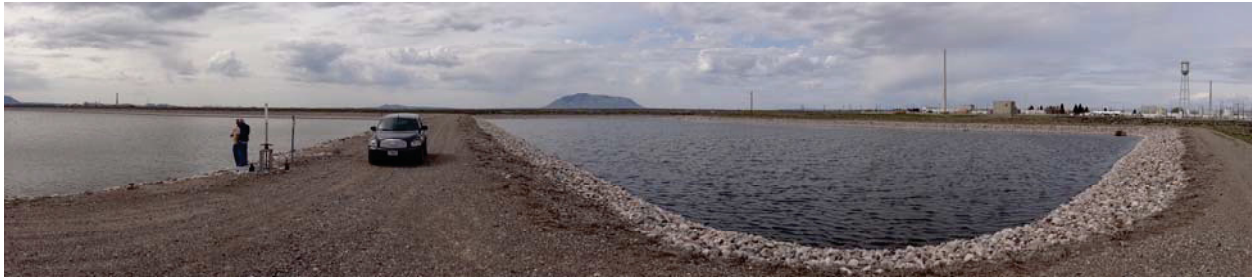
Figure 3-2. Photo of existing lagoons.

Figure 3-2 below is a photo of the lagoons with Cell #1 on the right and Cell #2 on the left.

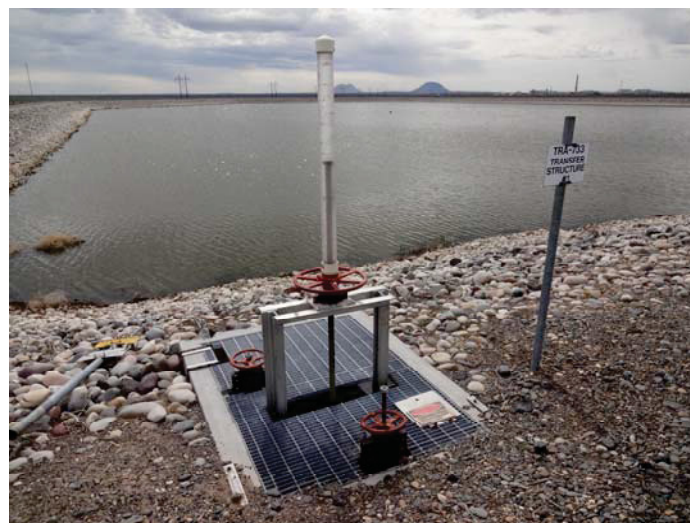
Figure 3-3. Photo of existing Transfer Structure #1.

Wastewater from the influent pump station normally enters the southwest corner of Cell #1 and flows out the northeast corner through an in-dike transfer structure into the adjacent Cell #2. This transfer structure consists of an overflow weir and does not allow the water level in Cell 1 to be lowered below 3 feet of water depth. The overflow weir is typically set to maintain an operating depth in Cell #1 of 7 to 7.5 feet, although occasionally it is lowered for operational and maintenance reasons. Figure 3-3 is a photo of Transfer Structure #1.

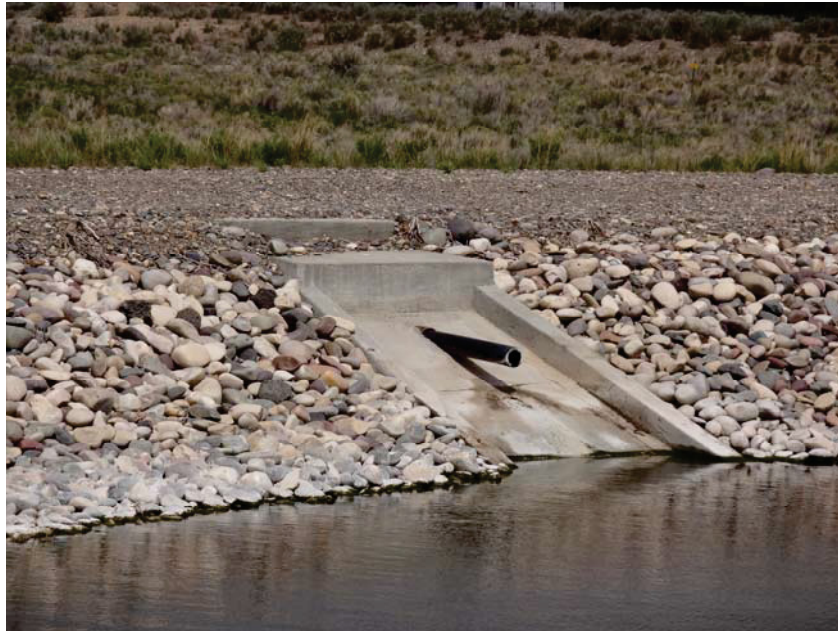
Figure 3-4. Photo of Cell #1 inlet splash pad.

Splash pads are provided at the Cell #1 and Cell #2 inlet. A second transfer structure is located in the southeast corner of Cell #2 to facilitate future expansion if needed. A line is provided which allows the flow from the influent pump station to be diverted directly to the southwest corner of Cell #2, thereby bypassing Cell #1. Figure 3-4 is a photo of the Cell #1 inlet splash pad.

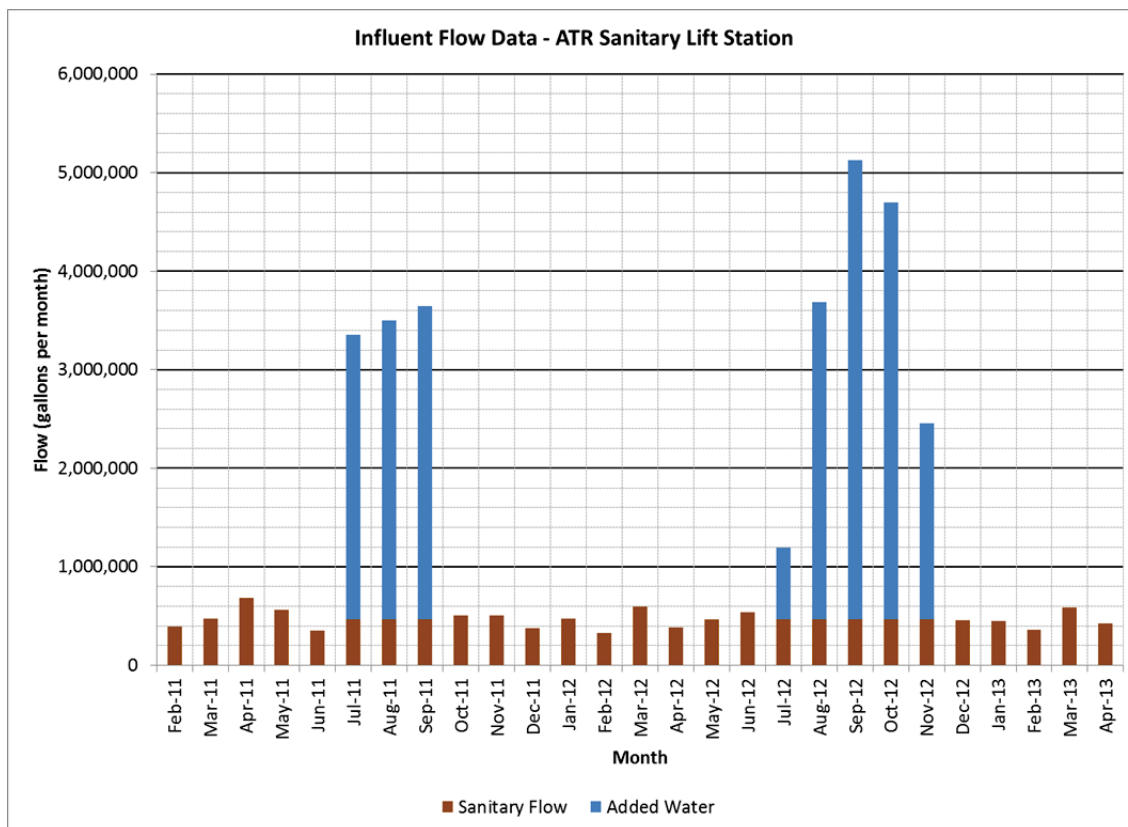
Figure 3-5. Influent flow data.

These data are graphically presented in Figure 3-5.

Based on the sanitary flow and the existing population, the average sanitary flow per worker based on a standard 8 hour workday is 34.5 gallons per worker-day. For comparison, according to Metcalf and Eddy's *Wastewater Engineering*, an "office" facility typically uses about 15 gallons per day per worker. BEA operators speculate that the higher flows at ATR may be a result of more frequent use of showers by the complex staff.

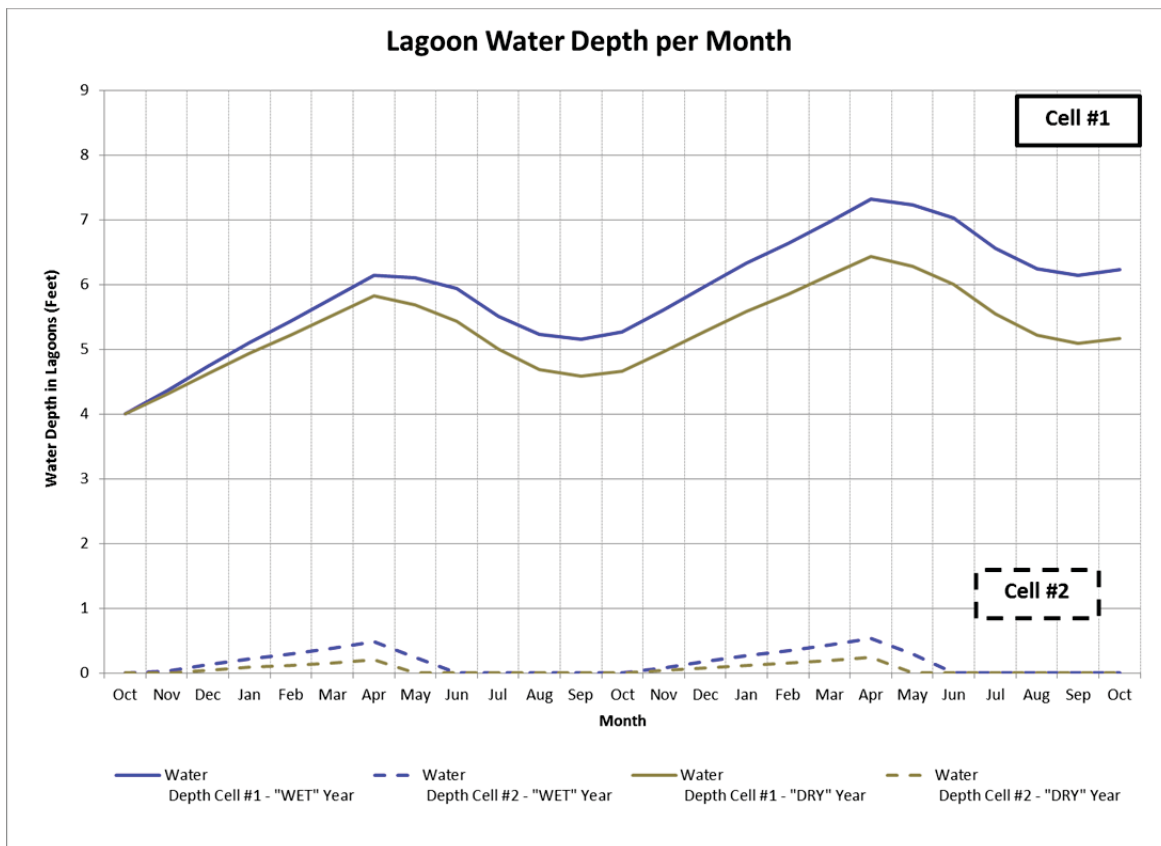
Figure 3-6. Water balance – existing conditions (with 4 foot initial Cell #1 depth).

The month-to-month water balance for Cell #1 and Cell #2 based on the model for existing "wet" and "dry" year conditions is shown in Figure 3-6 below for the two year water cycle period. In this figure, an initial water depth of 4 feet was assumed for Cell #1 and an empty depth for Cell #2.

In the above figure, the trendline of the water depth in Cell #1 is generally upward indicating that with the assumed seepage, evaporation, precipitation, and influent conditions, Cell #1 will fill over the course of multiple years until it overflows into Cell #2 during the spring and summer time periods until sufficient evaporation has occurred. This will occur even in “dry” year conditions.

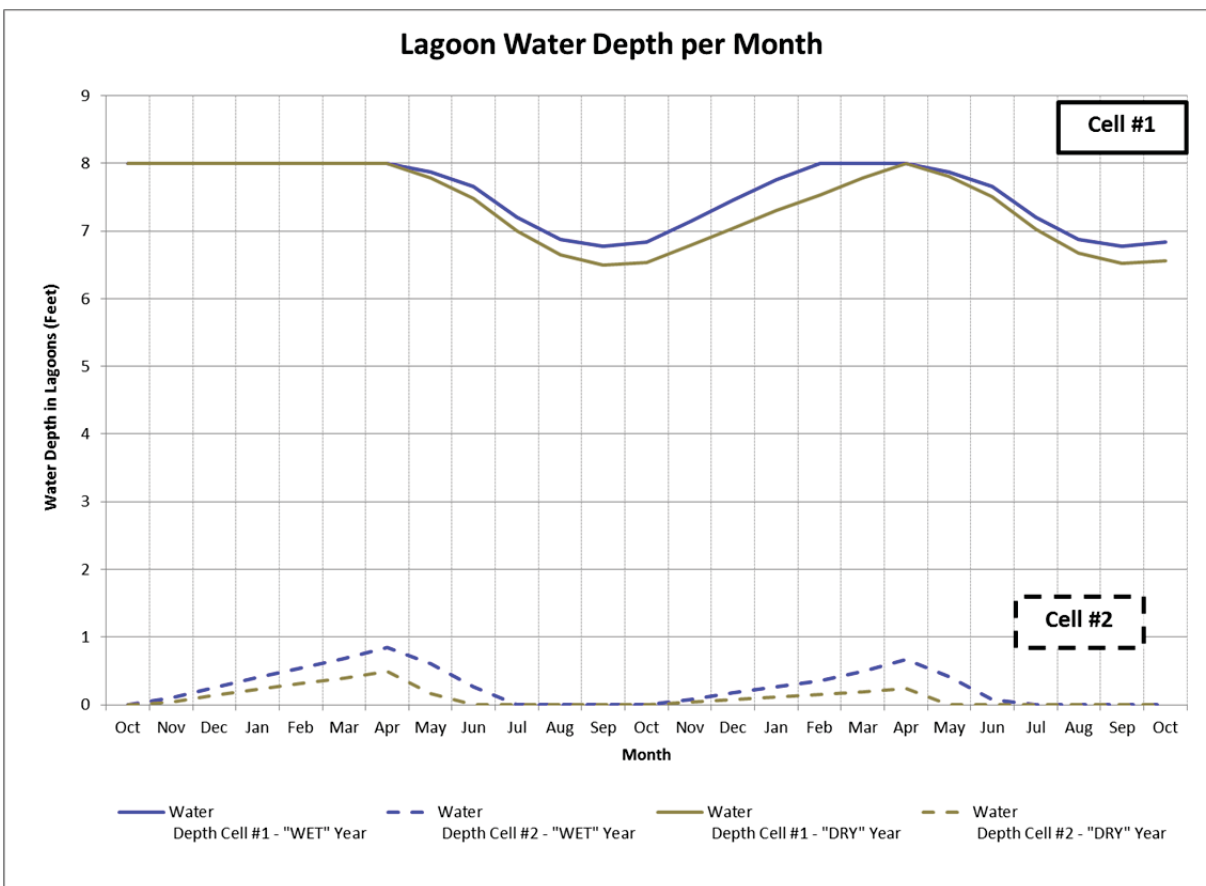
Figure 3-7. Water balance – existing conditions (with 8 foot initial Cell #1 depth).

To show a repeatable trend for a full water cycle year, the initial depth of Cell #1 was changed to the full depth of 8 feet, and the model was rerun. Figure 3-7 below shows the results.

The above figure shows that for “wet” year conditions, Cell #1 will be full and overflow into Cell #2 during the February to April timeframe. For “dry” year conditions, Cell #1 fills in April and briefly overflows a small volume into Cell #2. This indicates that Cell #1 is slightly undersized to be able to accommodate the existing influent flows for the assumed conditions.

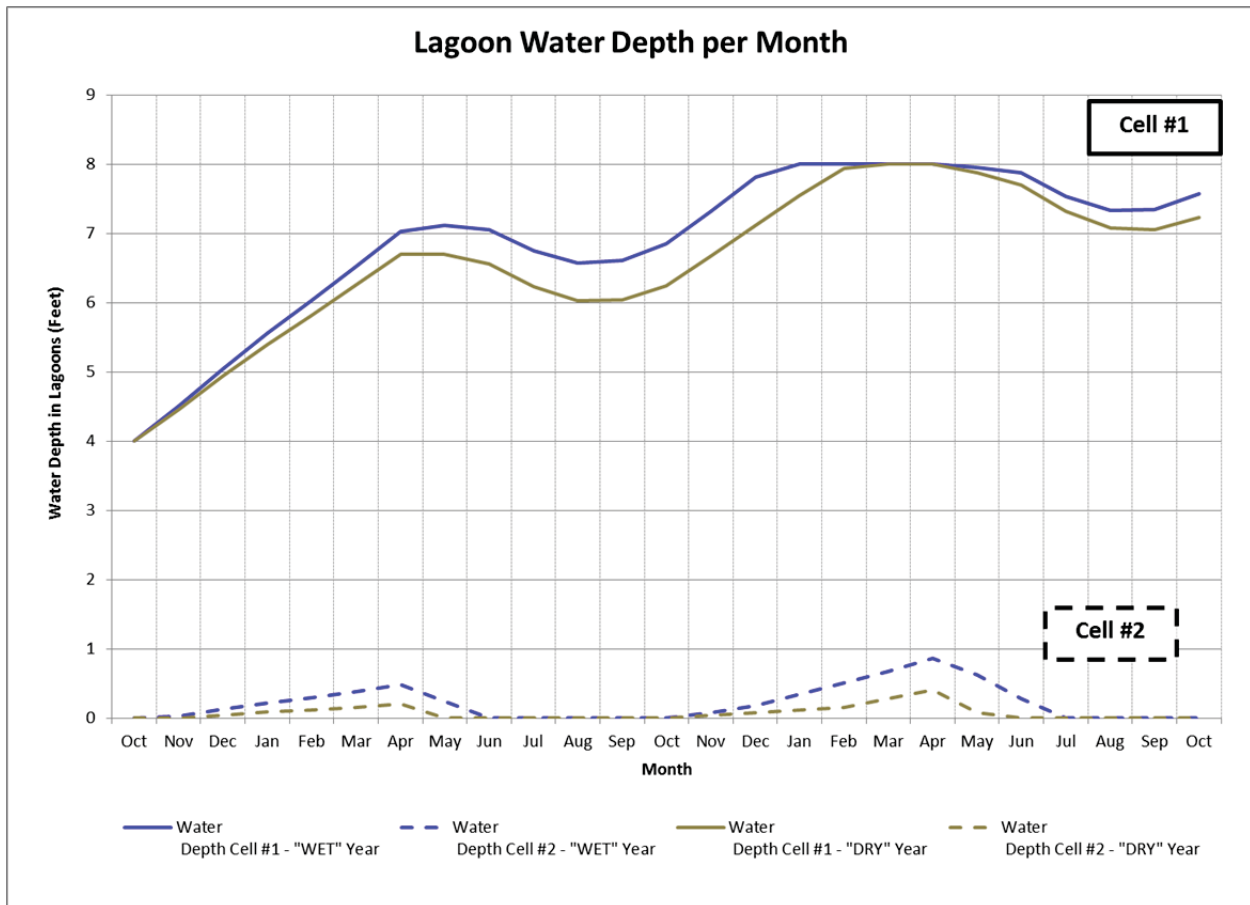
Figure 3-8. Water balance – existing conditions (25% increase in staffing).

A cursory sensitivity analysis was performed to assess the impact of the assumed influent and seepage input values on this conclusion. First, the number of worker-days per month was increased by 25% from 13,616 to 17,020. An initial depth of 8 feet in Cell #1 was used to show a repeatable trend over the course of a full water cycle year. Figure 3-8 below shows the results.

The above figure shows that Cell #1 remains full and overflows into Cell #2 over a longer period of time throughout the year. The additional overflow increases the maximum depth in Cell #2 by less than 1 foot.

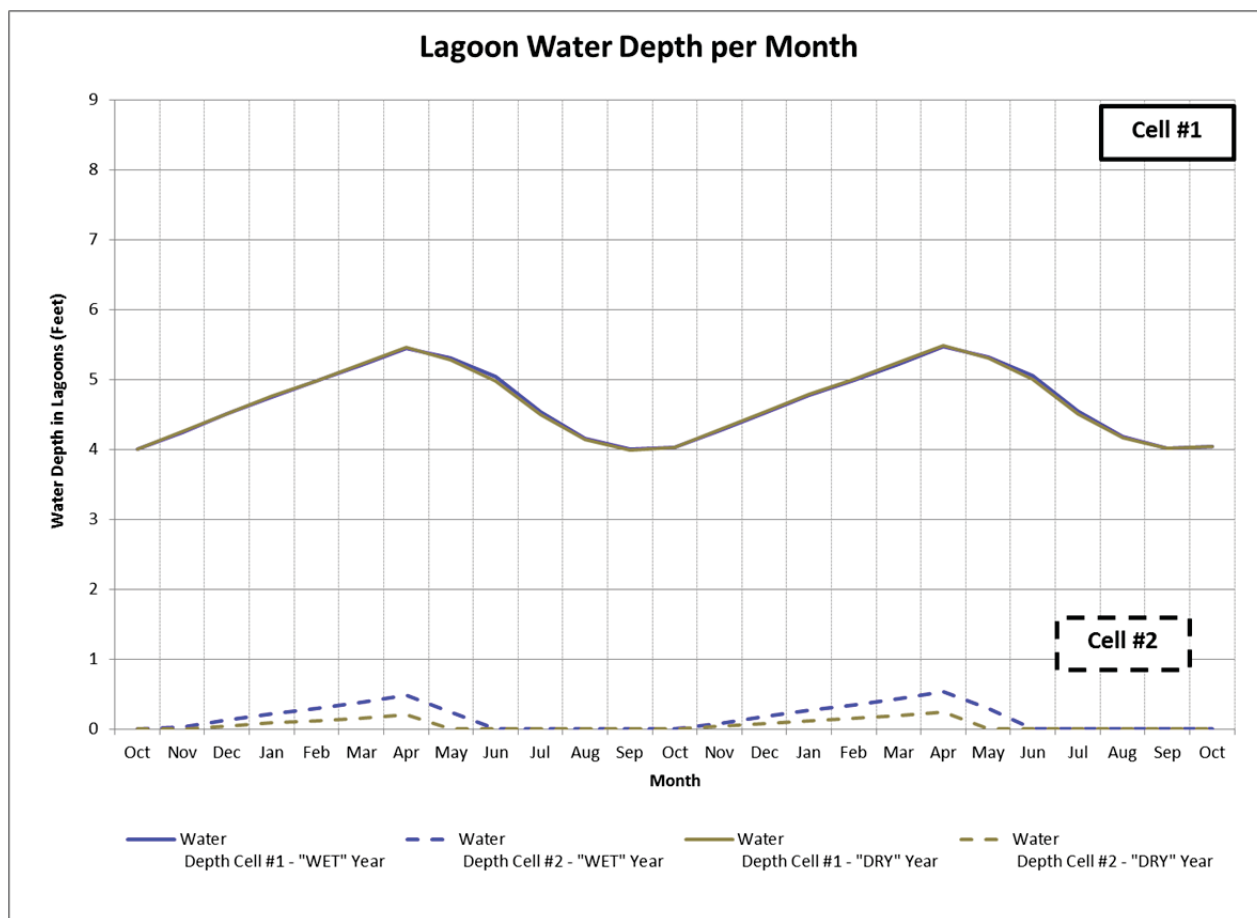
Figure 3-9. Water balance – existing conditions (increased seepage rates in Cell #1).

This indicates that if the seepage rate in Cell #1 increases above these values, there would eventually be insufficient influent flow to keep water in Cell #1 throughout the entire year, and supplemental water would need to be added. It should be noted that these values are still significantly less than the maximum rate of 0.25 inches per day of seepage that would be required by DEQ to pass a seepage test. Figure 3-9 below shows the results using these assumed seepage rates.

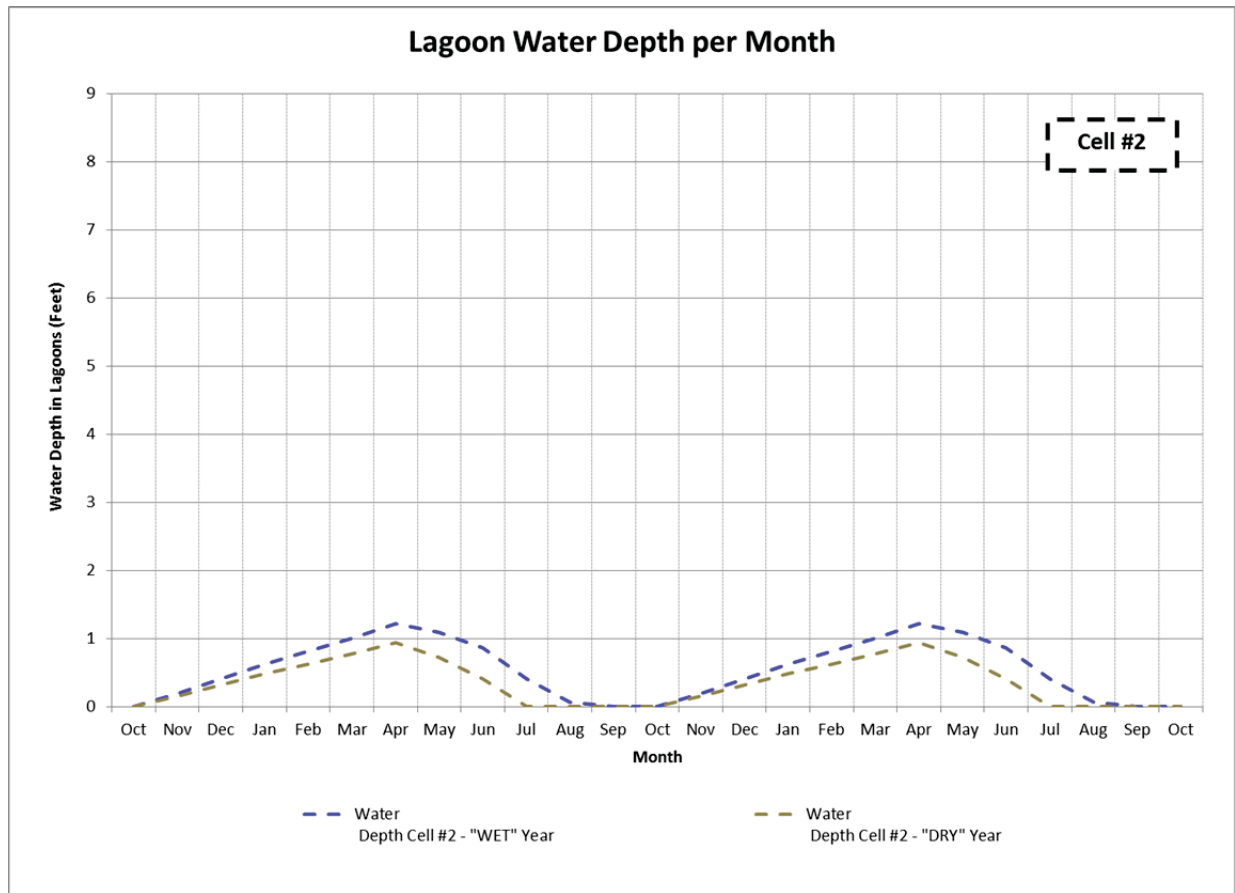
Figure 4-2. Water balance – Alternative LT-1).

If Cell #1 is abandoned, all of the influent flow will be diverted to Cell #2. The water balance model was used to verify that Cell #2 by itself is adequately sized for the anticipated flows as shown in Figure 4-2 below. A zero seepage rate was assumed to show the worst-case scenario.

As the figure shows, the water level in Cell #2 does not increase above approximately 1.5 feet indicating that the capacity in this cell is more than adequate for the anticipated flows. The figure shows that the lagoon will empty in the late summer or early fall timeframe depending on weather conditions.

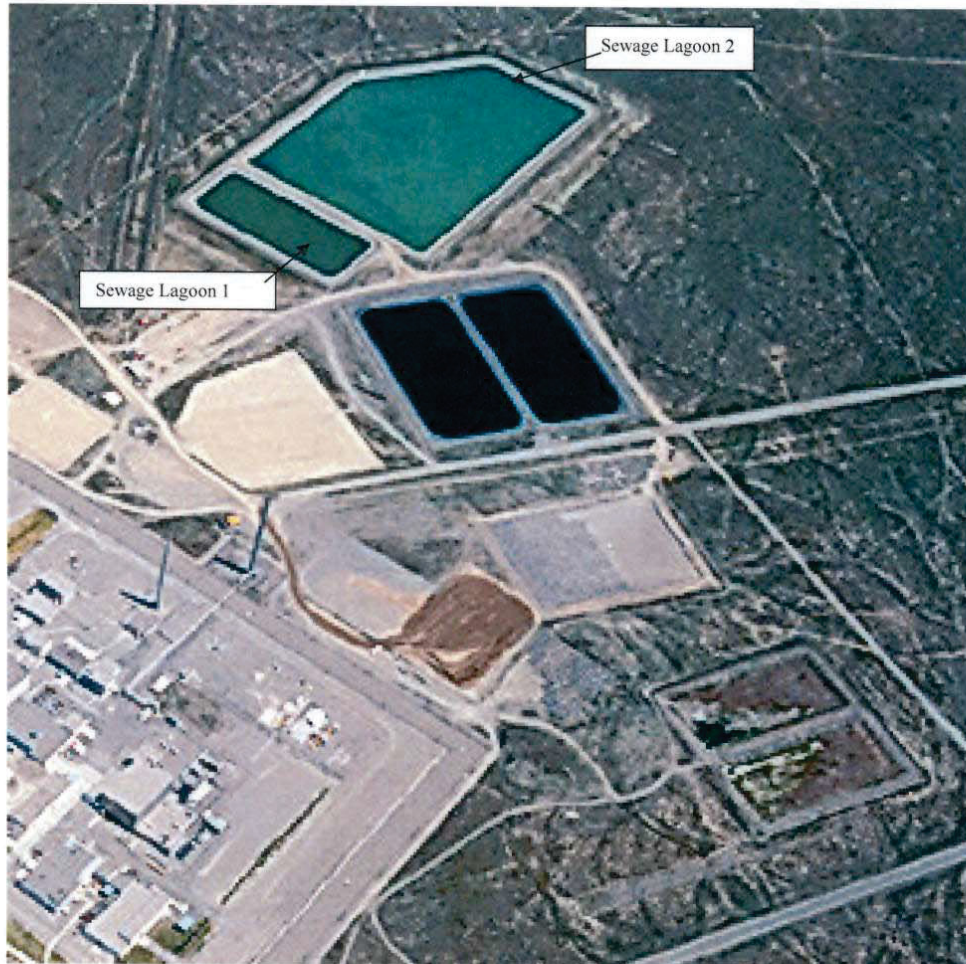
Figure 1. Aerial view of the ATR Complex sewage treatment lagoons.

The lagoons were designed to treat up to 60,000 gallons per day (gpd) with current flows averaging around 28,000 gpd. Wastewater flows by gravity from Lagoon 1 to Lagoon 2 through a transfer structure located on the north end of the berm between the lagoons. A second transfer structure, which was constructed for possible future expansion, is located on the east berm of Lagoon 2. See Figure 1 for an aerial view of the lagoons.

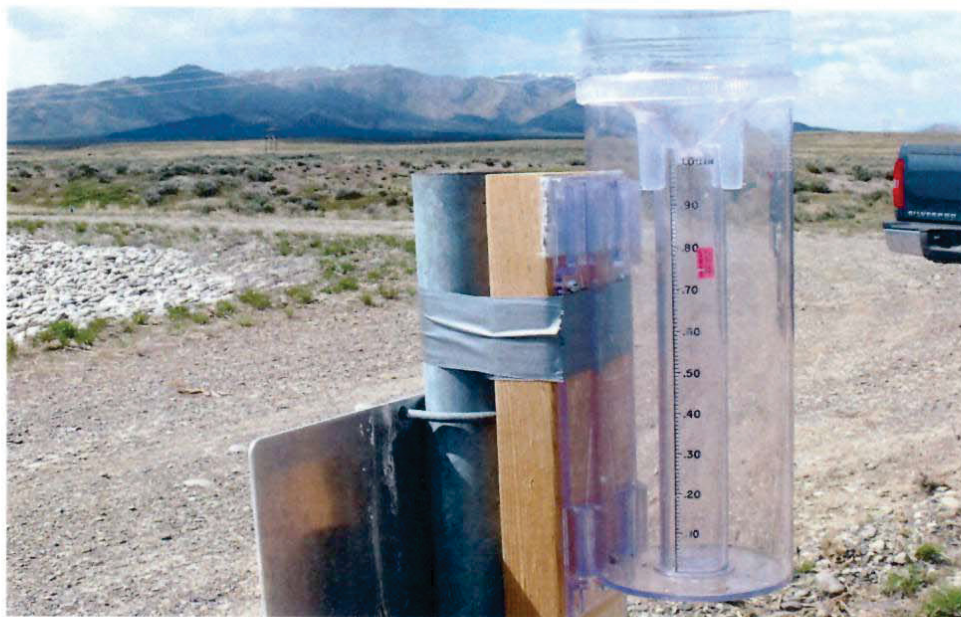
Figure 3. Precipitation Gauge.

A rain gauge and temperature data logger were installed on one of the transfer structure sign posts located on the berm between Lagoons 1 and 2. Precipitation was monitored using a Productive Alternatives All-Weather Rain Gauge. The gauge was a standard 4-in. orifice, funnel-type unit that was installed about 5 ft above the ground with the top orifice being several inches above the mounting post (See Figure 3). The gauge measuring tube had a 1.00 in. capacity with readout increments of 0.01 in. The gauge was read, recorded, and emptied (if precipitation was collected) at approximately 9:00 a.m. daily during the testing periods. Temperature data was collected using a HOBO® H8 Pro Series logger (See Figure 4). The temperature was recorded to the nearest 0.01°F at 1-hour intervals. Seventy-two-hour means were calculated for each water measurement period during the 15-day testing cycles.

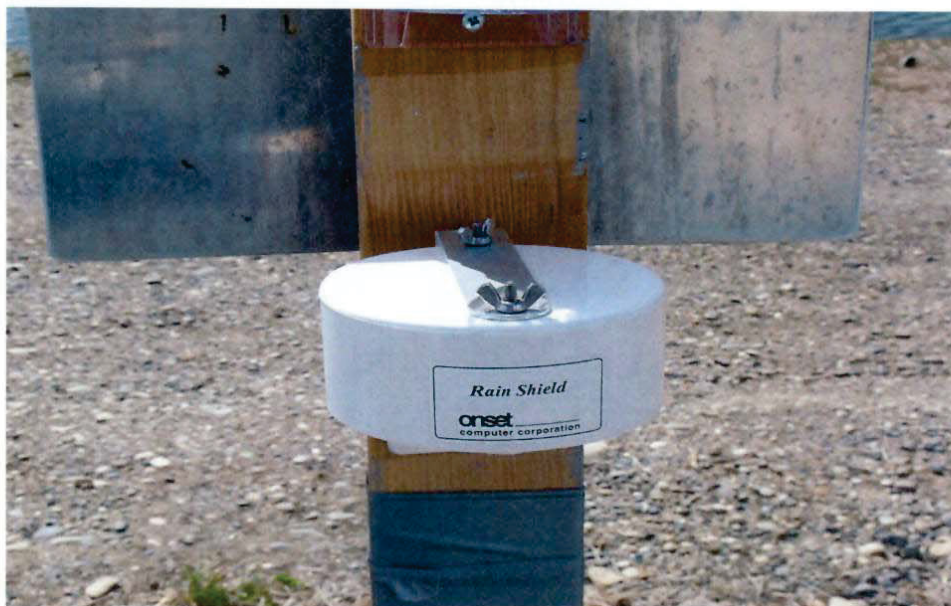
Figure 4. Temperature Logger.

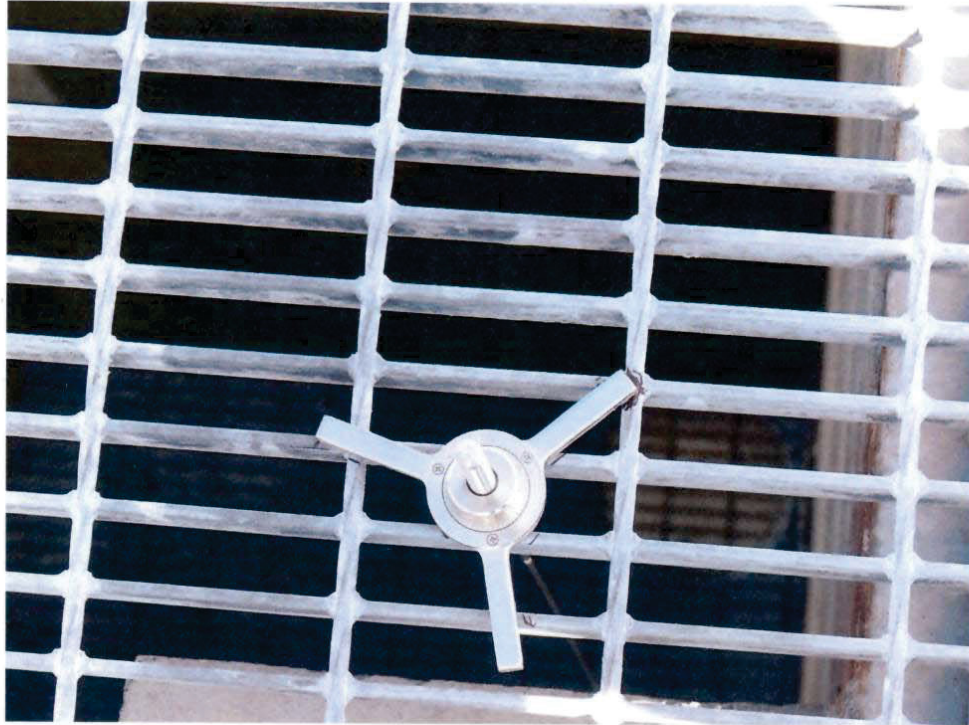
Figure 5. Hook Gauge.

Lagoon water elevation measurements were taken from reference points on the transfer box cover grates using an extended hook gauge. Hook gauge extensions were added to the hook gauge as needed to keep the water surface elevation within the travel distance of the hook gauge. The distance between the reference point and the water surface was re-baselined each time an extension or spacer was added or removed.

One individual made all hook gauge measurements associated with the sewage lagoons and evaporation pan. Verification hook gauge measurements were performed by additional individuals. Daily rain gauge measurements were taken by CFA utility personnel and recorded on the daily log sheets.
