AGC-2 Disassembly Report

INL/EXT-14-32060

The Very High Temperature Reactor (VHTR) Graphite Research and Development Program is currently measuring irradiated material property changes in several grades of nuclear graphite to predict behavior and operating performance within the core of these new high temperature reactor designs. The Advanced Graphite Creep experiment, consisting of six irradiation capsules, will generate the irradiated graphite performance data for VHTR reactor operating conditions. All six capsules in the experiment will be irradiated in the Idaho National Laboratory (INL) Advanced Test Reactor (ATR), disassembled in the INL Hot Fuel Examination Facility, and examined at the INL Research Center. This is the disassembly report describing the disassembly, shipment, post-irradiation inspection, and storage of the graphite specimens contained within the AGC-2 irradiation test series capsule (the second irradiation capsule of the series). The second capsule (AGC-2) began irradiation on ATR Cycle 149A on April 12, 2011, and ended with ATR Cycle 151B on May 5, 2012. A maximum dose of approximately 5 dpa was achieved. The capsule was removed from the ATR area and trans

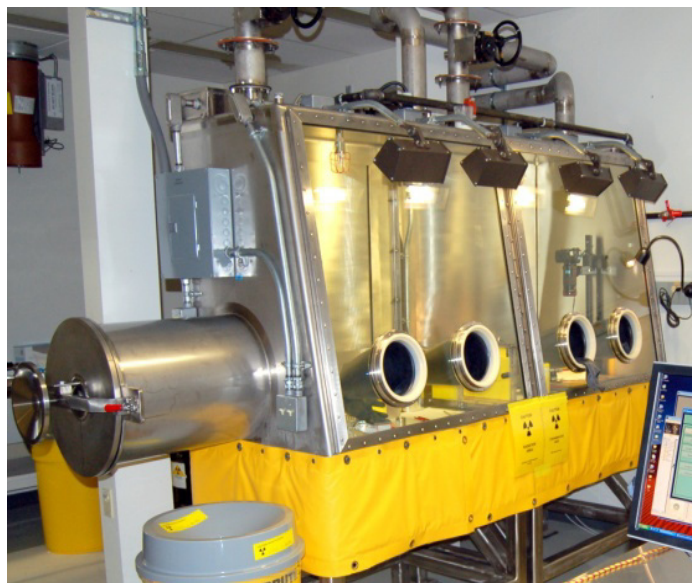
Figure 9. CCL radiologic glove box used to visually inspect graphite samples, photograph, and repack samples for storage.

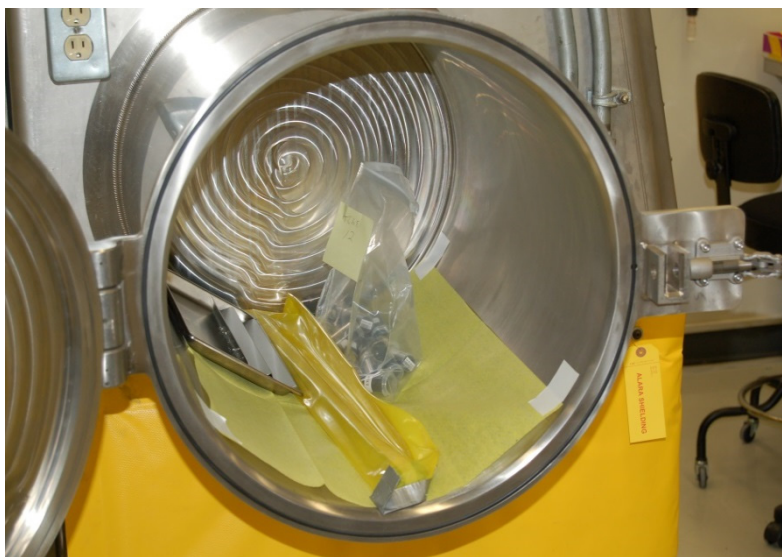
Figure 10. A single Plexiglas tube of specimens along with their corresponding snap caps placed in the antechamber for transfer into the glove box.

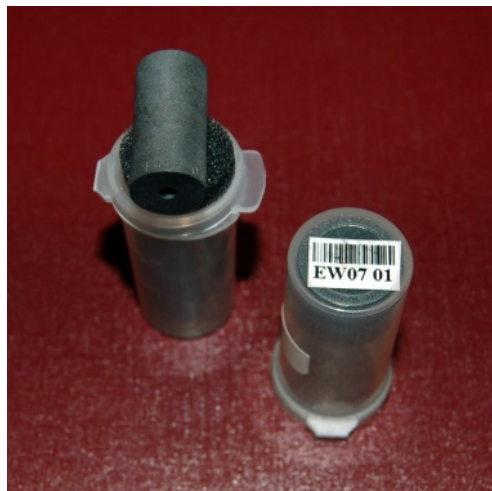
Once the specimen has been inspected and photographed it is placed in a snap cap plastic container that is barcode labeled with the corresponding specimen number (Figure 13). These bar codes are used to track the specimen throughout all post characterization activities and measurements. Initially it is used by a semiautomatic storage location data base. Using INL-developed software, the bar code is read and the next available storage location is identified in the shielded storage vault (Figure 14). As specimens are needed for post irradiation characterization, the desired specimen number is entered into the software and its storage location is identified for retrieval. Appendix A contains a listing of all AGC-2 specimens retrieved from the experiment capsule and there storage vault location. All digital photographs will be stored along with the results from thermal, mechanical, and physical testing with project files, becoming part of the permanent record for each individual sample.

Figure 13. Example of plastic snap cap container used to hold individual specimens.

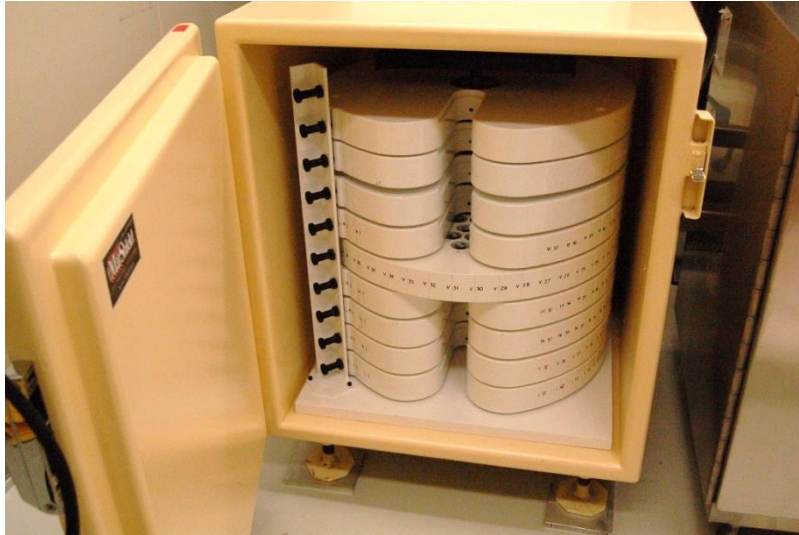
Figure 14. Shielded storage vault. Each platter is independently rotated to minimize direct radiation exposure from multiple specimens.
