Waste Isolation Pilot Plant Salt Decontamination Testing

September 2014

**Idaho National Laboratory
Environmental Engineering & Technology
Idaho Falls, Idaho 83415**

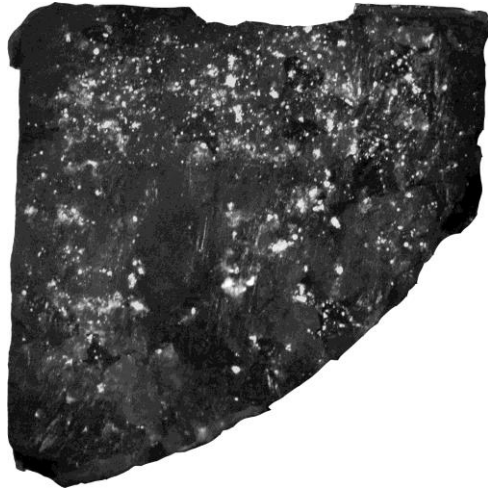
Figure 3. Image (after Photoshop processing) of a water washed coupon after decontamination.

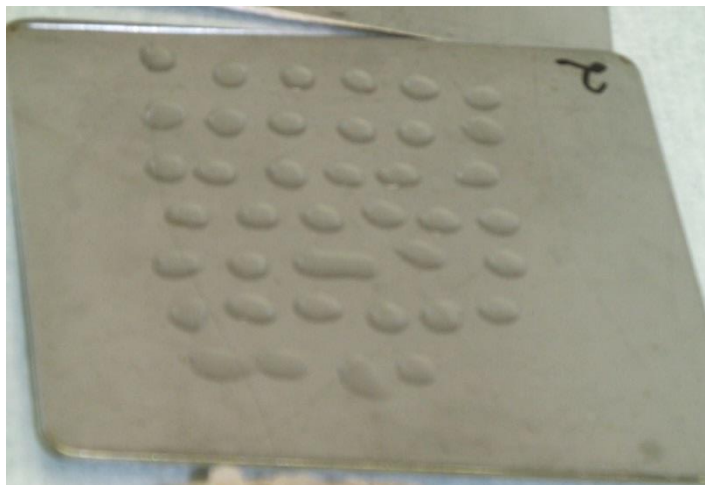
Figure 8. Stainless steel plate stippled with an ^{241}Am solution.

for preparing standards to determine matrix effects with radiometric instruments. A stippled steel plate is shown in Figure 8. The stippling was confined to an area the size of the radiometric detector probe being used for these tests.

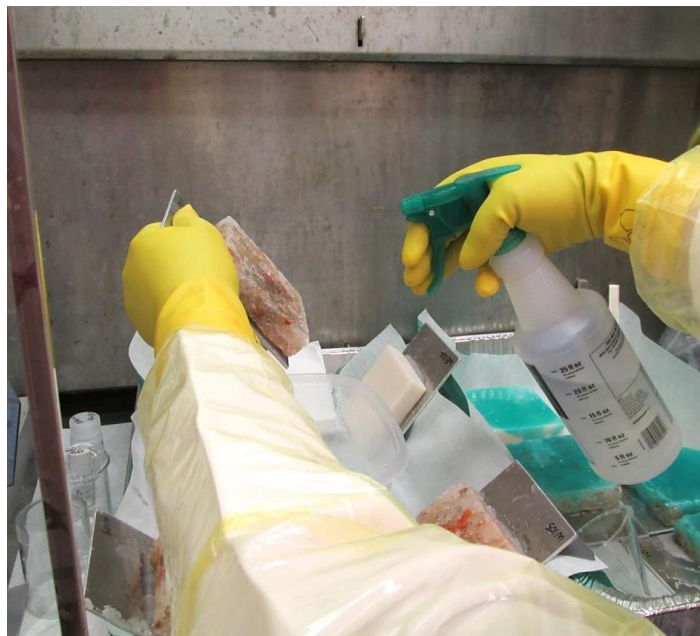
Figure 9. Water washing americium from a salt coupon.

Water washing was by far the easier method of decontaminating these coupons and was also highly effective. The process used matched that previously established during the non-radioactive testing: a 15 second water rinse using a spray bottle. A photograph of this method is shown in Figure 9. The rinsate was collected and found to be about 20 ml from each coupon, which is essentially complete recovery of the solution (as measured in earlier experiments). Scaled to practical use, the volume used for water washing is $\sim 2 \text{ L/m}^2$ of decontaminated surface. One ml of each 20 ml volume was counted using liquid scintillation to determine the amount of radioactivity recovered. The measured activity averaged 6,533 dpm alpha per coupon, which indicates that washing removed virtually everything from the surface, but only $\sim 31\%$ of the total applied (the steel control plates registered 21,000 dpm). The remaining contamination is thought to be entrained in the porosity of the coupon.

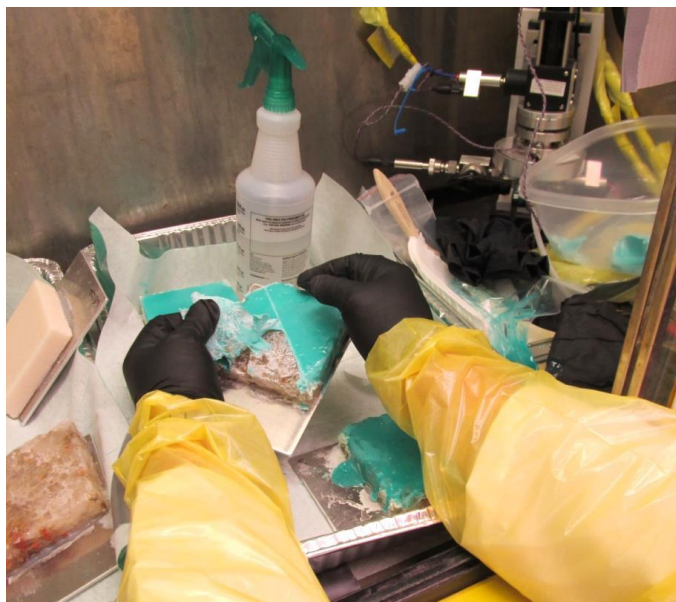
Figure 10. Removing DeconGel strippable coating from a salt coupon.

While the DeconGel strippable coating was also highly effective at removing contamination, it was time consuming and difficult to remove. It took, on average, 15 minutes to remove approximately 95% of the coating. Complete removal was not possible. Vetting what was seen with the non-radioactive tests, the strippable coatings became somewhat incorporated into the salt surface and were very difficult to remove – much more difficult to remove from the salt surface than from stainless steel or aluminum. A photograph of this portion of the test is seen in Figure 10. The surface of the coating was scored with a plastic knife to give a place to begin peeling the coating. The Stripcoat and DeconGel materials were found to work better as fixatives rather than strippable coatings.

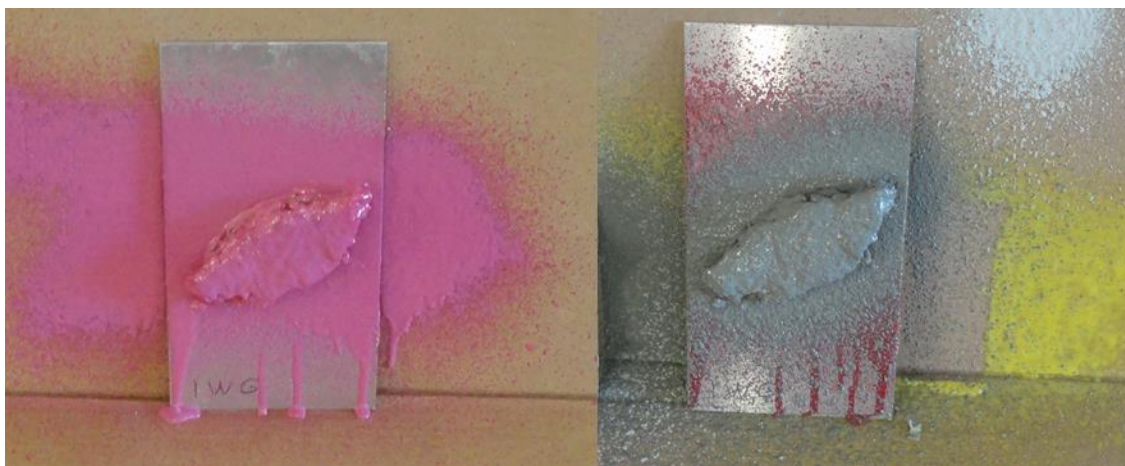
Figure 11. Application of PBS (left) and Tekflex (right) to a vertical surface. Note the propensity of the PBS coating to run during application.

Applying either material overhead may be quite messy. The Tekflex, on the other hand, stayed where it was applied. See Figure 11.

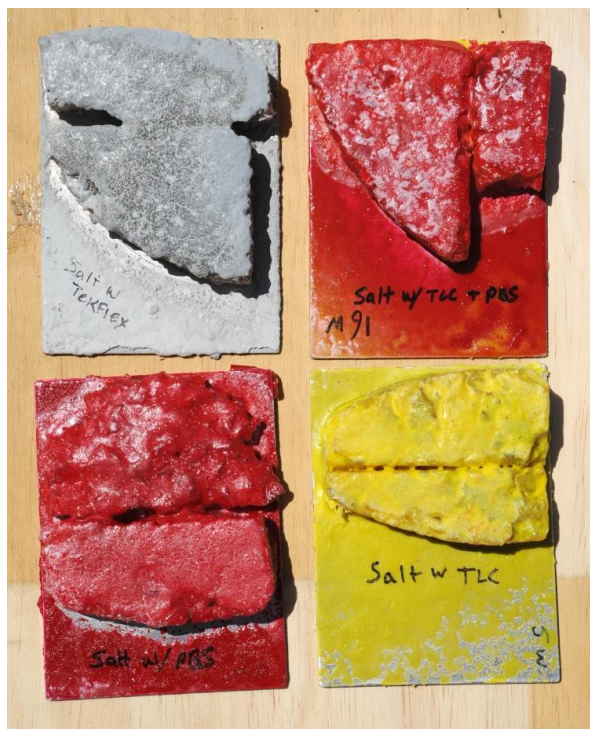
Figure 12. Solid salt coupons coated with (clockwise from upper left): Tekflex PM (gray), Stripcoat + PBS (red orange), Stripcoat (yellow), and PBS (red). Note the white spots on the surface – most evident against the red background.

Once applied and dry, all coatings formed a good barrier on the sample surfaces. White spots appeared on the surface of the coatings, likely fine salt crystals that dissolved in the wet solution and then recrystallized. The white spots are most evident on the samples coated with PBS, probably because of the higher contrast between the red coating and the white crystals. See Figure 12. The Stripcoat and PBS barriers formed fine bubbles upon application. The bubbles may have been entrained air from the pneumatic sprayer, or produced due to a chemical reaction between the solution and the underlying salt.

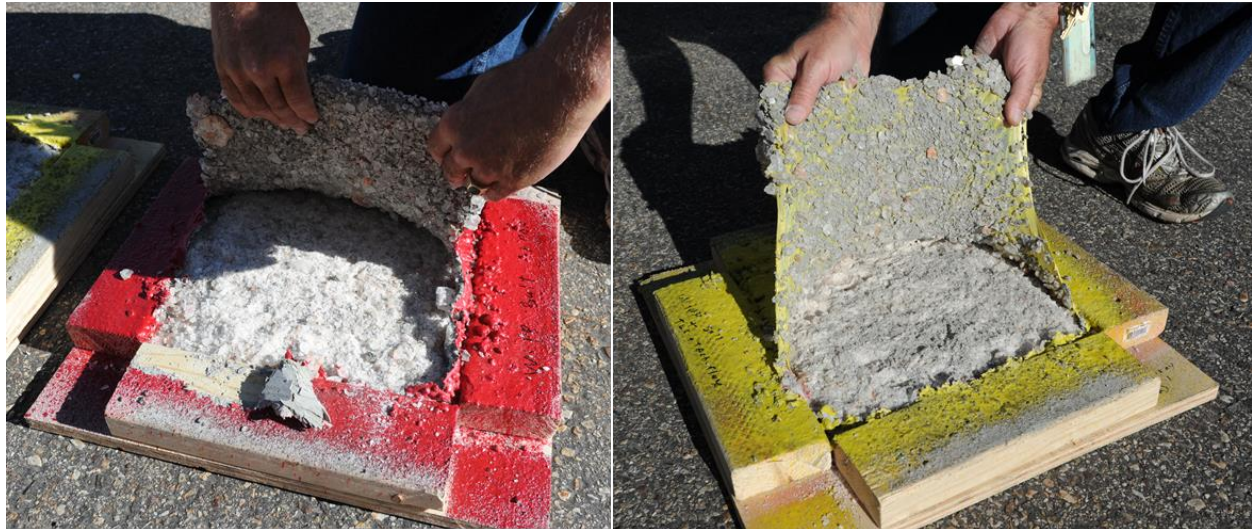
Figure 15. Rubble trays coated with Tekflex + PBS (left) and Tekflex + Stripcoat (right) after crush testing. The coating was manually peeled back to show that the integrity of the barrier was maintained under compression of the truck tire and tension as the membrane is peeled away from the tray frame.

In round two of testing, the coatings with a top layer of Stripcoat or PBS proved quite durable, with no failure of the membrane even after ten passes under the truck tire. See Figure 15. The coatings with a

top layer of Tekflex sloughed Tekflex powder with each pass under the tire, but the underlying elastic coating maintained its integrity. Based on these results it does not appear that Tekflex enhances coating strength or stability. When applied as an undercoat, it simply adds another, superfluous step in the process. When applied as an overcoat, it proves to be a dust source.

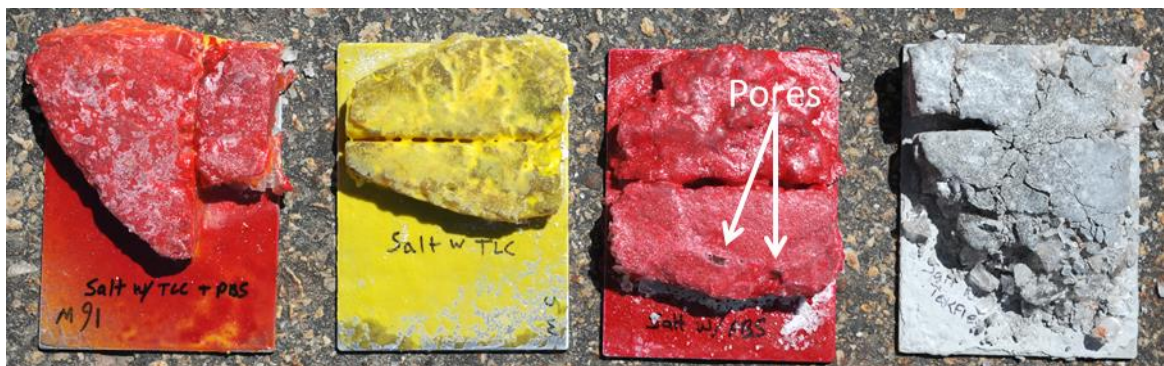
Figure 16. Solid coupons after crush testing. Note the two holes that developed in the PBS membrane, and the loss of structural integrity of the Tekflex coated coupon.

Unlike the rubble beds, the solid coupons did not have a frame to support their edges. As a result, all of the solid coupons exhibited some crumbling and fracturing along the fore and aft edges. In situ, edge effects may not be a significant issue, other than perhaps at wall corners. Aside from those edge effects, in round one of testing the more brittle Tekflex coating again fared the worst, fracturing extensively. The PBS and Stripcoat coated coupons showed virtually no wear or damage, other than along the edges. Two holes/pores were exposed in the PBS sample. A second spray coat of material would seal up the exposed porosity. See Figure 12 for the coupons before crush testing. Figure 16 shows the coupons after four passes under the truck tire.

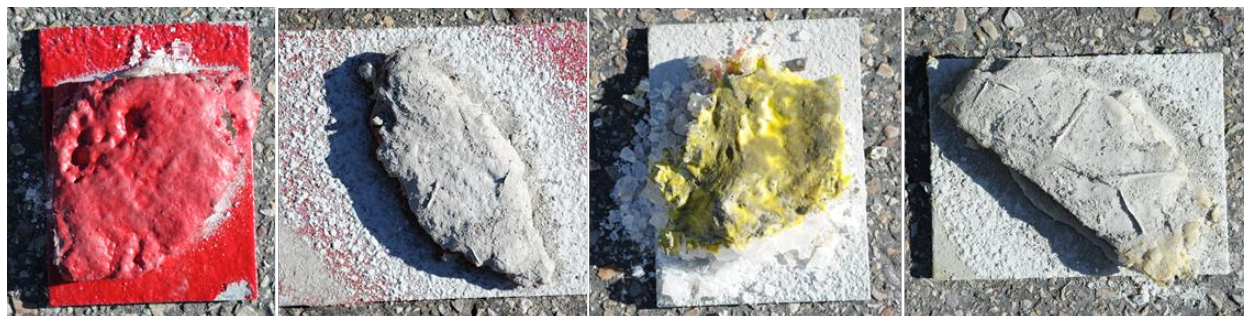
Figure 17. Solid coupons after crush testing. From left to right, the coatings are Tekflex + PBS, PBS + Tekflex, Tekflex + Stripcoat, and Stripcoat + Tekflex.

In round two of testing solid coupons, all four coating combinations survived ten passes under the truck tire with their membranes intact; however, the sample with an outer membrane of Stripcoat (third

pane from the left in Figure 17) lost much of its structural integrity around the perimeter of the coupon. The sample with an under layer of Stripcoat (rightmost pane in Figure 17) fared much better. It is not clear why that sample fared so much worse than the others. The Tekflex outer coating was ground down under tire wear, providing a powdery surface and a dust source – a result seen also in the rubble beds. The ground, powdery surface is most evident in the Stripcoat + Tekflex sample (rightmost image in Figure 17), where the tire tread is impressed into the loose coating. Like the rubble beds, the addition of the Tekflex layer does not appear to enhance coating integrity, except perhaps when combined with Stripcoat.
