RERTR-12 Post-irradiation Examination Summary Report

INL/EXT-14-33066
Revision 1

The following report contains the results and conclusions from post-irradiation examinations performed on RERTR-12 Insertion 2 experimental fuel plates. These examinations include eddy-current testing to measure oxide growth; neutron radiography for evaluating the condition of the fuel prior to sectioning and determination of fuel relocation and geometry changes; gamma scanning to provide relative measurements for burnup and indication of fuel- and fission-product relocation; profilometry to measure dimensional changes of the fuel plate; analytical chemistry to benchmark the physics burnup calculations; metallography to examine the microstructural changes in the fuel, interlayer and cladding; and microhardness testing to determine the material-property changes of the fuel and cladding. These characterization activities were conducted specifically to demonstrate that:

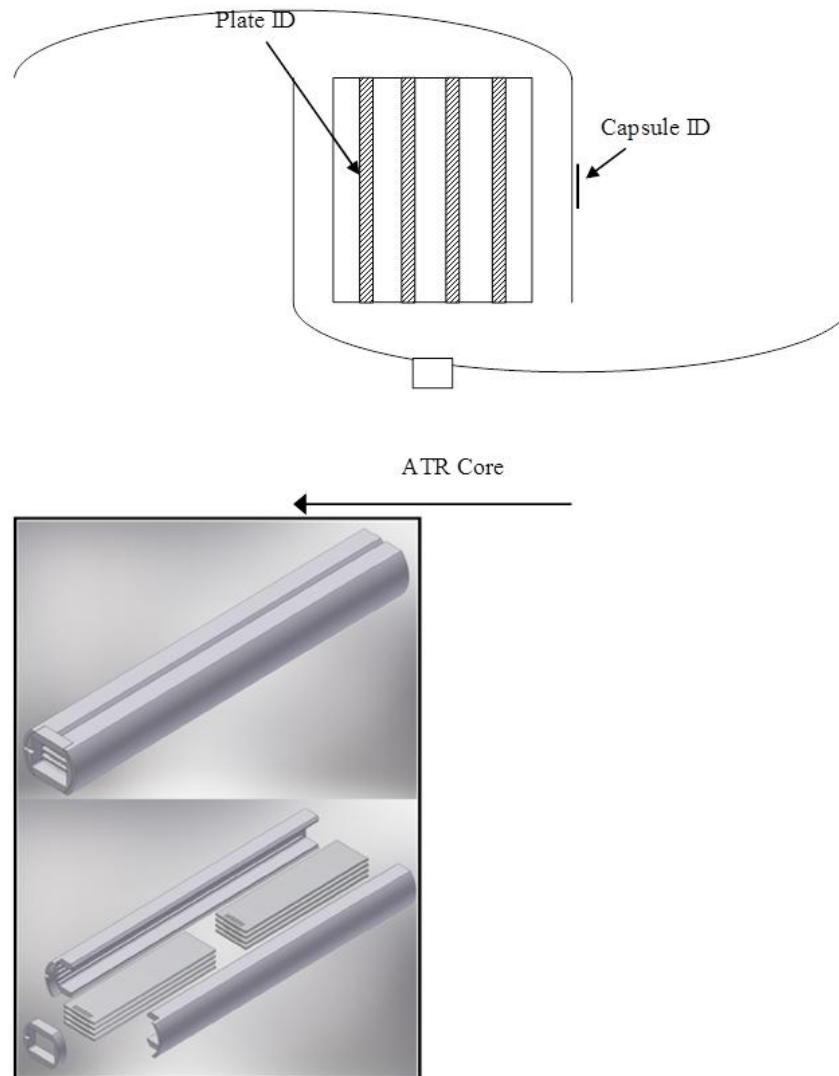
Figure 1. Orientation of RERTR-12 capsule and image of the layout of the capsule.

The capsules were oriented in the reactor in such a way that the first plate in the capsule is oriented facing the core center, with plates two, three and four behind each previous plate. This resulted in a plate-to-plate fission-density and fission-rate gradient, decreasing from plate one to four and from five to eight in all of the capsules. This capsule and plate orientation can be seen in Figure 1. Irradiation of the X1 and X2 capsules was completed first (referred to as RERTR-12 Insertion 1), and the capsules were shipped to the Hot Fuels Examination Facility (HFEF) at the Idaho National Laboratory (INL) for examination.

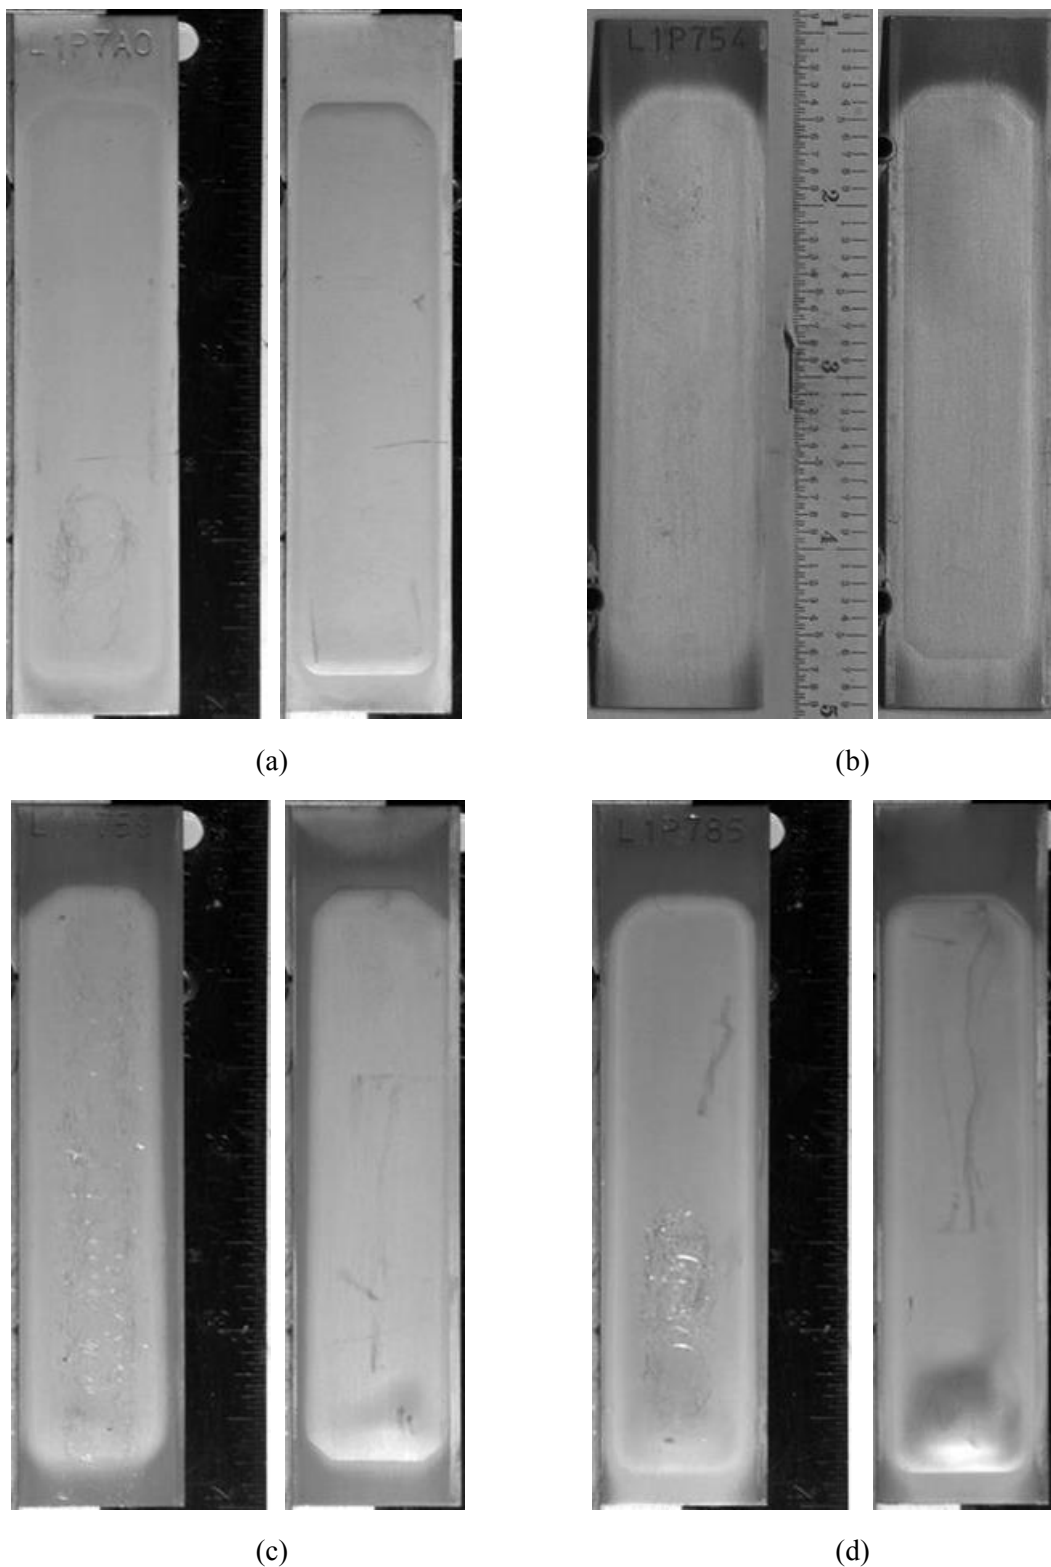
Figure 2. Photographs of plates that exhibited high swelling behavior. (a) L1P7A0 exhibited higher-than-projected volume increase, but did not exhibit blistering or pillowing, (b) L1P754 exhibited blistering/pillowing behavior (c) the blister/pillow on L1P759 was larger with increased fission density (d) further increasing pillow volume with increased fission density for plate L1P785.

Pillowing of fuel plates L1P785 and L1P759 was clearly identified during visual examination. The failure of plate L1P754 was suspected during visual examination and confirmed using neutron radiography (see Section 3.3). In delaminated fuel plates, the plate-swelling values shown in Figure 3 incorporate substantial void volume in addition to fuel-meat volume and are not representative of U-Mo alloy swelling. Plate L1P7A0 did not show indications of foil cracking or relocation during visual examination or neutron radiography. Plate L1P465 (46%, 3.78E+21) also has higher-than-anticipated swelling and was further investigated using point-by-point analysis of profilometry data (see Section 3.5).

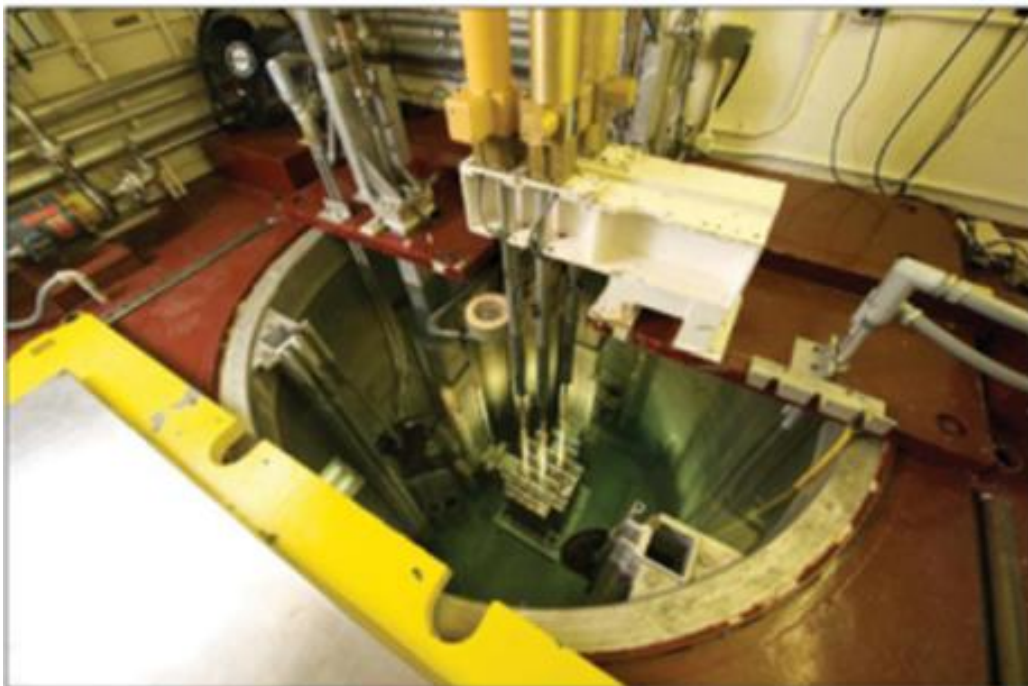
Figure 4. NRAD.

A Testing, Research, Isotopes, General Atomic (TRIGA) reactor, NRAD, (shown in Figure 4) is located below HFEF. NRAD makes use of the east radiography station (ERS) to perform NDE on radioactive samples. Schematics of the ERS are shown as Figure 5 and Figure 6.

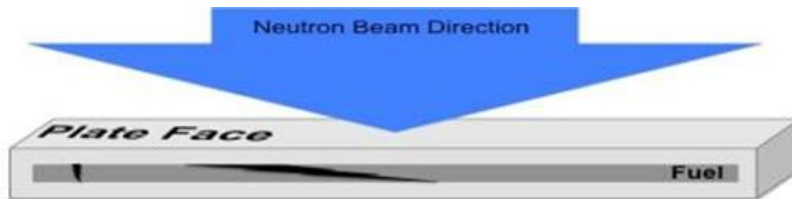
Figure 10. Resolvable cracks in fuel using a configuration perpendicular to plate face.

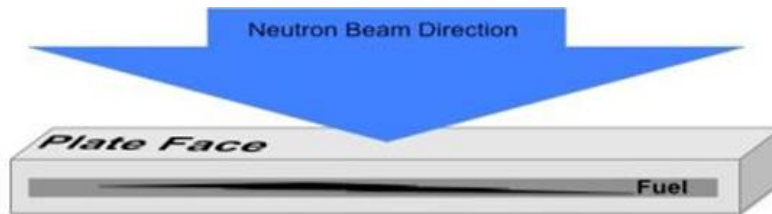
Figure 11. Non-resolvable crack in fuel using a configuration perpendicular to plate face.

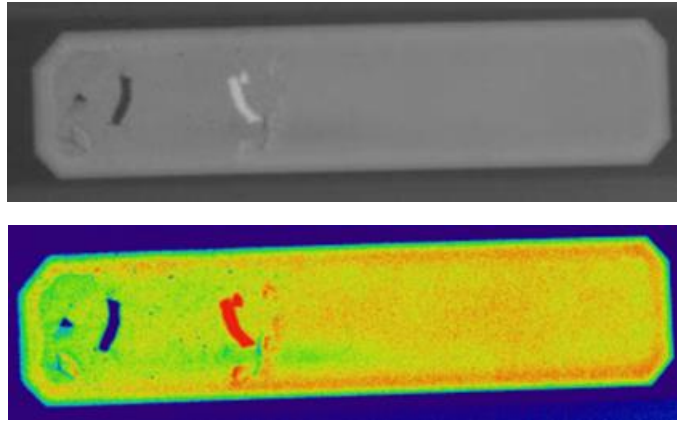
Figure 12. L1P754 radiograph (top) and color map (bottom).

Plate L1P754 was shipped to HFEEF for examination prior to the remainder of the plates discussed in this report. The mid plane of the plate shows swelling peaks inset from the edge of the foil caused by fuel creep and edge constraint. At an average fission density of 8×10^{21} fissions/cm³ (1.2×10^{22} peak fissions/cm³), fission-gas bubbles are clearly visible throughout the fuel foil under metallography. Figure 12 shows the pillowed region at the top of the plate with fuel relocation clearly evident.

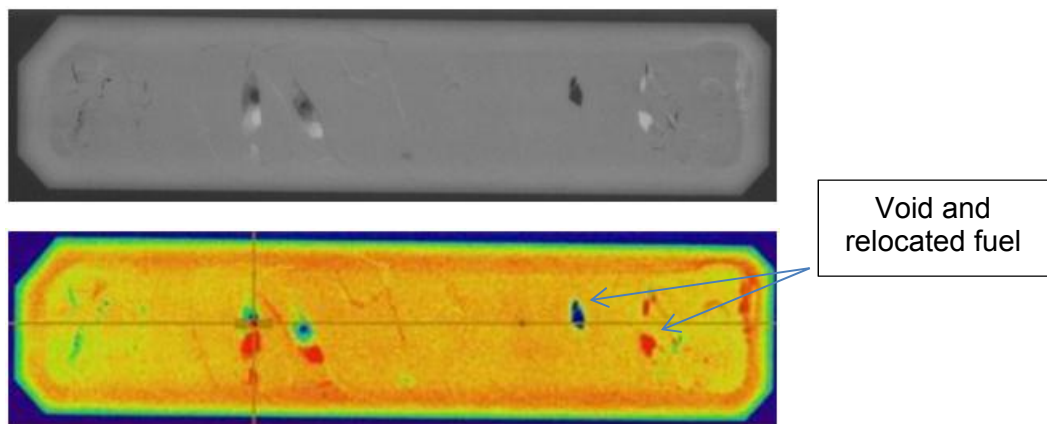
Figure 13. L1P759 radiograph (top) and color map (bottom).

L1P759 failed due to in-reactor pillowing. Fuel movement to positions near the edges of the fuel foil occurred as a result of fuel creep and edge constraint (see Figure 13). Profilometry measurements indicate that the plate failed over most of the fuel zone. Fuel relocation to the pillowed lower region of the plate occurred, causing peaks in image intensity in the radiograph (see Figure 14). The shape of relocated fuel matches the shape of the missing fuel locations in the lower third of the fuel plate. In the upper half of the plate, the bright areas that indicate relocated fuel are more closely positioned next to regions of lower image density. The radiographs indicate that the relocated fuel may have a conical aspect in the through-thickness direction. The fuel also shows extensive cracking without relocation of fuel over the entire fuel zone. This can be most clearly seen as higher intensity lines through the fuel zone in the color map. The cracking patterns differ with location on the fuel plate. Near the top and bottom regions of the fuel, the cracks are more closely spaced, and the cracking pattern gives the appearance of fuel that has been fractured, which could be the result of higher stress in these regions.³ At the bottom of the fuel zone, inside the area of increased fuel thickness caused by creep, a small cluster of bright spots appears, which indicates a region of high fuel density that does not appear to be associated with either fuel creep or cracking. In the central region of the fuel, cracks run at an angle of approximately 30 degrees from the lateral (horizontal) and are inclined in the same direction. Two of the cracks appear to exhibit increased fuel density along the crack line, potentially indicating fuel beginning to overlap across the crack.

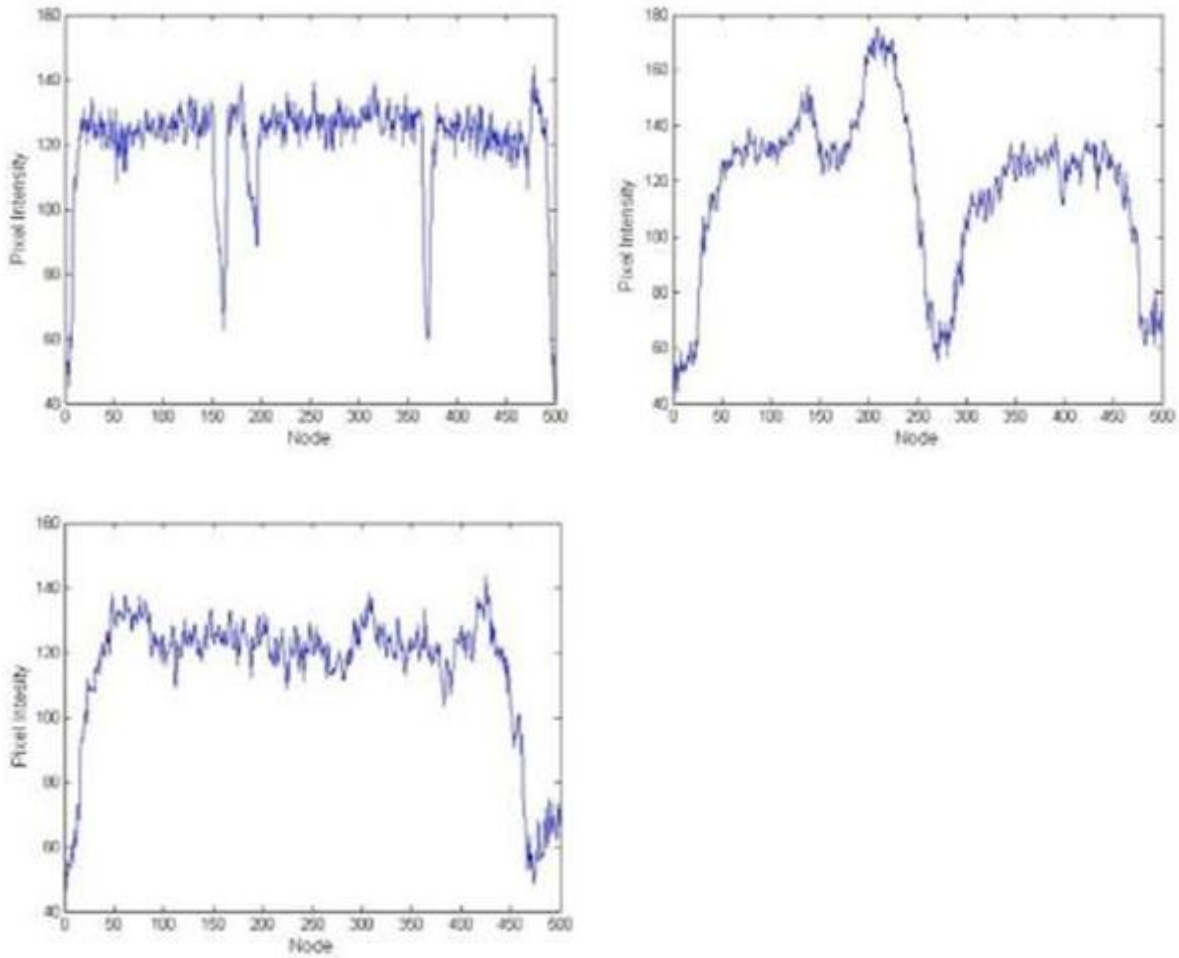
Figure 14. Relative pixel intensity for a longitudinal section (upper left, see Figure 13 for section line), transverse section across the center defect (upper right, see Figure 13 for section line), and across the pillow in the lower section of the plate (bottom).

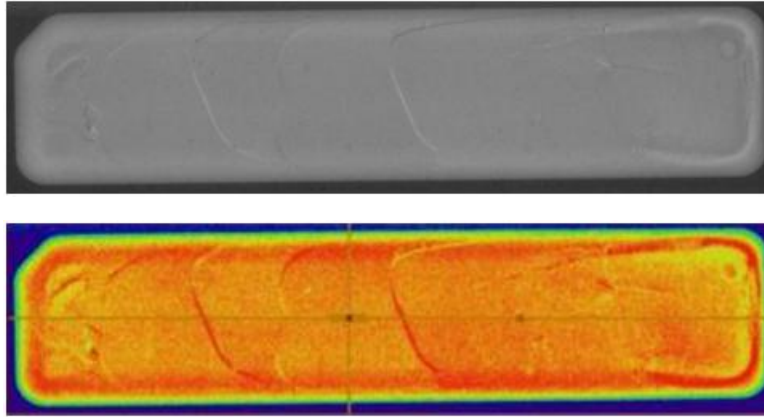
Figure 15. L1P785 radiograph (top) and color map (bottom).

L1P785 shows a large amount of cracking in the U–Mo fuel meat without clear indications of pieces of fuel breaking out of the foil and relocating. The appearance of features that appear to be ridges, where sections of fuel have pushed against each other and have begun to overlap, are evident in the color map in Figure 15. The transverse intensity plots shown at the top of Figure 16 indicate considerable fuel relocation by creep toward the edges of the fuel plate is higher in the pillowed region of the fuel plate than at the plate center.

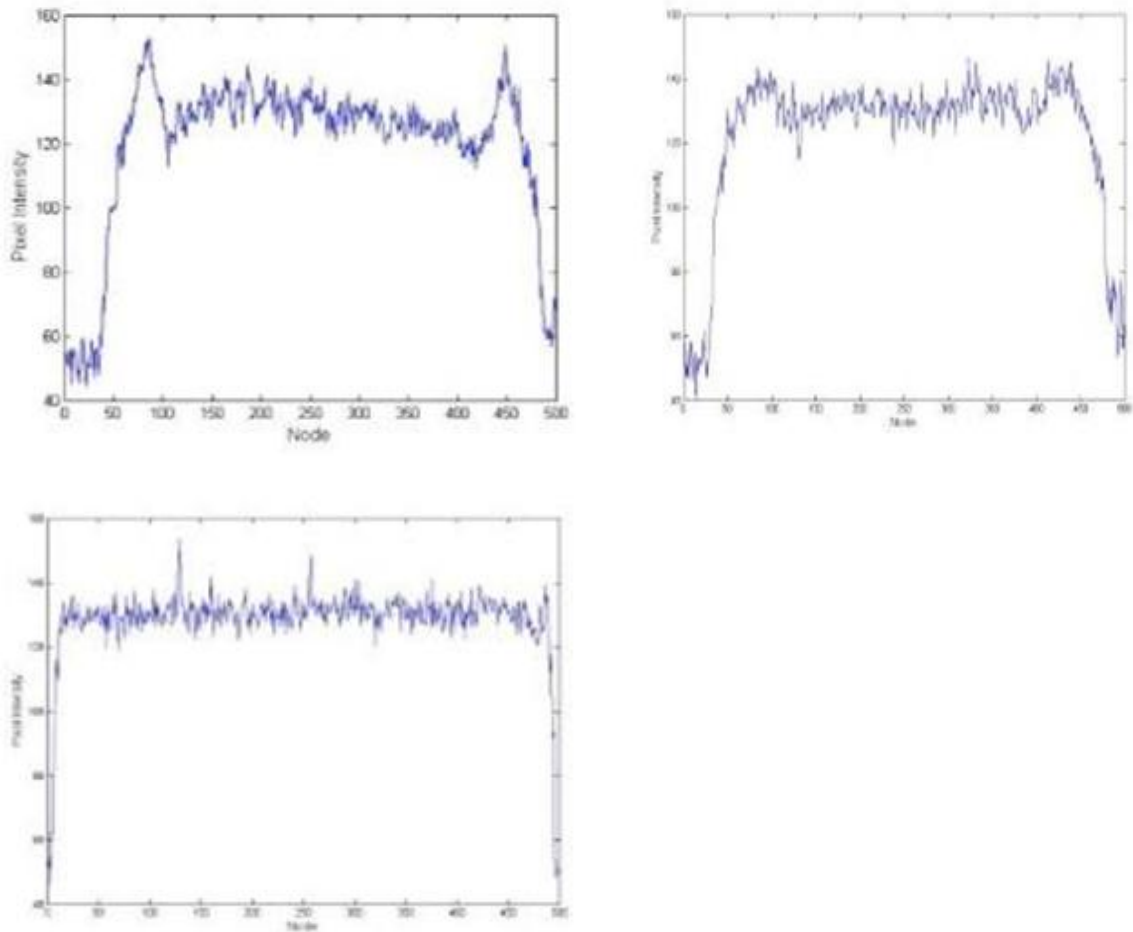
Figure 16. Relative pixel intensity in a transverse section across the pillow near the bottom (left) end of the fuel plate (upper left), transverse across the center section (upper right, see Figure 15 for section line), and in the longitudinal direction (bottom, see Figure 15 for section line).

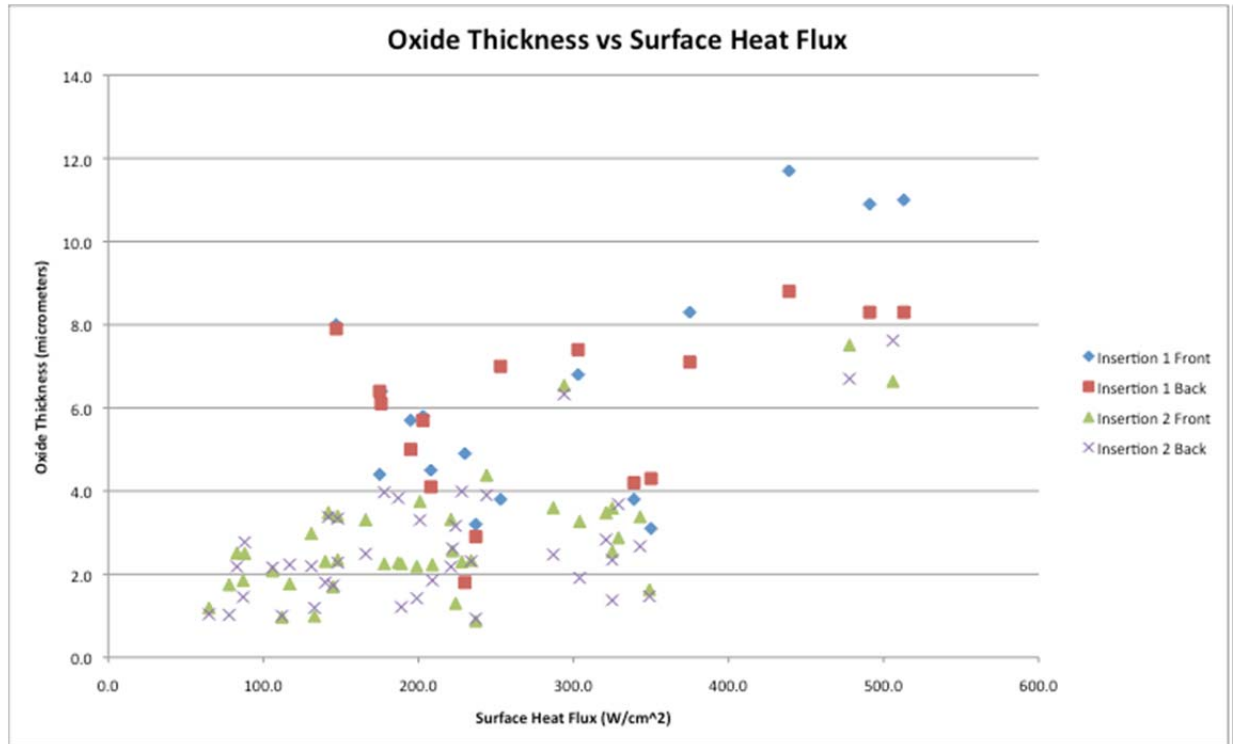
Figure 19. Plate surface oxide-thickness values as a function of average surface heat flux.

Based on the results shown, a similar oxide-growth behavior occurred in both the Insertion 1 and Insertion 2 capsules. The growth appears to be stable throughout the entire power regime tested in these two insertions.

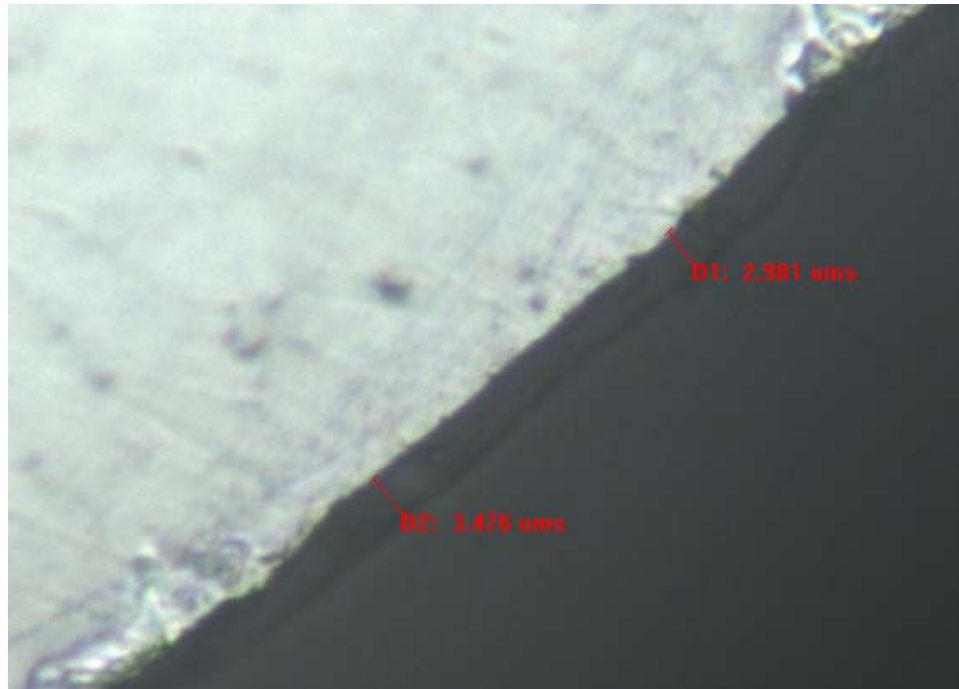
Figure 20. Metallographic image of L1P5C2 showing oxide growth on the plate surface with thickness measurements.

Oxide-thickness measurements were taken in several areas where the oxide layer was intact. The measured thicknesses can be seen in Table 8 as a function of plate and mount number. The plate average oxide measurements via metallography are provided for comparison with the plate average values measured using the eddy-current probe. Values observed using metallography are similar and exhibit relatively large scatter, similar to the values measured by the eddy-current method.

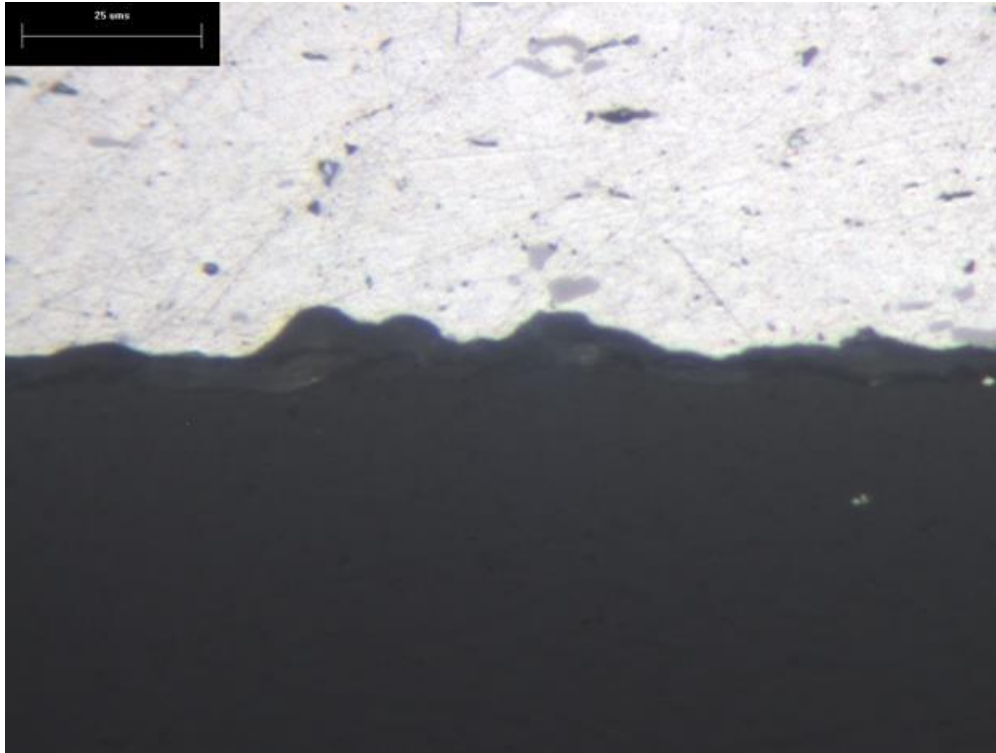
Figure 22. Image of L2P499 showing surface roughness.

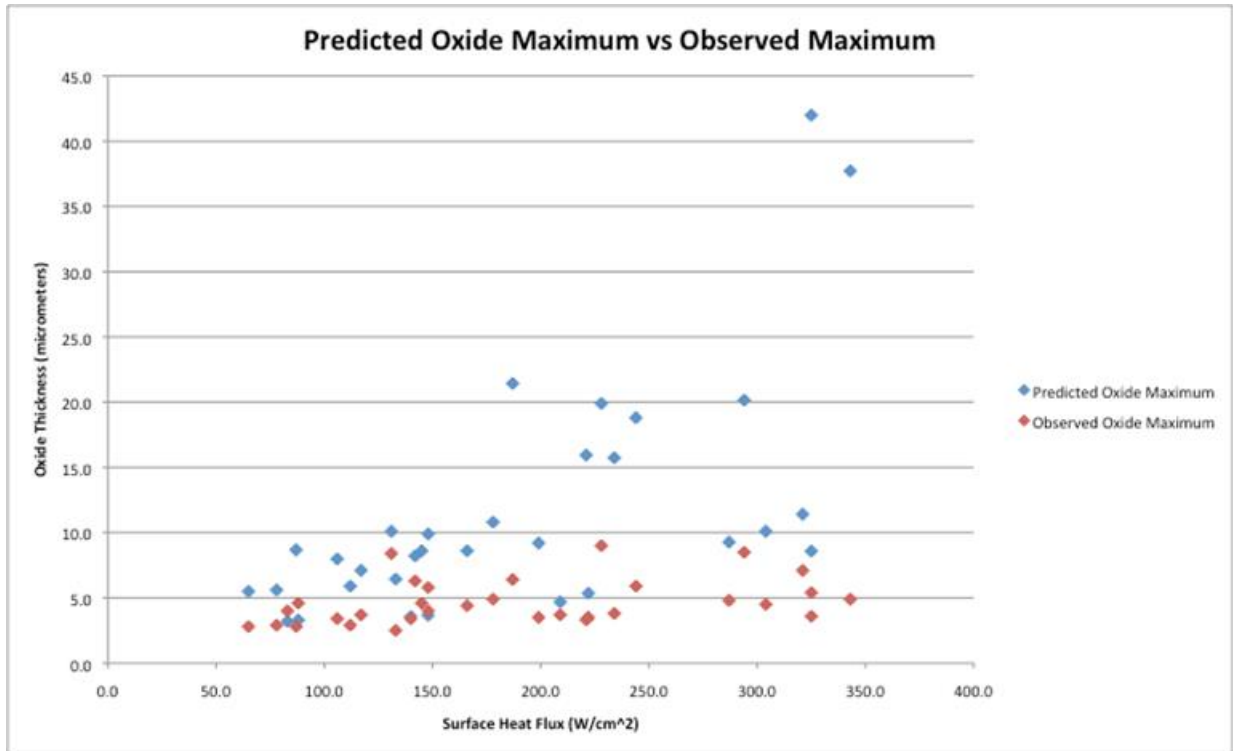
Figure 24. Predicted oxide-thickness maximums versus observed oxide-thickness maximums.

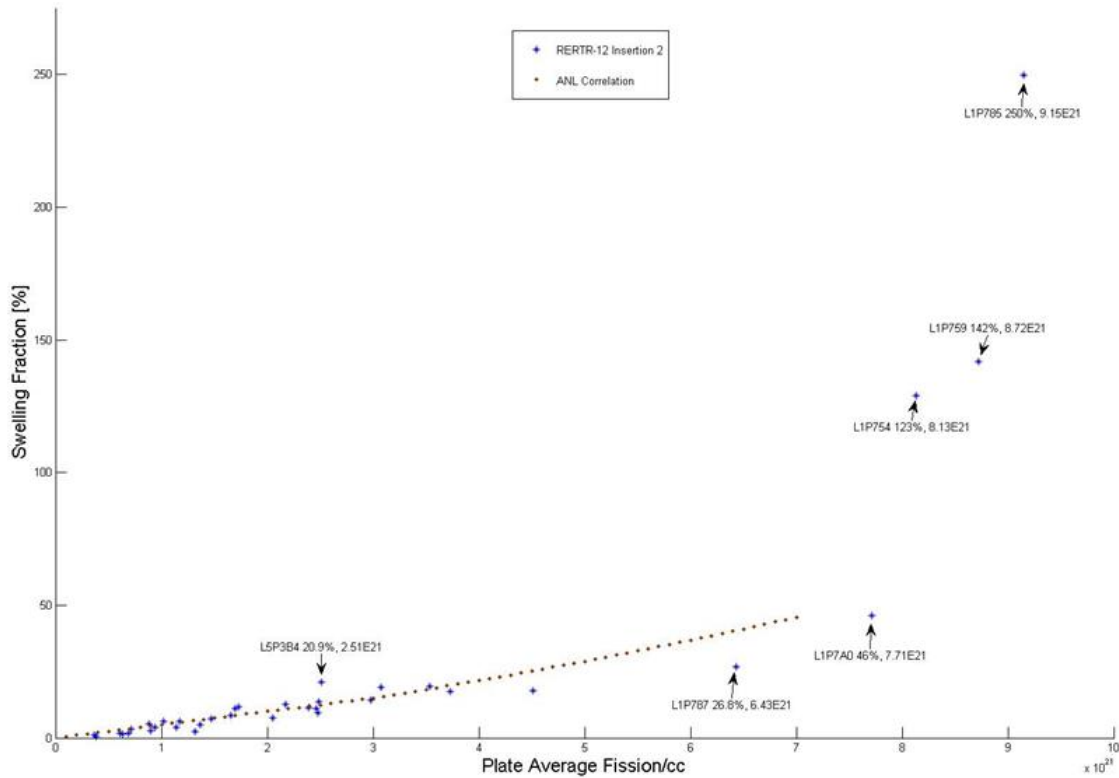
Figure 25. Profilometry-based swelling fraction vs average plate fission density for Insertion 2 and failed plates.

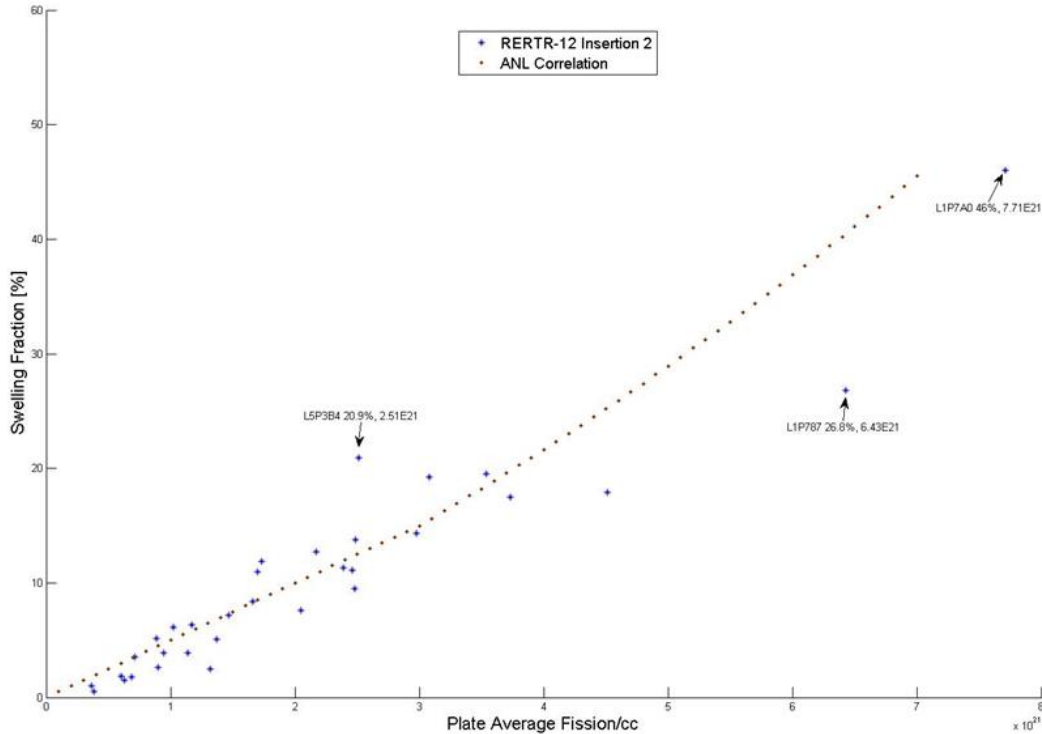
Figure 26. Profilometry-based swelling fraction % vs average plate fission density for Insertion 2 only.

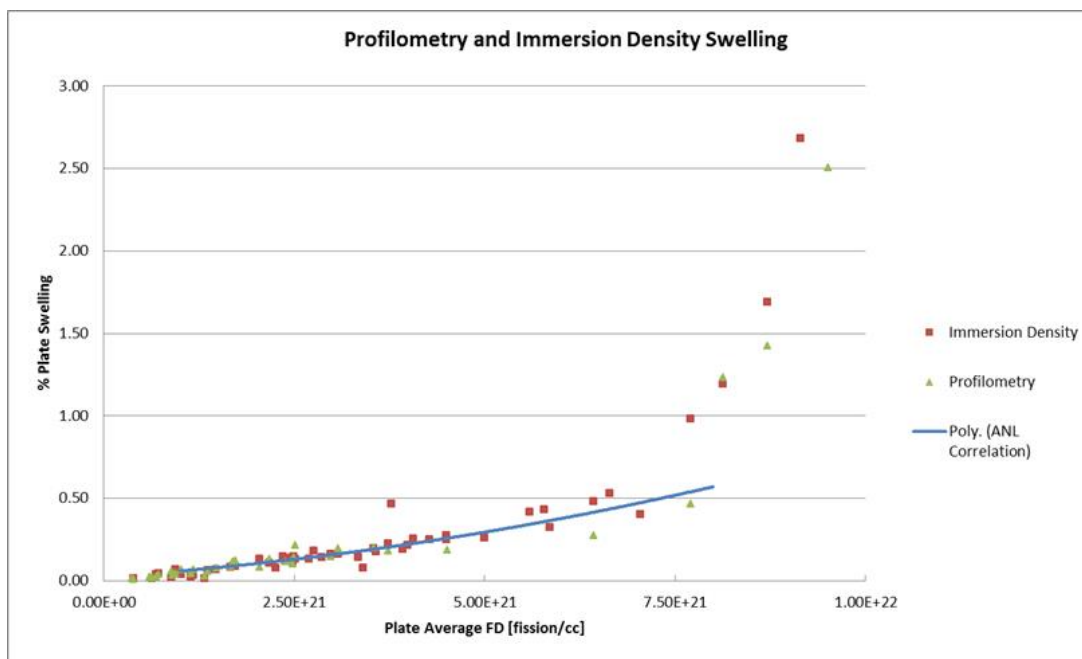
Figure 27. Profilmometry and immersion-density results.

The plates irradiated in the RERTR–12 insertion 2 experiment exhibited stable swelling behavior in accordance with the currently accepted U–Mo swelling correlation up to average fission densities of 7.6×10^{21} fission/cm³. Fuel-meat swelling in the majority of plates irradiated to fission densities less than 7.6×10^{21} fission/cm³ appears to be in line with the currently accepted U–Mo swelling correlation.

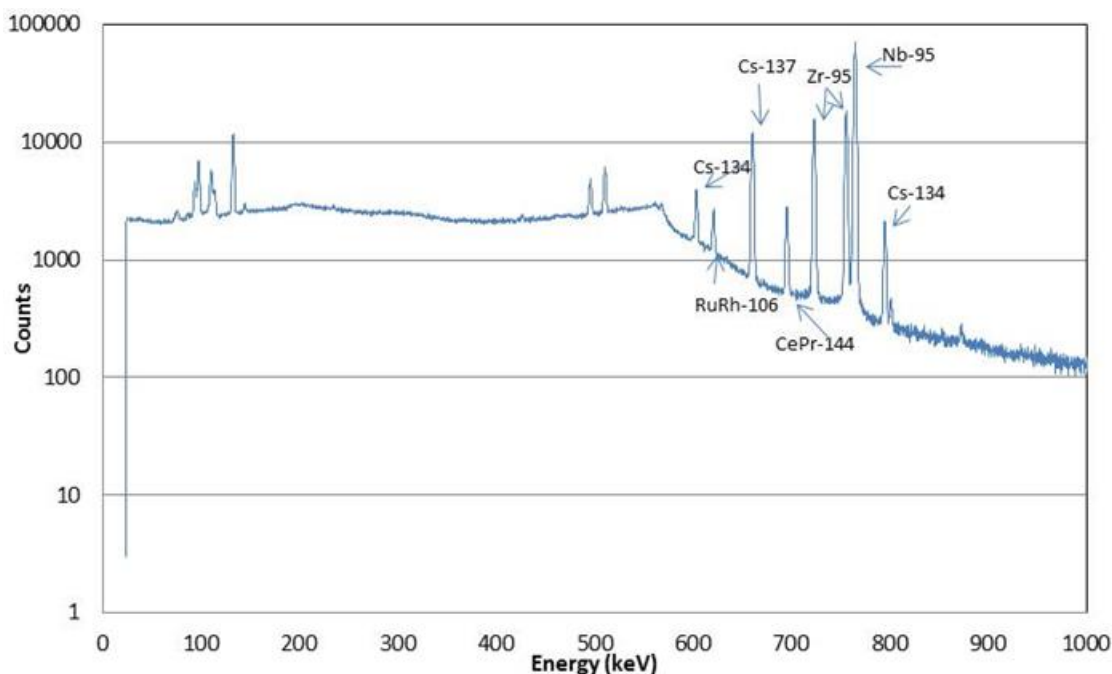
Figure 30. Typical RERTR-12 PGS Spectrum with key peaks labeled by their radionuclide. Plate L5P3B3, capsule 12E, 300 seconds live time.

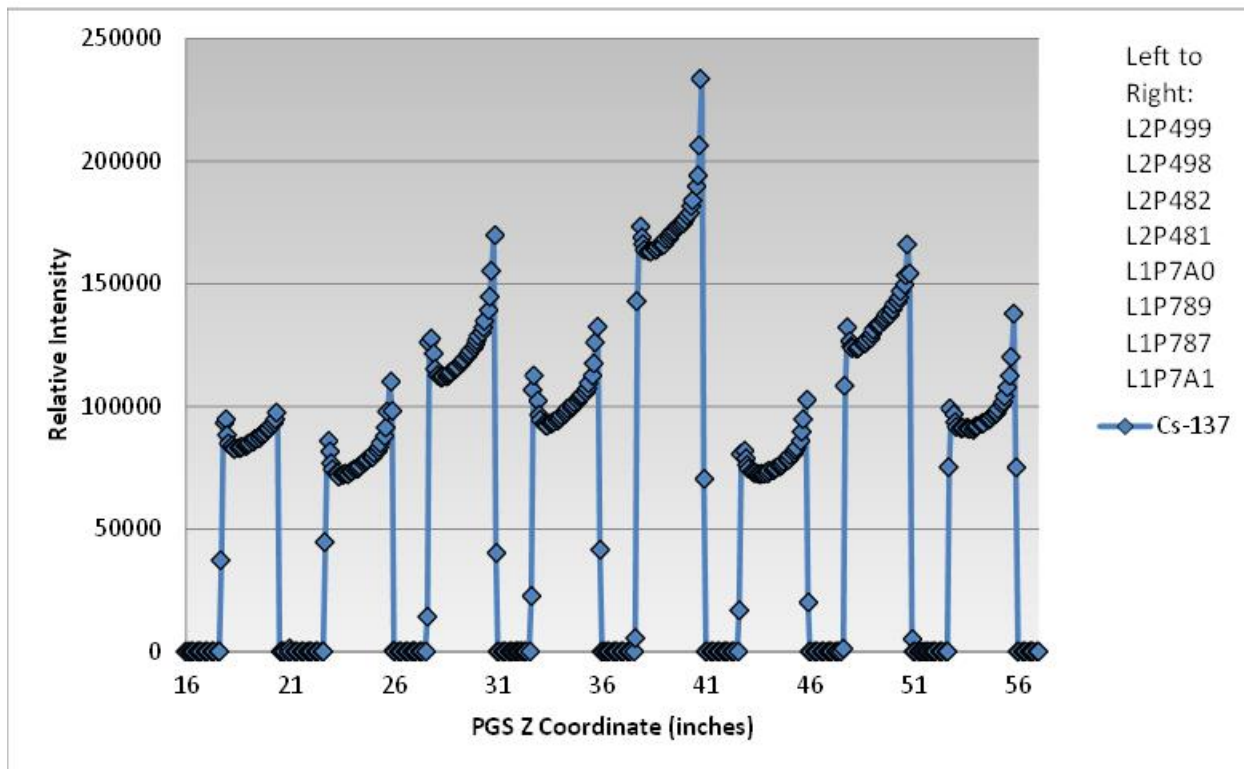
Figure 31. Vertical scan of plates from RERTR-12 Capsule A.

Figure 31). It should be noted that the three plates that exhibited pillowing are also three of the four plates with the highest fission density in the RERTR-12 irradiation.

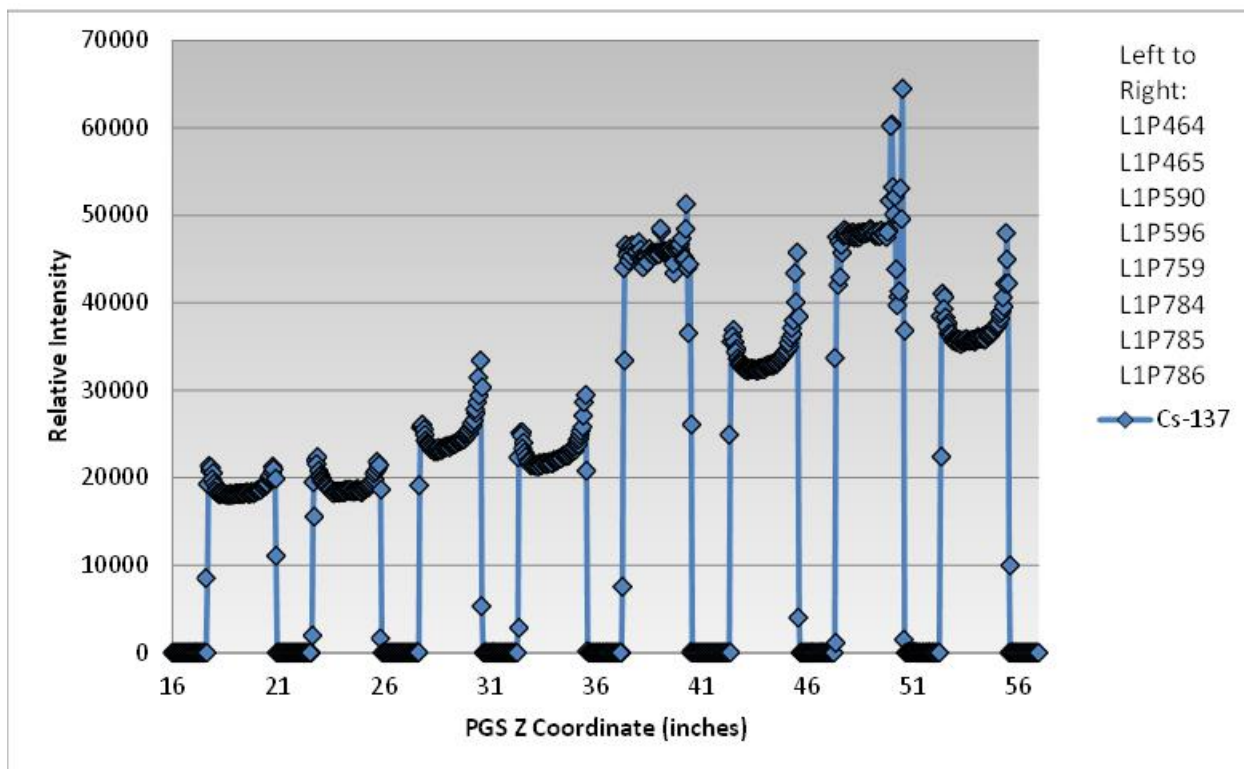
Figure 32. Vertical scan of plates from RERTR-12 Capsule B.

Figure 32). These plates both exhibited pillowing failure. The other atypical ^{137}Cs behavior is in capsule RERTR-12D plate L1P754 which also failed by pillowing (see Figure 34). Another plate, L1P7A0 from RERTR-12A, also indicated high swelling by immersion density, but not by profilometry.

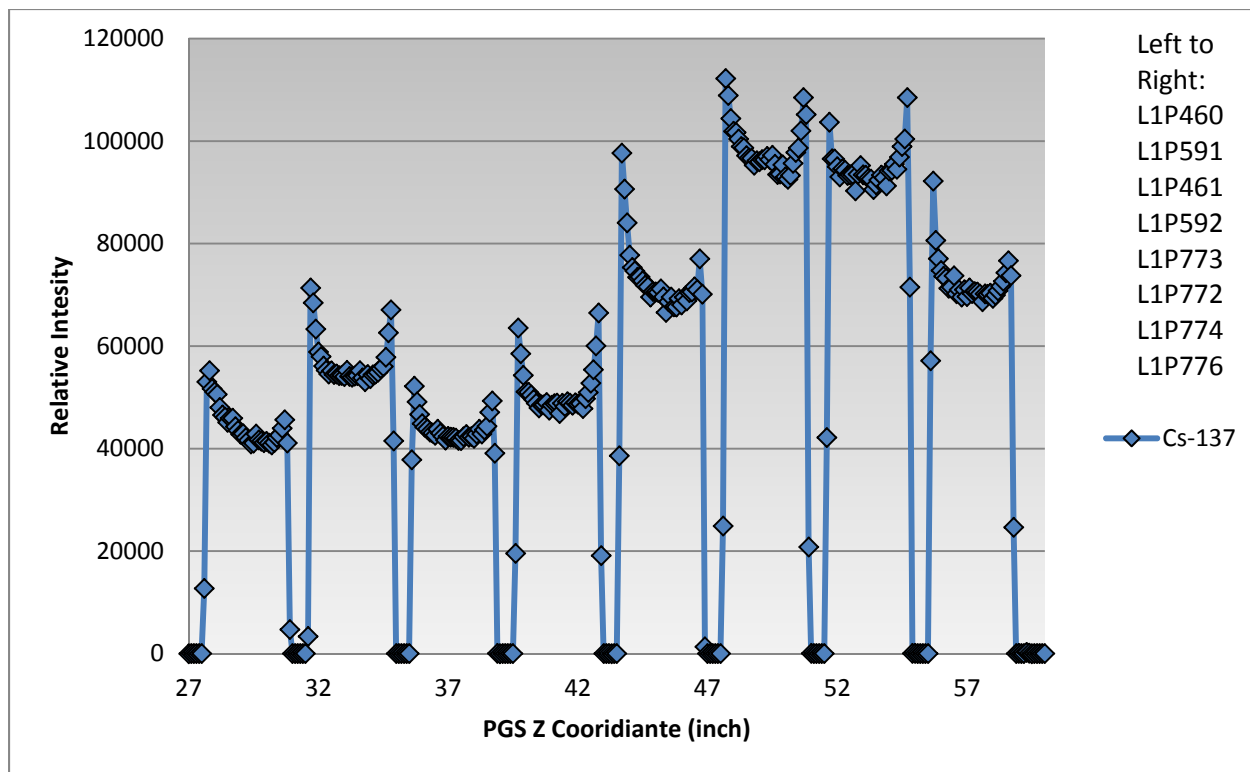
Figure 33. Vertical scan of plates from RERTR-12 Capsule C.

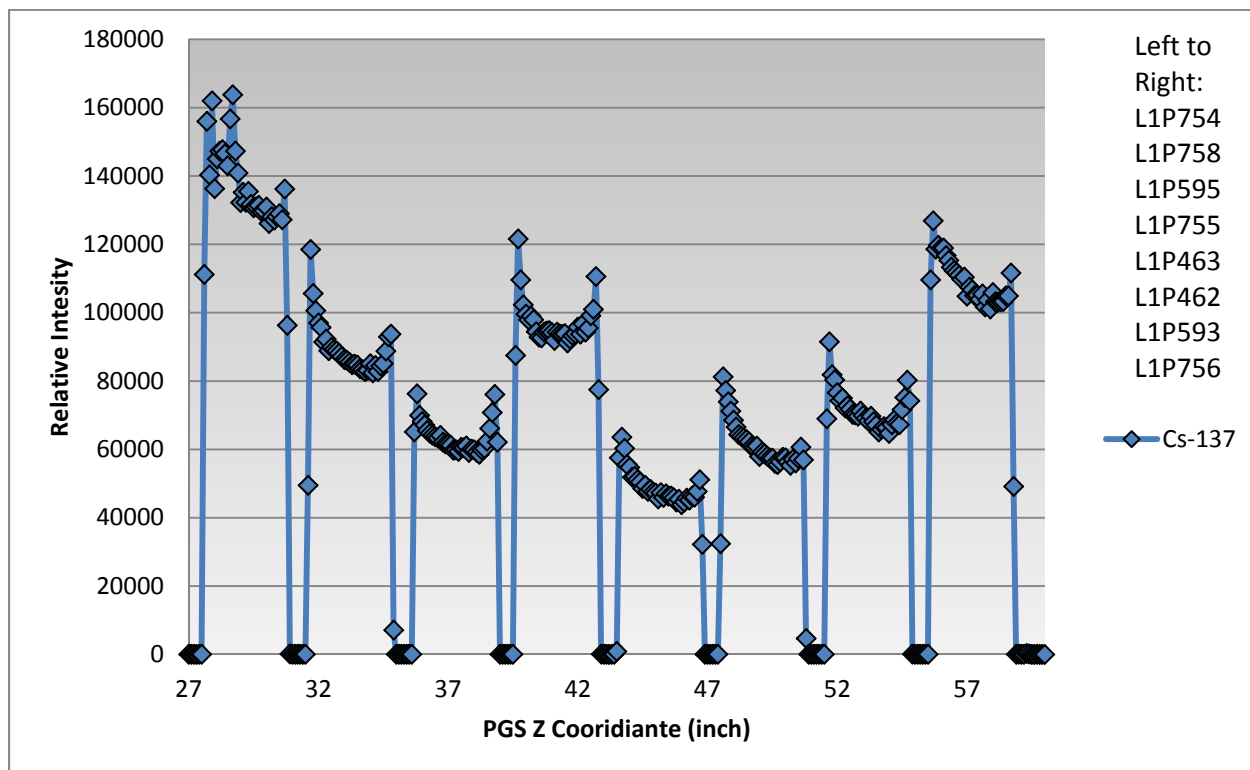
Figure 34. Vertical scan of plates from RERTR-12 Capsule D.

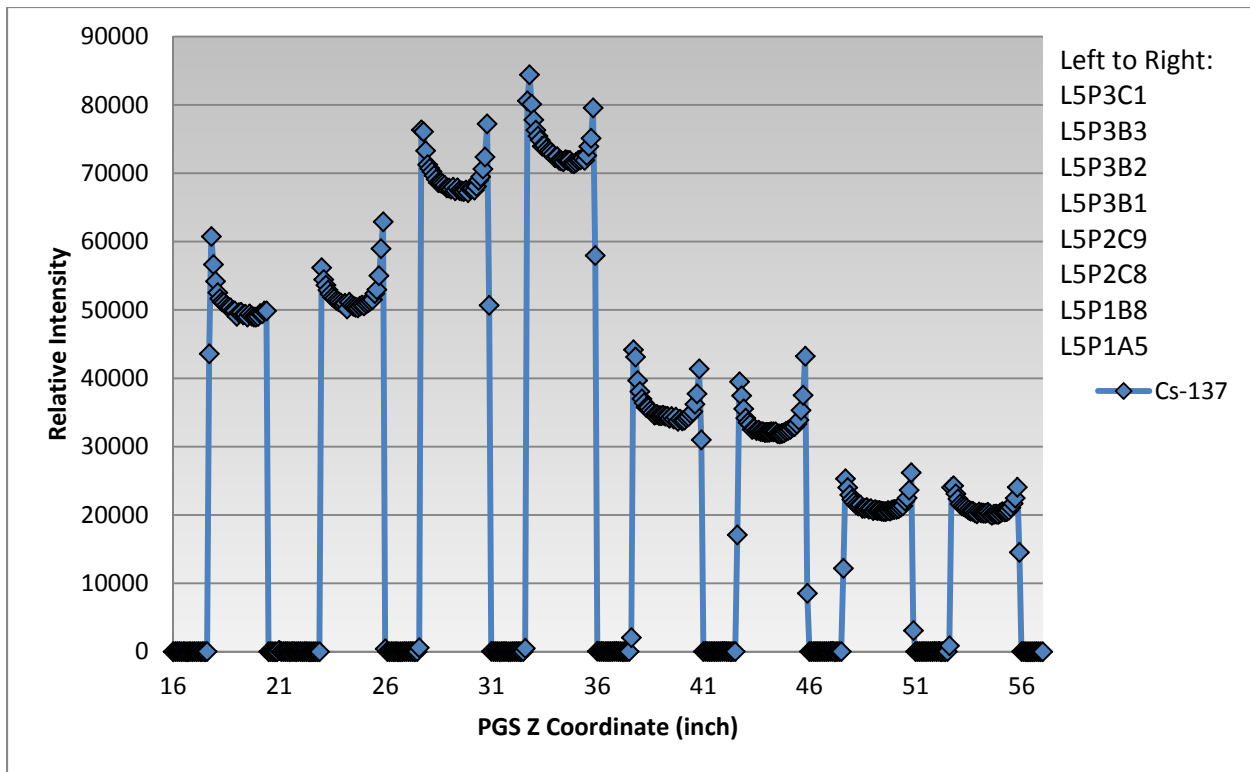
Figure 35. Vertical scan of plates from RERTR-12 Capsule E.

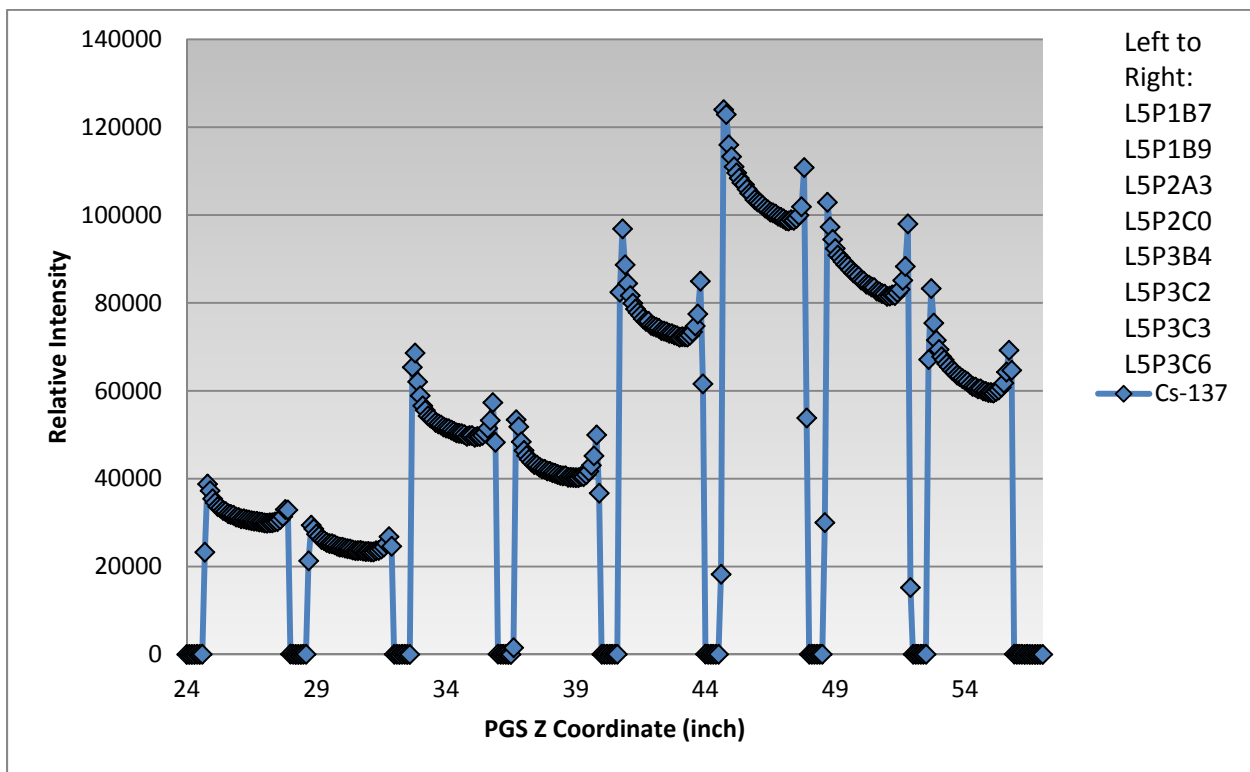
Figure 36. Vertical scan of plates from RERTR-12 Capsule F.

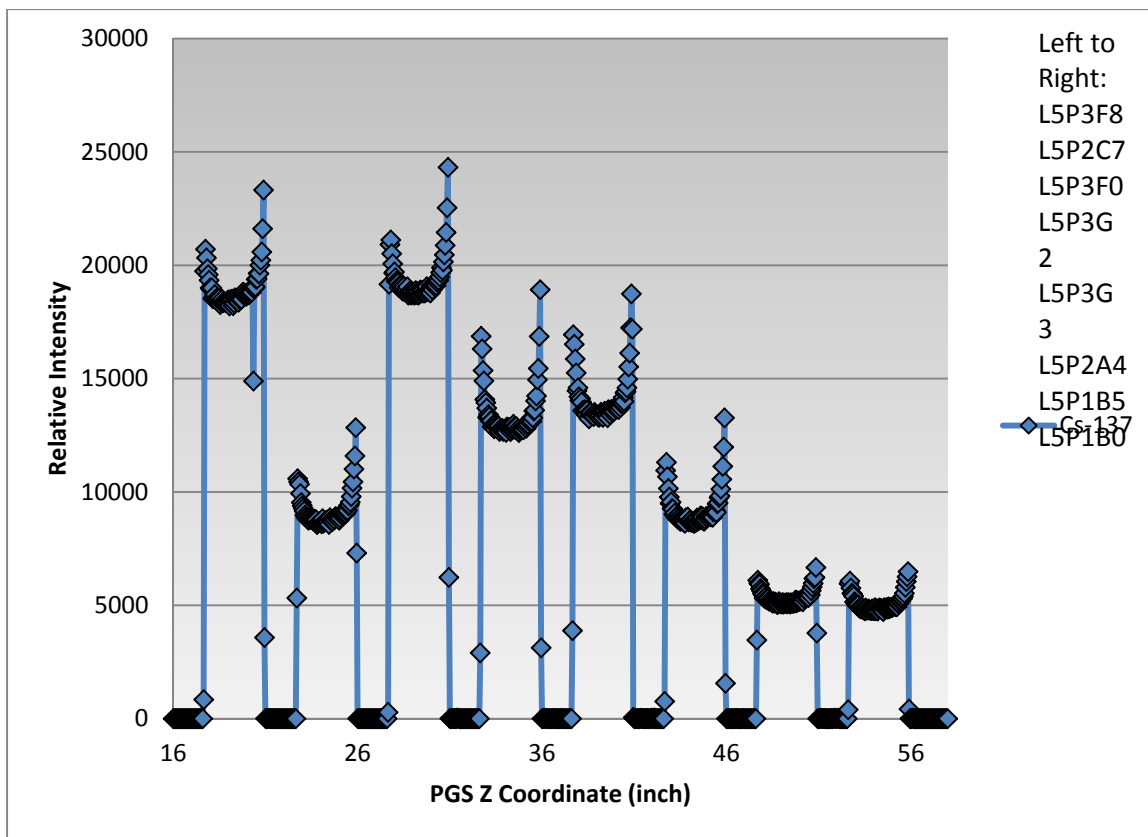
Figure 37. Vertical scan of plates from RERTR-12 Capsule G.
