RERTR-12 Post-irradiation Examination Summary Report

INL/EXT-14-33066
Revision 1

The following report contains the results and conclusions from post-irradiation examinations performed on RERTR-12 Insertion 2 experimental fuel plates. These examinations include eddy-current testing to measure oxide growth; neutron radiography for evaluating the condition of the fuel prior to sectioning and determination of fuel relocation and geometry changes; gamma scanning to provide relative measurements for burnup and indication of fuel- and fission-product relocation; profilometry to measure dimensional changes of the fuel plate; analytical chemistry to benchmark the physics burnup calculations; metallography to examine the microstructural changes in the fuel, interlayer and cladding; and microhardness testing to determine the material-property changes of the fuel and cladding. These characterization activities were conducted specifically to demonstrate that:

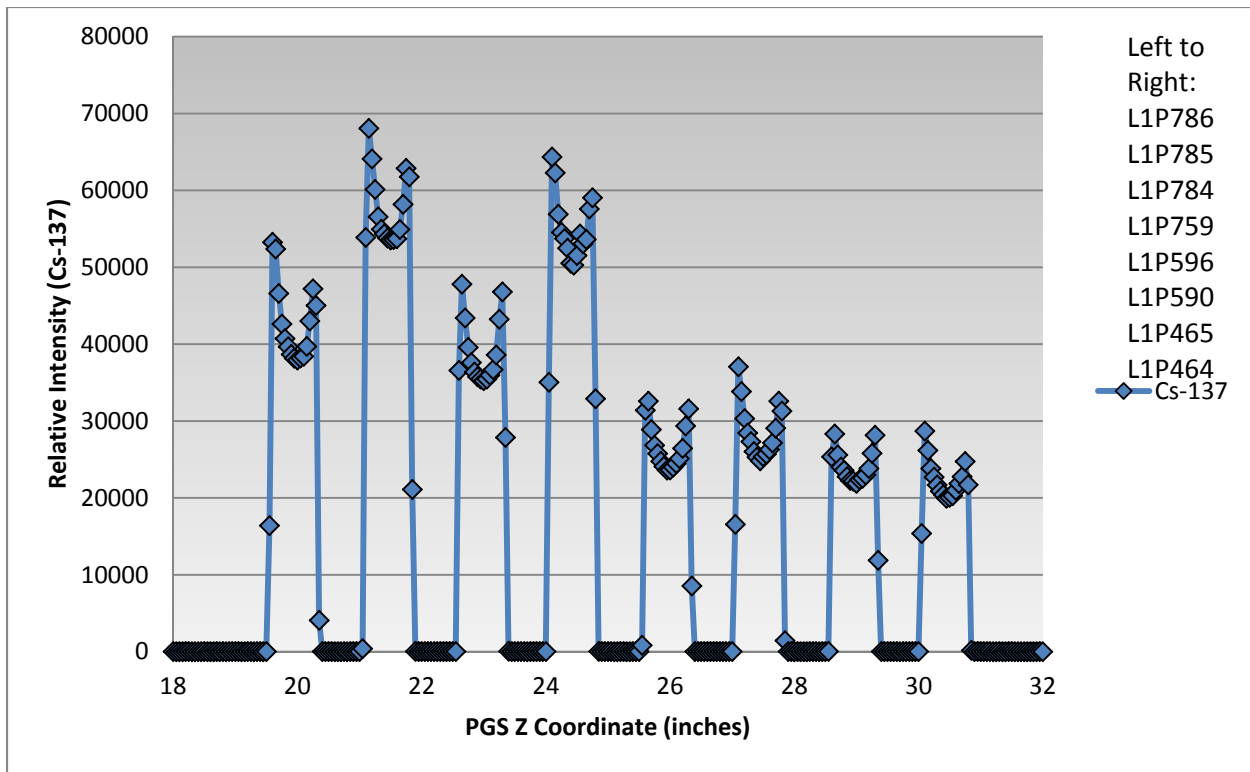
Figure 39. Transverse scan of plates from RERTR-12 Capsule B.

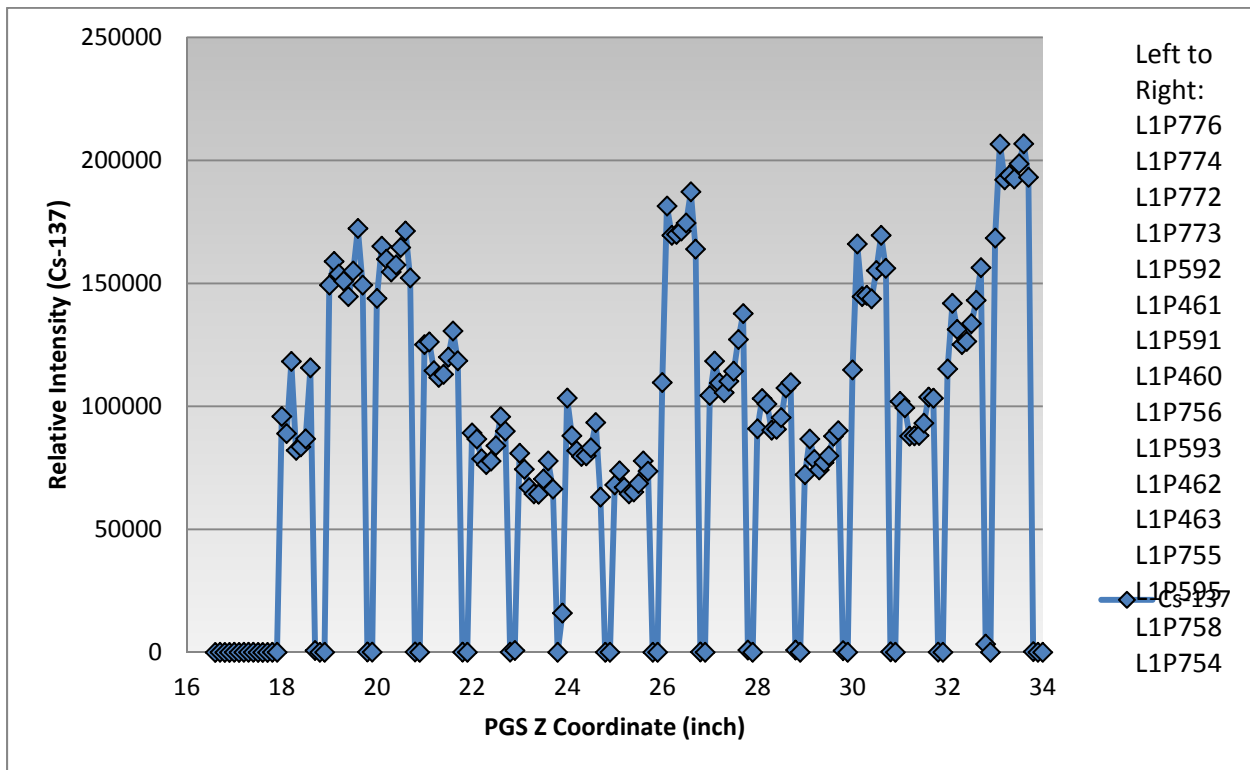
Figure 40. Transverse scan of plates from RERTR-12 Capsule C and Capsule D.

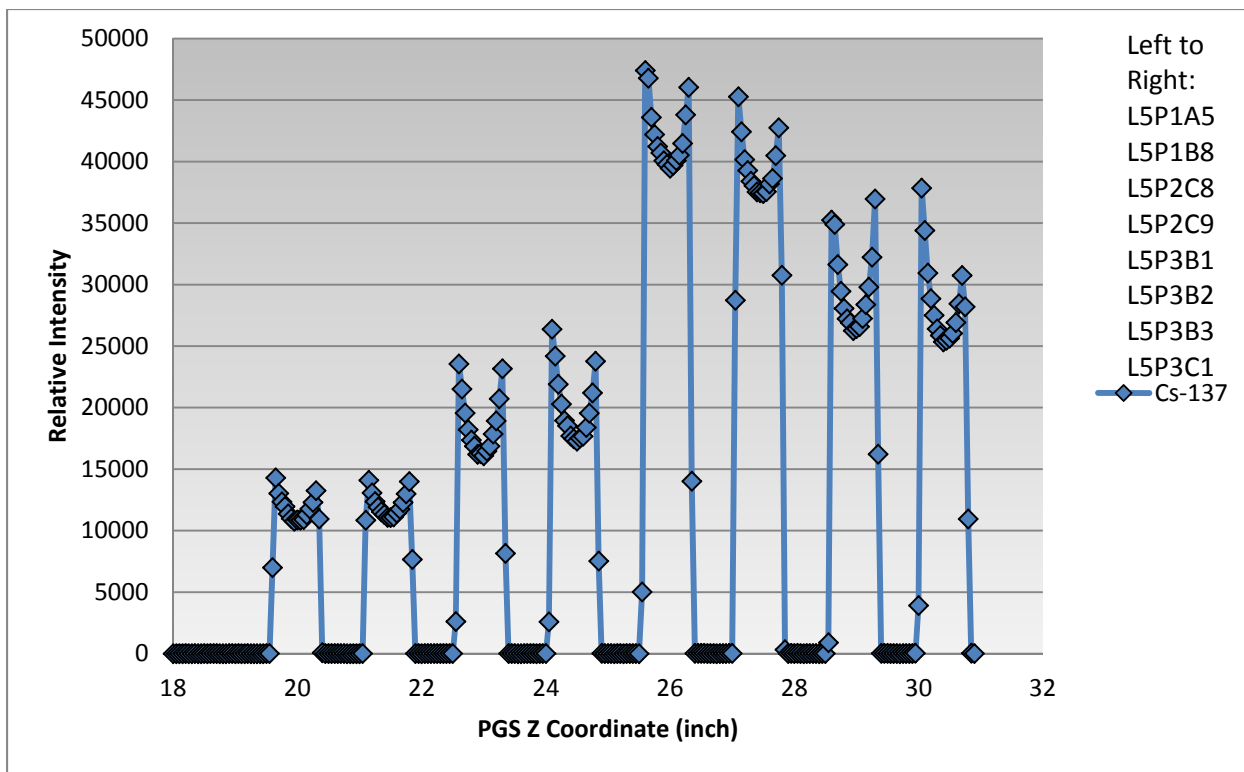
Figure 41. Transverse scan of plates from RERTR-12 Capsule E.

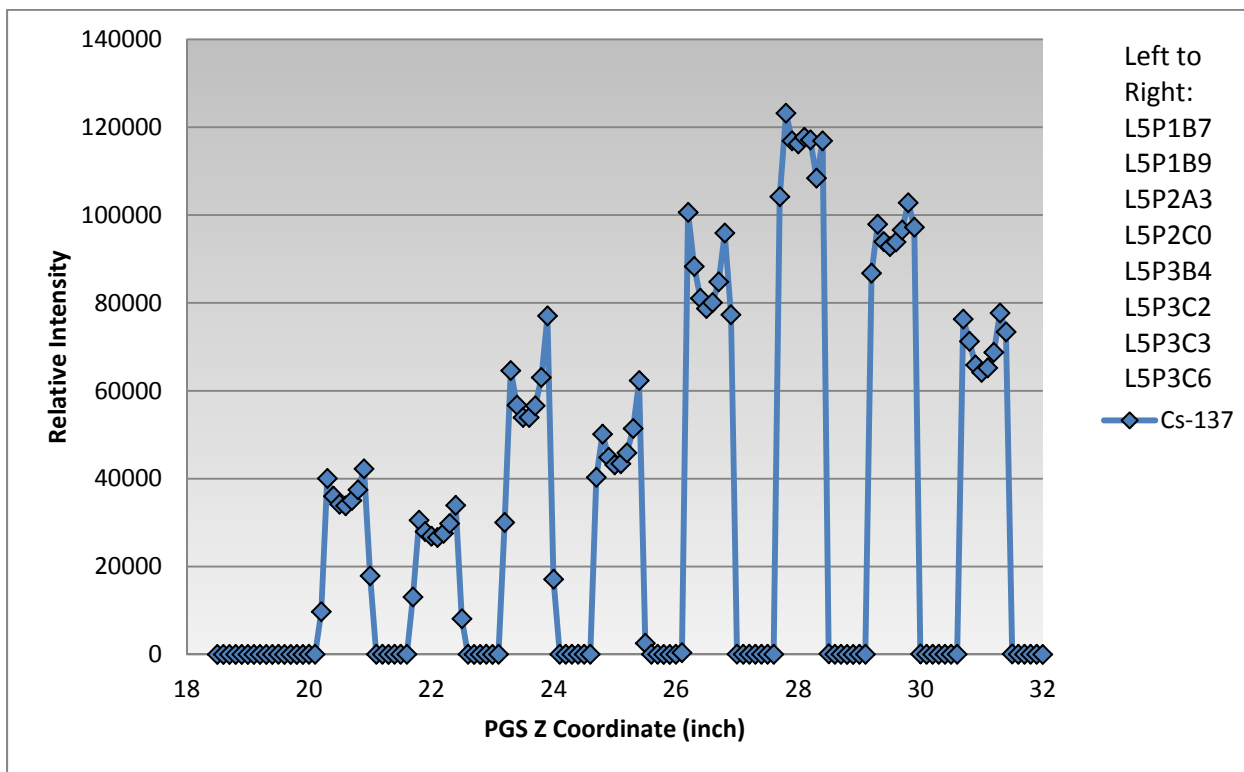
Figure 42. Transverse scan of plates from RERTR 12-Capsule F.

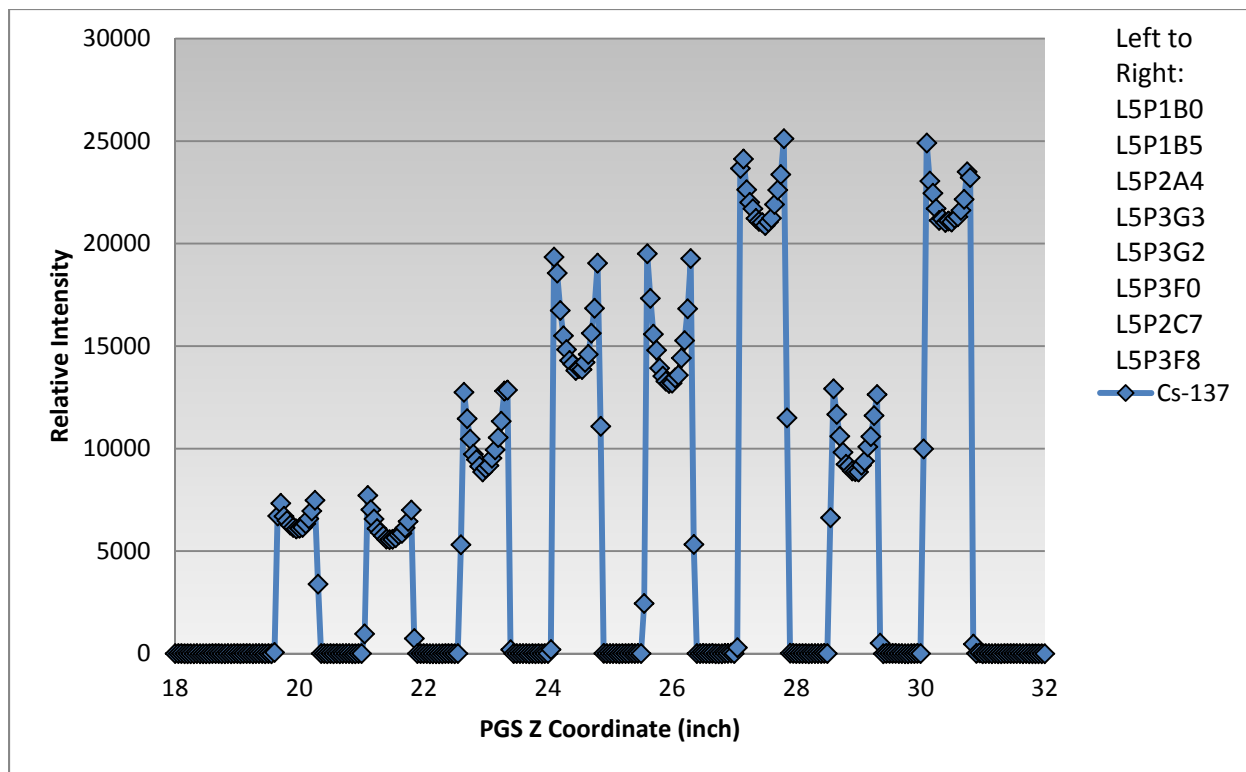
Figure 43. Transverse scan of plates from RERTR-12 Capsule G.

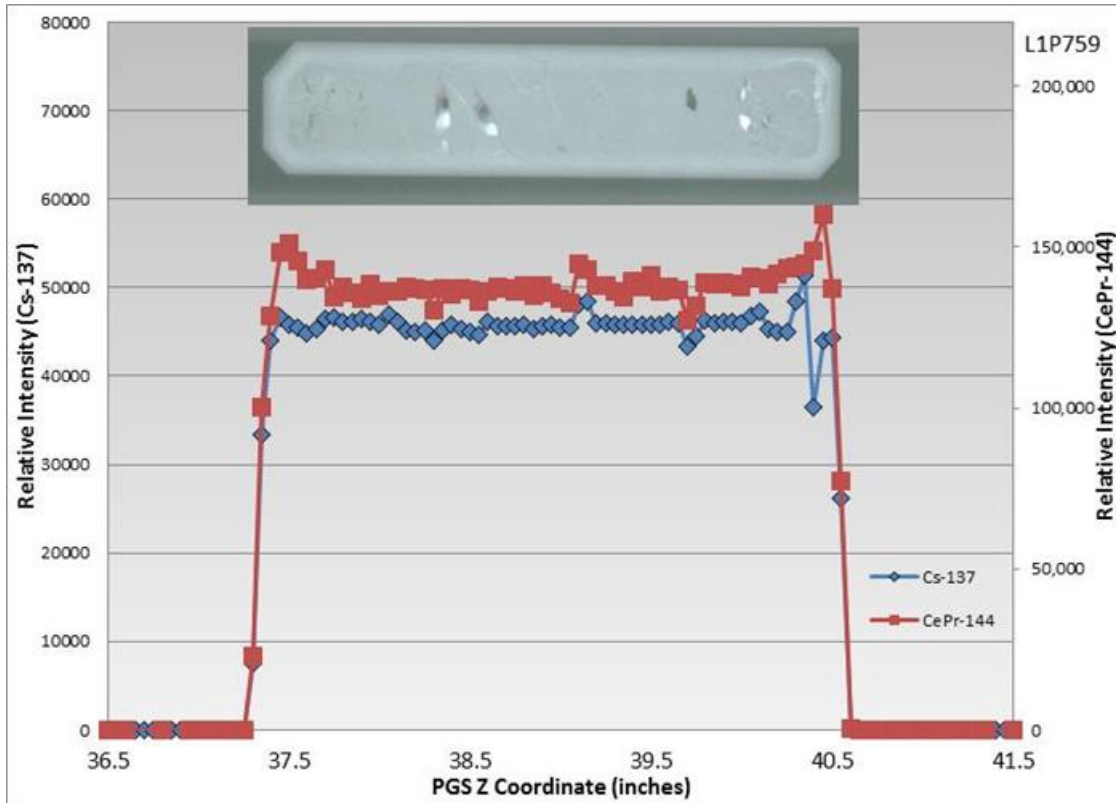
Figure 44. Gamma scan and neutron radiograph from plate L1P759.

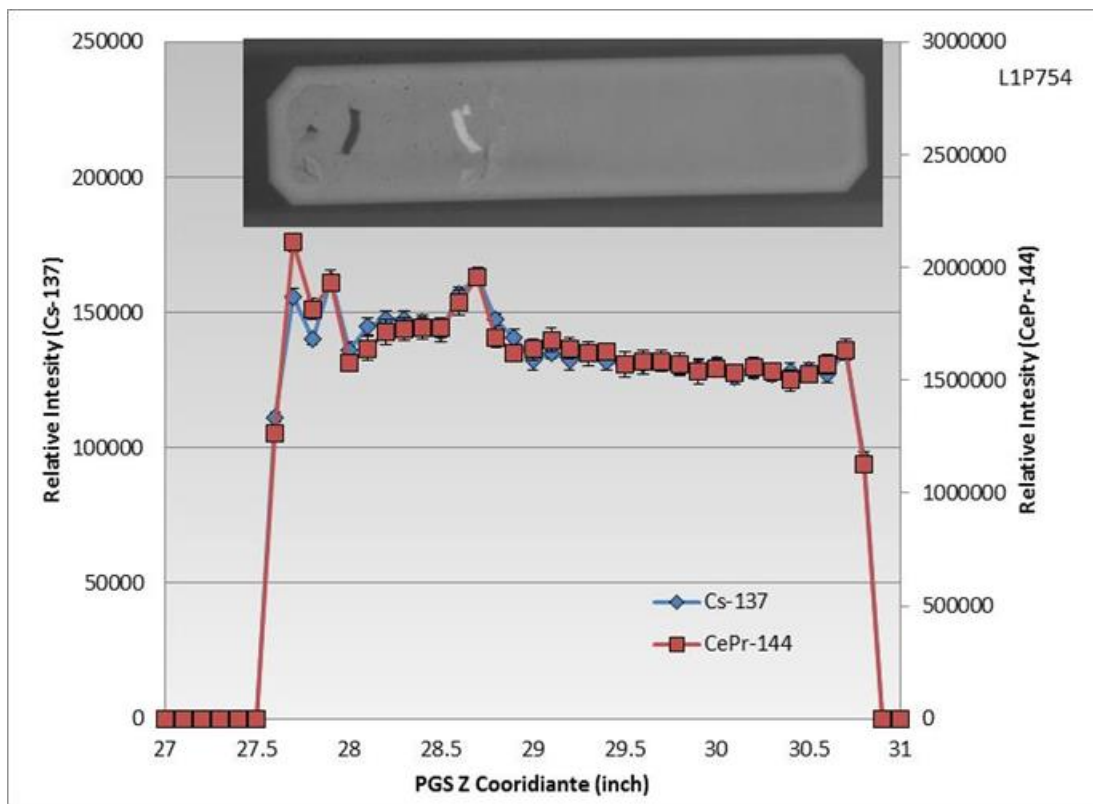
Figure 46. Gamma scan and neutron radiograph from plate L1P754.

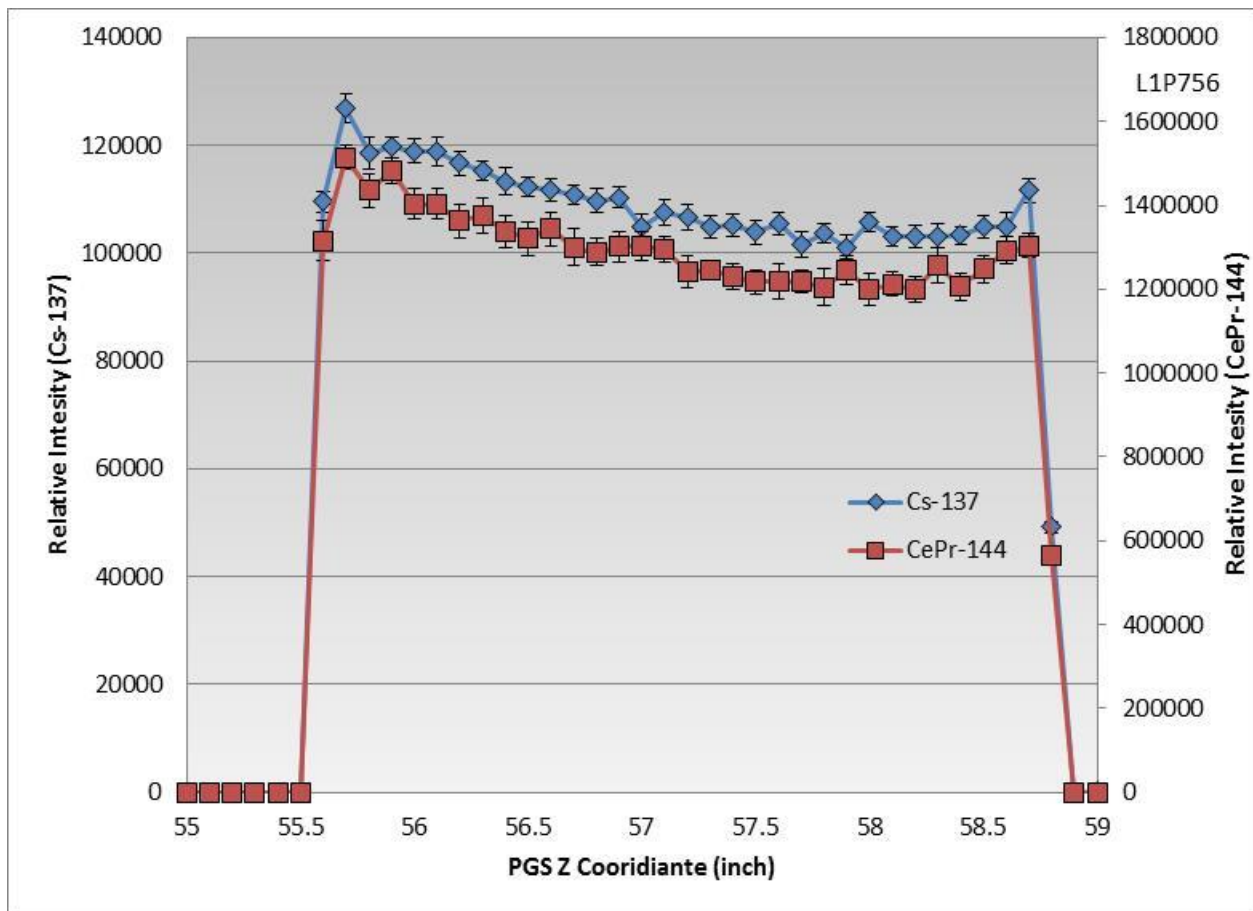
Figure 48. Gamma scan from plate L1P756.

Detail plots of the ^{137}Cs signal and $^{144}\text{Ce/Pr}$ signal from plates L1P7A0 and L1P756 are also shown in Figure 47 and Figure 48. Plate L1P7A0 is the plate lowest in fission density that exhibited anomalous swelling, and plate L1P756 is the plate with the highest fission density of all plates that did not pillow or exhibit signs of high swelling. There are no anomalies in the fission-product distribution that indicate failure in plate L1P7A0. Likewise, nothing appears in the fission-product distribution from L1P756 to indicate fission-product migration that could be used to predict impending failure.

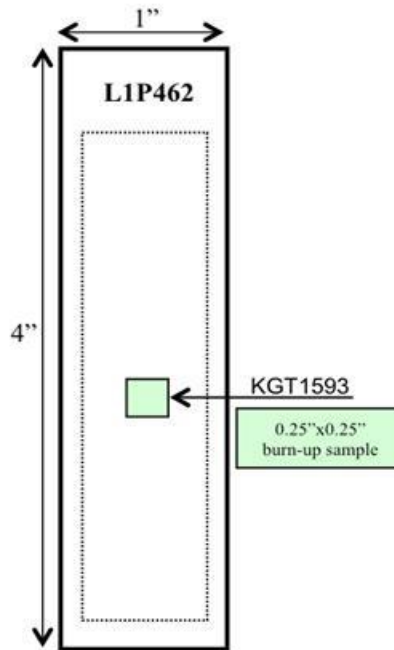
Figure 49. Example of sample location for verification of ^{235}U depletion in RERTR-12 plates.

A set of measurements involving six RERTR-12 plates verified ^{235}U depletion (via fission and neutron capture). For this purpose 0.25 in. \times 0.25 in. samples were taken from each plate just below the axial midplane, in the central region of the fuel meat (see Figure 49). These samples contained both fuel and cladding. The samples were weighed and dissolved, and the resultant solutions were analyzed for uranium, plutonium and selected fission-products isotopes using inductively coupled plasma mass spectrometry (ICP-MS). In addition, to confirm ICP-MS results for uranium and plutonium isotopes, the same samples were analyzed using thermal ionization mass spectrometry (TIMS).

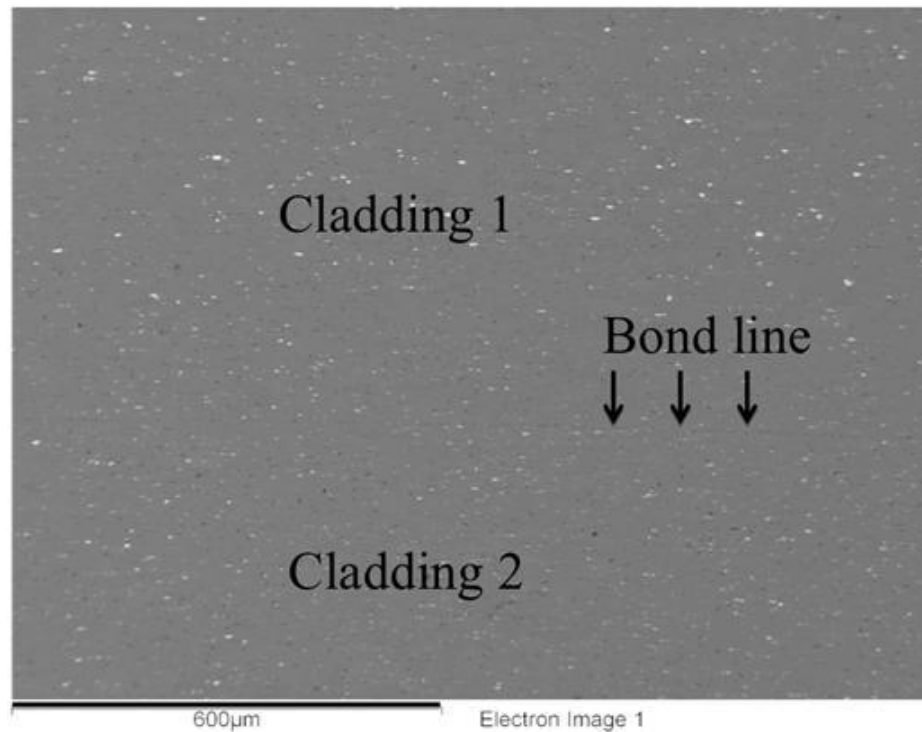
Figure 51. SEM image of the cladding-to-cladding bond line and surrounding area in unirradiated fuel plate L1P756.

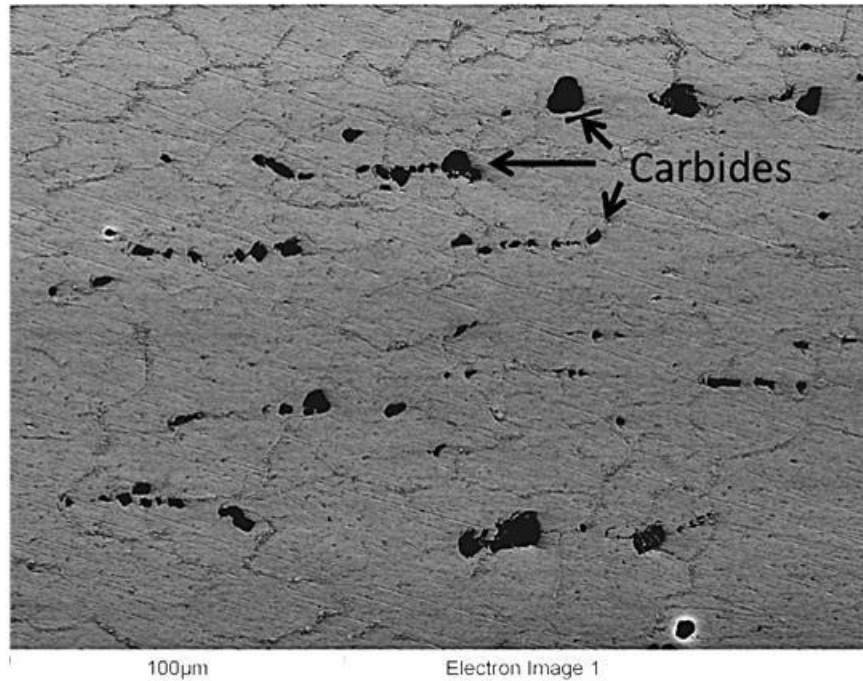
Figure 53. SEM micrograph of unirradiated archive plate L2P497 of the same feedstock material (alloy 344) that comprises L2P499 which was irradiated. It contains carbide/oxide inclusions that are characteristic of this feedstock with carbon content of > 500 ppm. It can be seen that the asymmetric grains up to 100 micrometers in length are present in the microstructure.

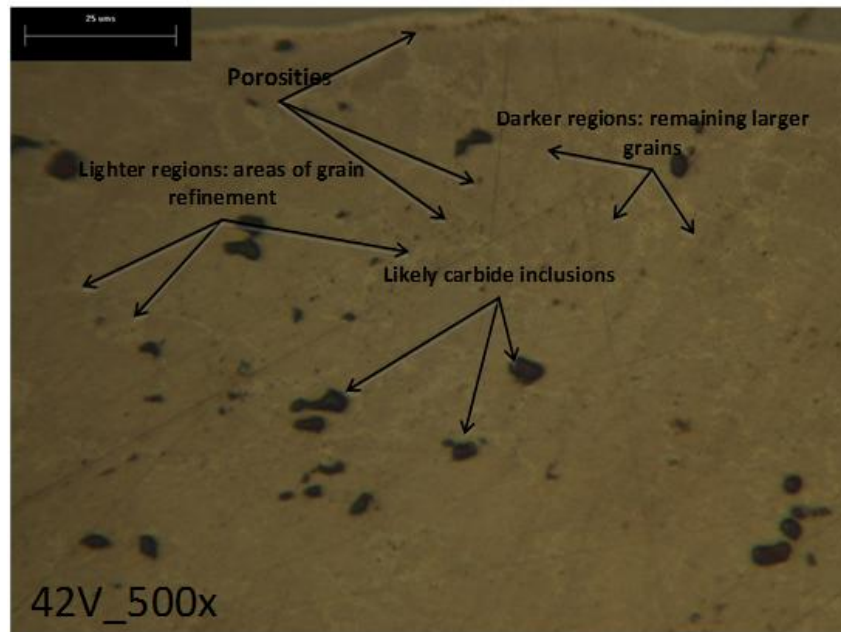
Figure 54. Optical micrograph of fuel plate L2P499 (Mount: 42V) after irradiation to a fission density of 2.5×10^{21} f/cm³. The remaining grains are approximately half of the starting grain size for this material. Fission-gas bubbles decorate the grain boundaries.

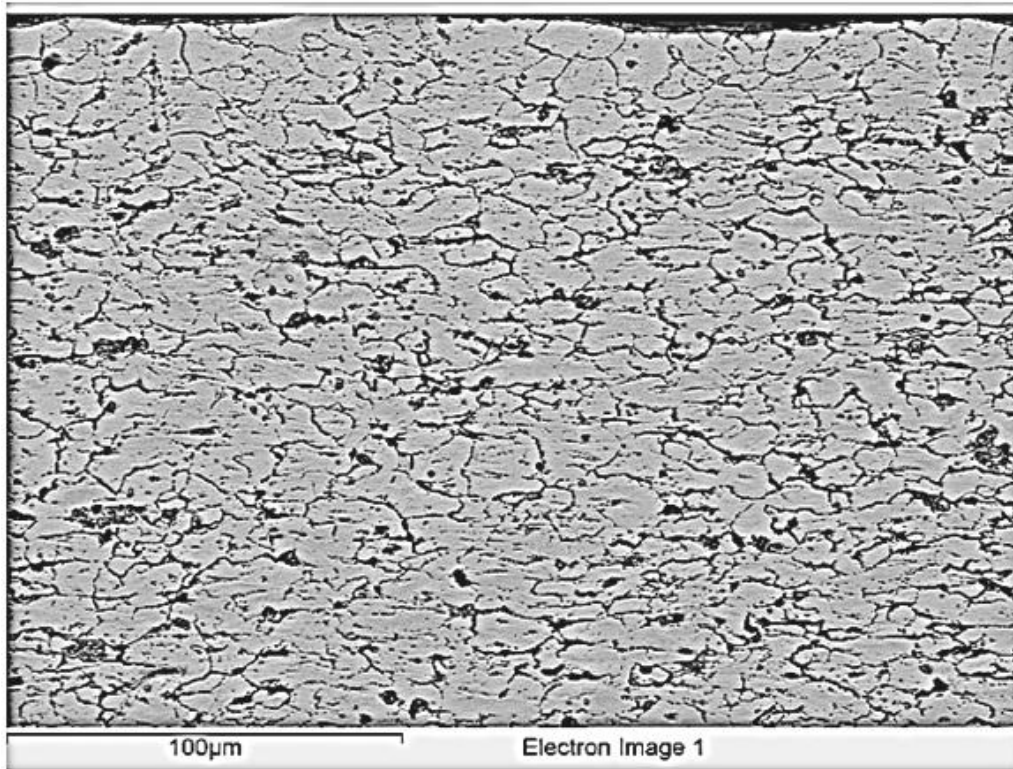
Figure 57. SEM micrograph of unirradiated plate L1P775, which is the same alloy material (alloy 328) and the starting microstructure as the irradiated plate L1P776 shown in Figure 58.

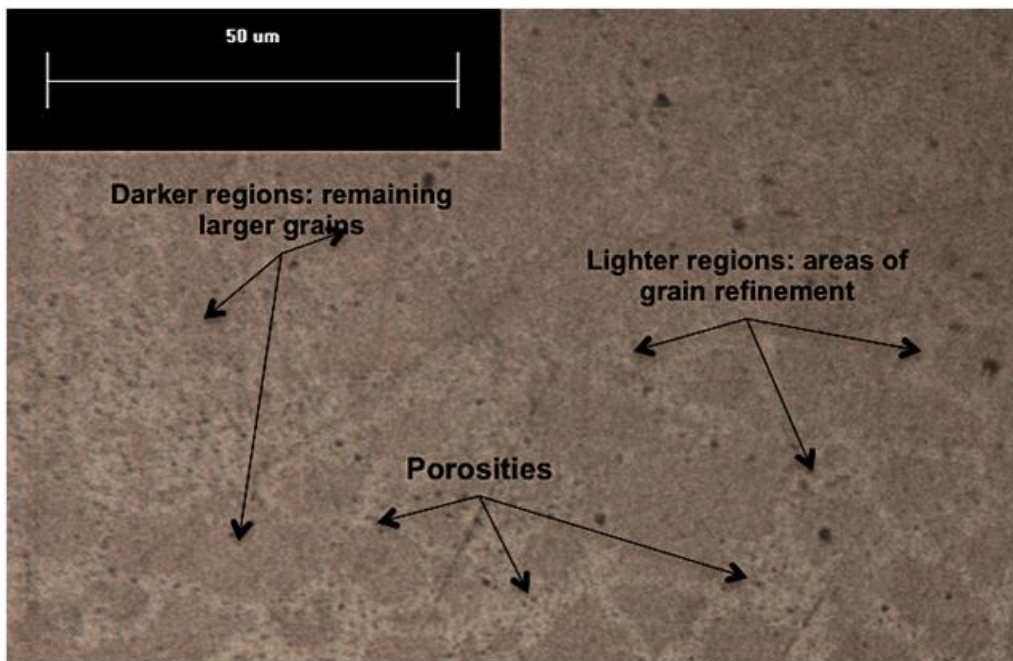
Figure 58. L1P776, mount of the mid-plane section. Fission density: $3.9 \times 10^{21} \text{ f/cm}^3$. The fraction recrystallized is obviously increasing and fission-gas bubbles are more apparent.

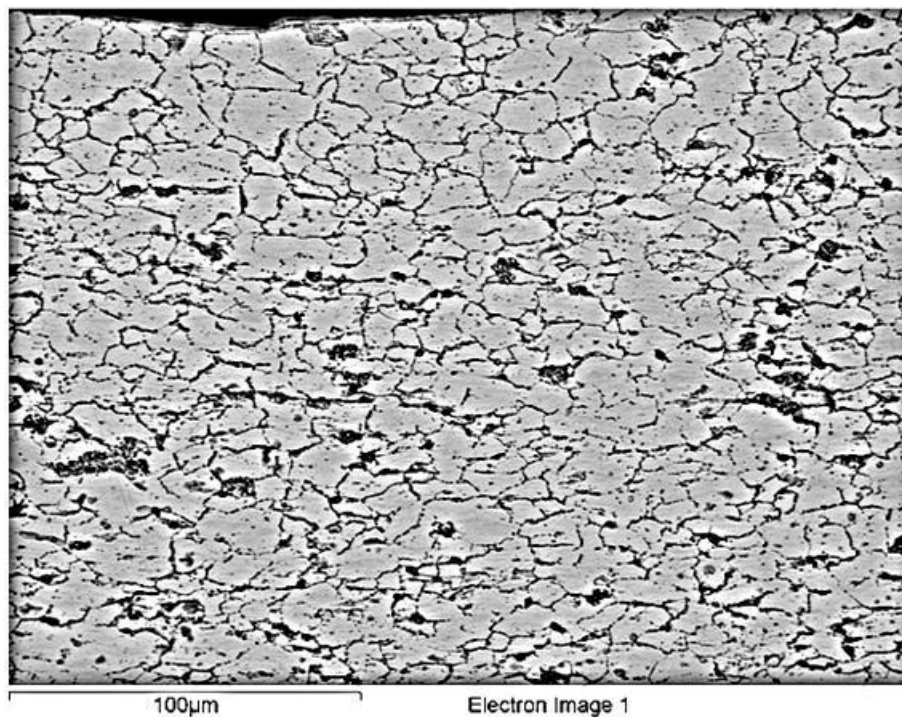
Figure 62. SEM micrograph of plate L1P757, which is the same alloy material (alloy 331) and the starting microstructure for the irradiated plate L1P759, shown in Figure 63.

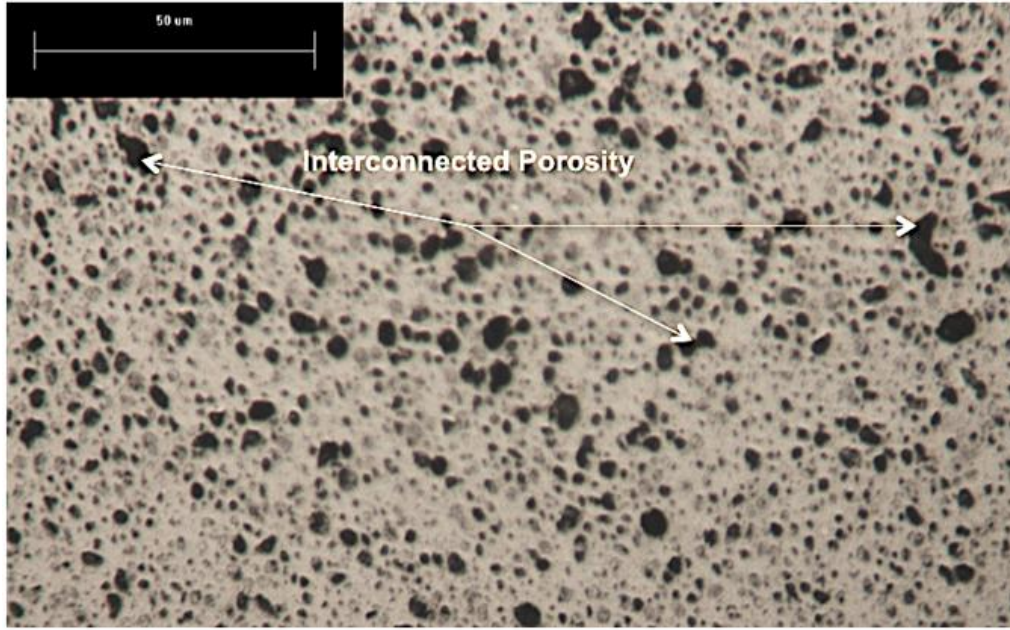
Figure 63. Plate L1P759, mount 26W. Average fission density: $8.7 \times 10^{21} \text{ f/cm}^3$. This plate blistered in-reactor. Interconnection of bubbles is evident in this micrograph of the middle of the fuel meat.

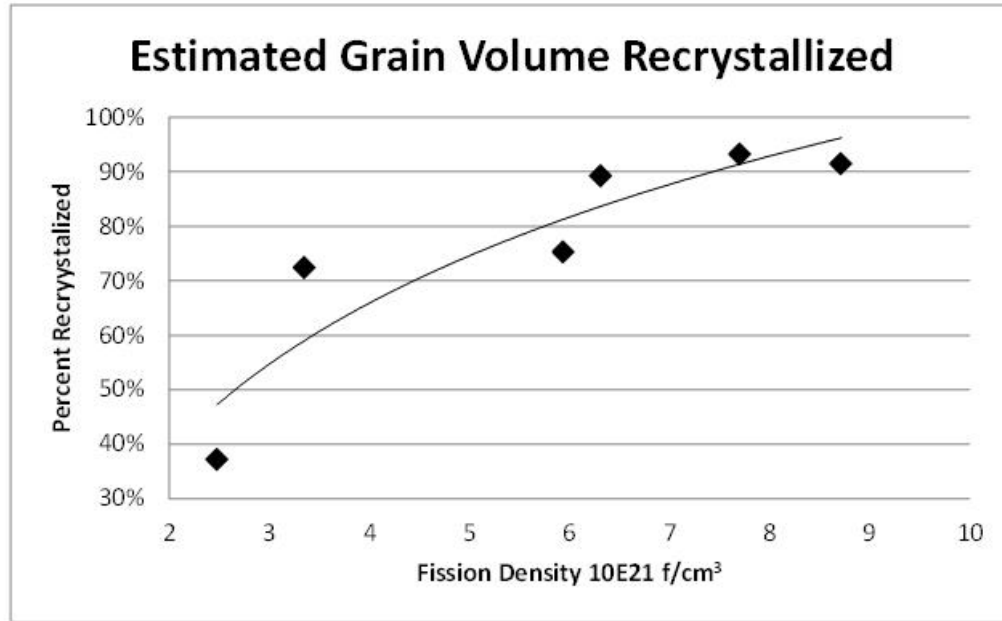
Figure 65. Estimated grain volume fraction recrystallized as a function of fission density. These data were generated using point counting (this method is explained in Section 4.2.2.5) and are considered preliminary pending studies of specimens following etching treatments (recommended to better resolve grains) and a larger sampling of microstructural data.

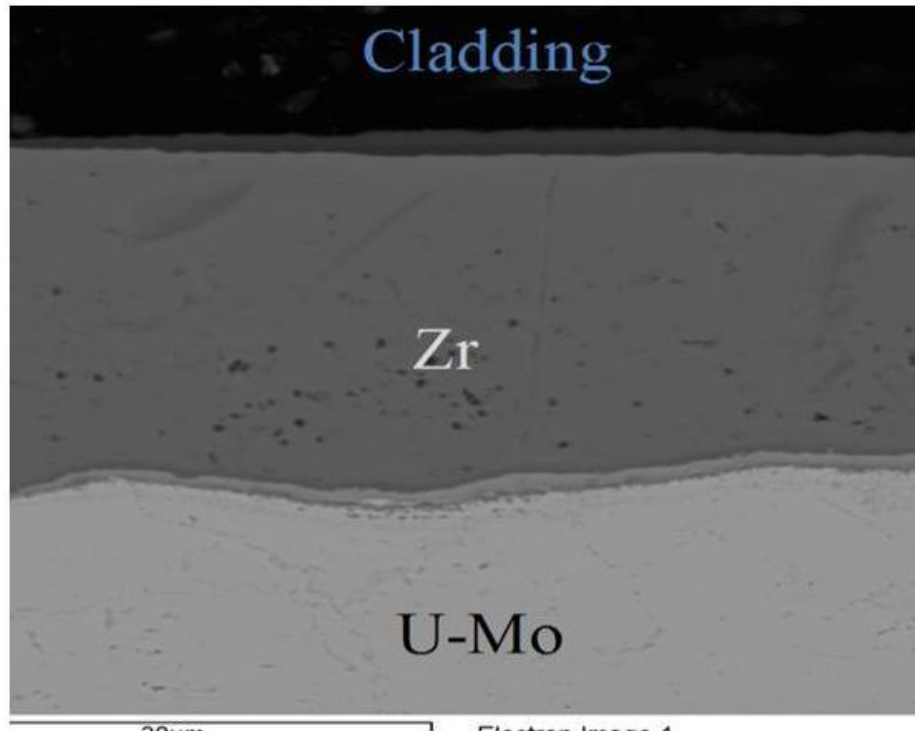
Figure 66. An SEM image of the cladding/zirconium/U-10Mo interfaces. A well-defined interaction layer can be observed at the cladding-to-zirconium interface.

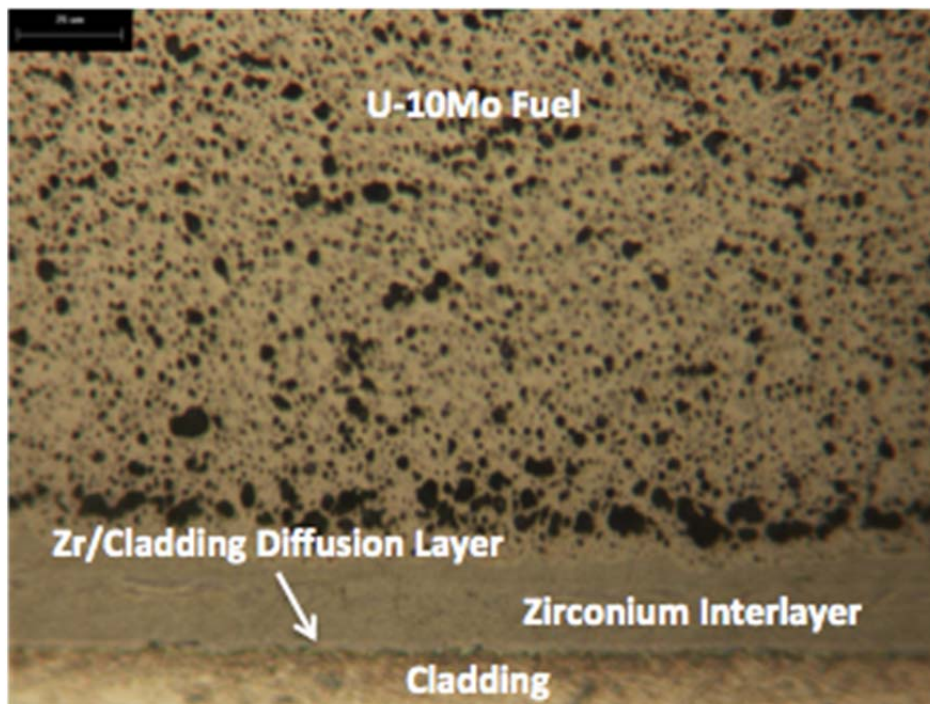
Figure 67. An optical image of plate L1P759, mount: 26W at 500× magnification. Average fission density: $8.7 \times 10^{21} \text{ f/cm}^3$. The indicated diffusion layer is typical of the post-irradiation condition.³

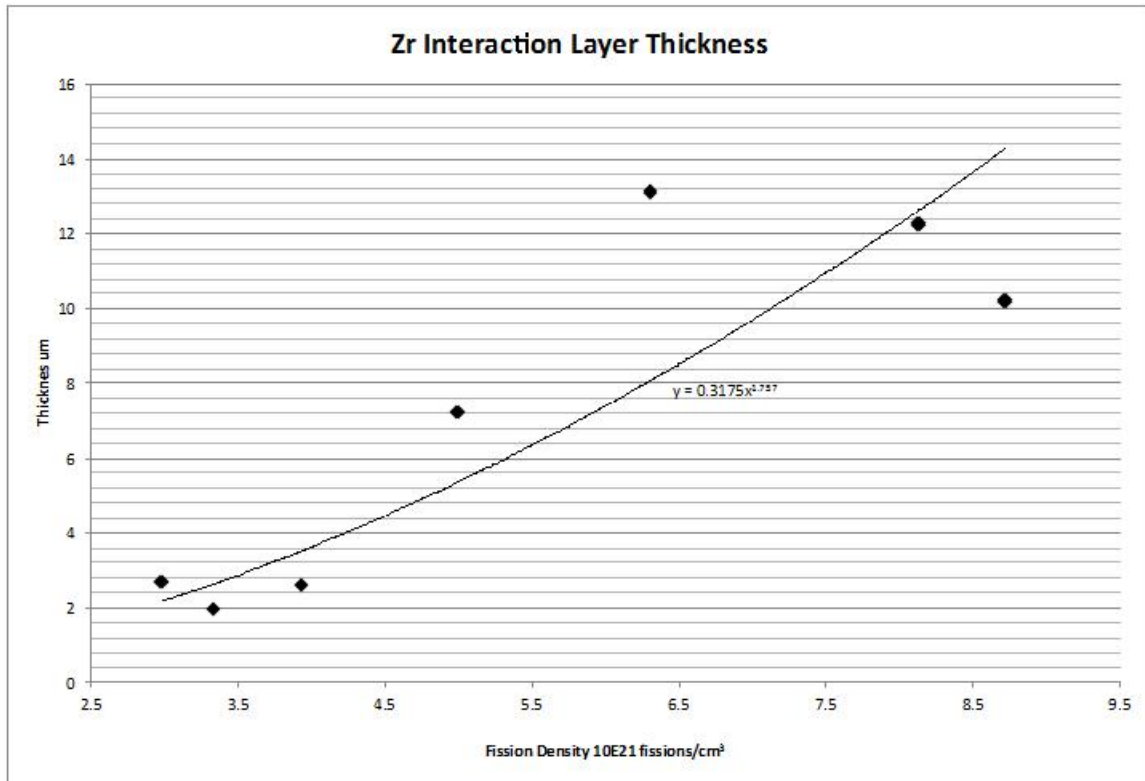
Figure 68. Preliminary trend approximation based of interaction layer growth as a function of fission density for plates shown in Figure 73–Figure 77.

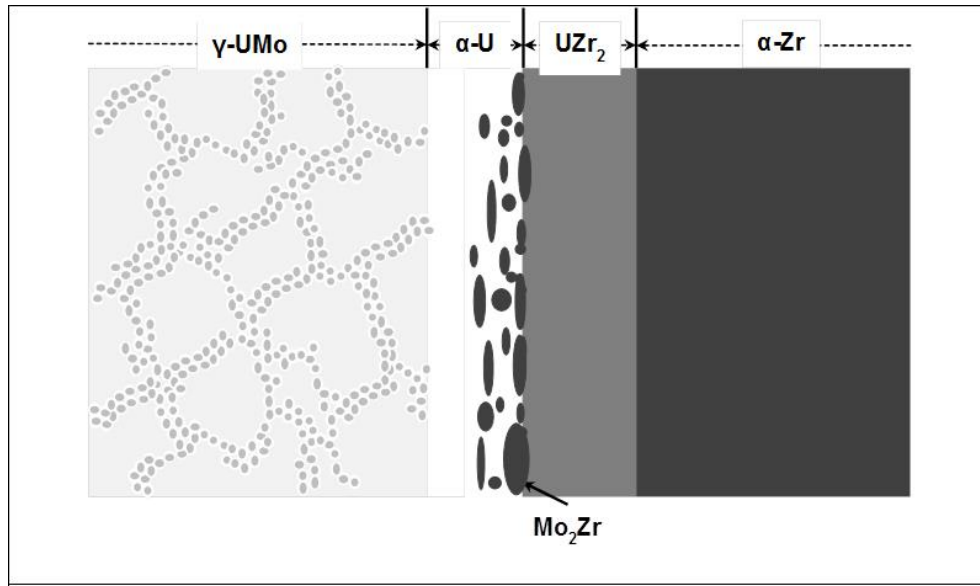
Figure 69. A schematic of the microstructure of a HIPed fuel plate co-rolled at 650°C and HIPed at 560°C with 70°C/hour cooling rate.

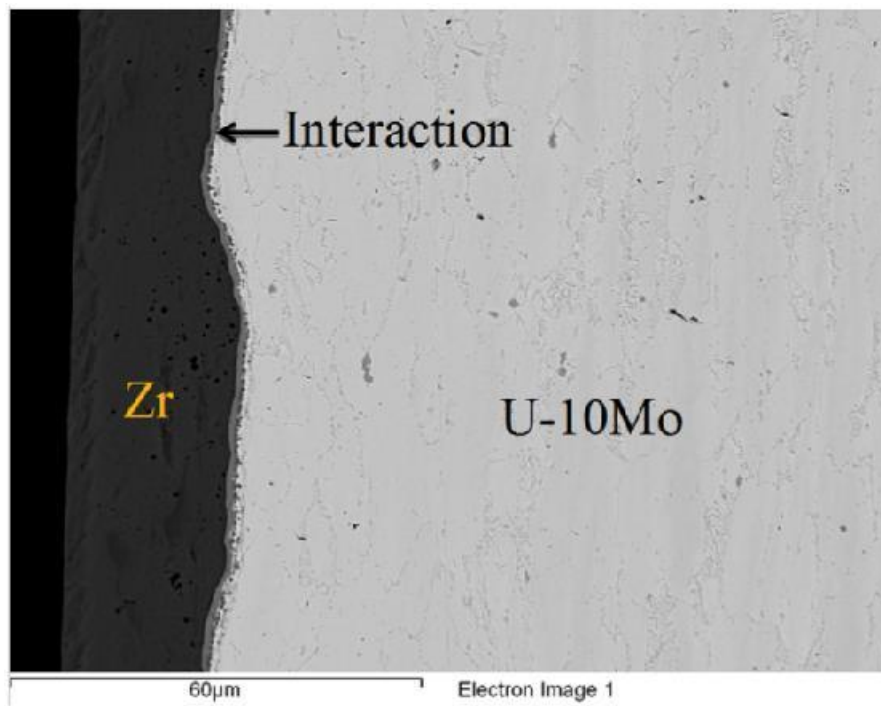
Figure 70. A low-magnification SEM micrograph showing the typical interaction layer between U–Mo and Zr.

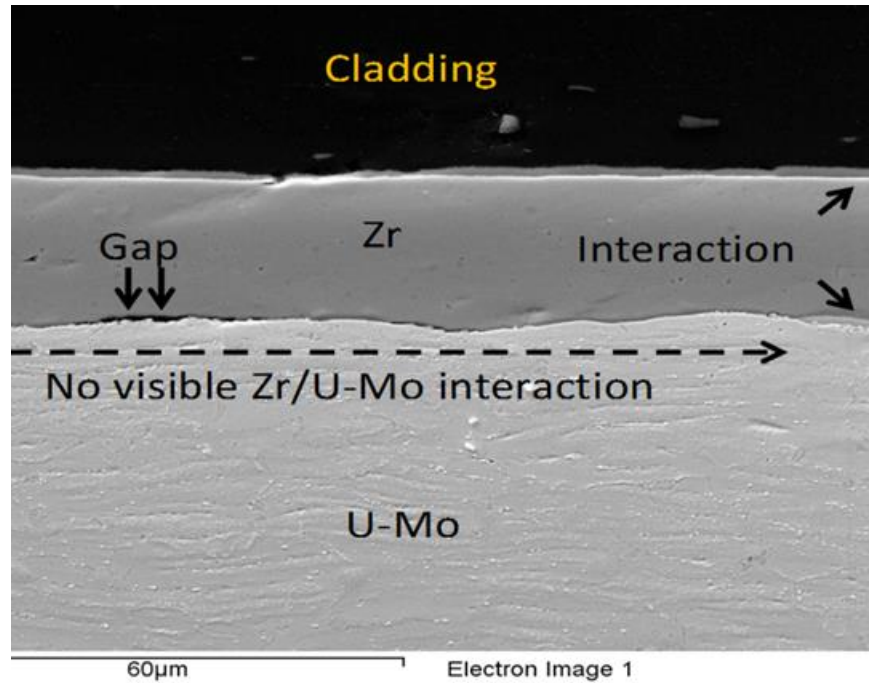
Figure 71. SEM image of met mount JJ1032 (the archived sister for the irradiated plate L1P776) shown in Figure 72, showing a large area without a visible interaction layer on U–Mo/Zr interface. A gap between Zr and U–Mo, about 20–30 μm long, was observed.

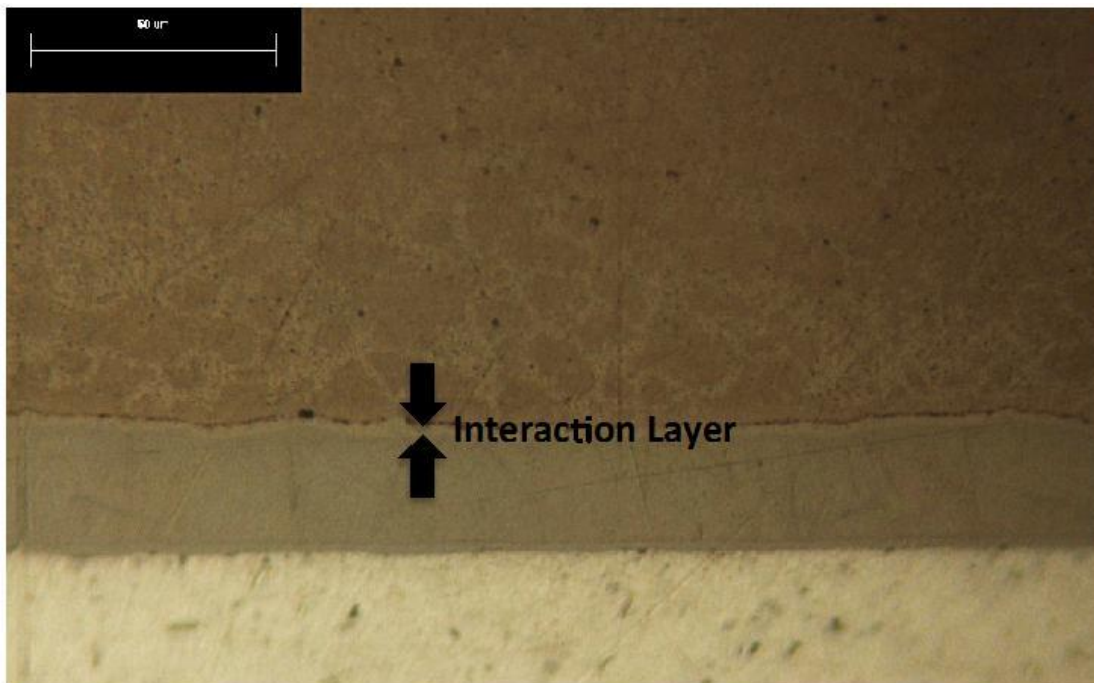
Figure 72. Plate L1P776. Average fission density $3.9 \times 10^{21} \text{ f/cm}^3$. APD: 25049 W/cm^3 .

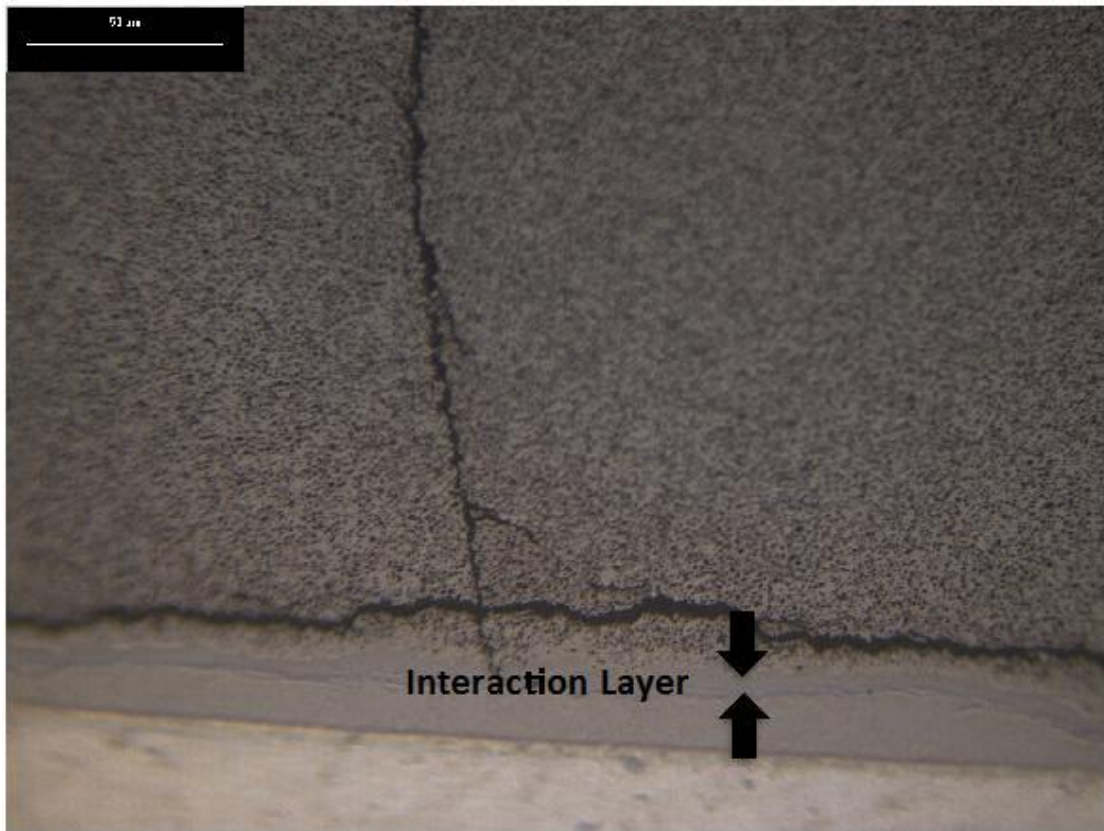
Figure 74. Plate L1P758. Average fission density: $5.0 \times 10^{21} \text{ f/cm}^3$. APD: 17251 W/cm^3 .

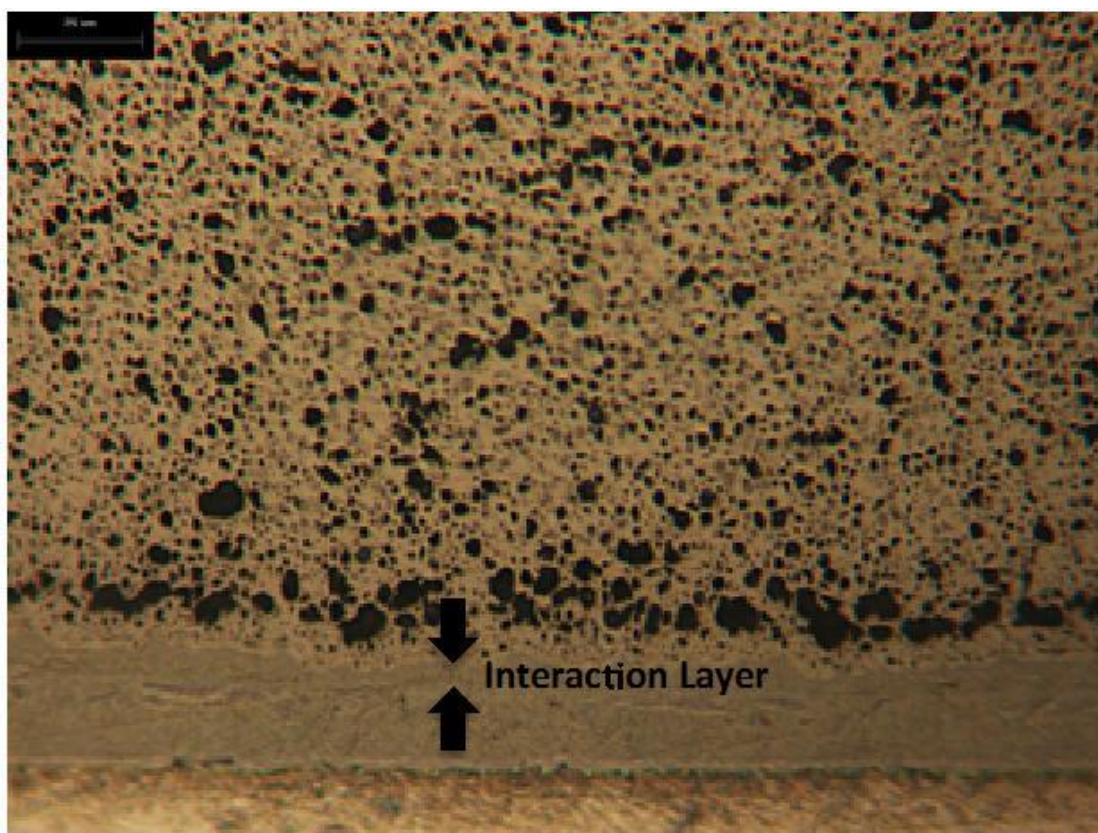
Figure 77. Plate L1P759. Average fission density: 8.7×10^{21} f/cm³. APD: 26745 W/cm³.

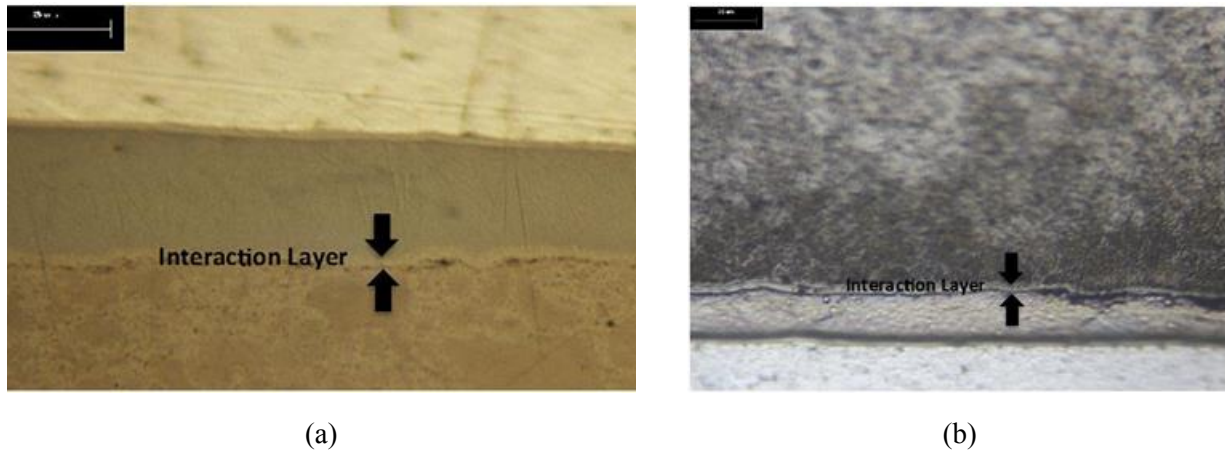
Figure 78. Optical image of plate L1P482. Average fission density: 3.0×10^{21} f/cm³. Average power density (APD): 5386 W/cm³. (a) and (b) are not etched and etched, respectively.

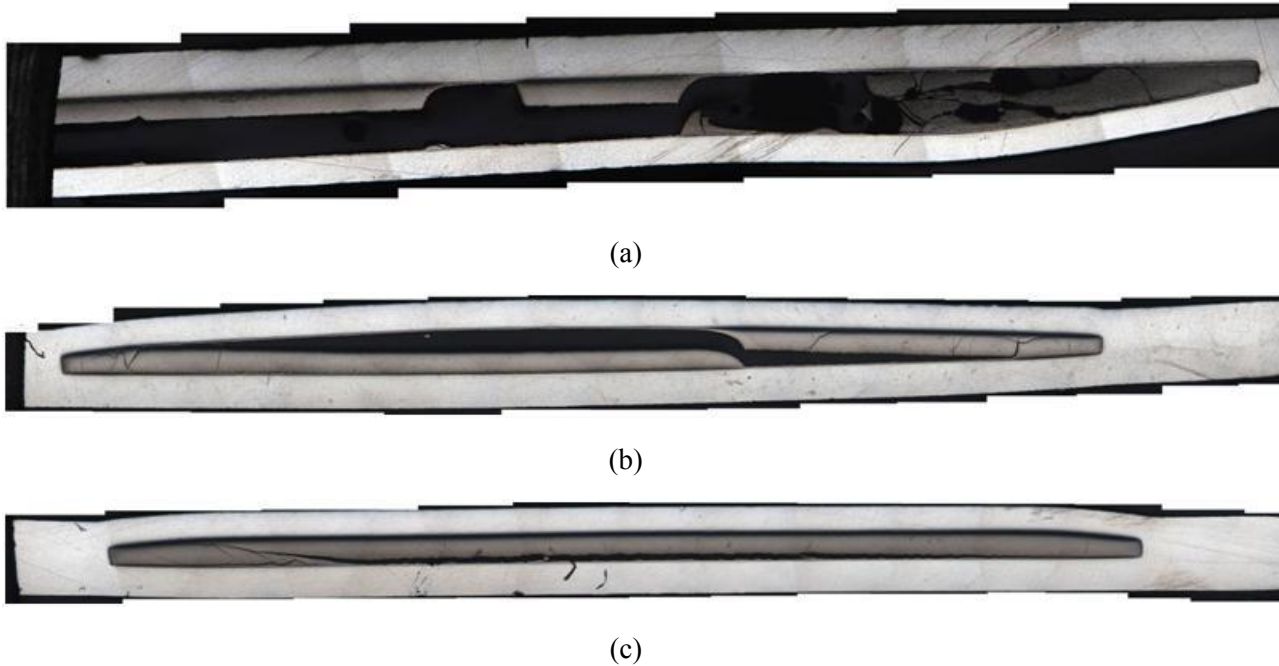
Figure 79. Cross-section montages of plates L1P754 (a) with a longitudinal segment, L1P759 (b) and L1P7A0 (c) with transverse segments.
