RERTR-12 Post-irradiation Examination Summary Report

INL/EXT-14-33066
Revision 1

The following report contains the results and conclusions from post-irradiation examinations performed on RERTR-12 Insertion 2 experimental fuel plates. These examinations include eddy-current testing to measure oxide growth; neutron radiography for evaluating the condition of the fuel prior to sectioning and determination of fuel relocation and geometry changes; gamma scanning to provide relative measurements for burnup and indication of fuel- and fission-product relocation; profilometry to measure dimensional changes of the fuel plate; analytical chemistry to benchmark the physics burnup calculations; metallography to examine the microstructural changes in the fuel, interlayer and cladding; and microhardness testing to determine the material-property changes of the fuel and cladding. These characterization activities were conducted specifically to demonstrate that:

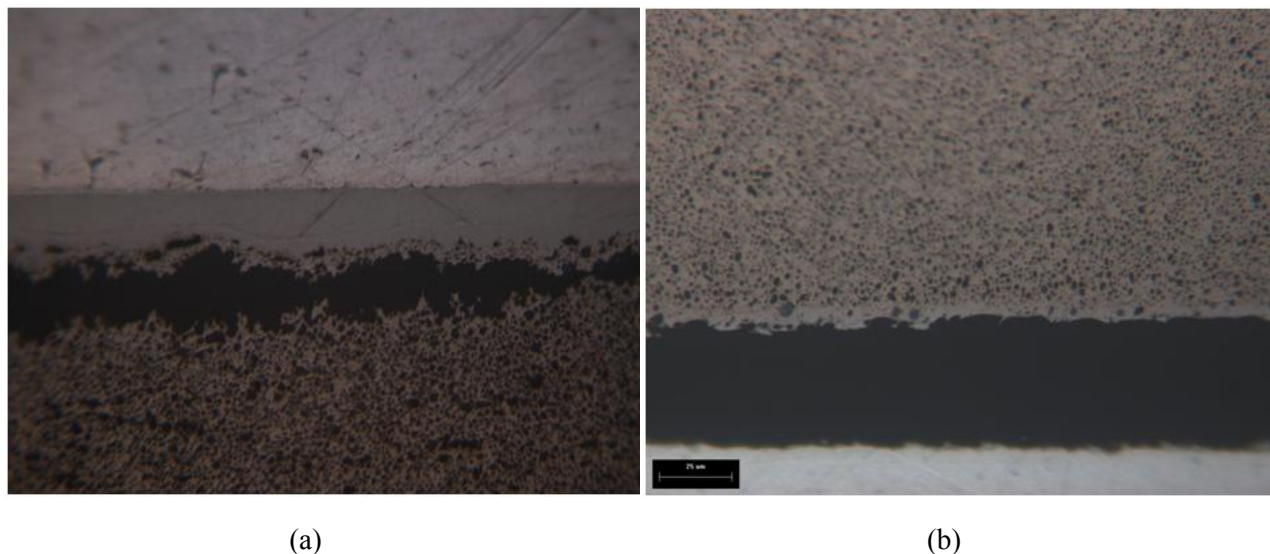
Figure 83. Examples of fuel separation with (a) and without (b) zirconium interlayer for plates L1P754 (RERTR-12, average fission density: 8.1×10^{21} f/cm³) and L1P020 (RERTR-8, average fission density: 6.0×10^{21} f/cm³), respectively. L1P754 was observed to be pillowed after irradiation and L1P020 separated during specimen preparation.

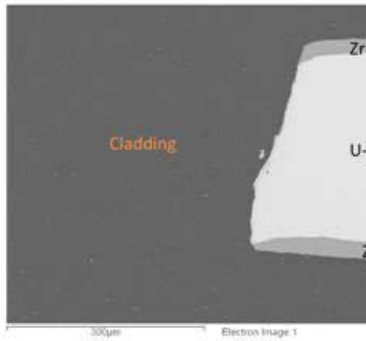
Figure 84. SEM image of a fresh fuel specimen showing features typical of the clad/U-Mo interaction layer.

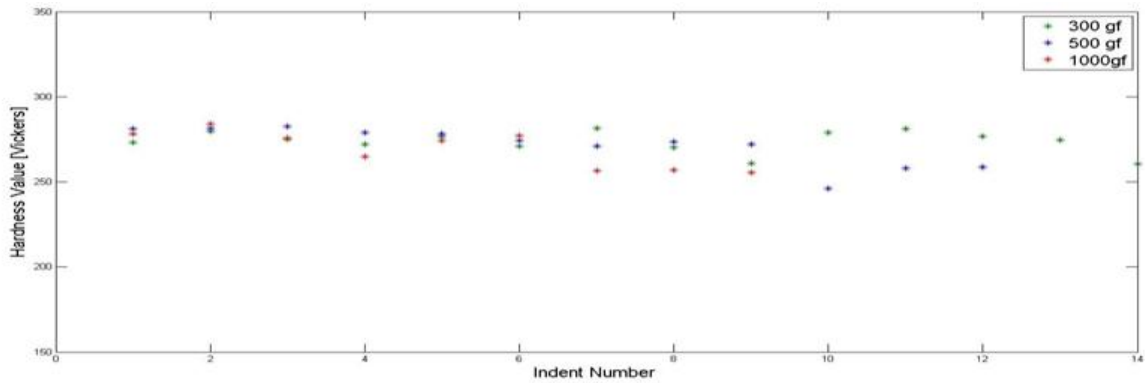
Figure 91. Load investigation.

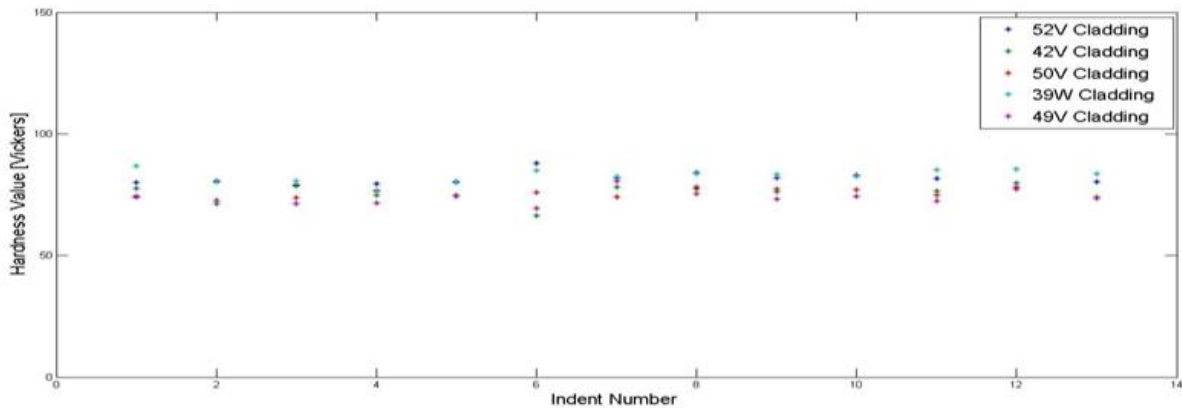
Figure 92. Cladding hardness values.

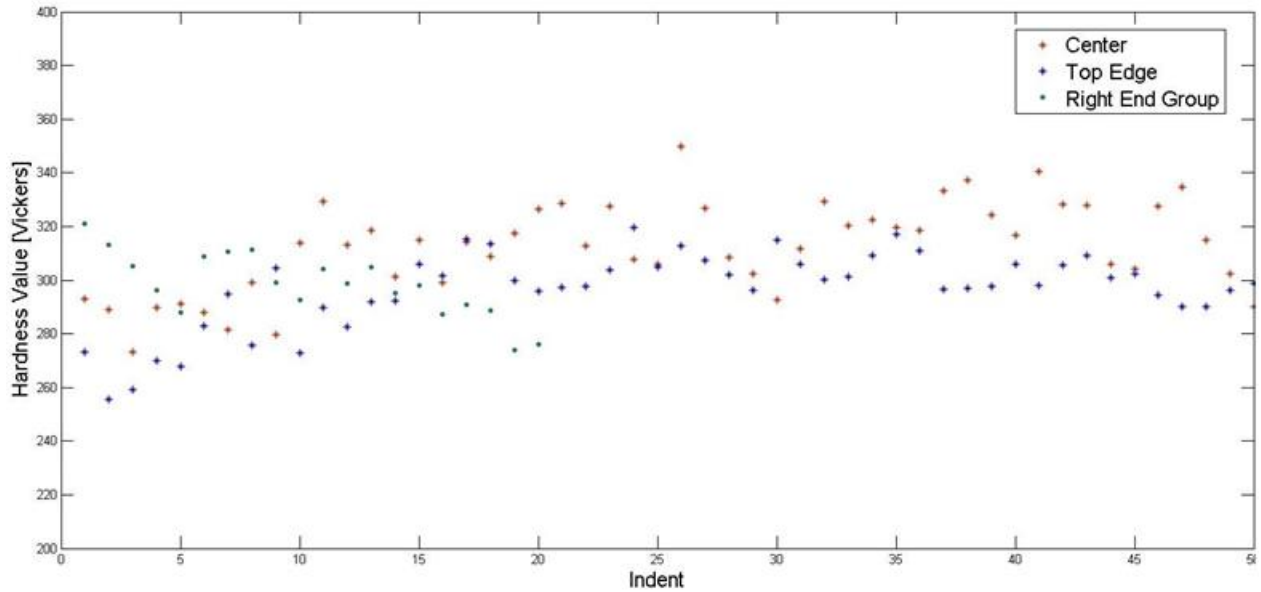
Figure 95. Hardness data from L5P3C2 (MNT 52V).

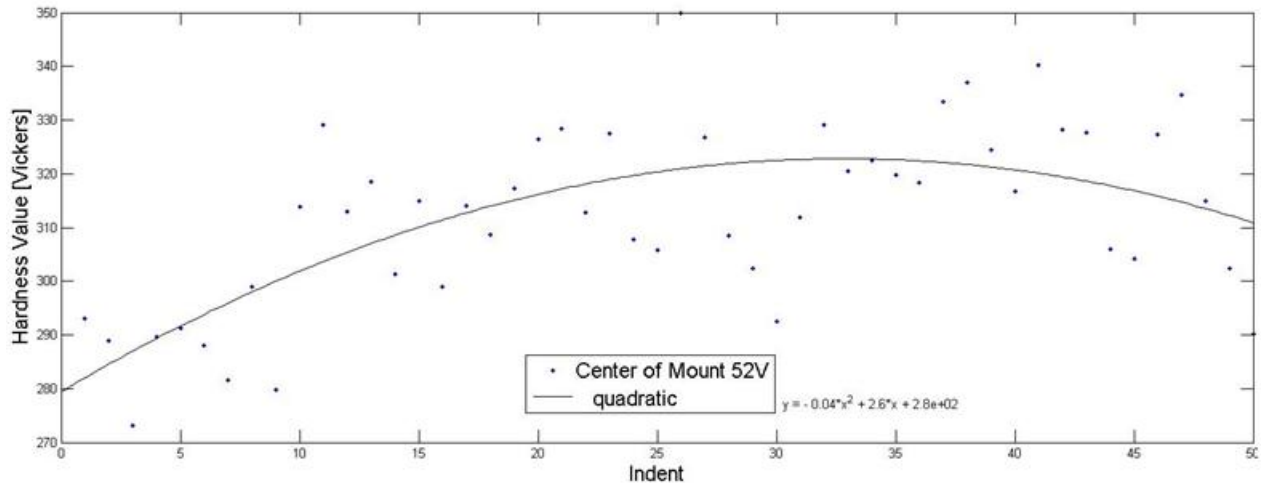
Figure 96. Hardness data from center of plate L5P3C2 center line.

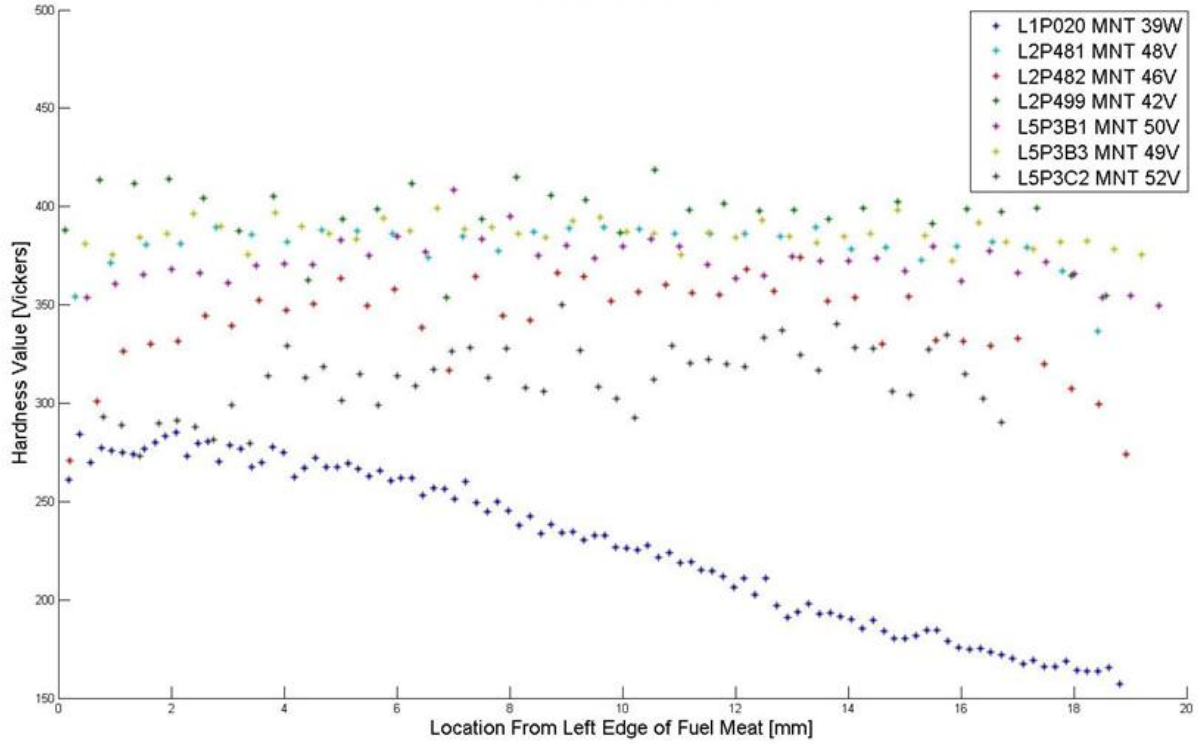
Figure 97. Hardness values through the center values of all mounts.

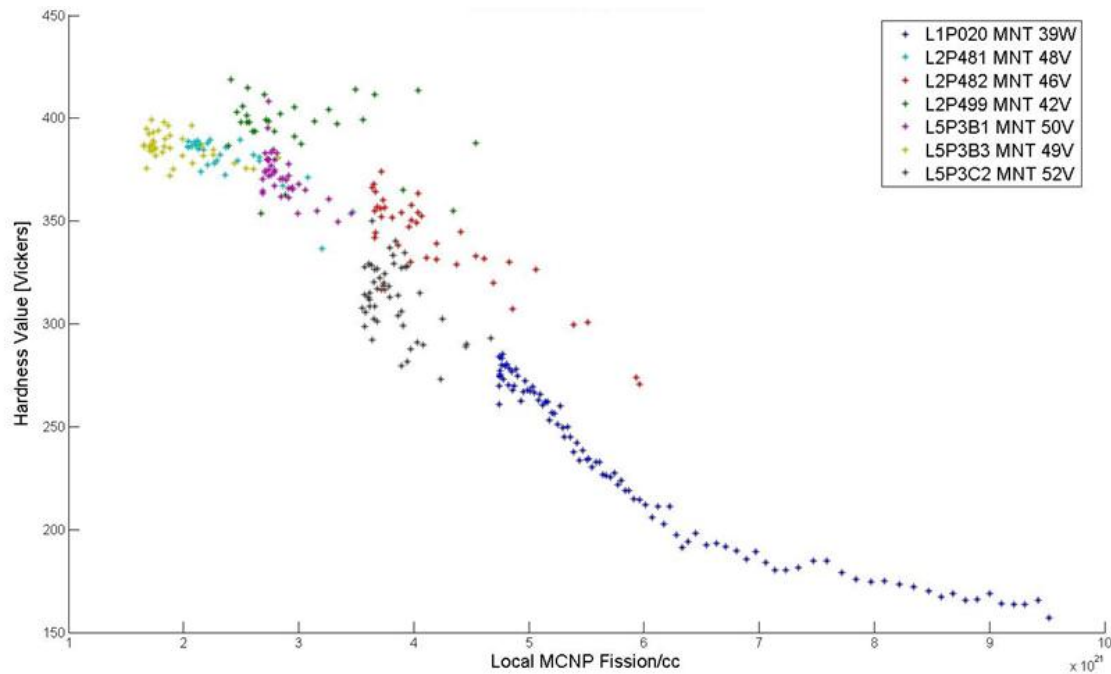
Figure 98. Hardness vs burnup by sample mount number (see Table 18).

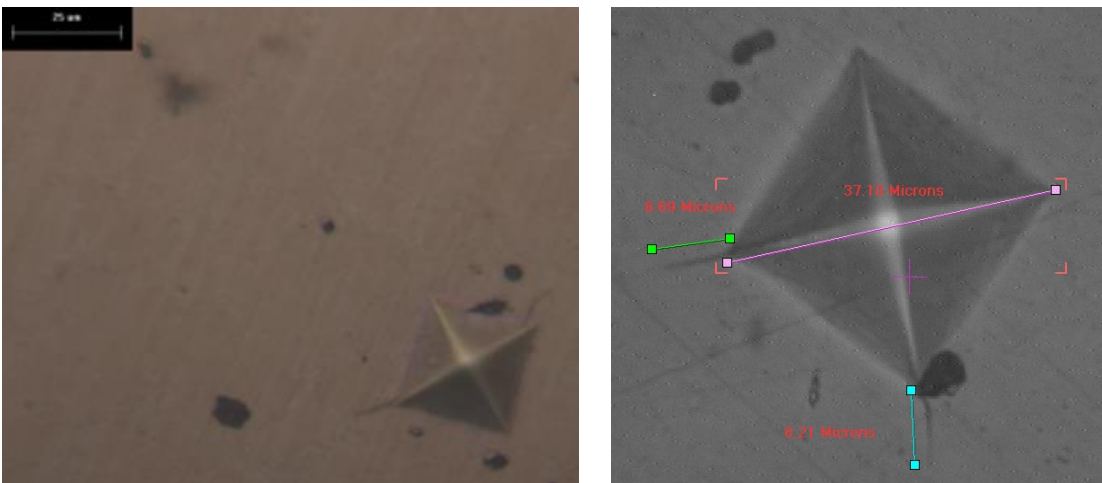
Figure 99. Indent on L2P499 (MNT 42V) micrograph (left) and microhardness tester (right).
