# Light Water Reactor Sustainability Program

## A Simple Demonstration of Concrete Structural Health Monitoring Framework

# **A Simple Demonstration of Concrete Structural Health Monitoring Framework**

**March 2015**

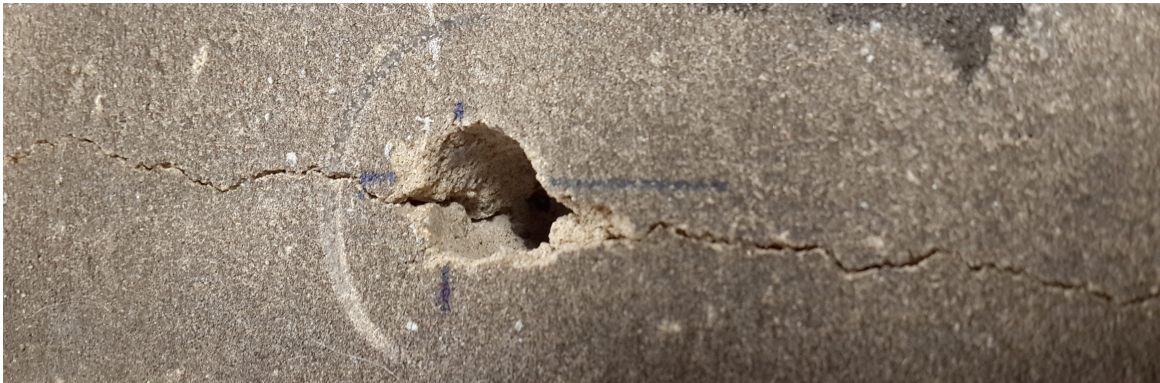
Figure 6. Crack produced by the freeze-thaw cycles.

Next, the concrete slab was submerged in a water bath for 4 hours, letting the pores to be filled and was placed in a freezer for 6 hours. As water changed to ice, the holes filled with water were subjected to a radial pressure, similar to the pressure created by ASR damage in concrete. Cracking, as shown in Figure 6, is observed in the slab after application of the freeze-thaw cycles.
