AGR-1 Post Irradiation Examination Final Report

August 2015

INL/EXT-15-36407
Revision 0

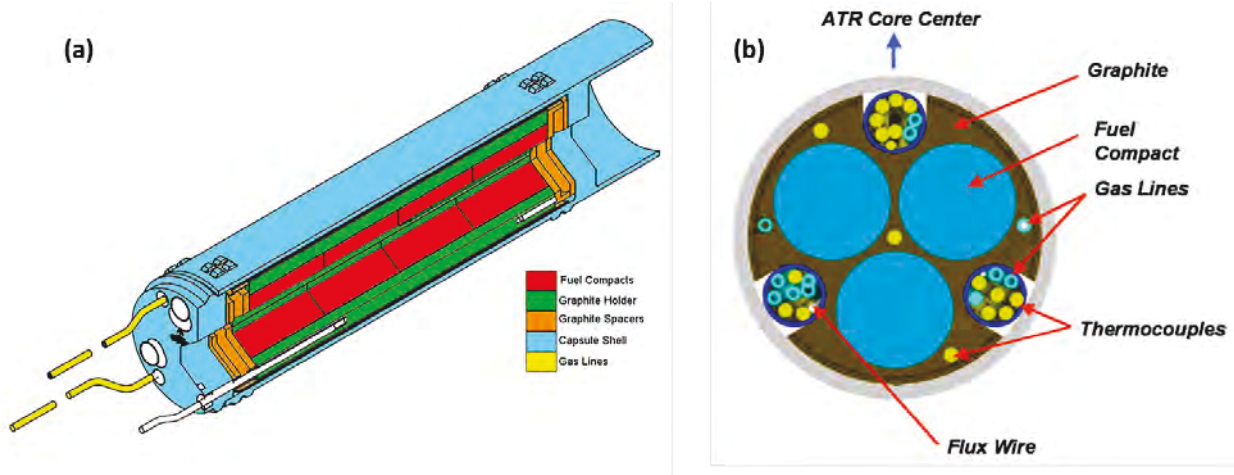
Figure 1. Cutaway diagram of an AGR-1 capsule showing (a) the key components and (b) cross-sectional view of a capsule.

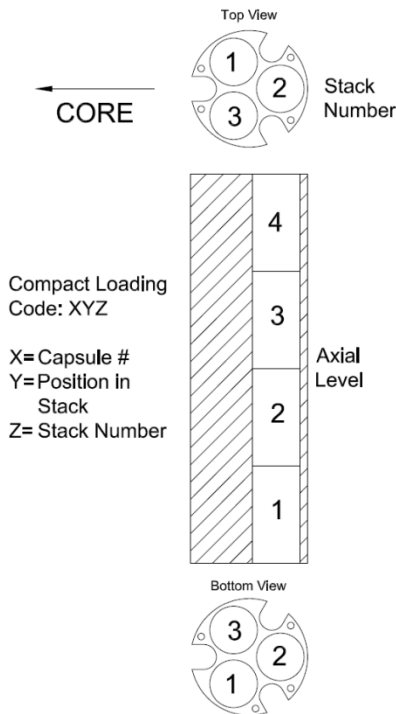
Figure 2. Numbering scheme used to identify compacts in the AGR-1 test train.

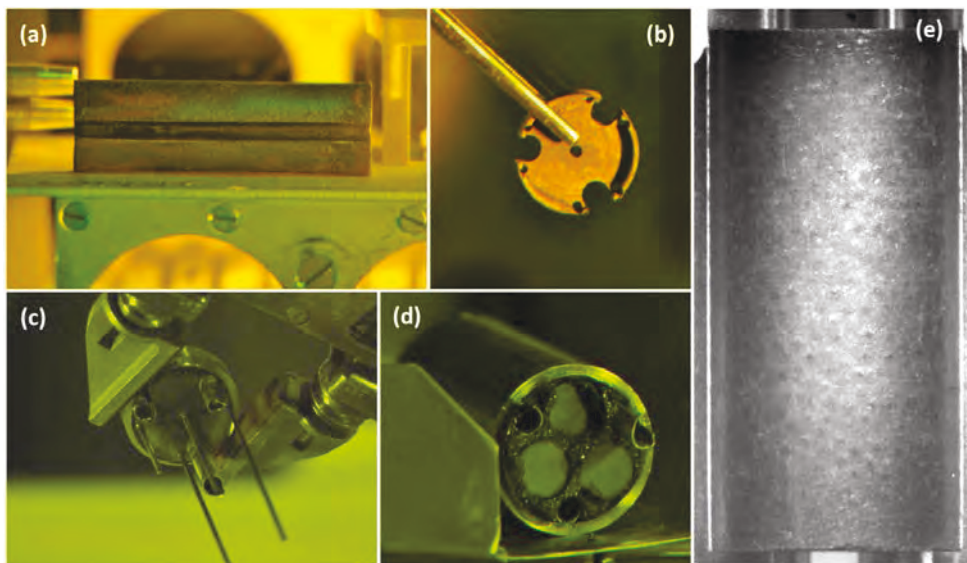
Figure 3. Images from AGR-1 disassembly: (a) Capsule 5 graphite fuel holder after removal from the capsule; (b) a graphite spacer from Capsule 5; (c) head piece from Capsule 4, showing through tubes fractured during disassembly; (d) Capsule 4 after the shell was cut mid-length and the graphite holder fractured in two pieces; (e) Compact 2-3-3 after removal from the graphite holder.

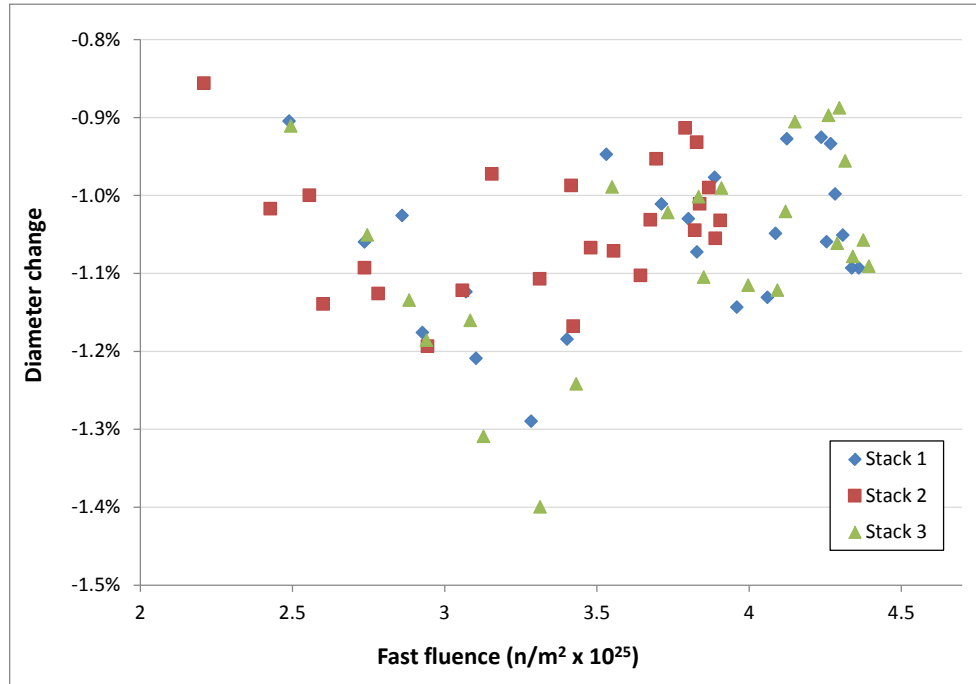
Figure 5. Average diameter change for all AGR-1 compacts as a function of calculated fast neutron fluence ($E > 0.18 \text{ MeV}$).

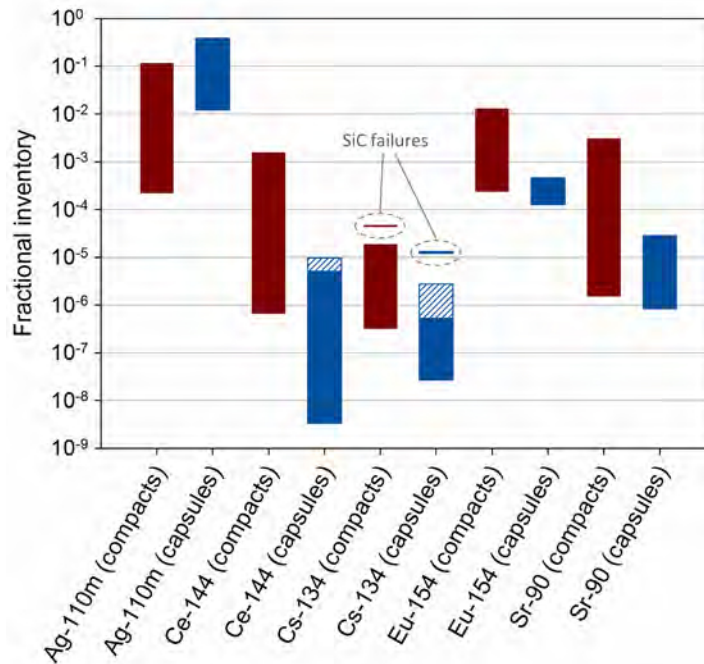
Figure 9. The range of inventory fractions found retained in irradiated compacts outside of the SiC layer (red columns) and on the capsule components (blue columns). The portions of the data circled and labeled as “SiC failures” are related to the presence of particles with failed SiC layers, as discussed in the text. The cross-hatched regions indicate values that correspond to measured inventories below the detection limit, which represent a conservative upper-bound on the range.

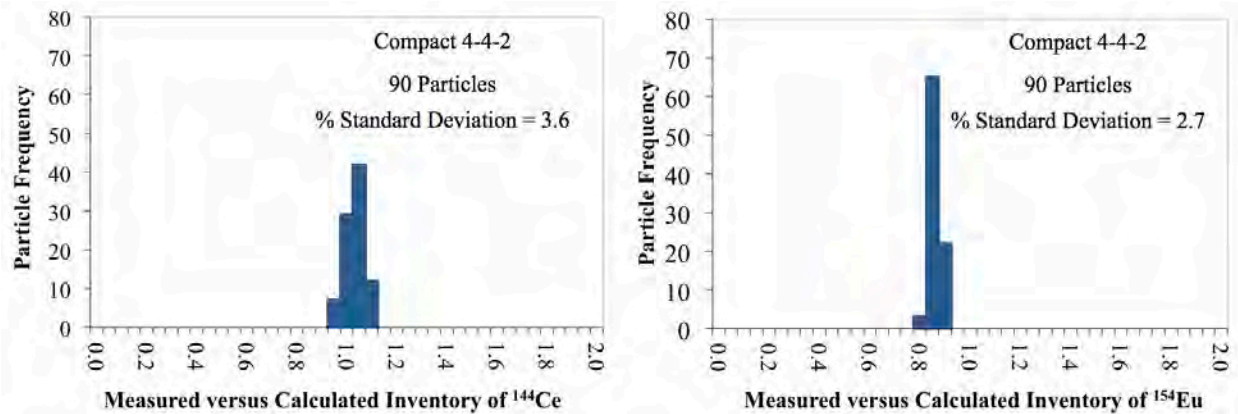
Figure 12. Distributions for the ^{134}Ce and ^{154}Eu measured-to-calculated ratio in particles from Compact 4-4-2.

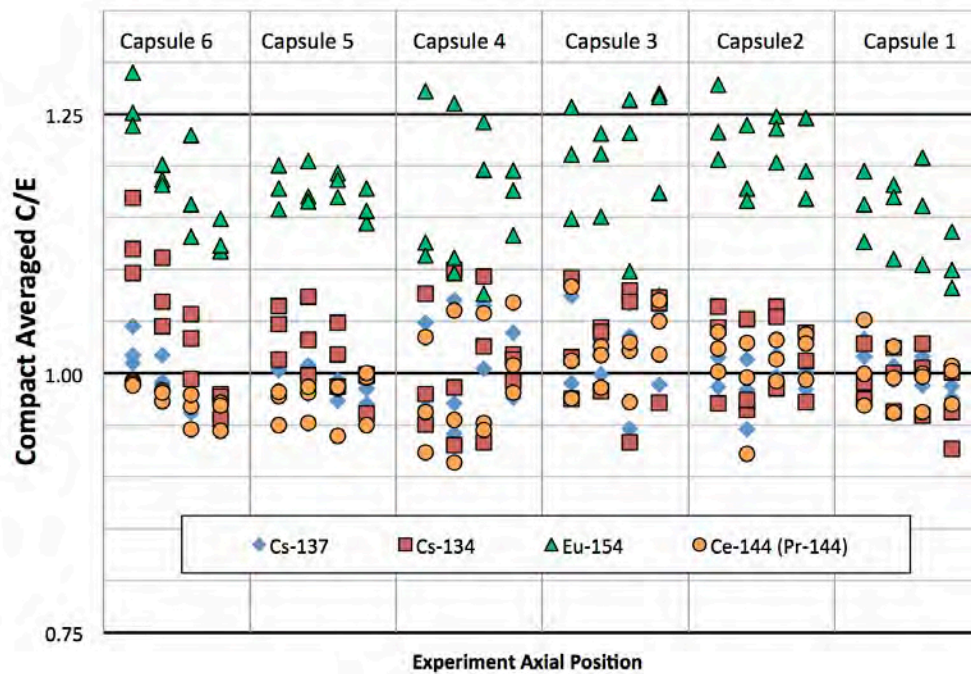
Figure 13. Calculated to Experimental (C/E) activity ratio for several different fission products for each fuel compact in the AGR-1 test train. Fuel compacts are plotted by vertical position in the AGR-1 test train, with the top of the test train at the left and the bottom at the right. There are three compacts at each axial location.

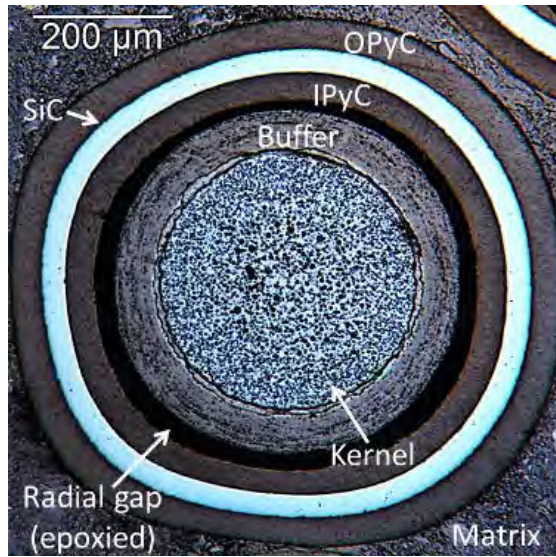
Figure 14. Irradiated AGR-1 Baseline fuel particle with continuous radial gap from inward shrinkage of the buffer layer.

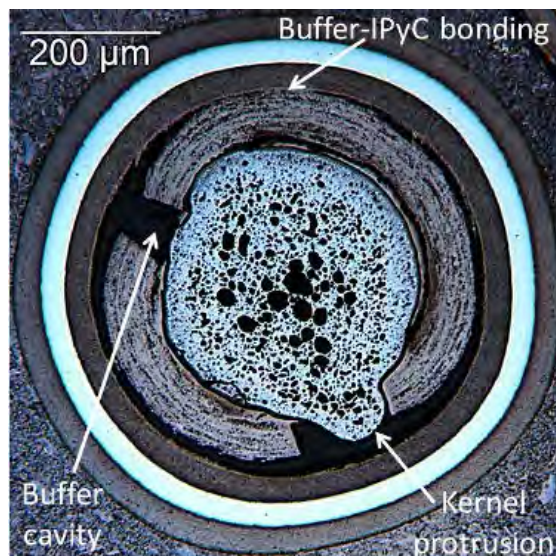
Figure 15. Irradiated AGR-1 Baseline fuel particle with local buffer-IPyC bonding, buffer fracturing, and protruding kernel.

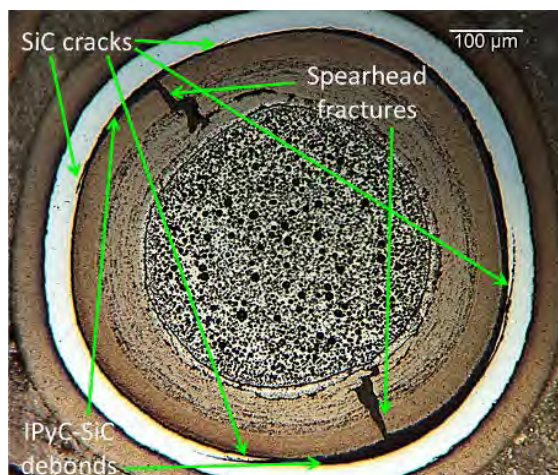
Figure 16. Irradiated AGR-1 Variant 1 particle, showing aligned buffer-IPyC fractures, IPyC-SiC debonds, and SiC crack formation.

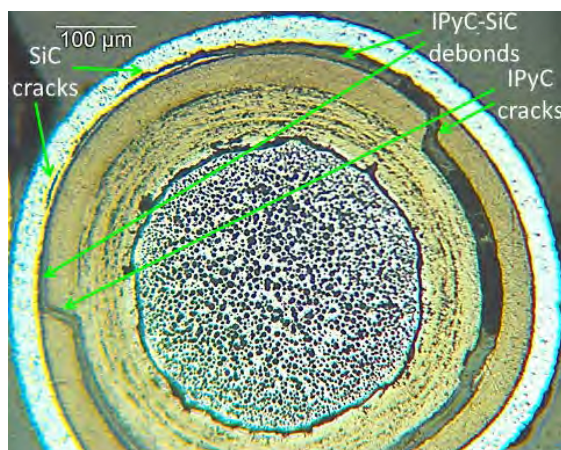
Figure 17. Irradiated AGR-1 Variant 1 particle, showing IPyC fracturing, IPyC-SiC delamination, and SiC crack formation without evidence of buffer fracture.

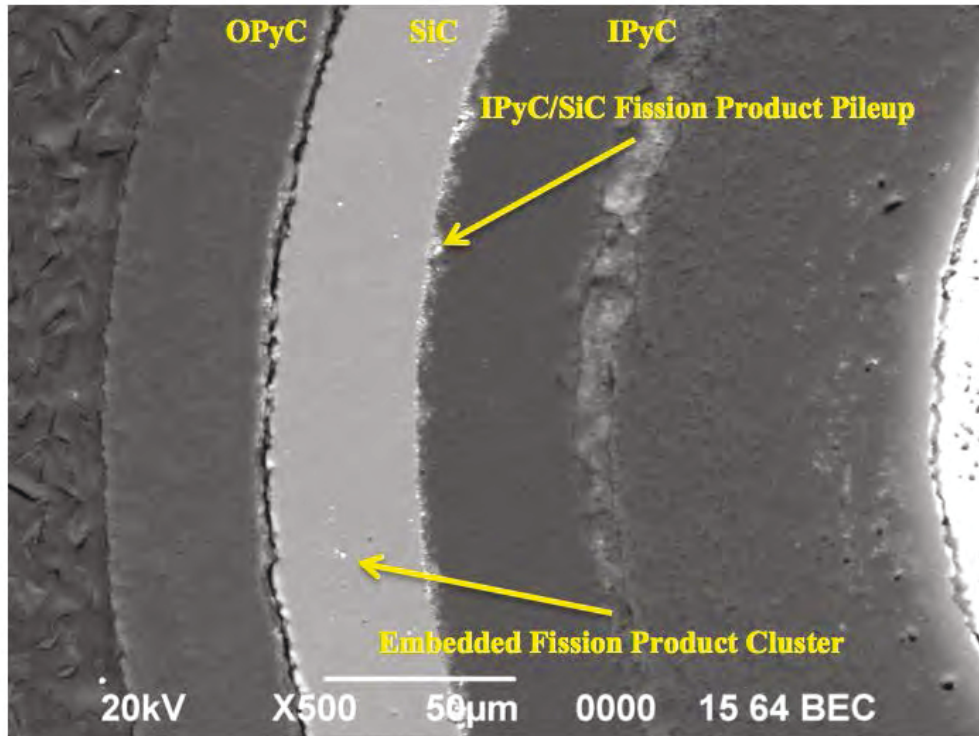
Figure 18. BEC micrograph of the TRISO layers from a Compact 5-2-3 particle with very low Ag retention ($M/C \leq 0.09$), bright areas at the IPyC-SiC interface and in the SiC layer are associated with segregated fission product features.

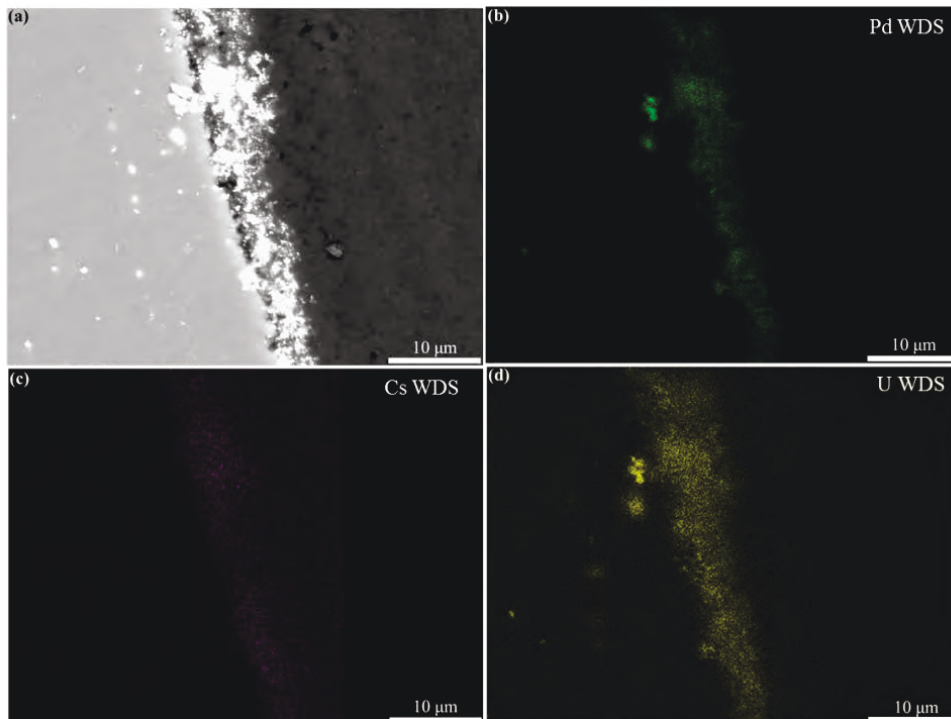
Figure 19. SEM micrograph showing Pd/Cs/U rich fission product features at the IPyC-SiC interface in AGR1-531-038, confirmed by WDS maps of Pd, Cs and U.

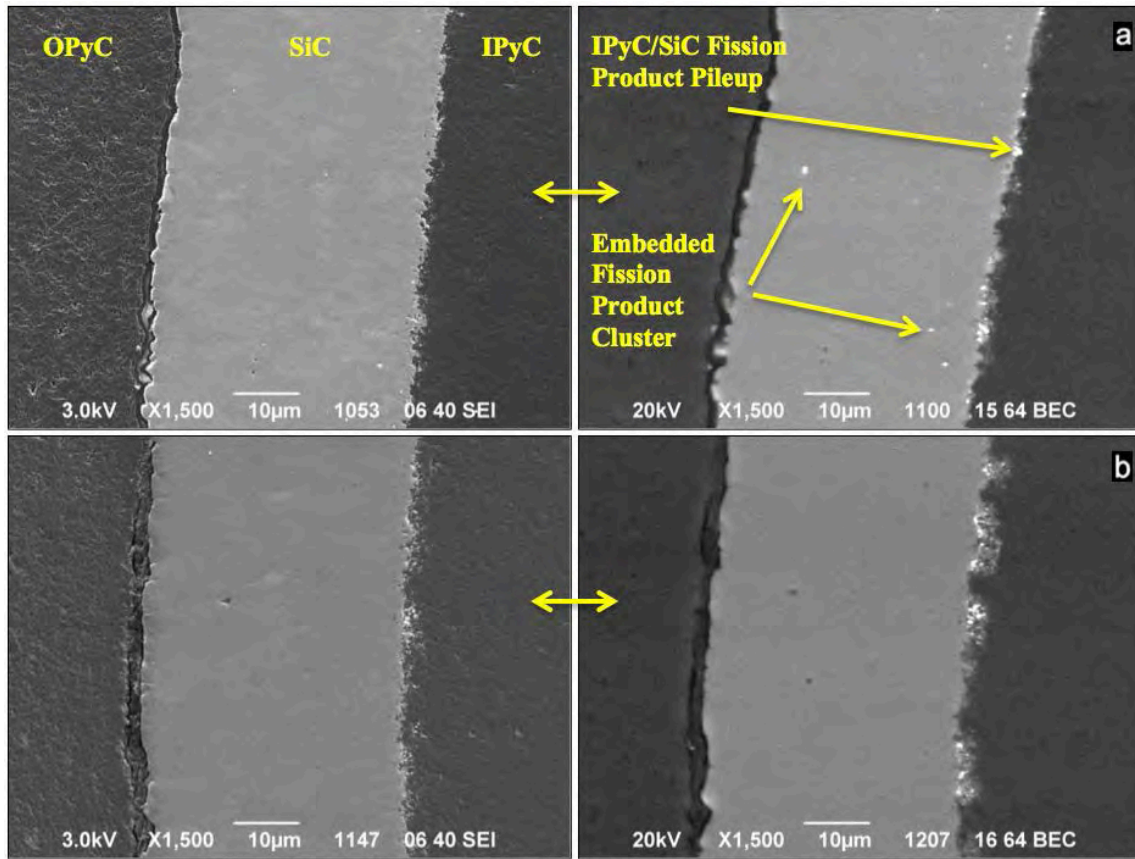
Figure 20. SEI/BEC-paired images of Compact 5-2-1, (a) very low Ag retention particle ($M/C \leq 0.25$) and (b) high Ag retention particle ($M/C = 1.03$). Areas of bright contrast in BEC micrograph indicate isolated fission product features.

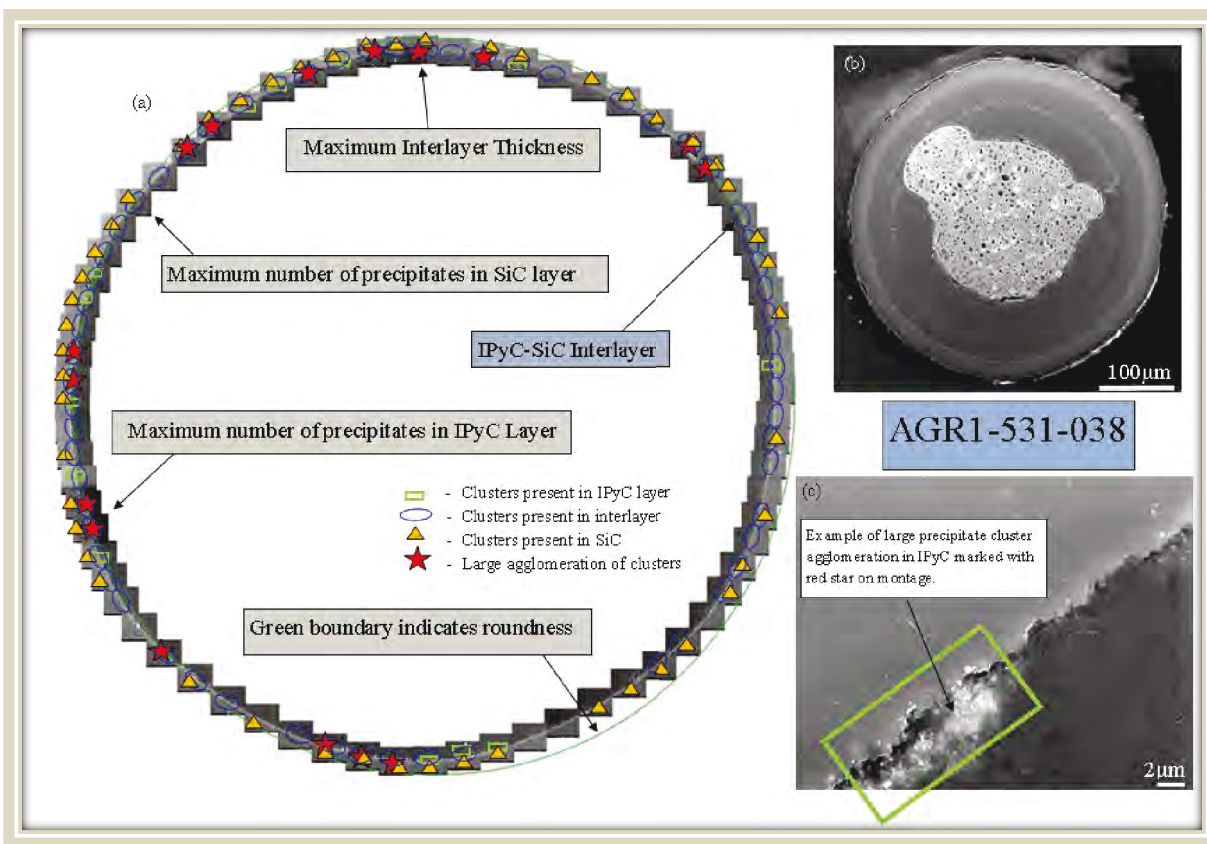
Figure 21. SEM images of particle AGR1-531-038 showing (a) an image montage representing the distribution of precipitate clusters, (b) an optical micrograph of the particle cross section, and (c) a representative SEM image of the IPyC-SiC interface.

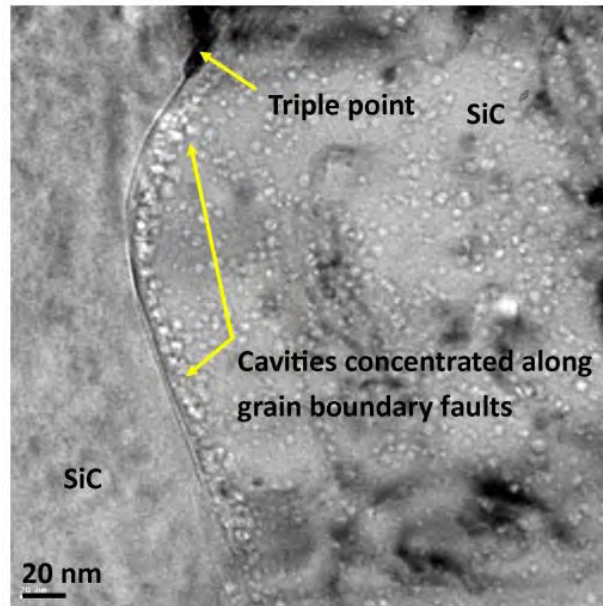
Figure 22. Spherical cavities concentrated alongside SiC grain boundaries near a Pd-rich precipitate in the triple point (image is adapted from Van Rooyen et al. 2014b).

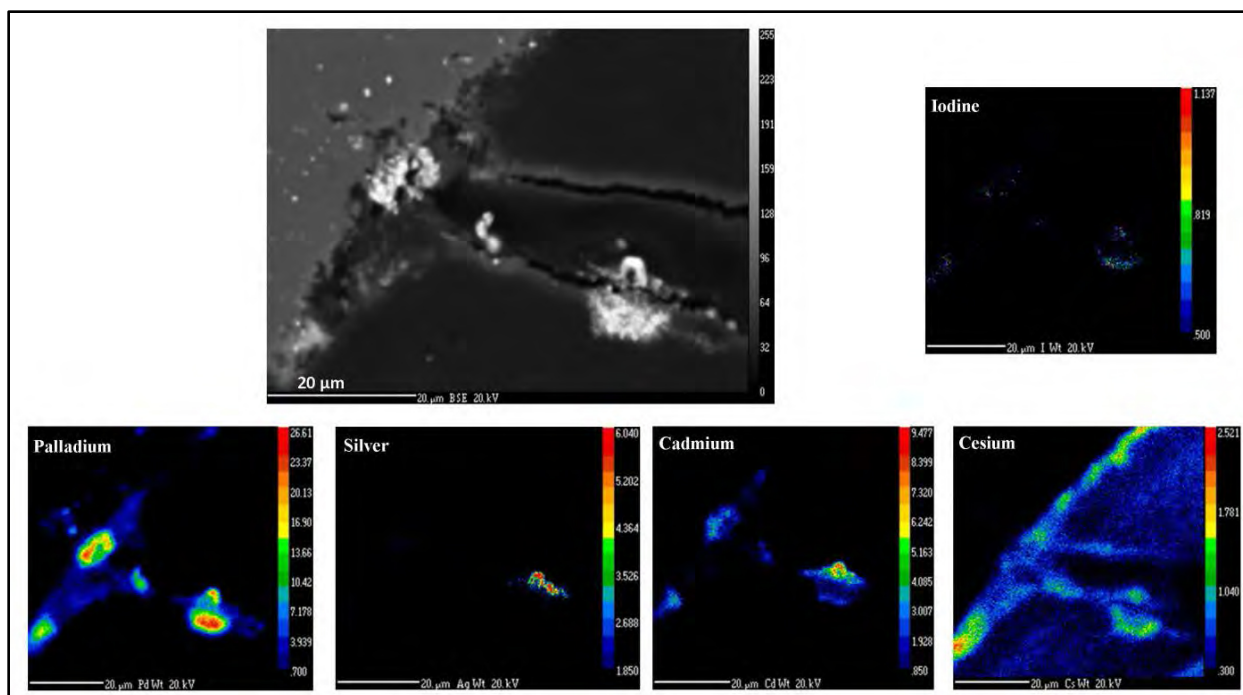
Figure 23. EPMA elemental maps at the tip of a crack in the IPyC layer of particle AGR1-523-SP01. Maps were corrected for peak overlaps. Detection limits were computed for x-ray images. Each image was scaled so that the lower end of the color scale is the detection limit in weight percent.

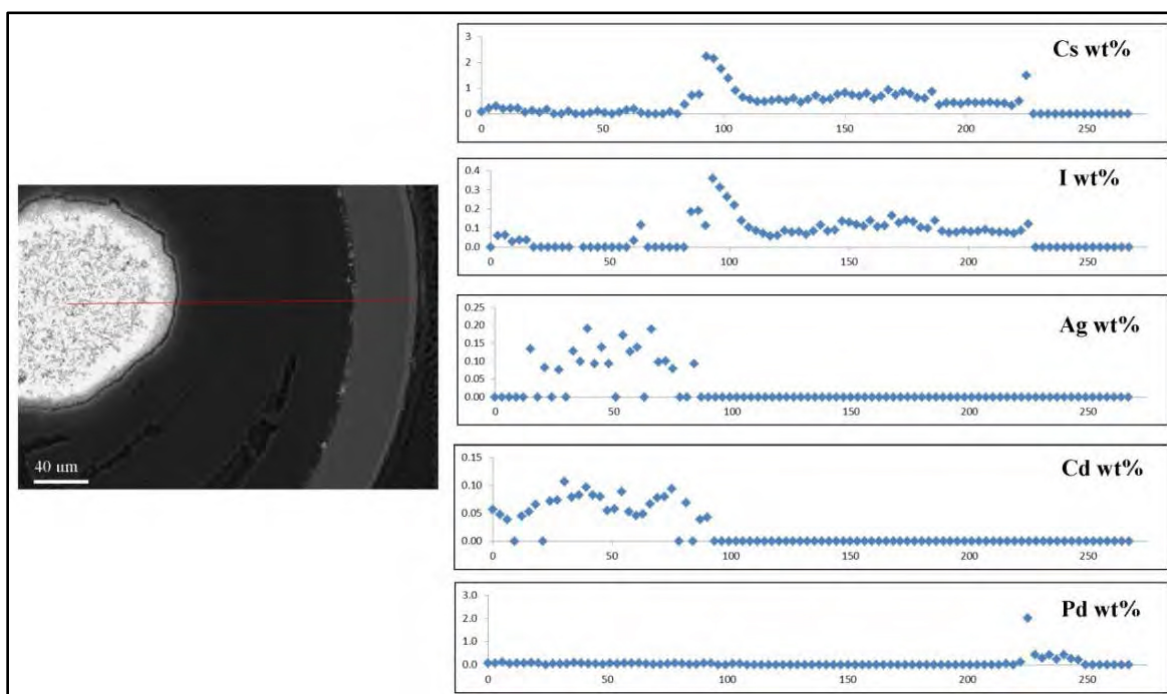
Figure 24. Results of an EPMA line scan on a cross section of particle AGR1-523-SP01. The red line indicates the path of quantitative radial traverse (analytical conditions 20kV, 200nA, 30 seconds peaks, 10 seconds background).

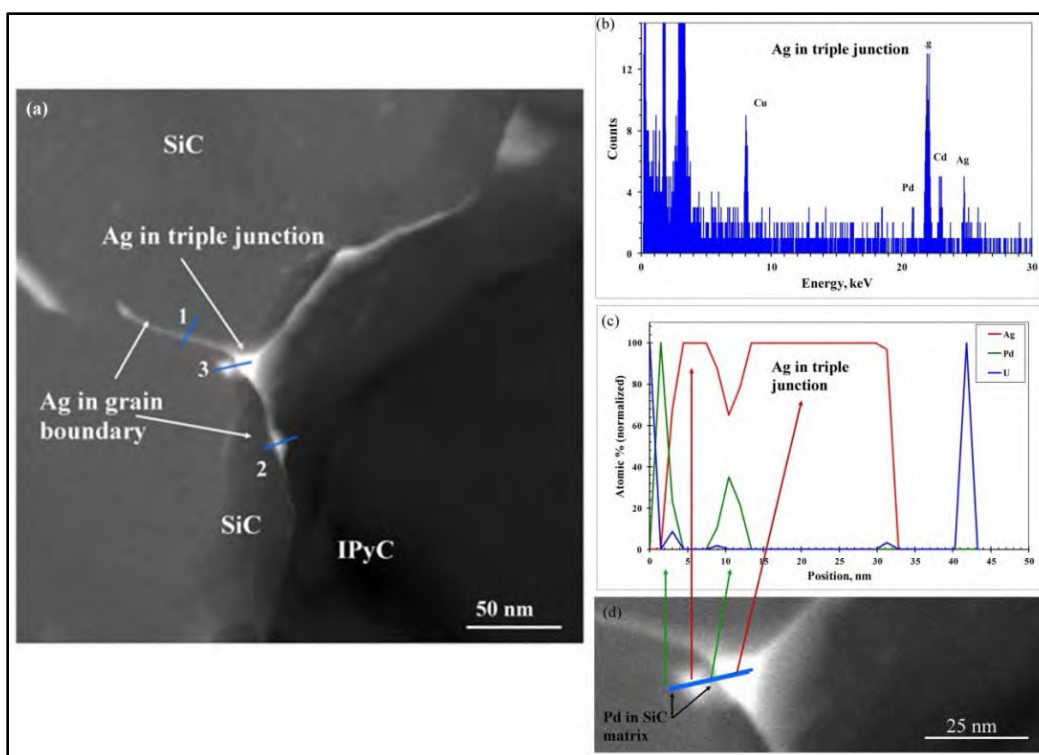
Figure 25. Image showing (a) a high-angle annular dark field (HAADF) STEM image of grain boundaries containing silver (labeled 1 and 2) and a triple junction (labeled 3) at the edge of the SiC adjacent to the IPyC from lamella AGR1-632-035-6b . Image showing (b) the EDS spectrum identifying the Ag $K\alpha_1$ peak at 22.163 keV and the presence of Cd in the center of the triple junction shown in (a) (Cu is an artifact from the grid holder), (c) the EDS line scan profile through the triple junction indicating the presence of Ag, and (d) higher magnification of Area 3 in (a). Although no Pd was observed in the triple junction, Pd and U were identified in the SiC matrix adjacent to this triple junction (Van Rooyen et al. 2014d).

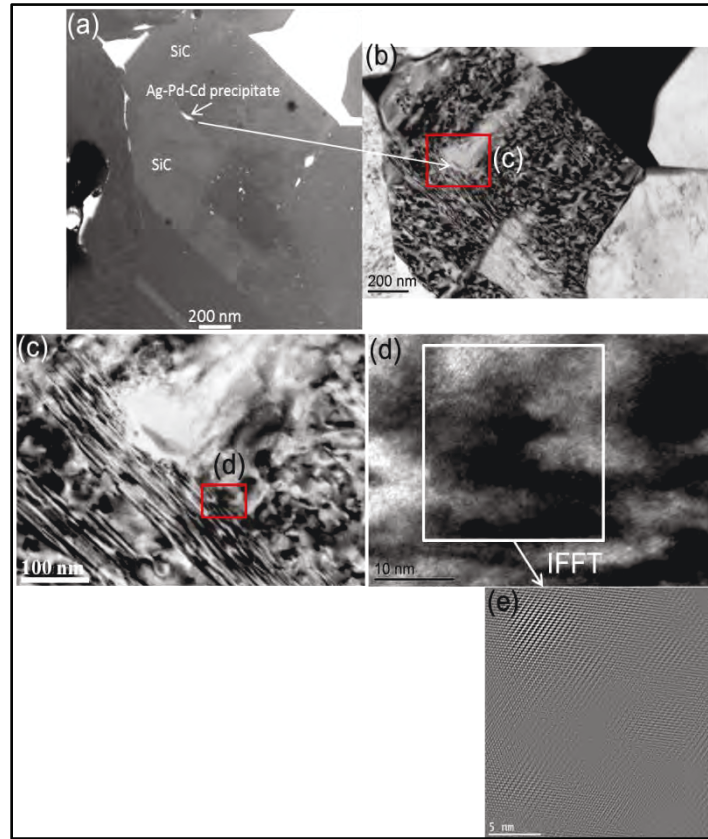
Figure 27. An Ag-Pd-Cd precipitate at a stacking fault inside a SiC grain of particle AGR1-532-SP01. (a) STEM image showing the location of the Ag-Pd-Cd precipitate, whose composition was determined by EDS; (b) TEM image corresponding to (a); (c) a magnification of the red rectangle in (b); (d) a magnification of the red rectangle in (c), where stacking faults are present; (e) inverse FFT of the white square in (d), where the continuous lattice fringes indicate absence of grain boundary and confirm the presence of stacking faults (Wen et al. 2015c).

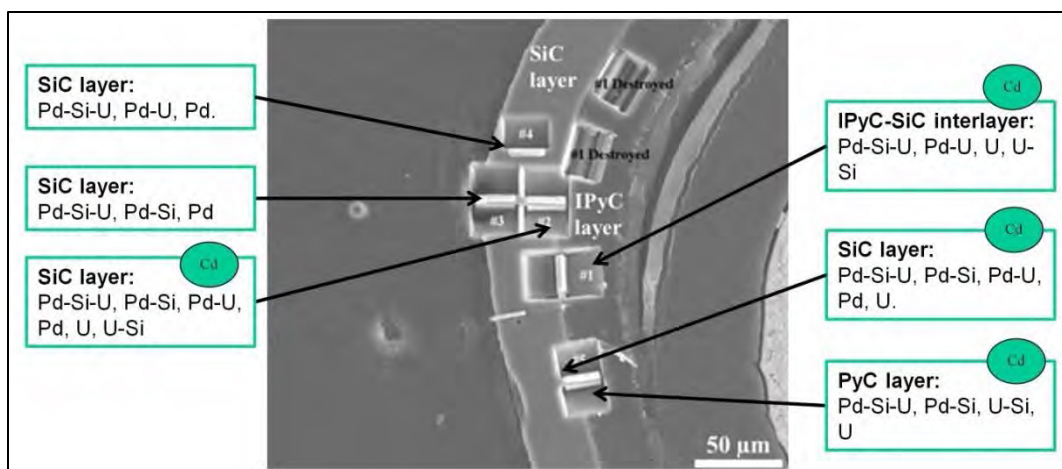
Figure 28. An overview of the precipitate type distribution found in particle AGR1-131-099 (figure adapted from Wen et al. 2015a). The predominant precipitate composition is shown for each area; additionally, small levels of Cd (denoted in green circles) were detected in the precipitates from the IPyC-SiC interface up to approximately the middle of the SiC.

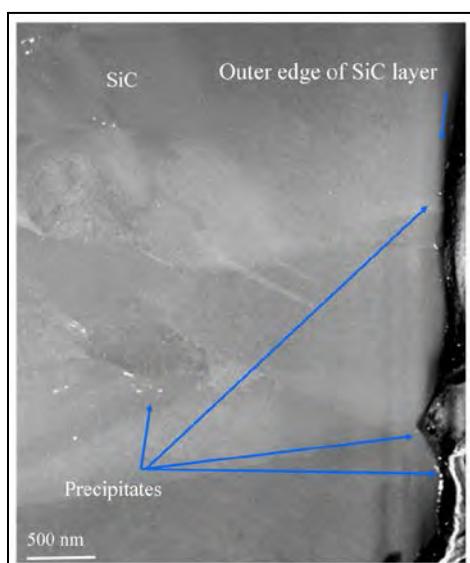
Figure 29. STEM micrograph showing evidence of a nano network of fission products at the outer edge of the SiC from particle AGR1-632-035-6b.

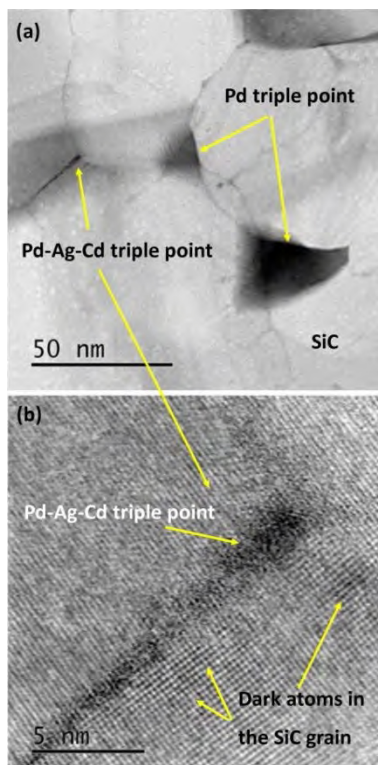
Figure 31. Bright field (BF) STEM image (a) of a triple point containing Pd, Ag, and Cd, with the corresponding high-resolution BF STEM image (b), where fission product atoms (dark spots) are also visible deeper in the SiC grain (Van Rooyen et al. 2014a).

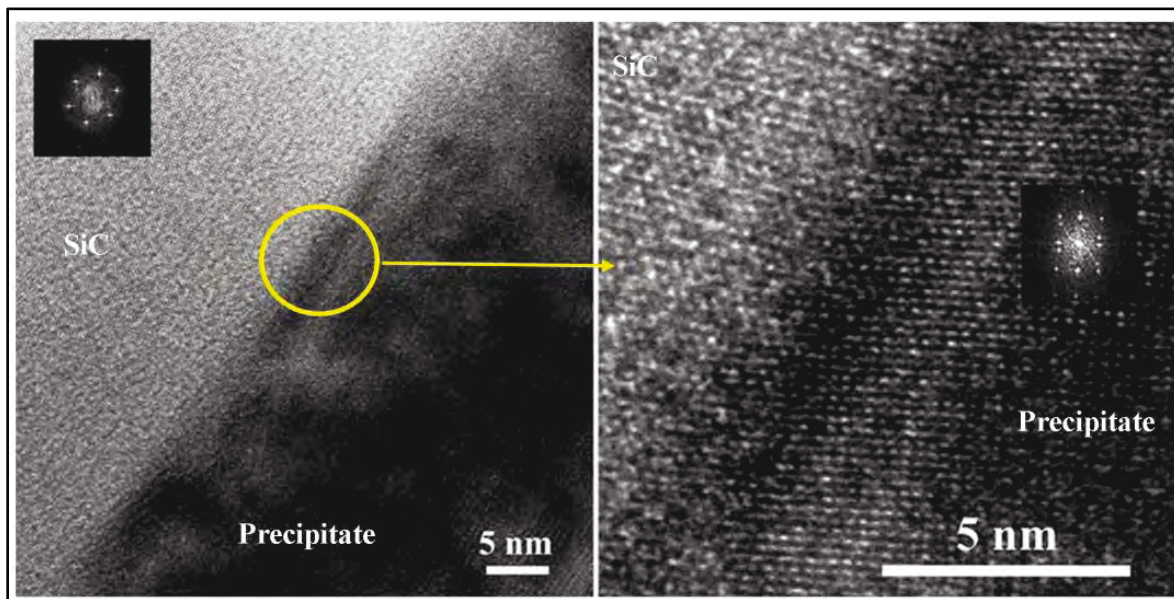
Figure 35. HRTEM images of the interface between a fission product precipitate and the SiC matrix in particle AGR1-131-099 lamella 1.

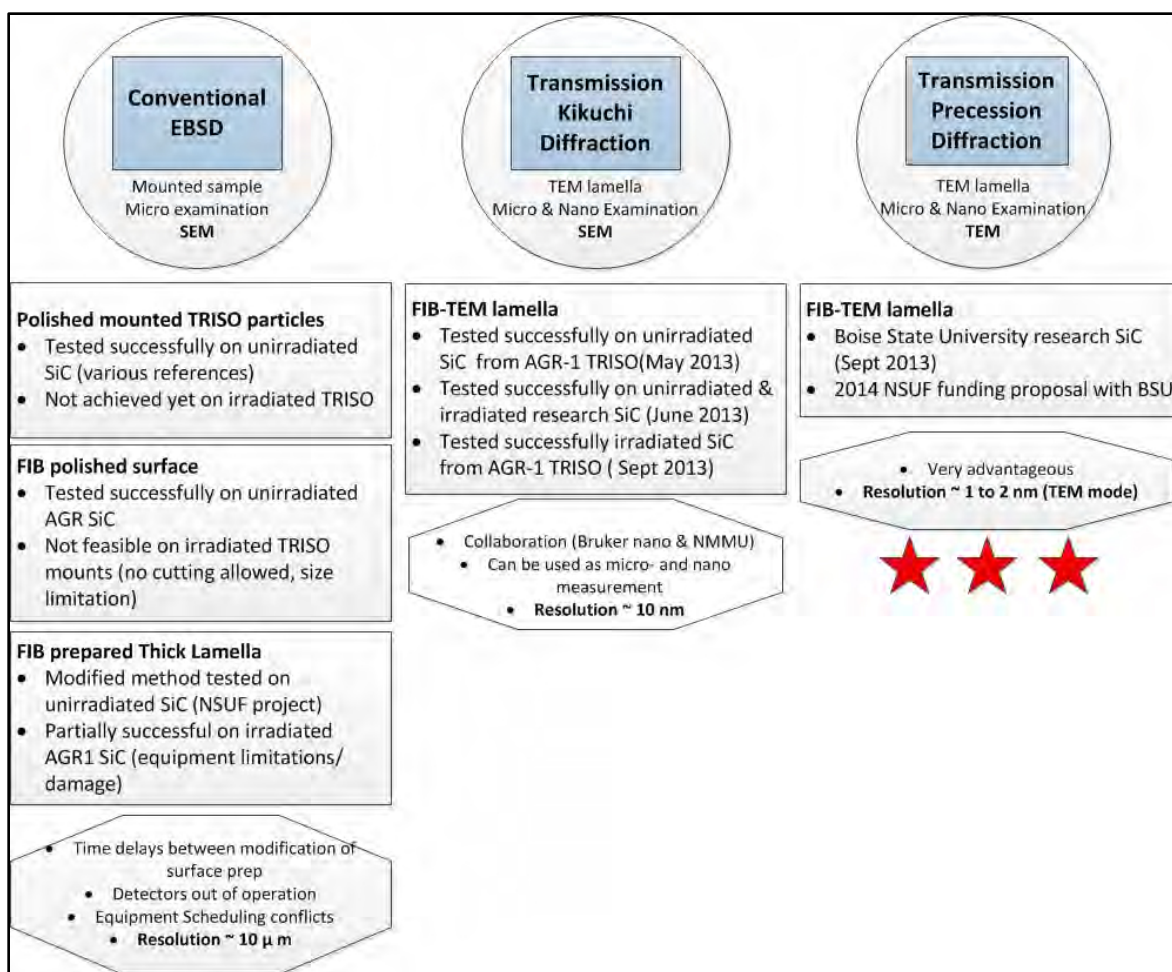
Figure 36. Schematic overview of the work done as part of AGR-1 PIE with complementary projects and other funding sources to assess crystallographic data on the SiC layer of particles and determine grain boundary misorientation (stars indicating the most successful results obtained at present).

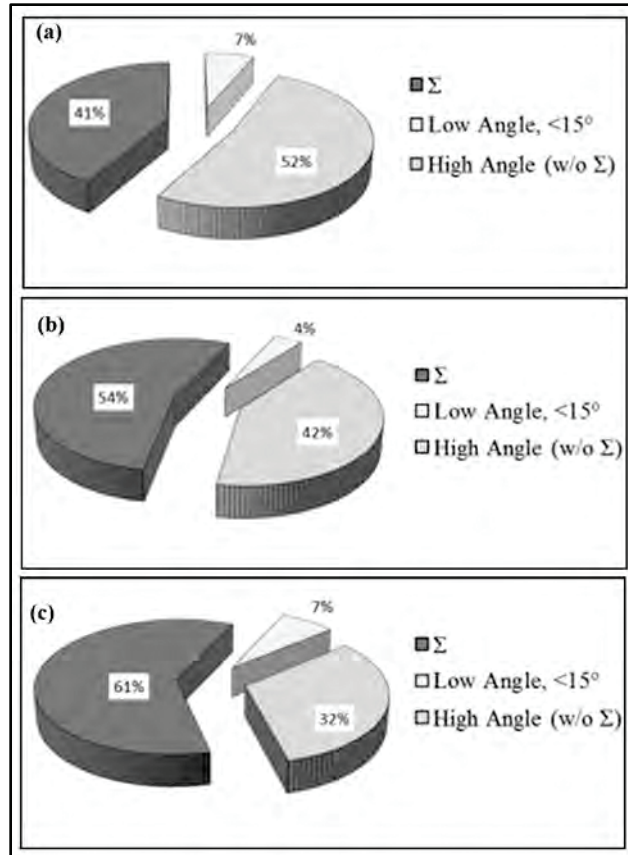
Figure 37. Distribution of grain boundary types for (a) inner, (b) center, and (c) outer areas in the SiC layer of an irradiated TRISO particle (AGR1-632-035) (adapted from Lillo et al. 2015b).

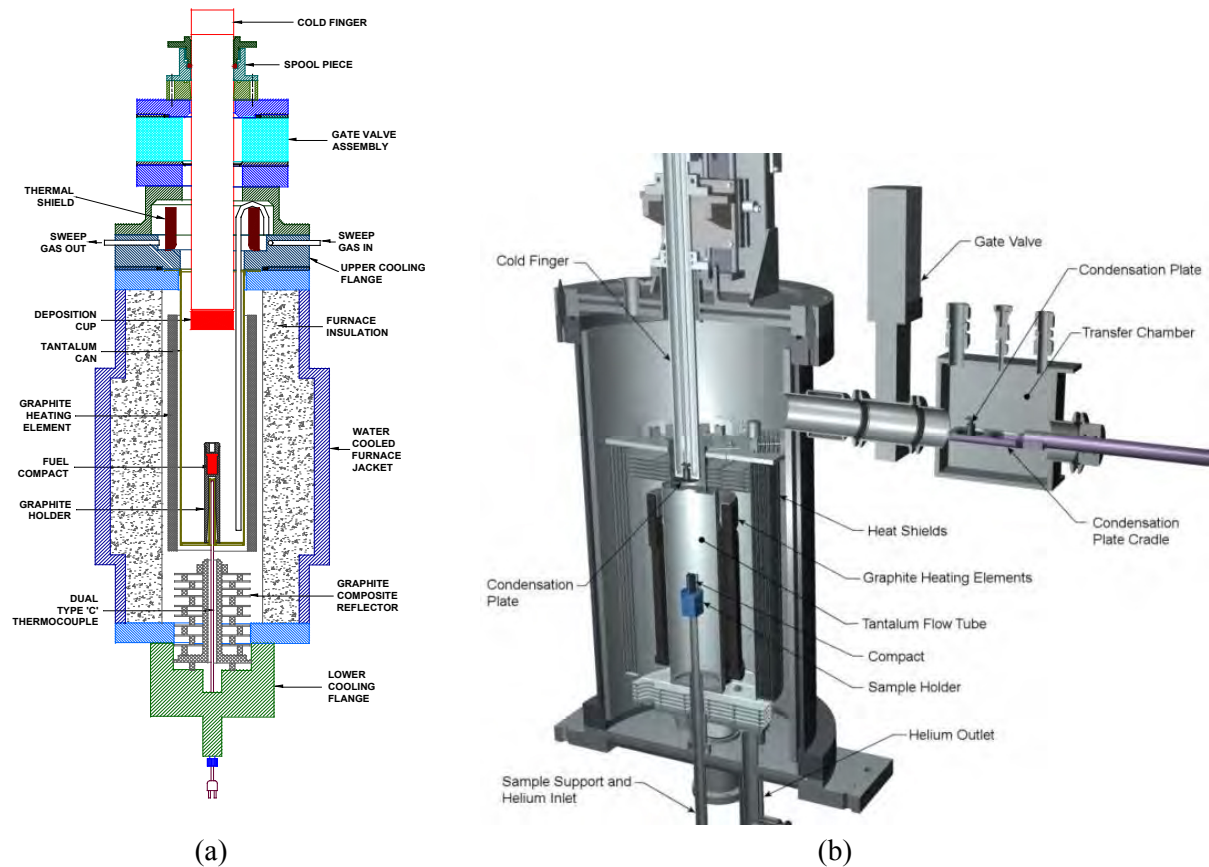
Figure 39. Schematic of the CCCTF (a) and FACS (b) safety test furnaces.

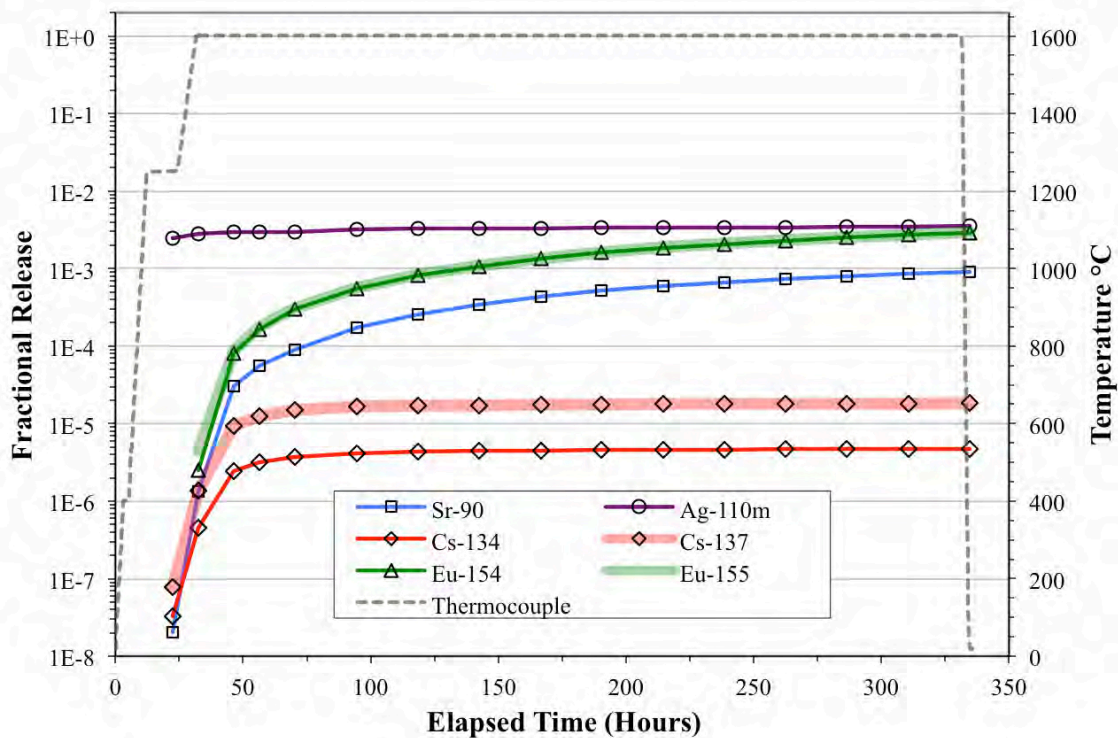
Figure 40. Compact 6-2-1 test results. Cesium release was very low; higher ^{137}Cs accumulation, compared to ^{134}Cs , indicates hot cell contamination.

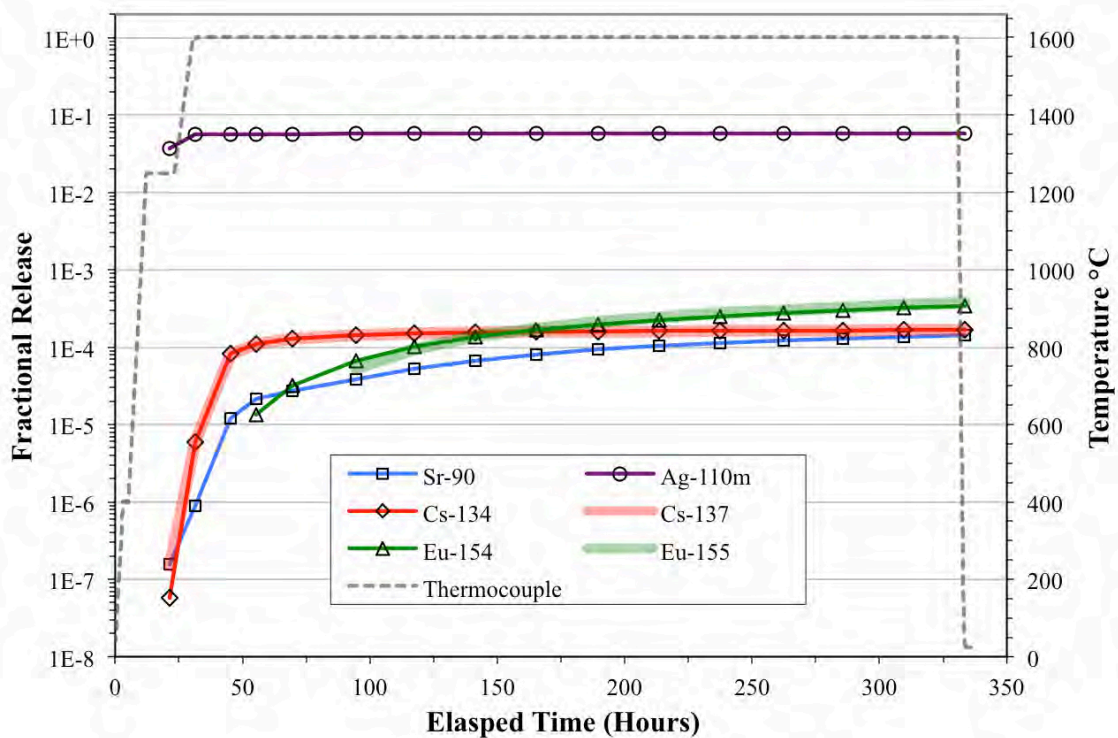
Figure 41. Compact 4-1-2 test results. Cesium release above 10^{-4} indicates that this compact contained a particle whose SiC layer was not intact.

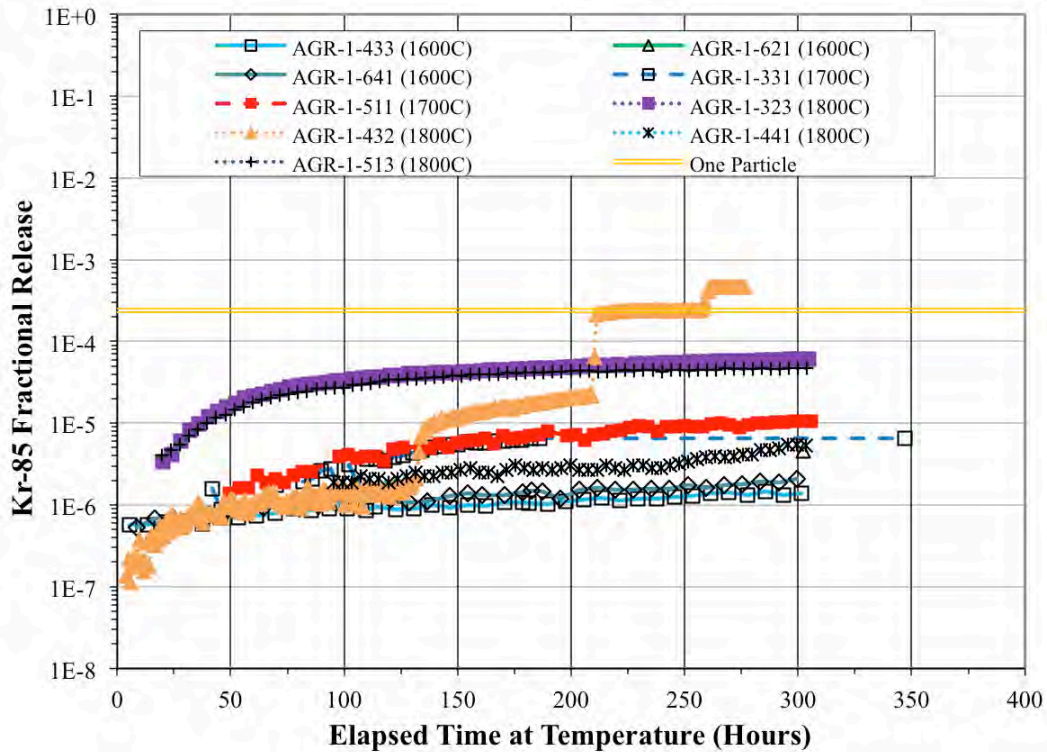
Figure 42. Fractional release of ^{85}Kr during safety testing. Only nine runs had measurable release, and Compact 4-3-2 showed the only TRISO failure.

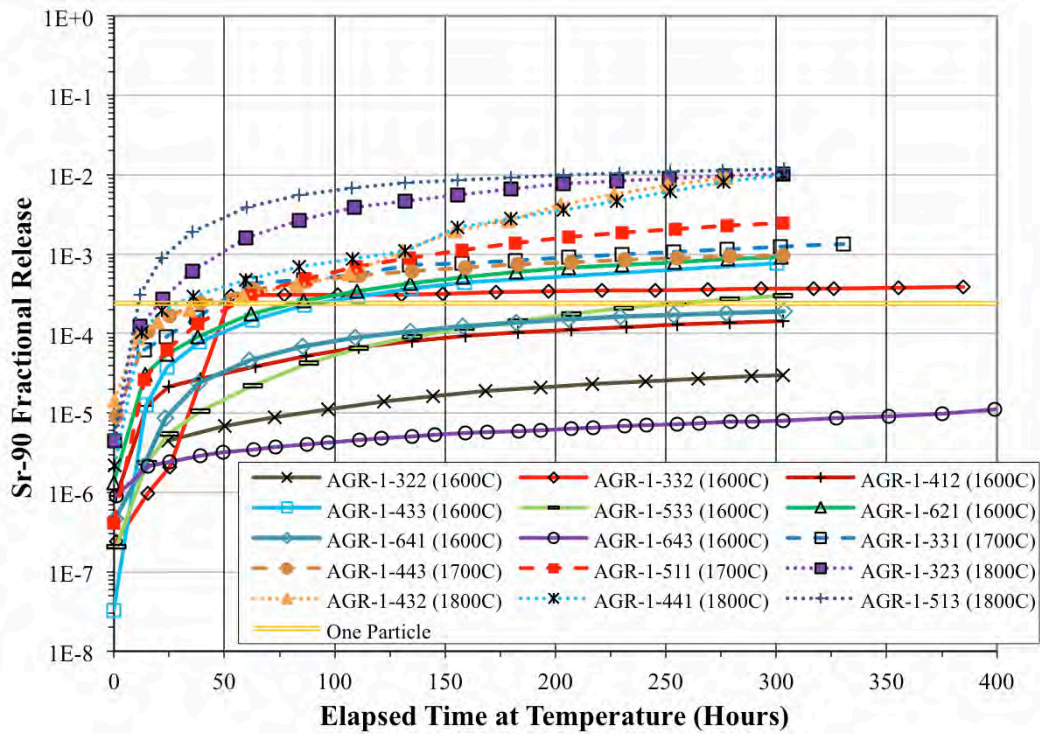
Figure 43. Fractional release of ^{90}Sr during safety testing. Release increased with temperature.

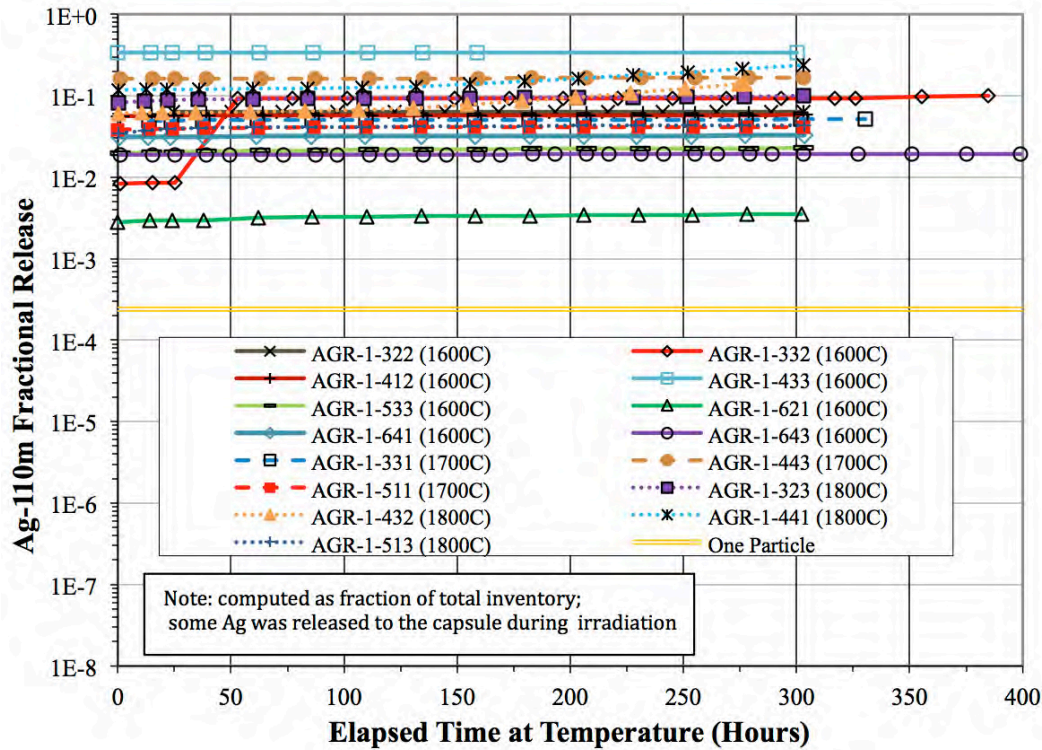
Figure 44. Fractional release of ^{110m}Ag during safety testing. Release peaked very early. Compact 3-3-2 showed secondary release related to thermal cycling of furnace.

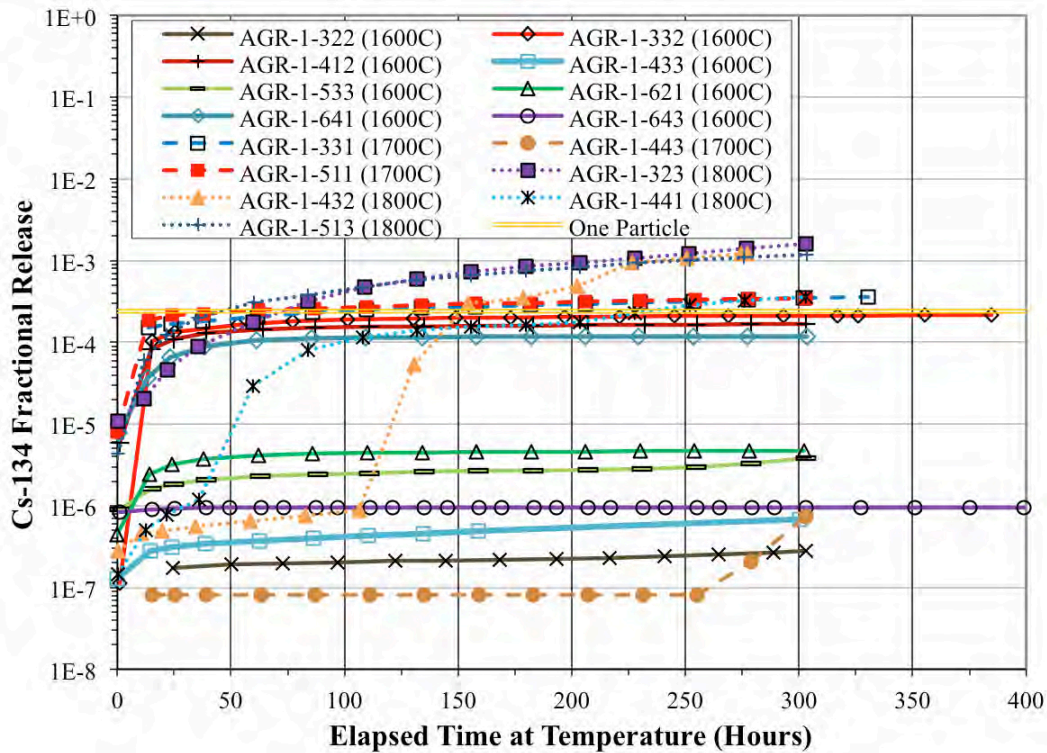
Figure 45. Fractional release of ^{134}Cs during safety testing. Sudden increases were due to SiC failure while either coming up to temperature or later in the run.
