AGR-1 Post Irradiation Examination Final Report

August 2015

INL/EXT-15-36407
Revision 0

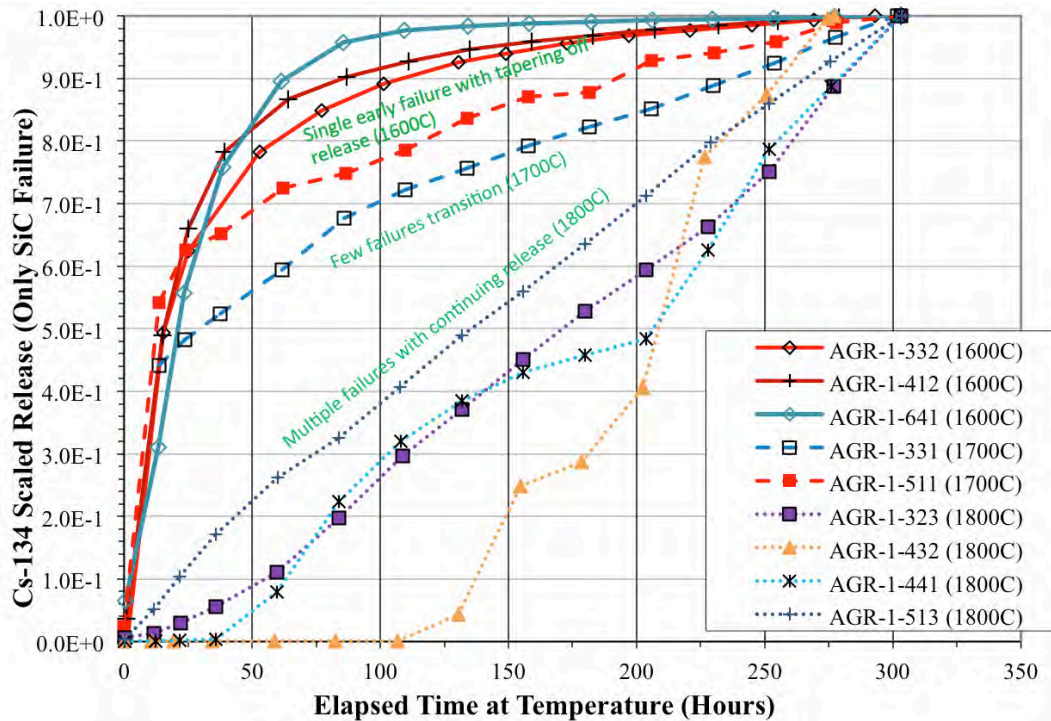
Figure 46. Scaled-release of ^{134}Cs illustrates the release history as a function of test temperature. The number of SiC failures increased with test temperature.

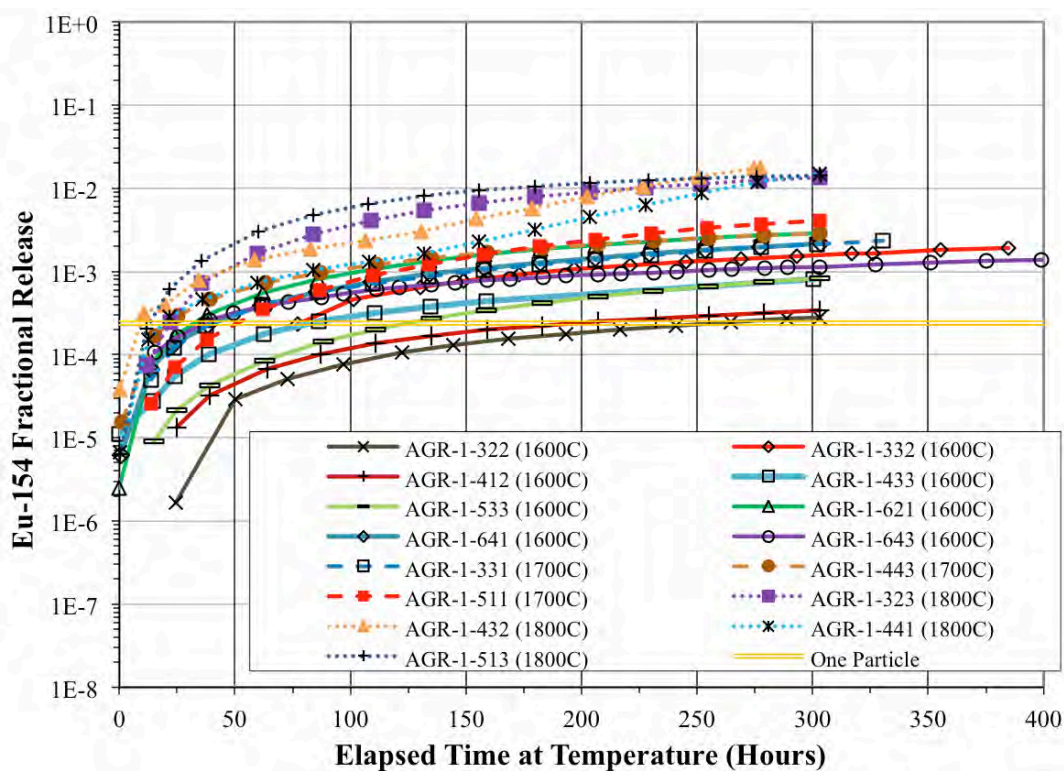
Figure 47. Fractional release of ^{154}Eu during safety testing. Release increased with temperature and exceeded single-particle inventory.

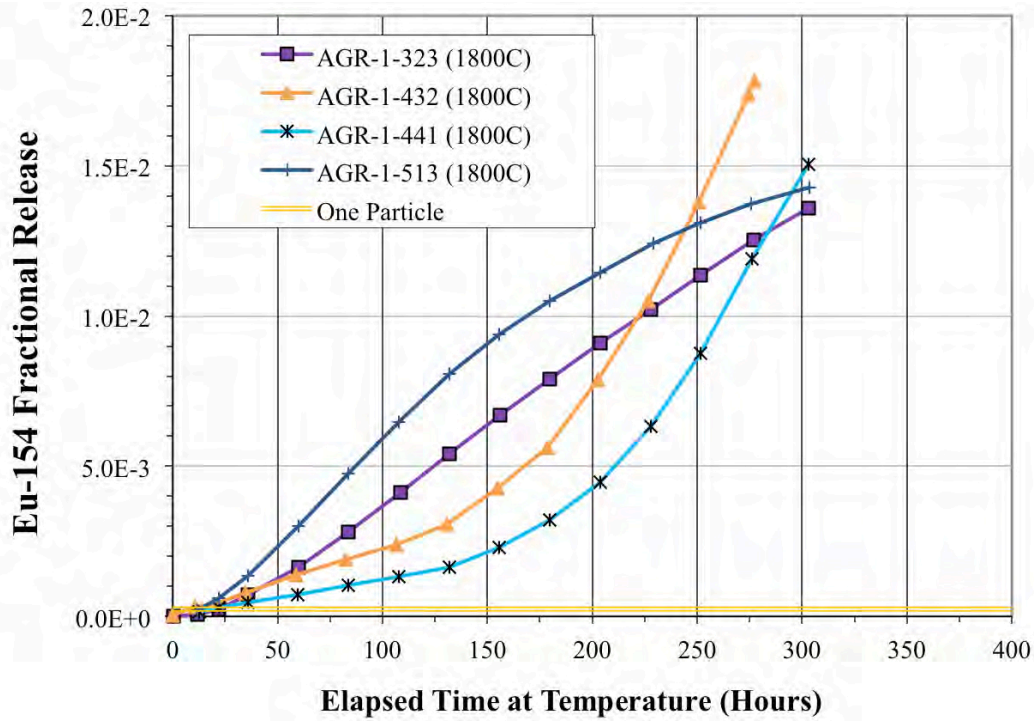
Figure 48. Comparison of the ^{154}Eu release from Baseline and Variant 1 (Compacts 3-2-3 and 5-1-3, respectively) versus Variant 3 Compacts 4-3-2 and 4-4-1; the Variant 3 compact behavior implies a diffusive release.

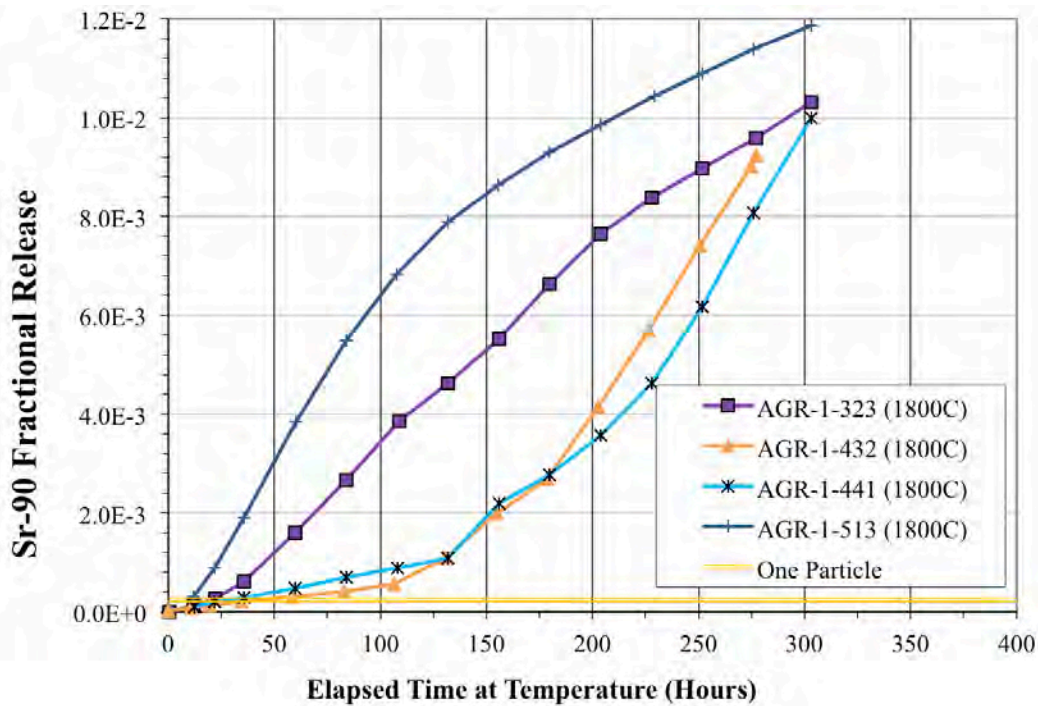
Figure 49. Comparison of the ^{90}Sr release from Baseline and Variant 1 (Compacts 3-2-3 and 5-1-3, respectively) versus Variant 3 Compacts 4-3-2 and 4-4-1; this result is consistent with the ^{154}Eu data.

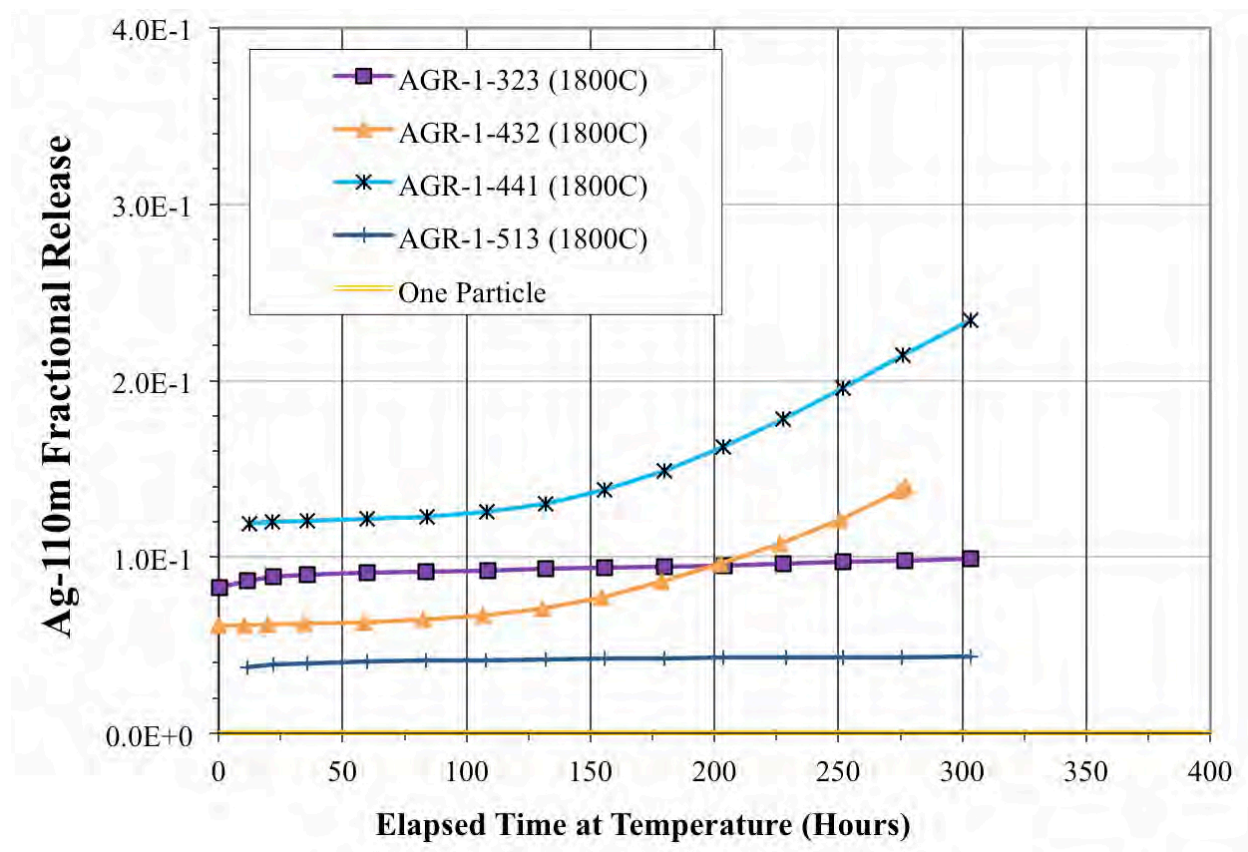
Figure 50. Contrast in silver behavior between Variant 3 (compacts 4-3-2 and 4-4-1) compared to Baseline (Compact 3-2-3) and Variant 1 (Compact 5-1-3). The results are qualitatively similar to Eu and Sr results.

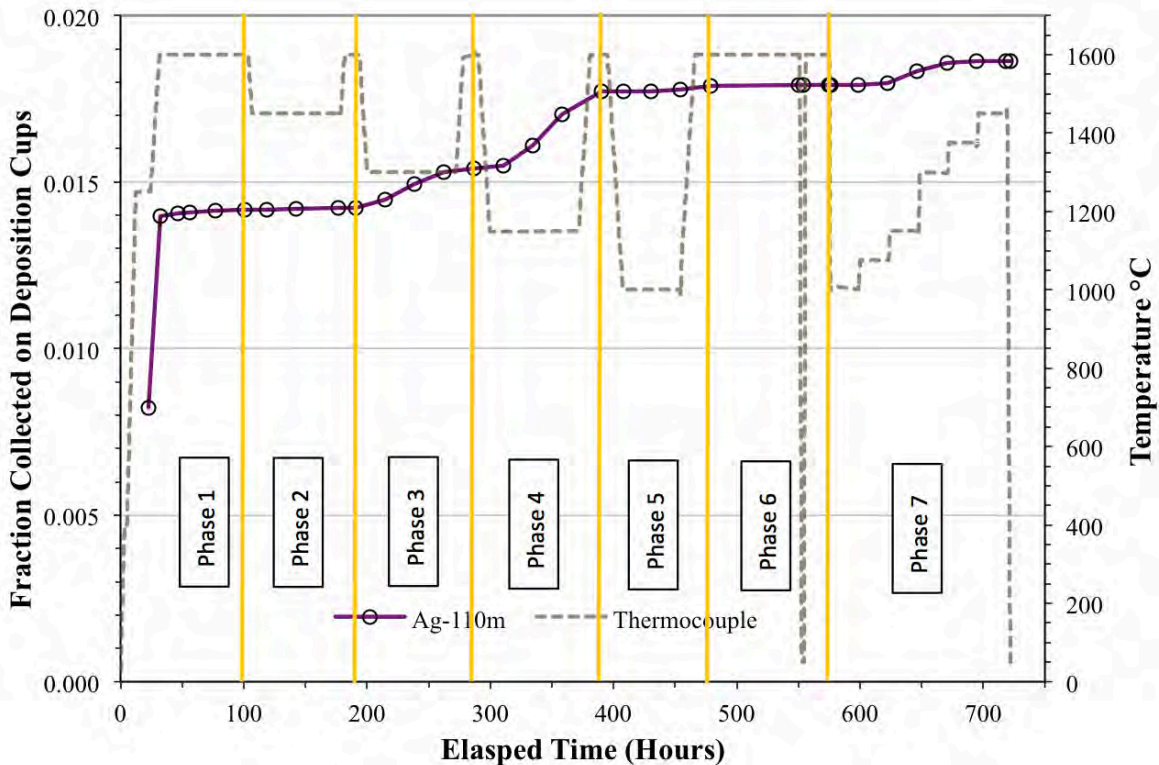
Figure 51. Collection of silver from Compact 4-2-2 during multiple-temperature safety test. The vertical axis shows the amount collected on the deposition cups; because the collection efficiency varied with temperature, this data may not directly scale to compact release.

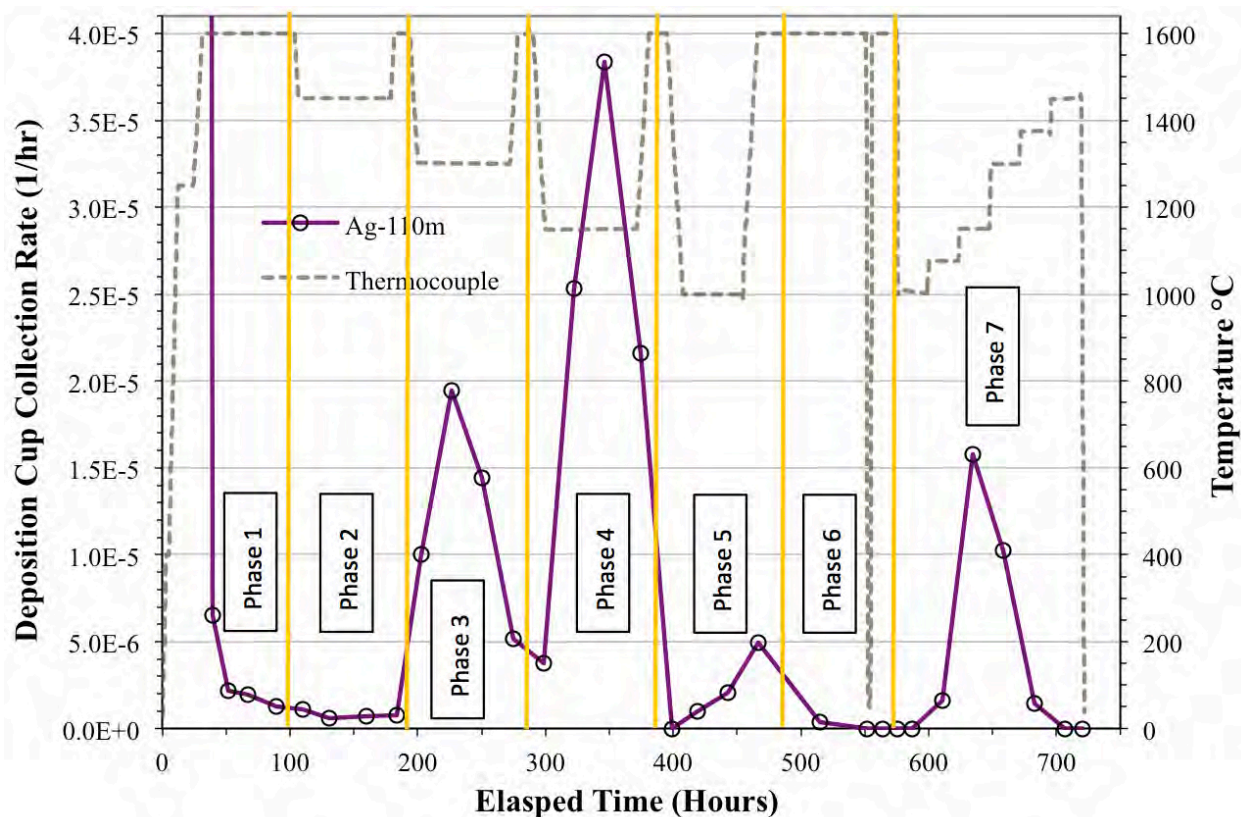
Figure 52. Collection rate of silver from Compact 4-2-2 test. Note the temperature dependence.

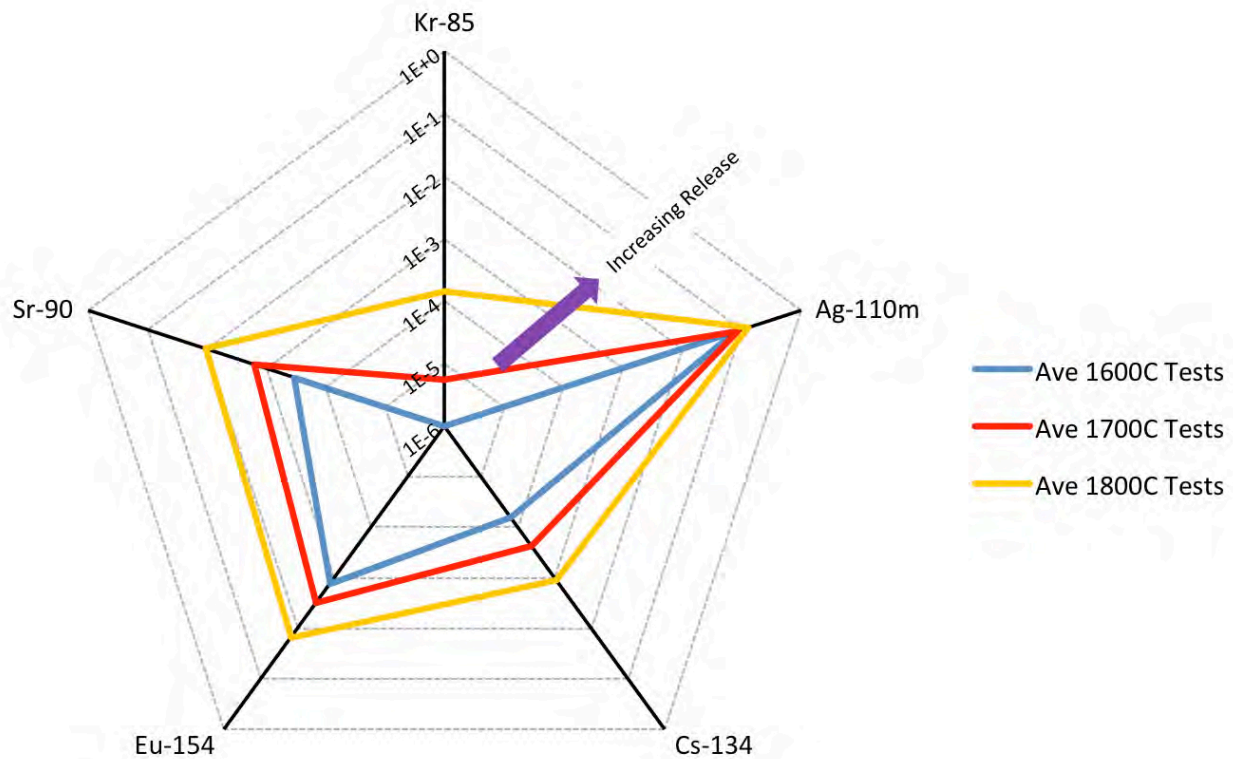
Figure 53. Summary of the average release fractions at the end of the safety tests for the three test temperatures. The general trend was a gradual increasing release with temperature, except for silver, which was almost independent of test temperature. Cesium release was an indicator of SiC failure, and krypton release was related to the same SiC failure (with highest release from Compact 4-3-2 due to concurrent TRISO failure).

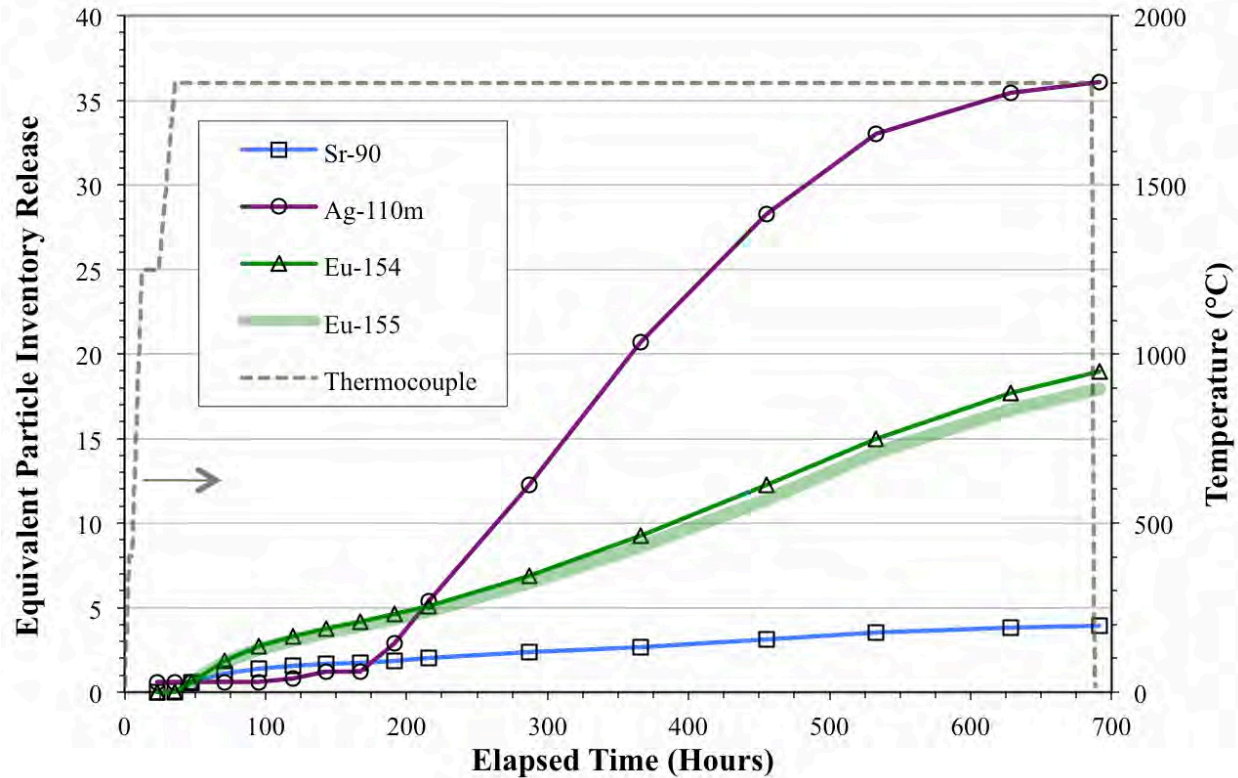
Figure 54. Cumulative release of silver, europium, and strontium from Compact 4-4-2 loose particles at 1800°C.

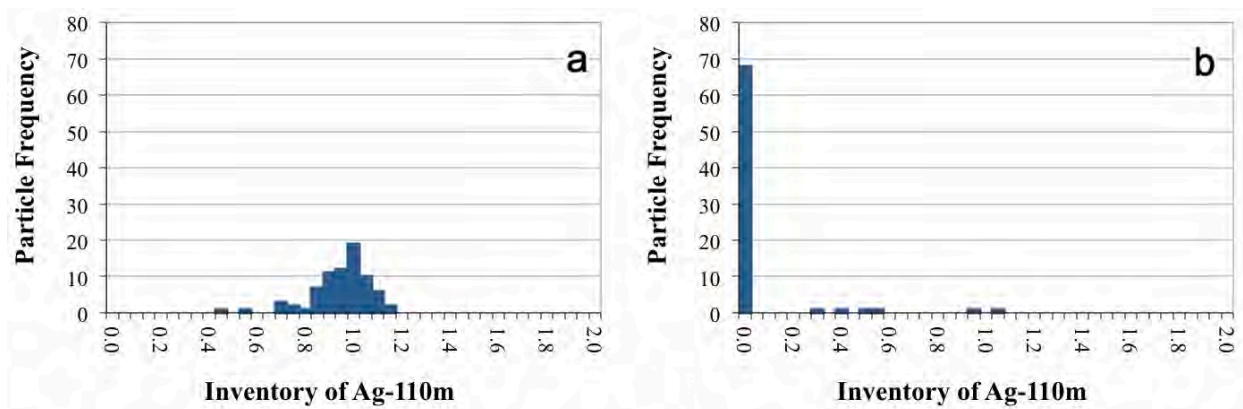
Figure 55. Ratio of measured ^{110m}Ag retained in 75 particles versus calculated inventory, adjusted for variation in fissionable material and burnup with the measured ^{106}Ru activity; (a) as-irradiated and (b) after 1800°C heating test (detection limit at the end of the test was $M/C < 0.21\text{--}0.41$).

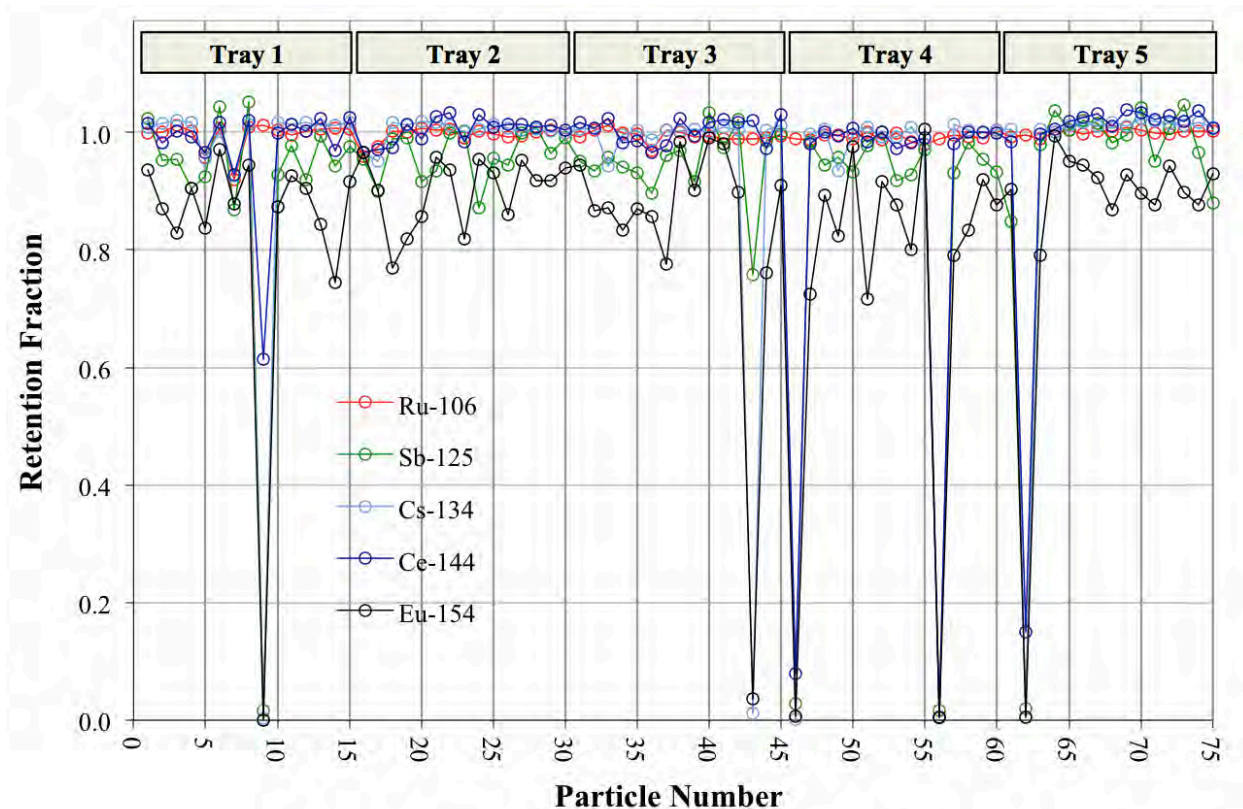
Figure 56. Radioisotope retention fraction of 75 particles after 1800°C safety testing.

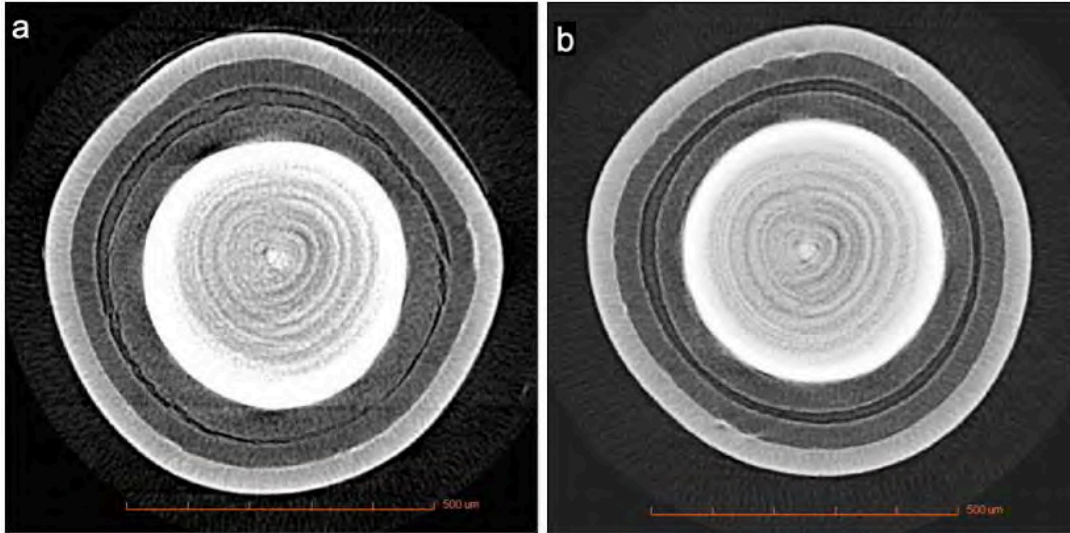
Figure 57. X-ray tomographs near midplane of Compact 5-3-3 particles, safety-tested at 1600°C: (a) particle with undetectable ^{110m}Ag inventory ($M/C < 0.22$), and (b) particle with average ^{110m}Ag inventory ($M/C = 0.88$). Bright features at the IPyC-SiC interface are fission products. Rings in kernel are tomography artifacts.

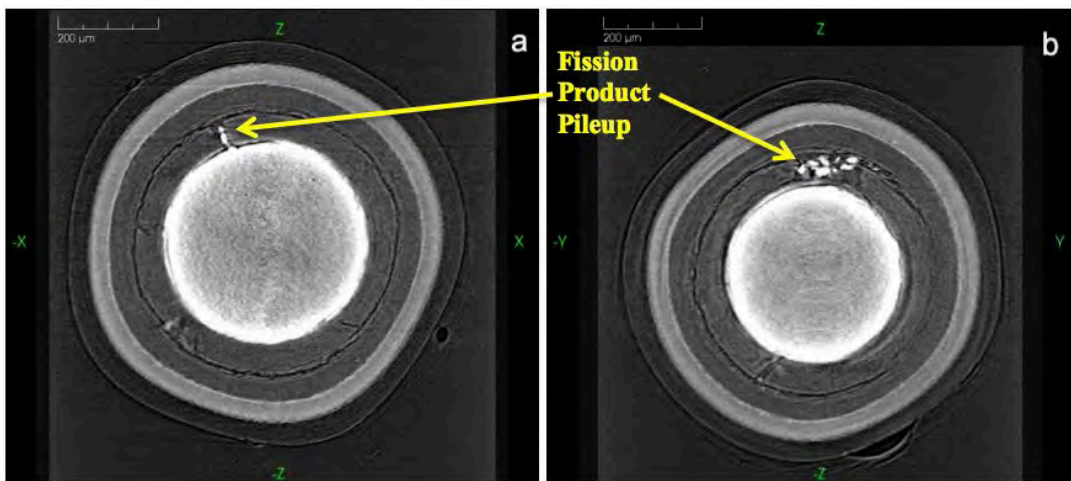
Figure 58. Orthogonal x-ray tomographs of a Compact 3-3-1 particle, safety tested at 1700°C with average ^{110m}Ag inventory near midplane (a) and offset from midplane (b) showing a fractured buffer, but no apparent IPyC damage. Bright features in the fractured buffer are fission product buildup.

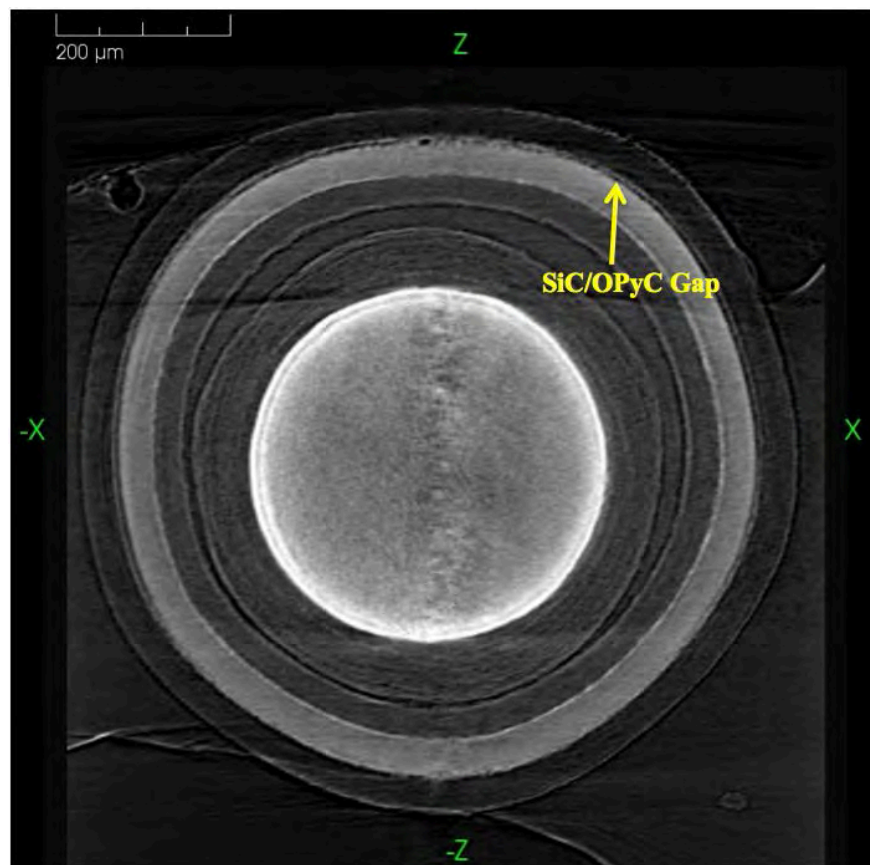
Figure 59. X-ray tomograph near midplane of an 1800°C safety-tested Compact 4-4-1 particle with low silver retention, showing the typical buffer densification and delamination from the IPyC, as well as a SiC/OPyC gap.

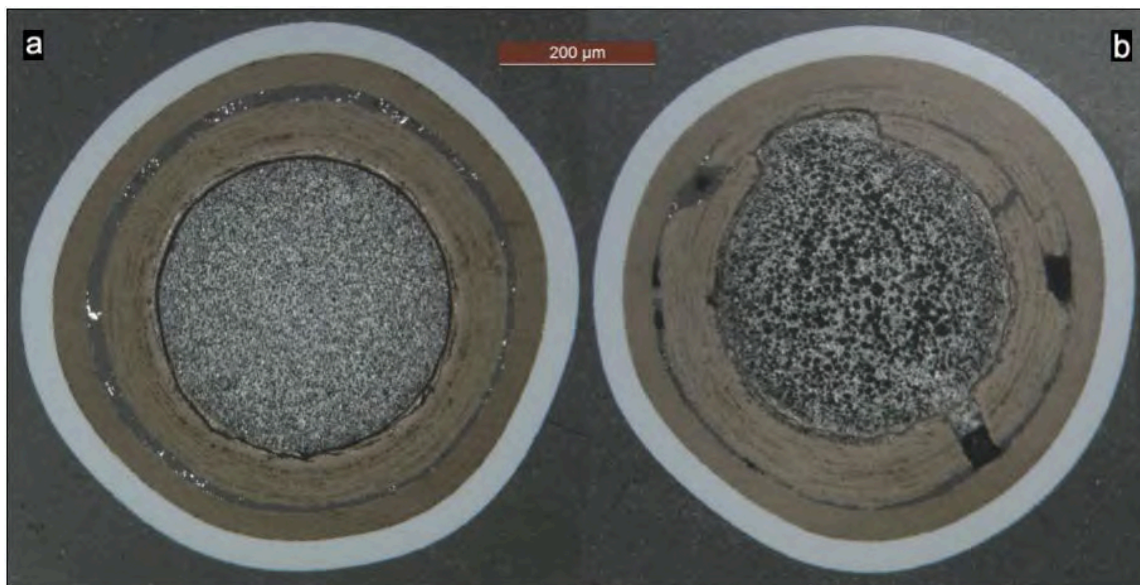
Figure 60. Optical micrographs of polished cross sections from 1600°C safety-tested Compact 3-2-2 particles with average silver retention, showing (a) typical buffer densification and delamination from the IPyC layer, and (b) buffer fracture and kernel protrusion due to limited delamination from the IPyC layer.

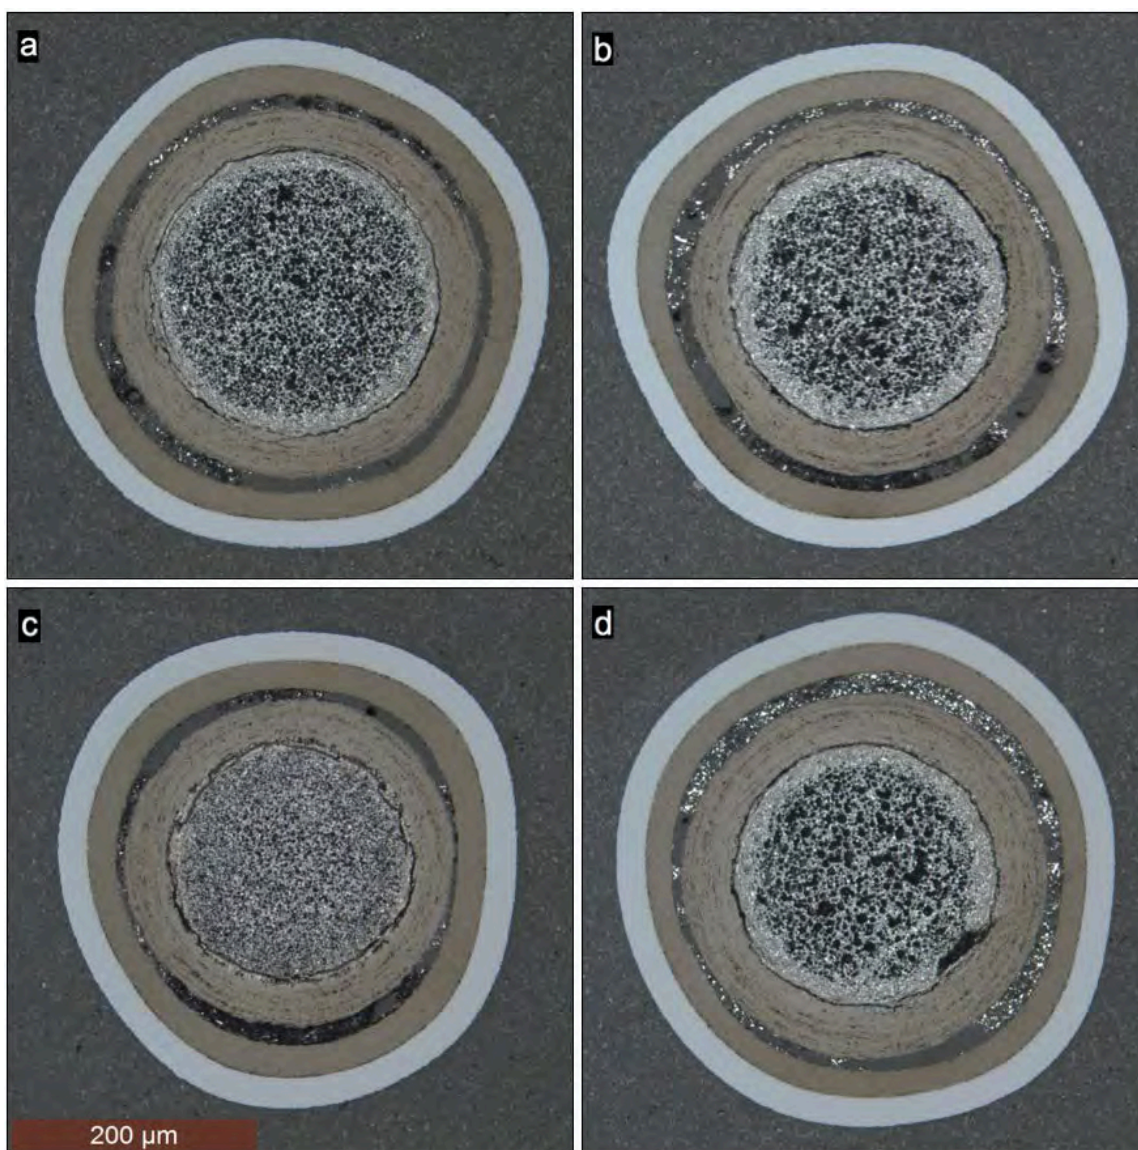
Figure 61. Optical micrographs near midplane of particles from 1600°C safety-tested Compact 5-3-3: (a) particle with high $^{110\text{m}}\text{Ag}$ release ($\text{M/C} < 0.21$), (b) particle with moderate $^{110\text{m}}\text{Ag}$ release ($\text{M/C} = 0.58$), (c) particle with approximately average $^{110\text{m}}\text{Ag}$ M/C (0.81), suggesting low or negligible release, and (d) particle with very low $^{110\text{m}}\text{Ag}$ release ($\text{M/C} = 1.10$).

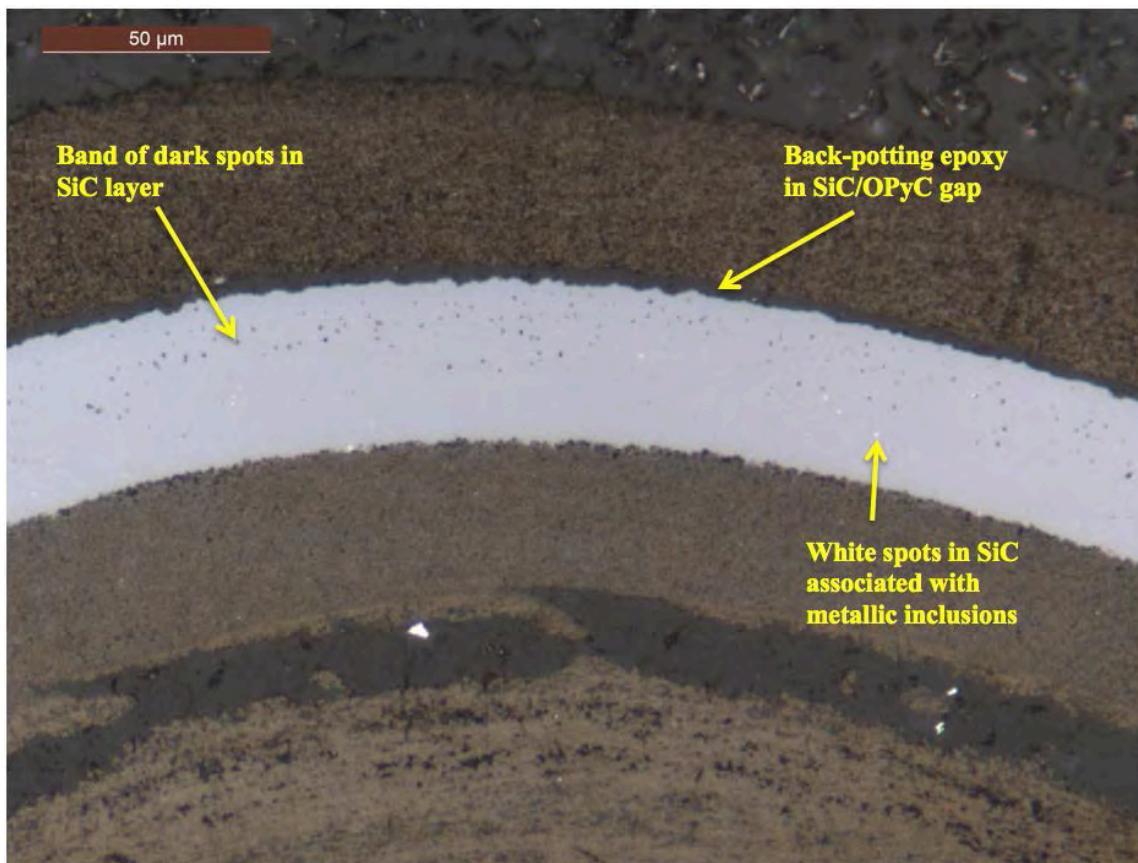
Figure 62. Optical micrograph near midplane of a typical particle from 1800°C safety-tested Compact 4-4-1 showing a wide gap between the SiC and OPyC (backfilled with epoxy during sample preparation), and a band of dark spots in the outer half of the SiC layer.

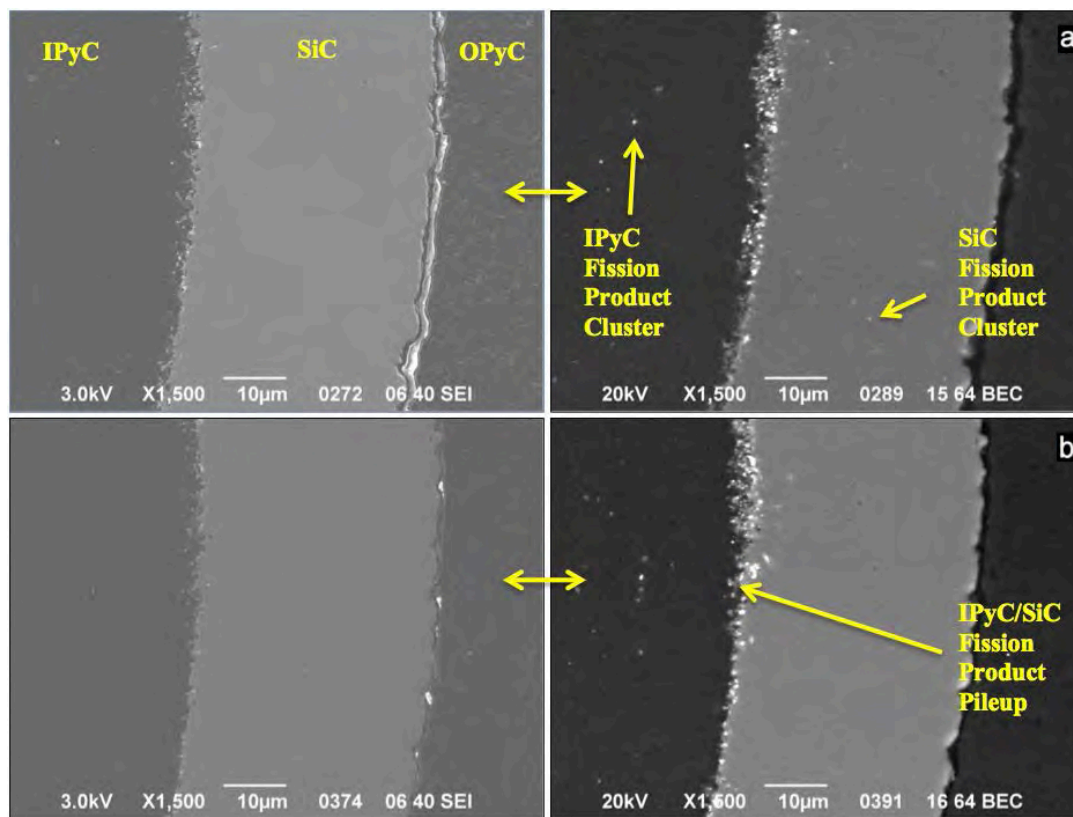
Figure 63. SEI/BEC-paired images of Compact 4-1-2, safety tested at 1600°C: (a) very low Ag retention particle ($M/C \leq 0.16$) and (b) high Ag retention particle ($M/C = 1.12$). Areas of bright contrast in BEC micrograph indicate isolated fission product features.

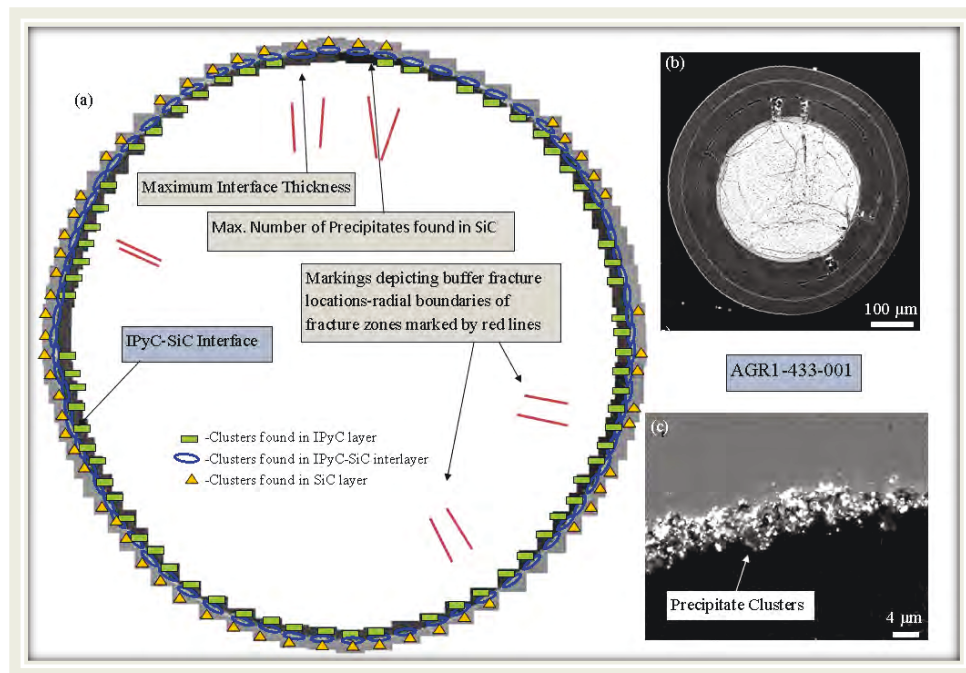
Figure 64. Particle AGR1-433-001 showing (a) an SEM image montage representing the distribution of precipitate clusters, (b) an optical micrograph of the particle cross section, and (c) a representative SEM image of the IPyC-SiC interface.

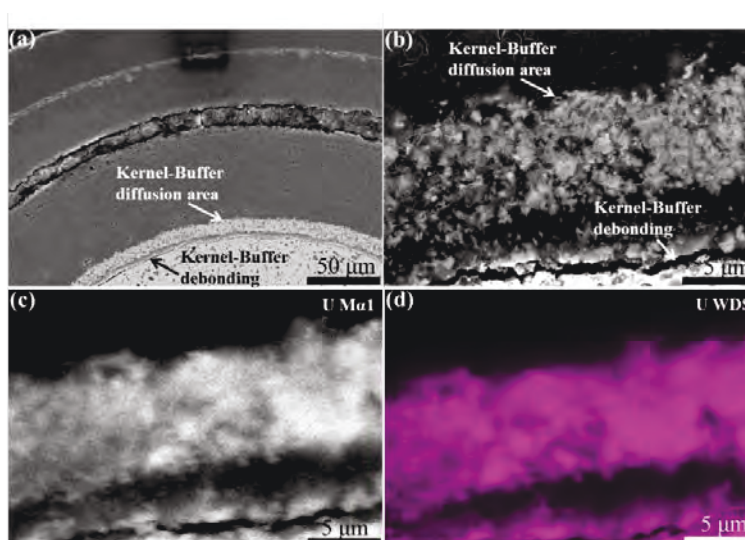
Figure 66. SEM images of AGR1-433-004 showing kernel-buffer diffusion area, with kernel-buffer debonding, and EDS and WDS maps of the area in (b).

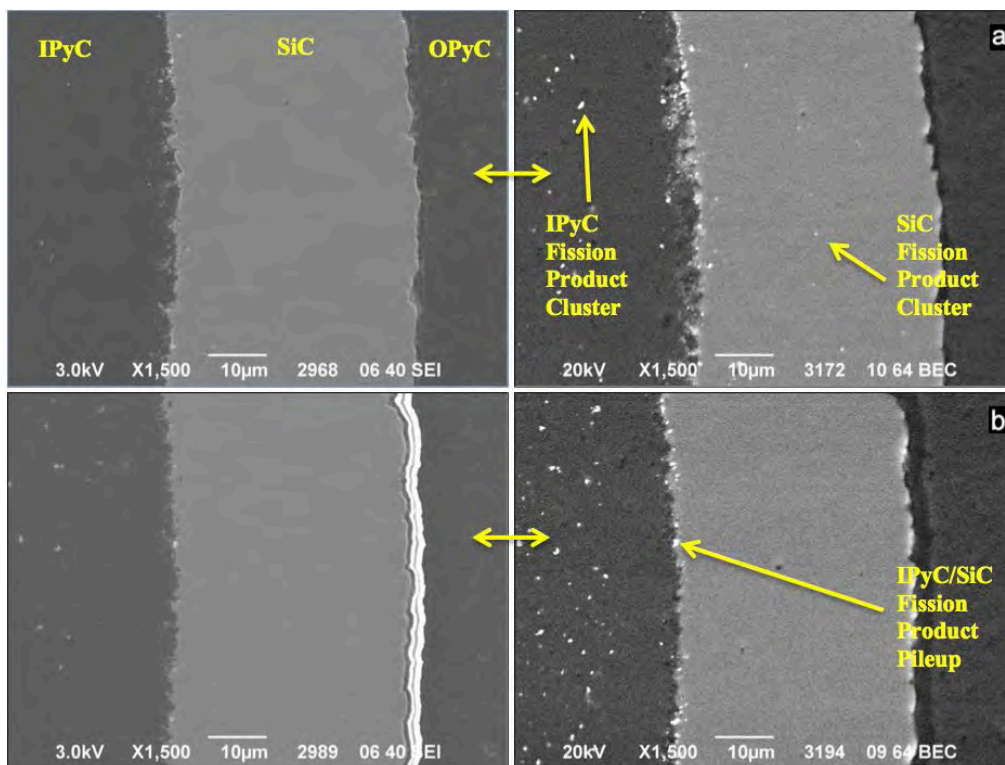
Figure 67. SEI/BEC-paired images of Compact 5-1-1, safety tested at 1700°C: (a) low Ag retention particle ($M/C \leq 0.61$) and (b) high Ag retention particle ($M/C = 1.01$). Spots of bright contrast in BEC micrograph indicate isolated fission product features. The bright material in the SEI image in the lower left corner is due to charging of epoxy infiltrating the gap between the SiC and OPyC.

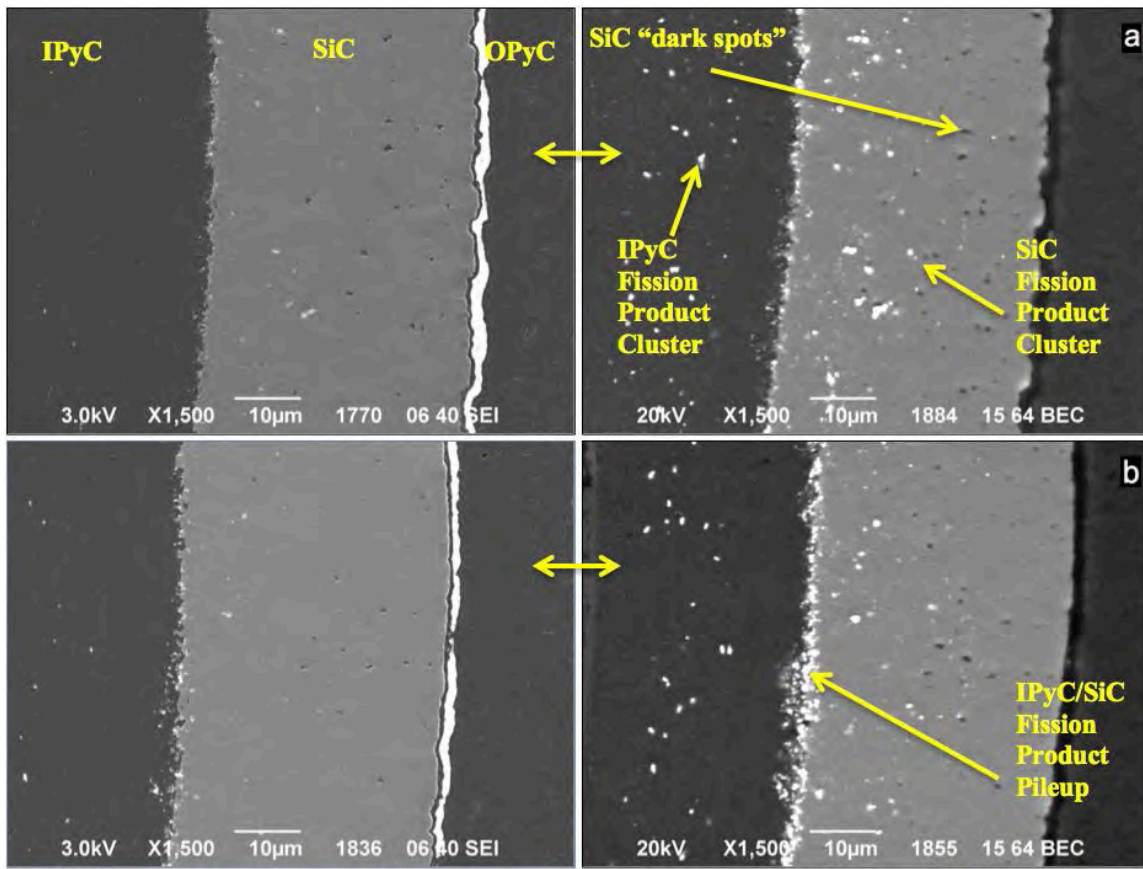
Figure 68. SEI/BEC-paired images of Compact 3-2-3, safety tested at 1800°C: (a) low Ag retention particle ($M/C \leq 0.25$) and (b) high Ag retention particle ($M/C = 1.17$). Areas of bright contrast in BEC micrograph indicate isolated fission product features.

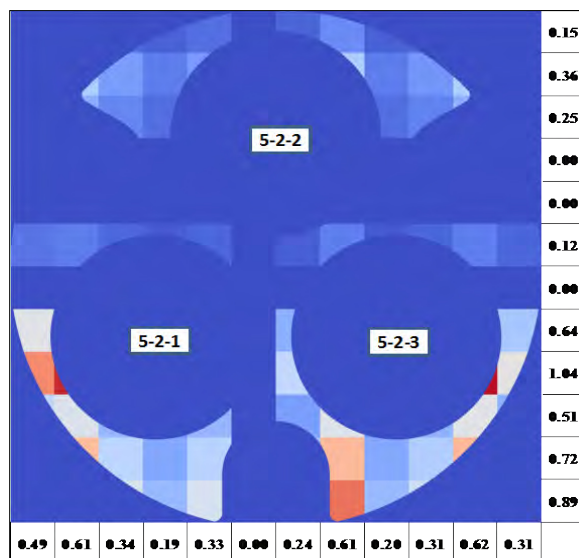
Figure 69. Intensity map of ^{134}Cs activity in one section of Capsule 5 graphite holder showing hot spots (red) adjacent to Compacts 5-2-1 and 5-2-3 (Harp et al. 2012).

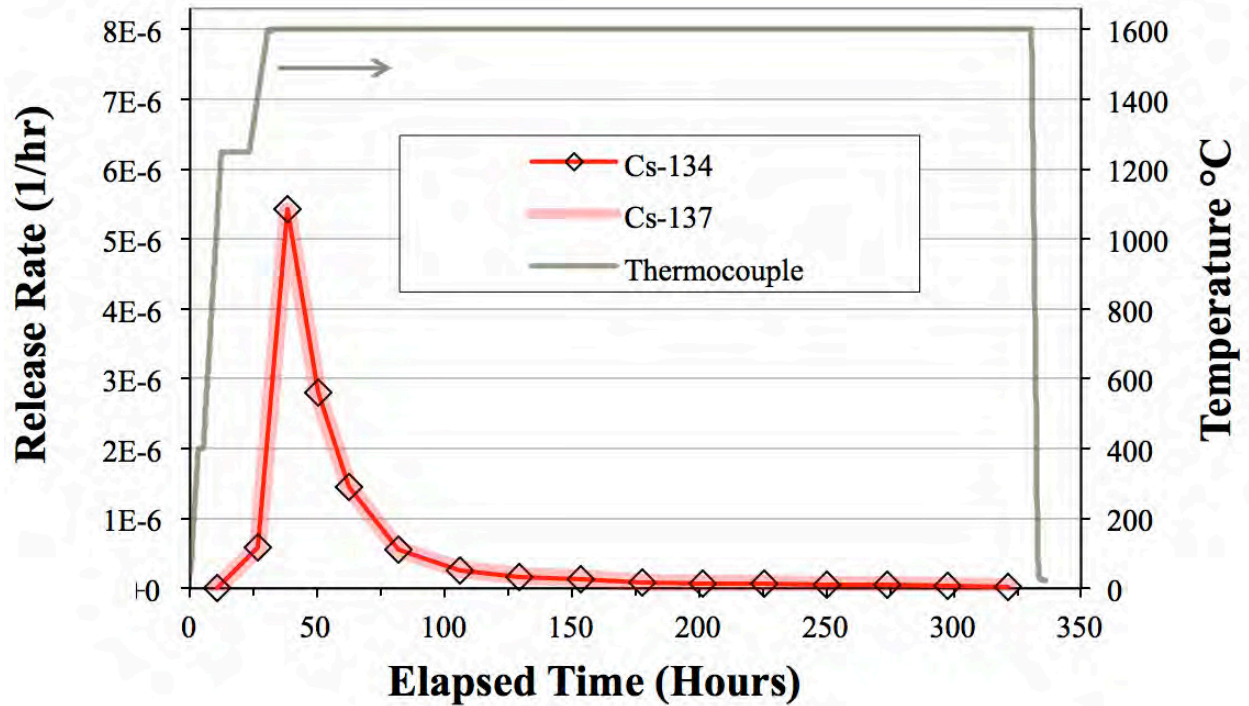
Figure 70. Fraction of the compact's cesium inventory released per hour during 1600°C safety testing of AGR-1 Compact 4-1-2.

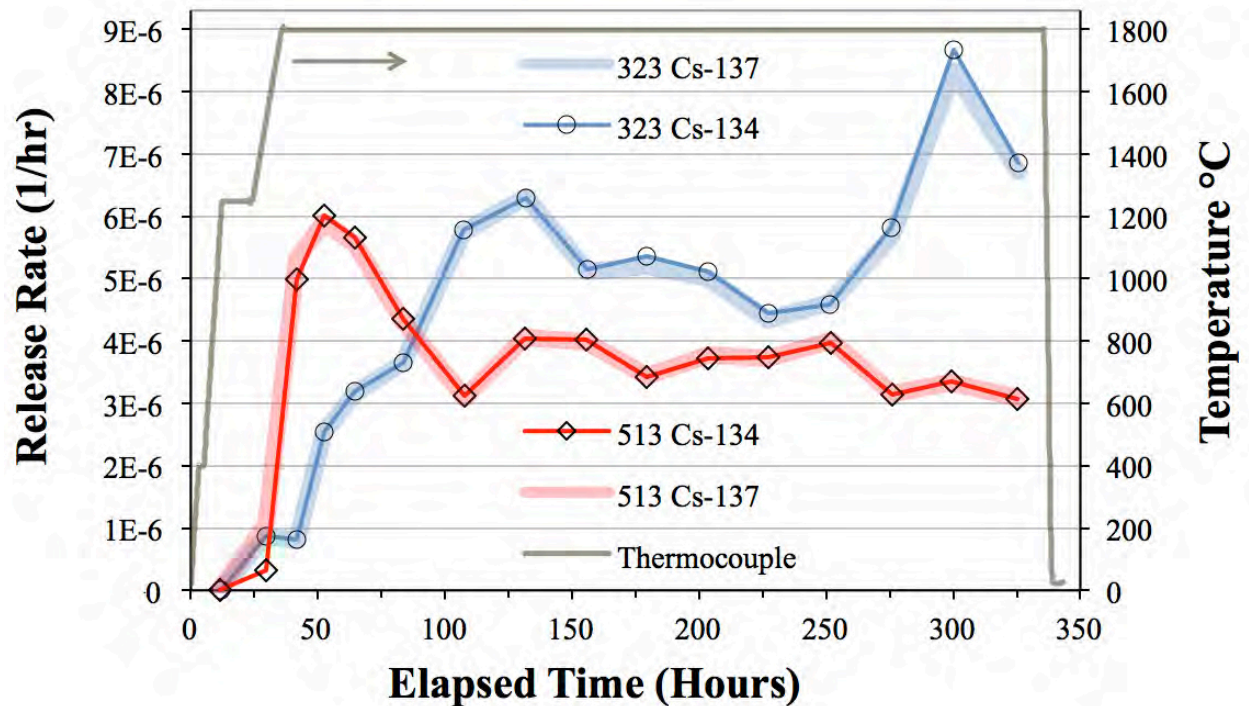
Figure 71. Fraction of the compact's cesium inventory released per hour during 1800°C safety testing of AGR-1 Compacts 3-2-3 and 5-1-3.

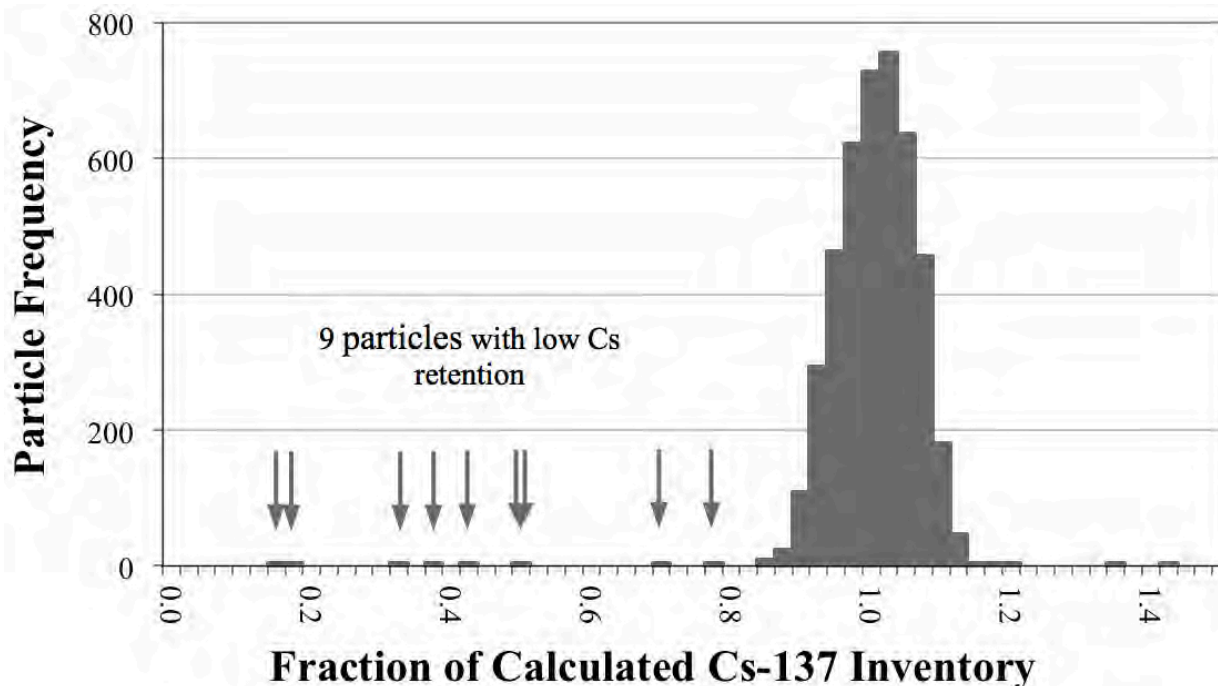
Figure 72. Cesium inventory distribution determined with IMGA for particles from 1800°C safety-tested AGR-1 Compact 3-2-3.

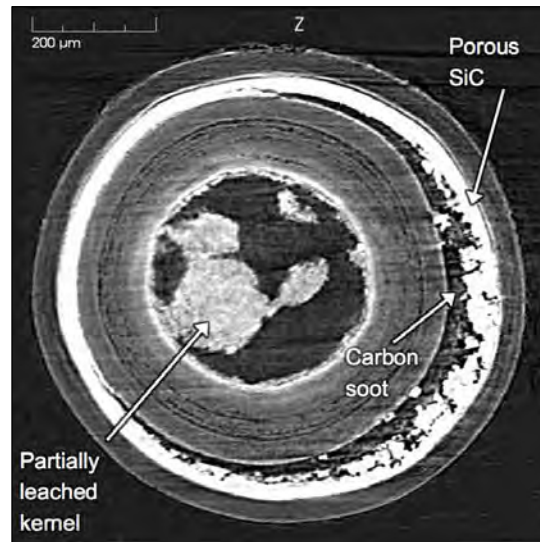
Figure 73. Particle that released cesium during 1600°C safety testing of Compact 3-3-2 due to an as-fabricated defect that led to SiC failure when the particle was heated above the irradiation temperature.
