AGR-1 Post Irradiation Examination Final Report

August 2015

INL/EXT-15-36407
Revision 0

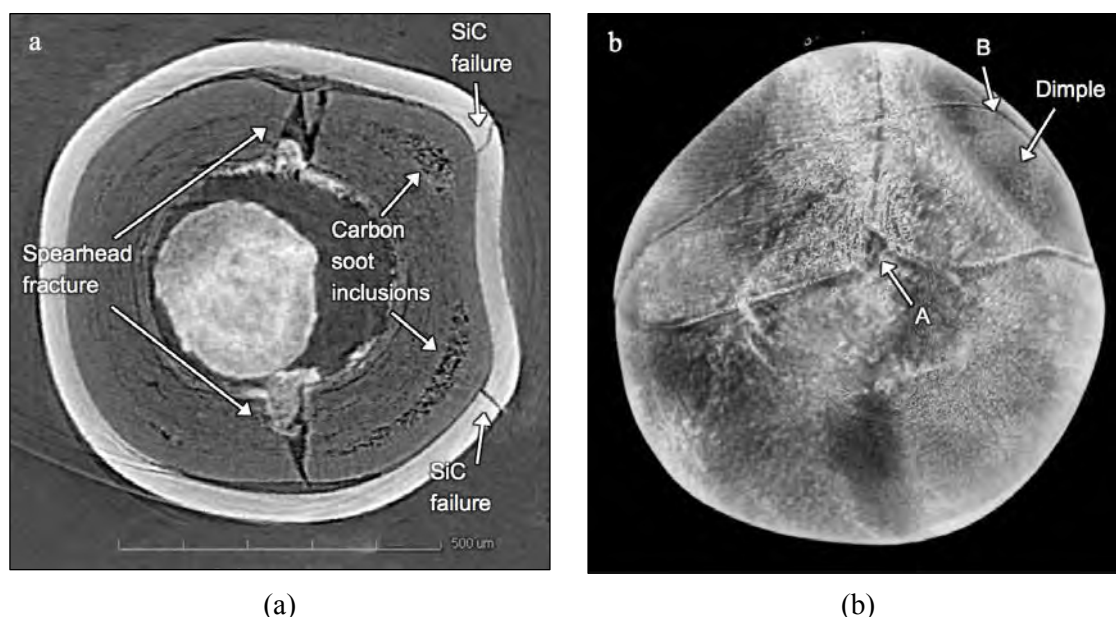
Figure 74. Particle that released cesium during safety testing of Compact 4-1-2; (a) x-ray tomograph and (b) semitransparent 3-D visualization of SiC surface.

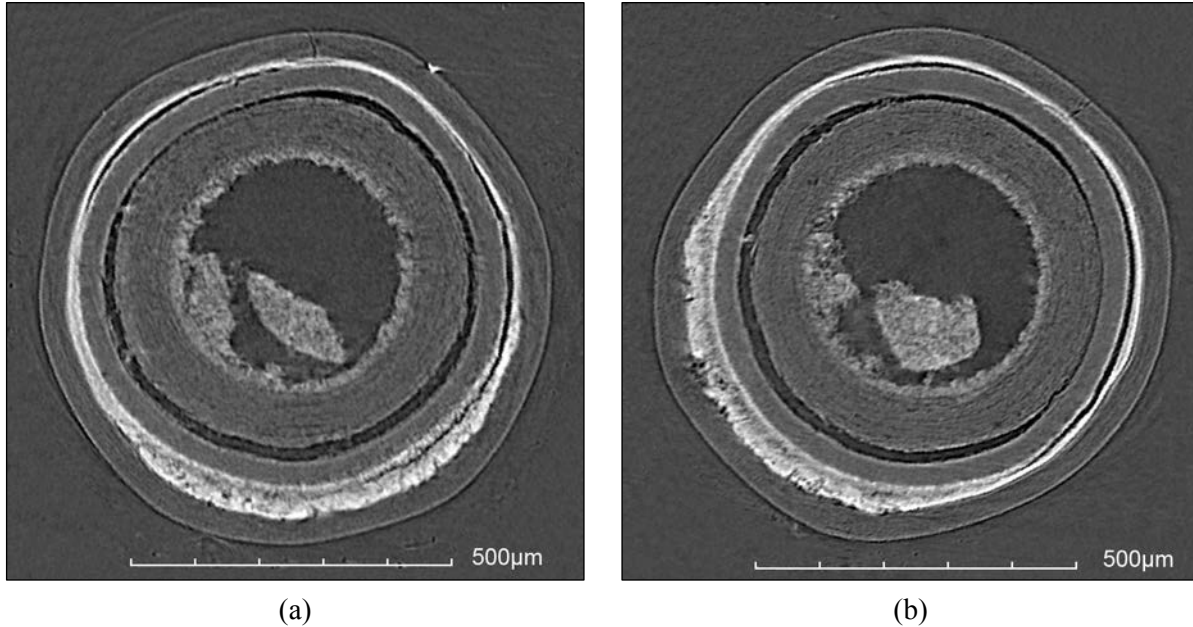
Figure 75. Low Cs/Ce Particle 3 (511-SP02): oblique orthogonal x-ray tomographs showing a gross SiC inclusion (pre-irradiation defect), and only residual kernel material remaining after pre-burn leaching.

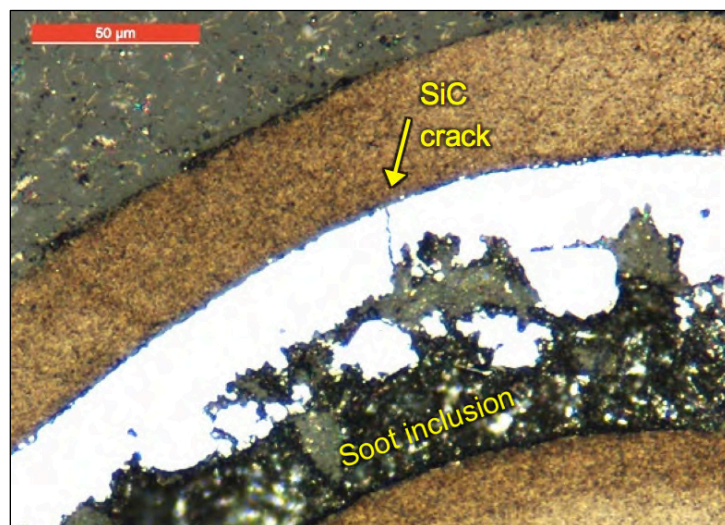
Figure 76. Compact 3-3-2 particle with soot inclusion defect that failed during 1600°C safety testing. A crack through intact SiC covering the porous region produced a pathway through the layer.

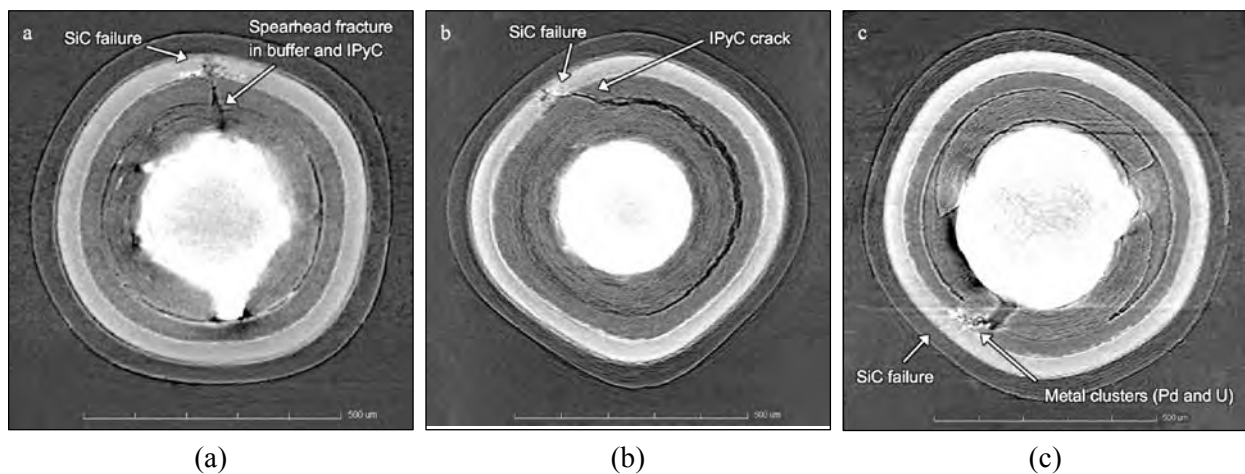
Figure 77. X-ray tomographs of AGR-1 particles with failed SiC; (a) Compact 3-2-3 Particle 5 after 1800°C safety testing, (b) Compact 3-3-1 Particle 1 after 1700°C safety testing, and (c) Compact 5-2-3 Particle 2 after completion of AGR-1 irradiation test.

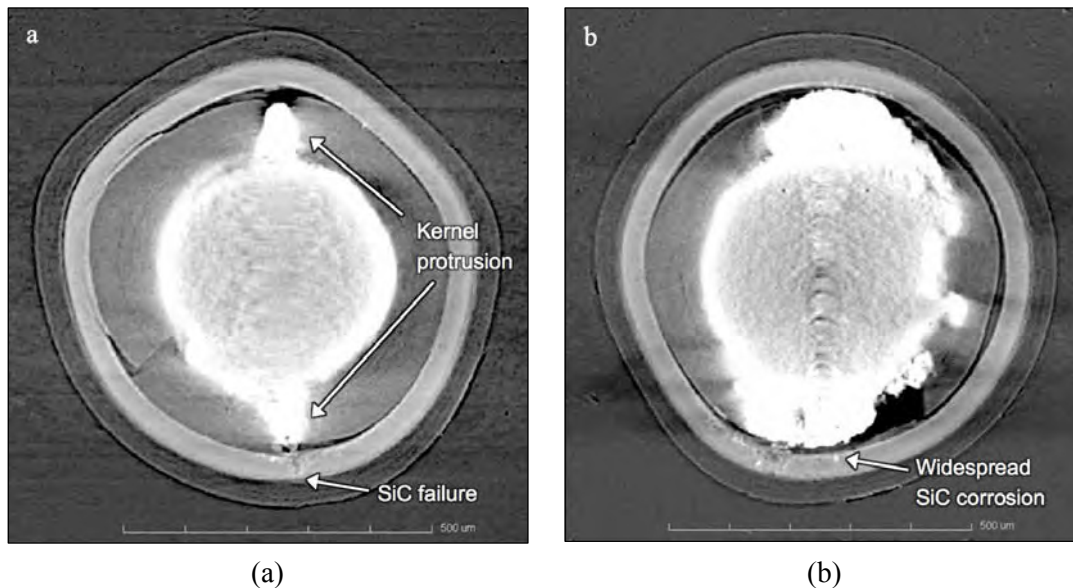
Figure 78. Orthogonal x-ray tomographs showing kernel protruding to the SiC in Compact 3-2-3 Particle 6 after 1800°C safety testing.
