# Decontamination Methods Testing for the Waste Isolation Pilot Plant - 15691

Waste Management Symposia (WM2015)

Stephen Reese, Rick Demmer, Michael Ancho

March 2015

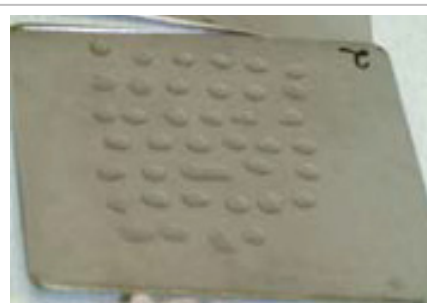
Figure 6. Stainless steel plate stippled with an  $^{241}\text{Am}$  solution.

The americium tracer was applied to two steel plates and six salt coupons. The salt coupons used were the most regular of the twelve,  $\sim 100\text{ cm}^2$ , 3 cm thick coupons. As the tracer was applied to the surface of the salt, it was observed that it did not bead, like in Figure 6, rather it wicked into the surface pores, cracks, and imperfections. The structure of the salt appears to have  $\sim 1\text{ cm}$  grains, which allows solution to imbibe into the intergranular areas. This explanation for the observed behavior is supported by the results of pre-decontamination measurements: The same amount of tracer returned  $\sim 13\%$  of the radiometric counts that were found on the steel plates. The tracer had likely penetrated into the salt matrix, attenuating its detectable activity.

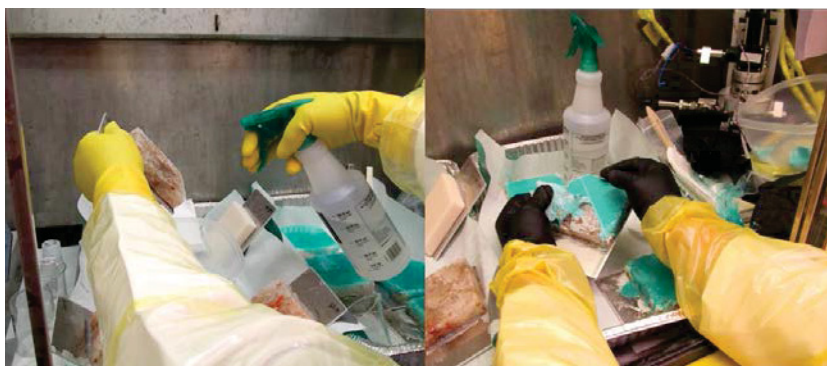
Figure 7. Left: Water washing americium from a salt coupon. Right: Removing DeconGel strippable coating from a salt coupon.

Water washing was by far the easier method of decontaminating these coupons and was also highly effective. The process used was the same as that previously established during the non-radioactive testing: a 15 second water rinse using a spray bottle. A photograph of this method is shown in the left pane of Figure 7. The rinsate was collected and found to amount to about 20 ml from each coupon, which is essentially complete recovery of the solution (as measured in earlier experiments). Scaled to practical use, the volume used for water washing is ~2 L/m<sup>2</sup> of decontaminated surface. One ml of each 20 ml volume was counted using liquid scintillation to determine the amount of radioactivity recovered. The measured activity averaged 6,533 dpm alpha per coupon, while only ~2700 dpm alpha surface

While the DeconGel strippable coating was also highly effective at removing contamination, it was time consuming and difficult to remove. It took, on average, 15 minutes to remove approximately 95% of the coating. Complete removal was not possible. Vetting what was seen with the non-radioactive tests, the strippable coatings became somewhat incorporated into the salt surface and were very difficult to remove – much more difficult to remove from the salt surface than from stainless steel or aluminum. A photograph of this portion of the test is seen in the right pane of Figure 7. The surface of the coating was scored with a plastic knife to give a place to begin peeling the coating. The coating materials were found to work better as fixatives rather than strippable coatings.

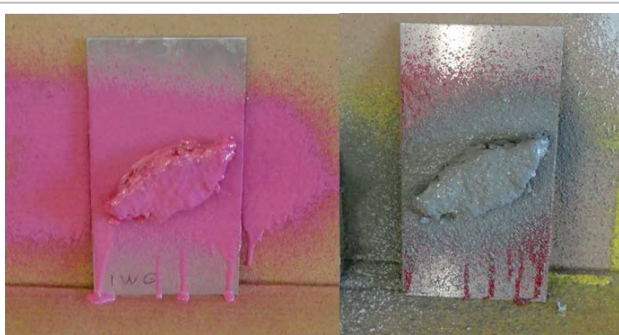
Figure 8. Application of PBS (left) and Tekflex (right) to a vertical surface. Note the propensity of the PBS coating to run during application.

On the rubble samples, PBS and Stripcoat tended to infiltrate rather than coat the material during application. This issue was overcome if a sufficiently thick coating of the solutions was applied. When these materials were sprayed on the vertically orientated samples, running was observed, but a continuous coating was still achieved.

Applying either material overhead may be quite messy. The Tekflex, on the other hand, stayed where it was applied. See Figure 8.

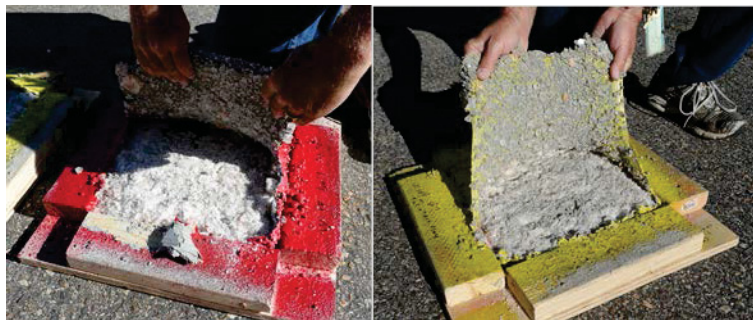
Figure 10. Rubble trays coated with Tekflex + PBS (left) and Tekflex + Stripcoat (right) after crush testing. The coating is manually peeled back to show that the integrity of the barrier was maintained under compression of the truck tire and under tension as the membrane is peeled away from the tray frame.

In round two of testing, the coatings with a top layer of Stripcoat or PBS proved quite durable, with no failure of the membrane even after ten passes under the truck tire. See Figure 10. The coatings with a top layer of Tekflex sloughed Tekflex powder with each pass under the tire, but the underlying elastic coating maintained its integrity. Based on these results it does not appear that Tekflex enhances coating strength or stability. When applied as an undercoat, it simply adds another, superfluous step in the process. When applied as an overcoat, it proves to be a dust source.
