Light Water Reactor Sustainability Program

Digital Image Correlation of Concrete Slab at University of Tennessee, Knoxville

September 2016

U.S. Department of Energy
Office of Nuclear Energy

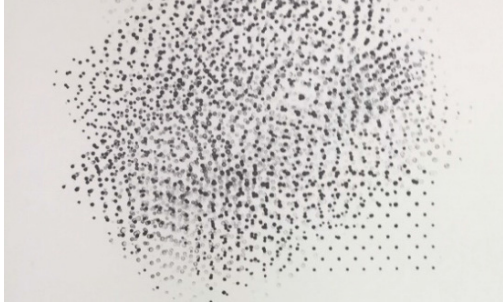
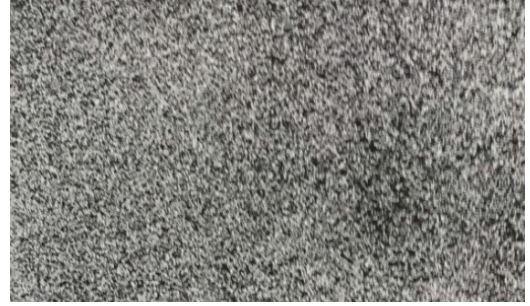
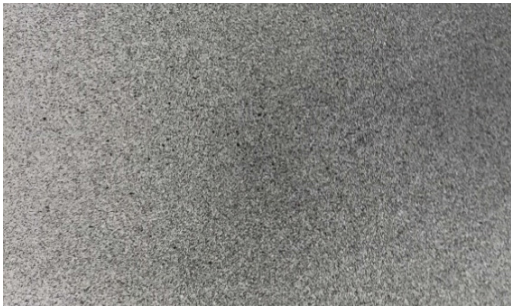
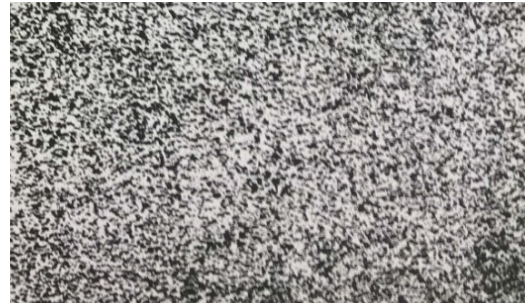
Figure 5. Available speckle patterns used for DIC study.

Six different speckle patterns shown in Figure 5 were tested. Speckle pattern (a) was created using a roller. Speckle patterns (b) – (f) were generated using spray paint. The nozzle position and angle of the spray can were varied to create different size and densities of speckles. The speckle pattern (b) was found to be the best option because of the optimum speckle size and density.

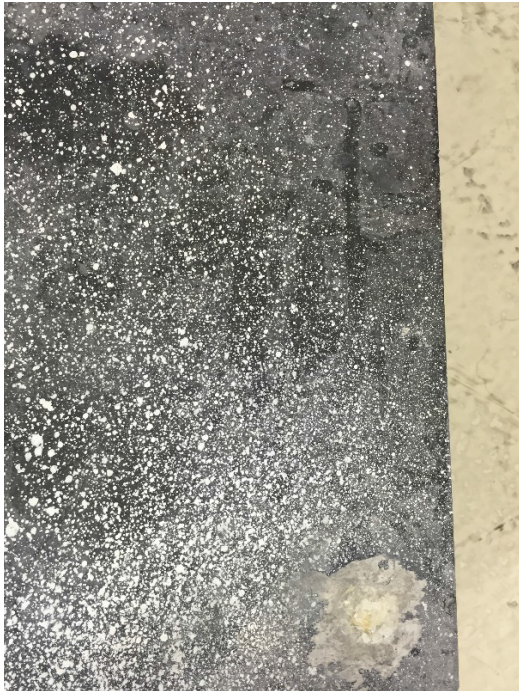
Figure 6. Durability test results of oil-based (a) and acrylic latex (b) spray paints on concrete surface.

In addition, the paint durability study also found that using the white background color and the black painted speckles creates a higher contrast than the other way around, as shown in Figure 6. Sample (b) (on the right of Figure 6, which has white background with black speckles) produces higher contrast than Sample (a), which has black background with white speckles.

Finding a paint that will adhere to concrete for 3 years in a moist environment of the chamber is a substantial challenging task. There are two types of paint can be used: oil-based and acrylic latex. Commonly, the oil-based spray paint is used for DIC due to convenience. However, oil-based paint can react with the high alkalinity in cement causing debonding of the paint surface and trapping any moisture within the concrete under the paint surface (The Family Handyman 2016). During the 3-year testing period, the slab of interest will be housed in an environmental chamber with almost 100% relative humidity most of the time, except for a few short times the slab surface become dry when the humidity is turned down for nondestructive testing. This leads to some moisture being trapped underneath the paint surface, which will adversely impact the DIC results. An alternative to oil-based paints is acrylic latex paints, which allow moisture passage. To test the performance of acrylic latex paint, the Krylon Eco-Guard latex spray paint was applied to a concrete sample and placed under accelerated curing conditions (i.e., almost 100% relative humidity at 60°C) at Vanderbilt's Laboratory for Systems Integrity and Reliability. The acrylic latex paint showed no debonding or cracking on the surface of the tested slab after being exposed for 3 weeks to the accelerated curing conditions. Figure 6 show the durability test results of oil-based (a) and acrylic latex and (b) spray paints on concrete surface. Sample (a) surface shows debonding area of paint surface while Sample (b) paint surface looks intact.

As a result, the acrylic latex paint (Sample [b]) on the right of Figure 6) was selected for use in the assessment of DIC monitoring technique.

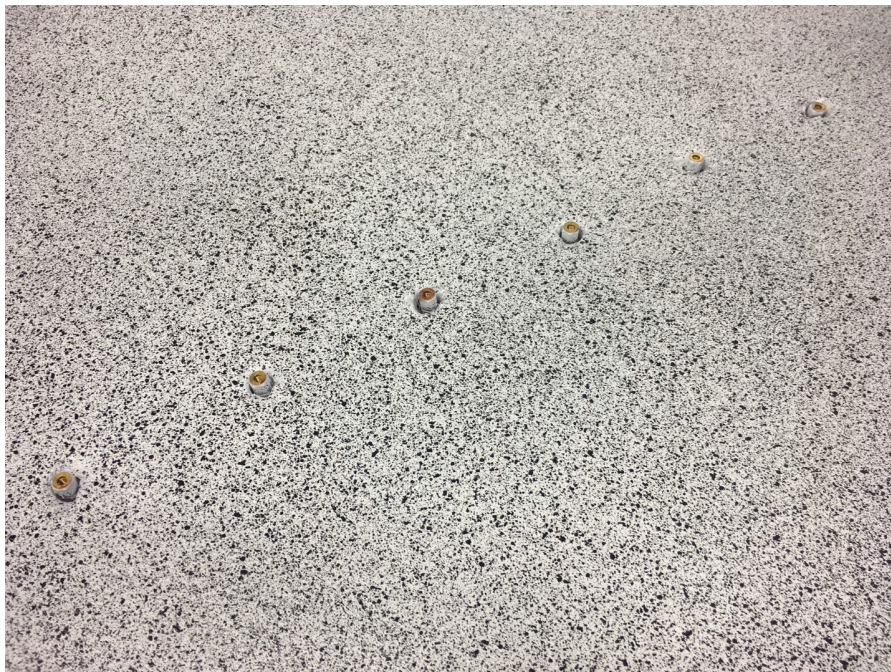
Figure 7. Speckle pattern painted on the 2 ft \times 2 ft area of the University of Tennessee Knoxville Slab.

The black-background-white-speckle pattern using acrylic latex paint (Sample b) is selected and applied to the slab casted at University of Tennessee, Knoxville during the third week of August as shown in Figure 7. This slab is used for the DIC monitoring study. At that time, the support fixtures for the DIC camera were installed inside the environmental chamber as shown in Figure 8.

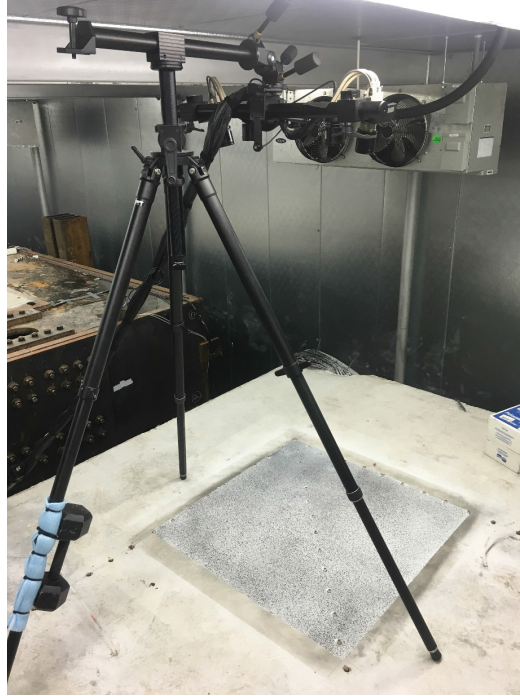
Figure 8. DIC camera support installation over the area of interest.
