Light Water Reactor Sustainability Program

Study of the Effect of Swelling on Irradiation-Assisted Stress Corrosion Cracking

September 2016

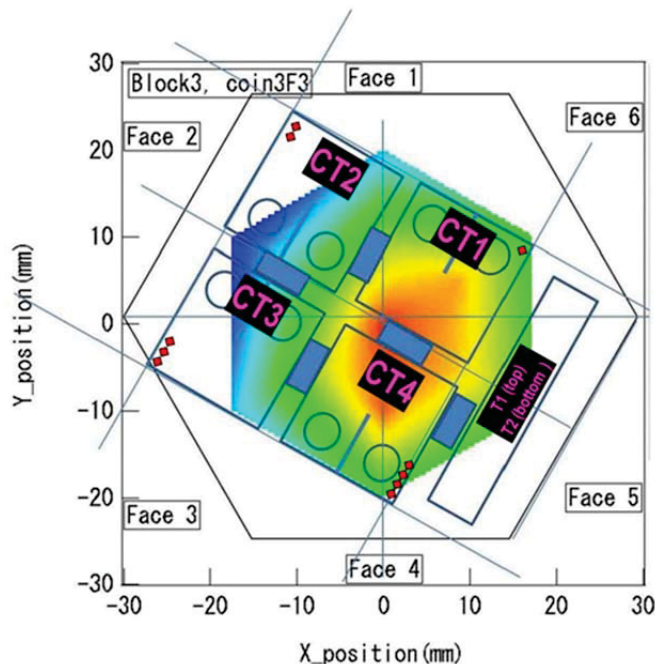
Figure 3. Location and orientation of the four CT specimens (CT1, CT2, CT3, and CT4) as they were cut in the hexagonal coin. T1 and T2 show the location of the tensile specimens.

Two pairs of compact tension (0.25T CT) specimens were machined. The location for machining was determined such as, for each pair of CT specimens, the cracks will grow in a material with similar swelling. Two specimens were machined so the cracks will grow in a material with 3.7% swelling and two specimens were machined so cracks will grow in less than 2% swelling. The percent swelling used is an estimation that is determined by ultrasonic technique. The orientation of the CTs with regard to the component was the same. Details on the machining steps can be found in INL/EXT-15-35594. The first specimens to be tested are specimens CT1 and CT2. Their location in the coin is shown in Figure 3. The specimens' dose rates are respectively 160 and 180 mR/hour at 30 cm.

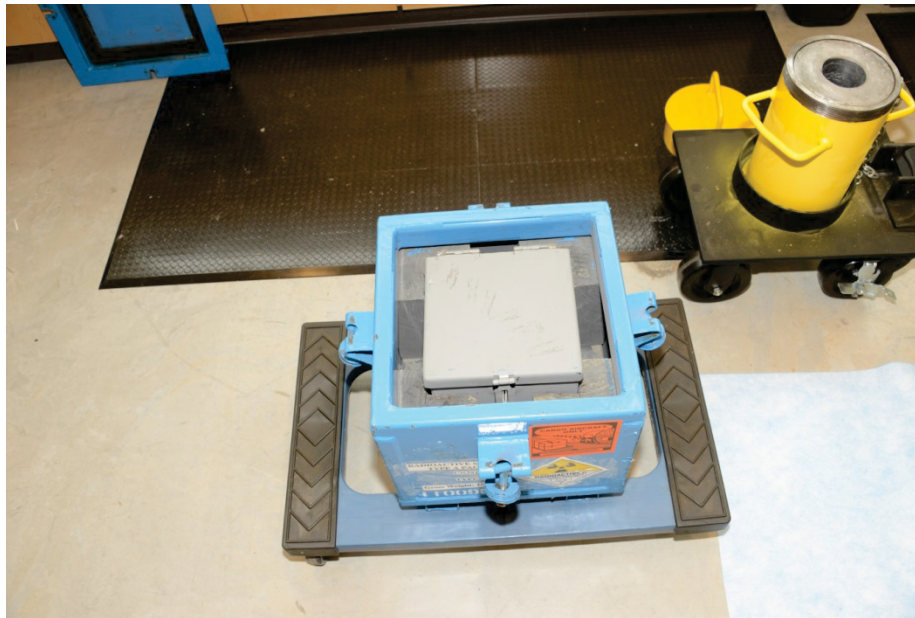
Figure 6. The shipping container (in blue) contains the specimens. Those specimens will be transferred to the yellow lead pig for storage and transport within the testing facility.

After reception of the shipping cask at the facility, the plastic bags containing the specimens were transferred to a lead pig (Figure 6). This lead pig was procured for this project by the facility where the experiments are performed. It has inside dimensions of a 4-in. diameter by 12-in. high with the lid on unit and has 2-in. walls, lid, and bottom. This container is used for specimen storage and transfer to the test jig.

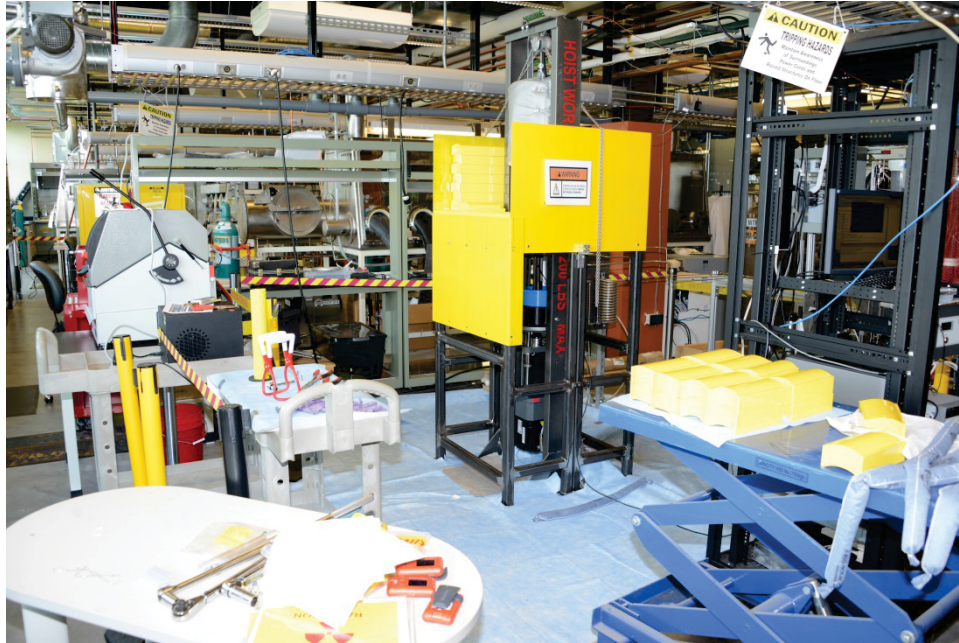
Figure 7. Laboratory prepared before reception of the specimen.

When the specimen is brought to the facility, the laboratory space is as presented in Figure 7. The front of the shield has been partially removed to allow operator access to transfer specimens. In the autoclave, a guiding jig has been placed for precise and quick loading of the specimens into the clevises (Figure 8).

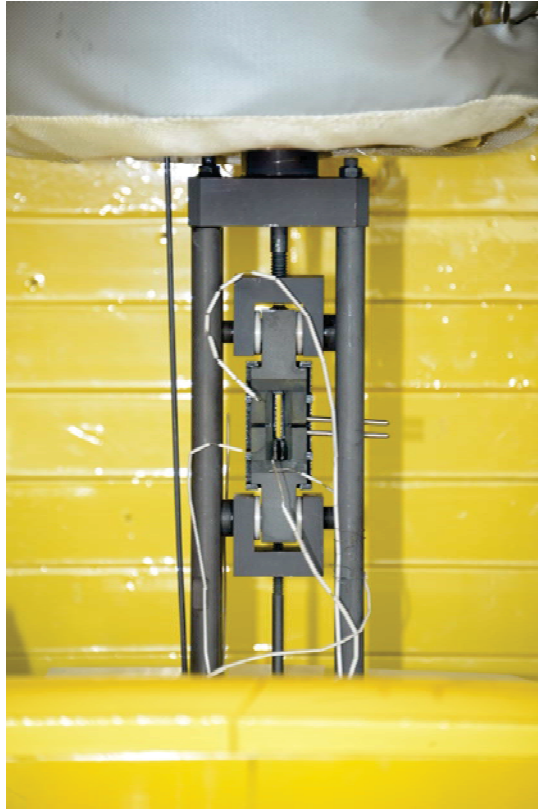
Figure 8. Clevises and guiding jig prepared before loading the specimen.

The bag containing the specimen is transferred from the yellow lead pig to the work area. The work area is equipped with a small storage niche that is available if there was a need to pause work. The can containing the specimen is removed from the plastic bag and opened. After verifying the specimen's identity, the specimen is loaded into the clevises and secured with the loading pin using long reach tongs. The guiding jig is then removed and the specimen is held in place by applying 50 lb of load.

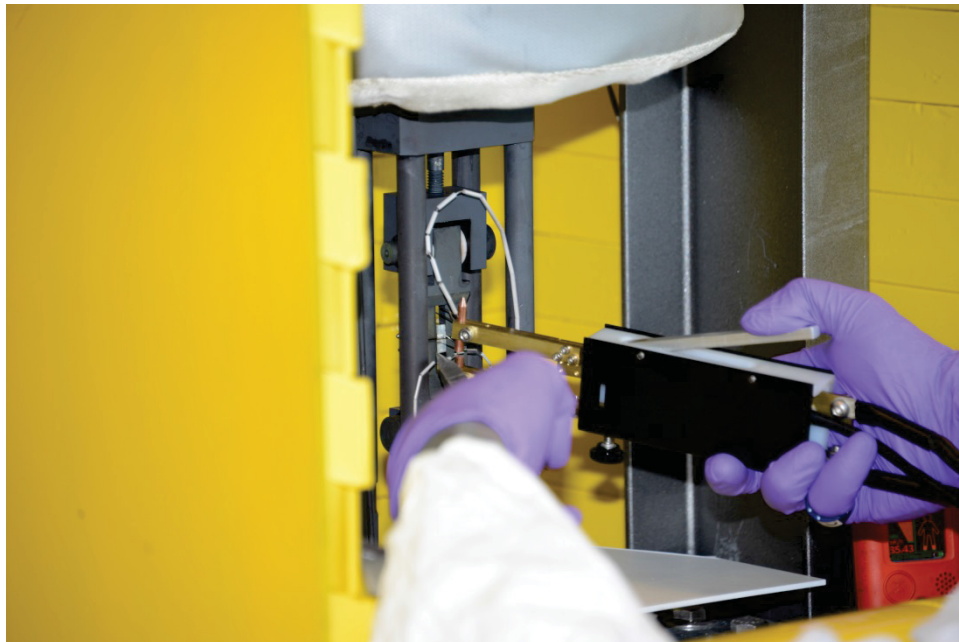
Figure 9. The direct current potential drop leads are being connected to the samples leads.

The next step consists of welding the direct current potential drop leads to the short leads that are attached to the specimen (Figure 9). After verifying the contact is strong enough and loading is satisfactory (Figure 10), the autoclave body is lowered and the autoclave is sealed. The front shield is then put into place (Figure 11).

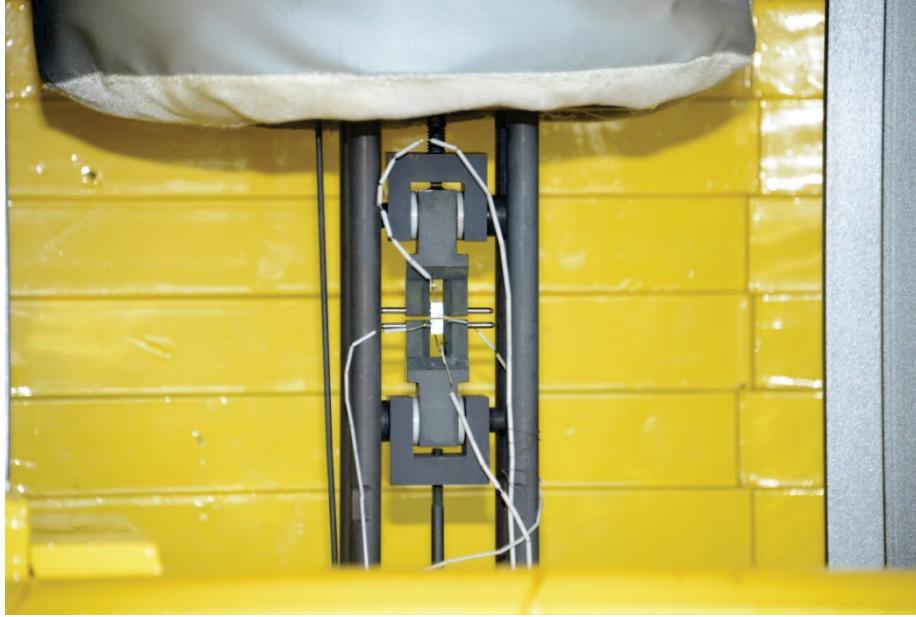
Figure 10. Specimen loaded in the autoclave and ready to be tested.

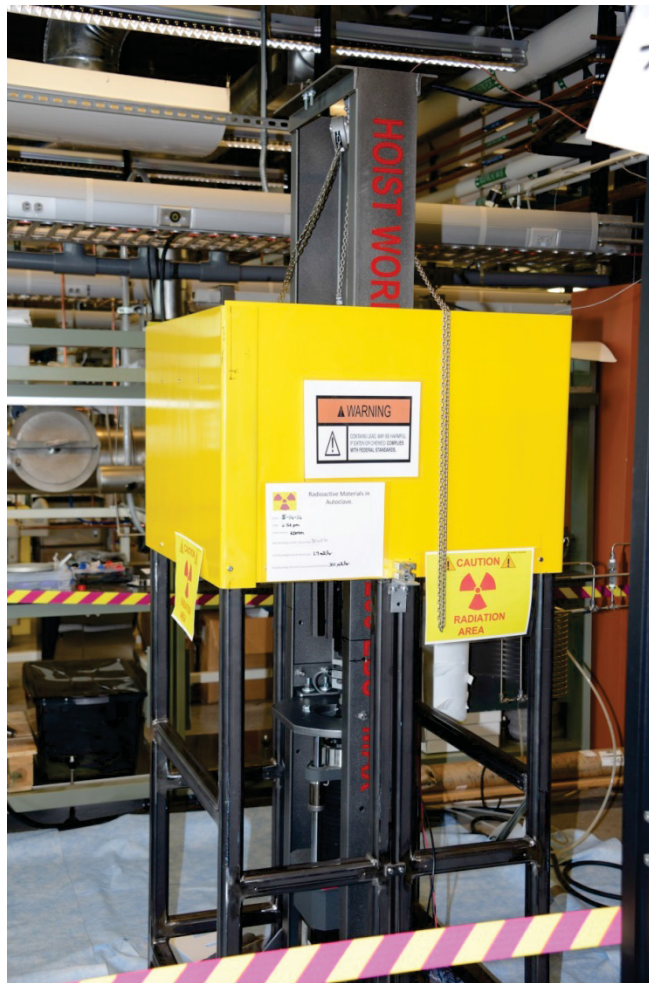
Figure 11. IASCC testing jig with shield closed.

For radiation protection, a support frame was installed around the autoclave. This frame offers a work space for specimen handling. The frame safely supports enough lead to provide shielding with 4-in. of lead on the walls and 2-in. of lead plus 1-in. of steel on the floor (i.e., sample loading side). The frame is not in contact with the autoclave, which prevents heat transfer for the autoclave to the lead bricks. Each of the lead bricks being used have been powder coated to avoid any lead oxidation and any subsequent health risk hazard. A 1/8-in. steel cover protects the shield walls. The front of the cover can be lowered down to provide access to the lead bricks that comprise the front wall. The front wall can be partially removed to allow specimen loading and unloading.

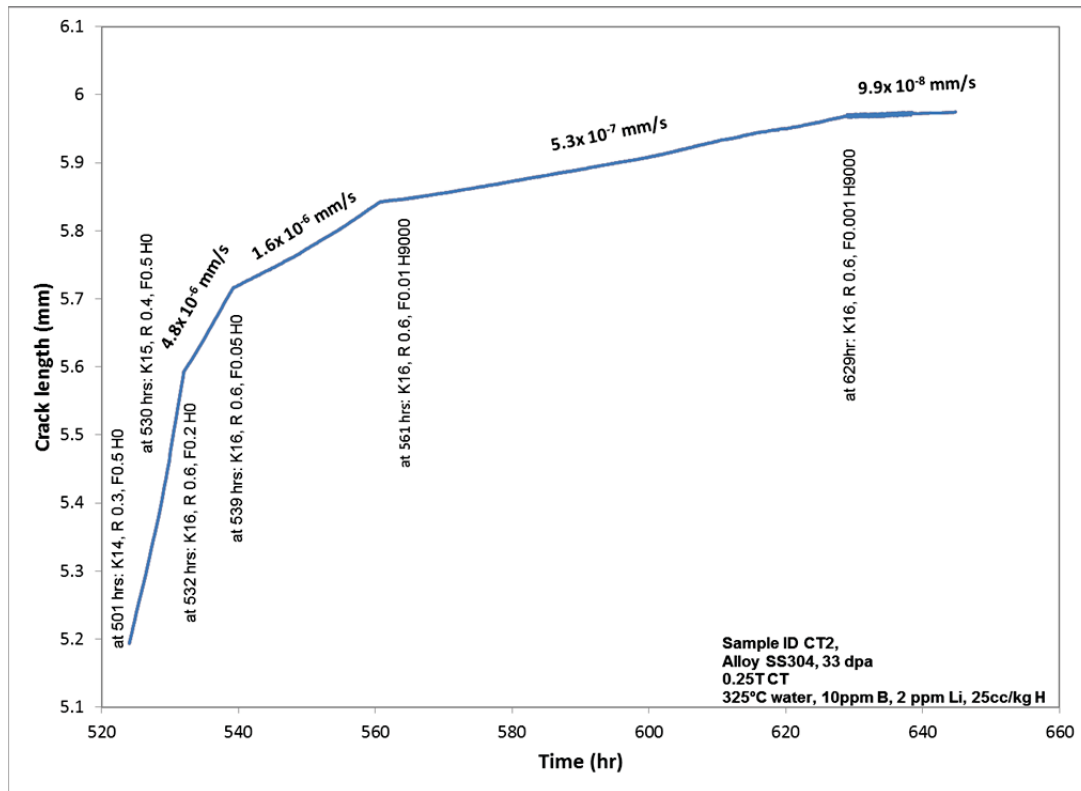
Figure 14. Initiation of the experiment, fatigue pre-crack.

The specimen (ID: CT2) is a 0.25T CT specimen. The specimen is tested at a nominal applied K level of 16 ksi $\sqrt{\text{in}}$ in a pressurized water reactor environment (325°C, 1,000 ppm boron, 2 ppm lithium, 25 cc/kg dissolved hydrogen). After several days in the environment to assure stabilization of the corrosion potential, the specimen was fatigue-pre-cracked at a maximum applied K of 14 ksi $\sqrt{\text{in}}$ and a loading ratio of 0.3 at a frequency of 0.5 Hz. In the following pre-cracking steps, the applied K was increased to the target test K (16 ksi $\sqrt{\text{in}}$) as R was increased and holding time under load was applied. A summary of the various steps used is described in Table 1. The specimen responded well to each loading change with a nice stable crack propagation rate at each step (Figure 11). At about 630 hours, a long power outage caused a controlled interruption of the experiment. The experiment was restarted and several steps were introduced in order to verify the specimen was still responding to the solicitation. Loading was then transitioned to constant K (Figure 12).

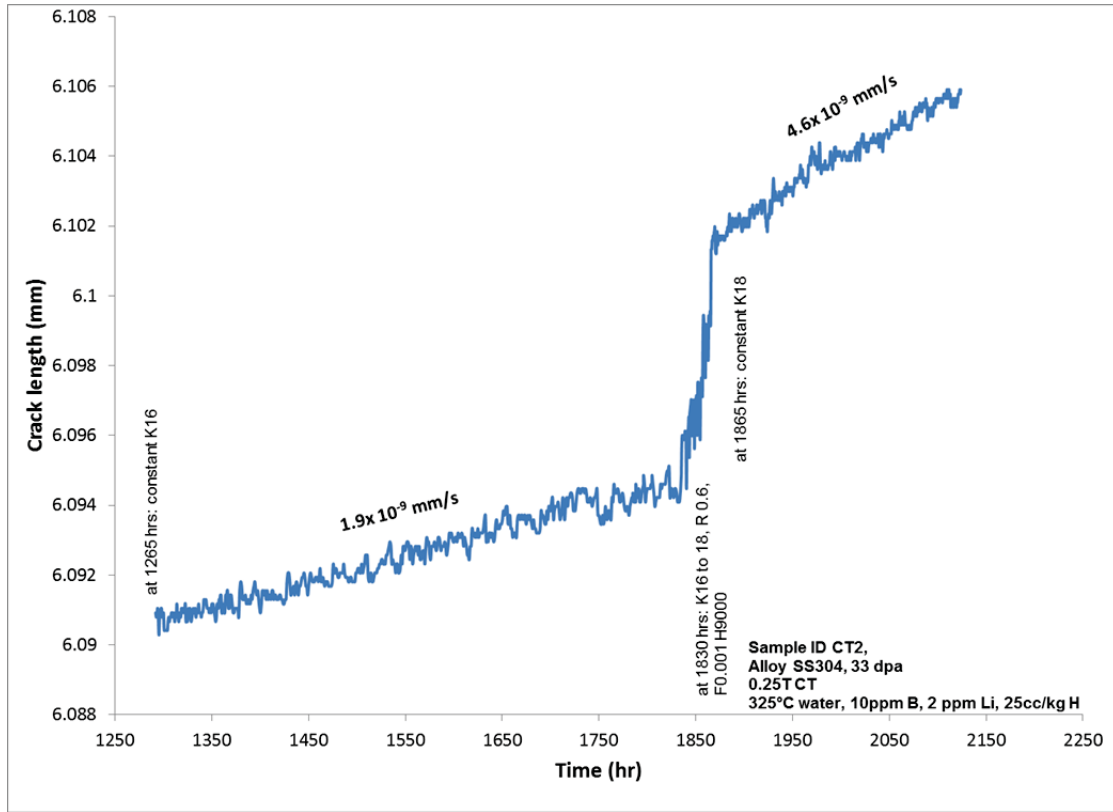
Figure 16. Effect of K applied on crack growth rate under constant K loading.

The crack growth rate measured at constant K=16 ksi $\sqrt{\text{in}}$ is 1.9×10^{-9} mm/s (or 1.9×10^{-12} m/s). From the information collected from NUREG/CR-7027, the CGR measured is about one order of magnitude below most of the data and the NUREG-0313 curve (which is about 1×10^{-10} m/s at K = 16 ksi $\sqrt{\text{in}}$). The Applied K was then increased to 18 ksi $\sqrt{\text{in}}$. under this condition, the CGR stabilized at 4.6×10^{-9} mm/s (Figure 16).
